Re: Building Assessment Report, Graphic Arts Building / Mitchell & Reed Auction House

Boreas Architecture & Civic Design, Inc
Building Condition Assessment Report
Mitchell & Reed Auction House and the Graphic Arts Building
5 October 2015

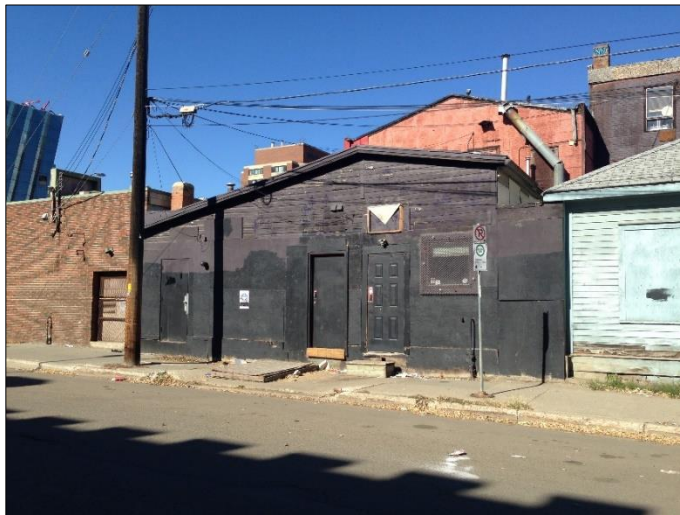
Figure 2. Mitchell & Reed Auction House, South Elevation, SW building.

The SW building is a one storey, light wood frame structure that has a pitched "gabled" roof with shingles, sitting on an apparent brick foundation. The SW building is clad in wood siding. It has one exit door to 101A Avenue; otherwise this building exits through the NW building. The SW Building is roughly 840 square feet (78 m²) and may be seen in *Figure 2*.

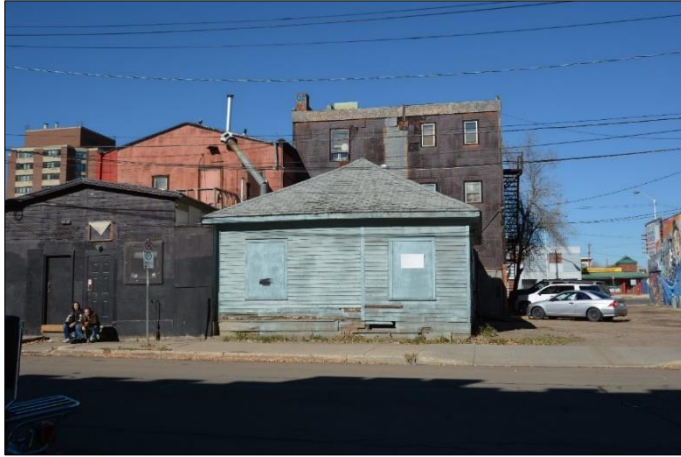
Figure 3. Mitchell & Reed Auction House, South Elevation, SE building (centre) and SW building (left - partial).

The SE building is a one storey, light wood frame structure that has a pitched "hip" roof with shingles, and a floor hatch to an underground crawl space. Visually, the SE building shows evidence of a brick foundation with wooden grade beams. The SE building is clad in wood siding. It has one exit door to 101A Avenue; otherwise this building exists through the NE building. The SE building is roughly 864 square feet, (80.3 m²) and may be seen in *Figure 3*.

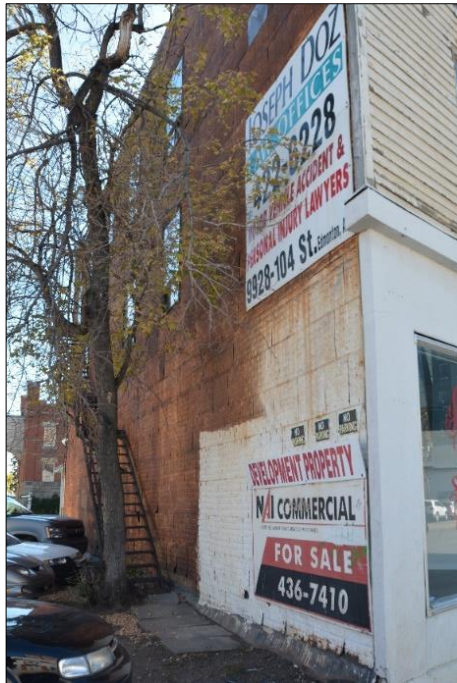
The NE building is a light wood frame, three storey structure constructed over a basement, with a flat roof. The north wall – which faces Jasper Avenue – is clad in wood clapboard siding, while the east wall is clad in stamped metal panels that simulate a stone pattern. South and west walls of the NE building are clad in stucco. This building has one interior stair and an exterior fire escape stair. On the second floor, nine inch floor tile exists throughout, which is lifting and crumbling. On the ground floor, water damage is noted on the floor and ceiling, as it well as on the second and third floors. It would seem that the roof has a major roof leak which has caused water damage throughout the building. While construction of the foundation is not noted, parts of a wooden foundation can be observed from the sidewalk. Additionally, a large, mature tree can be observed rooted within four feet of the east wall of the NE building. Each floor of the NE building is roughly 1400 square feet, having a

total floor area above grade of roughly 4200 square feet (390.3 m²). The east wall of the NE Building may be seen in *Figure 4*.

Figure 4. Mitchell & Reed Auction House, East Elevation, NE building, showing stamped metal panel wall and fire escape behind tree.

In general, the architectural systems are in poor condition. All roofs need to be replaced. The SE and SW buildings need to be shored and reinforced. All exterior siding needs to be repainted, while the pressed steel cladding on the east and south walls has rusted well beyond its serviceable life and needs to be replaced. The tree growing against the east wall should be removed, and the fire escape along that wall should be inspected and repaired. Given the size of this complex of buildings, life safety and exiting must be addressed, including items such as fire separations between buildings, floors and exits. The masonry foundations require pointing, while the foundations of the NE and NW buildings need to be further analyzed.

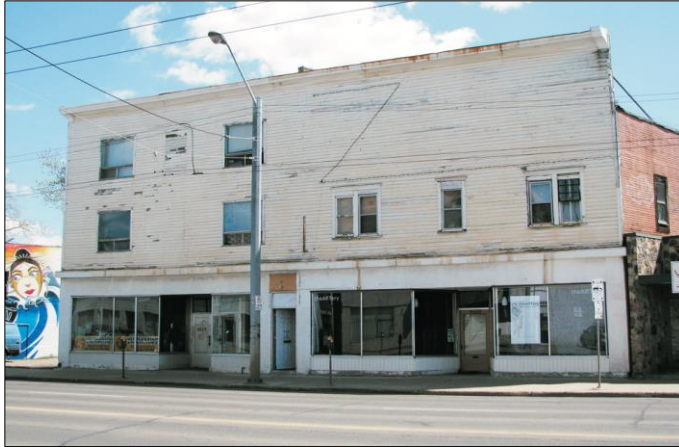
Figure 5. Mitchell & Reed Auction House, North Elevation, NE and NW buildings. Photo courtesy City of Edmonton

The NW building is a two storey, light wood frame structure, constructed over a basement. It has a pitched, gabled roof with shingles; the north wall being a “boomtown” front, meaning that the wall is taller than the roof in back of it, to present a flat parapet to the street. The north wall facing Jasper Avenue is clad in wood clapboard siding that blends in to the siding of the NE building. All other faces appear to be stucco. This building has one interior stair, and otherwise exists through the NE building. Each floor of the NW building is roughly 1180 square feet (109.6 m²), having a total floor area above grade of roughly 2360 square feet (219.3 m²). The north elevation of both the NE and NW buildings may be seen in *Figure 5*.

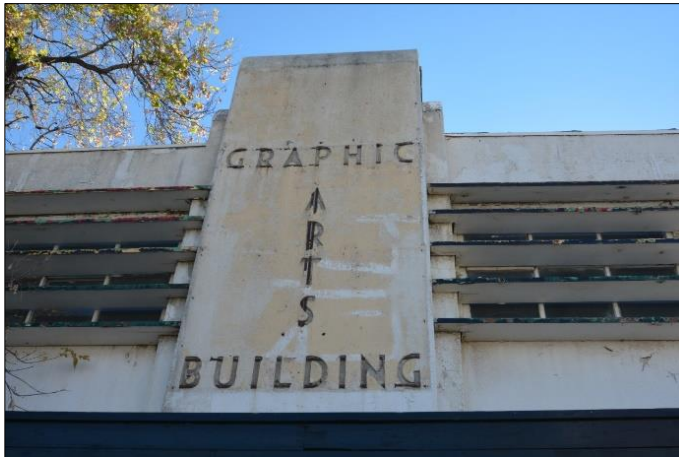
Figure 6. Graphic Arts Building, North Elevation.

As part of the City of Edmonton's 2004 Modern Historic Resources Inventory study, the Graphic Arts Building was one of over 2000 modern buildings across the City reviewed by heritage consultant, David Murray Architect. However, at that time, it was not included in the 100 modern historic resources now on the Inventory of Historic Resources in Edmonton. The Graphic Arts Building may be seen in *Figures. 6 & 7*.

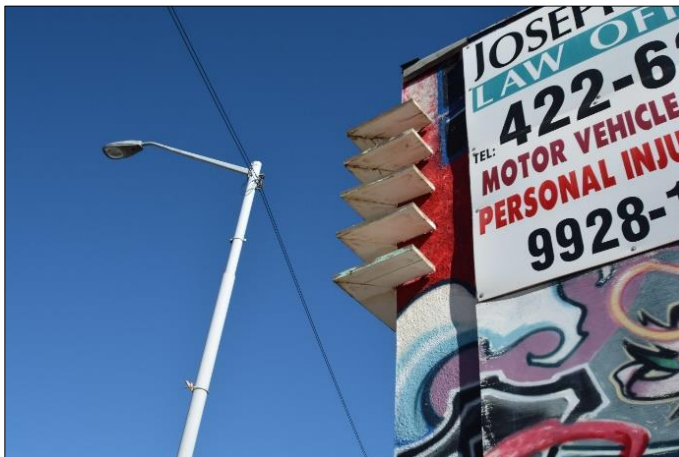
Figure 7. Graphic Arts Building, Northwest corner, showing fins.

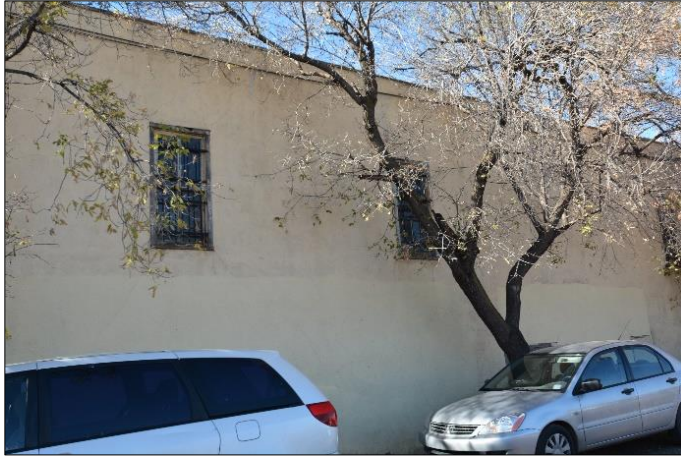
Figure 8. Graphic Arts Building, East wall.

The building is clad completely in stucco, the north elevation being exceptionally decorative. Each floor of this building is roughly 1650 square feet (153.3 m²), having a total floor area above grade of roughly 3300 square feet (306.7 m²). Additionally, there is an attached garage built of the south face of the building, having a rough area of 200 square feet (18.6 m²) and a raised patio / deck having a rough area of 130 square feet (12.1 m²) plus an exterior stair accessing grade. Photographs of the east, south and west walls of the Graphic Arts Building may be seen in *Figures 8 – 10*.

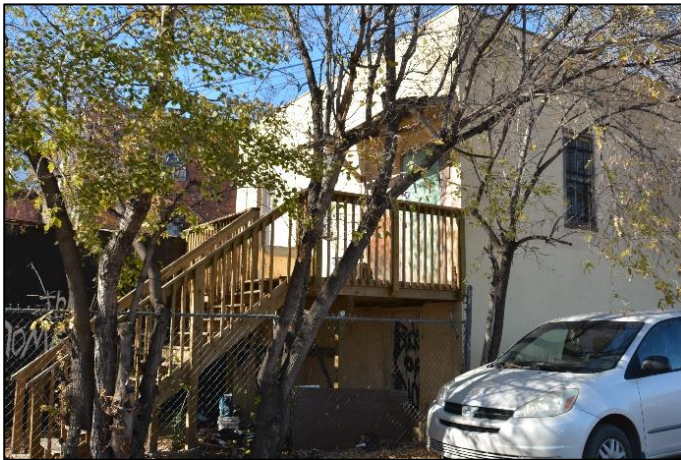
Figure 9. Graphic Arts Building, South elevation, showing deck.

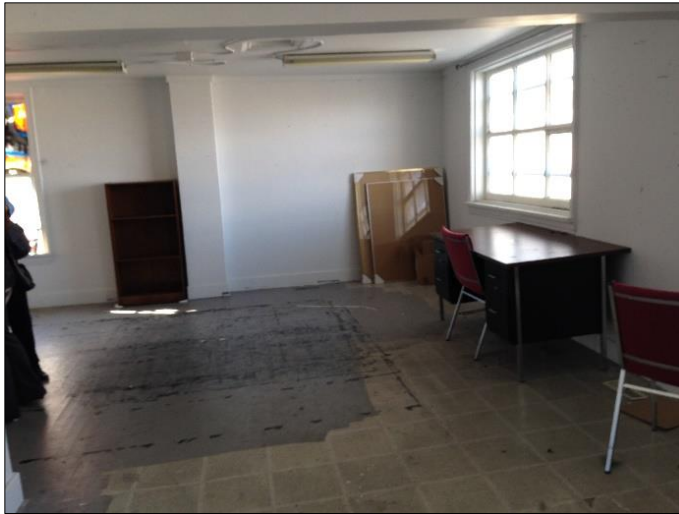
Figure 11. Graphic Arts Building. Interior, "Storefront" space.

The front of the building has a grade level “storefront” space, with a space above. Both spaces have ceiling heights of approximately eight feet (2.4 metres). The interior of these spaces are in good to very good condition, as seen in *Figure 11*.

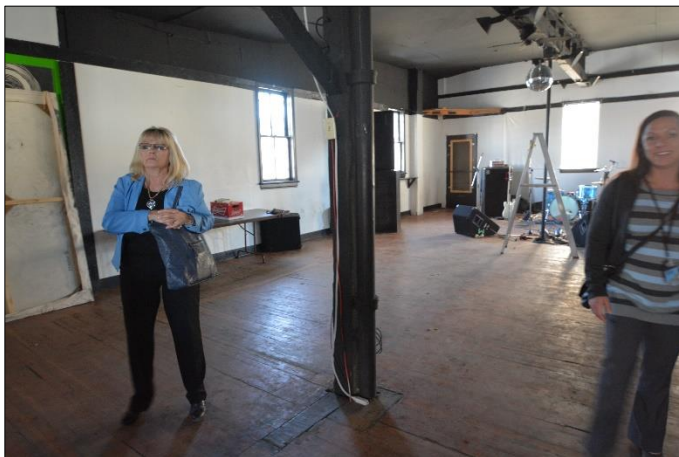
In the rear, there is a high ceilinged open space above grade, in good to very good condition. It has heavy wood plank flooring that is in excellent condition, as seen in *Figure 12*. Overhead framing is covered with fibreboard, presumably for acoustics, as this space is used for musical auditions. Structure that was visible appears to be straight and true. There is a sub-level space beneath this, a level slightly below grade, sitting over an apparent, inaccessible crawl space. The sublevel space likewise has heavy plank flooring, with evidence of nine inch floor tiles in places, as seen in *Figure 12*. It may be conjectured that if this part of the building was originally used for light industrial purposes, that the upstairs space with heavy plank flooring was used for processes, while the space downstairs was used for storage. The structure overhead in the downstairs is open and appears to be in excellent condition. The electrical system is exposed in the sub-level, and appears antiquated and in need of replacement. There were no apparent foundation cracks visible. This space appears to be in good condition. There is a one stall garage built in back of the building, accessible from this sub-level.

Figure 12. Graphic Arts Building. Interior, 'Rear' space. Note heavy plank wooden flooring.

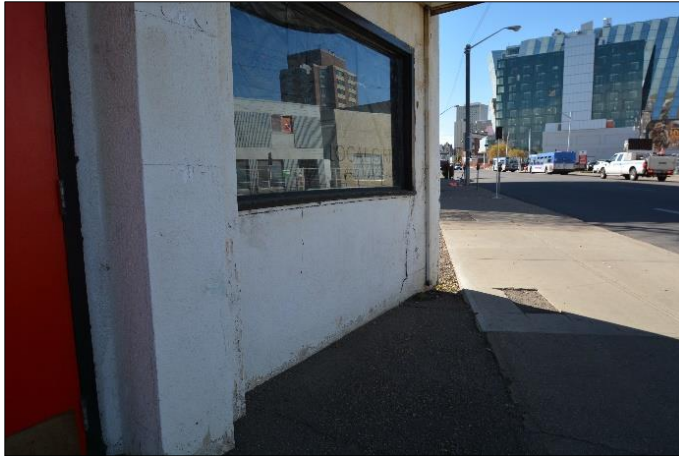
The canopy of the north elevation has sagging soffit material, while there is a large “buckling” of stucco apparent on the west wall at the juncture between the main building and a garage addition. The south elevation has an apparently well maintained patio/deck. There are several large trees growing immediately against the east wall. Given the difference in floor heights between the garage and sub-level, it can be assumed that the garage was a later addition with a different foundation, accounting for the buckling exterior stucco. These conditions may be seen in *Figures 14 – 16*.

Figure 14. Graphic Arts Building, North elevation, showing stucco damage.

In general, the architectural systems are in good condition. The roof needs replacement, and stucco requires patching and repair in localized places throughout. Should the rear garage be retained, it may require remedial foundation work. All stucco and wood trim needs repainting, though a recently painted mural against the west wall may be salvaged. Soffit trim on the north canopy needs replacement. Trees against the east wall need to be removed. The sub-level may require floor repair in localized places if the foundation is retained.

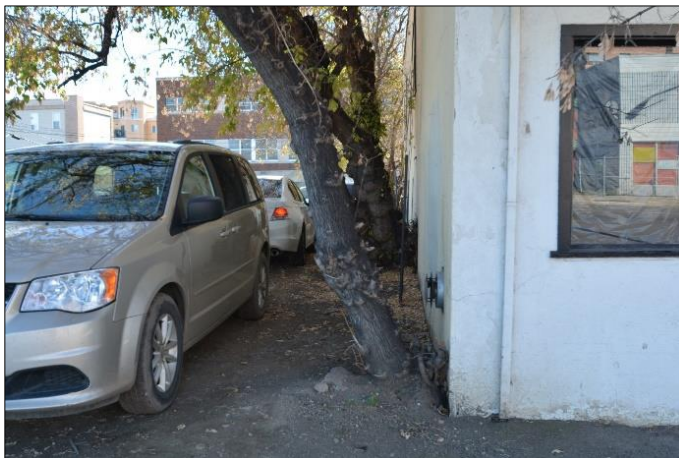
Figure 15. Graphic Arts Building, showing trees growing against east wall.

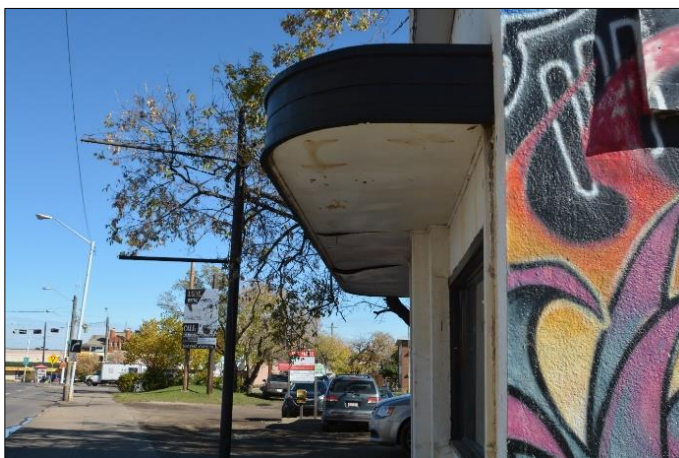
Figure 16. Graphic Arts Building, showing underside of canopy on north wall.

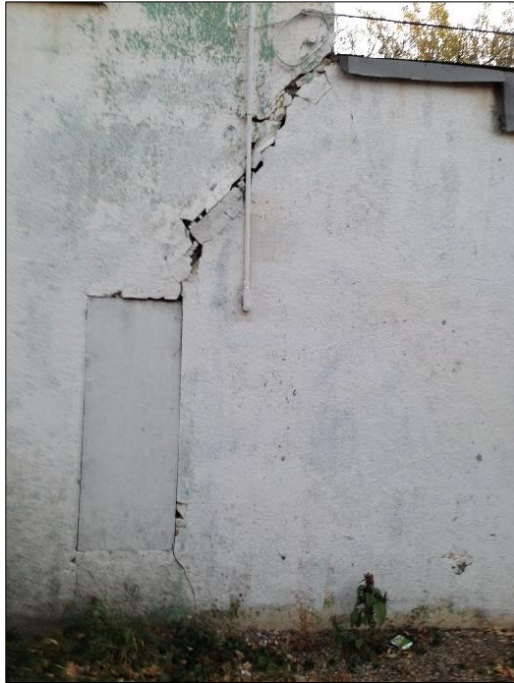
Figure 17. Graphic Arts Building, showing buckling between main building and garage at west wall.
