# **City of Edmonton**

**Environmental Impact Screening Assessment**

**City of Edmonton River Rescue Site Location**

***Final Report***

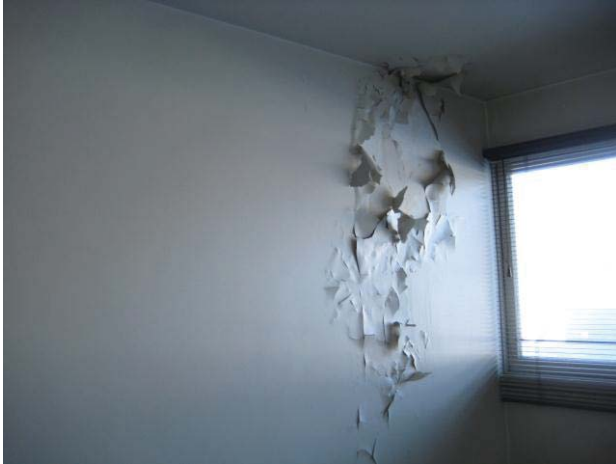
**C3010.11 – Interior Wall Painting**  
**Location** – Stairwell To Basement  
**Component** – Deteriorated Finish  
**Deficiency** – Study & Repair

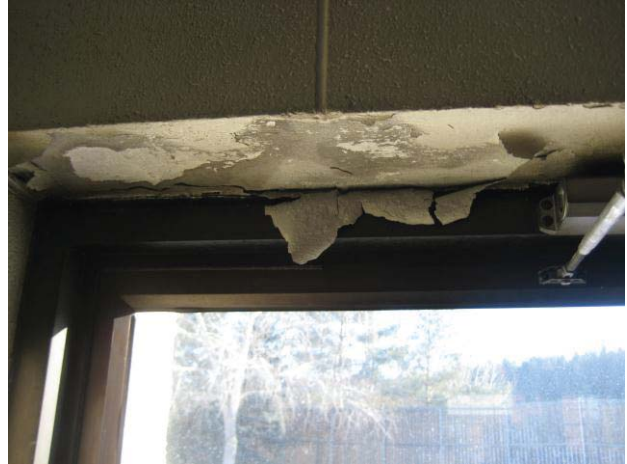
**C3010.11 – Interior Wall Painting**  
**Location** – Apparatus Floor  
**Component** – Deteriorated Finish  
**Deficiency** – Study & Repair

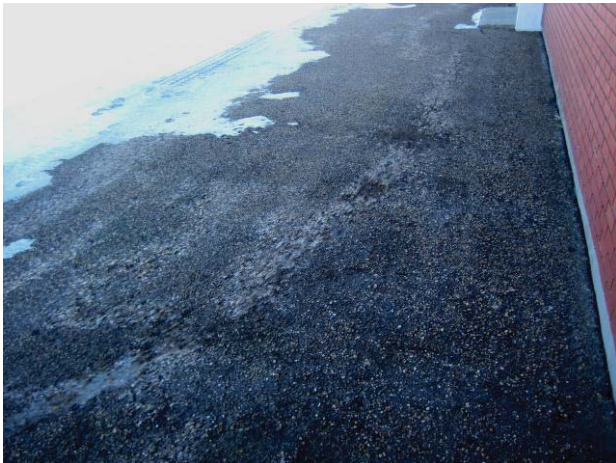
**G2010.02.02 –Flexible Pavement Roadway (Asphalt)**  
**Location** – Access Lane (West Elevation)  
**Component** – Asphalt Surfacing  
**Deficiency** – Deteriorated & Past Maximum EUL

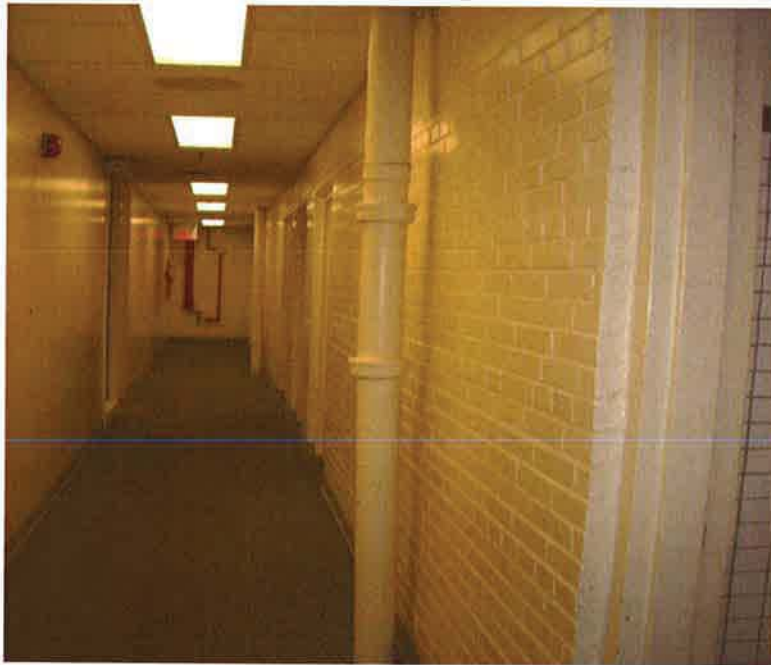
Photo 1: Suspect asbestos-containing Bell and spigot joint packing associated with cast iron waste/drain pipes (found in the corridor (Rm. 29)).

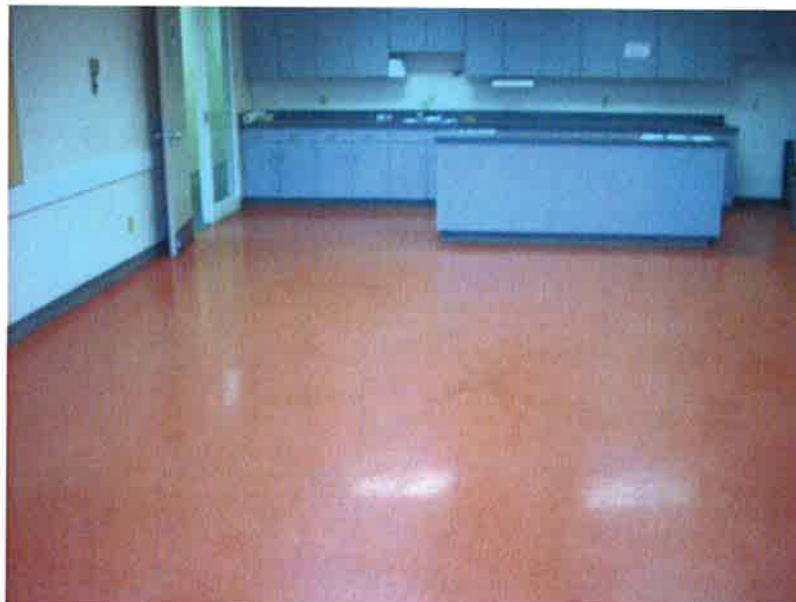
Photo 3: Asbestos-containing 12"x12" vinyl floor tile (Red) as found in the lunch room (Rm.28).

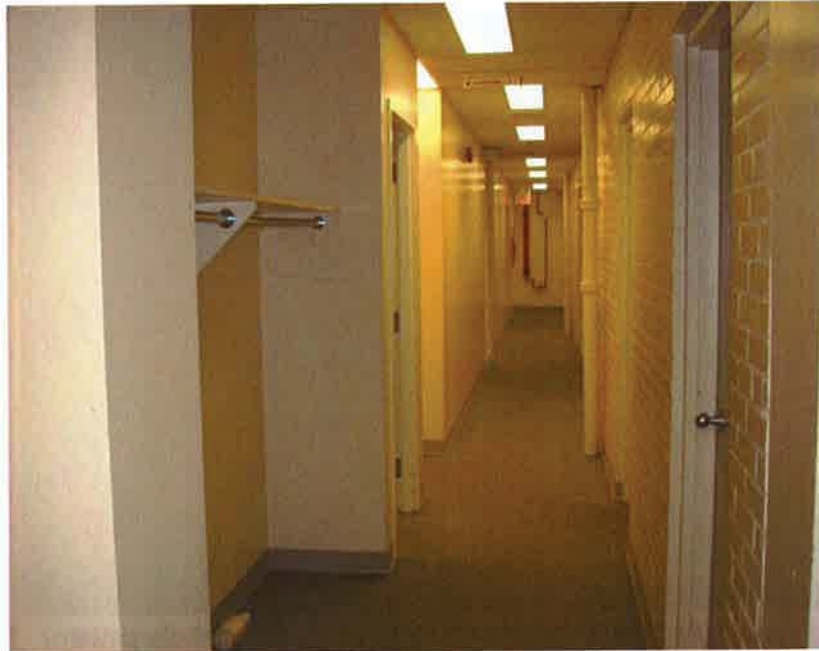
Photo 4: Asbestos-containing drywall joint compound as found in the corridor (Rm. 29).

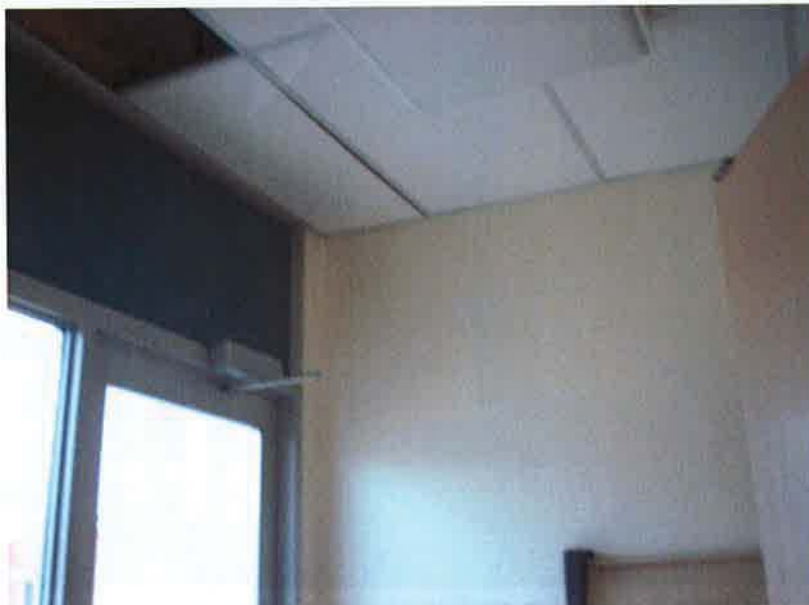
Photo 5: Asbestos-containing 2'x4' ceiling tile (pinhole pattern) as found in the side entrance (Rm. 27).

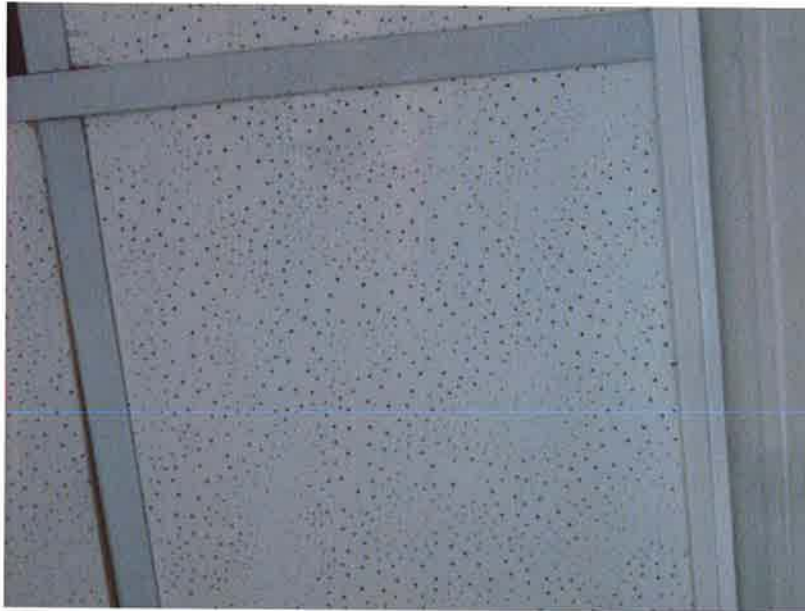
Photo 6: Asbestos-containing 2'x4' ceiling tile (pinhole pattern) as found in the side entrance (Rm. 27).

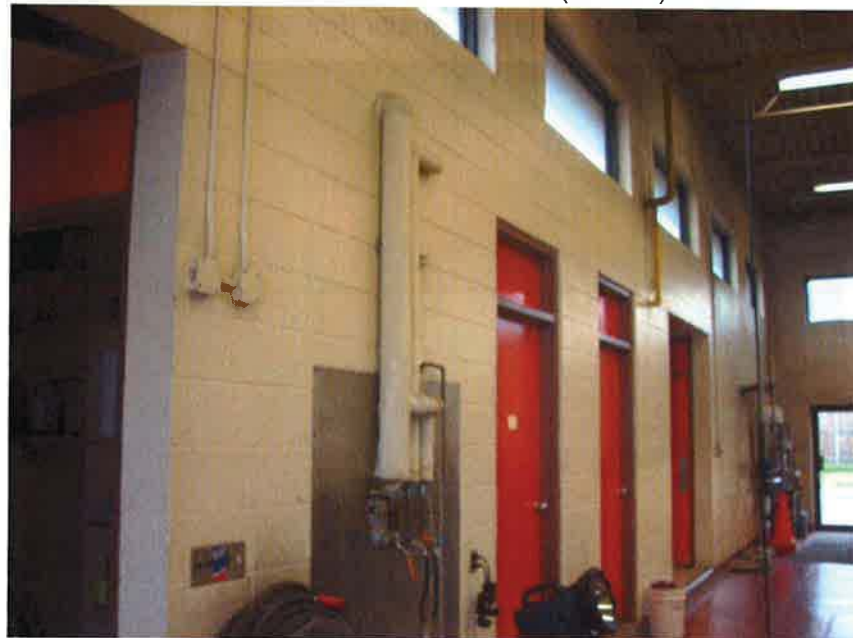
Photo 7: Asbestos-containing pipe parging insulation as found in the apparatus floor (Rm. 47).

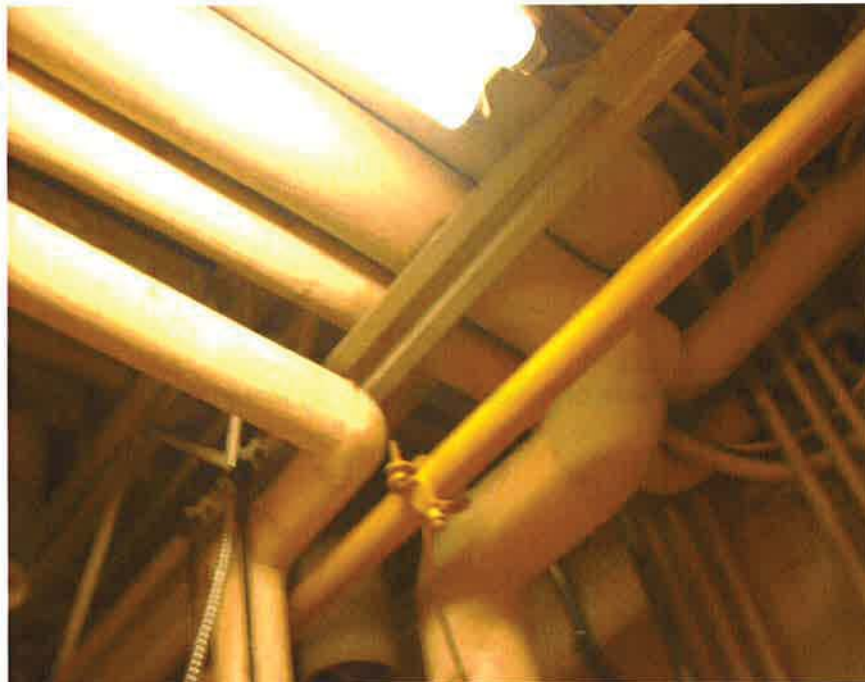
Photo 8: Asbestos-containing pipe parging insulation  
as found in the mechanical room (Rm. 53).
