# Leduc Annex – Gravel Roads Condition Assessment and Maintenance Program Review

Final Document Prepared on August 19, 2020

Project Report: 126265

## IBI Group

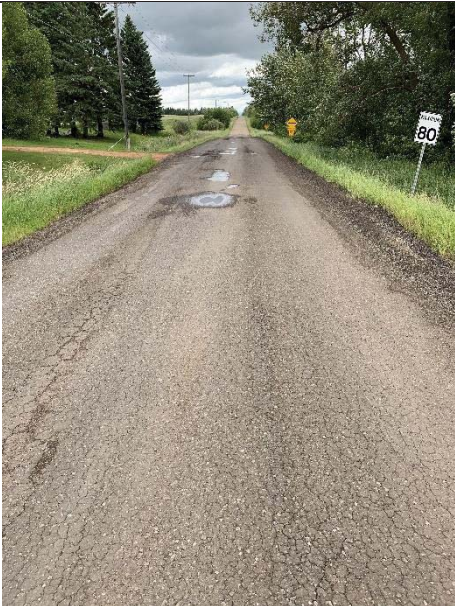
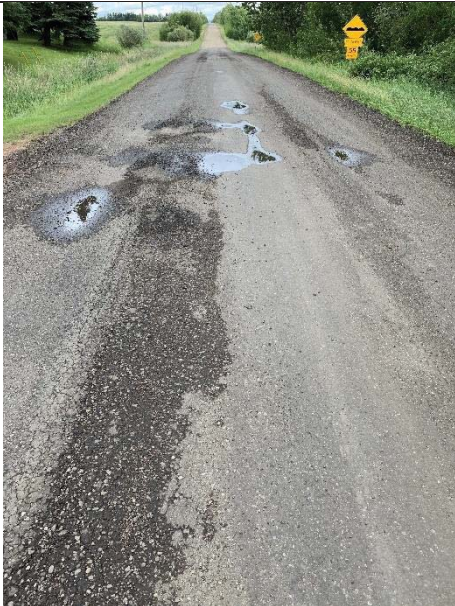
<p>1. In-situ asphalt (oiled) roadway surfacing. Slight to moderate alligator cracking, slight rutting, lack of a roadway crown. Slight washboarding. Approximately 10 metres east of 17<sup>th</sup> Street.</p>	<p>2. In-situ asphalt (oiled) roadway surfacing. Slight alligator cracking, depressions, ponding, slight channeling or rutting. Approximately 25 metres east of 17<sup>th</sup> Street.</p>

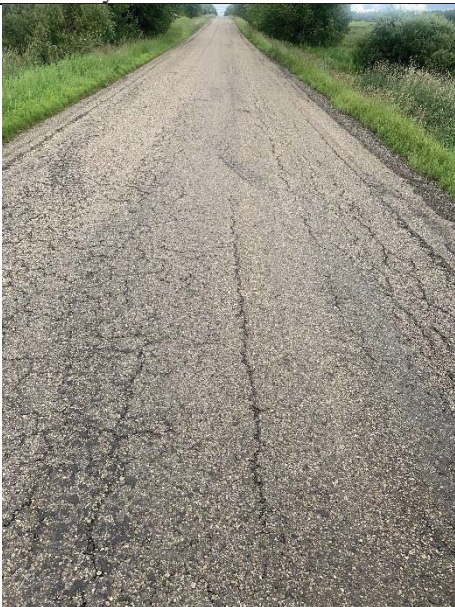
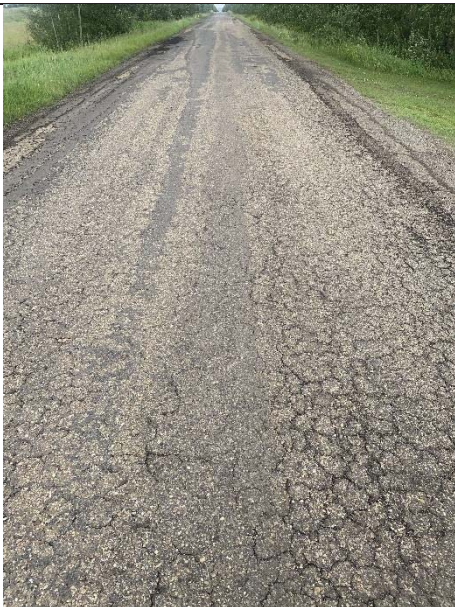
<p>3. In-situ asphalt (oiled) roadway surfacing. Slight longitudinal cracking, slight to moderate alligator cracking. Ride quality is fair, pavement structure holding up in spite of apparent subgrade failure. Approximately 175 metres east of 17<sup>th</sup> Street and 41<sup>st</sup> Ave SW intersection.</p>	<p>4. In-situ asphalt (oiled) roadway surfacing. Moderate alligator cracking over the entirety of the pavement areas. Roadway crown and ride quality preserved. Repairs present from prior rutting. Approximately 375 metres east of 17<sup>th</sup> Street and 41<sup>st</sup> Ave SW intersection.</p>

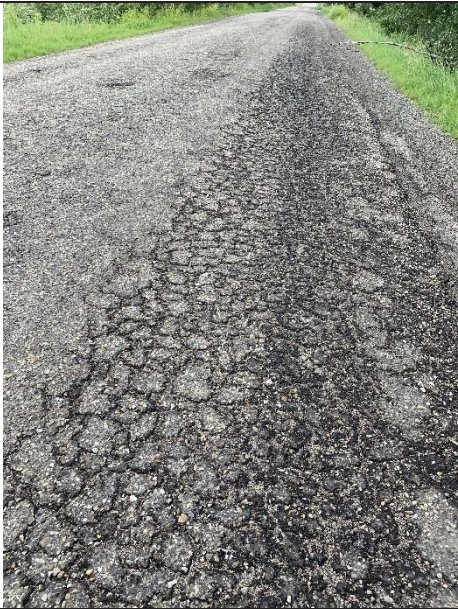
<p>13. In-situ asphalt (oiled) roadway surfacing. Severe alligator cracking (worse on south side) slight rutting. Indicative of subgrade failure. Approximately 1,500 metres east of 17<sup>th</sup> Street and 41<sup>st</sup> Ave SW intersection.</p>	<p>14. In-situ asphalt (oiled) roadways surfacing. Slight rutting, moderate alligator cracking, roadway crown lacking. Nearby intersection requires traffic braking and further deterioration expected rapidly. Approximately 15 metres west of Meridian Street and 41 Ave SW intersection.</p>

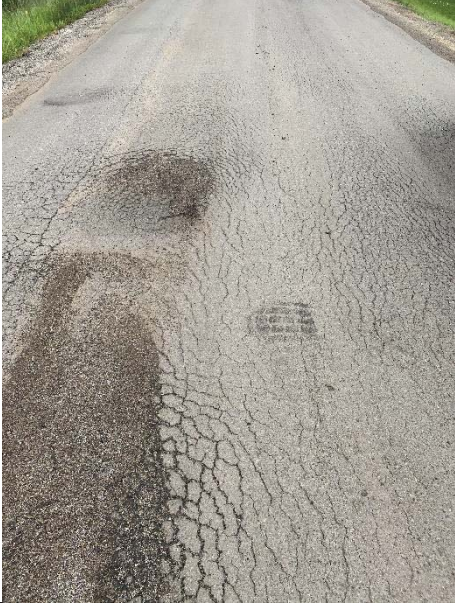
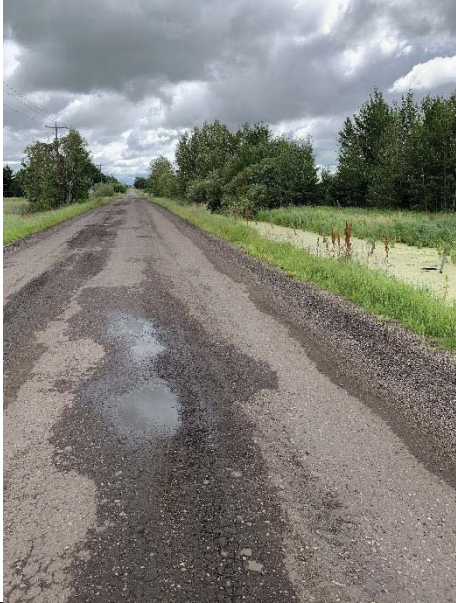
<p>1. In-situ asphalt (oiled) roadway surfacing. Severe alligator cracking, moderate slippage cracks, moderate rutting, slight wash-boarding. Subgrade failure and inadequate pavement structure. Approximately 20 metres east of 34<sup>th</sup> Street.</p>	<p>2. In-situ asphalt (oiled) roadway surfacing. Roadway crown minimal, moderate potholes, loose chips, slight alligator cracking. Approximately 150 metres east of 34<sup>th</sup> Street and 41<sup>st</sup> Avenue SW intersection.</p>

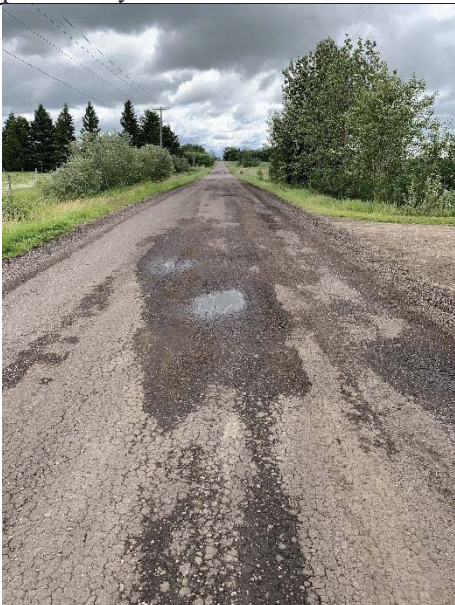
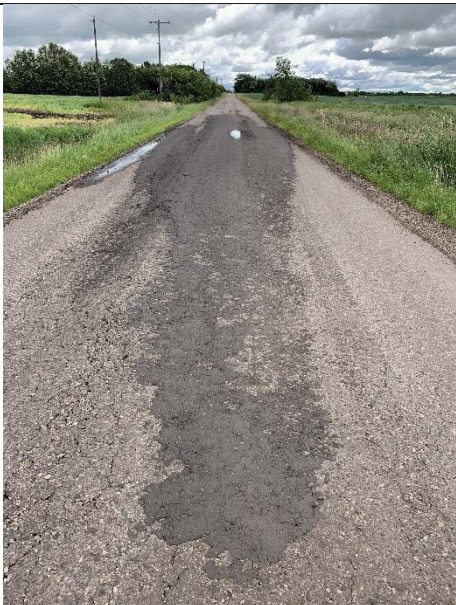
<p>3. In-situ asphalt (oiled) roadway surfacing. Moderate alligator cracking, slight washboarding, slight to moderate potholes, rough ride quality. Some slight rutting/ channeling. Approximately 200 metres east of 34<sup>th</sup> Street and 41<sup>st</sup> Avenue SW intersection.</p>	<p>4. In-situ asphalt (oiled) roadway surfacing. Fair ride quality, many deficiencies such as slight alligator cracking, lack of roadway crown, high shoulder, moderate rutting and potholes. Approximately 325 metres east of 34<sup>th</sup> Street and 41<sup>st</sup> Avenue intersection.</p>

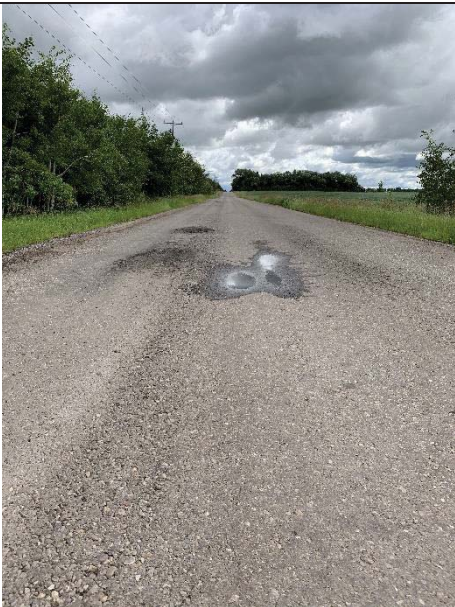
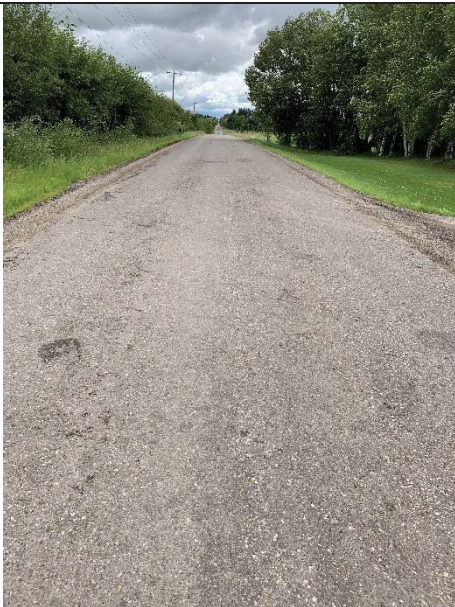
<p>5. In-situ asphalt (oiled) roadway. Slight alligator cracking, slight pothole(s), lack of definite roadway crown. High shoulder on north side of roadway. Good ride quality. Approximately 400 metres east of intersection of 34<sup>th</sup> Street and 41<sup>st</sup> Ave SW.</p>	<p>6. In-situ asphalt (oiled) roadway. Slight alligator cracking in initial stages. Roadway is generally in excellent shape. Good drainage condition. Approximately 775 metres east of intersection of 34<sup>th</sup> Street and 41<sup>st</sup> Ave SW.</p>

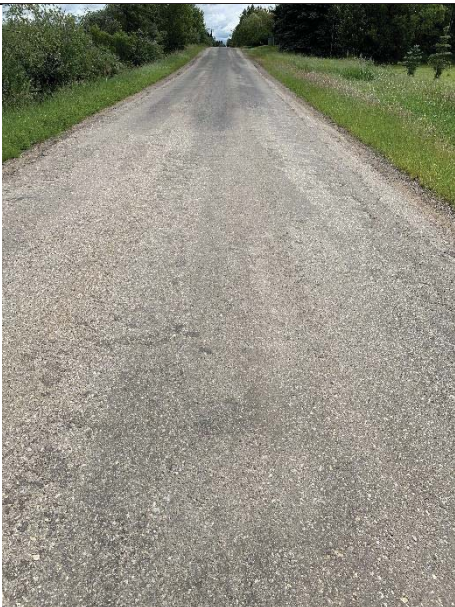
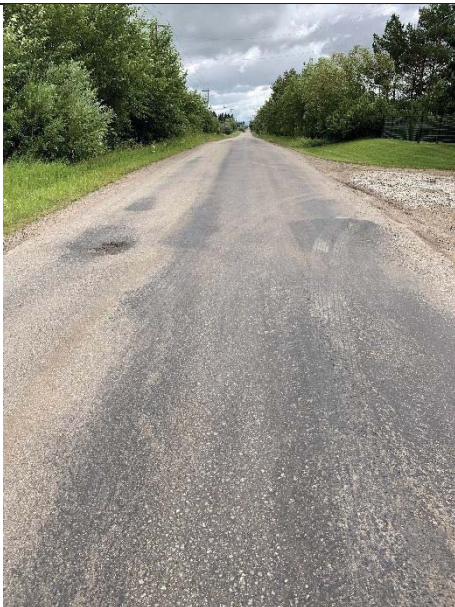
<p>7. In-situ asphalt (oiled) roadway. Slight washboarding, slightly rough ride quality. Road quality is fair to good. Drainage condition maintained. Approximately 1,100 metres east of the intersection of 34<sup>th</sup> Street and 41<sup>st</sup> Ave SW.</p>	<p>8. In-situ asphalt (oiled) roadway surfacing. Slight potholes and slight alligator cracking. High shoulder on north side of roadway. Roadway in fair to good condition. Approximately 1,225 metres east of the intersection of 34<sup>th</sup> Street and 41<sup>st</sup> Ave SW.</p>

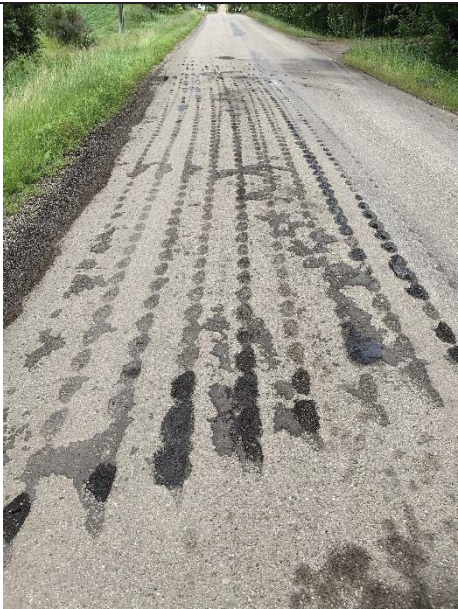
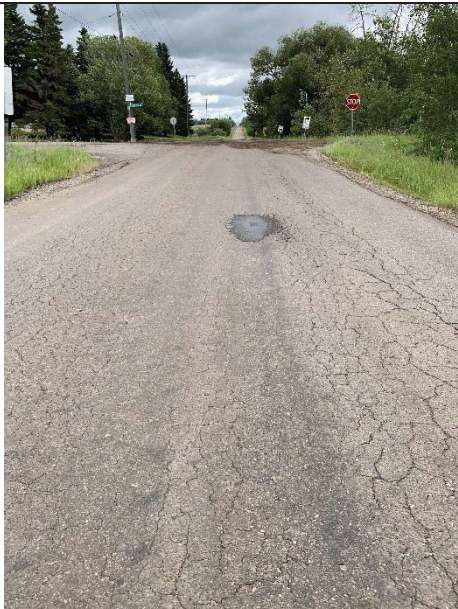
<p>9. In-situ asphalt (oiled) roadway surfacing. Damage from an unknown source, likely from overweight piece of construction/ farming equipment tracking the roadway. Approximately 1,450 meters east of 34<sup>th</sup> Street and 41<sup>st</sup> Ave SW intersection.</p>	<p>10. In-situ asphalt (oiled) roadway surfacing. Moderate alligator cracking within the drive paths and slight alligator cracking along roadway centre. Roadway crown lacking. Slight rutting. Approximately 25 metres west of 17<sup>th</sup> Street SW.</p>

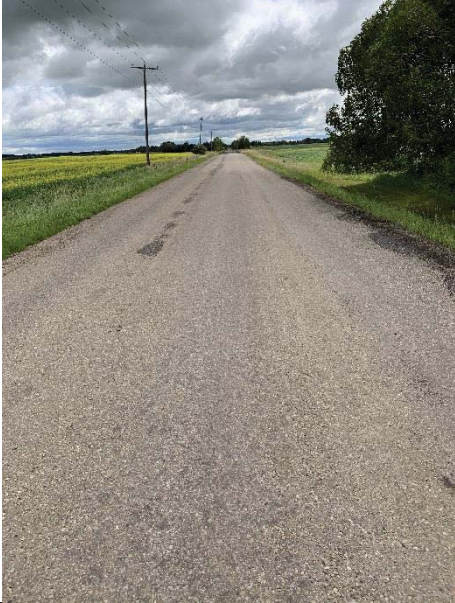
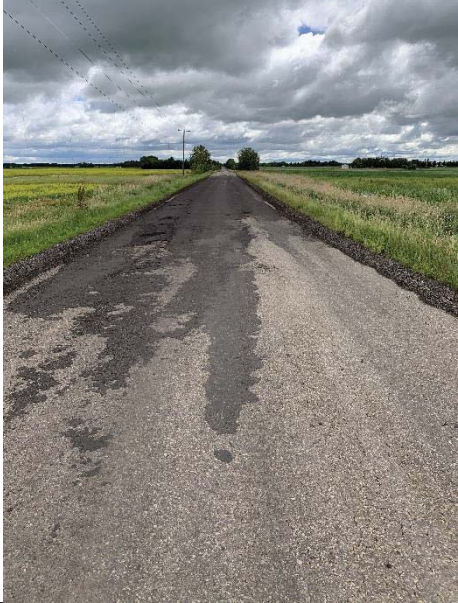
<p>1. In-situ asphalt (oiled) roadway surfacing. Slight channeling forming in south wheel path. Pavement in good condition, high point of roadway. Approximately 25 metres east of 50<sup>th</sup> Street and 41<sup>st</sup> Ave intersection.</p>	<p>2. In-situ asphalt (oiled) roadway surfacing. High shoulders, poor roadway crown. Cracked and ravelled overlay lift, appearing very thin. Slight alligator cracking in pavement areas outside of the overlay area. Approximately 275 metres east of 50<sup>th</sup> Street</p>

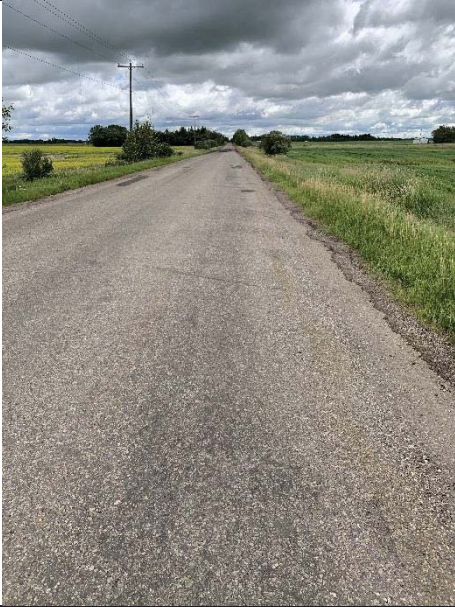
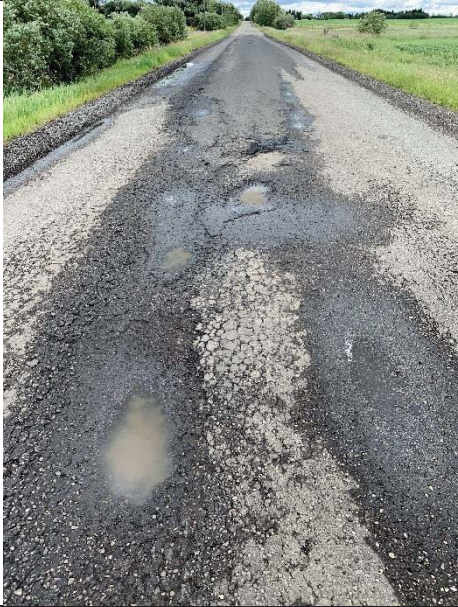
<p>3. In-situ asphalt (oiled) roadway surfacing. Slight channeling or rutting forming. Slight washboarding and slight potholing. Approximately 550 metres east of 41<sup>st</sup> Ave and 50<sup>th</sup> Street SW intersection.</p>	<p>4. In-situ asphalt surfacing. Several instances of severe alligator cracking, severe potholes, with a severe rut in the roadway centreline. High shoulder and ponding water at the toe of the pavement. Approximately 700 metres east of 50<sup>th</sup> Street.</p>

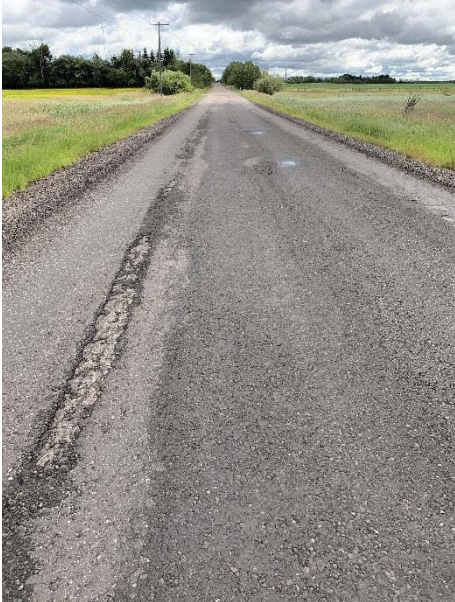
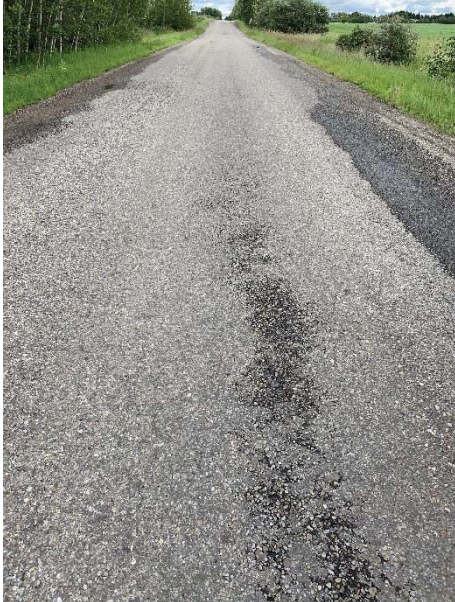
<p>5. In-situ asphalt (oiled) roadway surfacing. Slight slippage cracking, slight rutting, high roadway shoulder(s). Slight alligator cracking forming. Pavement in fair condition. Approximately 800 metres east of 50<sup>th</sup> Street and 41<sup>st</sup> Ave SW intersection.</p>	<p>6. In-situ asphalt (oiled) roadway surfacing. Roadway ditch drainage condition non-optimal. Slight alligator cracking forming. Pavement in fair condition. Approximately 1,050 metres east of 50<sup>th</sup> Street and 41<sup>st</sup> Ave NW intersection.</p>

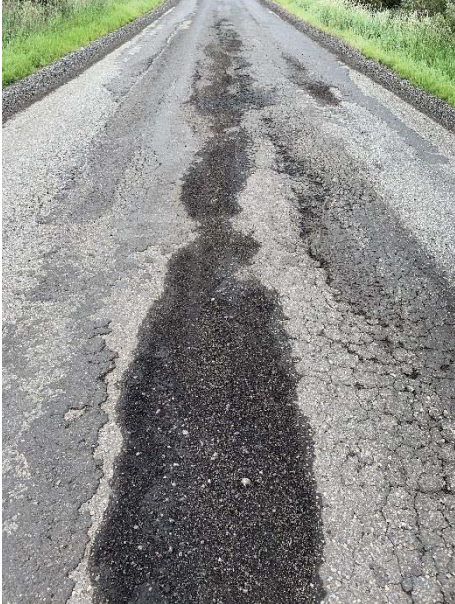
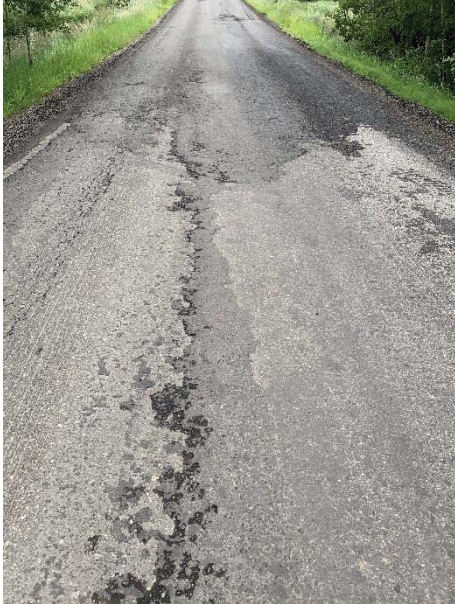
<p>7. In-situ asphalt (oiled) roadway surfacing. Moderate alligator cracking, moderate channeling/ rutting, destroyed remedial asphalt overlay, lack of a roadway crown, high shoulder(s). Very poor ride quality. Approximately 1,350 metres east of 50<sup>th</sup> Street and 41<sup>st</sup> Ave SW intersection.</p>	<p>8. In-situ asphalt (oiled) roadway surfacing. Remedial asphalt surfacing in poor condition. Slight to moderate washboarding or channeling, slight to moderate potholes. Poor ride quality. Lack of a roadway crown. Approximately 1,550 metres east of 50<sup>th</sup> Street and 41<sup>st</sup> Ave SW intersection.</p>

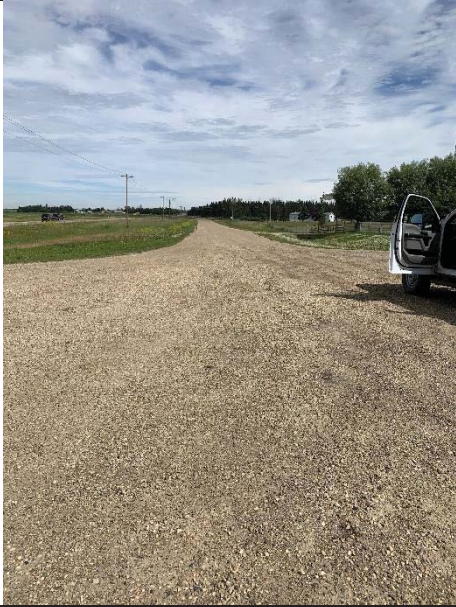
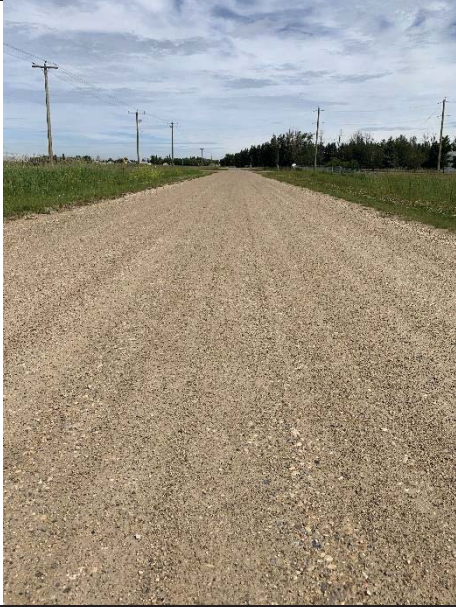
<p>1. Gravel roadway surfacing. Roadway fair. Ride quality good. Slight rutting and washboarding. Approximately 250 meters south of service road entrance.</p>	<p>2. Gravel roadway surfacing. Roadway in fair condition. Ride quality good. Slight rutting. Roadway crown could be increased. Approximately 100 metres south of service road entrance.</p>

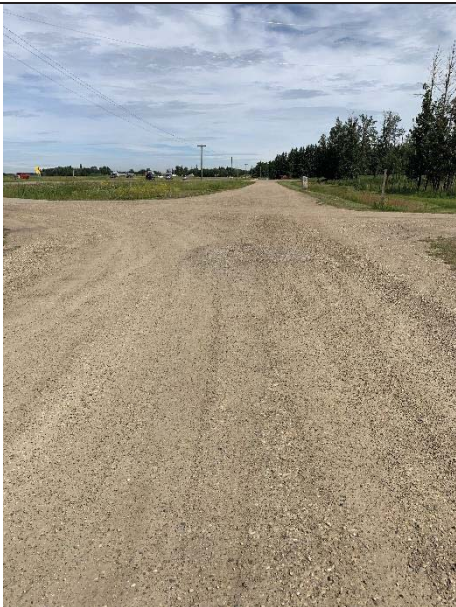
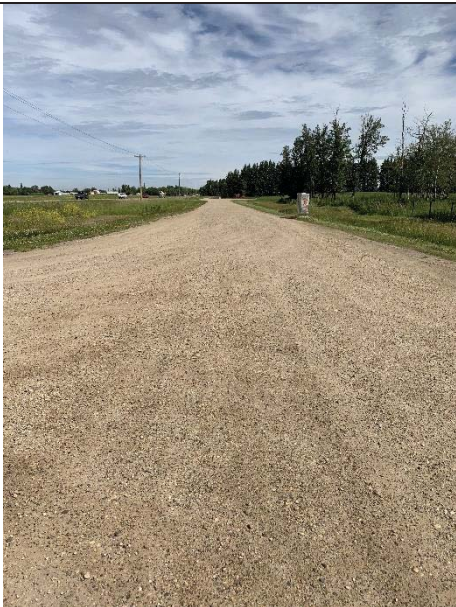
<p>3. Gravel roadway surfacing. Roadway in fair condition. Ride quality good. Slight rutting and washboarding. Roadway crown could be increased. 10 metres south of service road entrance.</p>	<p>4. Gravel roadway surfacing. Roadway in fair condition. Ride quality good. Slight rutting and washboarding. Roadway crown could be increased. Service road entrance.</p>

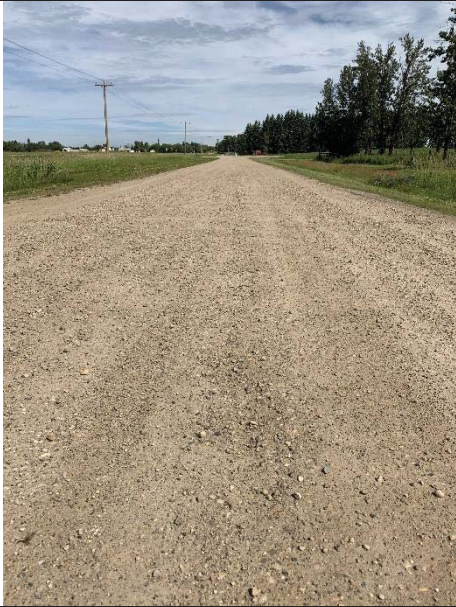
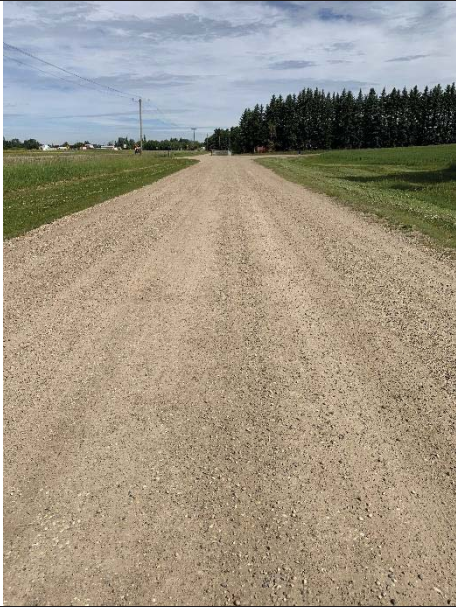
<p>5. Gravel roadway surfacing. Roadway in fair condition. Ride quality good. Slight rutting and washboarding. Roadway crown could be increased. Approximately 100 metres north of service road entrance.</p>	<p>6. Gravel roadway surfacing. Roadway in fair condition. Ride quality good. Slight rutting. Roadway crown could be increased. Approximately 150 meters north of service road entrance.</p>

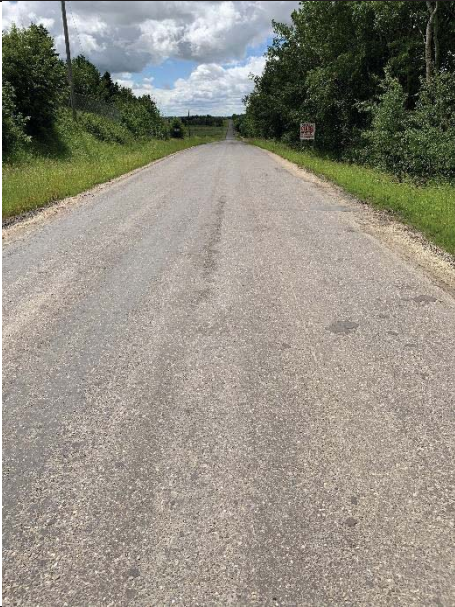
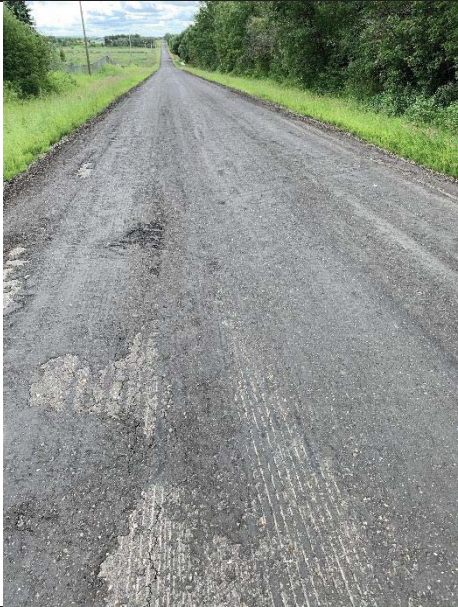
<p>1. In-situ asphalt (oiled) roadway surfacing. Near intersection. Roadway in good condition, good ride quality. Approximately 15 metres south of Range Rd 234/ Meridian and 41<sup>st</sup> Ave SW.</p>	<p>2. In-situ asphalt (oiled) roadway surfacing. Slight alligator cracking visible above surface lift. Slight washboarding. Approximately 50 metres south of 41<sup>st</sup> Ave SW.</p>

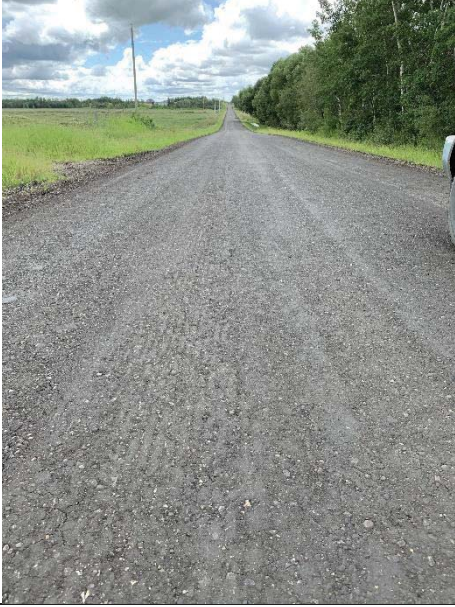
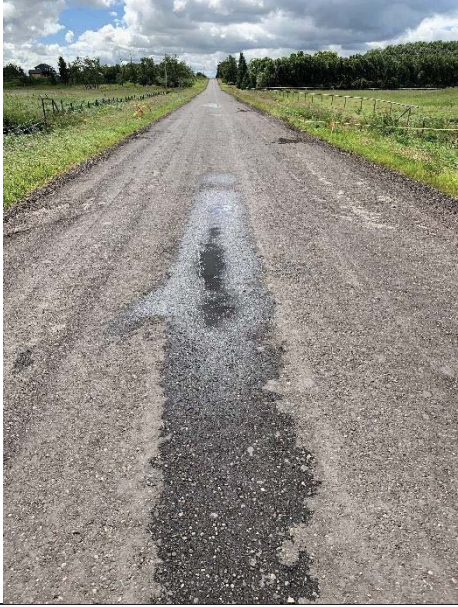
<p>3. In-situ asphalt (oiled) roadway surfacing. Slight alligator cracking. Ride quality is good. Approximately 200 metres south of 41<sup>st</sup> Avenue.</p>	<p>4. In-situ asphalt (oiled) roadway surfacing. Slight rutting, parabolic crown (ponding water), uncomfortable ride quality. Approximately 570 m south of 41<sup>st</sup> Ave SW.</p>

<p>5. Roadway culvert underneath roadway approximately 600 metres south of 41<sup>st</sup> Ave SW. High groundwater table with likely very wet subgrade conditions.</p>	<p>6. In-situ asphalt (oiled) roadway surfacing. Slight to moderate alligator cracking with slight tangential cracking and slight rutting. Approximately 625 metres south of 41<sup>st</sup> Ave SW.</p>

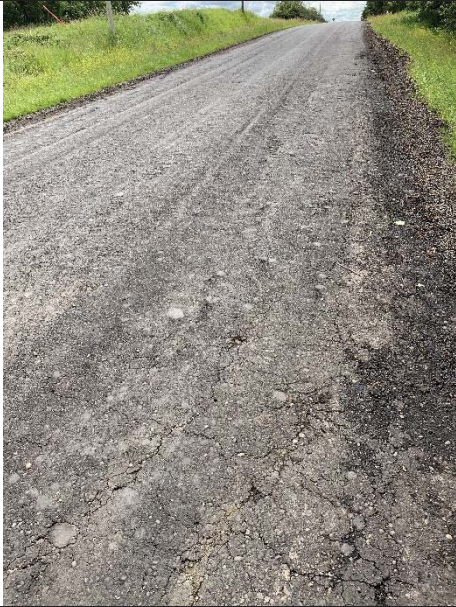
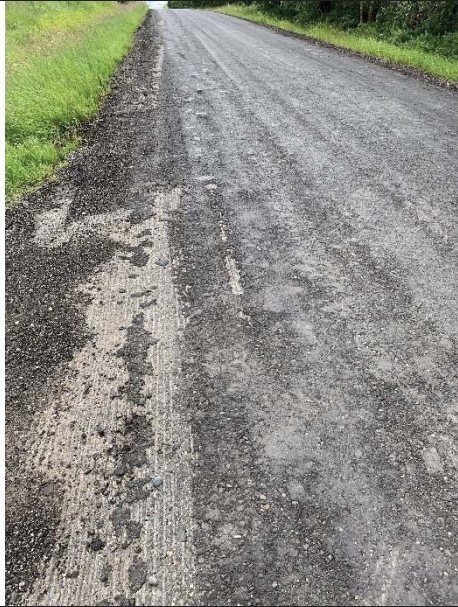
<p>7. In-situ asphalt (oiled) roadway surfacing. Slight alligator cracking. Fair ride quality. Ditch drainage suboptimal. Approximately 750 metres south of 41<sup>st</sup> Ave SW.</p>	<p>8. In-situ asphalt (oiled) roadway surfacing. Minimal washboarding/ corrugations. Fair to bumpy ride quality. Location approximately 775 meters south of 41<sup>st</sup> Ave SW.</p>

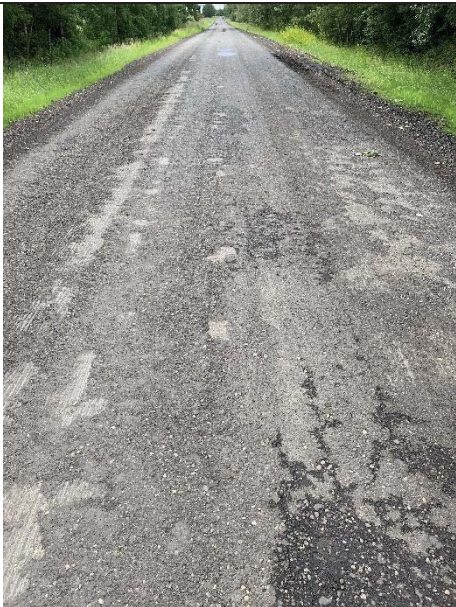
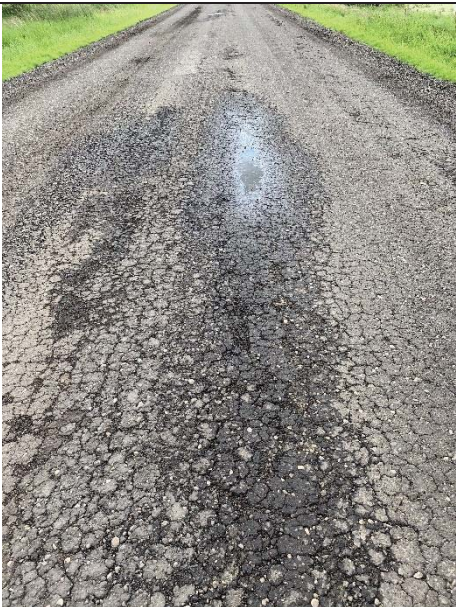
<p>17. In-situ asphalt (oiled) roadway surfacing. Slight alligator cracking and poor ride quality. Approximately 2.2 kilometers south of 41<sup>st</sup> Ave SW.</p>	<p>18. In-situ asphalt (oiled) roadway surfacing. Moderate to severe alligator cracking, lack of a roadway crown. Poor ride quality. Approximately 2.5 kilometers south of 41<sup>st</sup> Ave SW.</p>

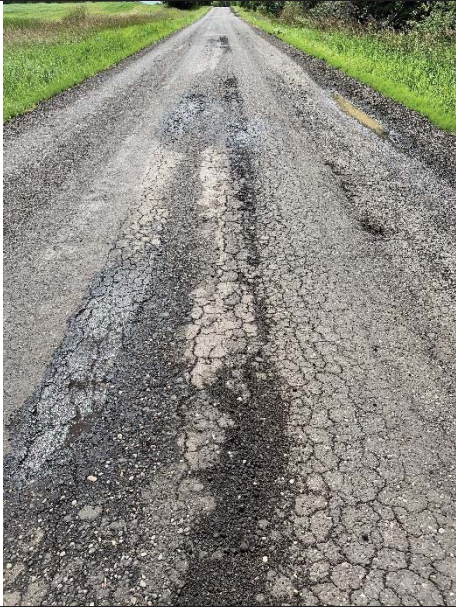
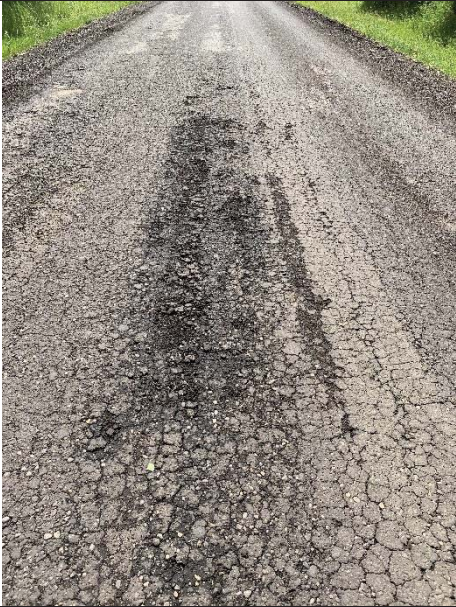
<p>19. In-situ asphalt (oiled) roadway surfacing. Moderate to severe alligator cracking. High shoulder. Slight rutting. Lack of a roadway crown and high roadway shoulders. Approximately 2.7 kilometers south of 41<sup>st</sup> Ave SW.</p>	<p>20. In-situ asphalt (oiled) roadway surfacing. Moderate to severe alligator cracking. High roadway shoulders, loose chips. Slight rutting. Poor ride quality. Approximately 3.0 kilometers south of 41<sup>st</sup> Ave SW.</p>

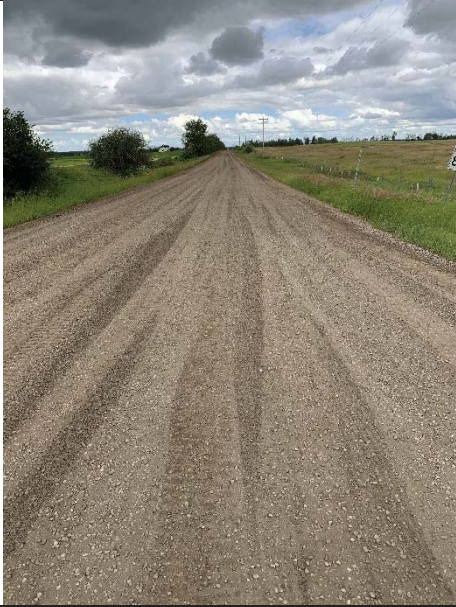
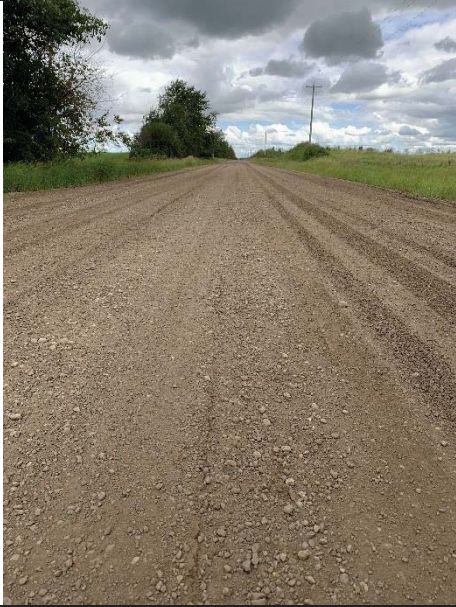
<p>1. Gravel roadway surfacing. Roadway fair. Ride quality good. Slight rutting. Roadway crown suboptimal, could increase. Approximately 15 meters north of TWP Rd 510.</p>	<p>2. Gravel roadway surfacing. Roadway fair. Ride quality good. Slight rutting. Roadway crown could be increased. 200 metres north of TWP Rd 510.</p>

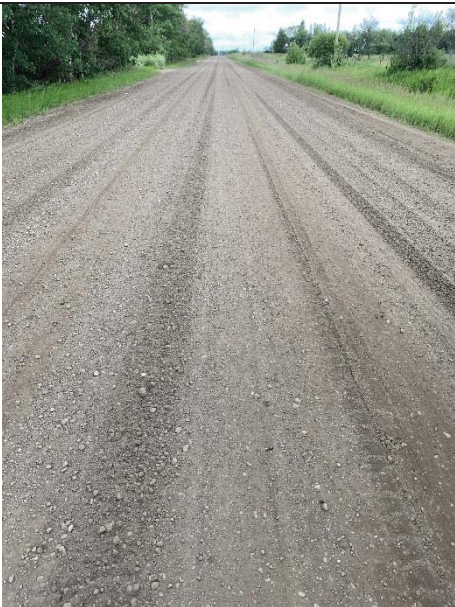
<p>3. Gravel roadway surfacing. Roadway in fair condition. Ride quality good. Slight rutting. Roadway crown could be increased. Approximately 400 metres north of TWP Rd 510.</p>	<p>4. Gravel roadway surfacing. Roadway in fair condition. Ride quality good. Slight rutting. Roadway crown could be increased. Approximately 600 metres north of TWP Rd 510.</p>

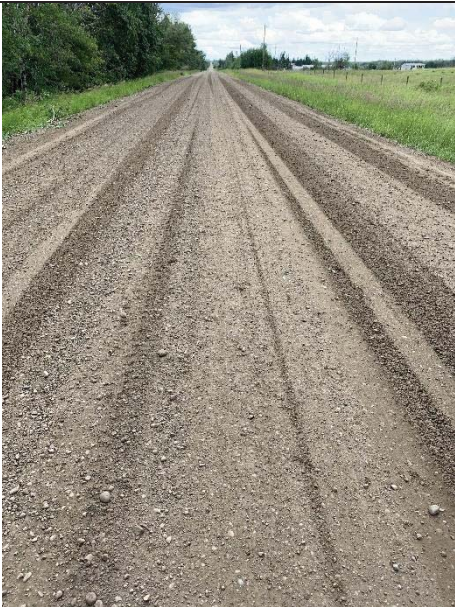
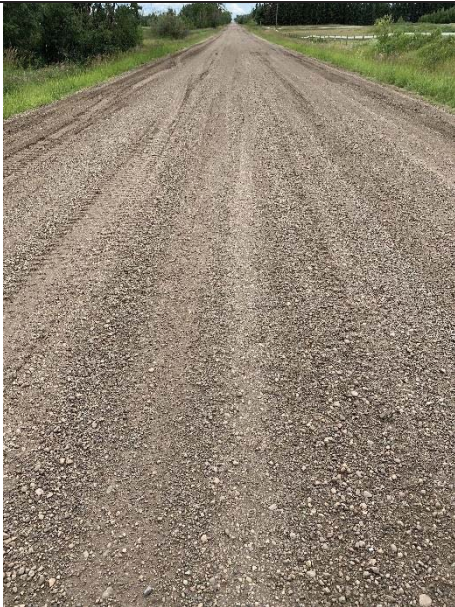
<p>5. Gravel roadway surfacing. Roadway in fair condition. Ride quality good. Slight rutting. Roadway crown could be increased. Approximately 800 metres north of TWP Rd 510.</p>	<p>6. Gravel roadway surfacing. Roadway in fair condition. Ride quality good. Slight rutting. Roadway crown could be increased. Approximately 1.1 kilometers north of TWP RD 510.</p>

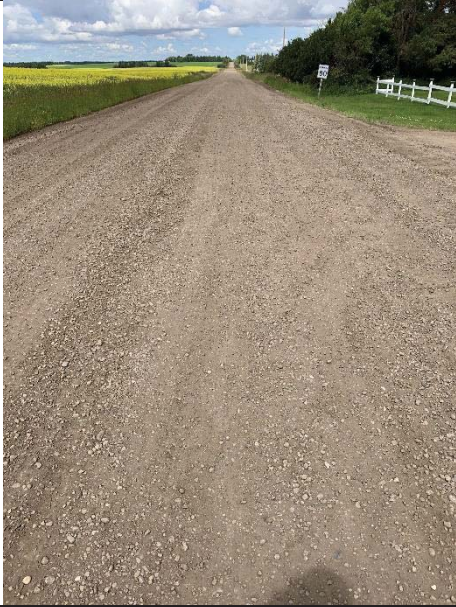
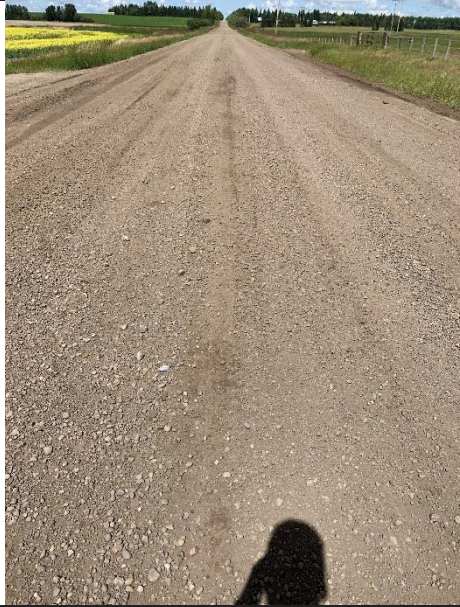
<p>1. Gravel roadway surfacing. Roadway fair. Ride quality good. Slight rutting and washboarding. Roadway crown suboptimal, could increase. Approximately 15 meters north of TWP Rd 510.</p>	<p>2. Gravel roadway surfacing. Roadway fair. Ride quality good. Slight rutting. High shoulder on west edge. Roadway crown could be increased. 300 metres north of TWP Rd 510.</p>

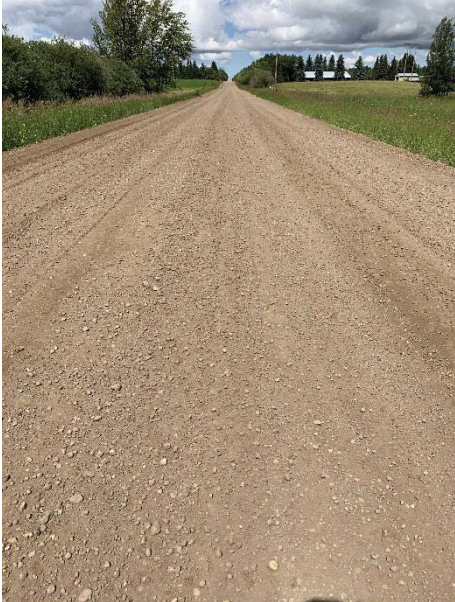
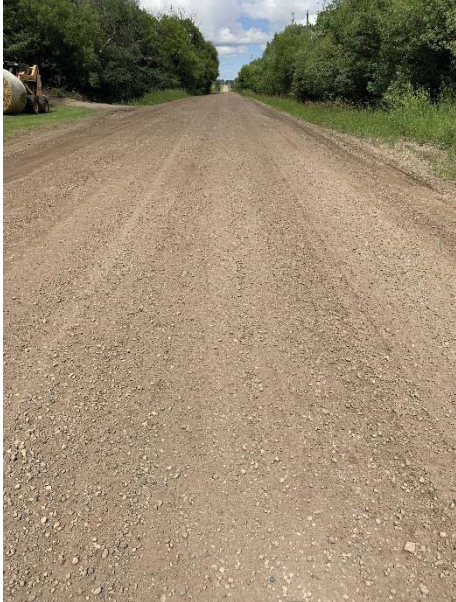
<p>3. Gravel roadway surfacing. Roadway in fair condition. Ride quality good. Slight rutting. Roadway crown could be increased. Approximately 500 metres north of TWP Rd 510.</p>	<p>4. Gravel roadway surfacing. Roadway in fair condition. Ride quality good. Slight rutting. Roadway crown could be increased. Approximately 900 metres north of TWP Rd 510.</p>

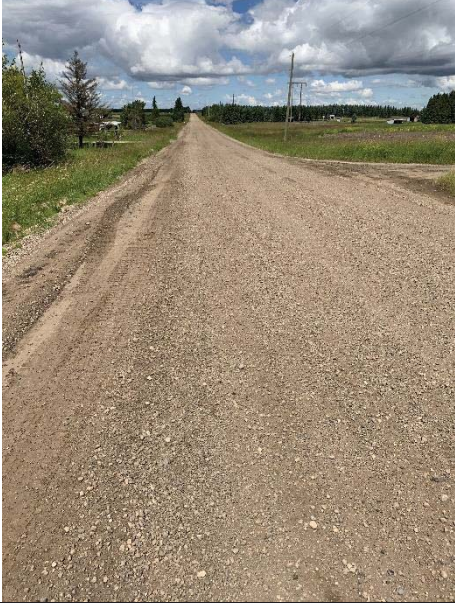
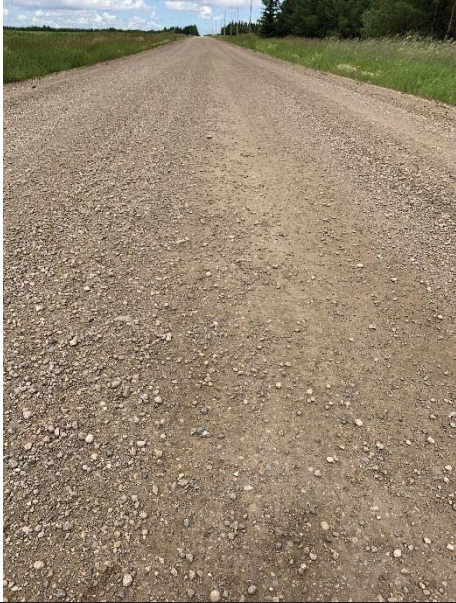
<p>5. Gravel roadway surfacing. Roadway in fair condition. Ride quality good. Slight to moderate rutting along west shoulder. Roadway crown could be increased. Approximately 1.3 kilometres north of TWP Rd 510.</p>	<p>6. Gravel roadway surfacing. Roadway in fair condition. Ride quality good. Slight rutting. Roadway crown could be increased. Approximately 1.8 kilometers north of TWP RD 510.</p>

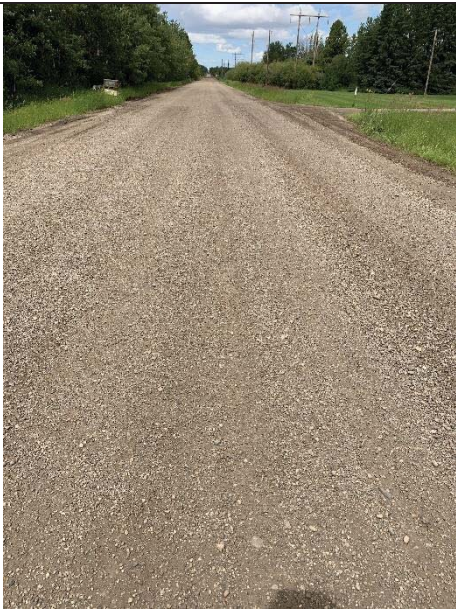
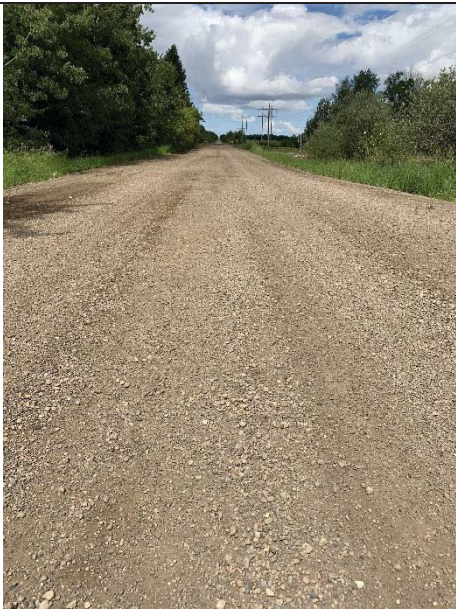
<p>7. Gravel roadway surfacing. Roadway in fair condition. Ride quality good. Slight rutting. Roadway crown could be increased. Approximately 2.2 kilometers north of TWP Rd 510.</p>	<p>8. Gravel roadway surfacing. Roadway in fair condition. Ride quality good. Slight rutting and slight washboarding. Roadway crown should be increased at this location. Approximately 2.8 kilometers north of TWP Rd 510.</p>

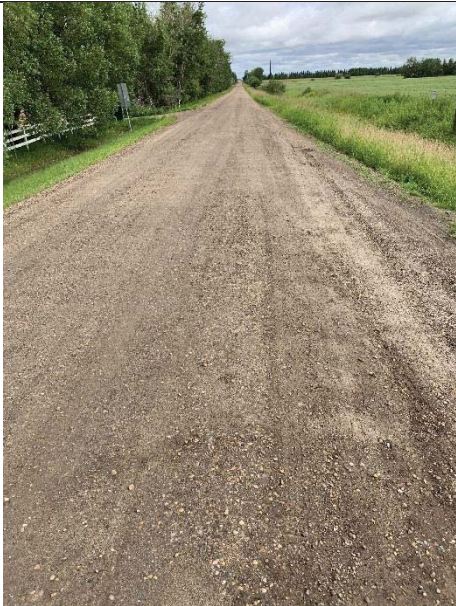
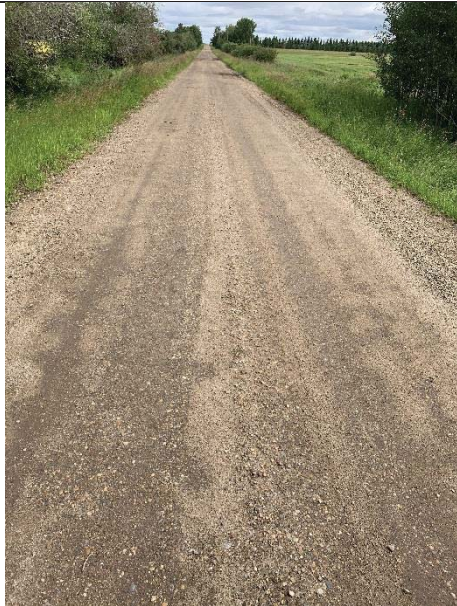
<p>1. In-situ asphalt (oiled) roadway surfacing. Slight washboarding/ corrugations, slight rutting, and slight potholes. Approximately 15 metres north of TWP Rd 510.</p>	<p>2. In-situ asphalt (oiled) roadway surfacing, slight corrugations. Approximately 50 metres north of TWP Rd 510.</p>

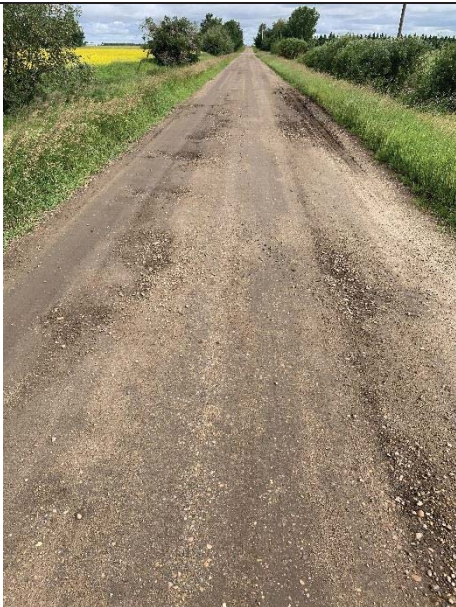
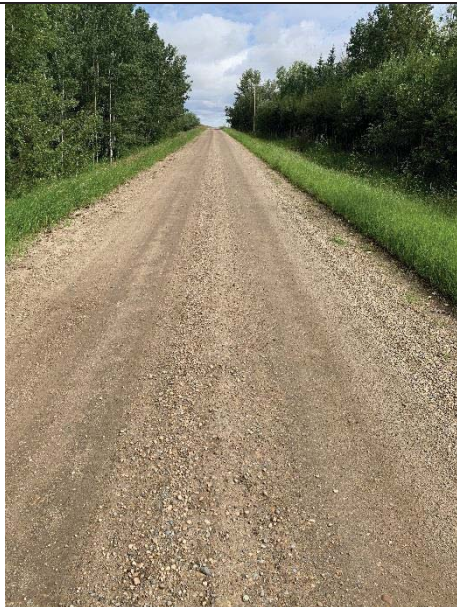
<p>3. In-situ asphalt (oiled) roadway surfacing. Slight rutting and several instances of slight to moderate potholes. Narrow area of 'driveable' road. Approximately 300 metres north of TWP Rd 510.</p>	<p>4. In-situ asphalt (oiled) roadway surfacing. Gravel bladed to the roadway centreline and shoulder indicative of prior pothole repair. Approximately 450 metres north of TWP Rd 510.</p>

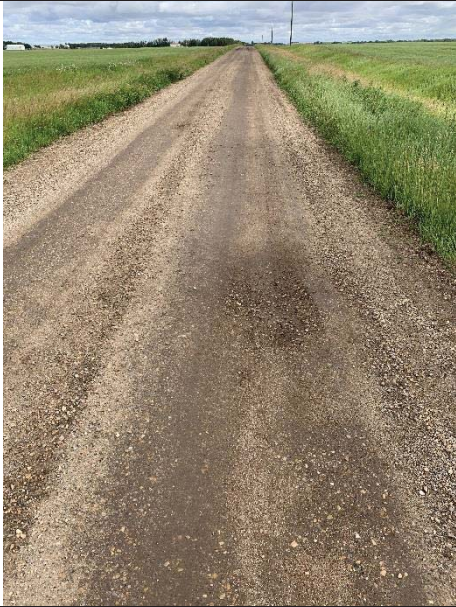
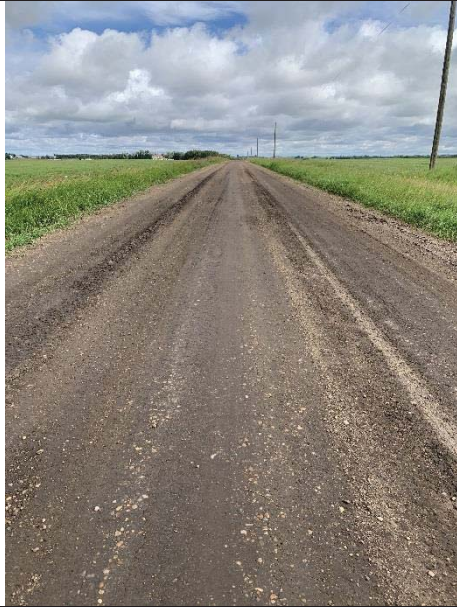
<p>5. In-situ asphalt oiled roadway surfacing, with gravel shoulders. Slight potholes and corrugations. Gravel bladed to the roadway centreline and shoulder indicative of prior pothole repair. Approximately 600 metres north of TWP Rd 510.</p>	<p>6. In-situ asphalt (oiled) roadway surfacing. Slight to moderate rutting or channelling. Roadway surfacing is lacking in thickness, with subsoils exposed partially. Ride quality fine. Approximately 800 metres north of TWP Rd 510.</p>

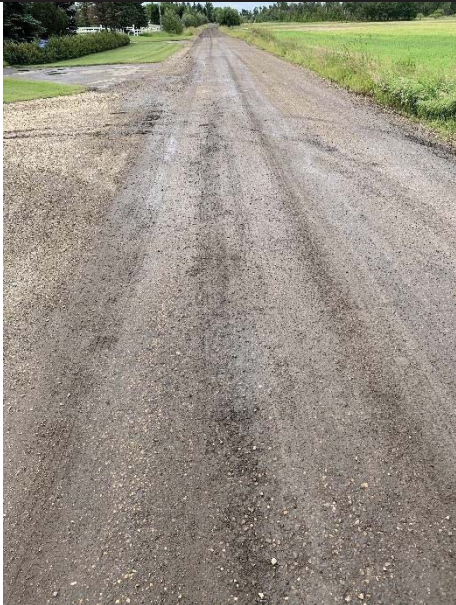
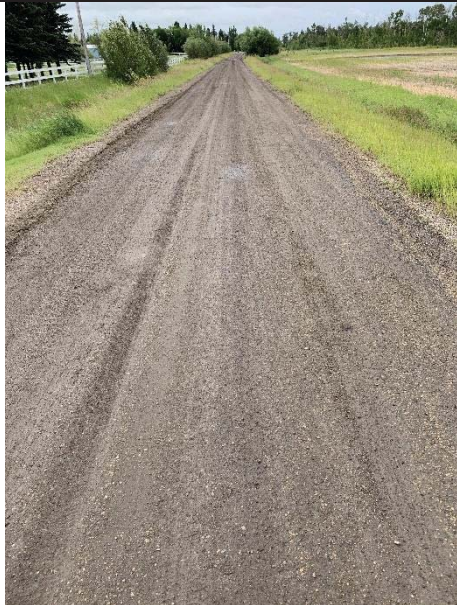
<p>3. In-situ asphalt (oiled) roadway surfacing. Fair shape. Slight rutting occurring. No other pavement distresses noted. Approximately 175 metres south of TWP Rd 511A.</p>	<p>4. In-situ asphalt (oiled) roadway surfacing. Fair shape. Possible high shoulder on east edge. Slight rutting or channelling. Ride quality fair. Approximately 225 metres south of TWP Rd 511A.</p>

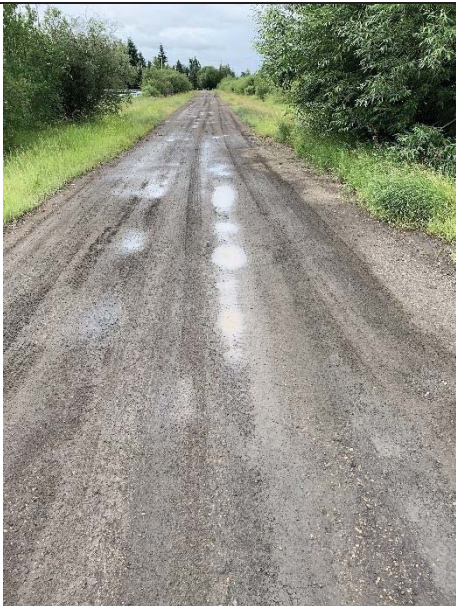
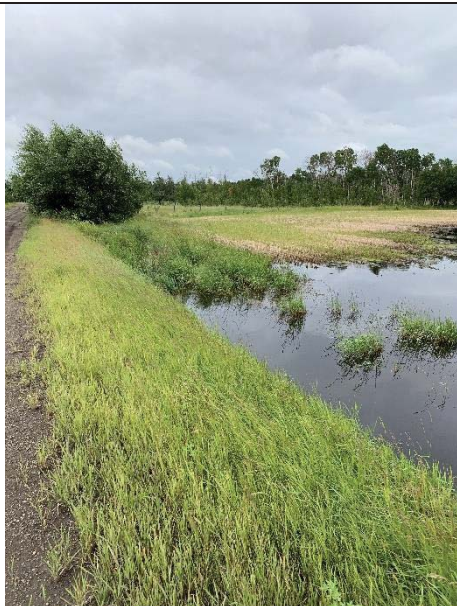
<p>5. In-situ asphalt (oiled) roadway surfacing. Many potholes of moderate severity. Slight rutting is beginning to occur, the roadway surfacing is fairly dirty from tracked clays and gravels from vehicular traffic, lack of a roadway crown. Approximately 400 metres south of TWP Rd 511A.</p>	<p>6. Ponding water is visible on the west side of the road approximately 375 metres south of TWP Rd 511A. Such ponding is estimated to lie two feet below the roadway surface subgrade. Impacts from future high-volume rain/ storm events may be experienced.</p>

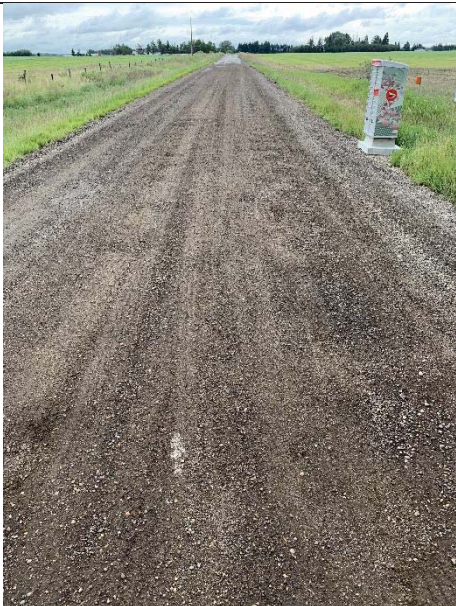
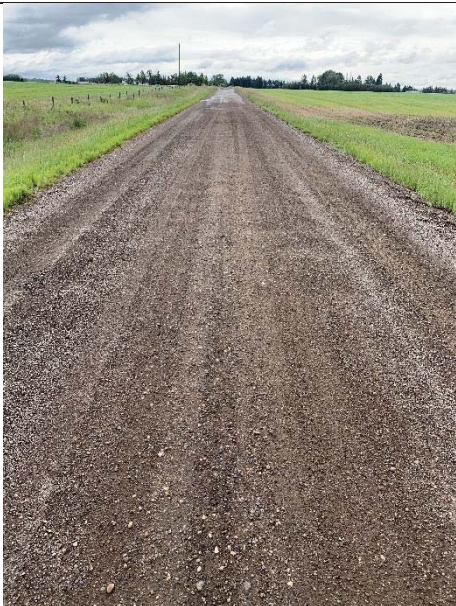
<p>1. Gravel road surfacing with moderate severity corrugations/ washboarding, likely related to vehicles braking from mailbox and nearby 91 Street intersection. Very rough ride quality. 10 metres east of 91 Street and TWP Rd 511A Intersection.</p>	<p>2. Gravel road surfacing with slight to moderate corrugations/ washboarding, likely related to vehicles braking at nearby 91 Street intersection. Rough ride quality. 70 metres east of 91 Street and TWP Rd 511A Intersection.</p>

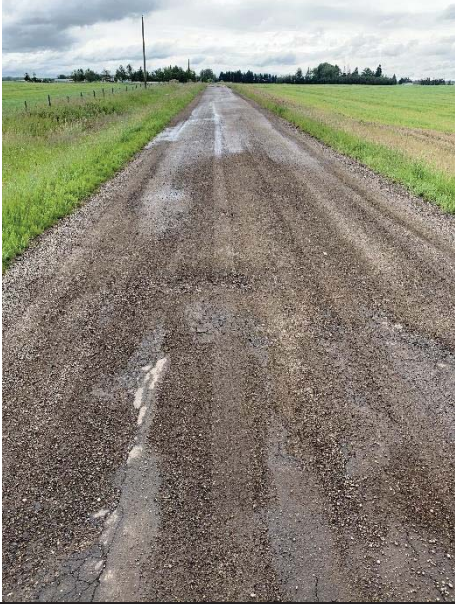
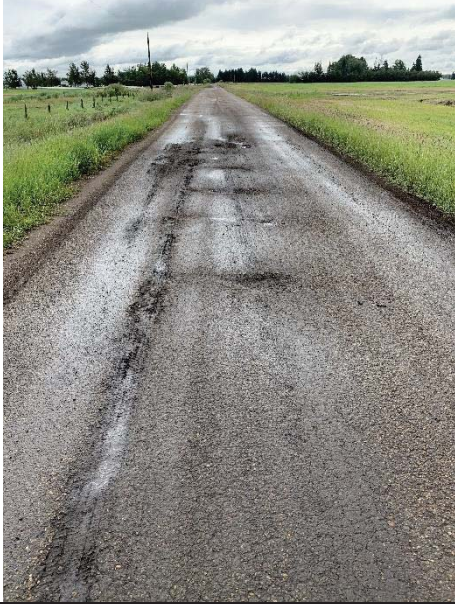
<p>3. In-situ asphalt (oiled) roadway surfacing and gravel roadway transition, slight to moderate pothole, slight rutting, and moderate alligator cracking on oiled roadway surfacing. Ponding of water on north edge of roadway shoulder and within ruts.</p>	<p>4. In-situ asphalt (oiled) roadway surfacing, several instances of moderate pot holes, slight alligator cracking, slight rutting, some spots of total pavement failure, lacking roadway crown. Approximately 275 metres east of 91 Street Intersection.</p>
