# Leduc Annex – Gravel Roads Condition Assessment and Maintenance Program Review

Final Document Prepared on August 19, 2020

Project Report: 126265

## IBI Group

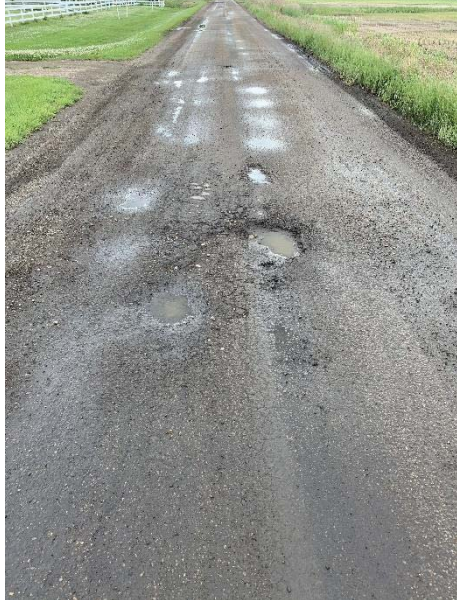
<p>7. In-situ asphalt (oiled) roadway surfacing. Slight to severe potholes with many instances, slight rutting or channeling, lack of a roadway crown. Approximately 375 metres east of 91 Street and TWP Rd 511A intersection.</p>	<p>8. In-situ asphalt (oiled) roadway surfacing. Slight to moderate potholes, many instances. Slight alligator cracking and ponding water from lack of roadway crown. Approximately 480 metres east of 91 Street and TWP Rd 511A Intersection.</p>

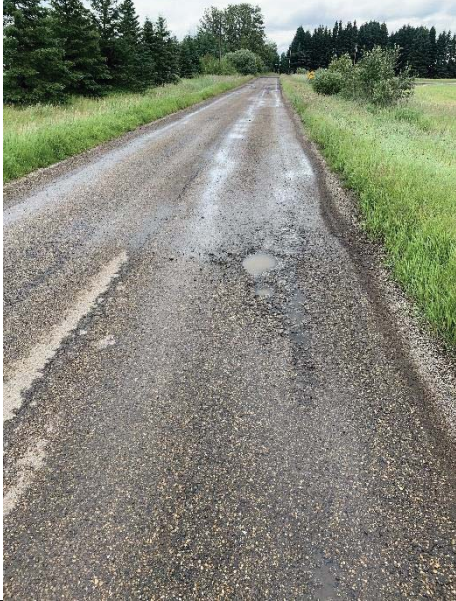
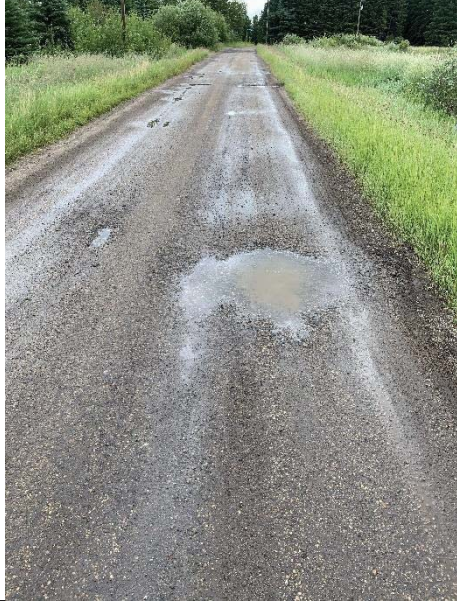
<p>9. In-situ asphalt (oiled) roadway surfacing. Slight corrugations/ washboarding, few instances of potholes (slight to severe), and slight rutting/ channeling leading to ponding water. Longitudinal cracking at roadway centreline. Approximately 600 metres east of 91 Street and TWP Rd 511A intersection.</p>	<p>10. In-situ asphalt (oiled) roadway surfacing. Slight rutting, potholes, and corrugations. Ponding within ruts/ roadway channels. Few instances of highly severe potholes. Approximately 700 metres east of 91 Street and TWP Rd 511A intersection.</p>
