HANGAR 11 - BLATCHFORD

- HISTORIC BUILDING RECORD
- HISTORIC BUILDING CONDITION ASSESSMENT
- CONSERVATION PLAN

December 20, 2019

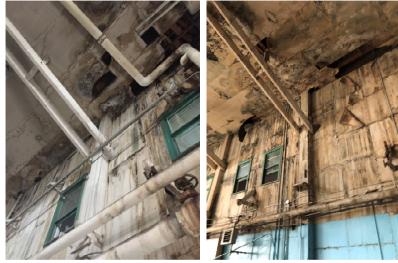
The hangar walls at the east and west sides of the hangar are more deteriorated than in 2017. The deteriorated condition is considered important as RJC believes they are load bearing and provide lateral stability to the building. They were observed to be in a highly saturated condition and were mushy (wet rot). There was also significant signs of biodegradation on the surface. It is likely these walls have lost structural capacity.

Photos 3 and 4: Hanger Walls - Signs of Deterioration

- The wood columns that support the trusses on east/west side of hanger were observed to be in a wet condition and soft in some locations, which would suggest the presence of wet rot in the columns.
 - One column was observed to be so significantly deteriorated that a screwdriver could penetrate into column at its base (on west wall, near north end). There was also observed loss of material at the column base. This loss of material at the column's base is of significance as it suggests a loss in structural capacity.

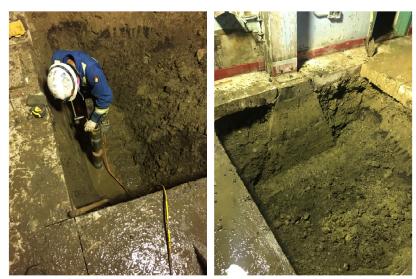
Photos 11 and 12: Foundation Testing and Exposed Foundation

In general, the concrete on the footing and the pilaster was found to be in fair condition. Tetra-tech completed two 100 mm cores in the footing. The cores were tested for concrete strength and were found to be 35 and 50 MPa (testing information below). When reviewed visually, the concrete at the one footing appears to be in fair condition for the location exposed.
