HANGAR 11 - BLATCHFORD

- HISTORIC BUILDING RECORD
- HISTORIC BUILDING CONDITION ASSESSMENT
- CONSERVATION PLAN

December 20, 2019

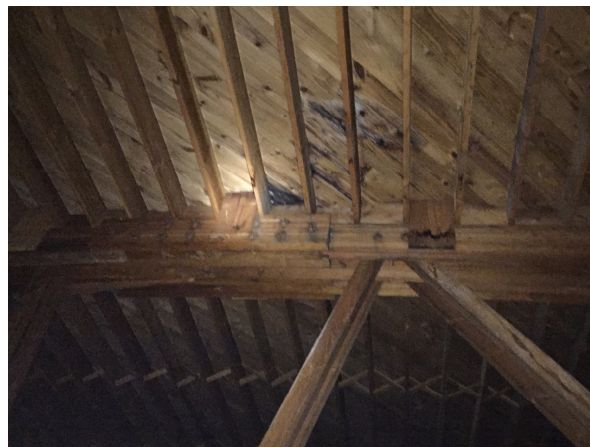
- In general, the main hangar wood framing has deteriorated further since 2017. We observed greater extents of staining of the wood and extensive areas of softened and darkened framing throughout.
- The wood roof framing (roof deck, joists, trusses and the ceiling support framing) shows signs of water infiltration and biodegradation. In general only a small portion of the hangar roof (<5%) was safely accessible for review along the main walkway through the attic space.
 - The glulam/timber trusses appeared generally in a similar condition as 2017; however, there was more exposure to moisture on the glulam members.

Photo 1: Truss top – signs of water infiltration

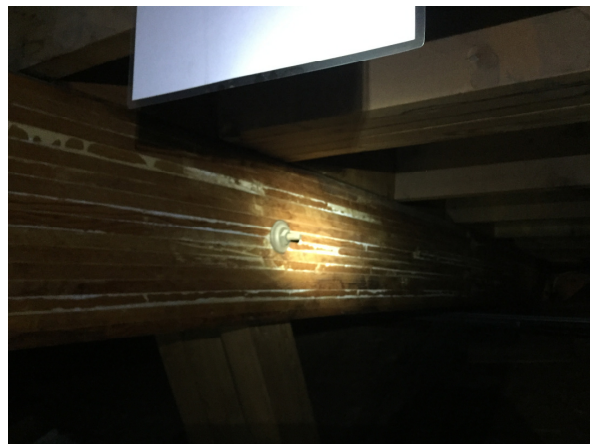
- RJC observed evidence of deterioration of the roof deck boards and joists, with the poorest conditions being concentrated at west/east ends of hangers.
- At one glulam truss chord, RJC observed what appears might be signs of glue deterioration between the laminations of the glulam members. Further investigation would be needed to confirm this observation since delamination of the glulam members (should it be present) would significantly impair the hangar truss load carrying capacities.

Photo 2: Chord – Potential glue deterioration

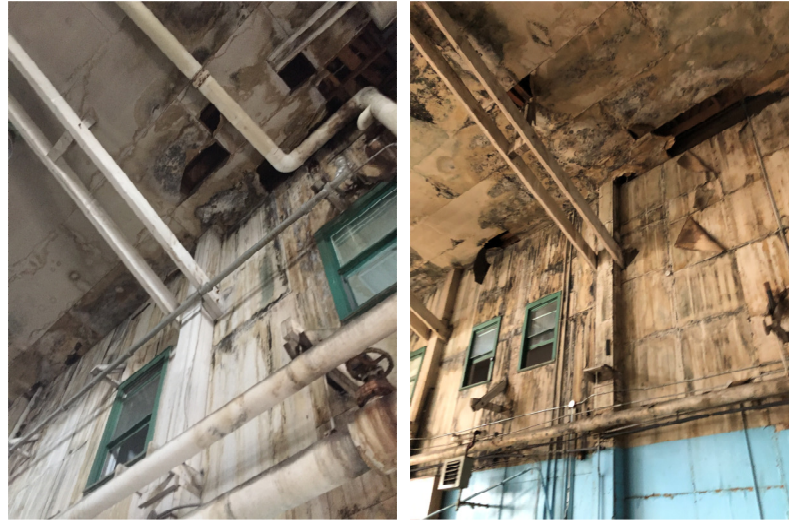
- The hangar walls at the east and west sides of the hangar are more deteriorated than in 2017. The deteriorated condition is considered important as RJC believes they are load bearing and provide lateral stability to the building. They were observed to be in a highly saturated condition and were mushy (wet rot). There was also significant signs of biodegradation on the surface. It is likely these walls have lost structural capacity.

Photos 3 and 4: Hanger Walls – Signs of Deterioration

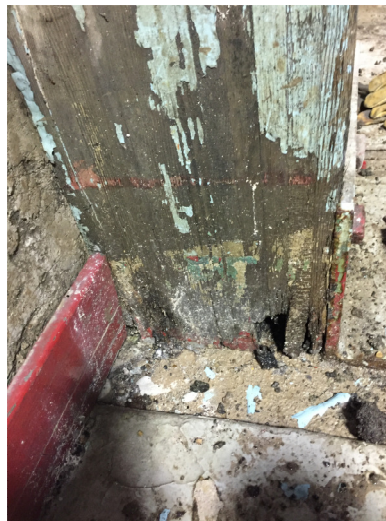
- The wood columns that support the trusses on east/west side of hangar were observed to be in a wet condition and soft in some locations, which would suggest the presence of wet rot in the columns.
 - One column was observed to be so significantly deteriorated that a screwdriver could penetrate into column at its base (on west wall, near north end). There was also observed loss of material at the column base. This loss of material at the column's base is of significance as it suggests a loss in structural capacity.

Photo 5: Damaged Column – Hole at Bottom where screwdriver could go in

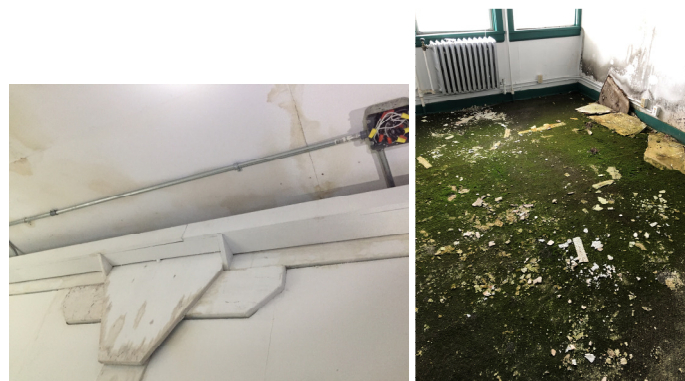
- In general, the condition of the ancillary superstructure framing has deteriorated further since 2017. Some of the areas are deteriorated to point where it is likely the structure is compromised beyond repair, especially the northern half of the western ancillary floors and roof.
- The superstructure (post and beams), where visible, had a greater number of locations with exposure to significant moisture on or directly adjacent to the framing. It appeared there was limited bio-degradation, but moisture reading in this portion of the structure will still quite high.
- Joist framing, where visible, was observed to be dark in color, wet, and exhibited significant deflections. It is anticipated a good portion of the joists are likely structurally compromised and beyond repair.

Photos 6 to 7: Ancillary Framing

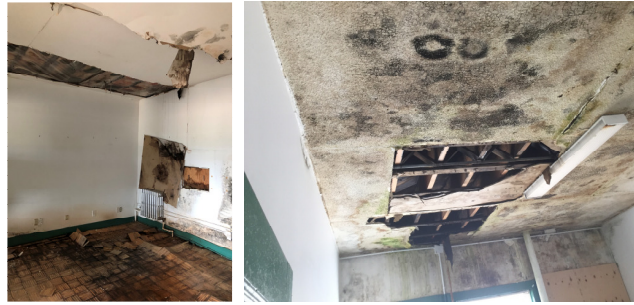
Photos 8 to 9: Ancillary Framing – Damaged Finishes due to water Infiltration

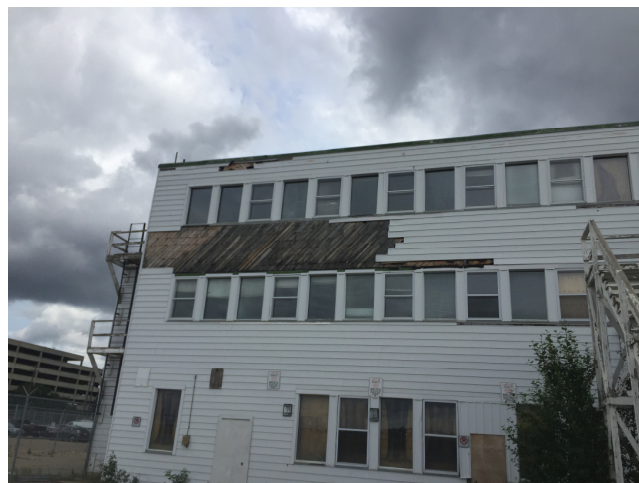
- In general, the condition of the building exterior has deteriorated further from the 2017 condition. More areas of the siding have fallen off or been damaged, exposing the framing below to continued weather and subsequent damage.

Photo 10: Exterior: General condition

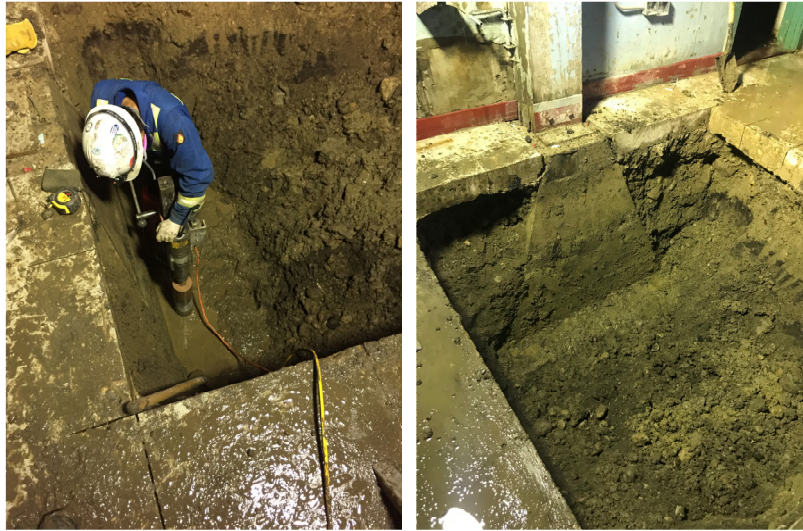
The truss column is supported by a concrete pyramid-shaped pilaster, which is supported below by a small footing. The top of the footing is located approximately 1.2 m below the slab elevation. The footing was at least 200 mm thick and roughly 300 mm wider than the pilaster at the base, but the extent and depth of the footing could not be fully exposed due to very wet conditions. Limited reinforcing was found when tested, although again was difficult given the wet conditions and rough top surface. The slab construction found is roughly 200 mm to 250 mm thick on generally loosely compacted clay subgrade.

Photos 11 and 12: Foundation Testing and Exposed Foundation
