Photographs of the Barto Residence

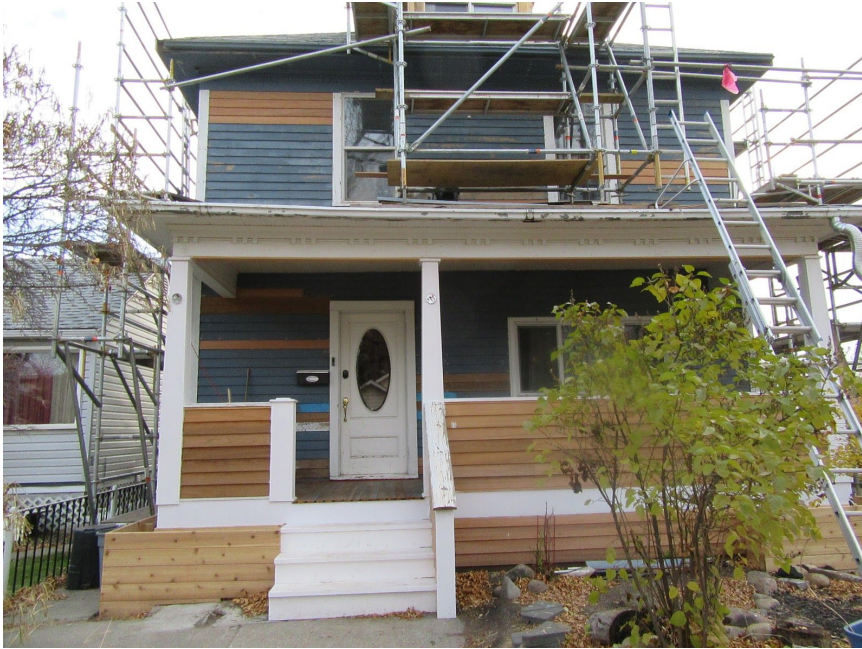
View of west (front) elevation, showing restoration of existing wood cladding.

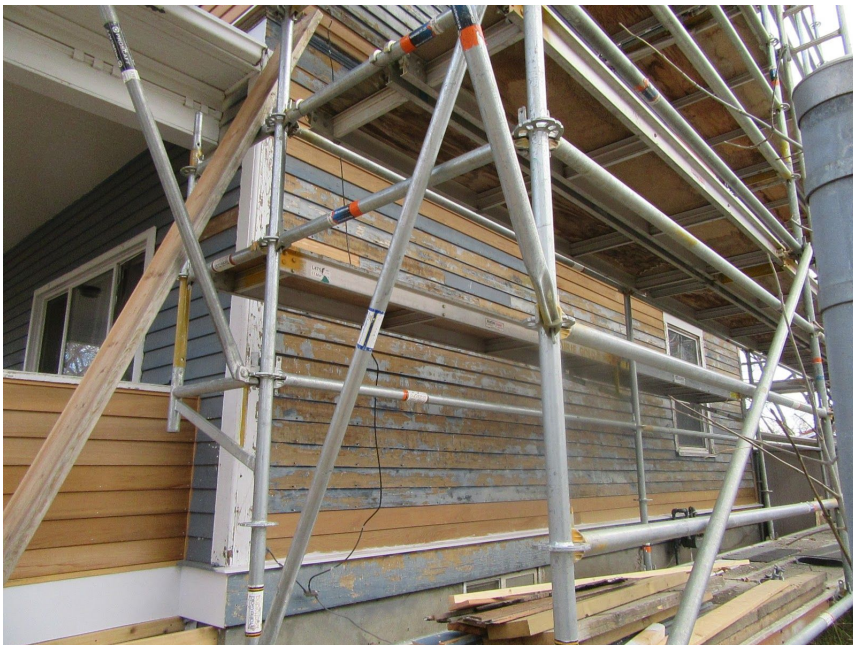
View of south elevation, showing restoration of existing wood cladding.
