Latta Bridge (B027) Replacement

Environmental Impact Assessment Pursuant to Bylaw 7188
Final Report

Project Number EP-917L
October 2021

Prepared by:
**Spencer Environmental
Management Services Ltd.**
Edmonton, Alberta

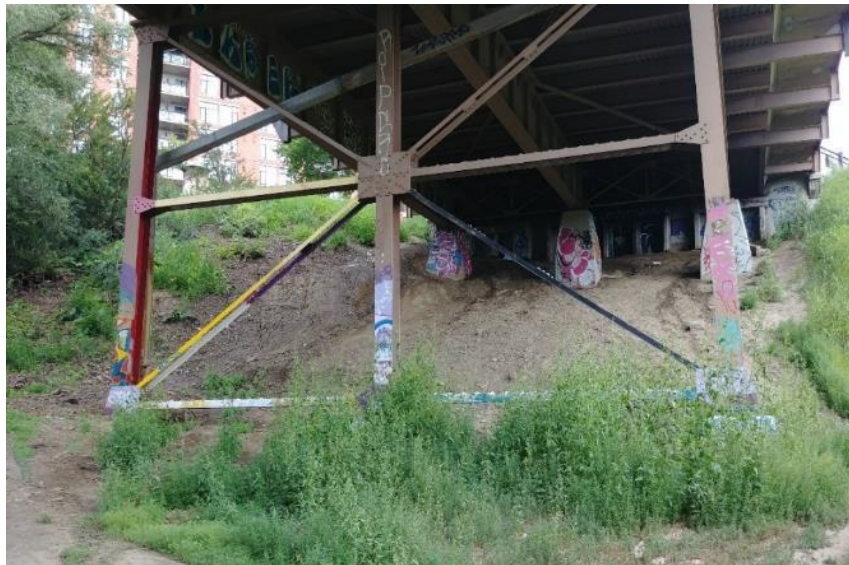
Plate 3.1. Erosion rills created by surface water runoff present on bridge abutment (02 August 2019)

A FWMIS (AEP 2021) search returned no results for a mapped watercourse or other waterbodies in Latta Ravine that would suggest the presence of a current or historical watercourse and no evidence of the presence of any waterbodies was observed in Latta Ravine during site investigations. Local surface water runoff, particularly after significant rainfall or snow melt events, likely periodically collects in the bottom of the ravine under the bridge and flows downhill along the informal maintenance path towards Dawson Park. The NSR is located approximately 290 m east of the bridge and it is unlikely that surface water flows would directly enter the river from the bridge area considering the distance to the river from the bridge and the presence of vegetation on intervening lands. Evidence of some erosion from surface runoff was observed on the bridge abutments during site visits (Plate 3.1).

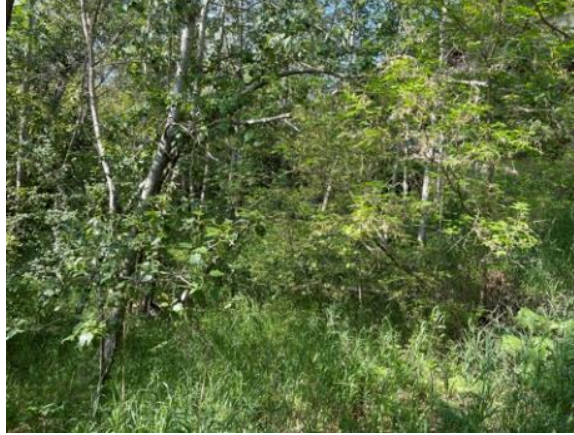
Plate 3.3. Balsam poplar mixed shrubs plant community with balsam poplar overstorey and smooth brome dominated understorey (13 July 2021).

The balsam poplar mixed shrubs plant community was found immediately east of the bridge on the ravine slope and continued to the south along the greater NSRV slope. There was an additional small area of this plant community observed northeast of the bridge. The forest canopy was a mature overstorey 10-15 m in height, dominated by balsam poplar (*Populus balsamifera*). The understorey canopy was sparse and contained Manitoba maple (*Acer negundo*) and small amounts of red elderberry (*Sambucus racemosa*) and Tatarian honeysuckle (*Lonicera tatarica*). The forb and grass layer was dominated by smooth brome (*Bromus inermis*) with common dandelion (*Taraxacum officinale*), prostrate saltbush (*Atriplex prostrata*), lamb's-quarters (*Chenopodium album*), quackgrass (*Elymus repens*) and summer-cypress (*Kochia scoparia*) also occurring occasionally. The noxious weeds woolly burdock (*Arctium tomentosum*), creeping thistle (*Cirsium arvense*) and creeping bellflower (*Campanula rapunculoides*) were observed in this community.

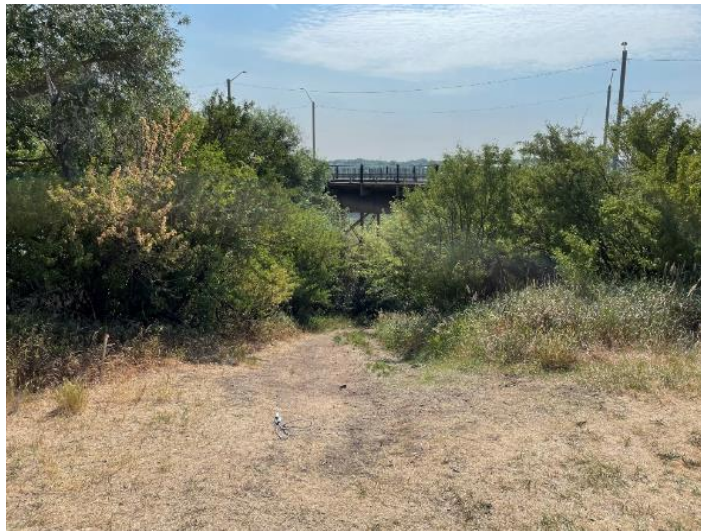
Plate 3.4. View to east of Non-forest caragana - steep slopes community dominated by common caragana; beginning of City maintenance path in foreground (13 July 2021).

The non-forest caragana - steep slopes community was found on both the north and south ravine slopes on the west side of the bridge. This community comprised exotic shrub species. Many of the shrubs were 4 to 5 m in height with the larger, exotic white willow, occurring as a few individuals, reaching heights of approximately 10 m. Common caragana was the dominant shrub in this community with Manitoba maple, Tatarian honeysuckle and lilac (*Syringa sp.*) also occurring occasionally. The forb and grass layer was very sparse within this community owing to the dense shrub layer. However, many exotic grasses and forbs were present along the margins of this community including crested wheatgrass (*Agropyron cristatum*), prostrate saltbush, smooth brome, quackgrass, alfalfa (*Medicago sativa*) and yellow sweet clover (*Melilotus officinalis*). The noxious weeds woolly burdock, white cockle (*Silene latifolia*) and common tansy (*Tanacetum vulgare*) were also observed along the margins of this community.

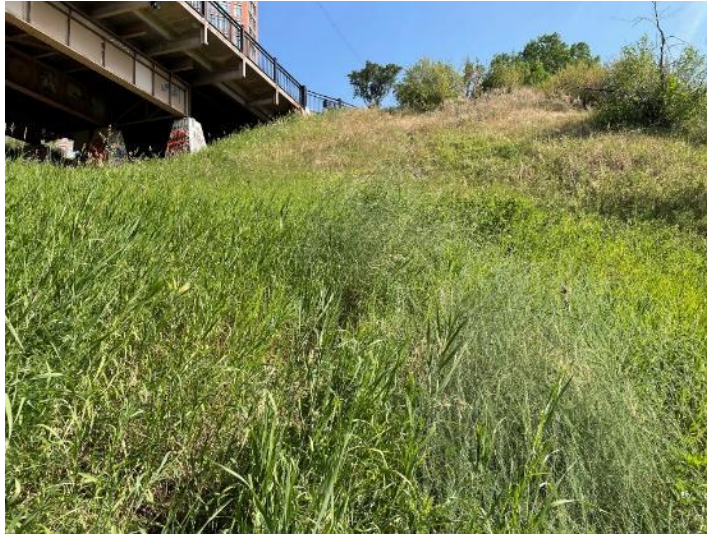
Plate 3.5. Non-forest smooth brome - steep slopes community dominated by smooth brome (13 July 2021).

The non-forest smooth brome - steep slopes community was found on the north ravine slope and river valley slope on the east side of Latta bridge. The community was dominated by smooth brome with shrubs, forbs and other grasses scattered throughout. Shrubs comprised Manitoba maple, common caragana, Tartarian honeysuckle, lilac and buckbrush (*Symphoricarpos occidentalis*). Frequent and occasionally occurring forb species include prostrate saltbush, wild licorice (*Glycyrrhiza lepidota*) and alfalfa. Quackgrass was the only other grass species found in this community. The noxious weeds woolly burdock and creeping thistle were observed scattered throughout this community.

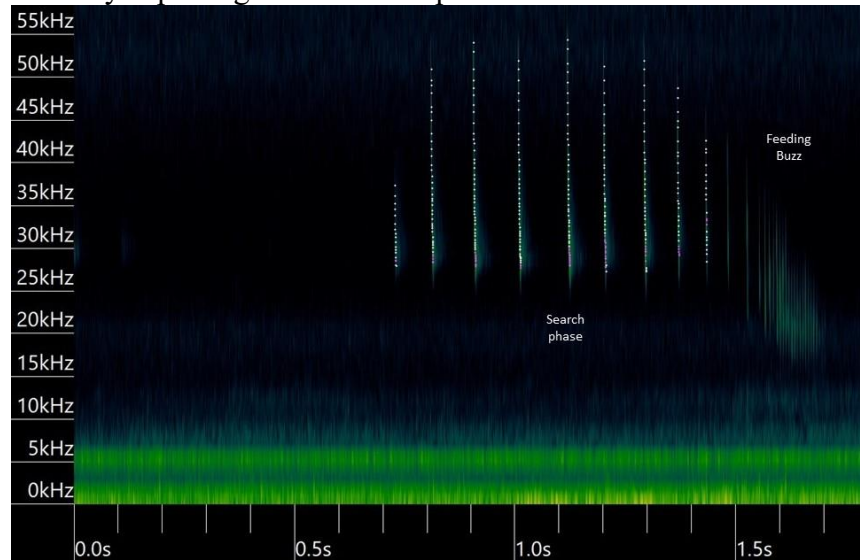
Plate 3.9. 25kHz big brown bat/silver-haired bat (25 kHz) recorded at Station 2 (real time; search phase followed by feeding buzz in cluttered environment)(25 June 2021)

recordings (e.g., 4s). All recordings, however, did show distinct search phase calls of a 25kHz bat species (Plate 3.9). It can be very difficult and even impossible to distinguish calls between 25kHz bat species, particularly in cluttered environments. Considering the species most likely to occur in Edmonton [e.g., *Eptesicus fuscus* (big brown bat) and *Lasiorycteris noctivagans* silver-haired bat), these calls most closely fit either of those species flying in a high clutter environment (steep slope and calls starting at 25kHz) and it is normal convention to name the call as potentially big brown bat/silver-haired bat without committing to one species or the other (Lausen *et. al.* 2019). Identification to species could only be achieved by capturing these bats for positive identification in hand.
