Smith Crossing Pedestrian Bridge Replacement

Environmental Impact Assessment Pursuant to Bylaw 7188
Final Report

Project Number EP-860
21 September 2021

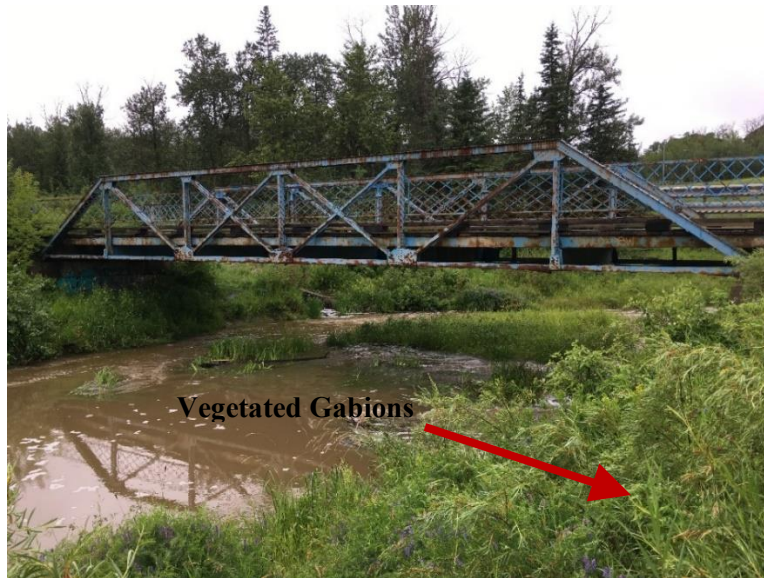
Plate 1.1. View to southwest of upstream side of pedestrian bridge crossing Whitemud Creek (prior to bank bioengineering) (19 July 2019).

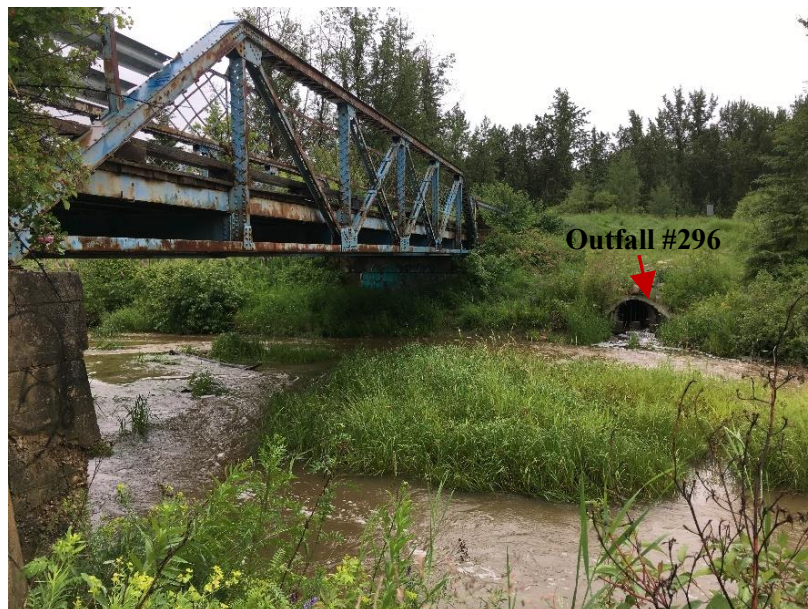
Plate 1.2. View to south of downstream side of bridge over Whitemud Creek showing proximity of Outfall #296 to south side of bridge (prior to bank bioengineering) (19 July 2019).

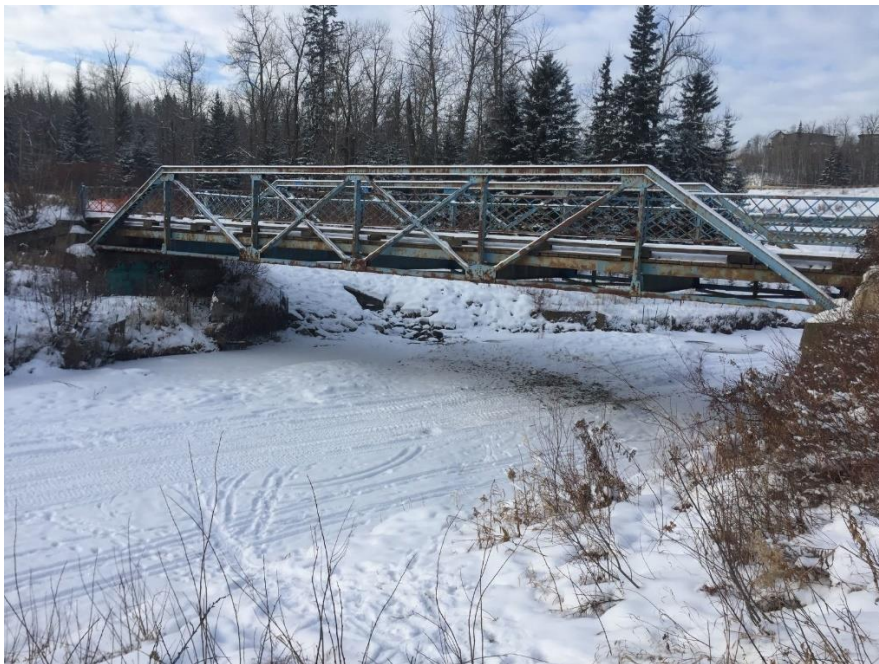
Plate 1.4. View to southwest (downstream) of bridge crossing Whitemud Creek including fenced bank bioengineering areas at south abutment and downstream of Outfall #296 (30 January 2021).

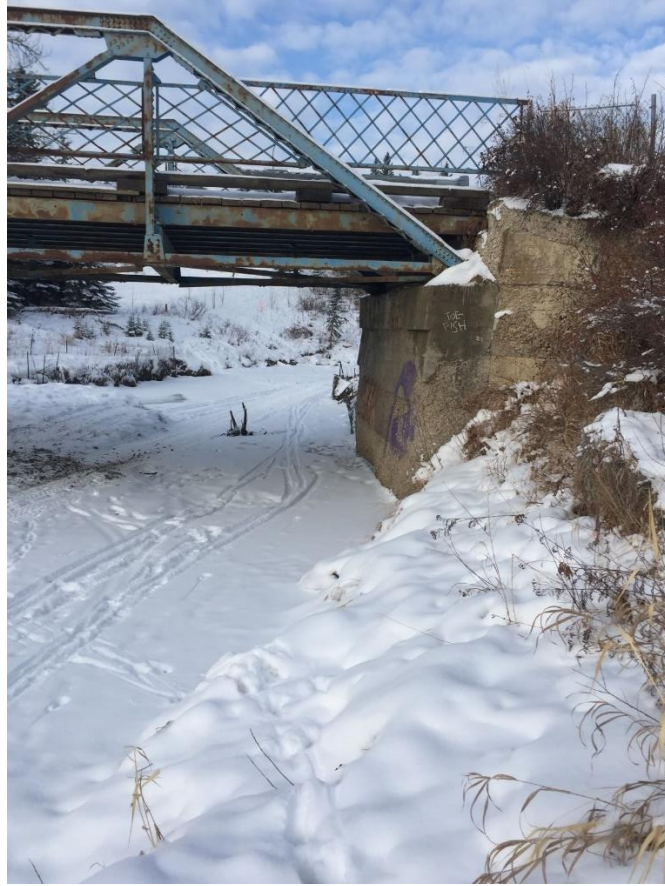
Plate 1.5. View to west (downstream) of the north pedestrian bridge abutment and bioengineered south bank in distance (30 January 2021).

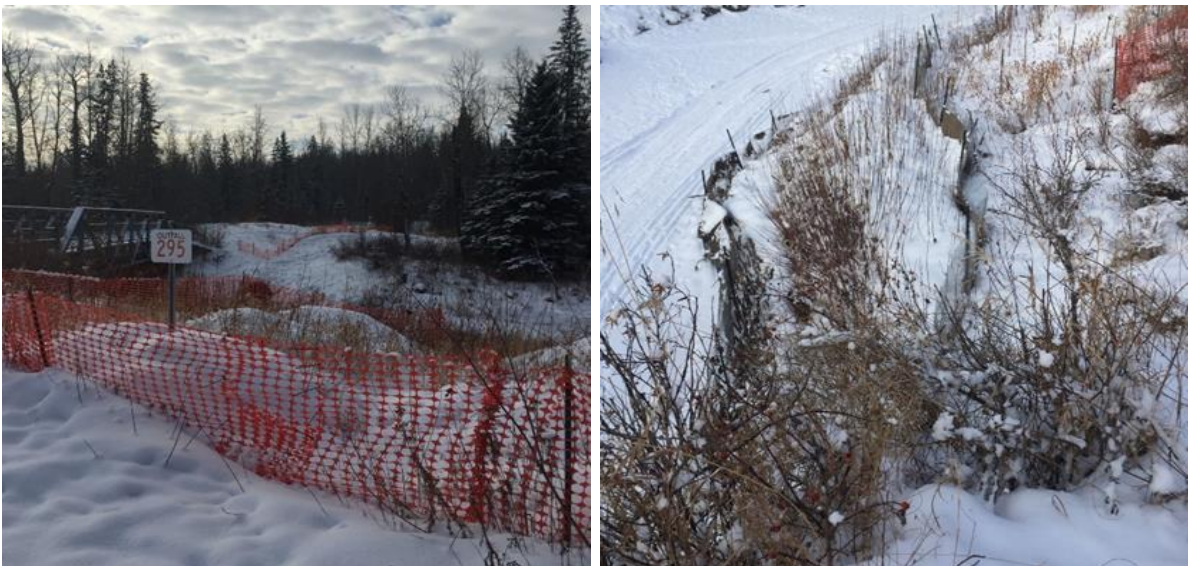
Plate 1.6. View to south of pedestrian bridge and fenced area of bioengineered bank at Outfall #295 on north creek bank (left); view downstream from bridge of bioengineered north bank at Outfall #295 (right) (30 January 2021).

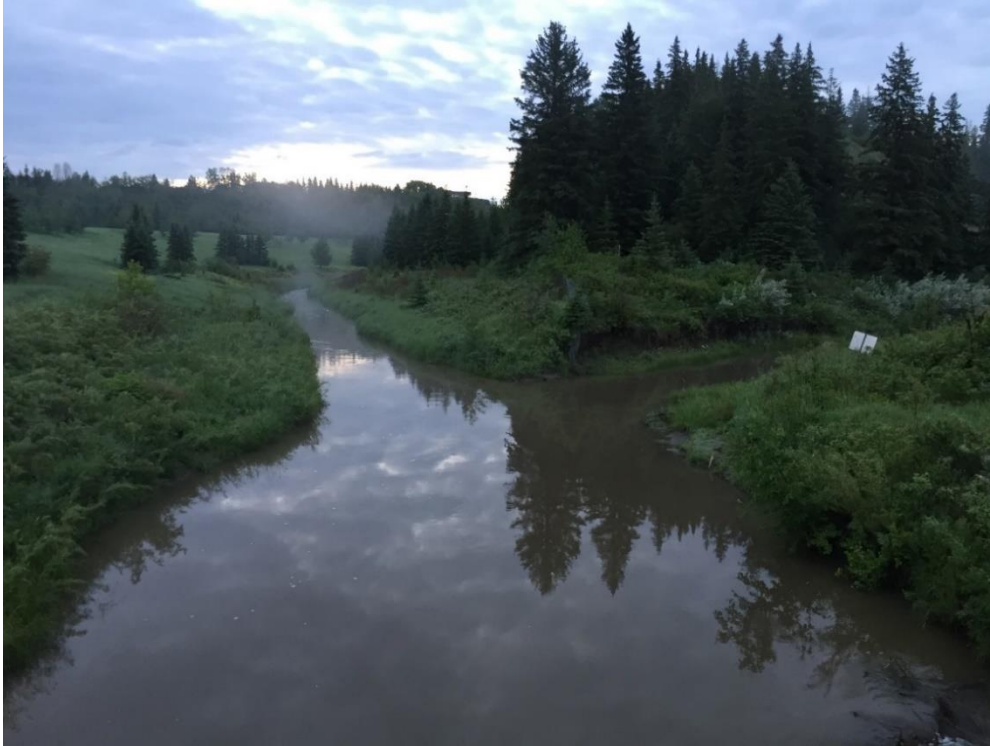
Plate 3.1. Looking upstream from the existing pedestrian bridge at the confluence of Blackmud (left) and Whitemud (right) Creeks (26 June 2019).

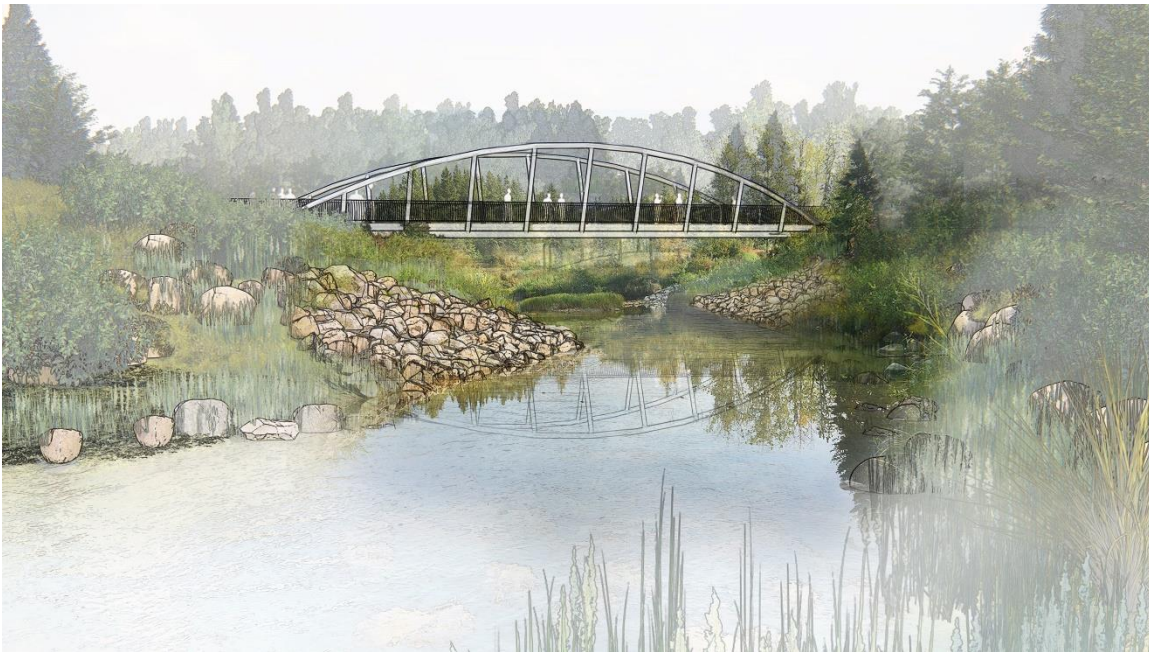
Plate 4.3. Conceptual Plan View of Proposed Steel Tied-Arch Bridge Design at Smith Crossing (Provided by: Morrison Hershfield, City of Edmonton and EDA Planning + Urban Design 2021)

Five superstructures type options were considered for pedestrian bridge replacement: 1) tilted tied arch; 2) pony truss; 3) slab-on-girder; 4) steel tub girder; and 5) FRP bridge. Evaluation criteria included life-cycle cost/maintenance, sustainable urban integration/aesthetics, hydraulic clearance improvements, design risk, and constructability/schedule (with respect to supply chains, ease of fabrication and erection feasibility). Project stakeholders also identified bridge aesthetics as an important consideration in bridge design considering the natural environment in the project area. Based on these criteria, the City selected Option 1- tilted tied arch as the preferred option to advance to detailed design. Conceptual renderings of the proposed new bridge are provided below in Plates 4.3 and 4.4.

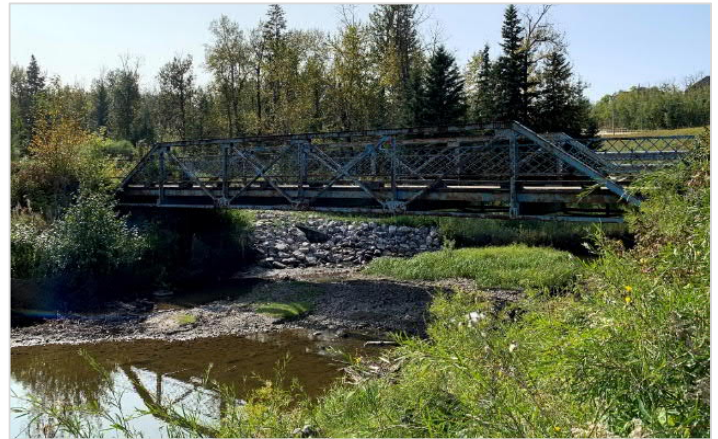
The Bridge is a single span (24.38 m) steel pony truss fabricated and constructed by Alberta Transportation in the early 1900s. The bridge carries the MacTaggart Sanctuary trail system across Whitemud Creek. The bridge is much loved by the public and a commemorative plaque on a boulder identifies the namesakes of the bridge.

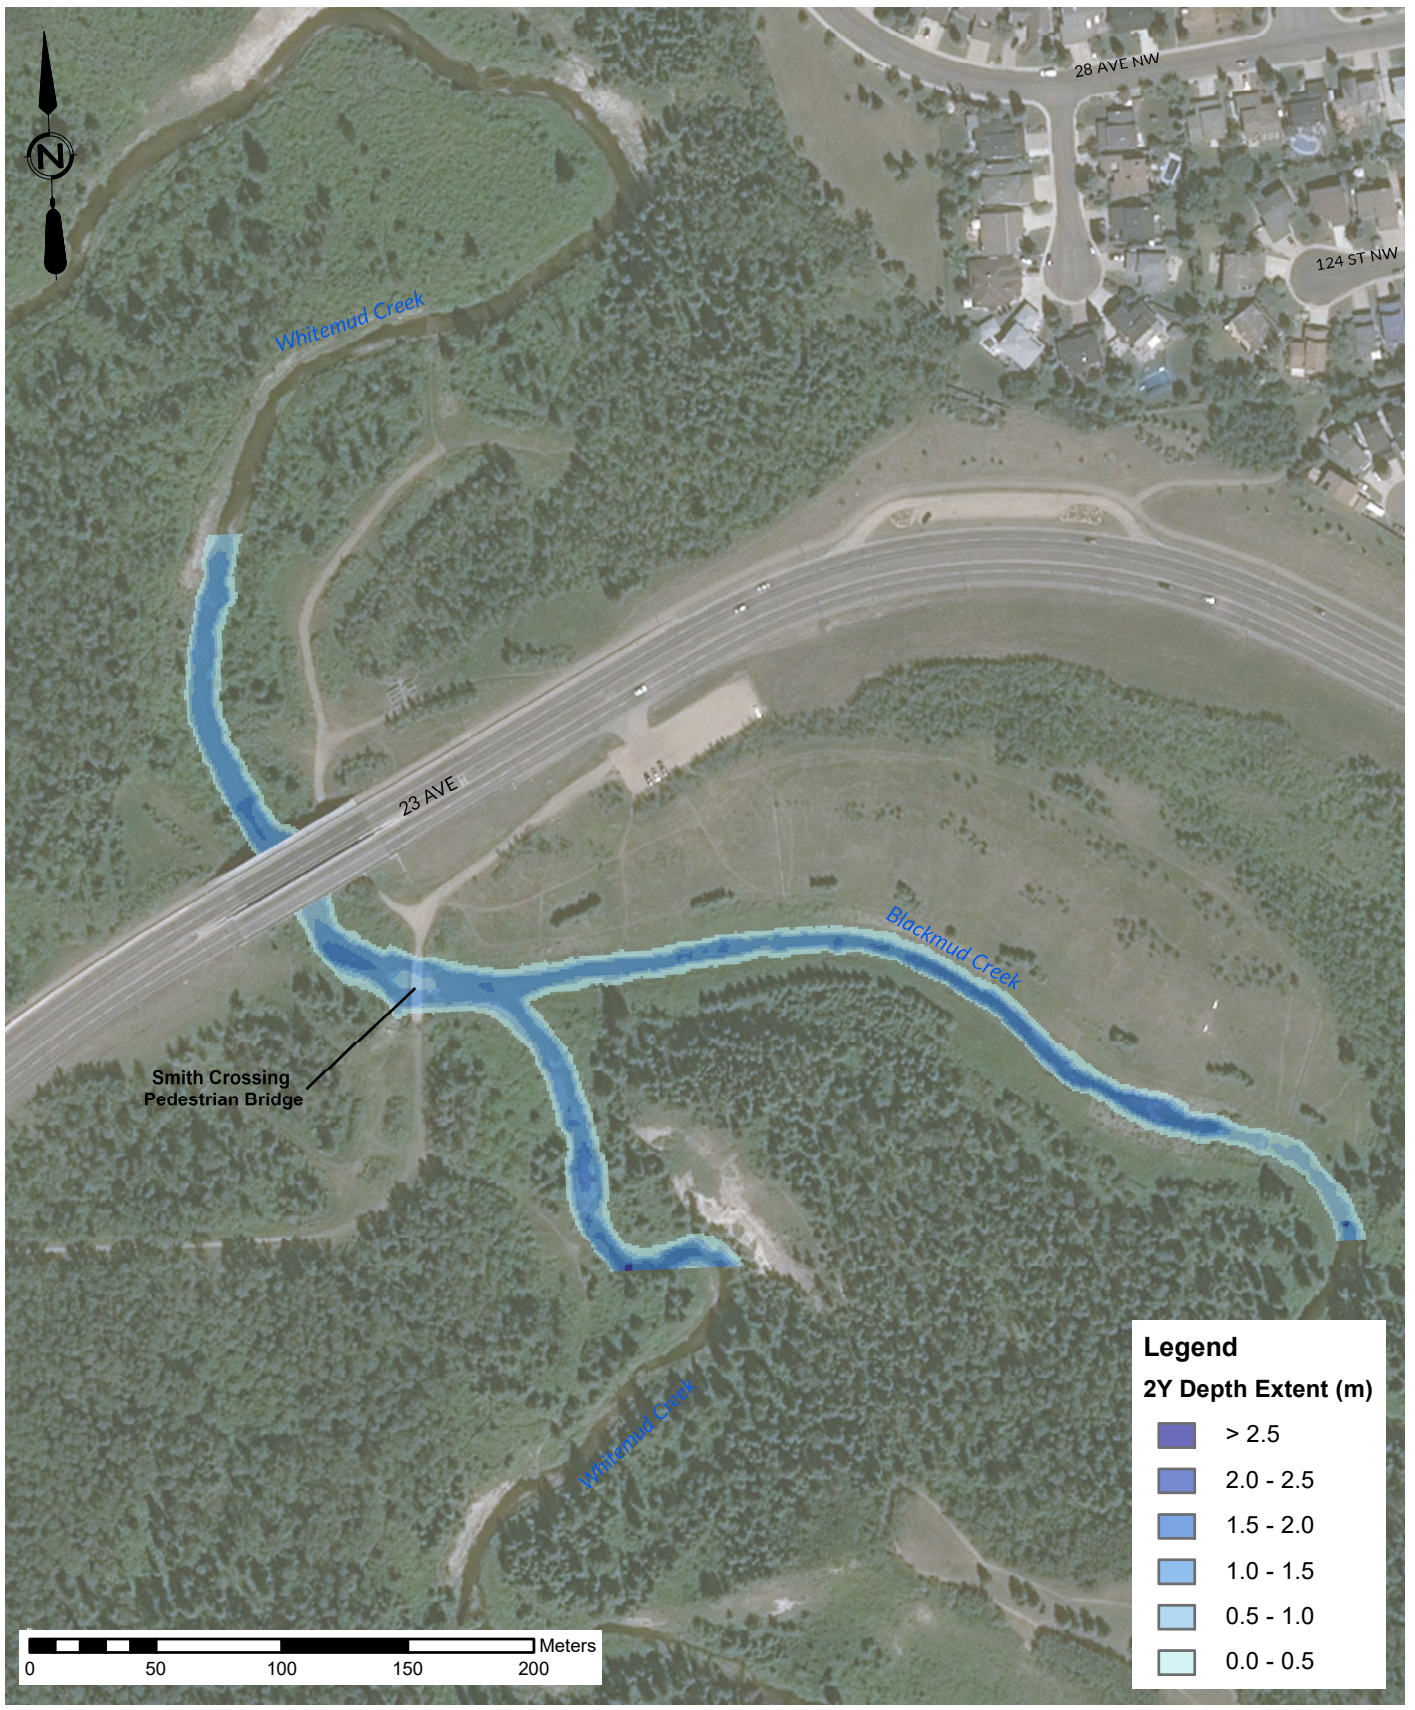
FIGURE 4-2

Figures 4-2 and 4-3 show the maximum simulated flood depths and extents within the 2D model domain during each design flood event. The water level elevations at the Smith Crossing Pedestrian Bridge during each model simulation are summarized in Table 4-1.

Results indicate that during the 100-year design flood event, the existing bridge soffit elevation is under water. High water levels have not significantly impacted the bridge during its lifespan. Therefore, the replacement pedestrian bridge bottom of soffit elevation should be located at or above the existing elevation.

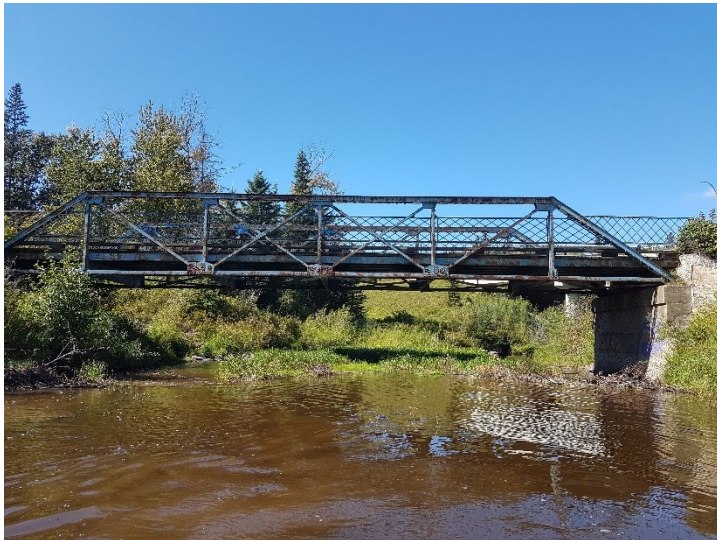
Plate 3: Looking downstream at the bridge structure.

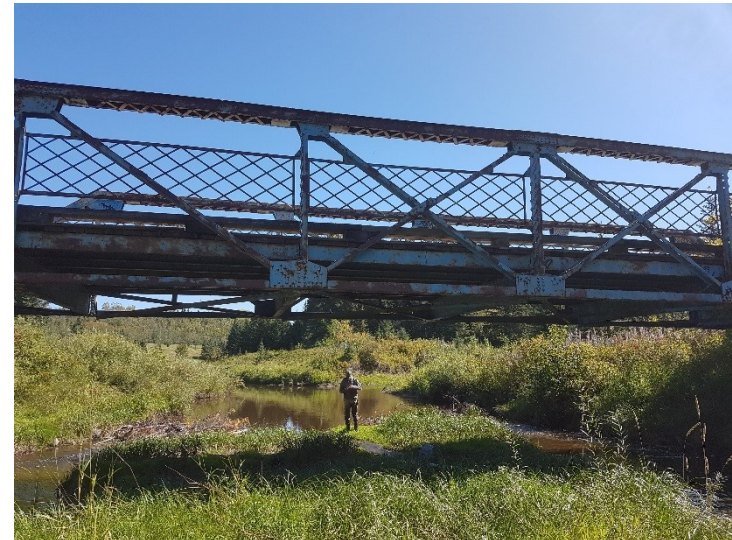
Plate 4: Looking upstream at the bridge structure.

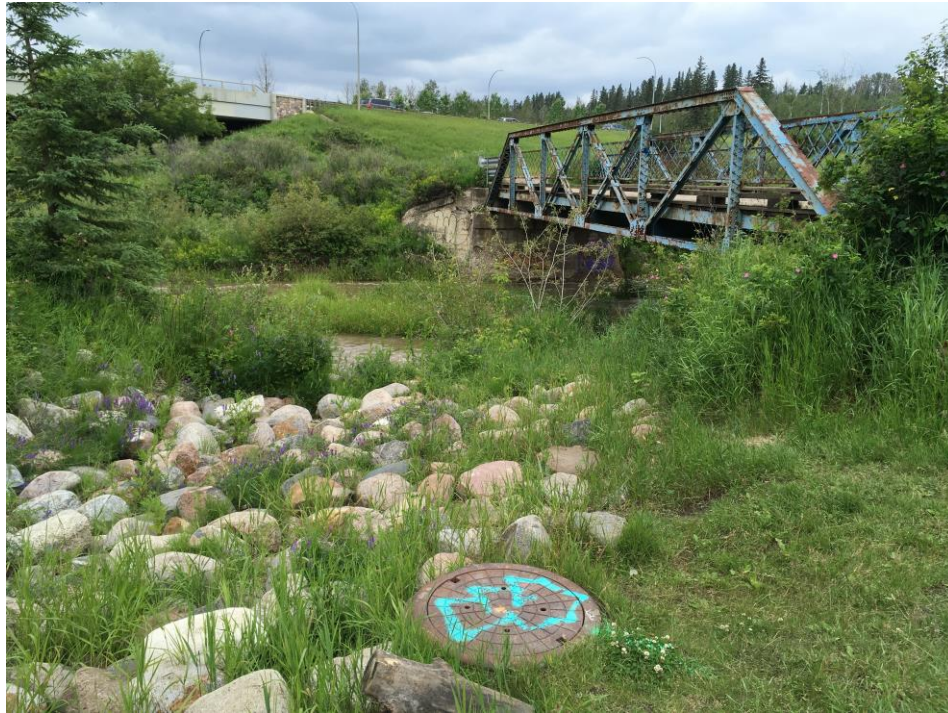
Photo 1 – View of Smith Crossing Bridge (Looking North).

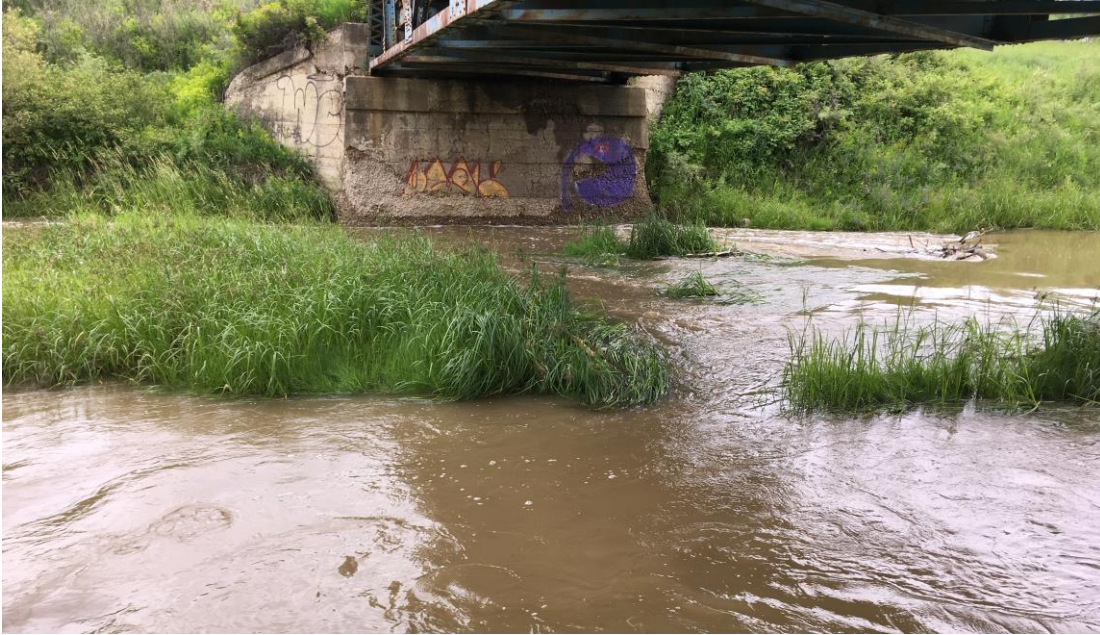
Photo 3 – View of Existing North Abutment (Looking North)

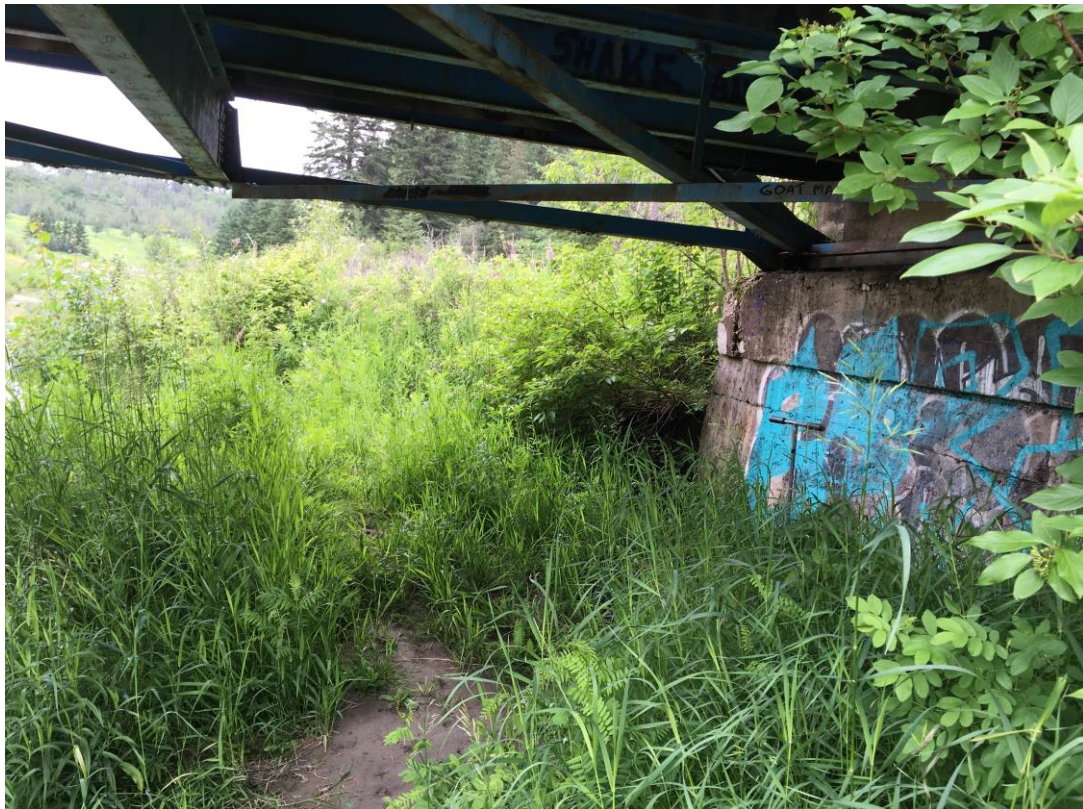
Photo 4 – View of Existing South Abutment (Looking from East)
