Environmental Impact Assessment

Mill Creek Ravine Pedestrian Bridge #278

Rehabilitation and Trail Upgrades

Project: EB213002

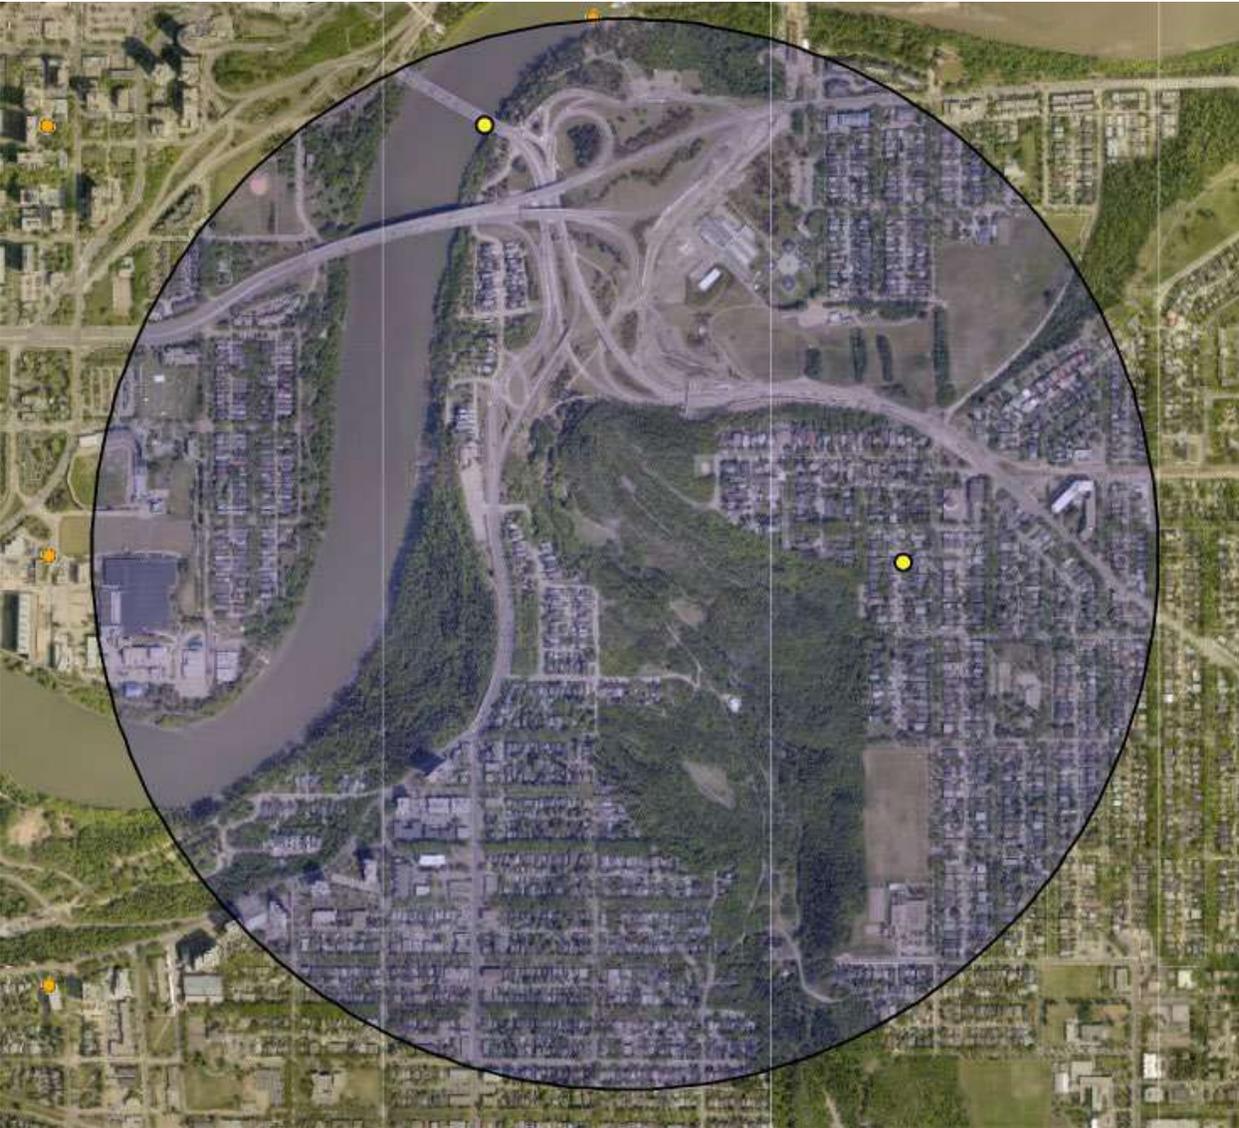
Figure 3. Alberta Water Well Database Image Showing Water Wells Within a 1,000 m Radius of the Project Site

The water well records summarized in the Reconnaissance Report (Appendix F) show that neither borehole log indicates the use of water wells near the LSA, nor the presence of a domestic use aquifer (DUA) as defined in AEP's (2016) Alberta Tier 1 Soil and Groundwater Remediation Guidelines.

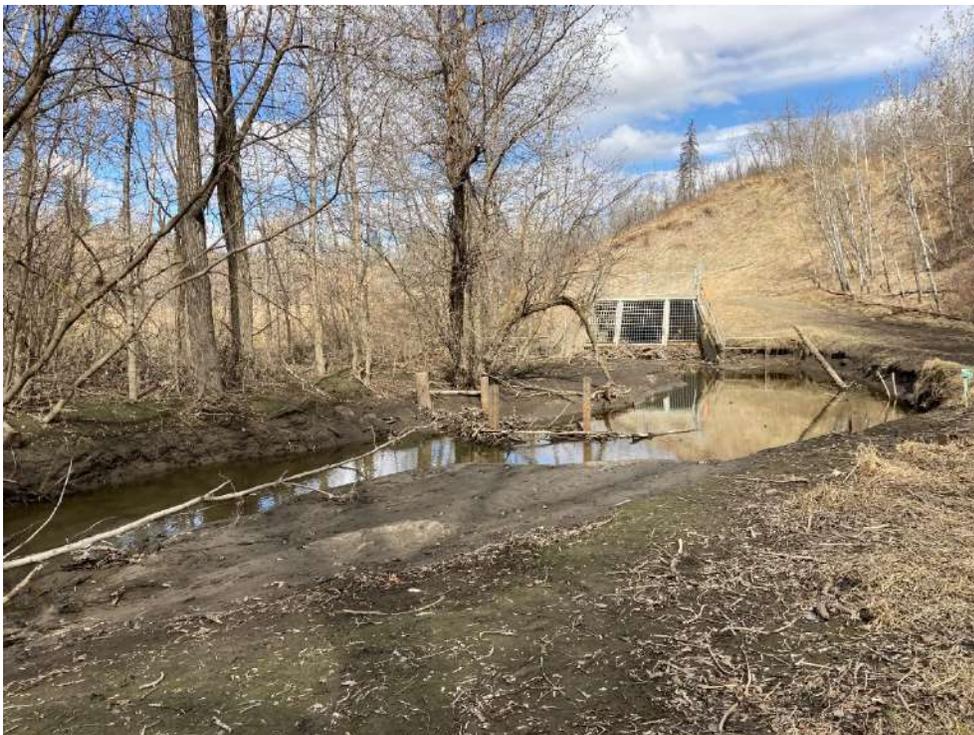
Figure 2-1: Looking at EPCOR Inlet Structure (Note; Debris catcher in channel and debris blockage at inlet screen (April 19, 2021 site visit photo)

SPCSP culvert followed by 300 m of 3800 mm dia concrete lined tunnel ending at the outfall to the North Saskatchewan River (See EPCOR Drawings in Appendix D). As mentioned previously, the study site is prone to backwater effects due to blockage at the EPCOR water intake structure (See Figure 2-1).

- 1- EPCOR inlet structure with zero blockage (a datum elevation of the surveyed creek bed of 625.0 was used, which shows that sediment and silt accumulation on the face of the grating is in the order of 2m deep)
- 2- Blockage of 10% of the area of the grating above the datum elevation up to elevation 625.8
- 3- Blockage of 20% of the grating up to elevation 626.1
- 4- Blockage of 33% of the grating up to elevation 626.5, which represents the existing surveyed debris blockage. This inlet blockage was also used to calibrate or validate the HEC-RAS model with the surveyed 2020 flood high water marks (elevation of 628.5).
- 5- At the request of the City, blockage up to 50% of the grating to an elevation of 627.1 (which would represent over 2 m (almost 7') of accumulated debris.

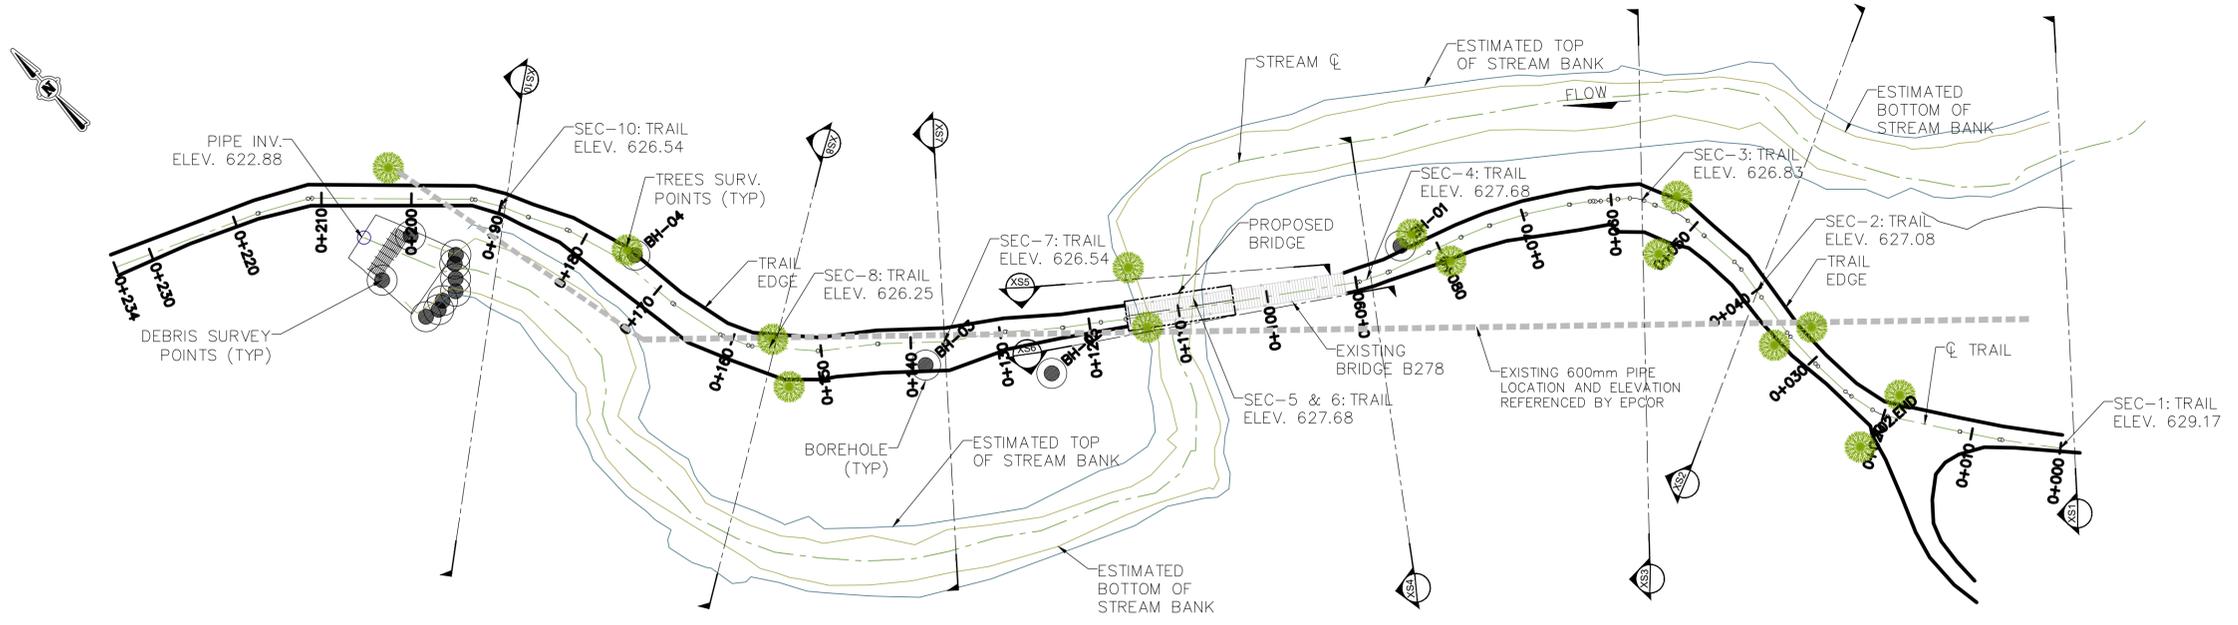
SITE PLAN
PROJ NO. EB213002 Scale 1:400

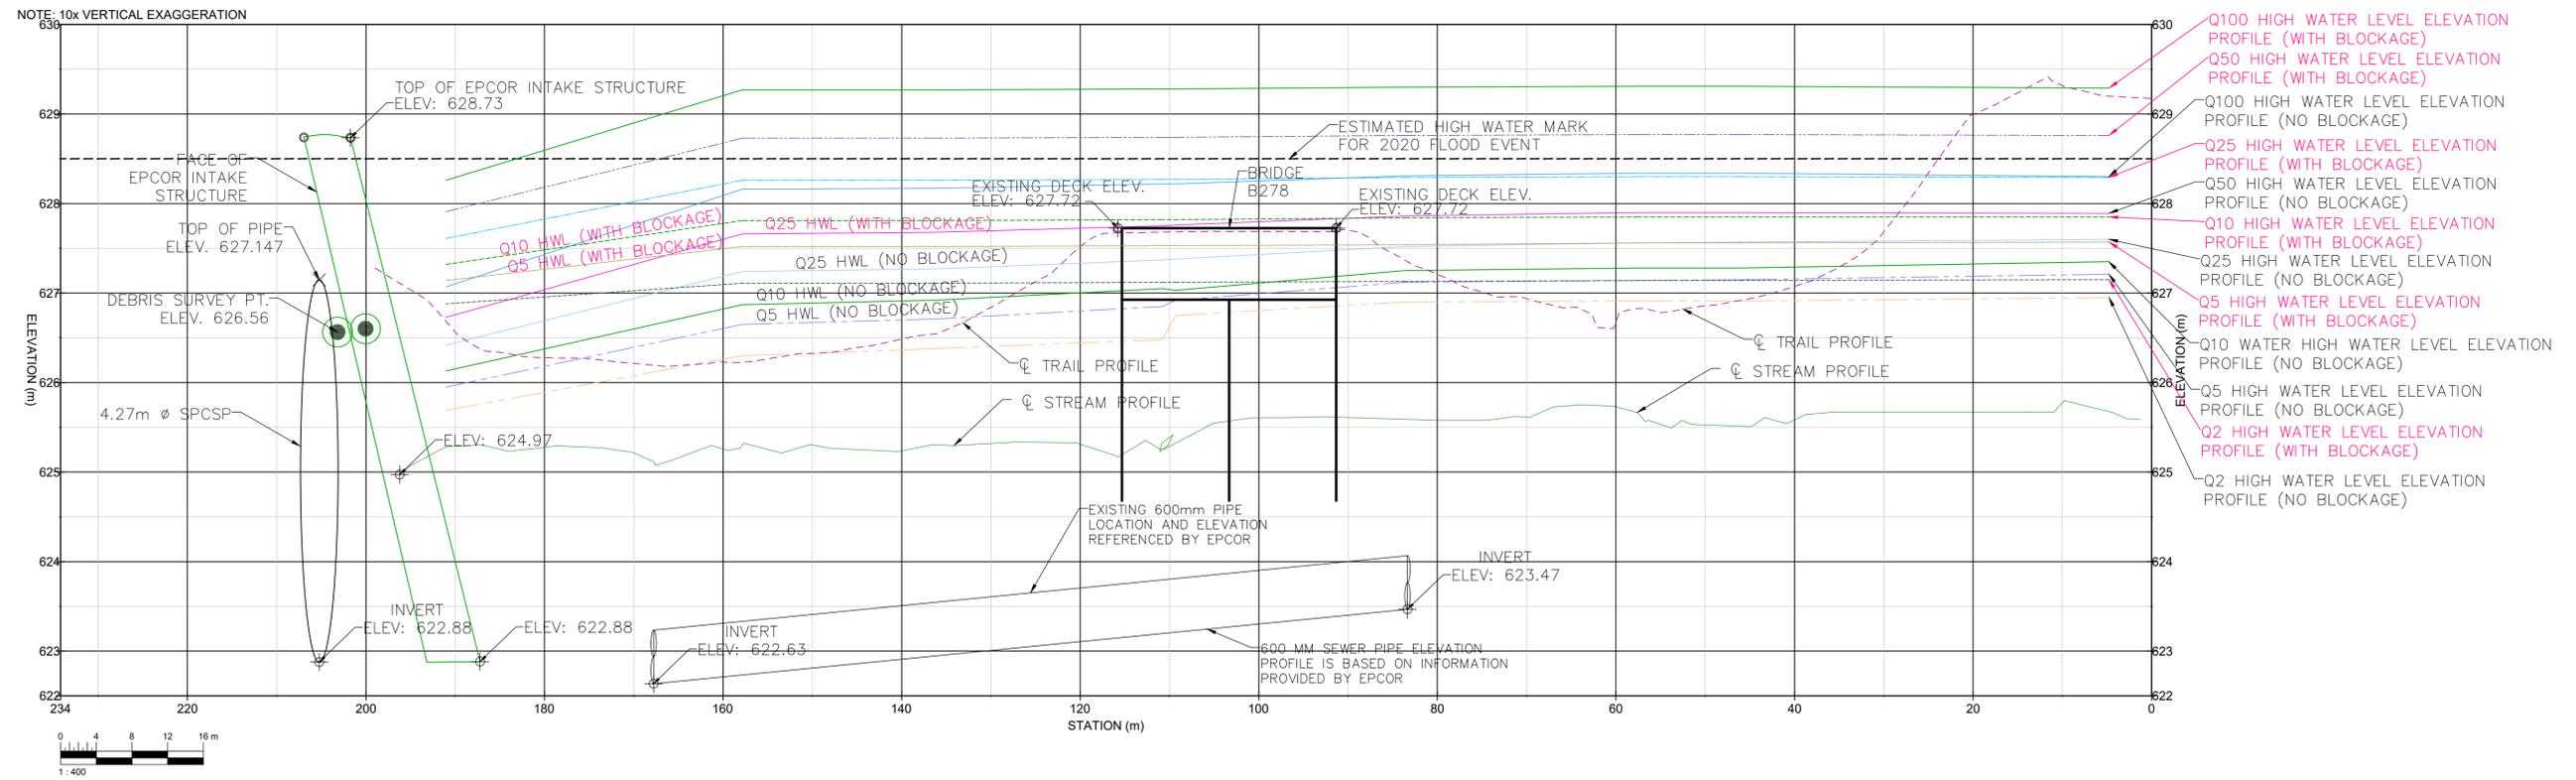
B278 BRIDGE AND ASSOCIATED TRAIL PROFILE WITH WATER LEVELS NO BLOCKAGE AND WITH 33% BLOCKAGE TO ELEVATION 2.5
PROJ NO. EB213002 Scale HORIZ: 1:400 VERT 1:40

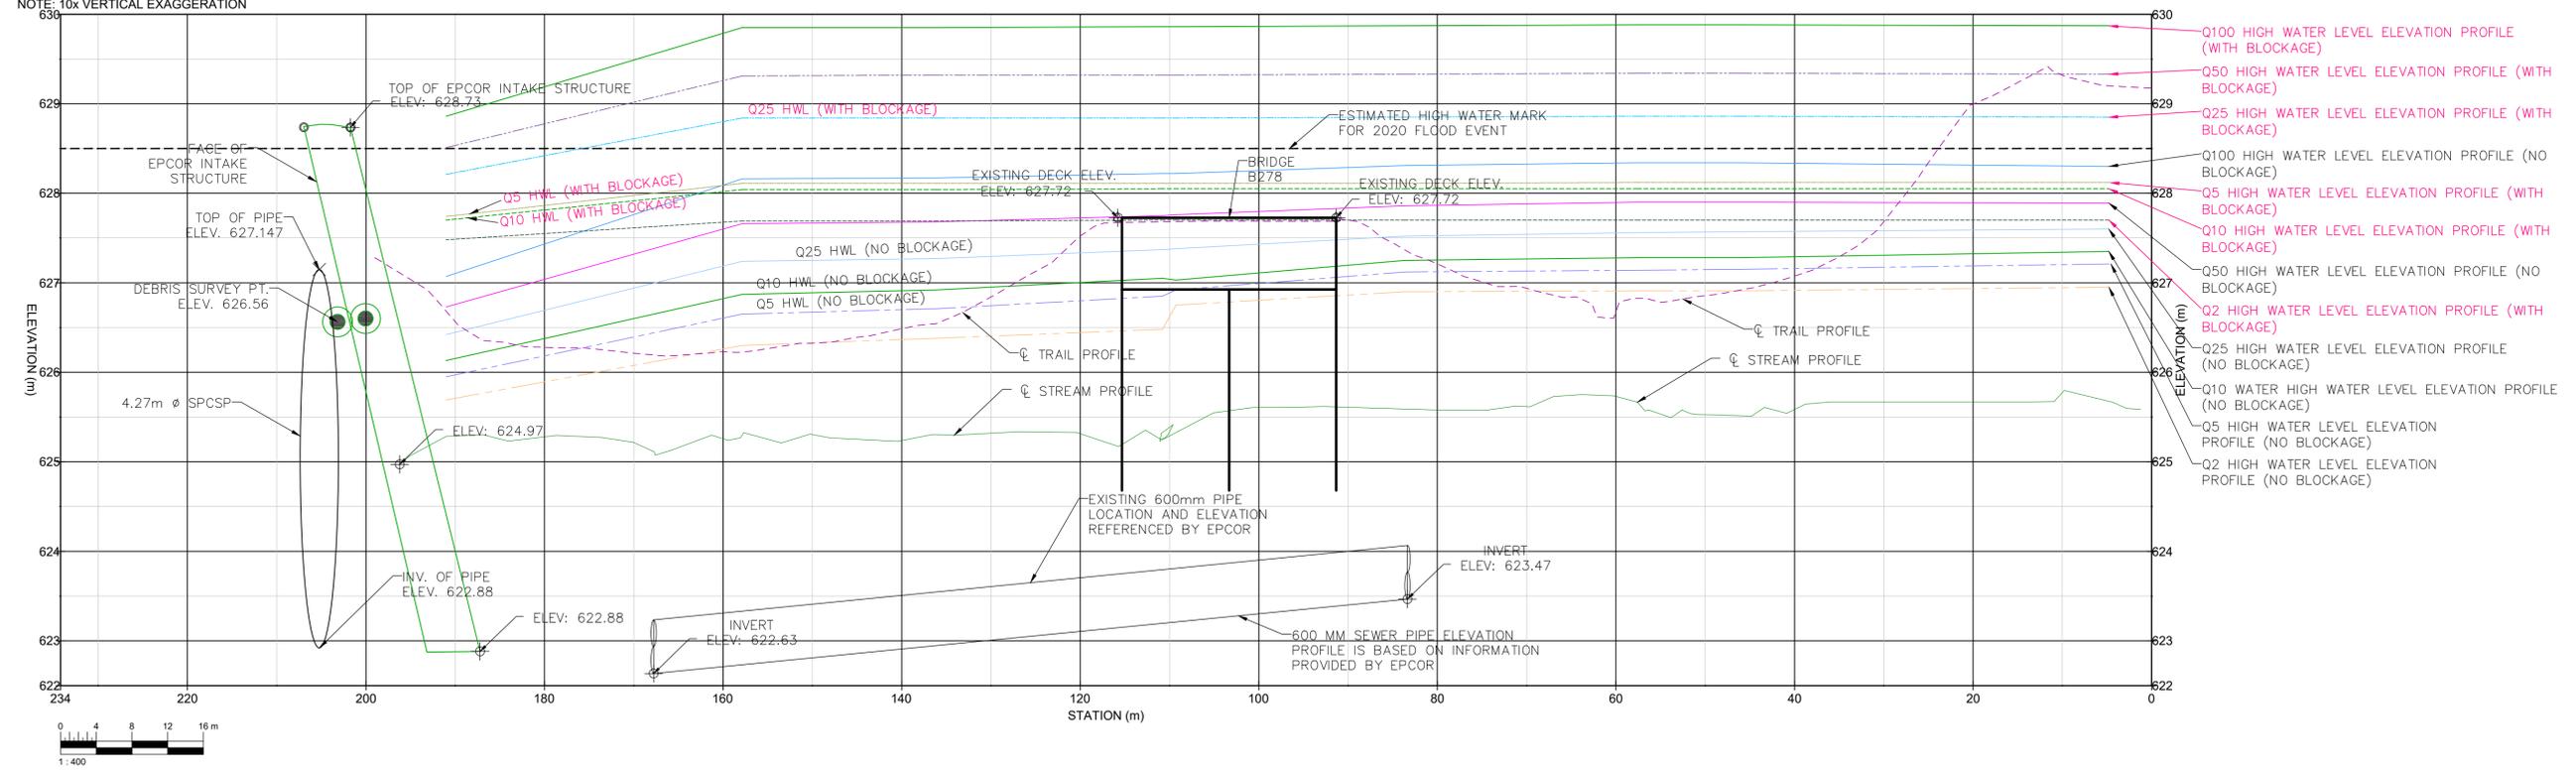
B278 BRIDGE AND ASSOCIATED TRAIL PROFILE WITH WATER LEVELS NO BLOCKAGE AND WITH 50% BLOCKAGE TO ELEVATION 271
 PROJ. NO. EB213002 Scale HORIZONTAL 1:400 VERTICAL 1:40

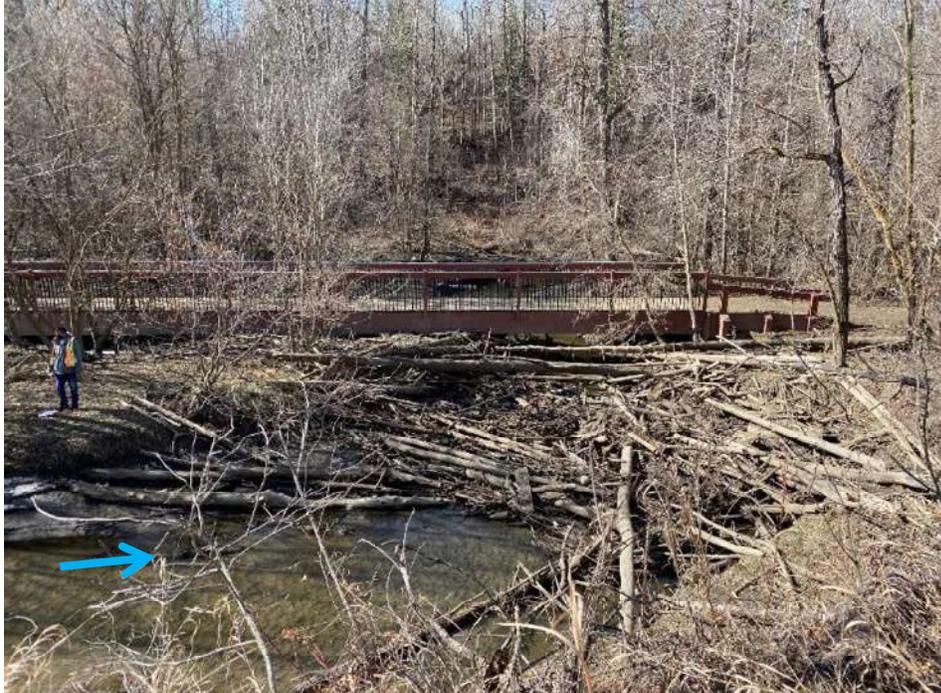
<p>Photo 1</p> <p>Looking downstream (southwest) at the west section of the bridge B278. Note the accumulated debris upstream of the bridge. Also note that Mill Creek main channel is only under the west bridge span. Photo taken April 19, 2021.</p>

Wood debris, some of it substantial in size and length compared to the bridge opening, is accumulated immediately upstream of the bridge, which considerably restricts the bridge's hydraulic opening (see Photos 1, 2 and 3). Rock filled gabion baskets were located along the toe of the north (right) bank at the bridge site (see Photo 4).

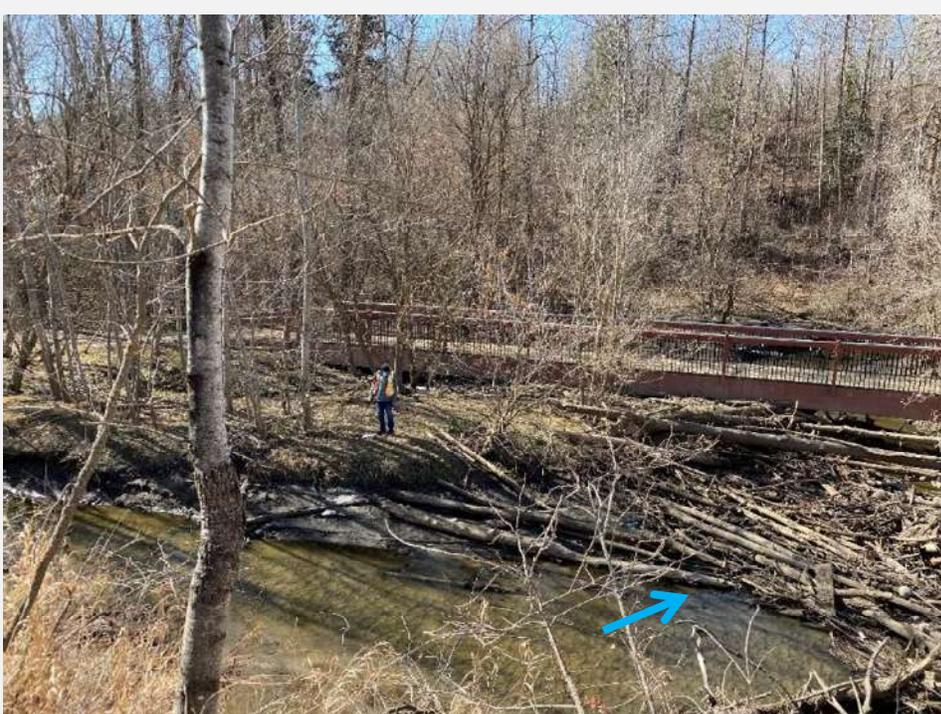
<p>Photo 2</p> <p>Looking downstream (southwest) at the east section of the bridge B278. Note the accumulated debris upstream of the bridge. Also note that the east bridge span is in the floodplain. Photo taken April 19, 2021.</p>

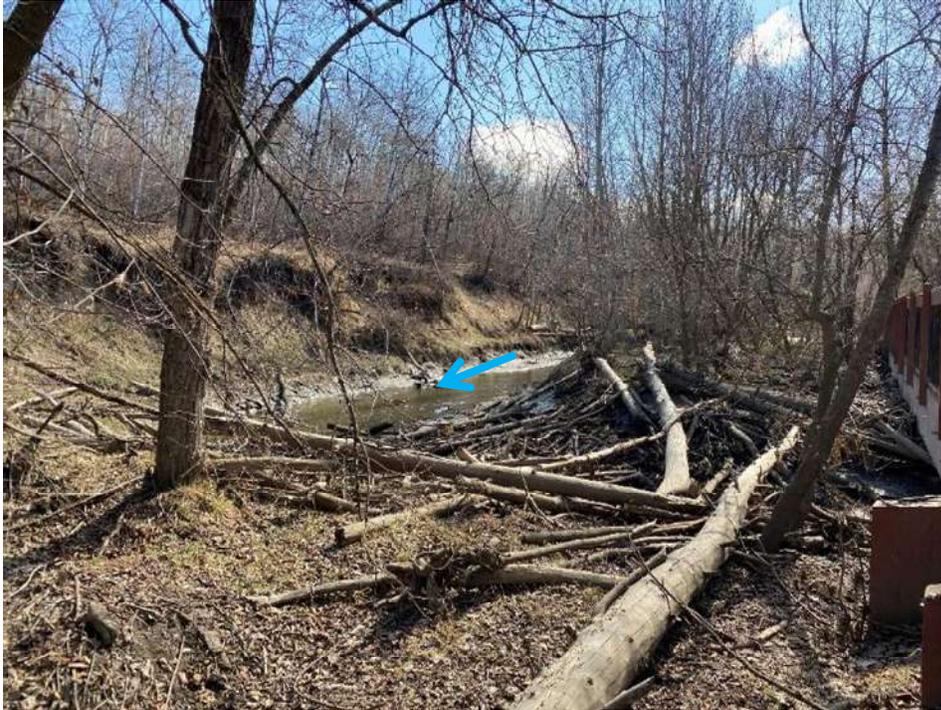
Photo 3
Looking upstream (southeast) Note the accumulated debris upstream of the bridge. Also note the 90-degree meander bend and the steep east (right) bank. Photo taken April 19, 2021.

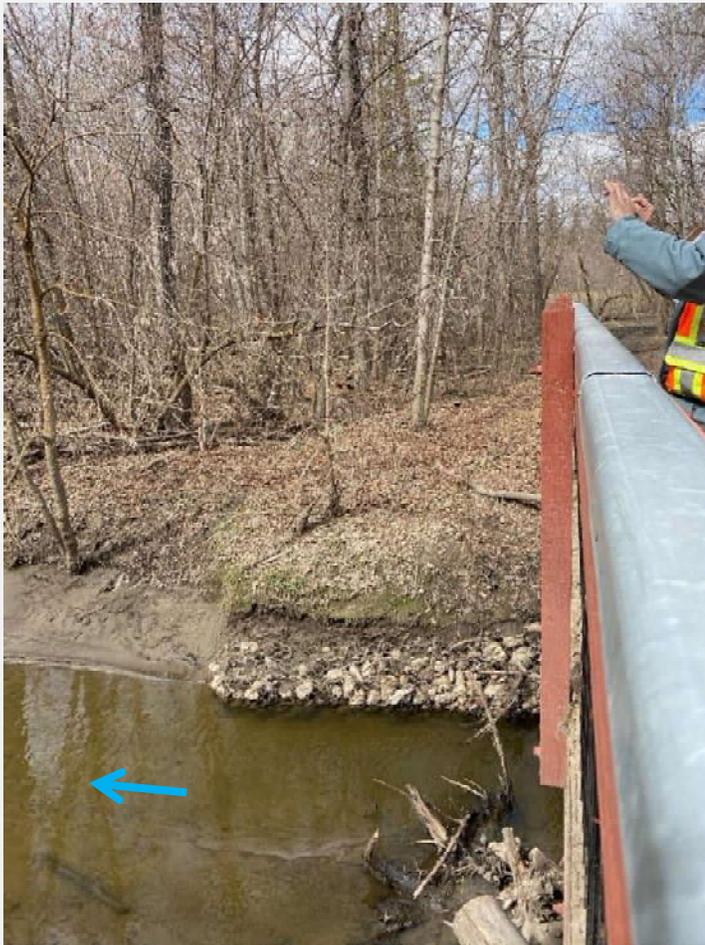
Photo 4
Looking northwest at the downstream end of bridge B278. Note rock filled gabion baskets along the northwest (right) bank. Photo taken April 19, 2021.

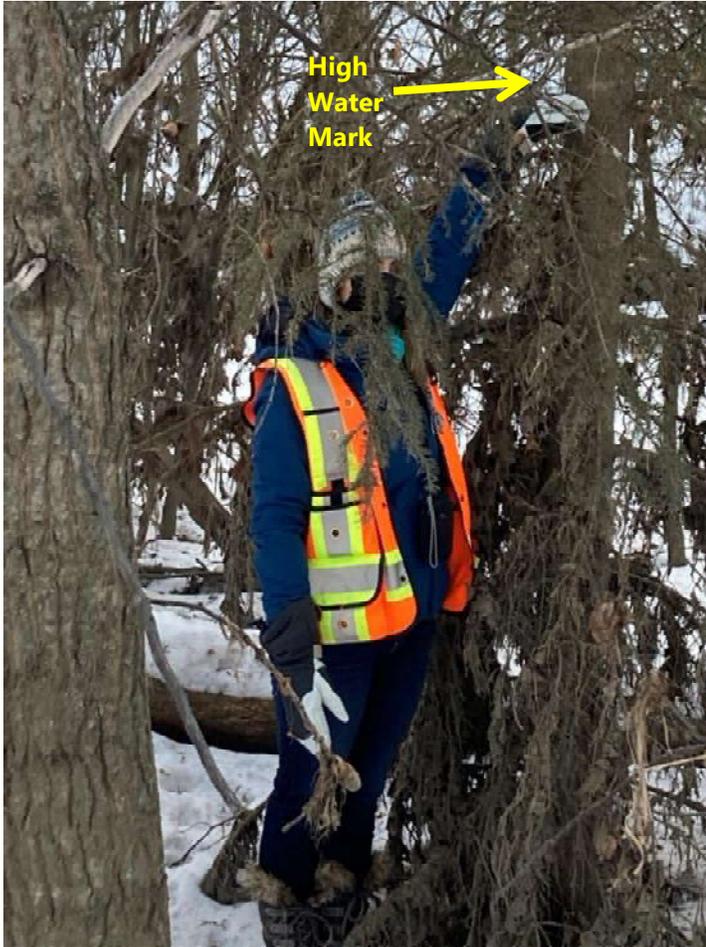
Photo 5
High water mark located in the floodplain northwest of bridge B278. Photo taken January 5, 2021.

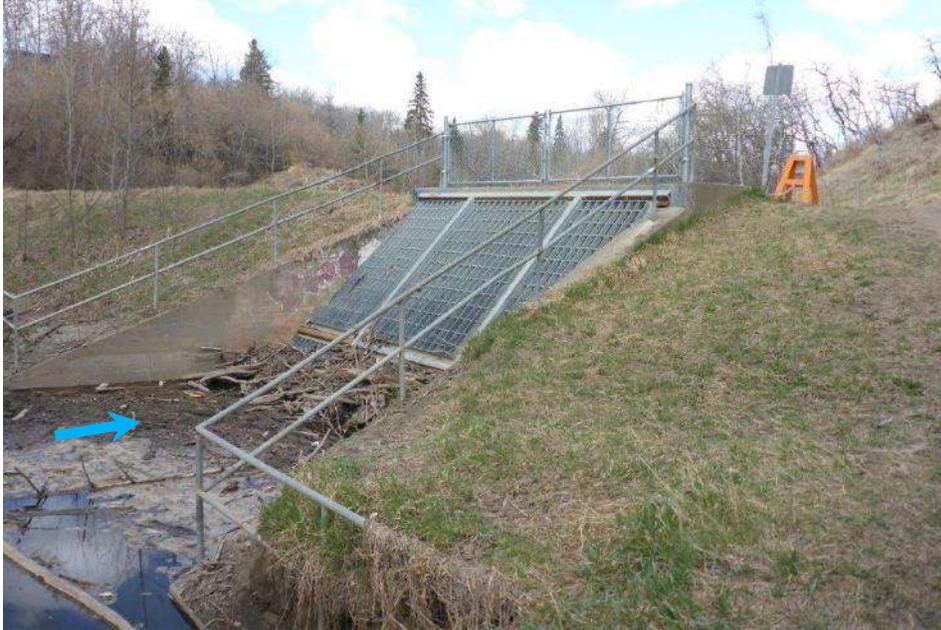
Photo 7
Looking north at
EPCOR SPCSP
structure. Note
debris on trash
rack upstream of
SPCSP structure.
Photo taken
May 5, 2021.

Approximately 100 m downstream of the bridge, Mill Creek flows into a structural plate corrugated steel pipe (SPCSP) with an approximate diameter of 4.3 m, which is operated by EPCOR (see Photo 6). The reinforced concrete inlet structure has an angled grating (screen) to block debris from entering the culvert; debris was accumulated at the base of the grating during the site visit (see Photo 7).

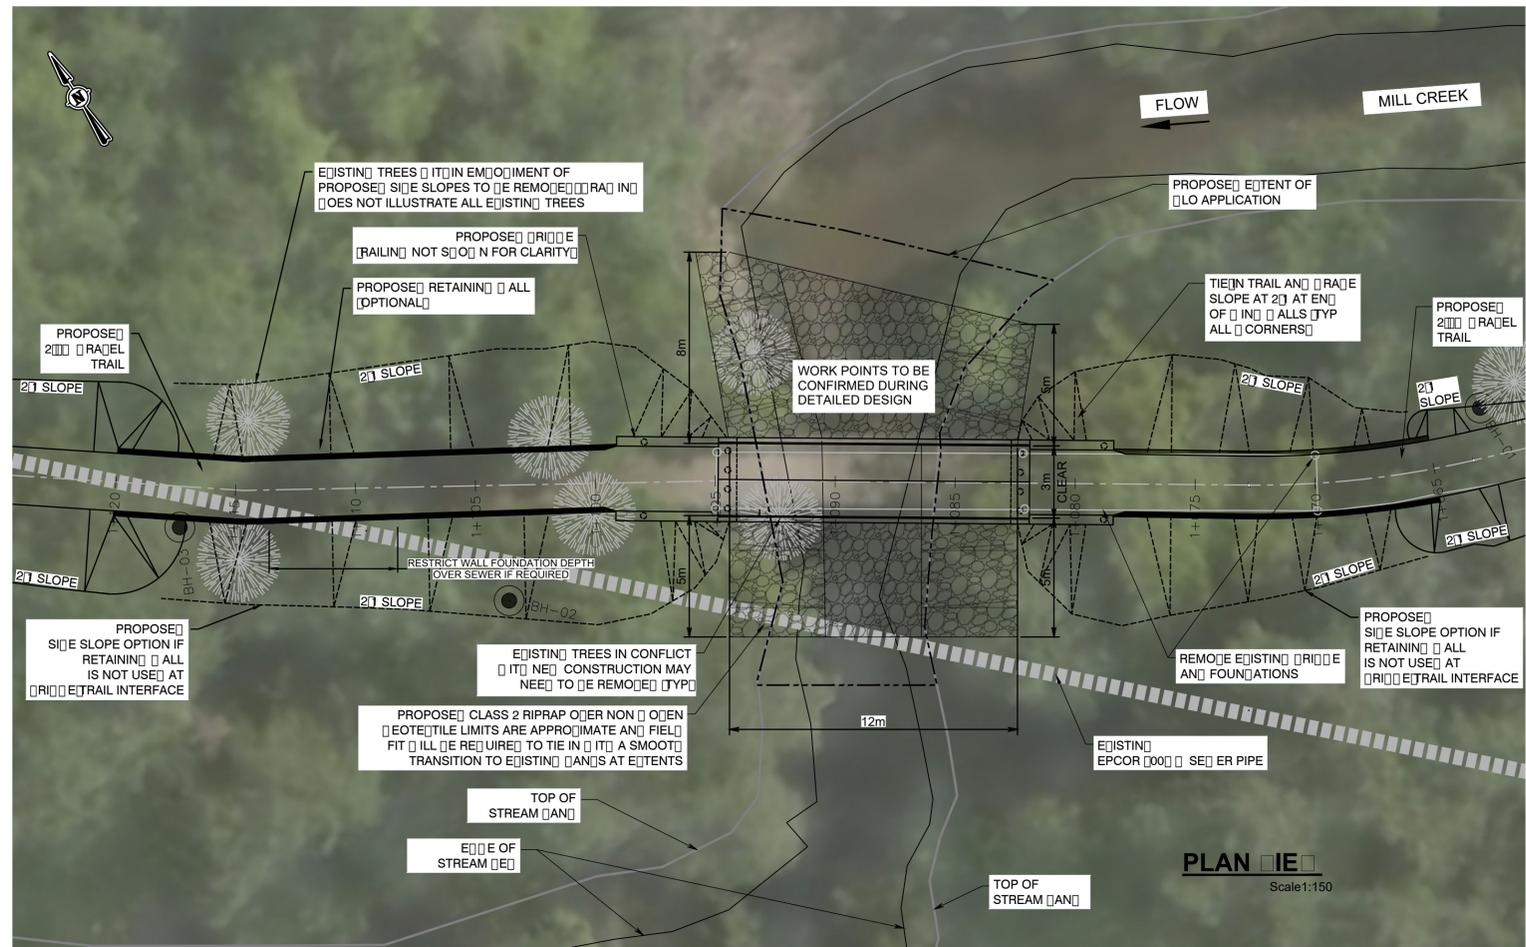
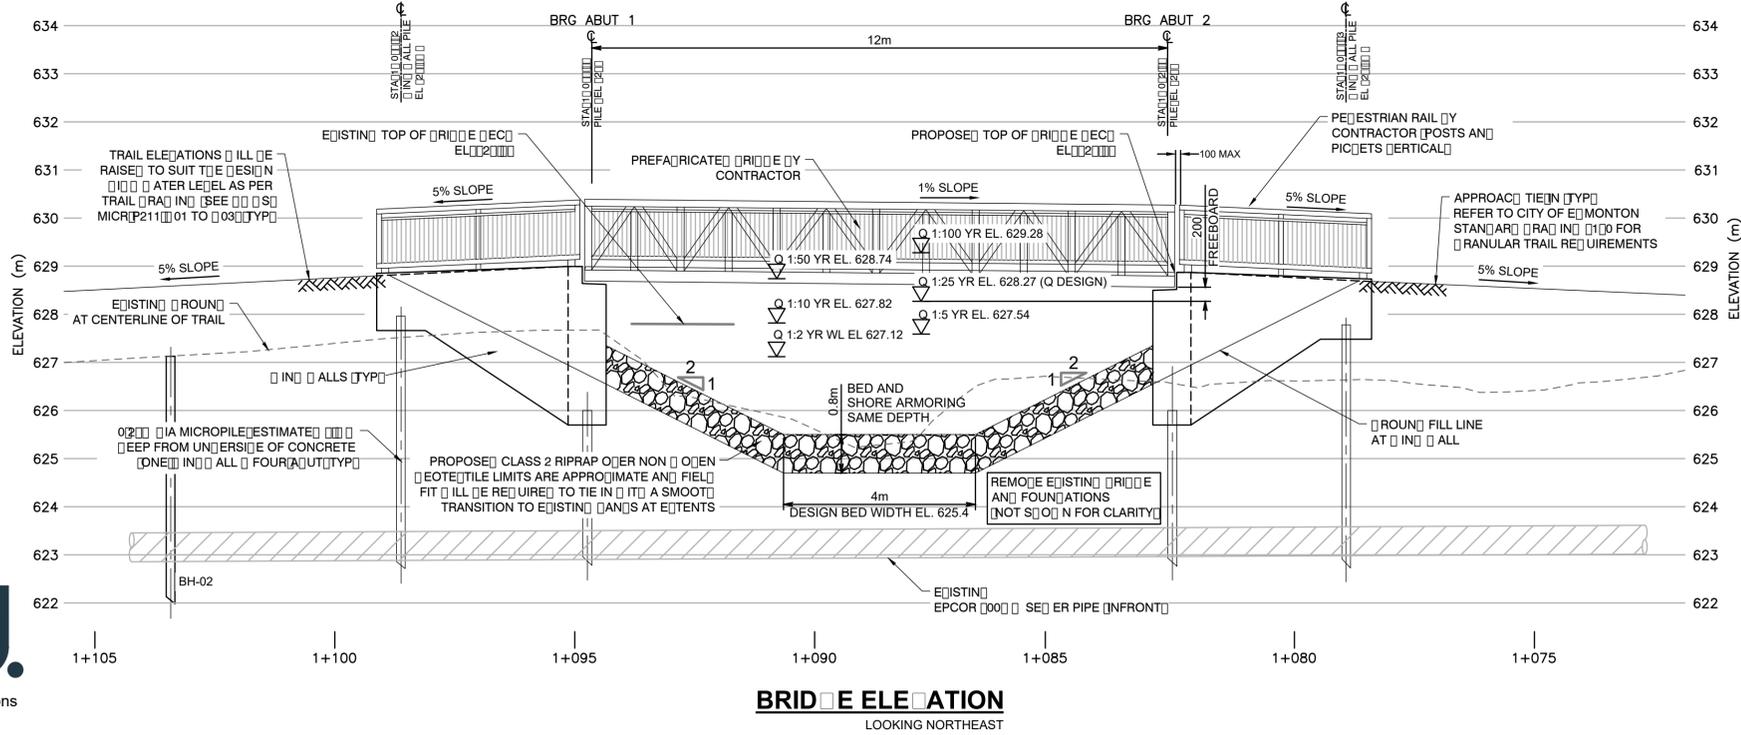
DRAWING: MICR-P211-S01

- NOTES
- 1) TOP OF DECK ELEVATION HAS BEEN ESTIMATED BY ALLOTTING IN 300mm ABOVE TO BE ESTIMATED TO LIFT 200mm FREEBOARD
 - 2) ALL ELEVATIONS ARE FROM THE ELEVATION POINTS LOCATED ON THE EPCOR INTAKE STRUCTURE RATING TO AN ELEVATION APPROX 1m ABOVE CURRENT STREAM PROFILE
 - 3) EXISTING SLOPE NOT SHOWN APPLICATION FOR NEW SLOPE PER OUTLINE SHOWN IN PLAN
- FOR POINTS TO BE CONFIRMED IN DETAIL DESIGN

RETURN PERIOD (YEARS)	MAX INSTANTANEOUS DISCHARGE (m³/s)	WATER LEVEL ELEVATION (m) (See Note 2)	SOFFIT ELEVATION OF PROPOSED BRIDGE (m) (See Note 1)	TOP OF DECK ELEVATION FOR PROPOSED BRIDGE OPTION (m) (See Note 1)	COMPARE TO ELEVATION OF THE EXISTING BRIDGE DECK (m) (+/- ABOVE OR BELOW EXISTING)
100	50	629.28	629.48	629.78	2.10
50	36	628.74	628.94	629.24	1.56
25 - Q DESIGN	25	628.27	628.47	628.77	1.09
10	16	627.82	628.02	628.32	0.64
5	11	627.54	627.74	628.04	0.36
2	5	627.12	627.32	627.62	-0.16

The Project will involve replacement of the existing two-span timber bridge with a new 3.0 m wide by 12m length single span steel truss with bridge abutments outside or above the active channel defined by the ordinary high-water level (OHW⁵). Headslopes will be constructed at 2H:1V slope and armoured with Class 2 rock riprap extending over the full width of the channel for a depth of 800 mm underlain by non-woven geotextile fabric. The streambed and banks will be reconstructed with riprap extending upstream for 8 m along the north (right) bank and 5 m along the south (left) bank to arrest lateral bank erosion and scour. Riprap will also extend for a 5 m length downstream of the bridge. The channel armoring will transition smoothly into the upstream and downstream natural channel bed and profile elevations and channel widths, as per drawing MICR-P211-S01 (Appendix A.2).

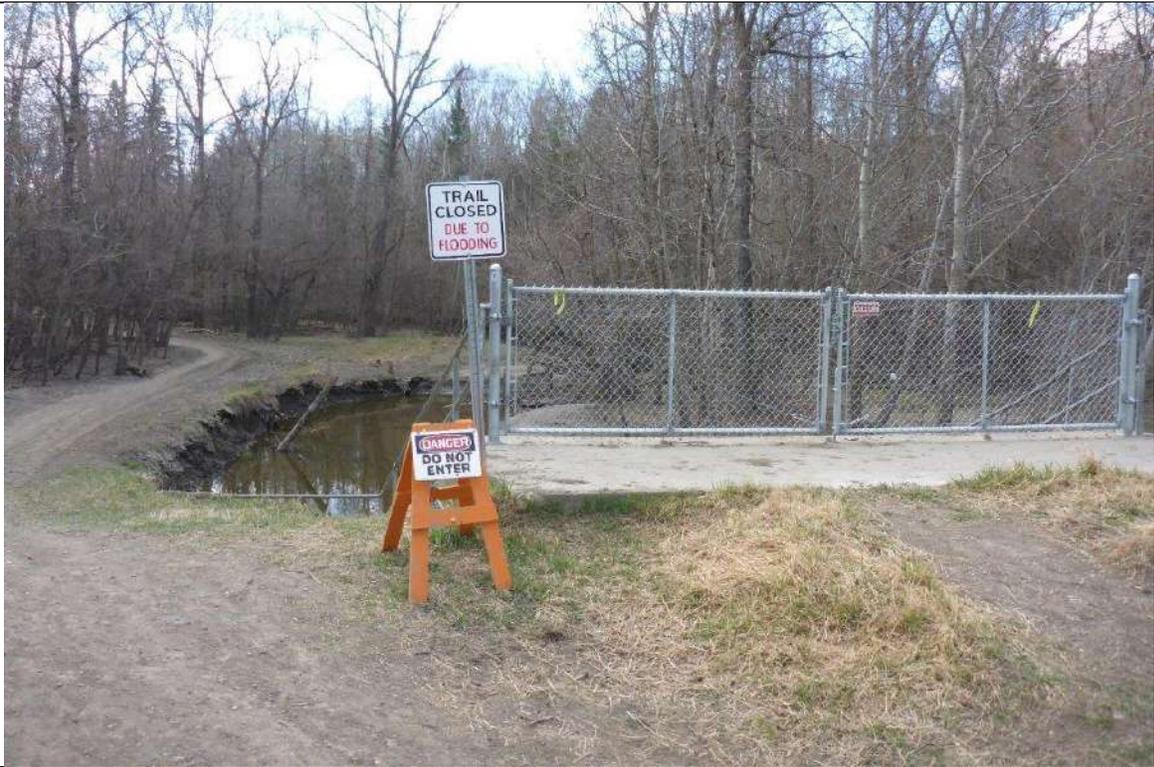
Photograph 1: Signage on Site indicating trail closure due to flooding.

At the time of the visual inspection, signage on Site was observed indicating a trail closure due to flooding in the area as shown in Photograph 1 in Appendix F. Soil erosion was observed in the area around the pedestrian bridge as shown in Photograph 7 in Appendix F. Bridge 278 was viewed during the Site visit, as shown in Photographs 3 through 5 in Appendix F.

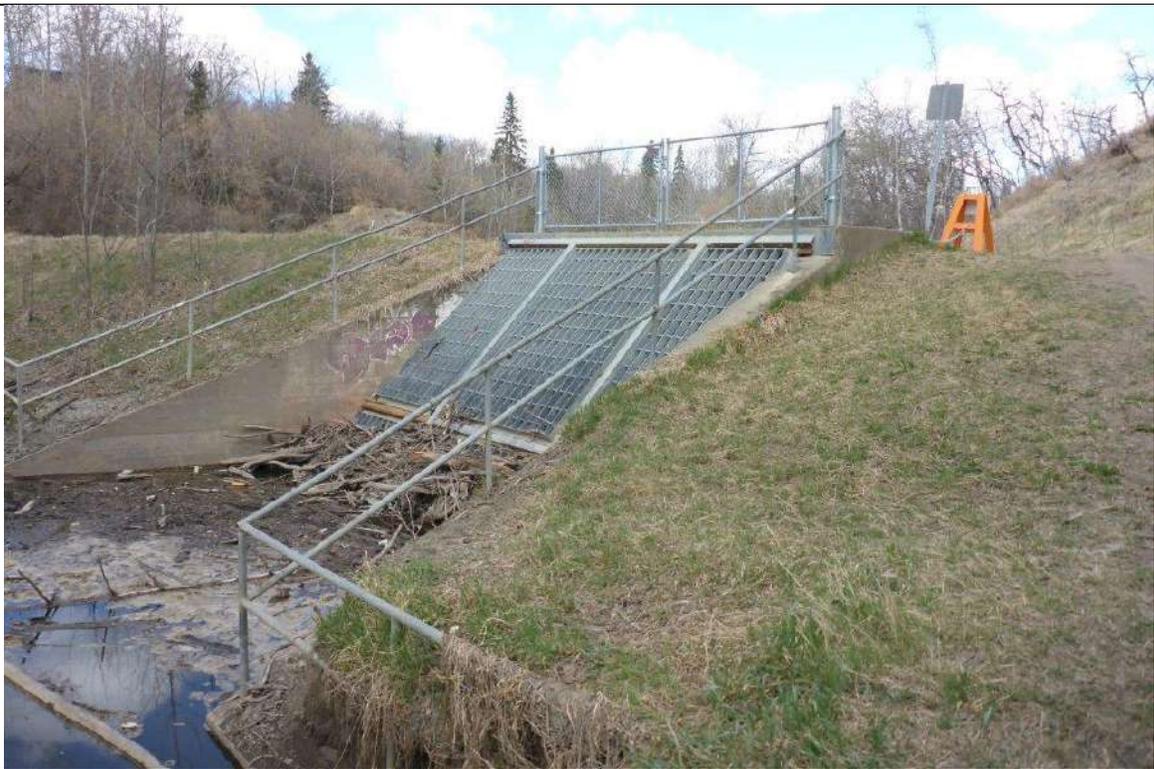
Photograph 2: Inlet structure connecting Mill Creek Ravine to the North Saskatchewan River.

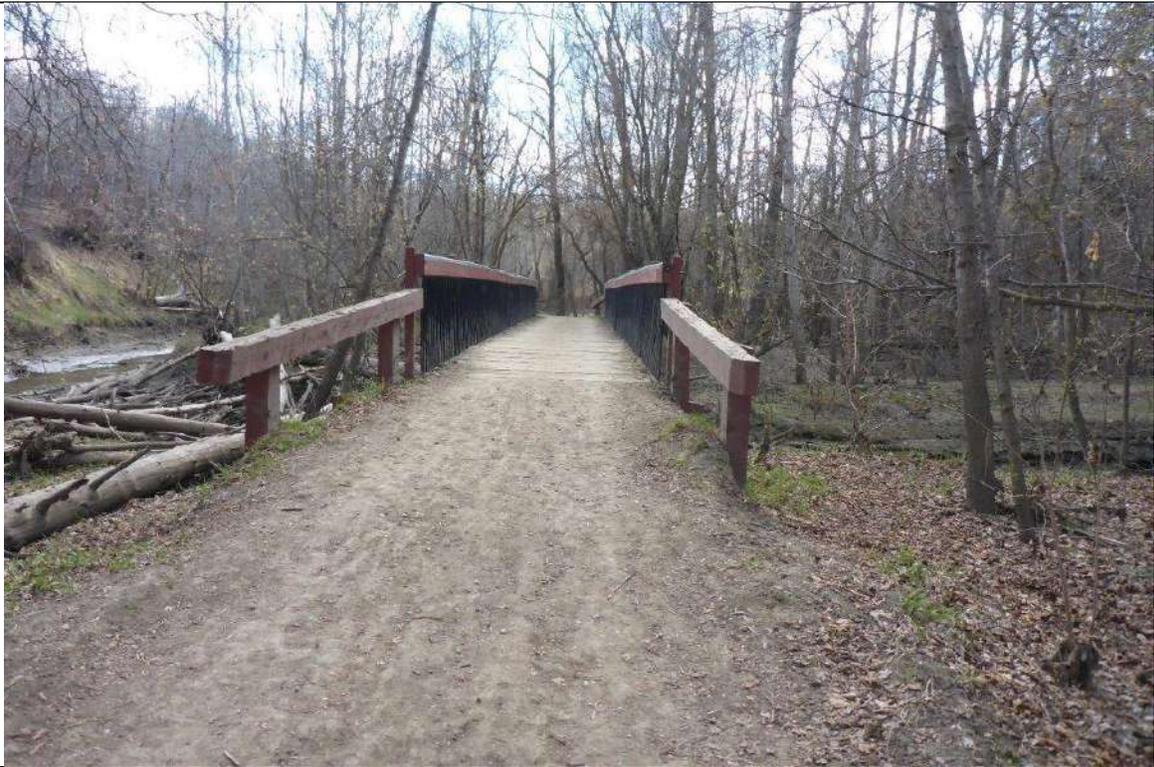
Photograph 3: Bridge 278 as viewed from the southeast.

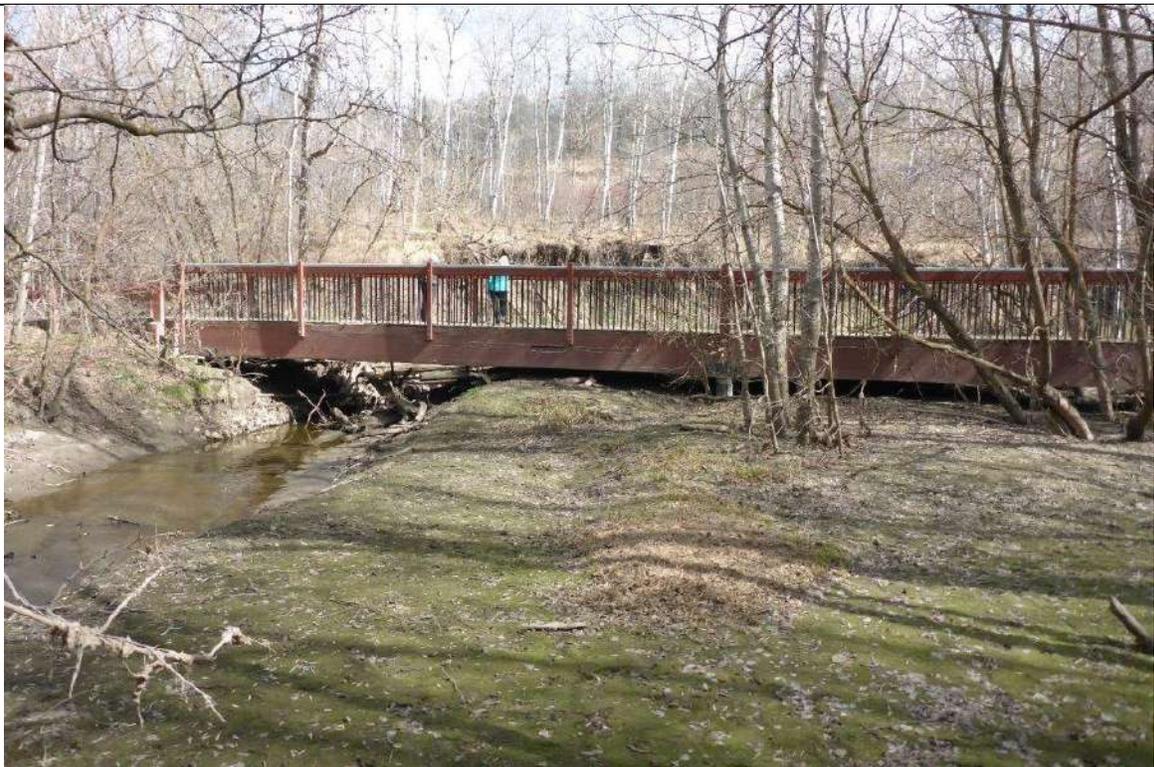
Photograph 4: Bridge 278 as viewed from the southwest.

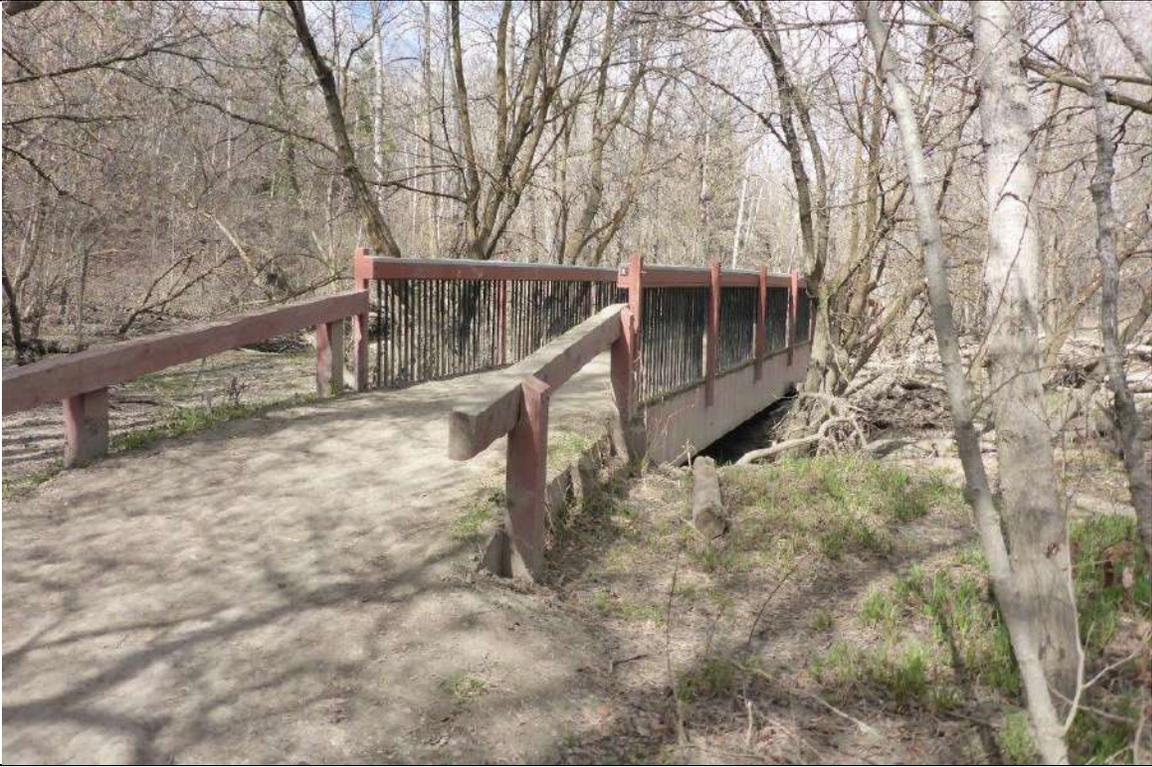
Photograph 5: Bridge 278 as viewed from the south.

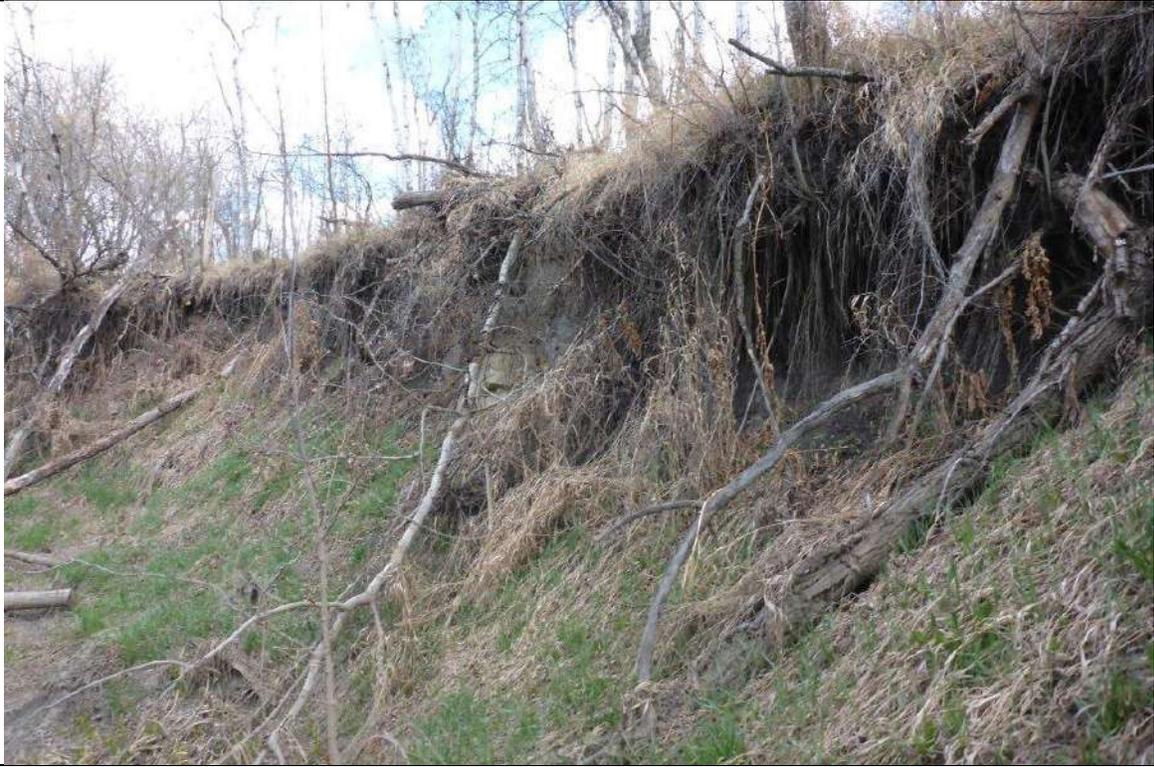
Photograph 7: Erosion visible along the creek bank.
