Environmental Impact Assessment

Mill Creek Ravine Pedestrian Bridge #278

Rehabilitation and Trail Upgrades

Project: EB213002

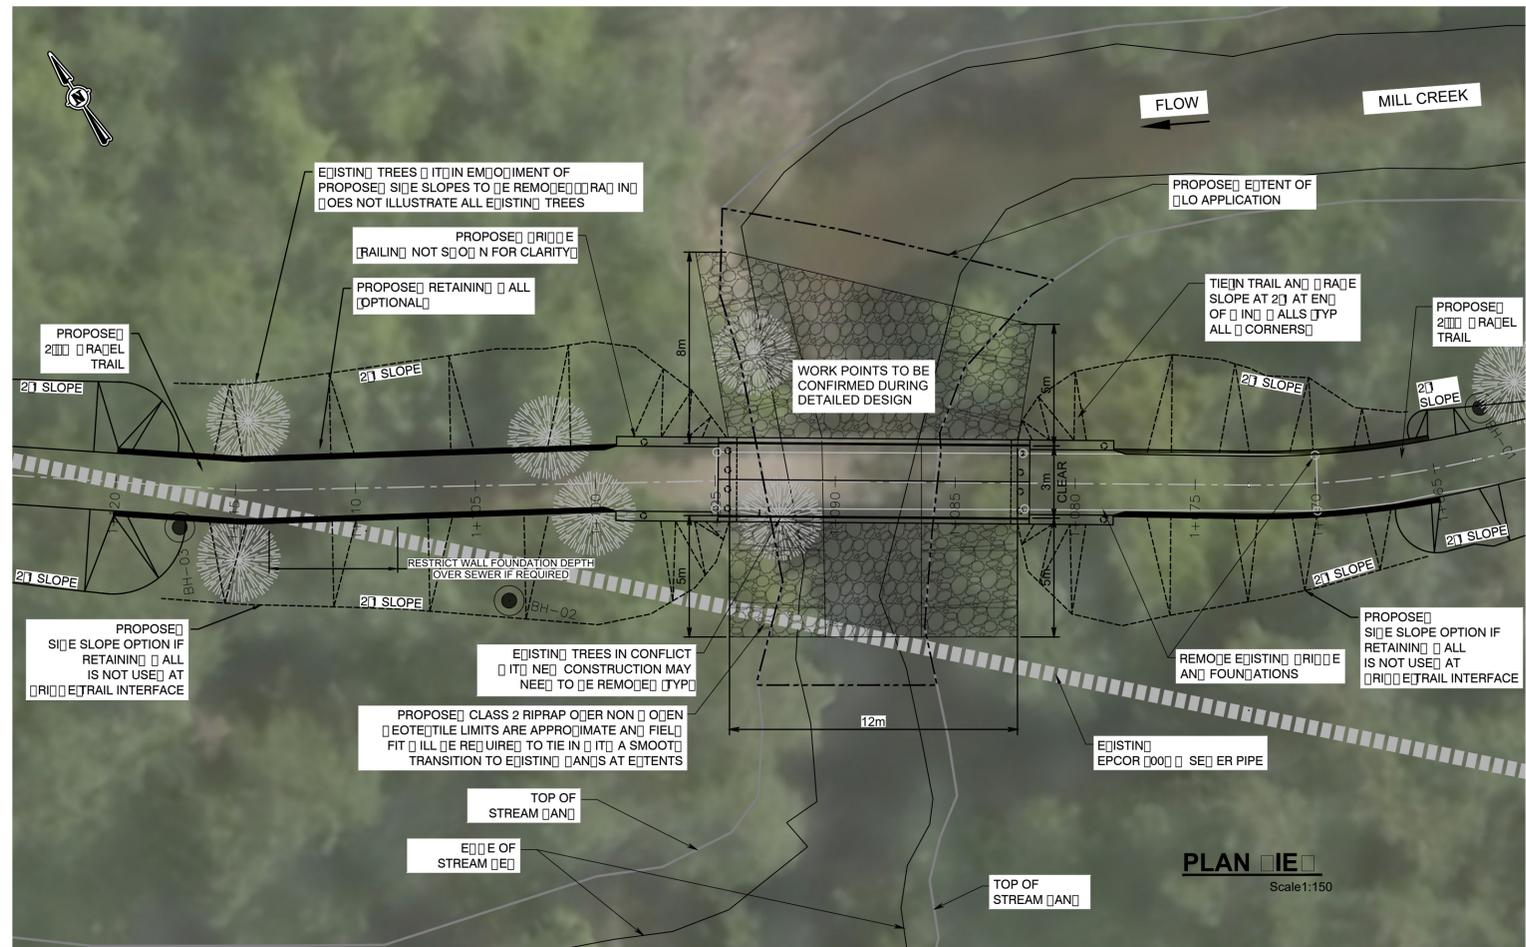
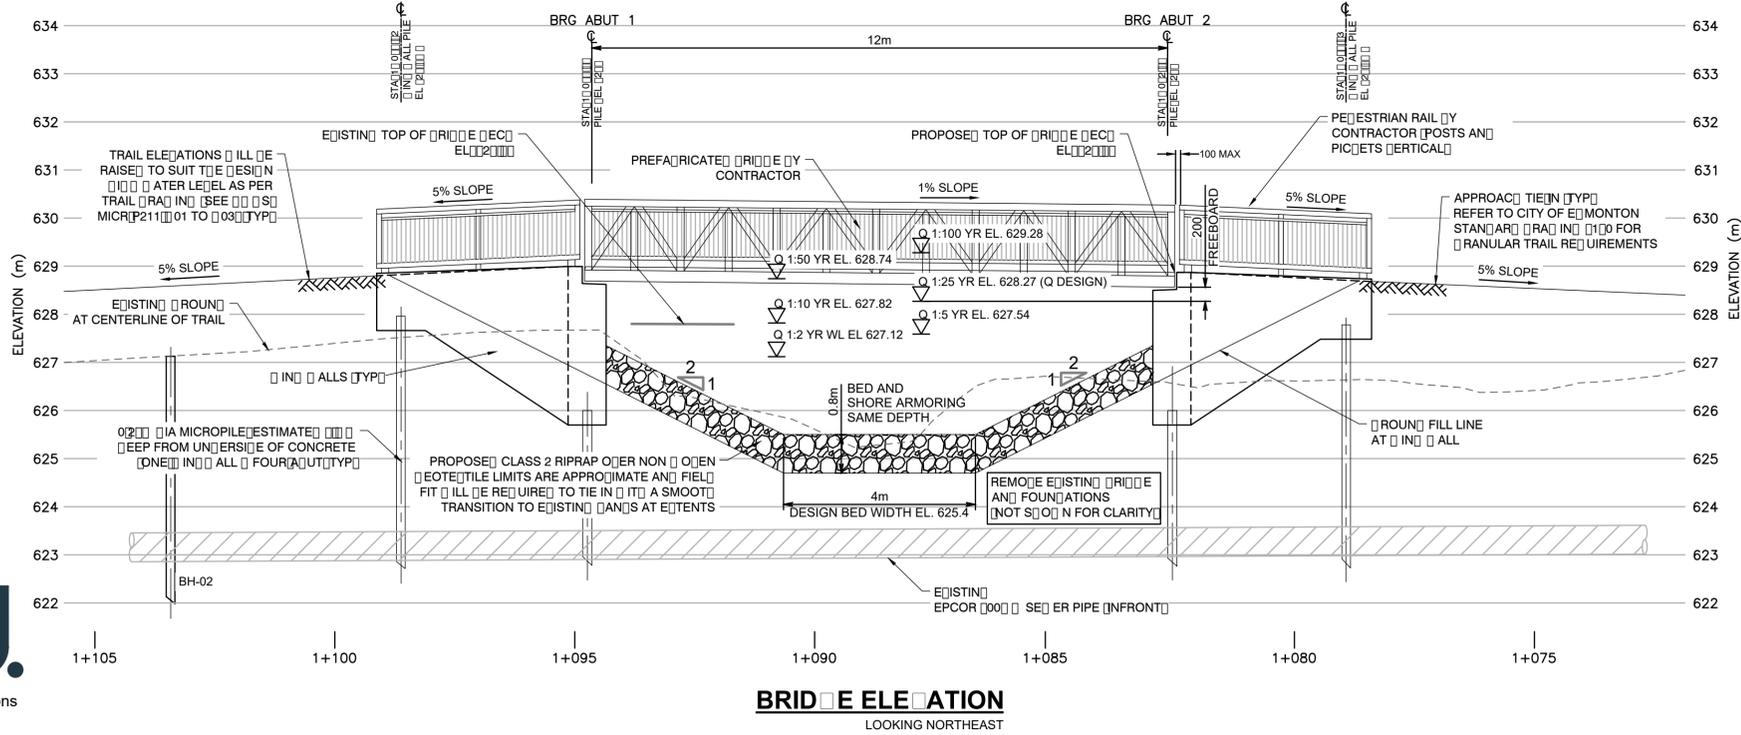
DRAWING MICR-P211-S01

- NOTES
- 1) TOP OF DECK ELEVATION HAS BEEN ESTIMATED BY ALLOTTING 300mm ABOVE TO ESTIMATE LEVEL AT 200mm FREEBOARD
 - 2) ALL ELEVATIONS ARE FROM THE EPCOR TECHNICAL MODEL BASED ON 33% LOCATION OF THE EPCOR INTAKE STRUCTURE RATING TO AN ELEVATION APPROX 1m ABOVE CURRENT STREAMBED PROFILE
 - 3) EXISTING SLOPE NOT SHOWN APPLICATION FOR NEW SLOPE PER OUTLINE SHOWN IN PLAN
- ALL CORNER POINTS TO BE CONFIRMED IN DETAIL DESIGN

RETURN PERIOD (YEARS)	MAX INSTANTANEOUS DISCHARGE (m³/s)	WATER LEVEL ELEVATION (m) (See Note 2)	SOFFIT ELEVATION OF PROPOSED BRIDGE (m) (See Note 1)	TOP OF DECK ELEVATION FOR PROPOSED BRIDGE OPTION (m) (See Note 1)	COMPARE TO ELEVATION OF THE EXISTING BRIDGE DECK (m) (+/- ABOVE OR BELOW EXISTING)
100	50	629.28	629.48	629.78	2.10
50	36	628.74	628.94	629.24	1.56
25 - Q DESIGN	25	628.27	628.47	628.77	1.09
10	16	627.82	628.02	628.32	0.64
5	11	627.54	627.74	628.04	0.36
2	5	627.12	627.32	627.62	-0.16

The Project will involve replacement of the existing two-span timber bridge with a new 3.0 m wide by 12m length single span steel truss with bridge abutments outside or above the active channel defined by the ordinary high-water level (OHW⁵). Headslopes will be constructed at 2H:1V slope and armoured with Class 2 rock riprap extending over the full width of the channel for a depth of 800 mm underlain by non-woven geotextile fabric. The streambed and banks will be reconstructed with riprap extending upstream for 8 m along the north (right) bank and 5 m along the south (left) bank to arrest lateral bank erosion and scour. Riprap will also extend for a 5 m length downstream of the bridge. The channel armoring will transition smoothly into the upstream and downstream natural channel bed and profile elevations and channel widths, as per drawing MICR-P211-S01 (Appendix A.2).

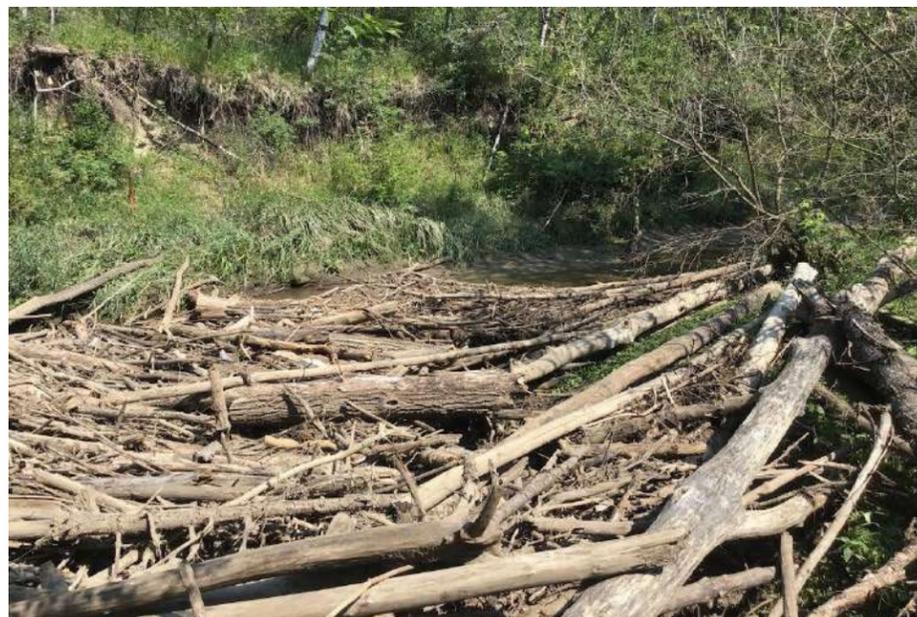
Plate C1: July 27, 2021. Facing upstream (east), from 2 m upstream of B278, showing steeply eroded and slumping right (east) bank. Note woody debris jam at B278 bridge opening.

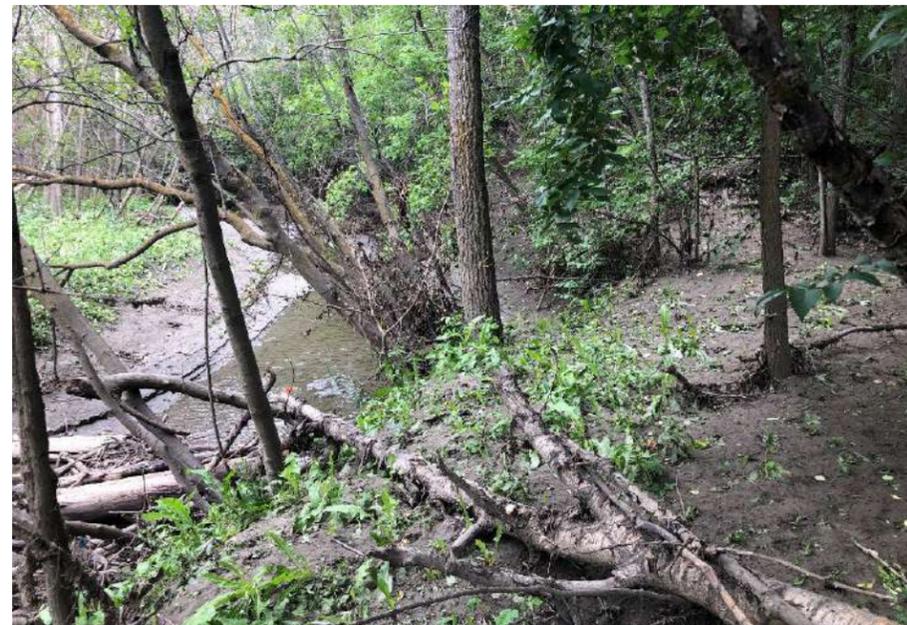
Plate C2: June 17, 2021. Facing south from the west bank of Mill Creek, approximately 80 m downstream of B278, showing recovering understory vegetation covered with soil deposits from recent flooding. Understory vegetation was still recovering during the August rare plant survey.

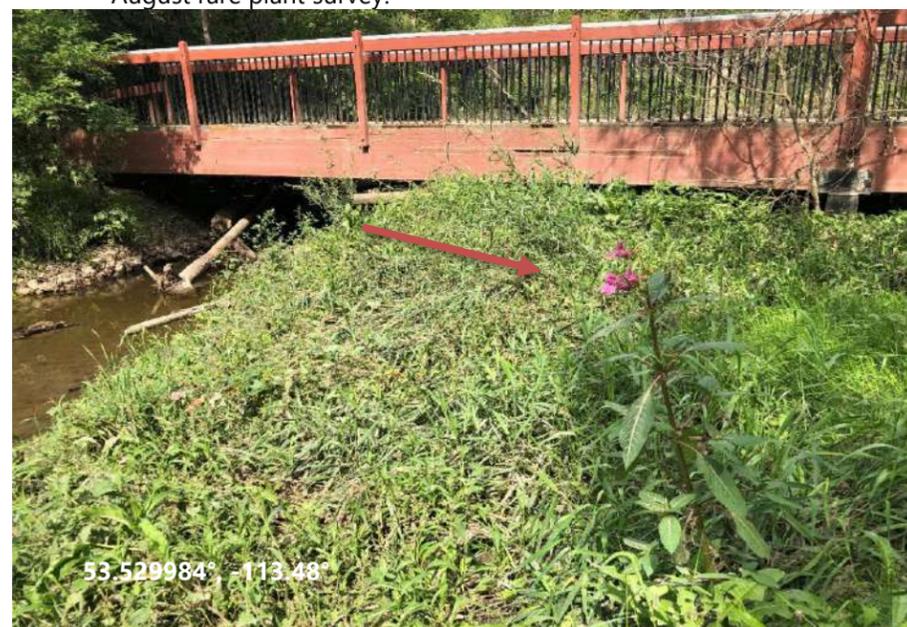
Plate C5: 12 August 2021. Facing east, a single plant of Himalayan balsam was observed on east bank downstream of B278, which was removed and disposed of on 12 August 2021.

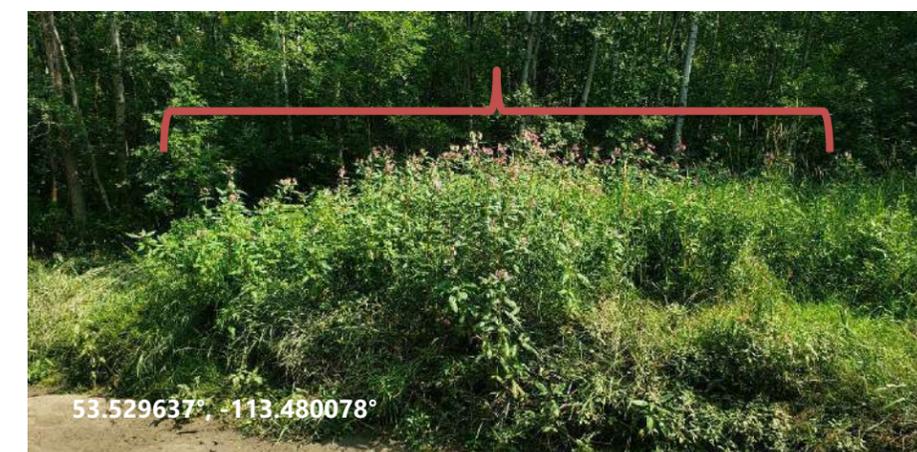
Plate C6: July 27, 2021. Facing northwest (downstream) from 100 m upstream of B278, showing Himalayan balsam on the right bank.

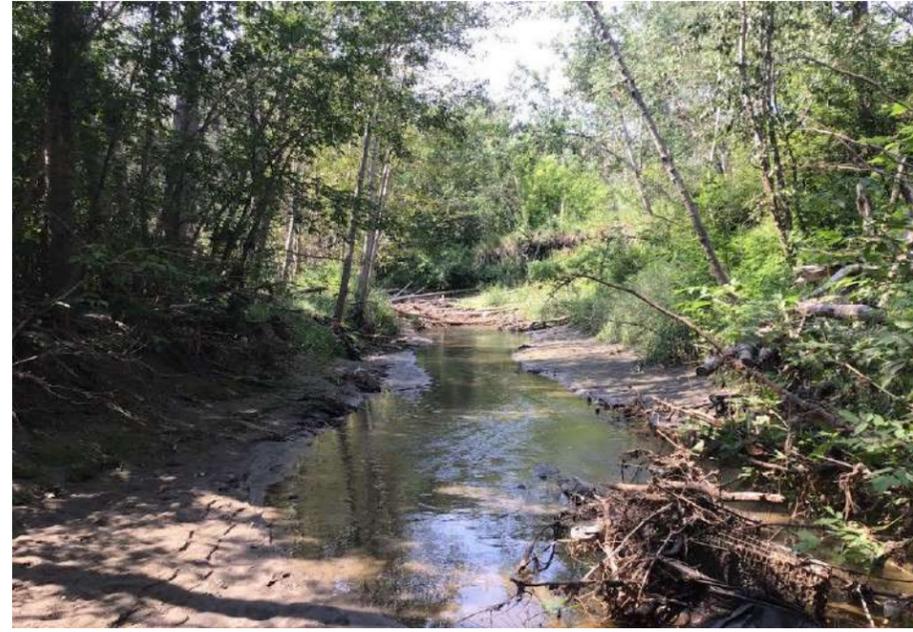
Plate C8: July 27, 2021. Facing downstream from 50 m upstream of B278, showing runhabitat in the upstream sub-reach. Note side channel bars composed of fine-textured material.

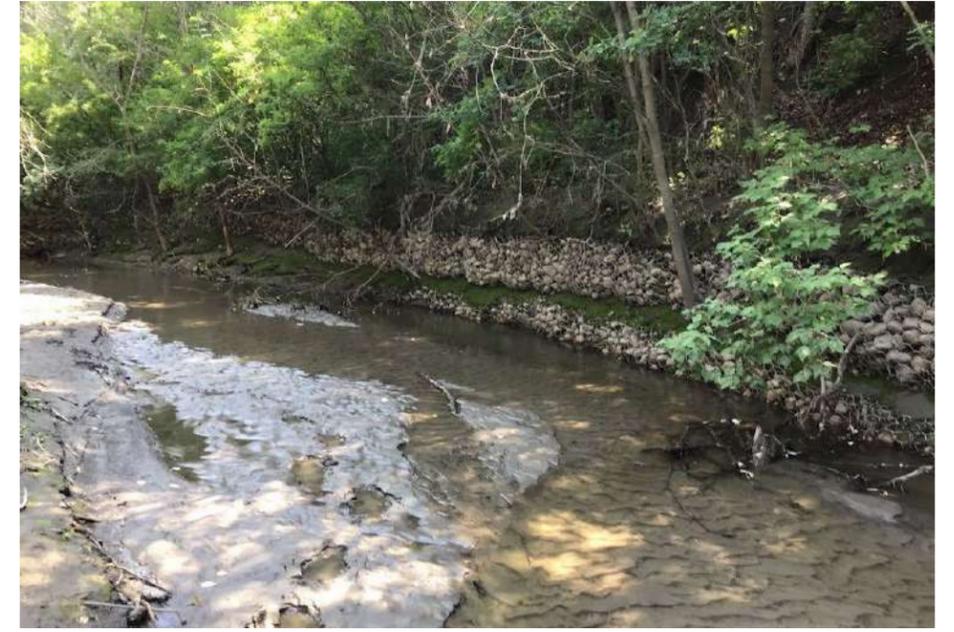
Plate C9: July 27, 2021. Facing upstream (southeast) from 75 m downstream, showing run habitat in the downstream sub-reach. Note rock filled gabion baskets along the right (west) bank.

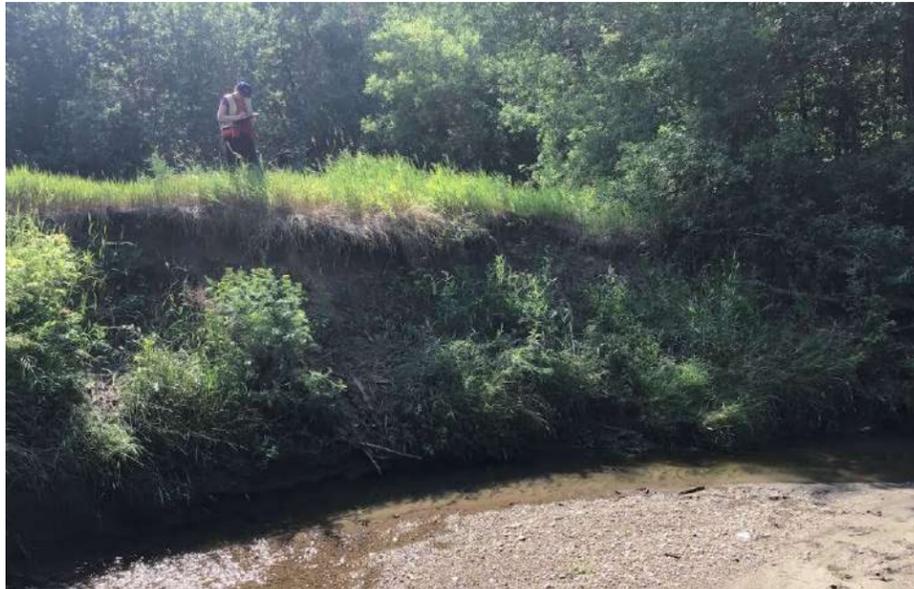
Plate C10: July 27, 2021. Facing southwest showing the high, steeply eroded and slumping left (west) bank, located 100 m upstream of B278. Note side channel bars composed of fine-textured and gravel material.

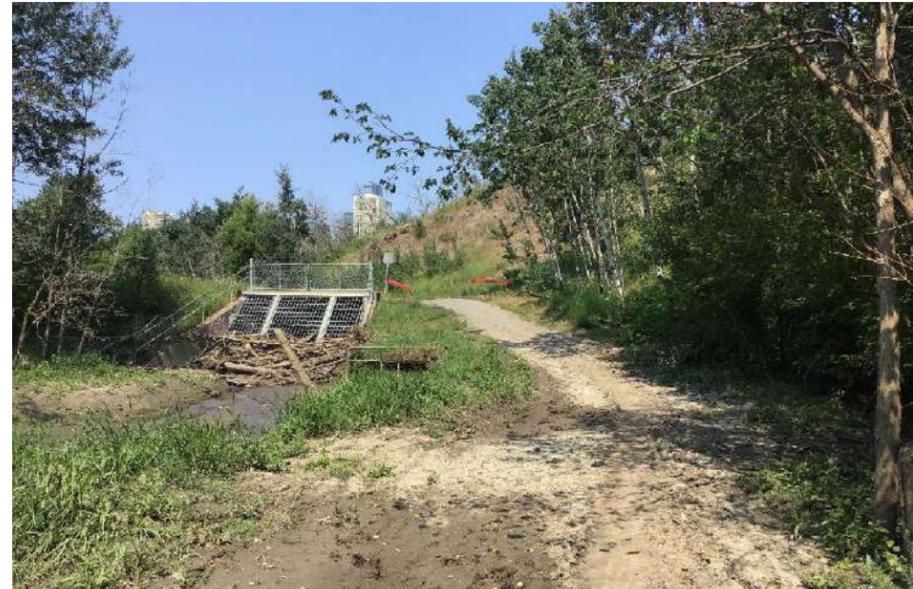
Plate C11: July 27, 2021. Facing downstream (northwest) from the pedestrian trail approximately 55 m north of B278, showing woody debris jam at the EPCOR inlet structure.

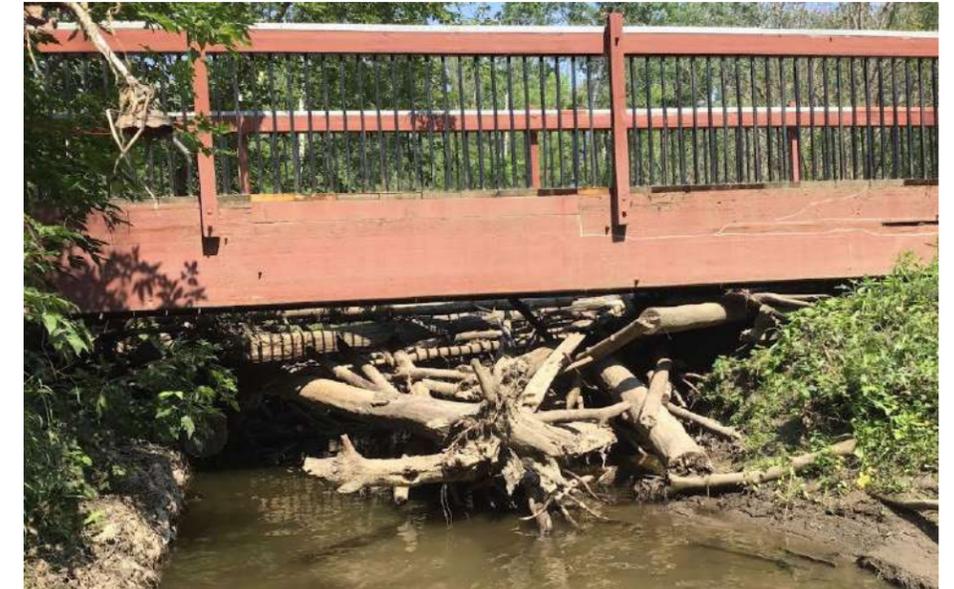
Plate C12: July 27, 2021. Facing upstream (northeast) from downstream of B278, showing pool habitat with fine textured substrate material at the crossing. Note woody debris jam and rock filled gabion basket on the right bank, at the crossing.

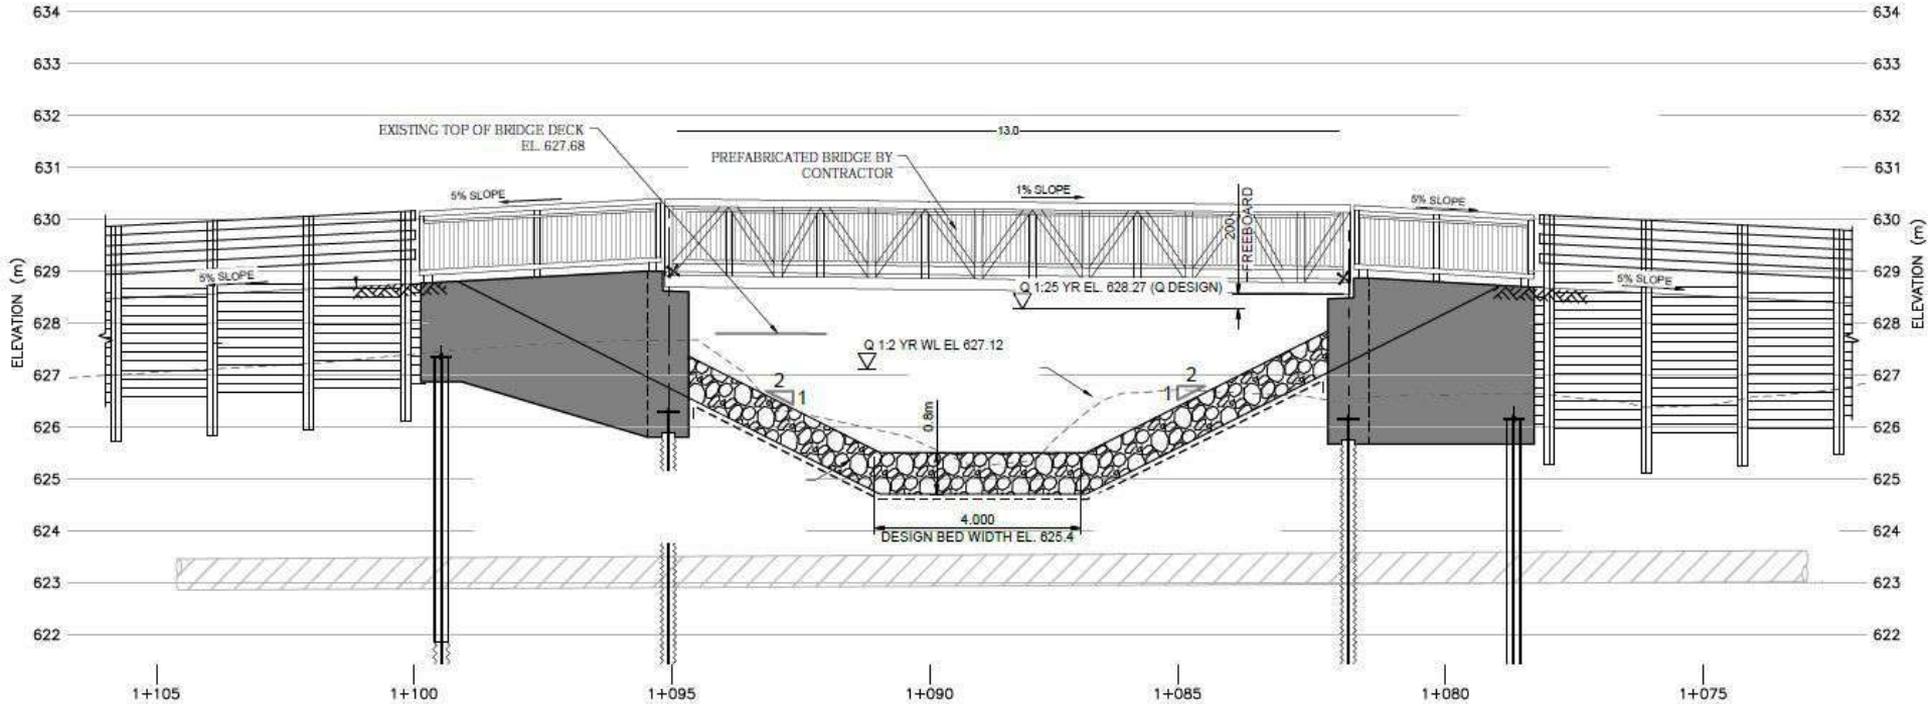
BRIDGE ELEVATION
LOOKING NORTHEAST - SCALE 1:75
