**Environmental Impact
Assessment Report for Maple
Road Crossing of Fulton
Creek, Edmonton, Alberta**

Prepared for:
Lehndorff Land General Partner
Inc.

Prepared by:
Stantec Consulting Ltd.

May 2017
110219456

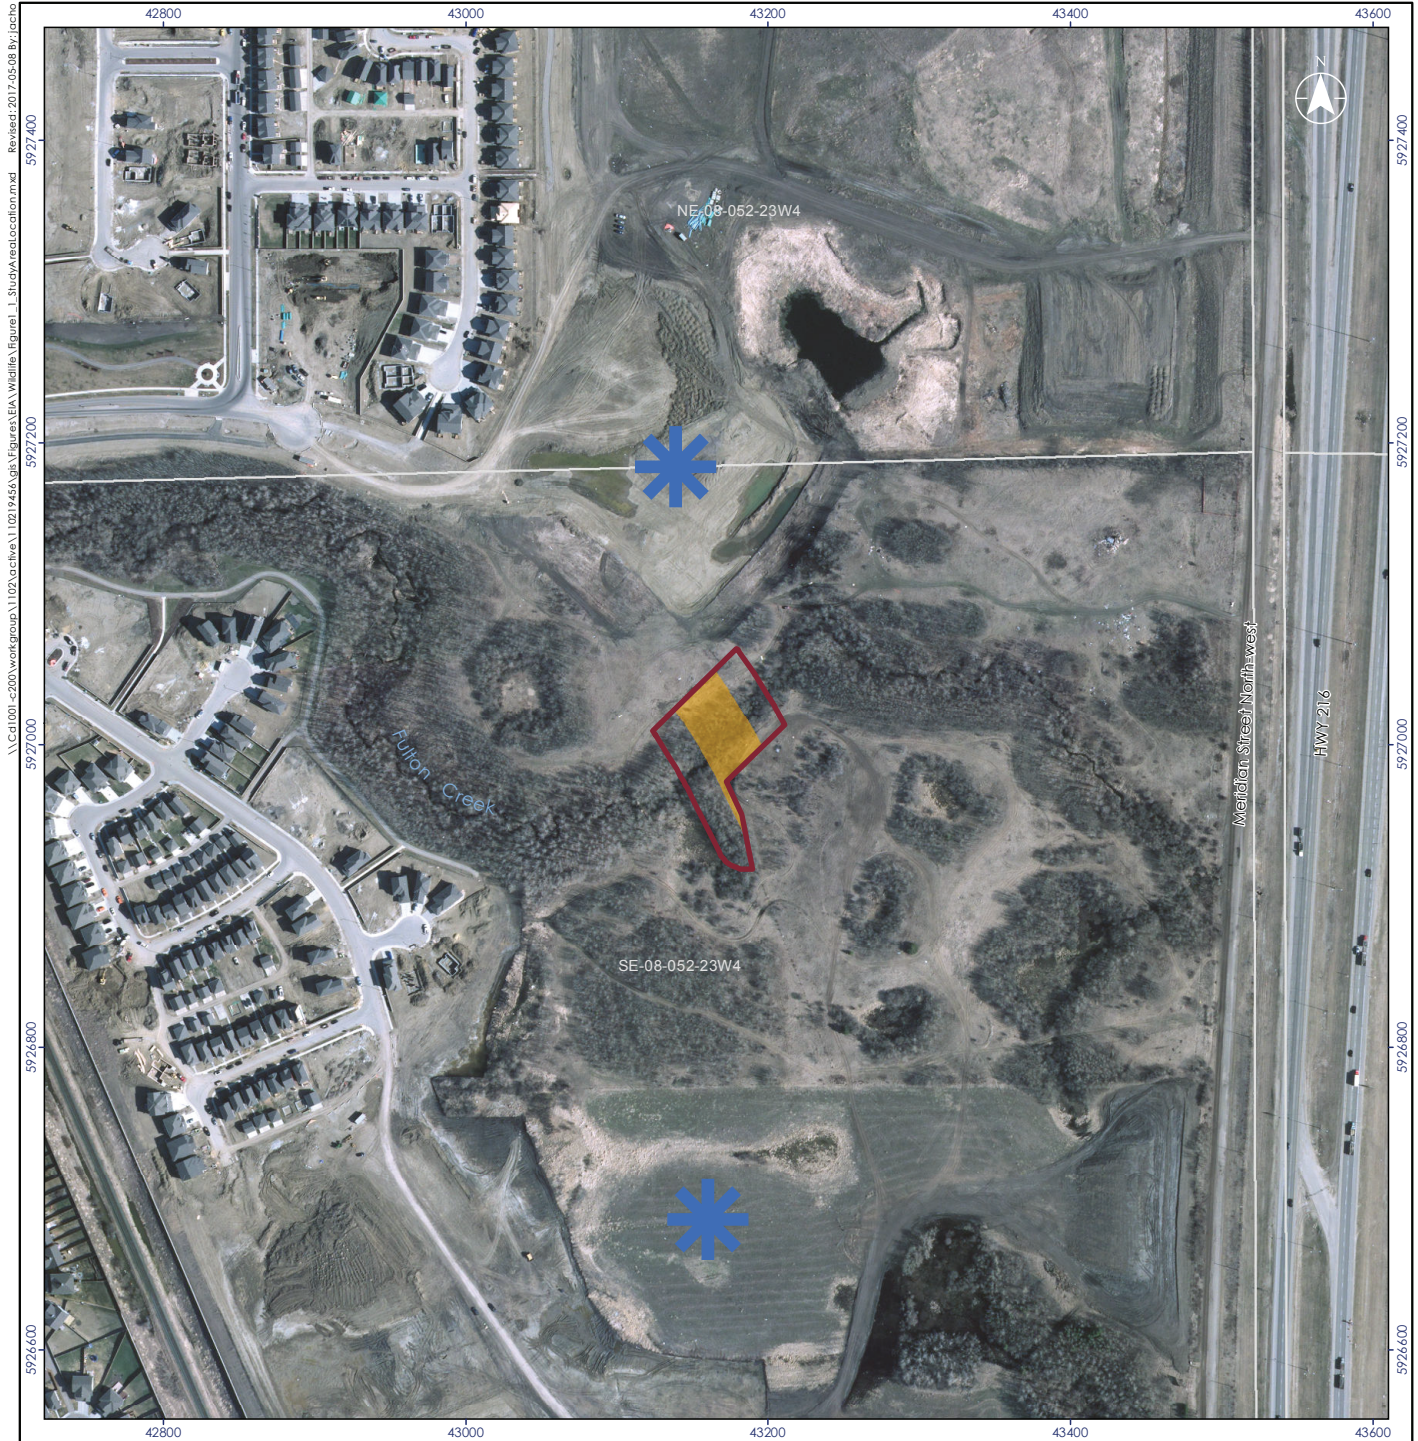
The Study Area was selected to characterize local biophysical conditions, and discuss the effects of the Project on the environment. It covers an area of 0.57 ha and is limited to the extent of the NSRVARP boundary.

- Potential Laydown Area
- Study Area
- Area of Disturbance
- Quarter Section

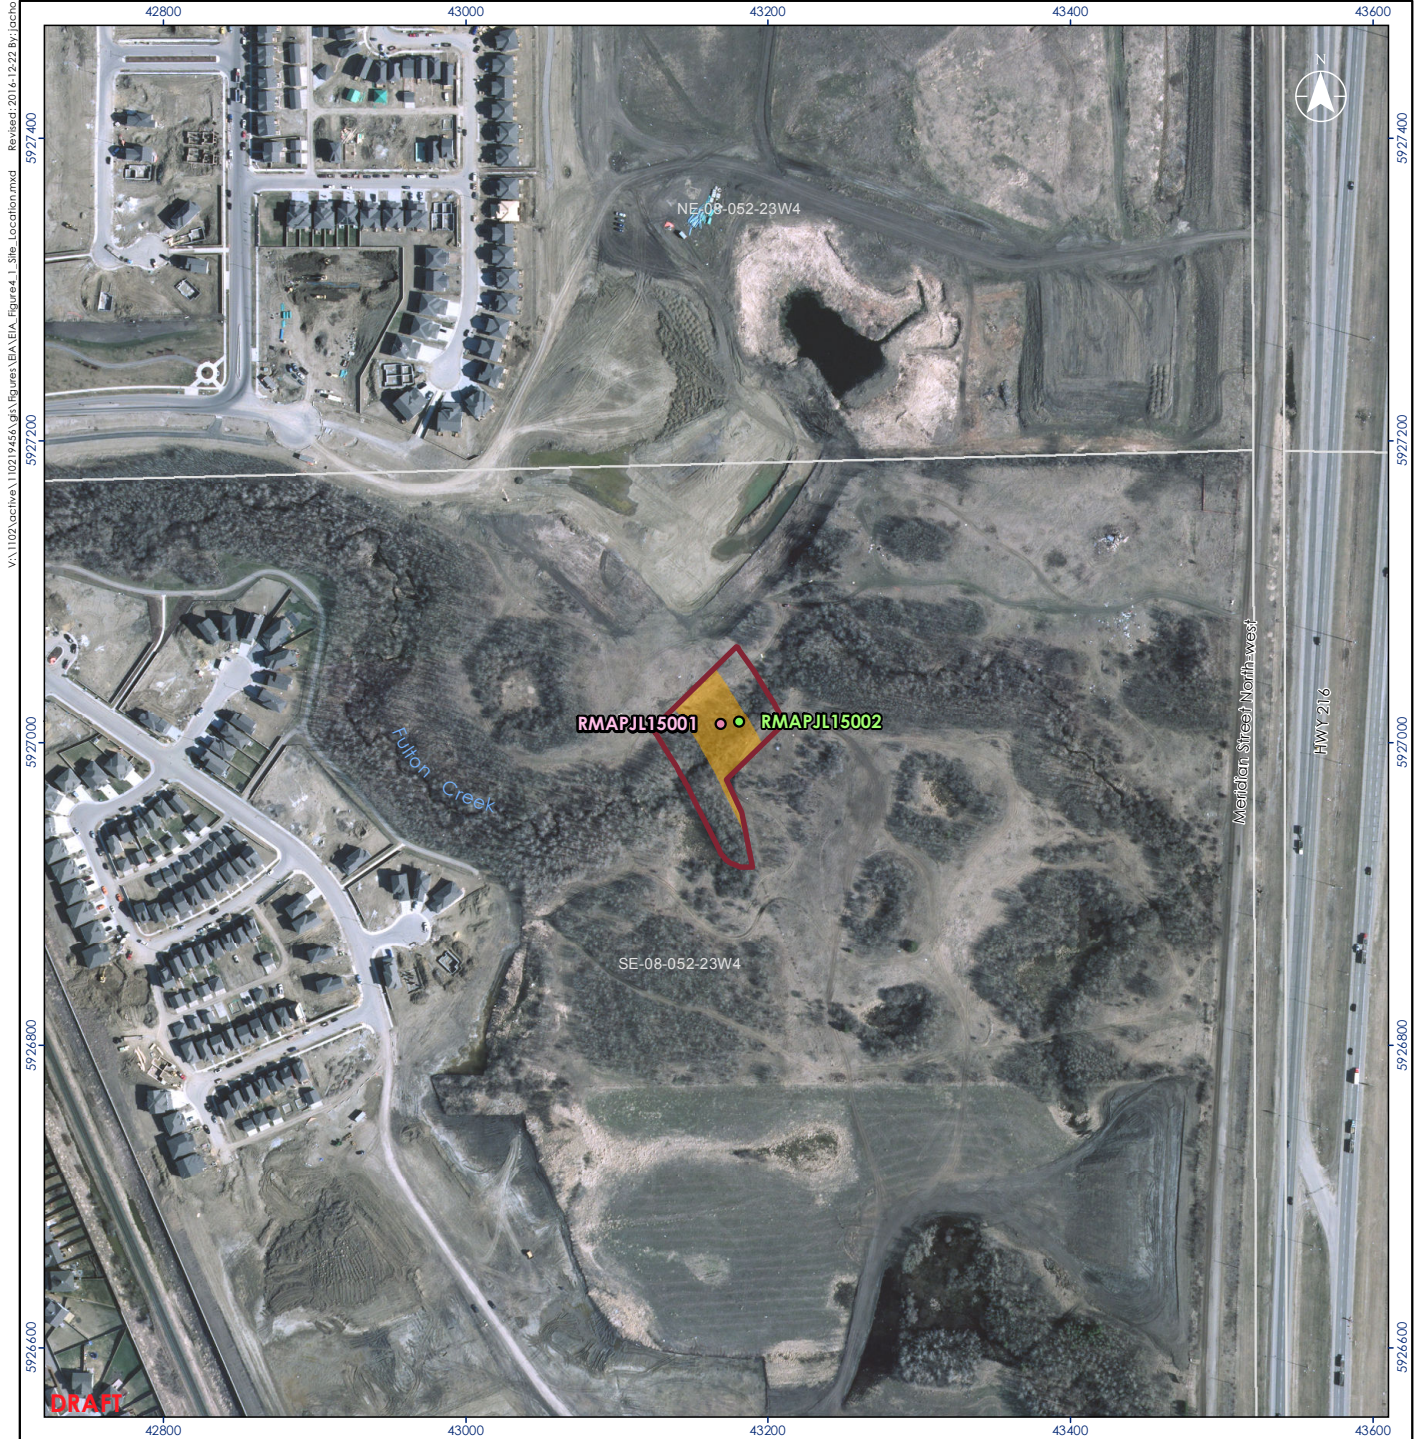
- Spring Rare Plant Survey
- Summer Rare Plant Survey
- ▭ Study Area
- ▭ Area of Disturbance
- ▭ ATS Quarter Section Grid

For the rare plant surveys, a meander survey within the plant community was completed. A comprehensive species list was compiled at each site until no new species were found. Specimens requiring further examination or species confirmation were collected, with the exception of plants where seed heads or flowers required for identification to species level were unavailable or where plant populations were small (i.e., no more than 1 in 50, Alberta Native Plant Council 2006).

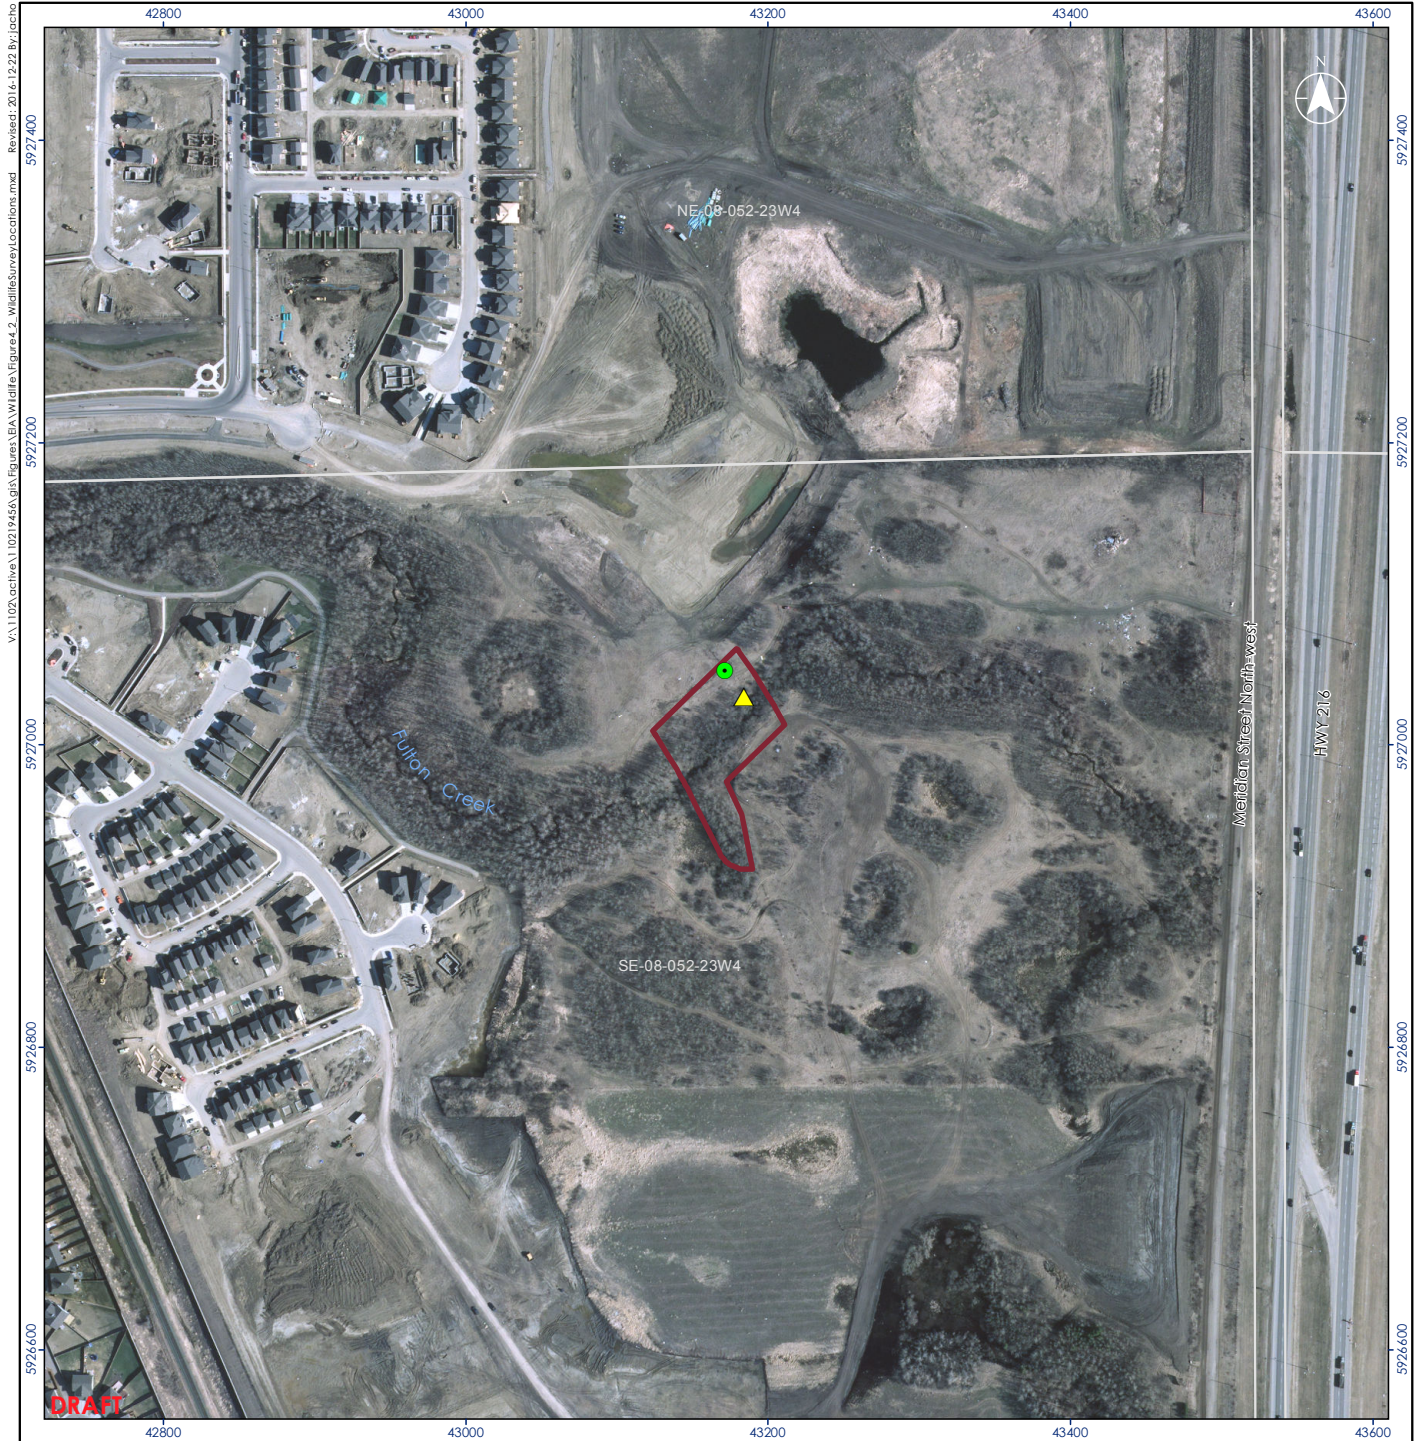
- Wildlife Survey Location**
- Amphibian
 - ▲ Bird
 - Study Area
 - ATS Quarter Section Grid

A breeding bird survey was conducted in the Study Area on June 11 and June 25, 2015 between sunrise and 10:00 a.m. during the peak breeding period for migratory songbirds (Figure 4-2). A modified fixed-radius point count sampling survey procedure (Bibby et al. 1993) was used to document bird species diversity and abundance. Surveys were preceded by two minutes of silence to minimize any disturbance caused by the arrival of observers.

Amphibian surveys were conducted in the Study Area on May 15th and 21st, and June 3rd, 2015, at one location from 30 minutes after sunset to 2:00 AM (Figure 4-2). The amphibian survey was conducted in accordance with standard protocols (ESRD 2013). The amphibian survey consisted of a two minute period of silence to reduce disturbance effects associated with the arrival of observers, followed by a five minute listening period where all amphibian species detected were recorded. The amphibian survey was conducted at wind speeds below 20km/h (i.e., Beaufort 3) and conditions not exceeding a light rain to optimize the ability of observers to effectively hear all amphibians vocalizing. Incidental wildlife species encountered during the amphibian survey were also recorded.

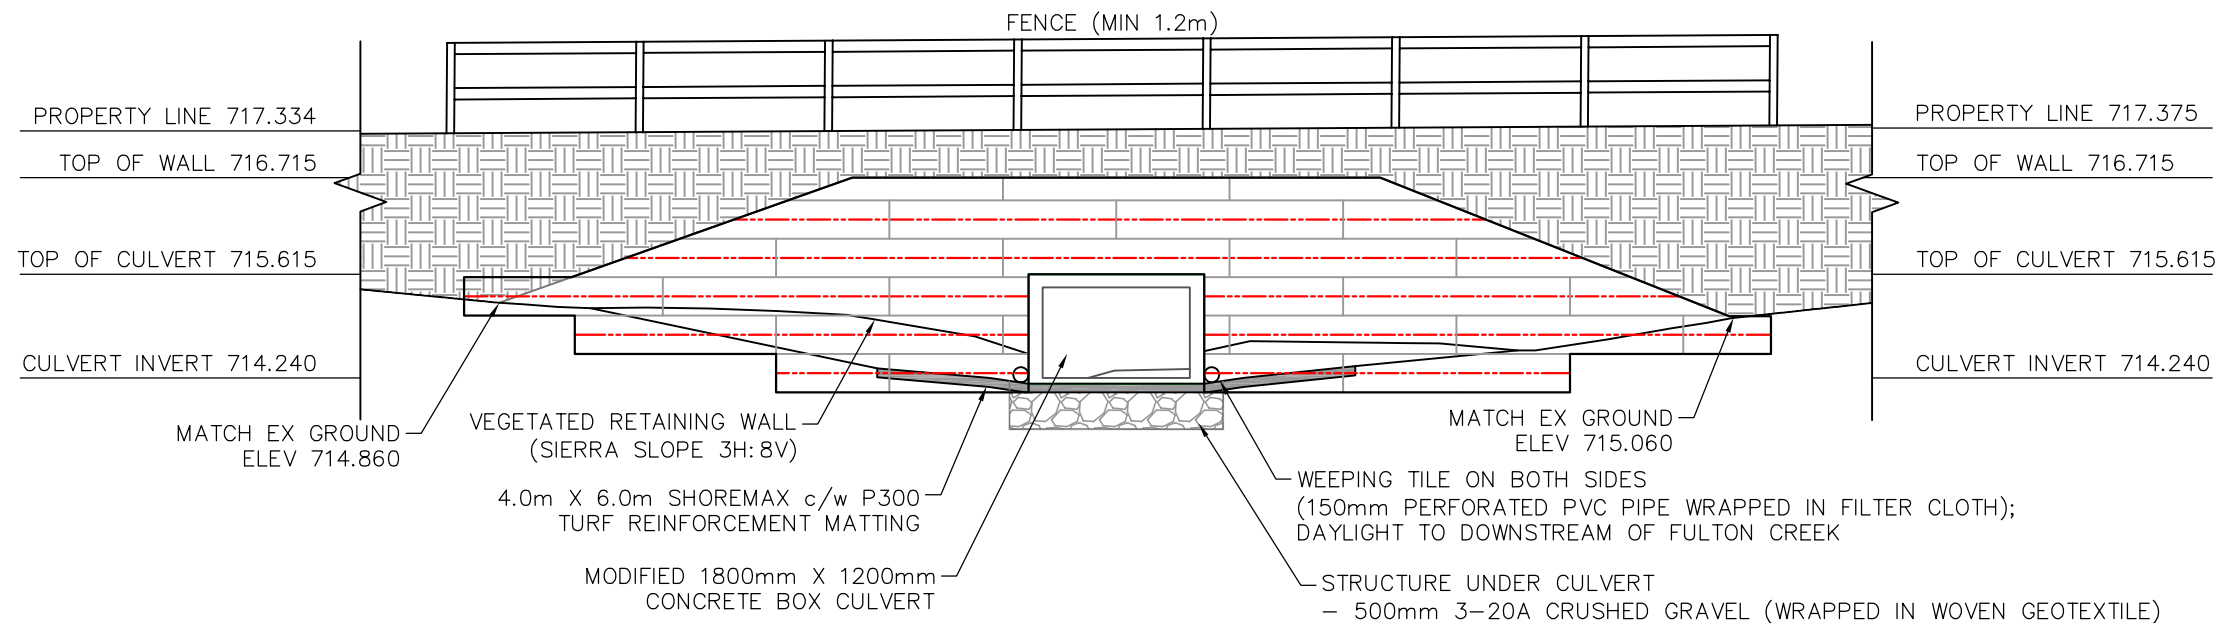
FULTON CREEK WILDLIFE CROSSING
NORTH ELEVATION

HORIZONTAL SCALE: 1:100
VERTICAL SCALE: 1:100

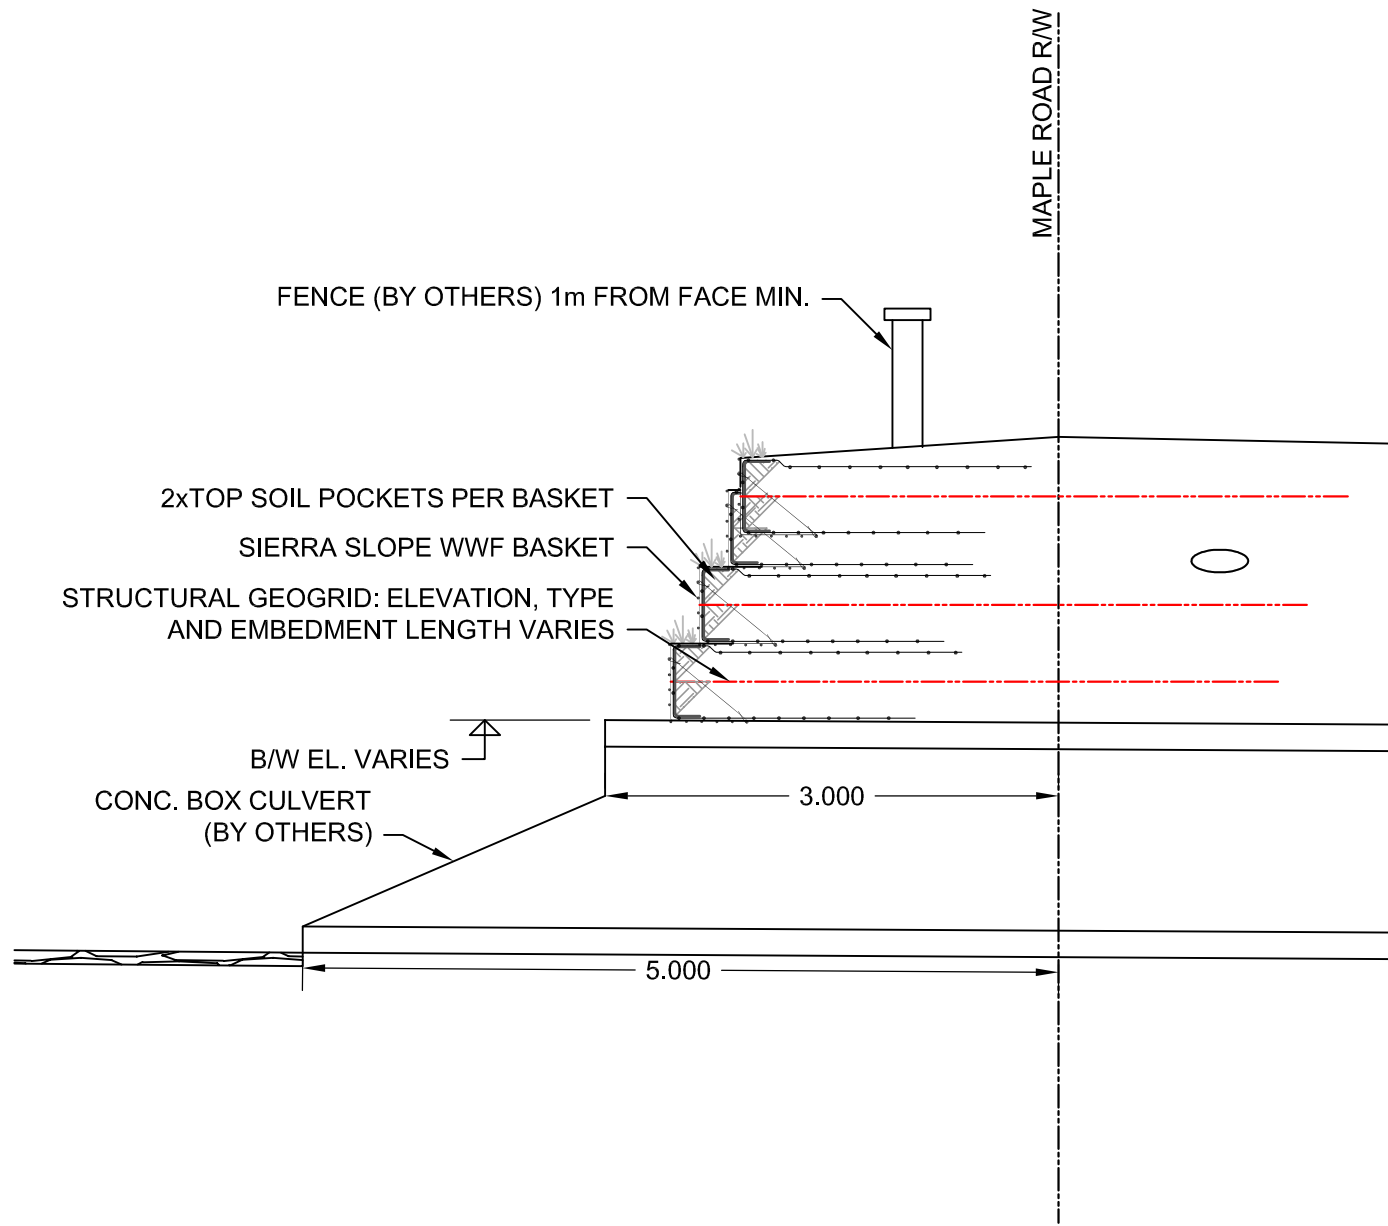
CROSS SECTION OVER THE CULVERT
SCALE: 1:50

Shallow utilities (Telus, power and gas) will be installed 0.3 to 0.5 m above the top of the box culvert. The roadway will sit 1.42 m high from the top of the box culvert and will be 11.7 m wide. An asphalt shared used pathway, safety railing and a concrete sidewalk will be found at ground level within the 37 m right of way (RoW). For more details, consult the Project design in Appendix A.

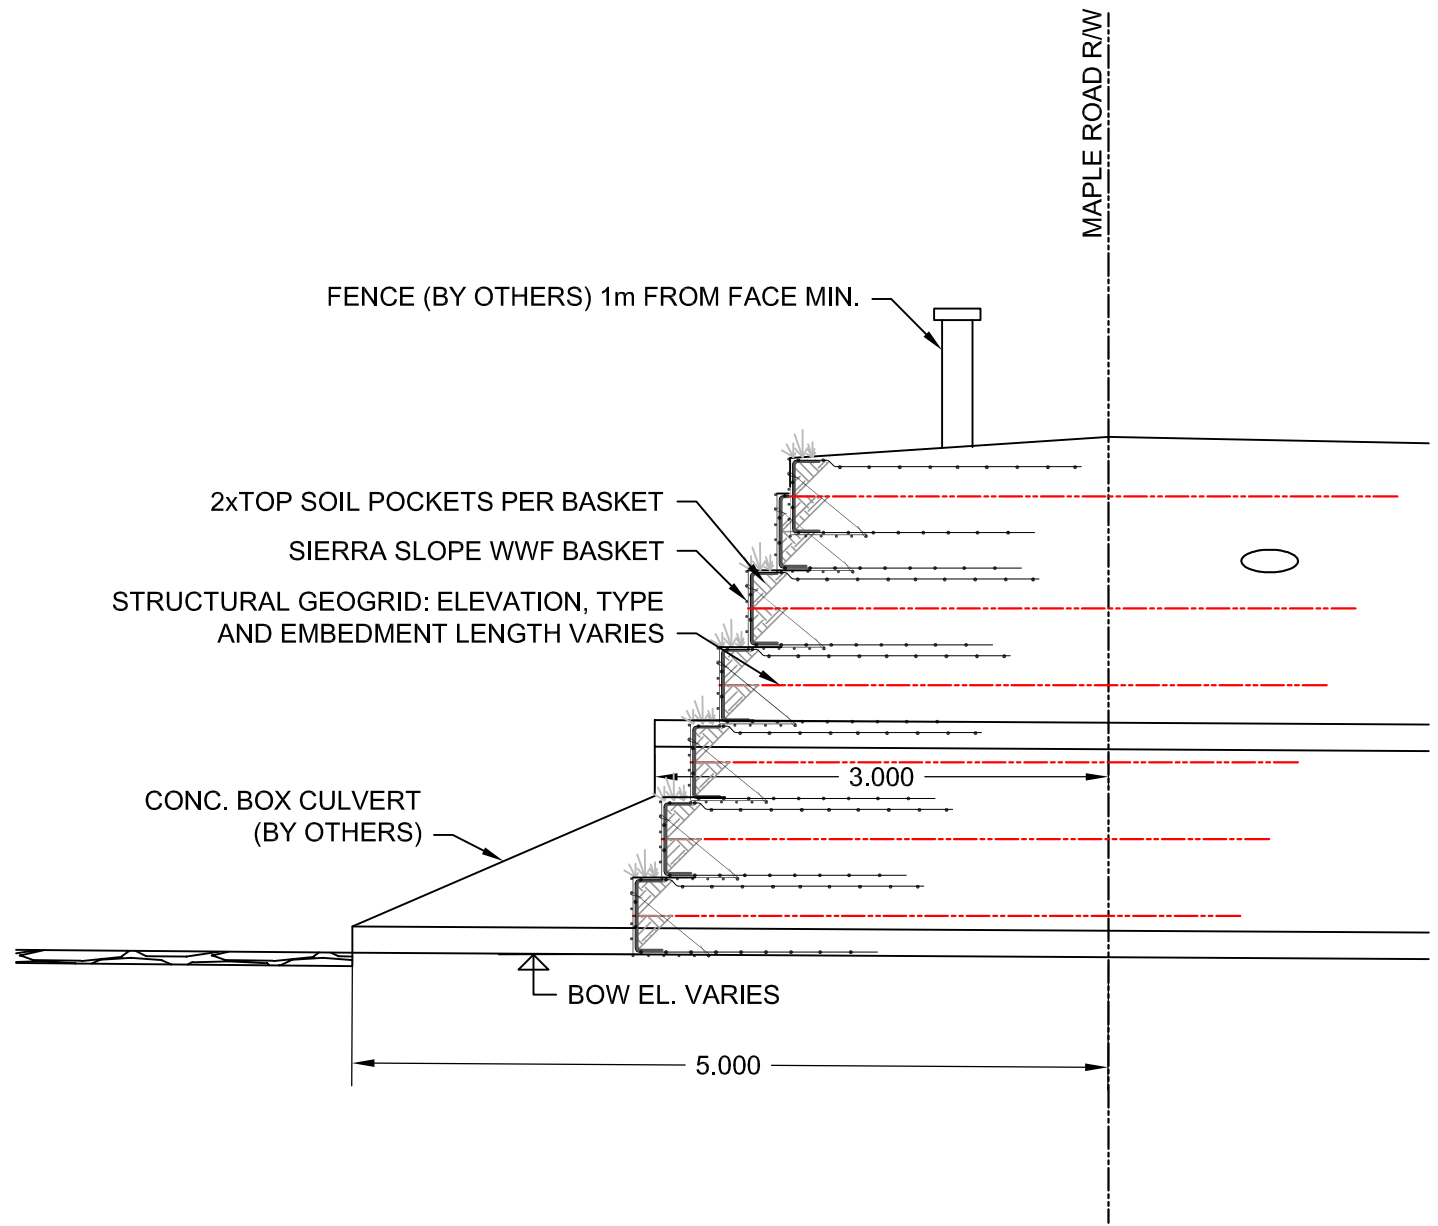
CROSS SECTION BESIDE THE CULVERT
SCALE: 1:50

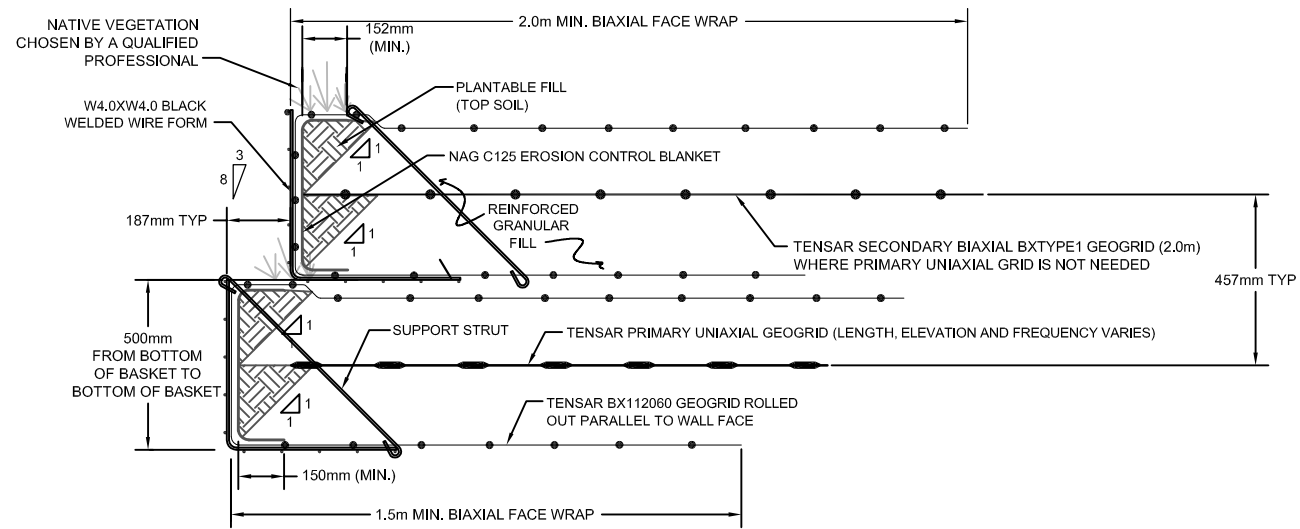
SIERRA SLOPE WELDED WIRE STEPPED FACE DETAIL
NOT TO SCALE

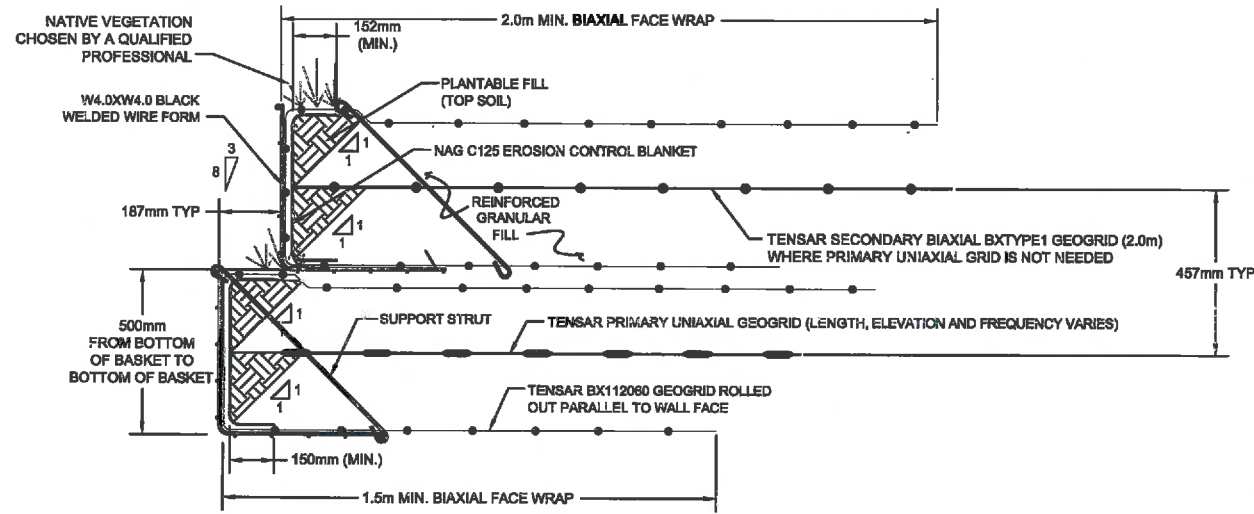
SIERRA SLOPE WELDED WIRE STEPPED FACE DETAIL
NOT TO SCALE

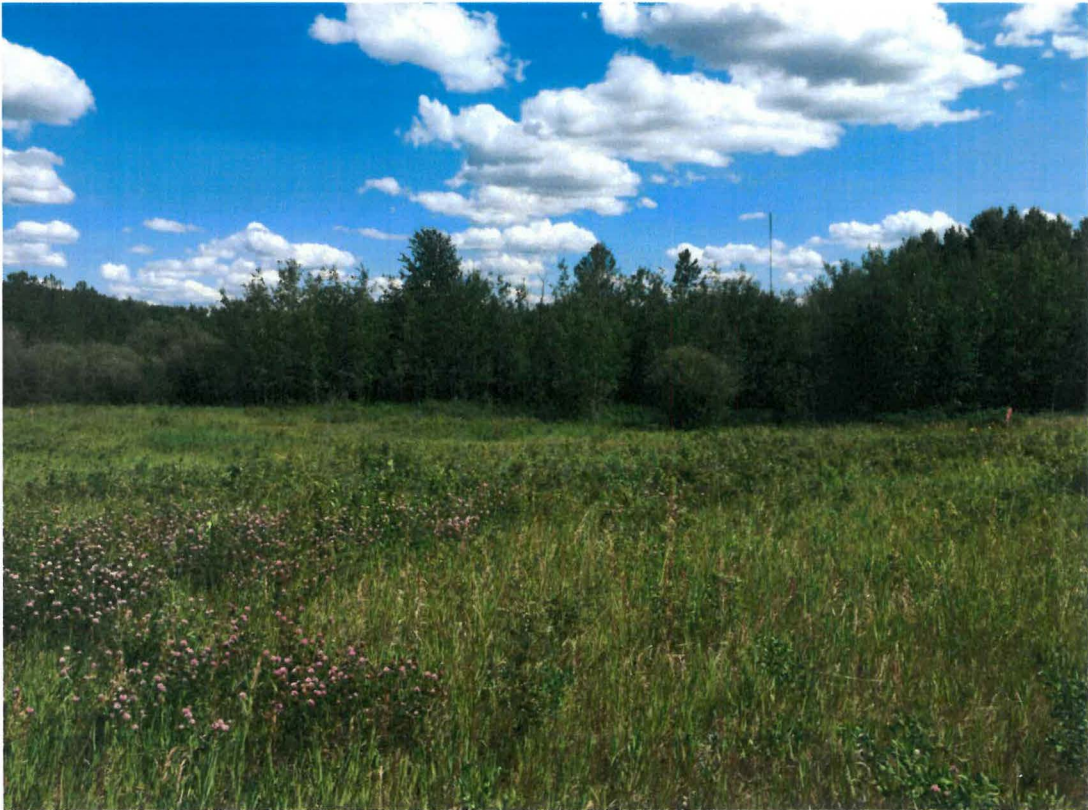
Photo 1: Area of roadway approach to creek area, to north of creek and looking southeast.

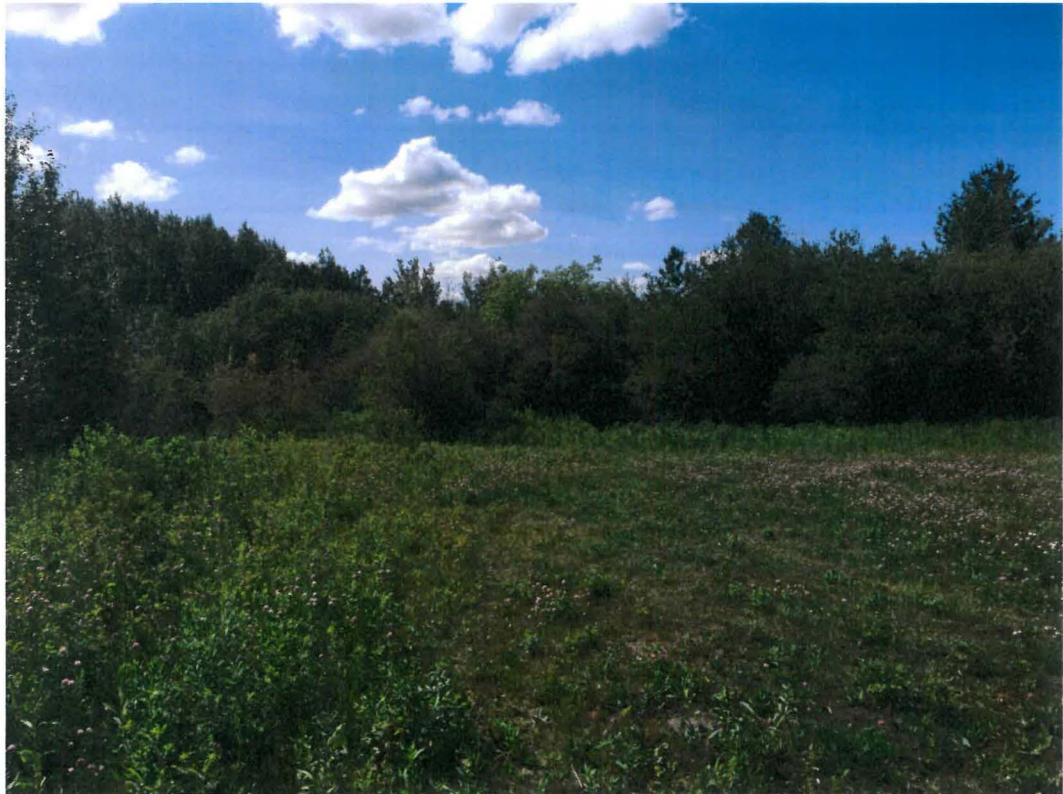
Photo 2: Area of roadway approach to creek area, to south of creek and looking northwest.

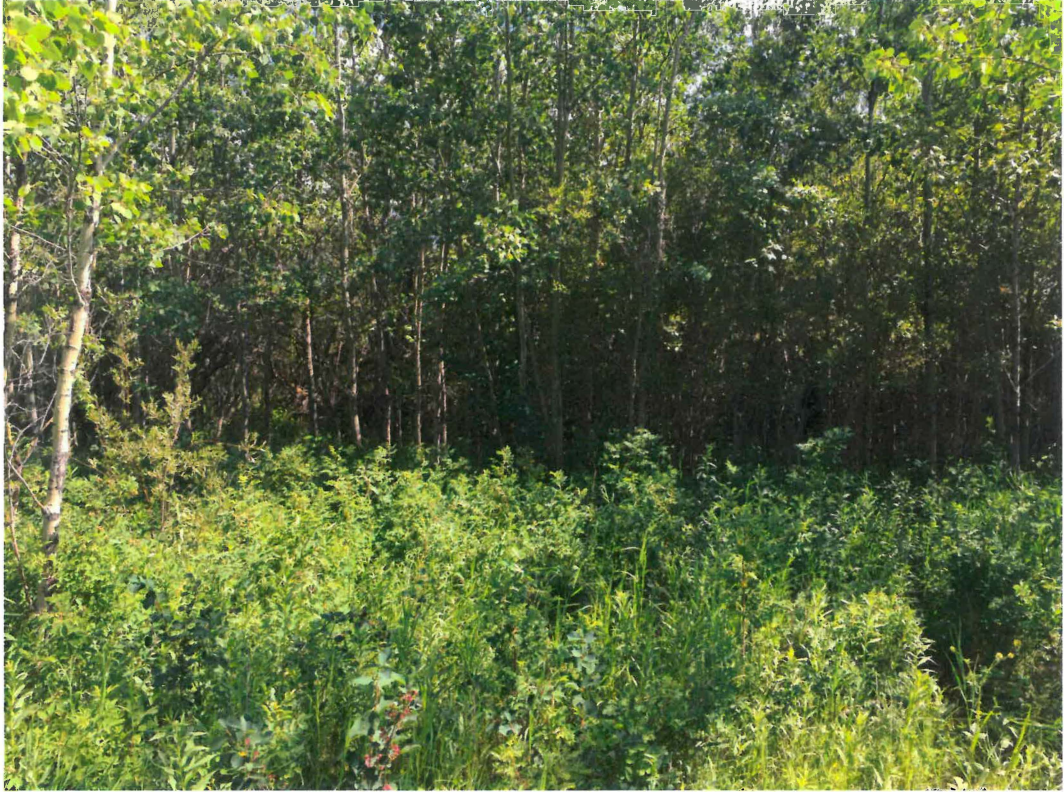
Photo 3: Area of roadway approach near culvert crossing, to north of creek and looking south.

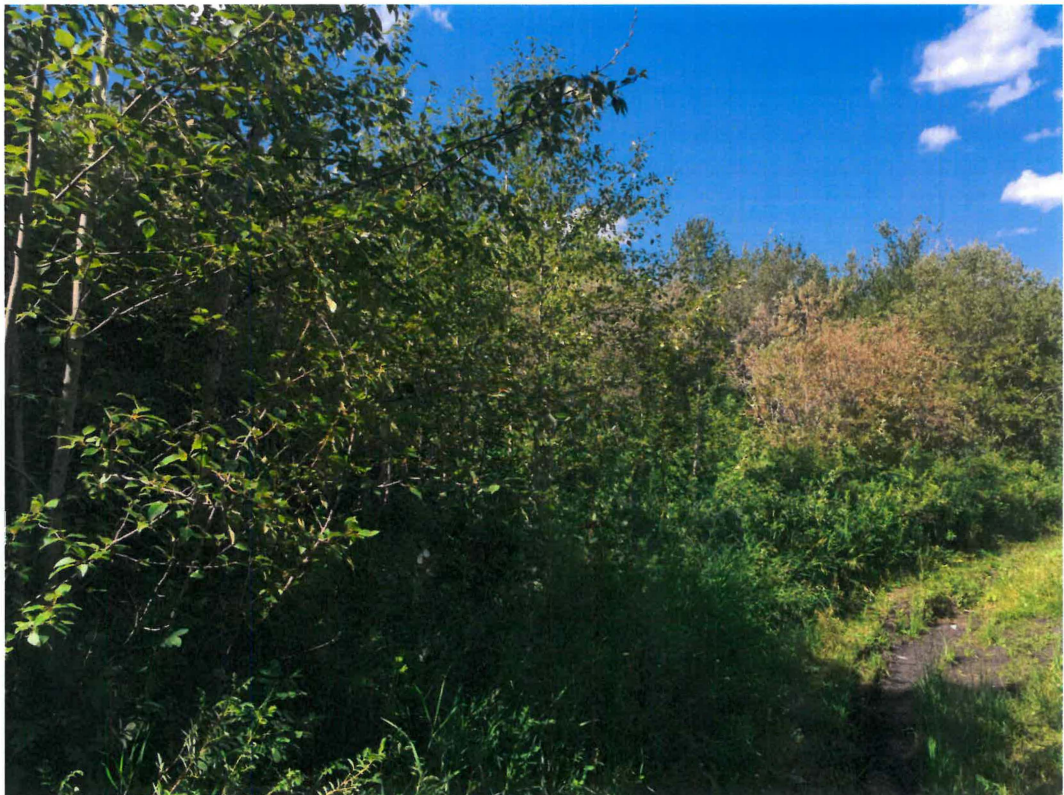
Photo 4: Area of roadway approach near culvert crossing, to south of creek and looking northeast.

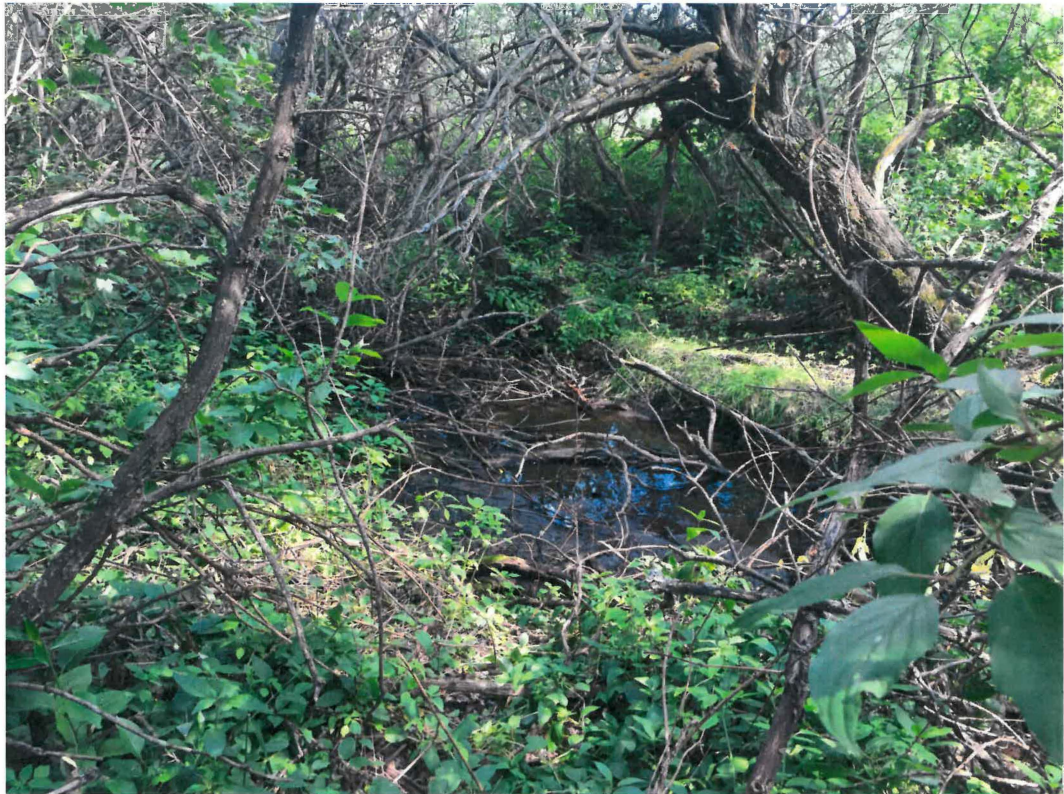
Photo 5: Creek condition and water flow (July 14, 2015).

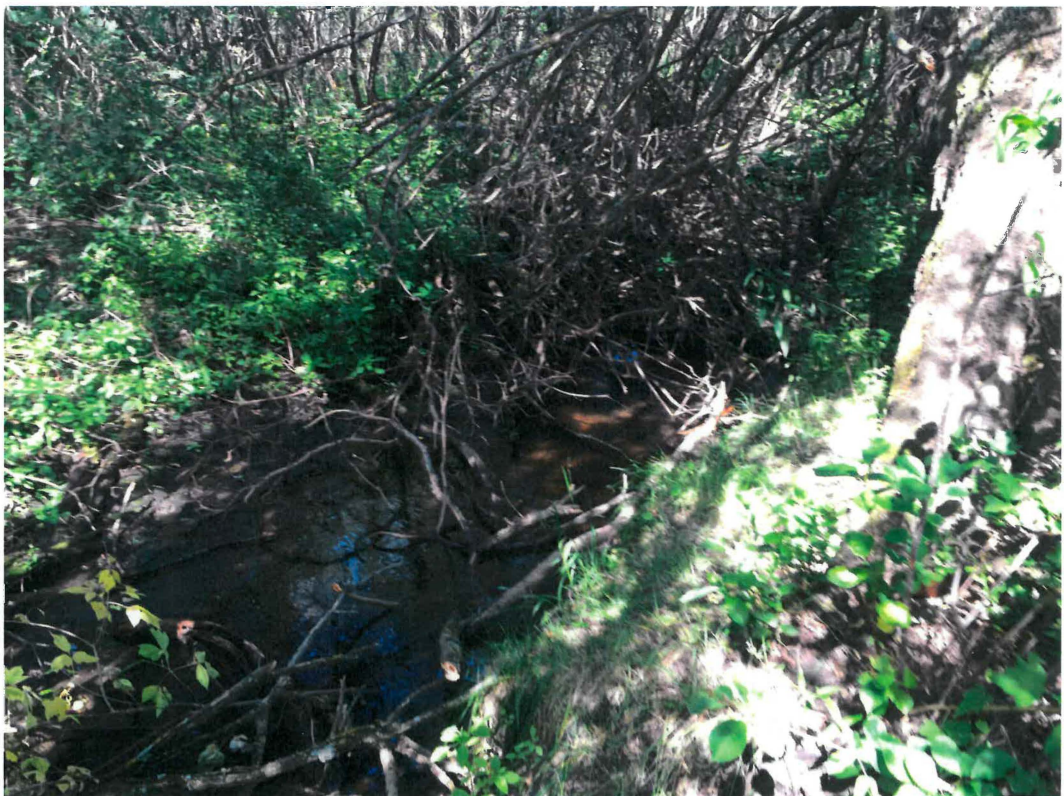
Photo 6: Creek condition and water flow (July 14, 2015).
