**Groat Road Bridges Rehabilitation Project:
Groat Road Bridge over the North Saskatchewan River (B059),
Groat Road Bridge over Victoria Park Road (B060) and
Emily Murphy Park Road Bridge over Groat Road (B099)
Environmental Impact Assessment**

Final Report

**City of Edmonton Transportation Planning & Design and Transportation
Infrastructure Delivery**
Edmonton, Alberta

**Spencer Environmental
Management Services Ltd.**
Edmonton, Alberta

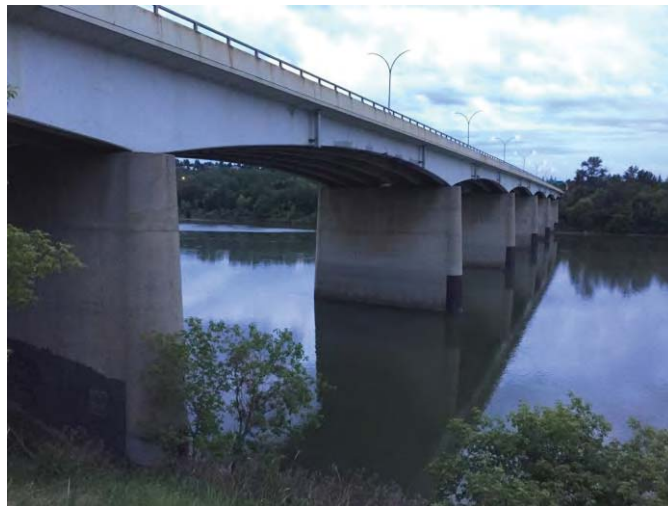
**Plate 1.1. Groat Road Bridge over the North Saskatchewan River – view to south
(08 June 2016)**

The Groat Road Bridge over the North Saskatchewan River (B059) was constructed in 1955 and is a 289.56 m, 7-span, cast-in-place concrete girder bridge with a composite concrete deck supported on six piers; piers one and six are located on the river bank and the remaining four are located within the main river channel (City of Edmonton 2015) (Plate 1.1). A major rehabilitation was completed on the bridge in 1989-1990 in which longitudinal post-tensioning was added, the deck was widened to provide a wider sidewalk, the two previously separate decks were joined, and other miscellaneous repairs were completed. The bridge carries two lanes of traffic northbound and southbound, respectively, separated by a concrete median, over the North Saskatchewan River and has a sidewalk on the east side of the structure. Street lighting is located in the median. This bridge is not located on a designated truck route.

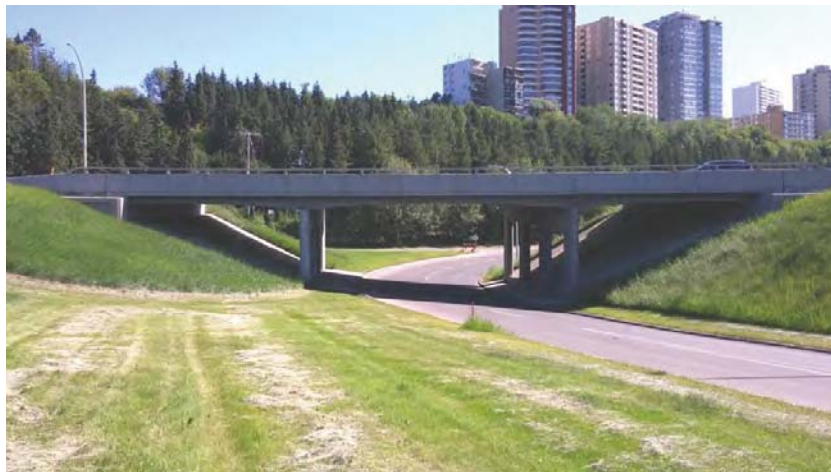
Plate 1.2. Victoria Bridge – view to northeast (20 June 2016)

Victoria Park Road Bridge (Victoria Bridge) was constructed in 1954 and is a 32.62 m, 3-span, concrete haunched T-girder bridge (City of Edmonton 2015). The bridge carries two lanes of traffic northbound and one southbound, separated by a concrete median, over Victoria Park Road (Plate 1.2). DIALOG undertook a load rating and condition assessment of the Victoria Bridge in 2013 (DIALOG 2016a) and the City would like to proceed with rehabilitation of this bridge. The proposed repairs are expected to extend the service life of the bridge by 50 years, with a deck overlay and regular maintenance performed over that time period (City of Edmonton 2015). This bridge is not located on a designated truck route.

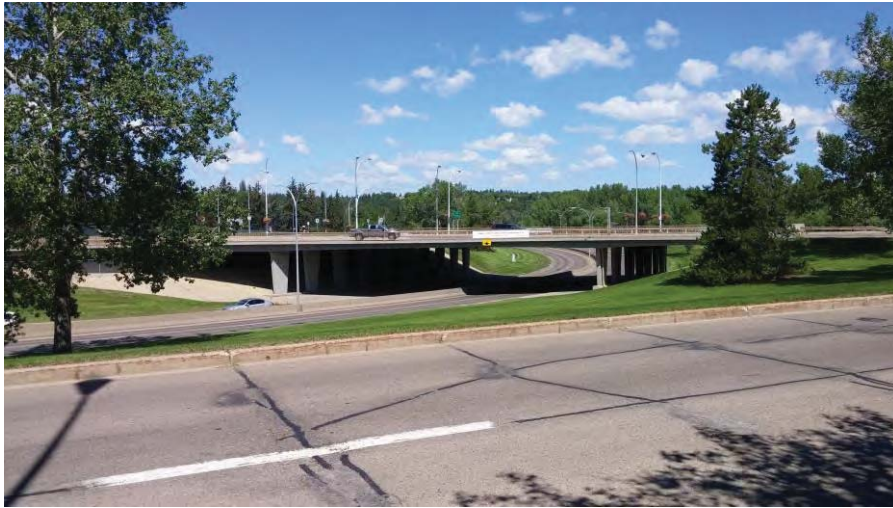
Plate 1.3. Emily Murphy Bridge – view to north (20 June 2016)

Emily Murphy Park Road Bridge (Emily Murphy Bridge) was constructed in 1963 and is a 59.13 m, 3-span post-tensioned concrete, haunched slab-type bridge (City of Edmonton 2015). The bridge carries up to seven lanes of traffic at the west end merging to four lanes at the east end (two westbound and two eastbound) over Groat Road (Plate 1.3). DIALOG undertook a load rating and condition assessment of the Emily Murphy Bridge in 2013 (DIALOG 2016b) and the City proposes to proceed with rehabilitation of this bridge. The proposed repairs should preserve the remaining service life of the bridge, assuming regular maintenance is maintained, with more extensive repairs required in the future (in approximately 10 years) (City of Edmonton 2015). This bridge is not located on a designated truck route.

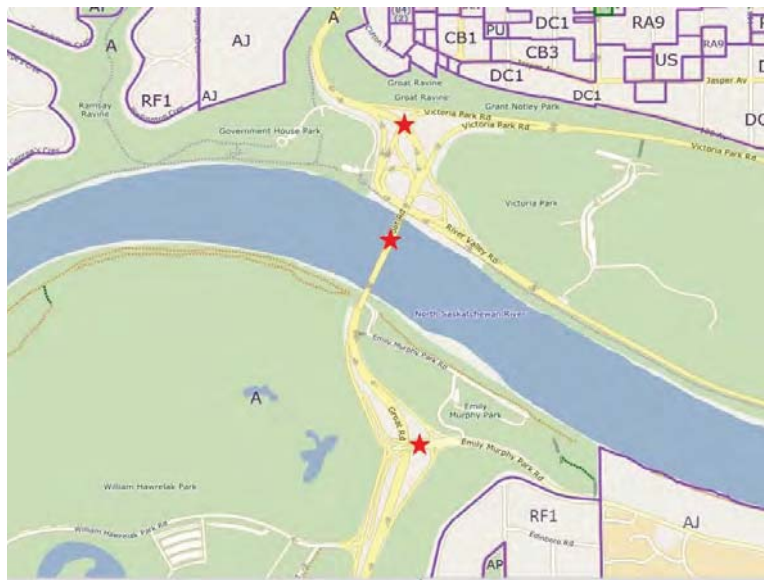
Figure 2.1. Land Use Zoning in the Groat Bridges Rehabilitation Project Area (taken from City of Edmonton Zoning Bylaw No. 12800, as amended)—red stars denote the three bridge locations

The North Saskatchewan River Valley in the study area is zoned as A (Metropolitan Recreation Zone (Figure 2.1). Land uses in the immediate vicinity of the proposed project include a major transportation corridor (Groat Road), Government House Park and Victoria Golf Course and Driving Range on the north side of the river, and Emily Murphy Park on the south side of the river. Shared-use paths (SUPs) in this area comprise part of the City's North Saskatchewan River Valley and ravine system trail network. On the tablelands on the north side of the river are the Westmount neighbourhood (various zonings) and the Royal Alberta Museum (now closed to the public) (zoned AJ). On the tablelands on the south side of the river is the Windsor Park neighbourhood (various zonings) and the University of Alberta (zoned AJ).

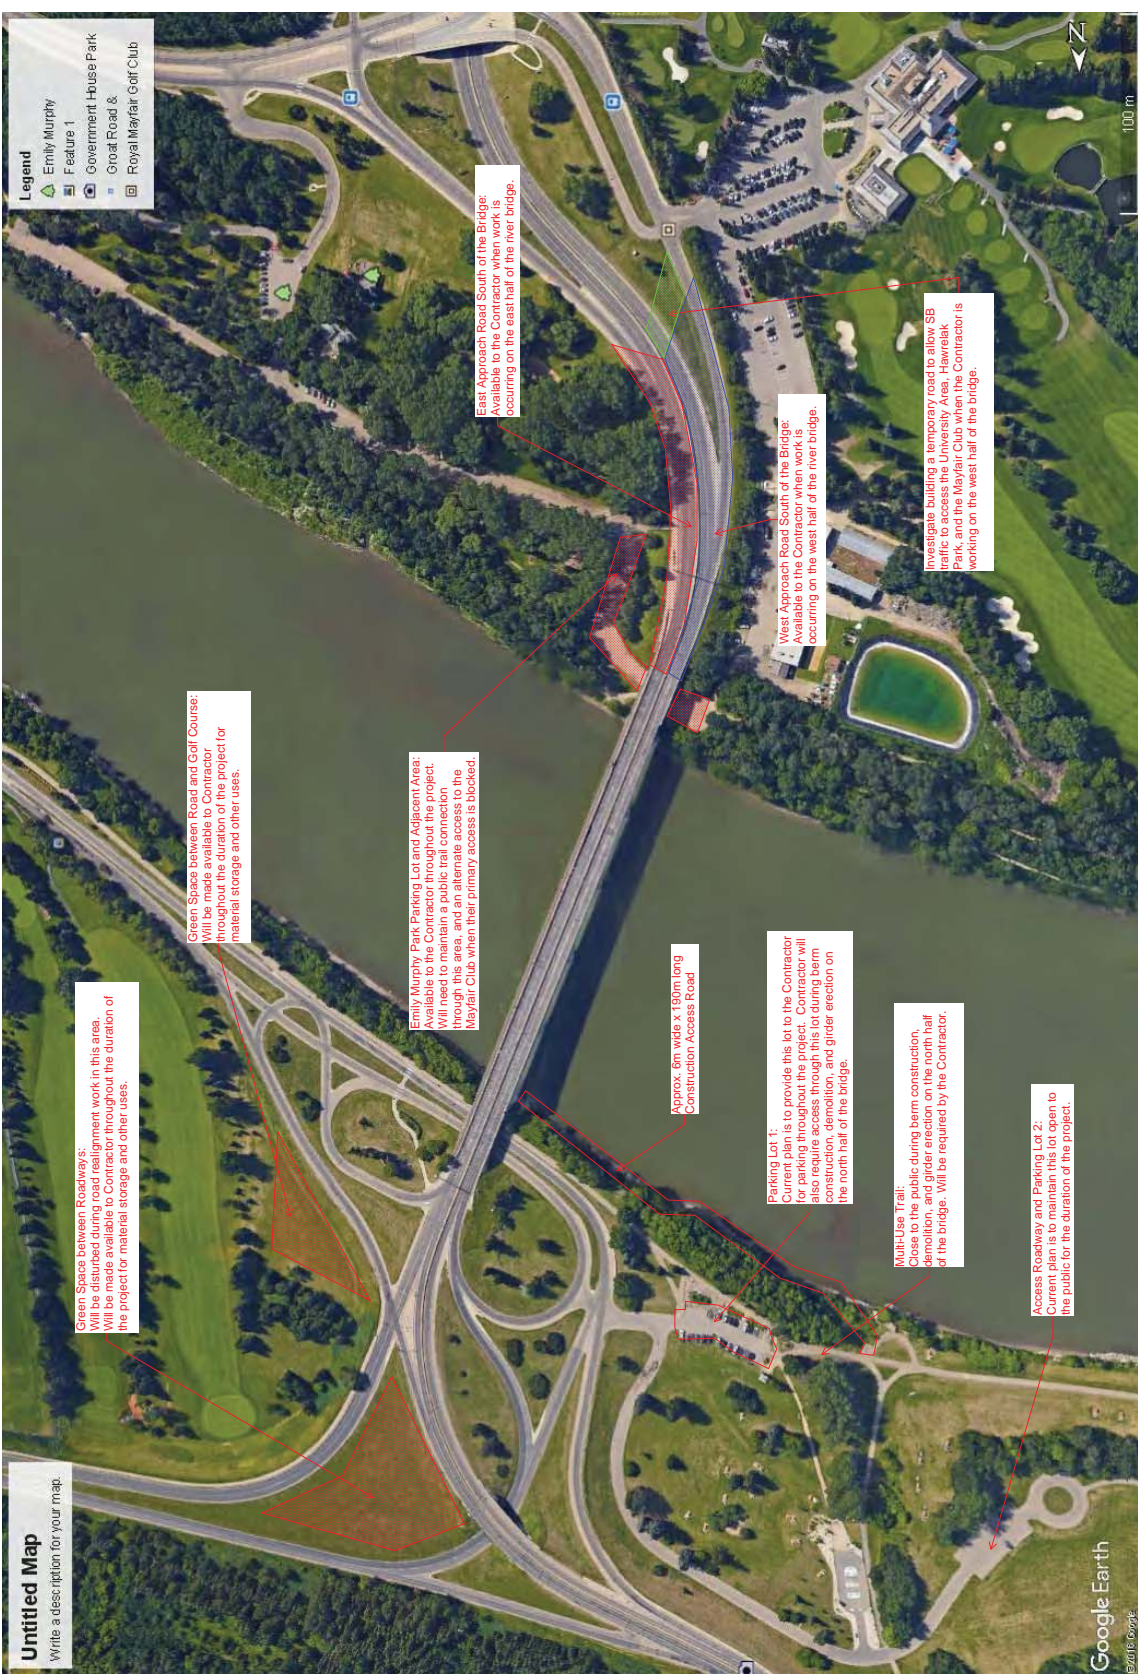
Figure 2.6
Construction Laydown Areas and Access Points

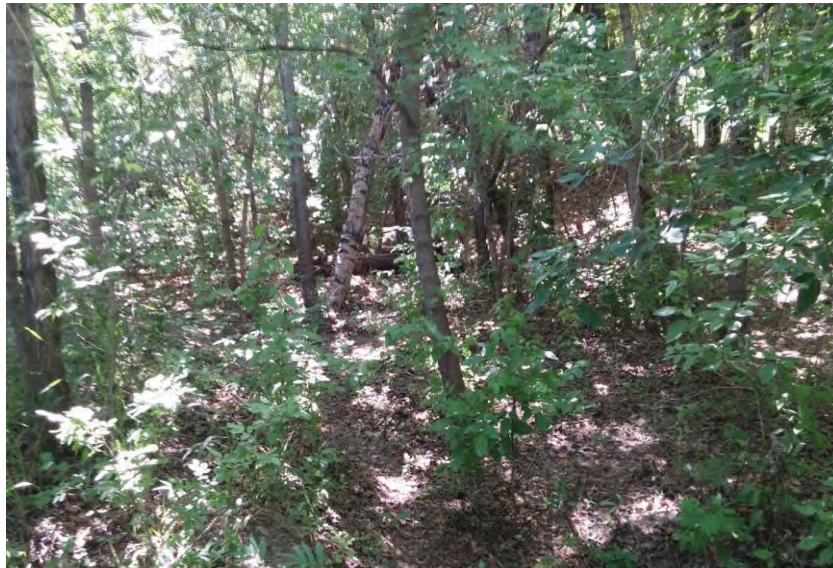
Plate 4.1. A P2 community dominated by balsam poplar and white spruce in Emily Murphy Park, near Groat Road Bridge (20 June 2016)

The balsam poplar-white spruce community was characterized by a canopy dominated by balsam poplar, with frequent occurrences of white spruce and Manitoba maple (Plate 4.1). The shrub layer was characterized by abundant occurrences of prickly rose, red-osier dogwood and buckbrush. The understory was characterized by abundant wild sarsaparilla and frequent occurrences of woodland horsetail, Lindley's aster, star-flowered Solomon's seal and wild lily-of-the-valley.

Overall, 21 vascular plant species were observed in the P2 community (Appendix F). Of these, 17 (81%) were native, while the remaining four species (19%) were exotic. No special status species were observed in the P2 community. One noxious weed species, creeping thistle, was observed in this community. No prohibited noxious species were observed.

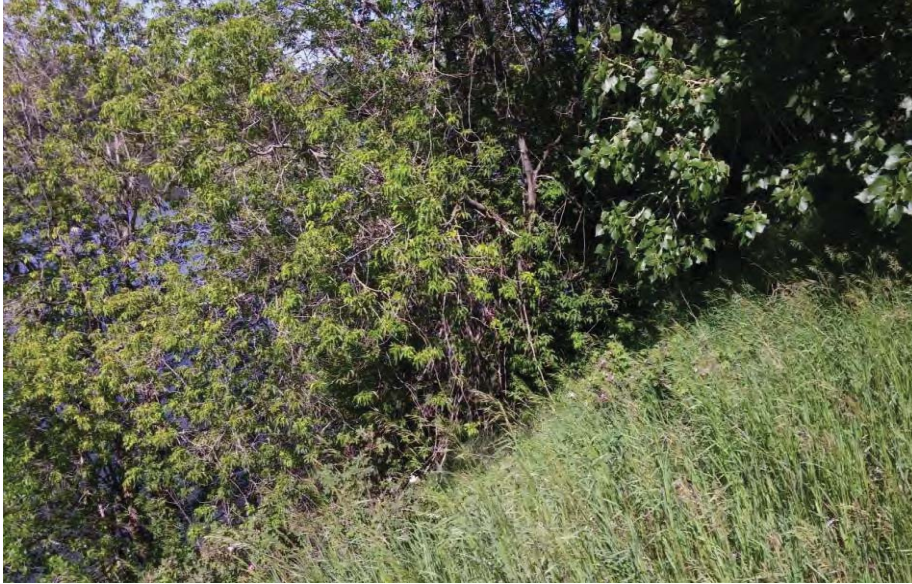
Plate 4.2. A P3 community dominated by balsam poplar and Manitoba maple on the north bank of the North Saskatchewan River upstream of Groat Road Bridge (20 June 2016)

bank of the North Saskatchewan River in the vicinity of Groat Road Bridge (Figure 4.2). At that site, balsam poplar and Manitoba maple were dominant, with abundant occurrences of aspen (Plate 4.2). Prickly rose and buckbrush were widespread in the shrub layer. The understorey was characterized by abundant smooth brome and quack grass, with occasional common goat's-beard and alsike clover.

Overall, 40 vascular plant species were observed in the P3 community (Appendix F). Of these, 25 (63%) were native, while the remaining 15 (38%) were exotic. No special status species were observed in the P3 community. Two noxious weed species, creeping thistle and common tansy, were observed in this community. No prohibited noxious species were observed.

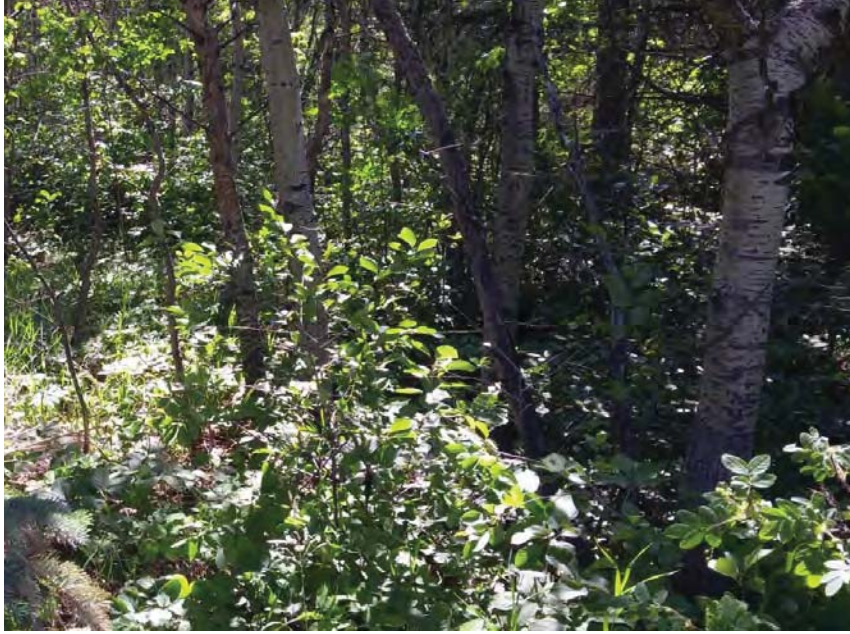
Plate 4.3. An A2 community dominated by aspen and prickly rose near Emily Murphy Bridge (20 June 2016)

Overall, 36 species were observed in the A2 community (Appendix F). Of these, 26 (72%) were native, while the remaining 10 (28%) were exotic. No special status plant species were observed in this community. Three noxious weed species were detected in the A2 community: creeping thistle, common toadflax and common tansy. No prohibited noxious weed species were observed in this community.

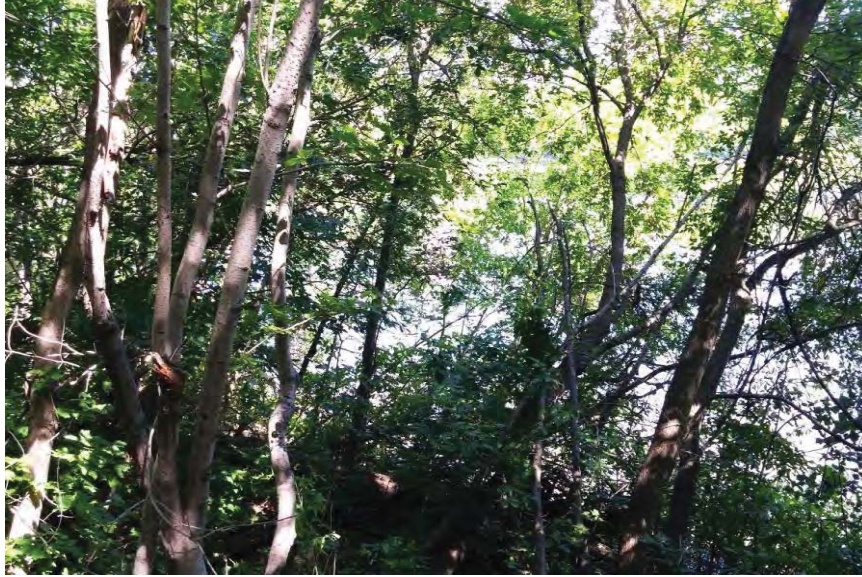
Plate 4.4. A typical Manitoba maple community on the south side of Groat Road Bridge (B059) (20 June 2016)

Overall, 32 species were observed in the MM community (Appendix F). Of these, 20 (63%) were native, while the remaining 12 (38%) were exotic. One special status species, high-bush cranberry (S3S4) was observed within the MM community, near the south end of Groat Road Bridge. Two noxious weed species were observed in this community: common burdock and creeping thistle. No prohibited noxious weed species were observed.

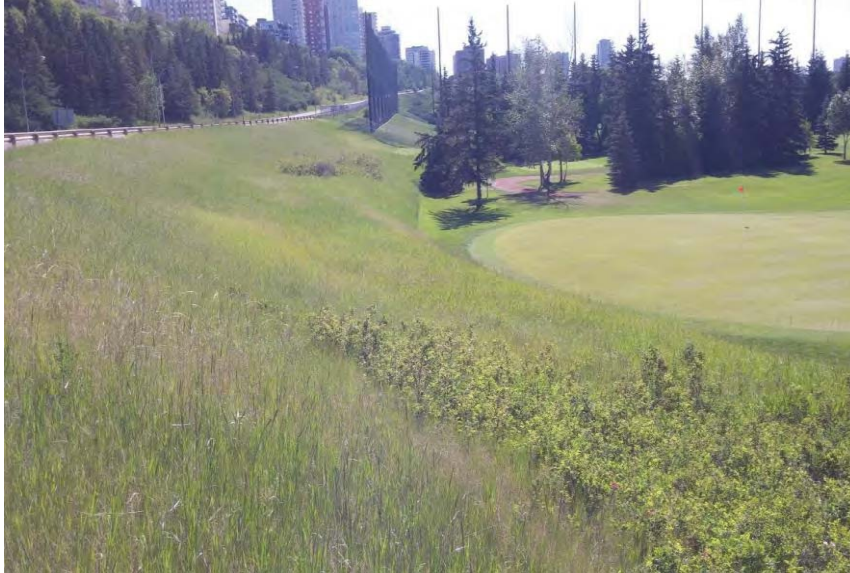
Plate 4.5. A grassland community characterized by smooth brome and scattered prickly rose, on the slope above the Victoria Park Golf Course, adjacent to Victoria Park Road (20 June 2016)

The grassland community was dominated by unmown smooth brome, quack grass and Kentucky bluegrass, with frequent crested wheatgrass and common dandelion. A small patch of low shrubs included prickly rose, buckbrush and snowberry (Plate 4.5).

Overall, 16 species were observed in the grassland community (Appendix F). Of these, four (25%) were native, while the remaining 12 (75%) were exotic. No special status species were observed in this community. Two noxious weed species were observed: creeping thistle and scentless chamomile. No prohibited noxious weeds were observed.

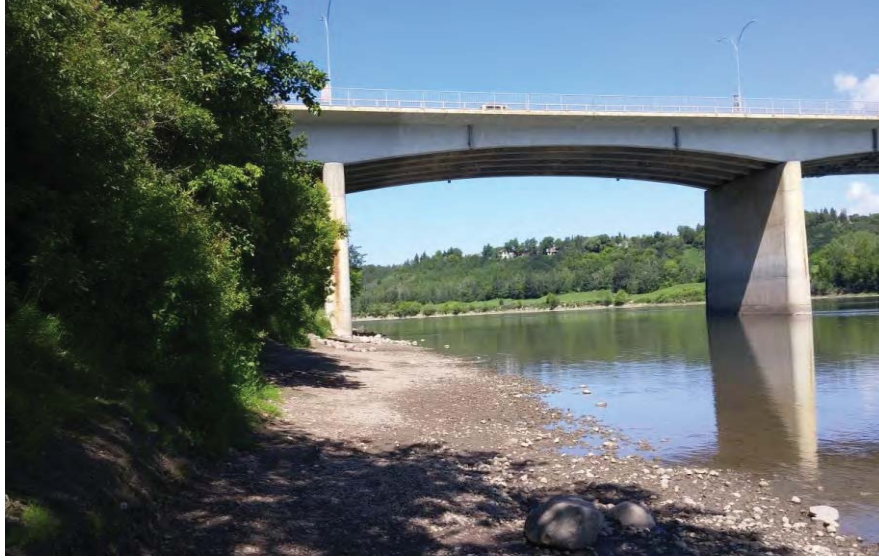
Plate 4.6. Sparsely-vegetated shoreline community on the south side of the river at Groat Road Bridge (20 June 2016)

Overall, 20 species were observed in the shoreline community at Emily Murphy Park on the south side of the river. Of these, nine species were native and 11 species were exotic (Appendix F). No special status species were observed, and one noxious weed species, common tansy, was occasionally observed.

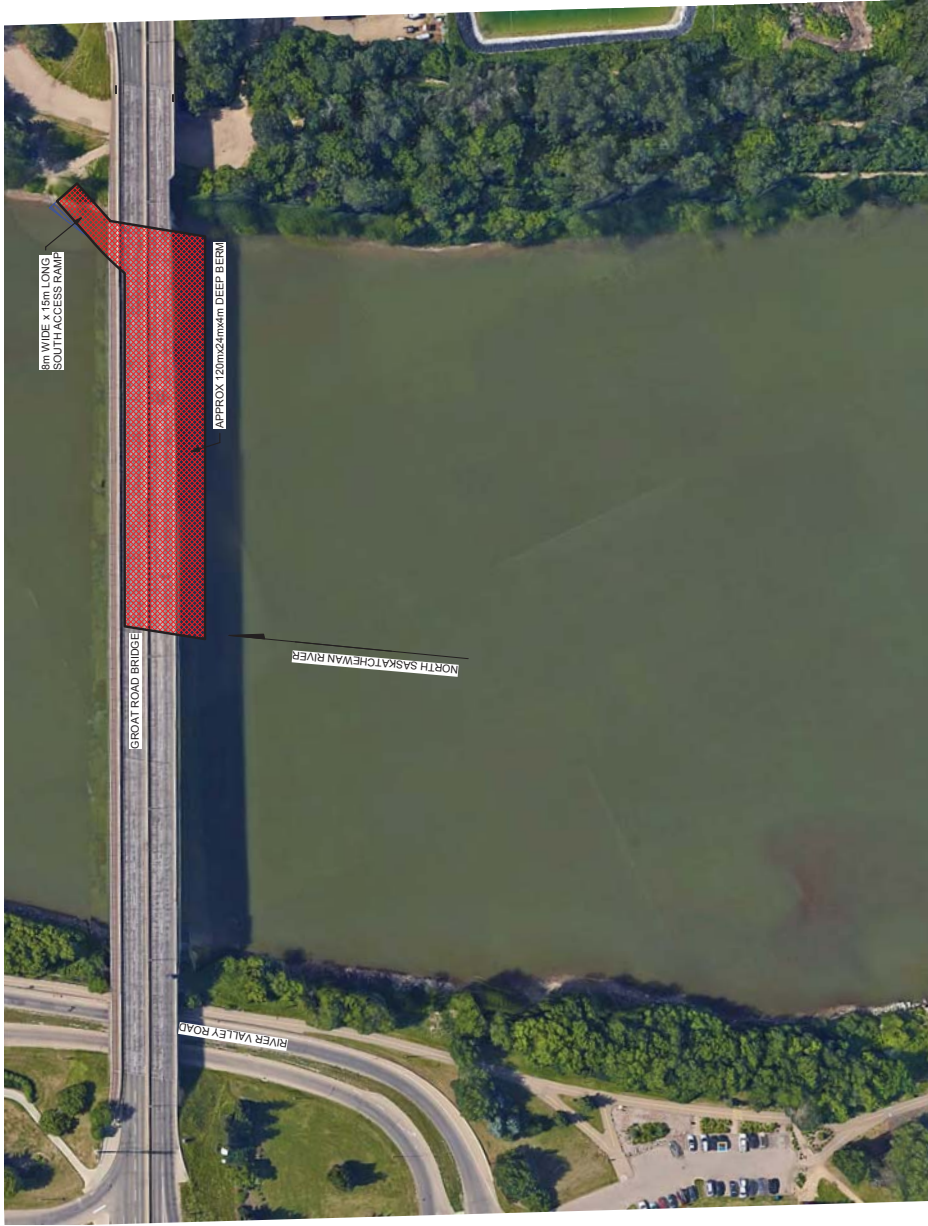
BERM STAGE 1
(ESTIMATED CONSTRUCTION SCHEDULE)

1. INSTALL BERM FROM SOUTH SIDE - APPROX 80% OF RIVER WIDTH - LATE AUGUST 2018
2. DEMOLISH WEST GIRDERS FROM SOUTH ABUTMENT TO PIER #3 - SEPTEMBER 2018
3. ERECT WEST GIRDERS FROM SOUTH ABUTMENT TO PIER #4 - OCTOBER 2018

Detailed drawings showing the proposed seven (7) berm stages and associated access points from the north and south banks of the North Saskatchewan River may be found in Appendix A of this document and a proposed construction schedule for instream works is provided in Figure 2.3. The proposed overall bridge construction period is expected to extend from June 2018 to August 2020, with the instream berm component extending from August 2018 to April 2020.

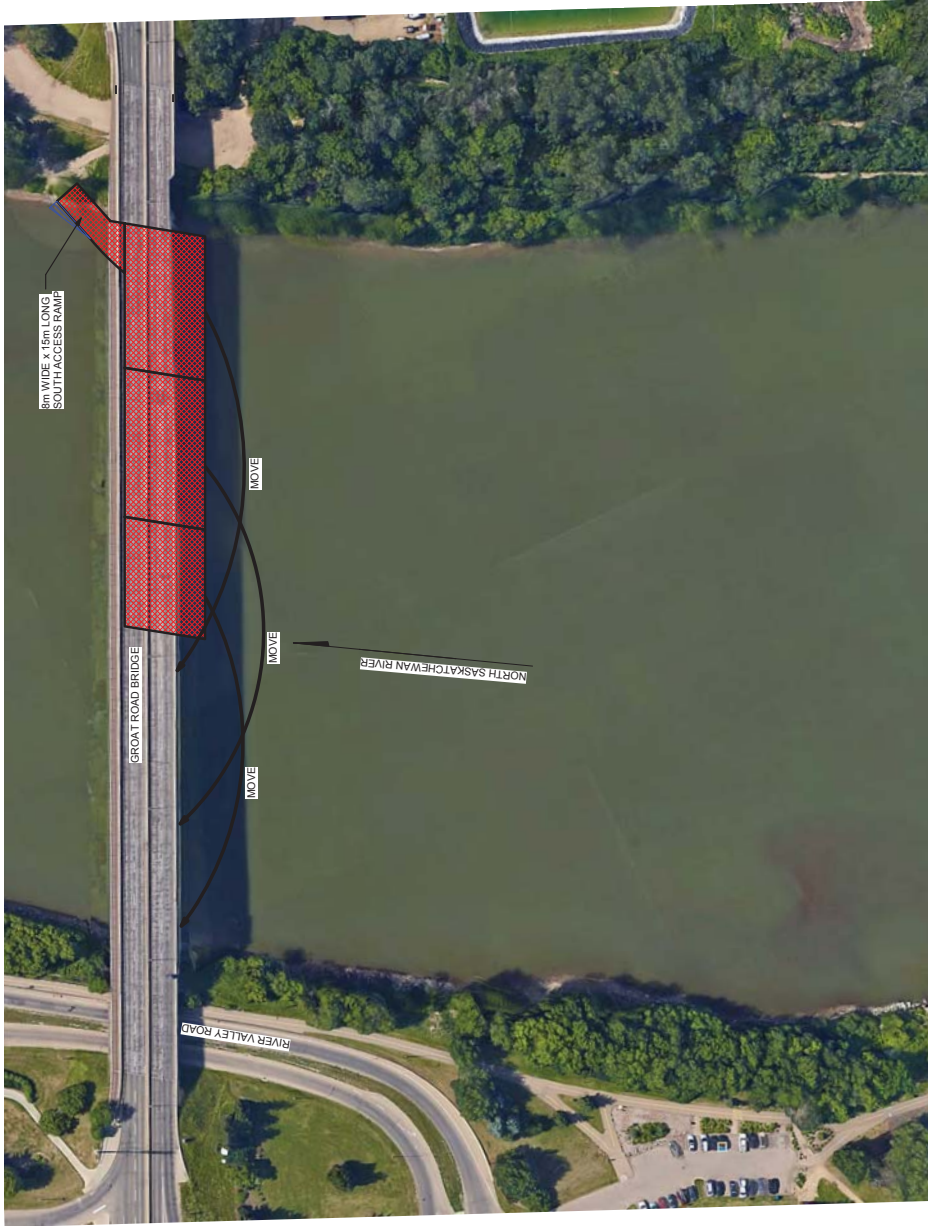
BERM STAGE 2
 (ESTIMATED CONSTRUCTION SCHEDULE)
 1. MOVE BERM FROM SOUTH HALF OF THE RIVER TO
 NORTH HALF OF RIVER IN STREAM - NOVEMBER 2018

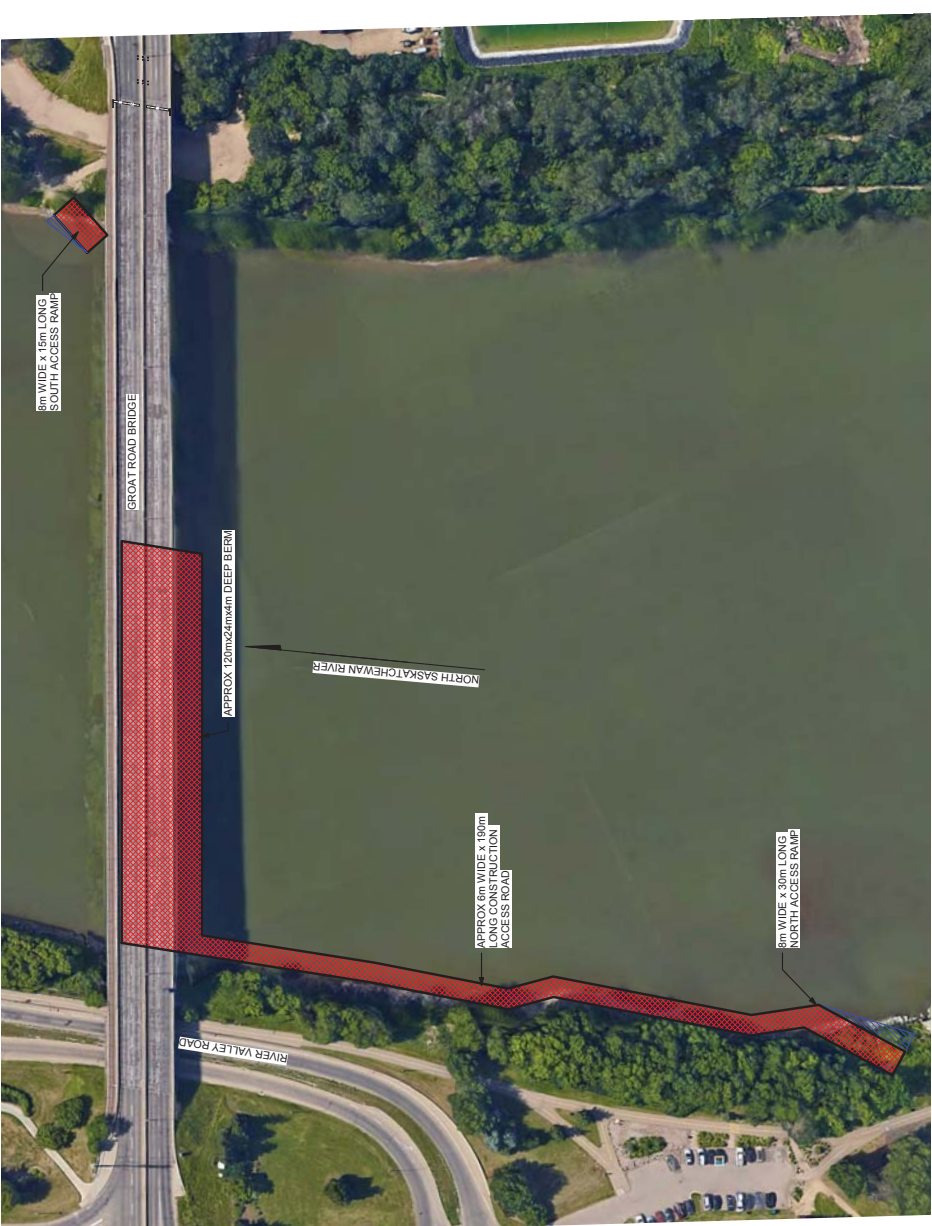
BERM STAGE 3
(ESTIMATED CONSTRUCTION SCHEDULE)

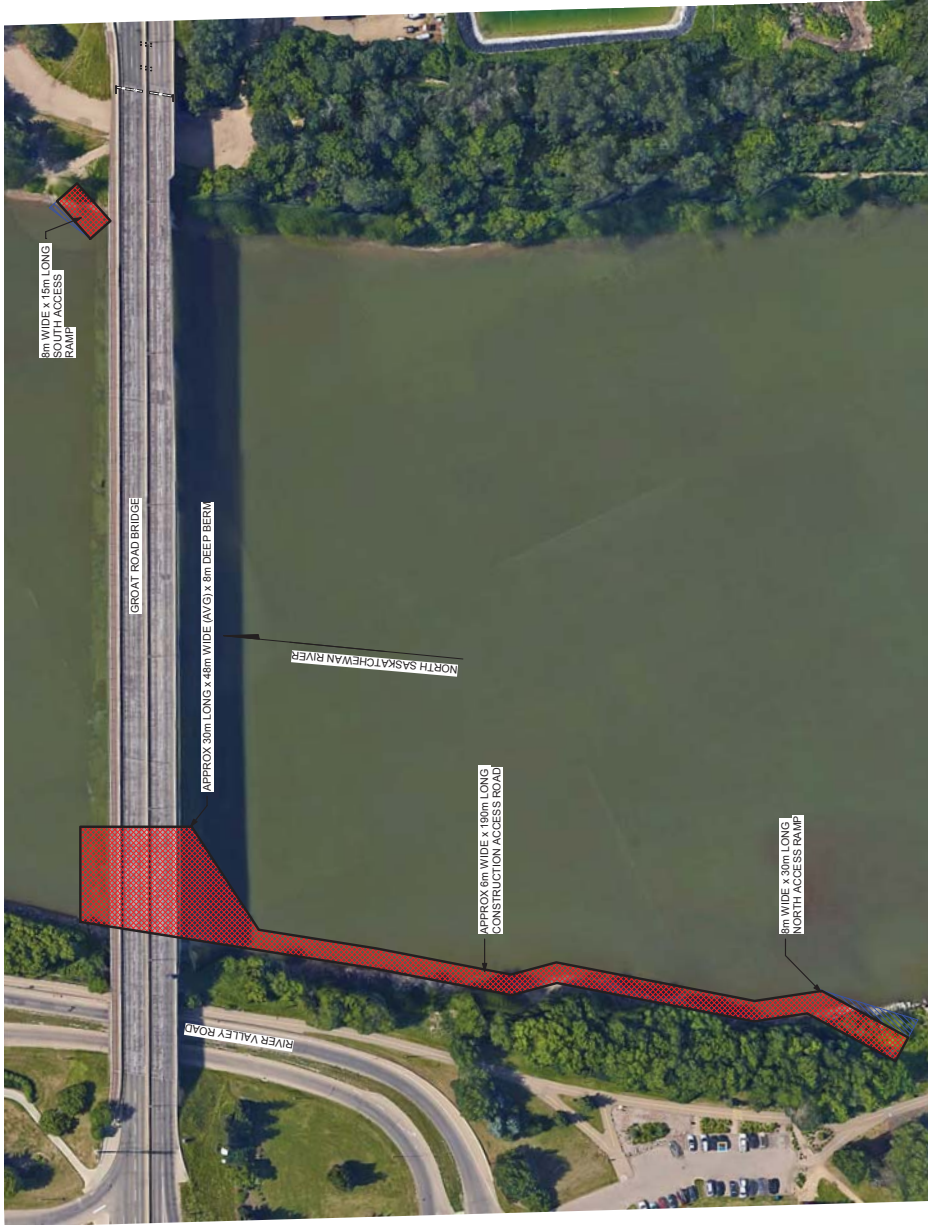
BERM STAGE 4
 (ESTIMATED CONSTRUCTION SCHEDULE)
 1. SHIFT BERM MATERIAL AGAINST NORTH BANK - FEBRUARY 2019
 2. STORE BERM MATERIAL AGAINST NORTH BANK - FEBRUARY TO AUGUST 2019

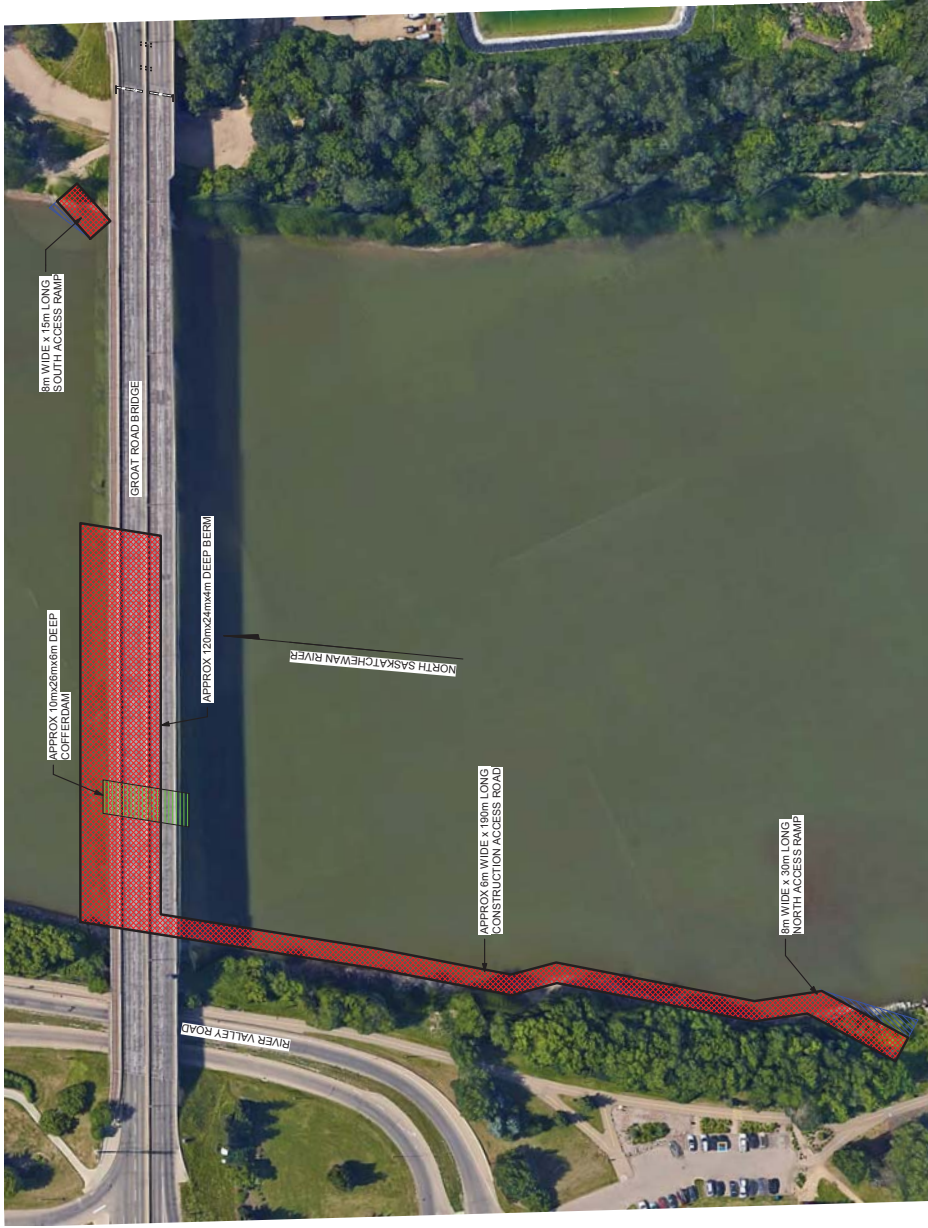
BERM STAGE 5
(ESTIMATED CONSTRUCTION SCHEDULE)

1. EXTEND BERM BELOW NORTHEAST GIRDERS - LATE AUGUST 2019
2. DEMOLISH EAST GIRDERS FROM NORTH ABUTMENT TO PIER #4 - SEPTEMBER 2019
3. ERECT EAST GIRDERS FROM NORTH ABUTMENT TO PIER #3 - OCTOBER 2019

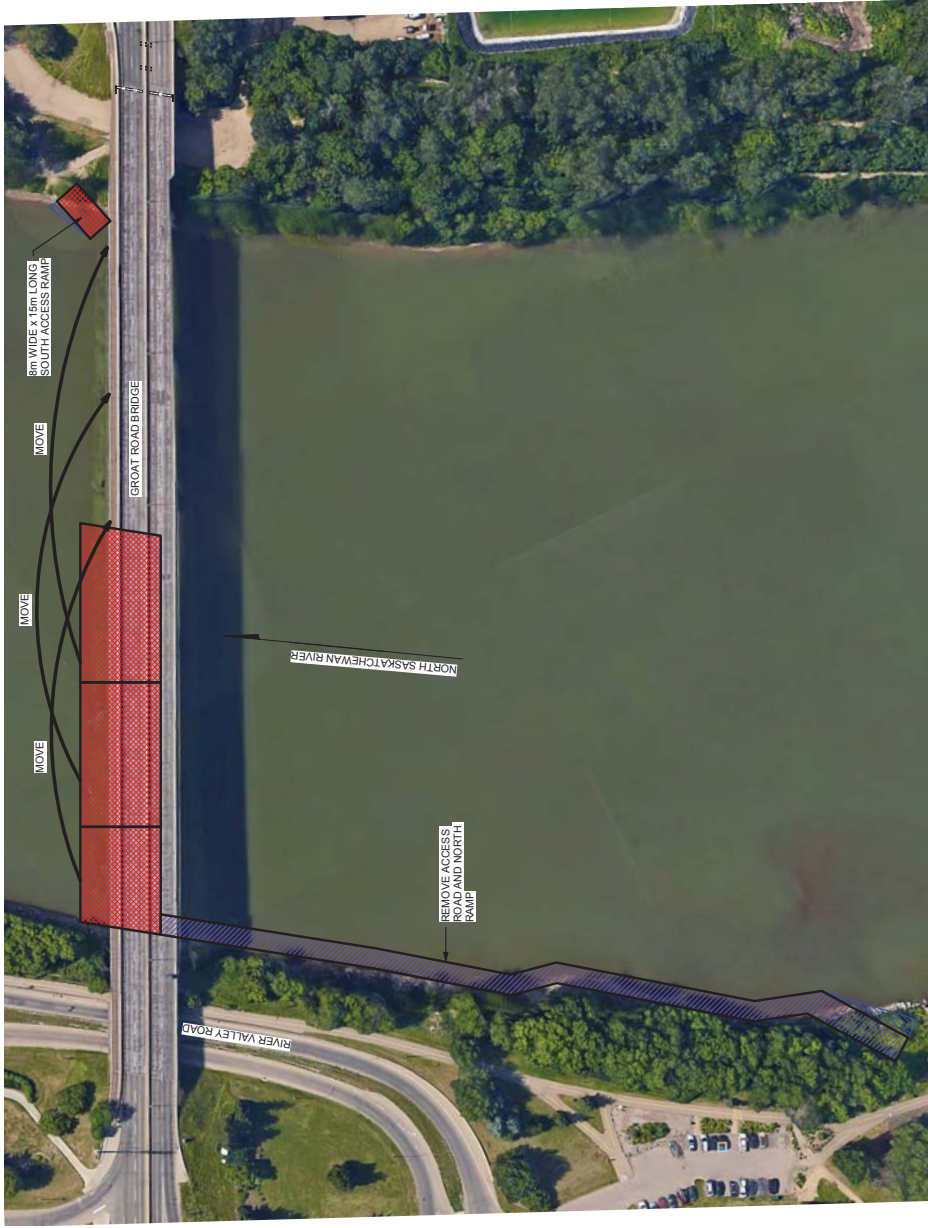
BERM STAGE 6
(ESTIMATED CONSTRUCTION SCHEDULE)

1. MOVE BERM FROM NORTH HALF OF THE RIVER TO SOUTH HALF OF RIVER INSTREAM - NOVEMBER 2019
2. REMOVE NORTH CONSTRUCTION ACCESS ROAD AND RAMP - DECEMBER 2019

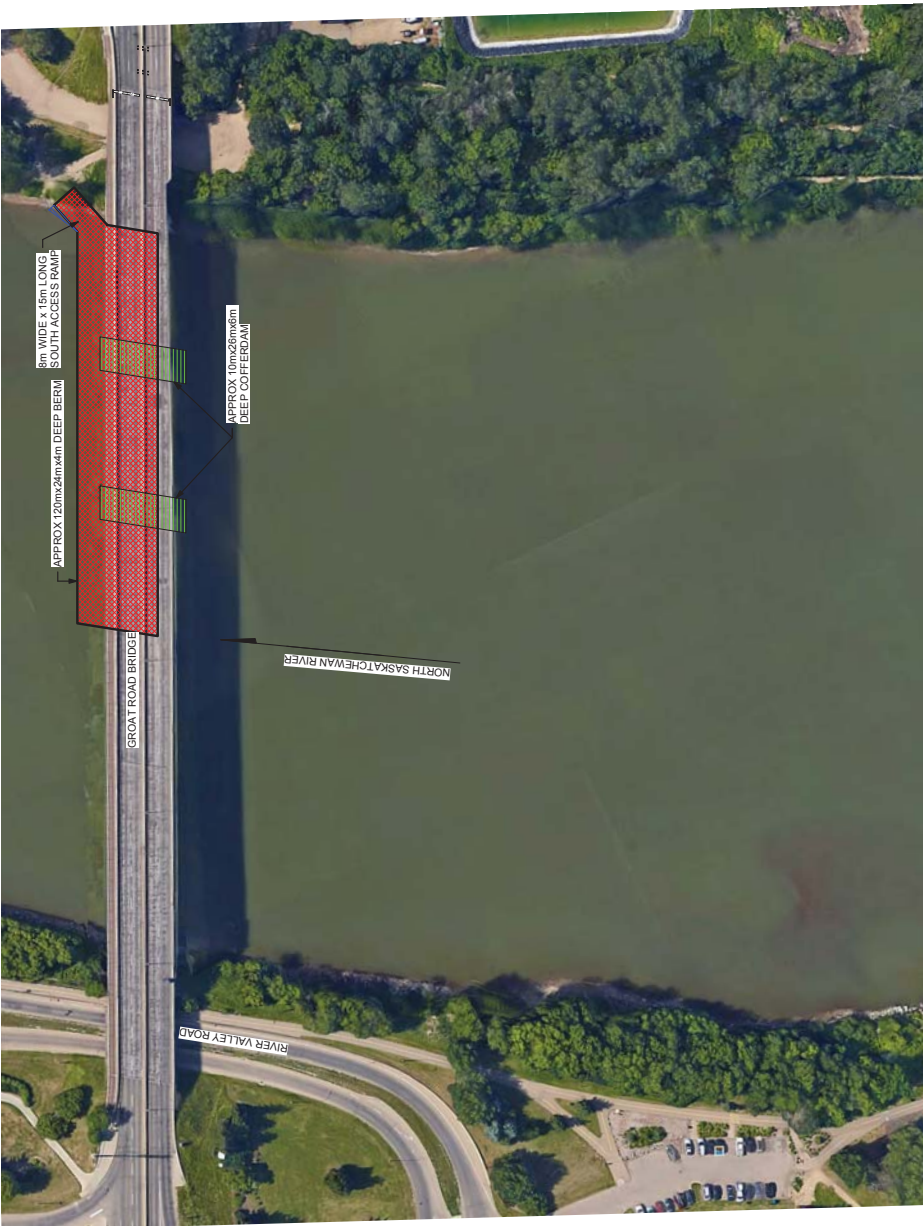
BERM STAGE 7
(ESTIMATED CONSTRUCTION SCHEDULE)

1. DEMOLISH BALANCE OF BRIDGE - DECEMBER 2019
2. ERECT REMAINING STEEL GIRDERS - JANUARY 2020
3. REMOVE ALL BERM AND RAMP MATERIAL - FEBRUARY 2020
