WEST END BRIDGE  
EDMONTON  
PIER 3

**Westbound Victoria Road to Northbound Groat Road Ramp  
Back Slope Stability  
3H:1V Cut Slope**

**PHASE I ENVIRONMENTAL SITE ASSESSMENT  
GROAT ROAD BRIDGES  
REHABILITATION PROJECT  
EDMONTON, ALBERTA**

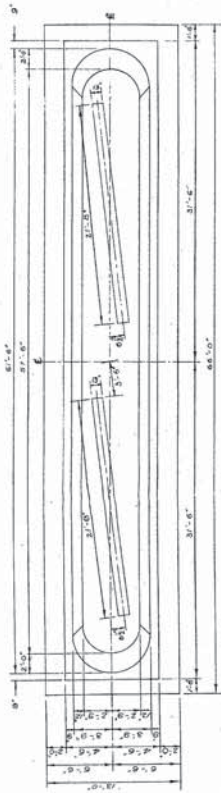
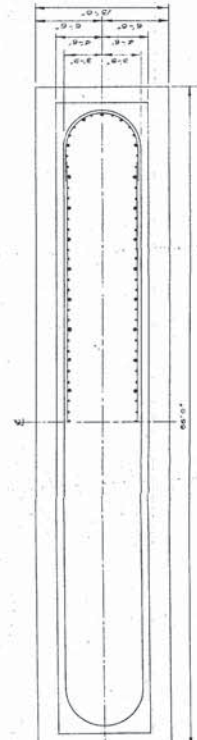
PIER 3 FOR CONCRETE STRUCTURE	
CONCRETE	3300' CLASS 2 837 CU YD
CONCRETE	3000' CLASS 2 810 CU YD
REINFORCING STEEL	26600 LBS
MISCELLANEOUS IRON	7248 LBS
NET COMMON EXCAVATION	433 CU YD
BACKFILL	775 CU YD

- 1) TOP OF PIER ELEV TO BE 104.98
- 2) PIER TO BE RIGID AT BASE, DELETE ALL FOOTING AND SHAFT AS DETAIL FOR PIERS 1, 3, 4 & 5
- 3) DELETE ROCKER WELLS AND CHANNELS AT TOP OF PIER AND FINISH BEARING SECTIONS IN ACCORDANCE WITH CONCRETE WORKING SPECIFICATIONS
- 4) TOP OF PIERSTEEL ELEV. TO BE 93.92
- 5) SPALL AND SQUAND

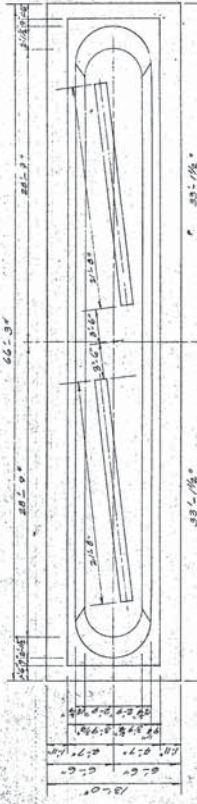
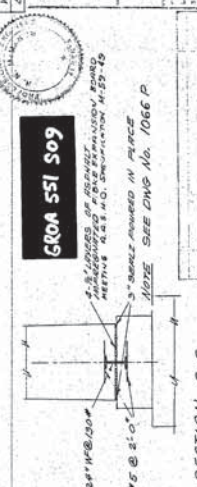
**WEST END BRIDGE**  
 EDMONTON  
 PIER 4

PIER 4 FOR STEEL STRUCTURE	
CONCRETE 2500 CLASS 8	89 CU YD
CONCRETE 3000 CLASS A	7.0 CU YD
REINFORCING STEEL	39970 LBS
WELLS AND WELLS EXCAVATION	383 LBS
BASEFILL	188 CU YD
PIER 4 FOR CONCRETE STRUCTURE	
CONCRETE 2500 CLASS 8	89 CU YD
CONCRETE 3000 CLASS A	7.0 CU YD
REINFORCING STEEL	39970 LBS
WELLS AND WELLS EXCAVATION	383 LBS
BASEFILL	188 CU YD

- 1) TOP OF PIER ELEV TO BE 104.63
- 2) PIER AND DECK TO BE 104.63 AT BASE. ALL STEEL TO BE 360 LBS PER LINEAL FOOT. PIER AND DECK TO BE 360 LBS PER LINEAL FOOT.
- 3) ALL STEEL TO BE 360 LBS PER LINEAL FOOT. PIER AND DECK TO BE 360 LBS PER LINEAL FOOT.
- 4) TOP OF PIER ELEV TO BE 104.63
- 5) ELEVATION AND BOTTOM OF FOOTING TO BE 104.63

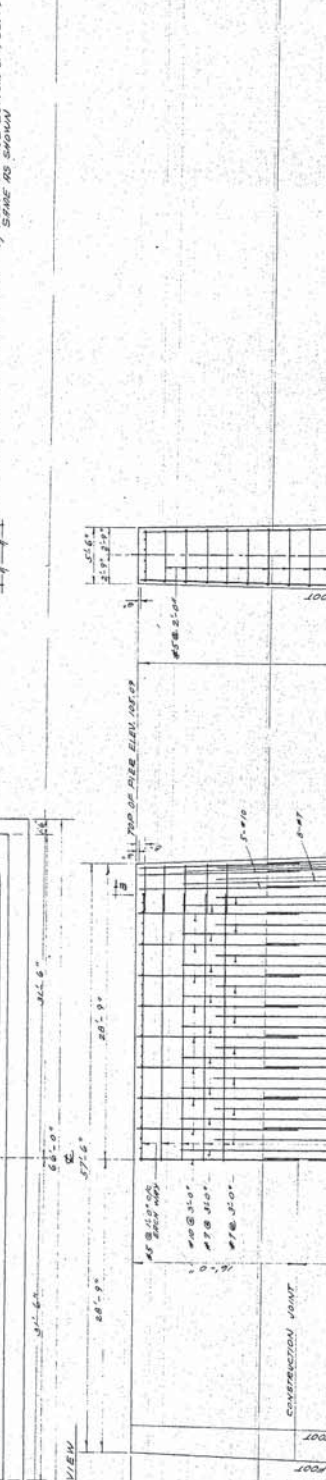
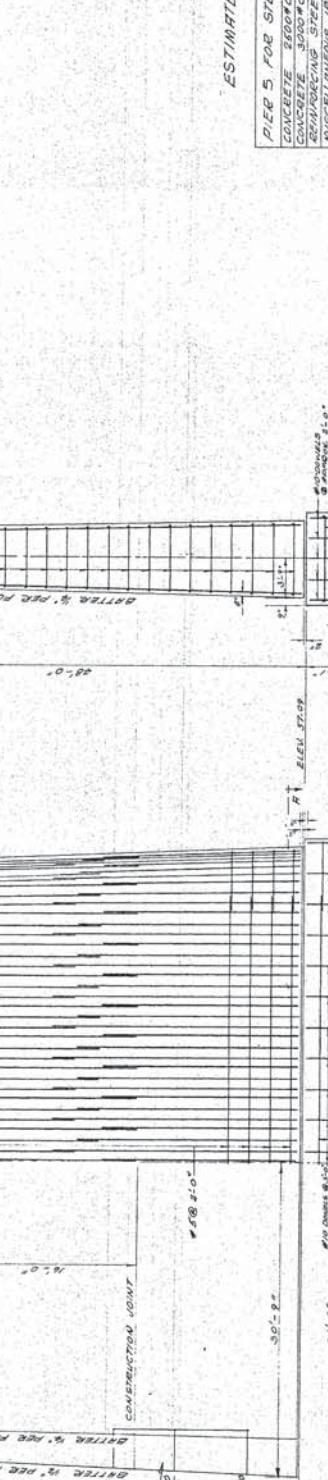
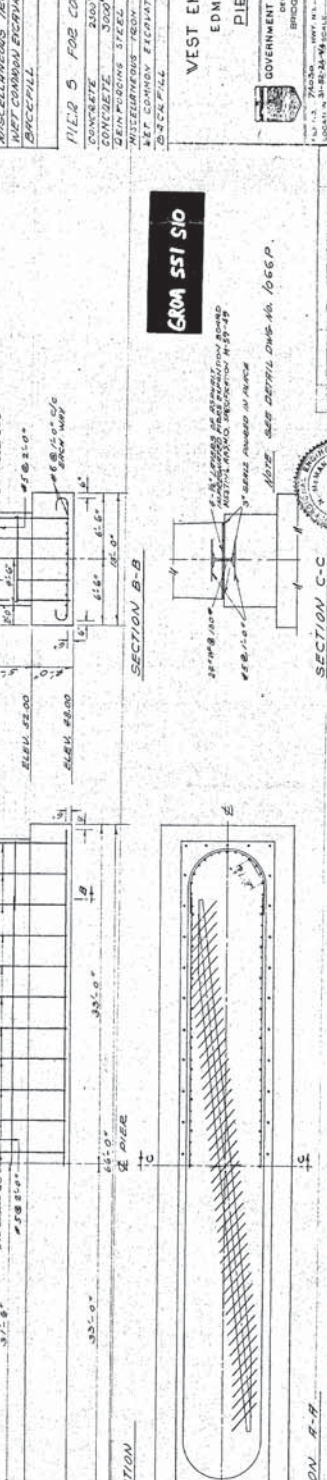
**VEST END BRIDGE**  
EDMONTON  
PIER 5

PIER 5 FOR STEEL STRUCTURE	
CONCRETE 2000# CLASS	339 CU YD
CONCRETE 3000# CLASS	670 CU YD
REINFORCING STEEL	38,590 LBS.
MISCELLANEOUS IRON	3,595 LBS.
NET COMMON EXPERTISE	6 1/2 CU YD
BRICKFILL	285 CU YD

PIER 5 FOR CONCRETE STRUCTURE	
CONCRETE 2000# CLASS	234 CU YD
CONCRETE 3000# CLASS	468 CU YD
REINFORCING STEEL	27,116 LBS.
MISCELLANEOUS IRON	10,995 LBS.
NET COMMON EXPERTISE	6 1/2 CU YD
BRICK FILL	285 CU YD

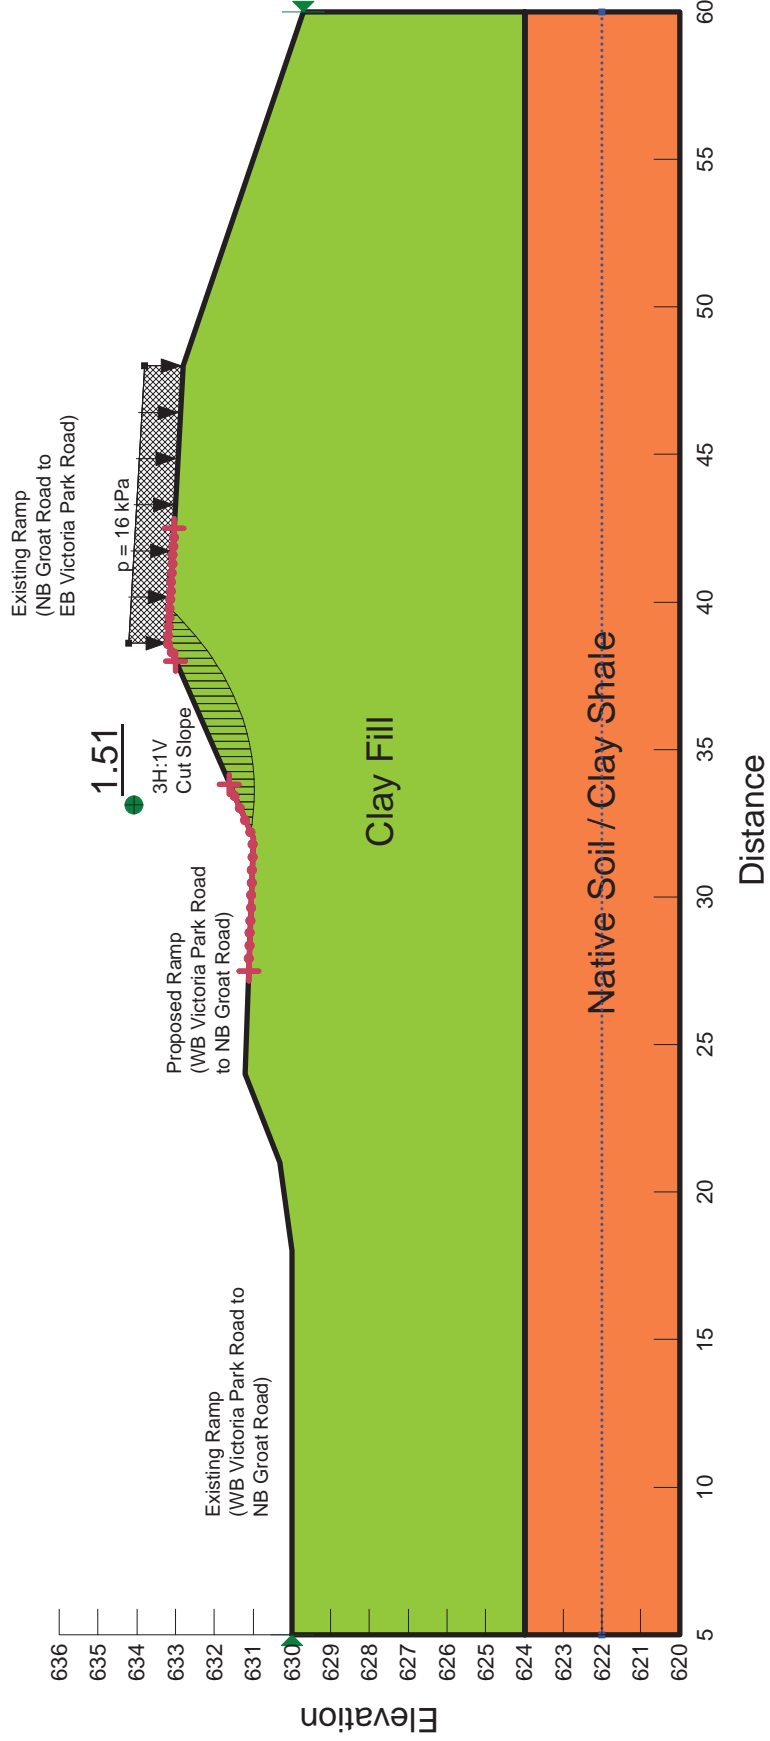
**Figure E1**

Directory: H:\10000\10298 Groat Road River Bridge Rehabilitation & Associated Road Work\Calculations\SlopeW1  
 File Name: Victoria Park Road Ramp\_Long Term\_3H-1V\_HER.gsz  
 Date: 7/4/2016  
 Method: Morgenstern-Price

Name: Clay Fill  
 Model: Mohr-Coulomb  
 Unit Weight: 19 kN/m<sup>3</sup>  
 Cohesion: 2 kPa  
 Phi: 22 °  
 Ru: 0.1

Name: Native Soil / Clay Shale  
 Model: Bedrock (Impenetrable)
