Northwest Hydraulic Consultants Ltd. (NHC) are pleased to provide the following report to establish design flood and hydraulic conditions for the two proposed berm arrangement plans associated with rehabilitation of the existing Groat Road Bridge on the North Saskatchewan River in Edmonton, Alberta (**Appendix A**). The proposed construction process will be staged over two seven month periods, with each period beginning in August and ending late-February. In Period One, the downstream half of the bridge will be replaced. This will commence by first constructing a berm to isolate the south half of the bridge in August and keeping that in place until the end of October. Between the end of October and end of November, the berm will be moved from the south to the north half of the bridge. It is expected that work along the north half will take place starting late November and the berm be removed by late February. Period Two would be the mirror image of Period One with the berms being placed to work on the upstream half of the bridge, commencing from the north side and then moving to the south. Each of the berm arrangements for both Periods will constrict the flow to approximately 40% o

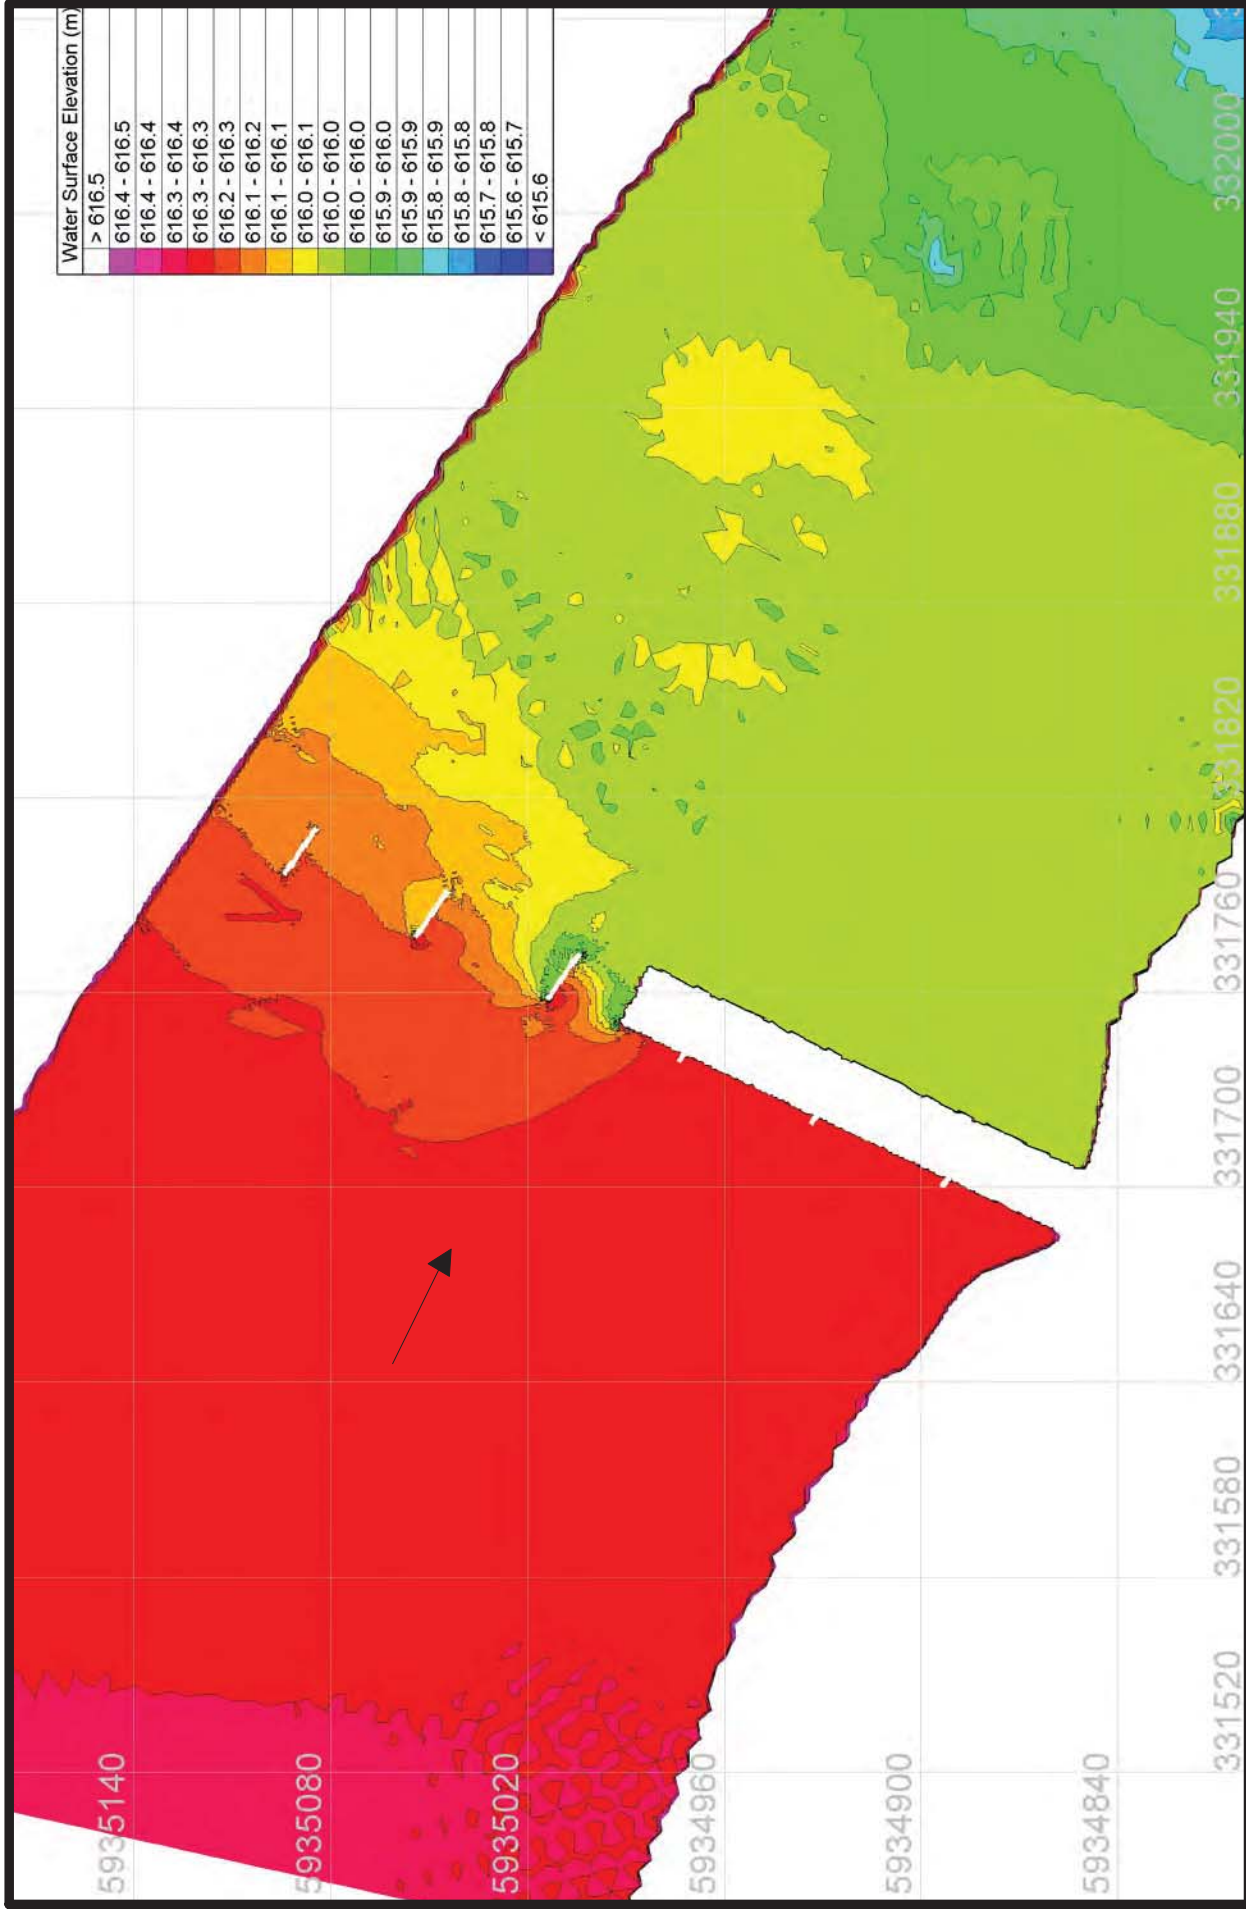
Figure 3 - Water Surface Elevation - Right Berm

Q = 343 cms

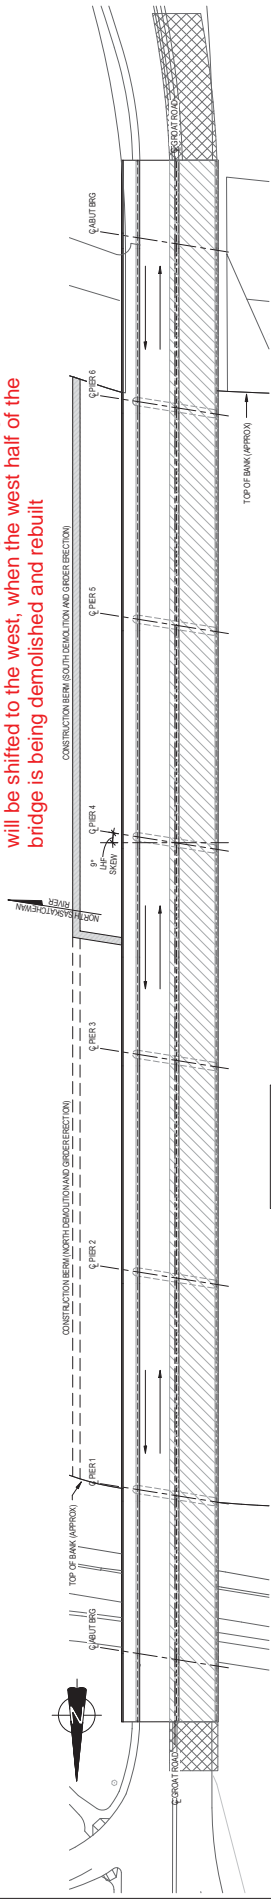
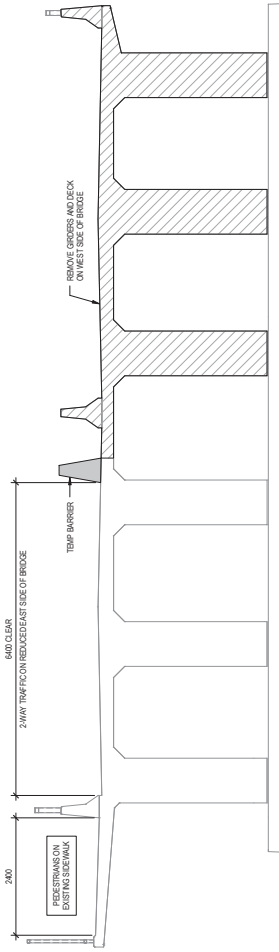
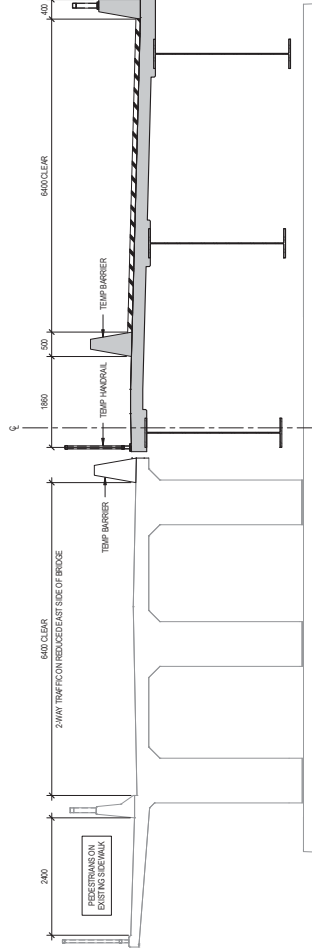
Note - Berms are drawn on wrong side of bridge. Berms will be shifted to the west, when the west half of the bridge is being demolished and rebuilt

Approx dimensions of Class 2
rock riprap berm:

- 16m wide at top
- 20m wide at base
- 3.8 to 4.0m high

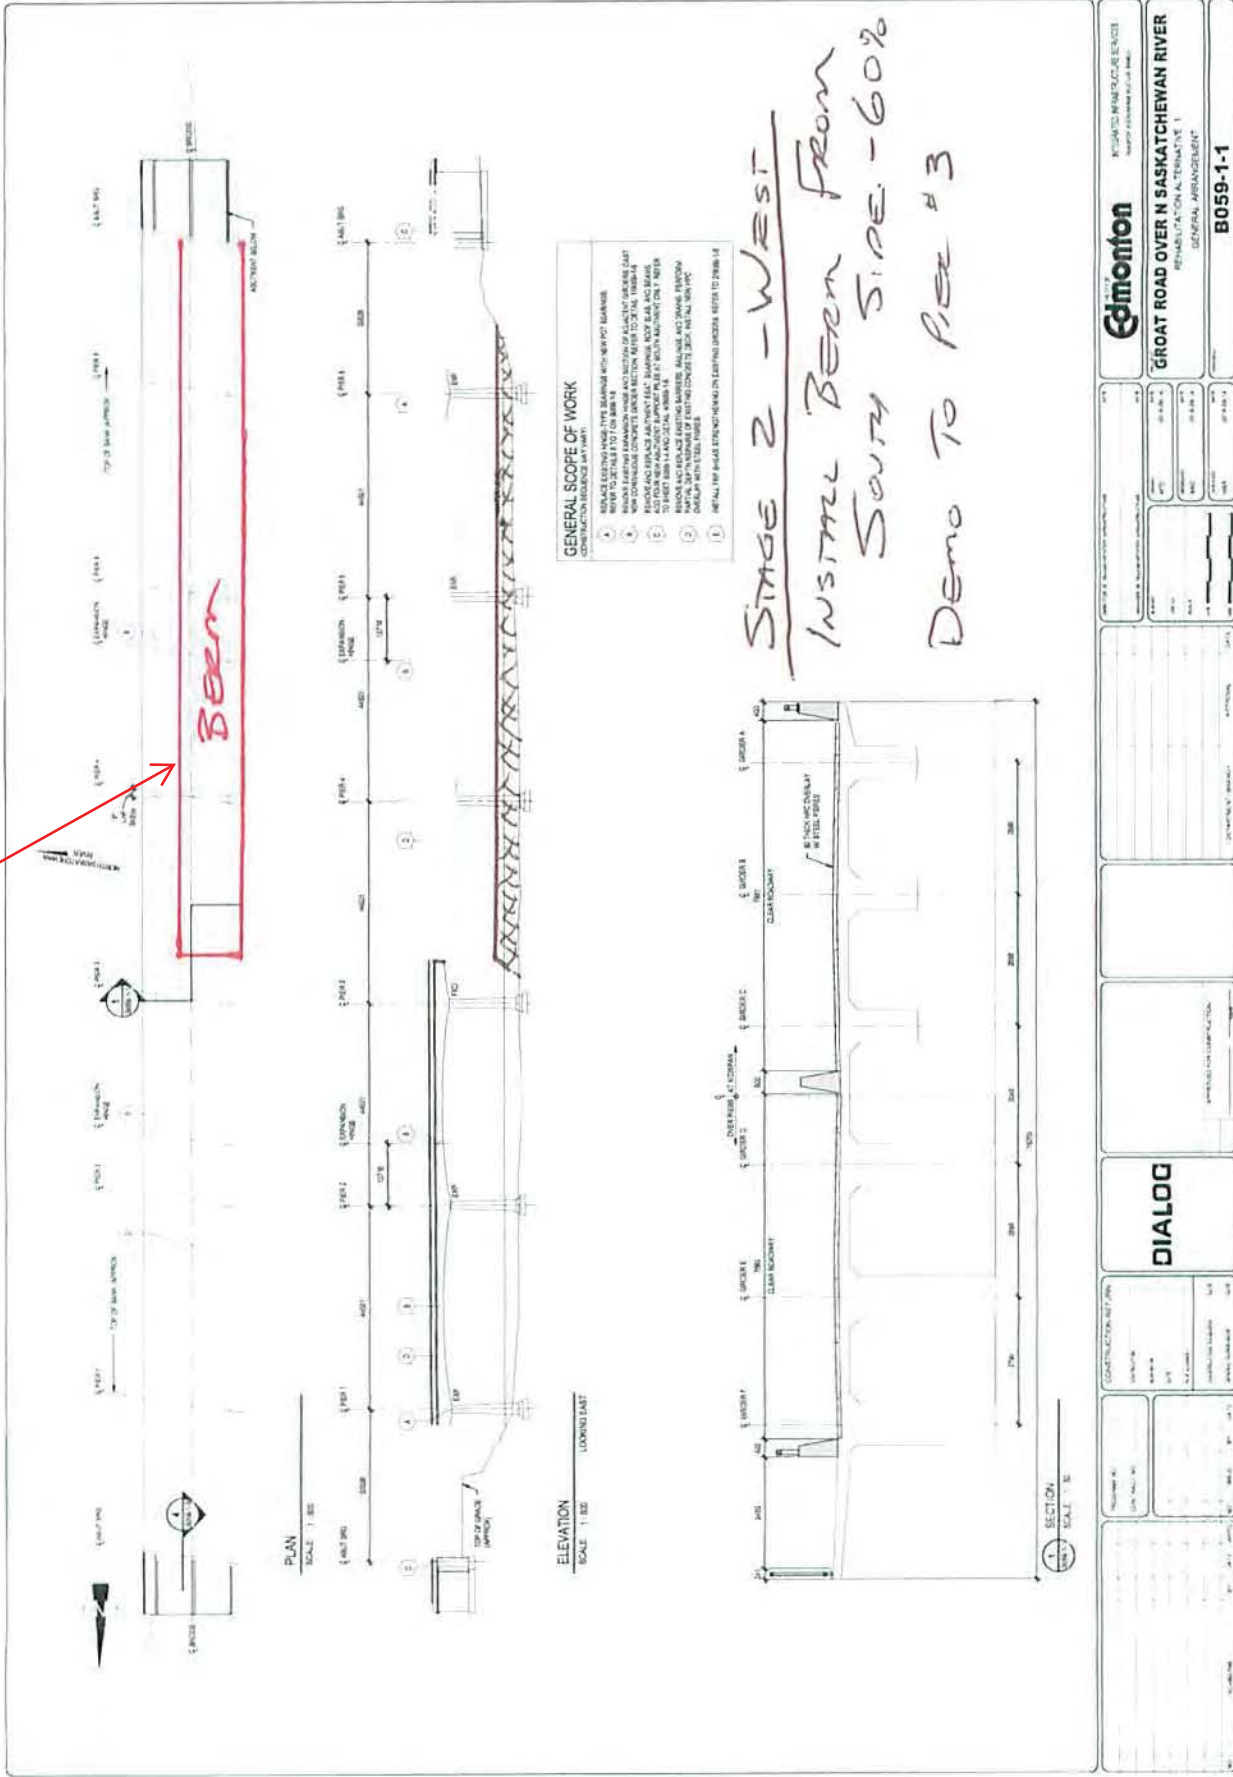
Estimated Construction Schedule:
Install Berm in Late August 2018
Demolition occurs in September 2018

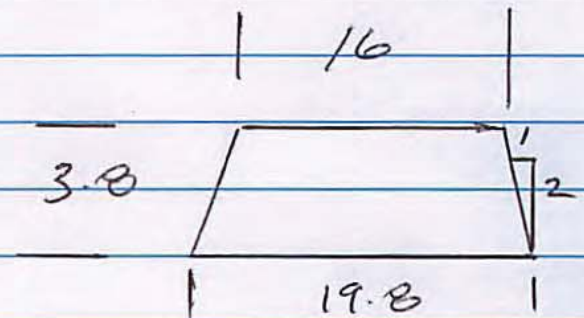
$$V = 138 \times 17.9 \times 3.8$$

$$V = 9400 \text{ m}^3$$

Assumption is that all material is rock riprap.

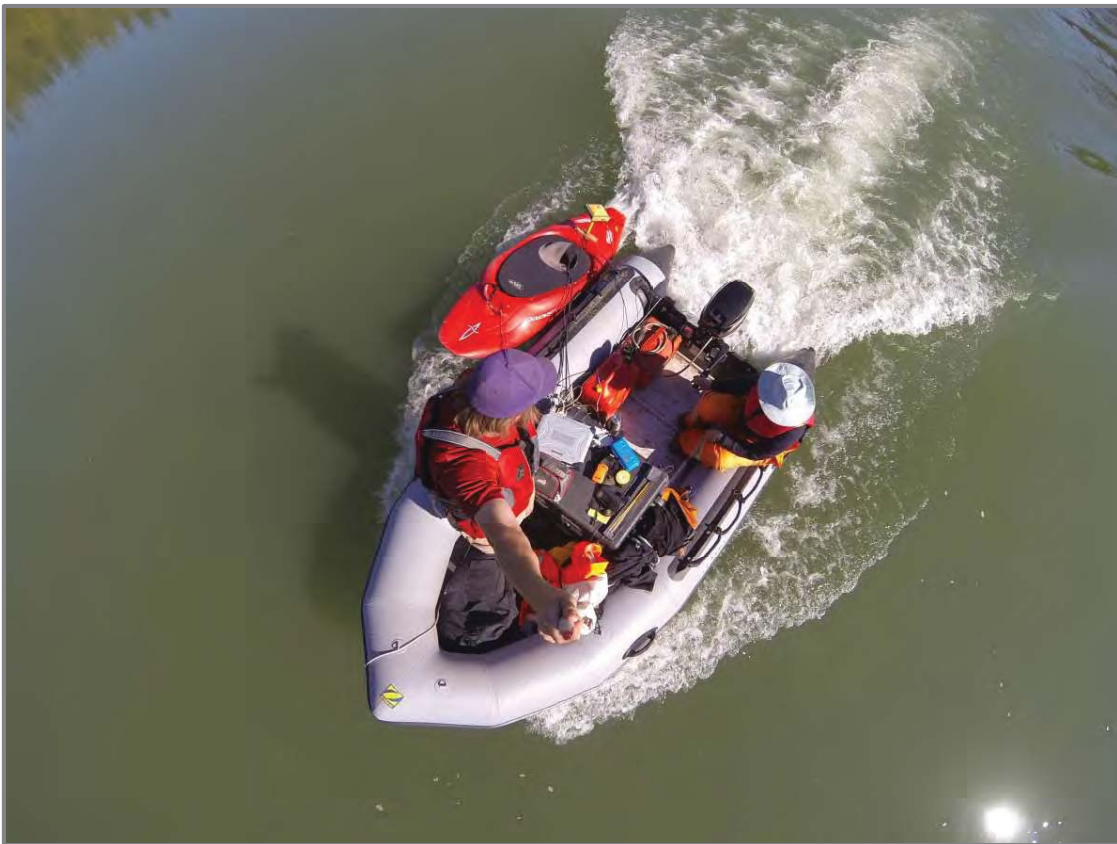
Photo 1: Bird's Eye View of Bathymetry Survey Vessel. Note kayak with GPS unit mounted on top. The GPR and sonar heads were mounted inside the kayak, while all topside electronics were contained in the zodiac.

The GPR and sonar antennas were enclosed inside a plastic whitewater kayak such that they were transmitting and receiving their respective signals through the bottom of the kayak; the GPS unit was mounted directly above the sonar transducer. The kayak was then lashed to the right side of a 12' zodiac (Photo 1), which was used as the survey vehicle and contained all topside electronics. The horizontal and vertical positions of the instruments and water line relative to the GPS antenna were carefully measured so that these positional offsets could be accounted for when processing the data. The GPR and GPS data were simultaneously collected to a rugged field laptop using software supplied by the GPR manufacturer. The sonar and GPS data streams were collected to the same laptop using software developed by EBA's geophysics group.

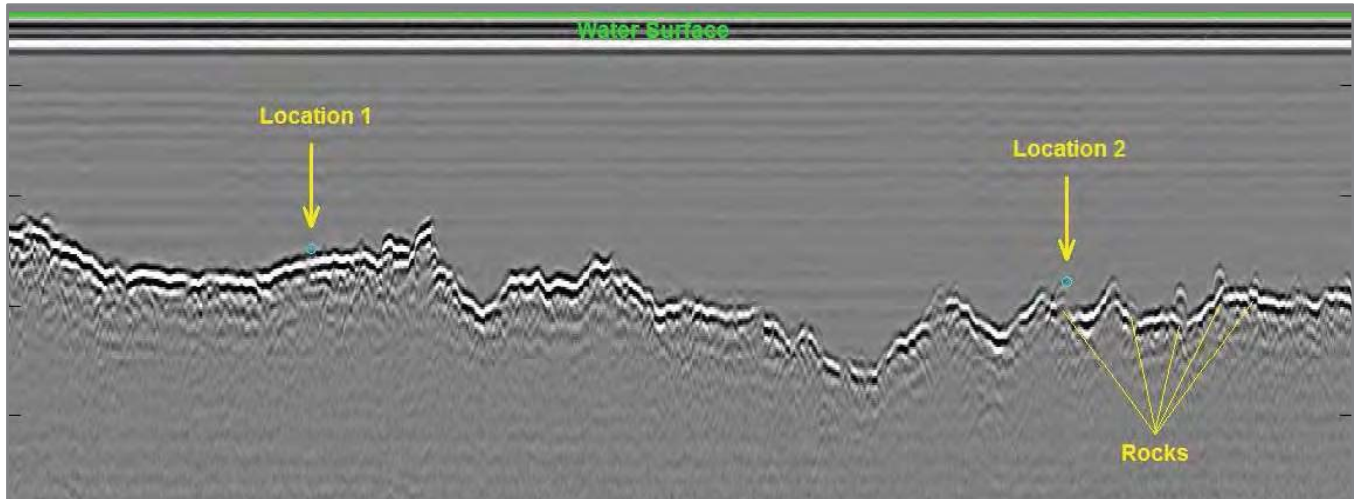
Photo 2: GPR profile collected during the two calibration events, exhibiting a flat river bottom surface at Location 1 and undulating, rocky river bottom at Location 2.

The results at Location 1 all agree to within 1%, while the results at Location 2 exhibit slightly more discrepancy. This is likely explained by the fact that the GPR profile collected through the calibration points exhibits a relatively flat, smooth bottom at Location 1, but undulates considerably more at Location 2 and is rockier, as shown in the GPR profile image below.
