**Re: SOUTH WHITEMUD BOARDWALK RESTORATION - ENVIRONMENTAL IMPACT  
ASSESSMENT**

### Whitemud Creek Boardwalk Replacement Environmental Impact Assessment

**April 2017**

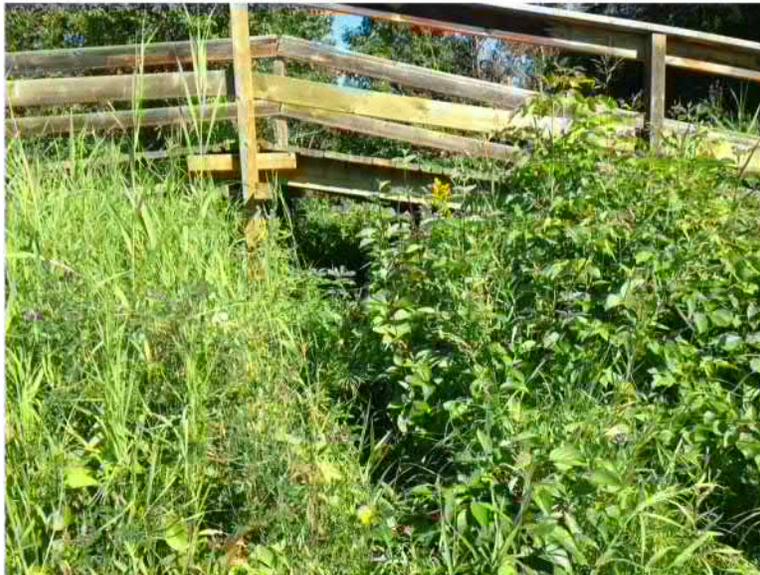
Photograph 2. Low area between the oxbow and Whitemud Creek. This may form the connection between the two waterbodies during periods of high flow. The old boardwalk to be removed is visible.

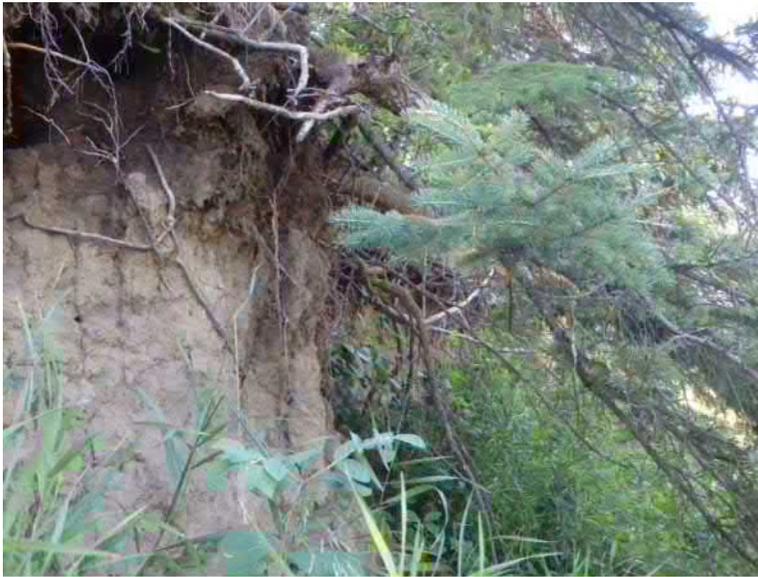
**Photograph 3.** Slope on the north side of the oxbow with exposed roots of a tree not currently planned to be removed.

The slope on the north side of the oxbow crossing poses significant erosion potential particularly where the existing stairs and boardwalk are located. Restoration plans should include erosion protection measures for this slope to prevent slope failure and sedimentation to both the oxbow and Whitemud Creek.

A mature spruce tree was noted during the field visit at the edge of the slope along the existing trail, with a substantial portion of its root system exposed against the slope. The tree was observed as a potentially unstable safety hazard; however, removal of this tree is not within the project footprint.

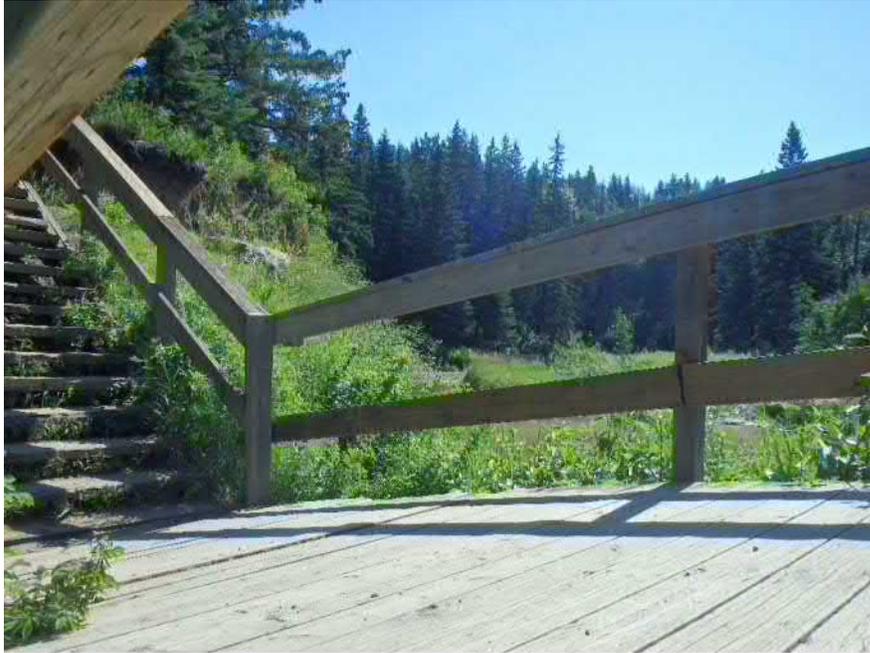
**Existing boardwalk stairs**

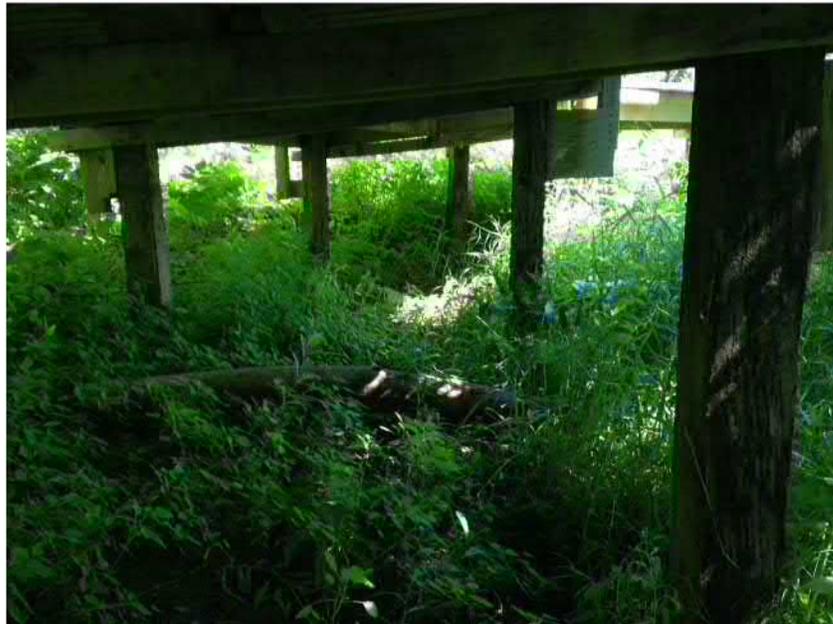
**View under existing boardwalk**

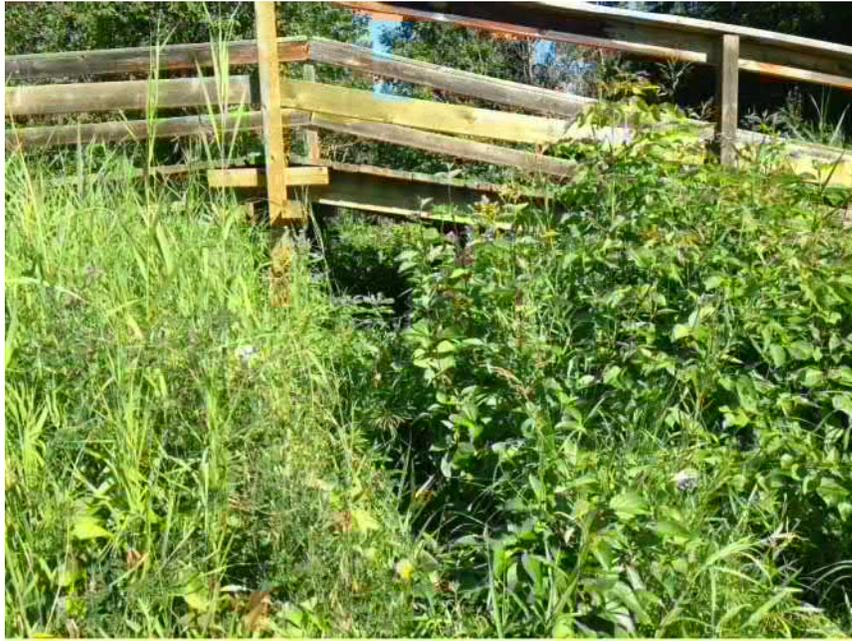
Low point, where the oxbow has the potential to join the creek in the event of a flood
