**Aurum Road Environmental
Impact Assessment,
Edmonton, Alberta**

Final

Prepared for:
Aurum Industrial Development
Partnership

Prepared by:
Stantec Consulting Ltd.

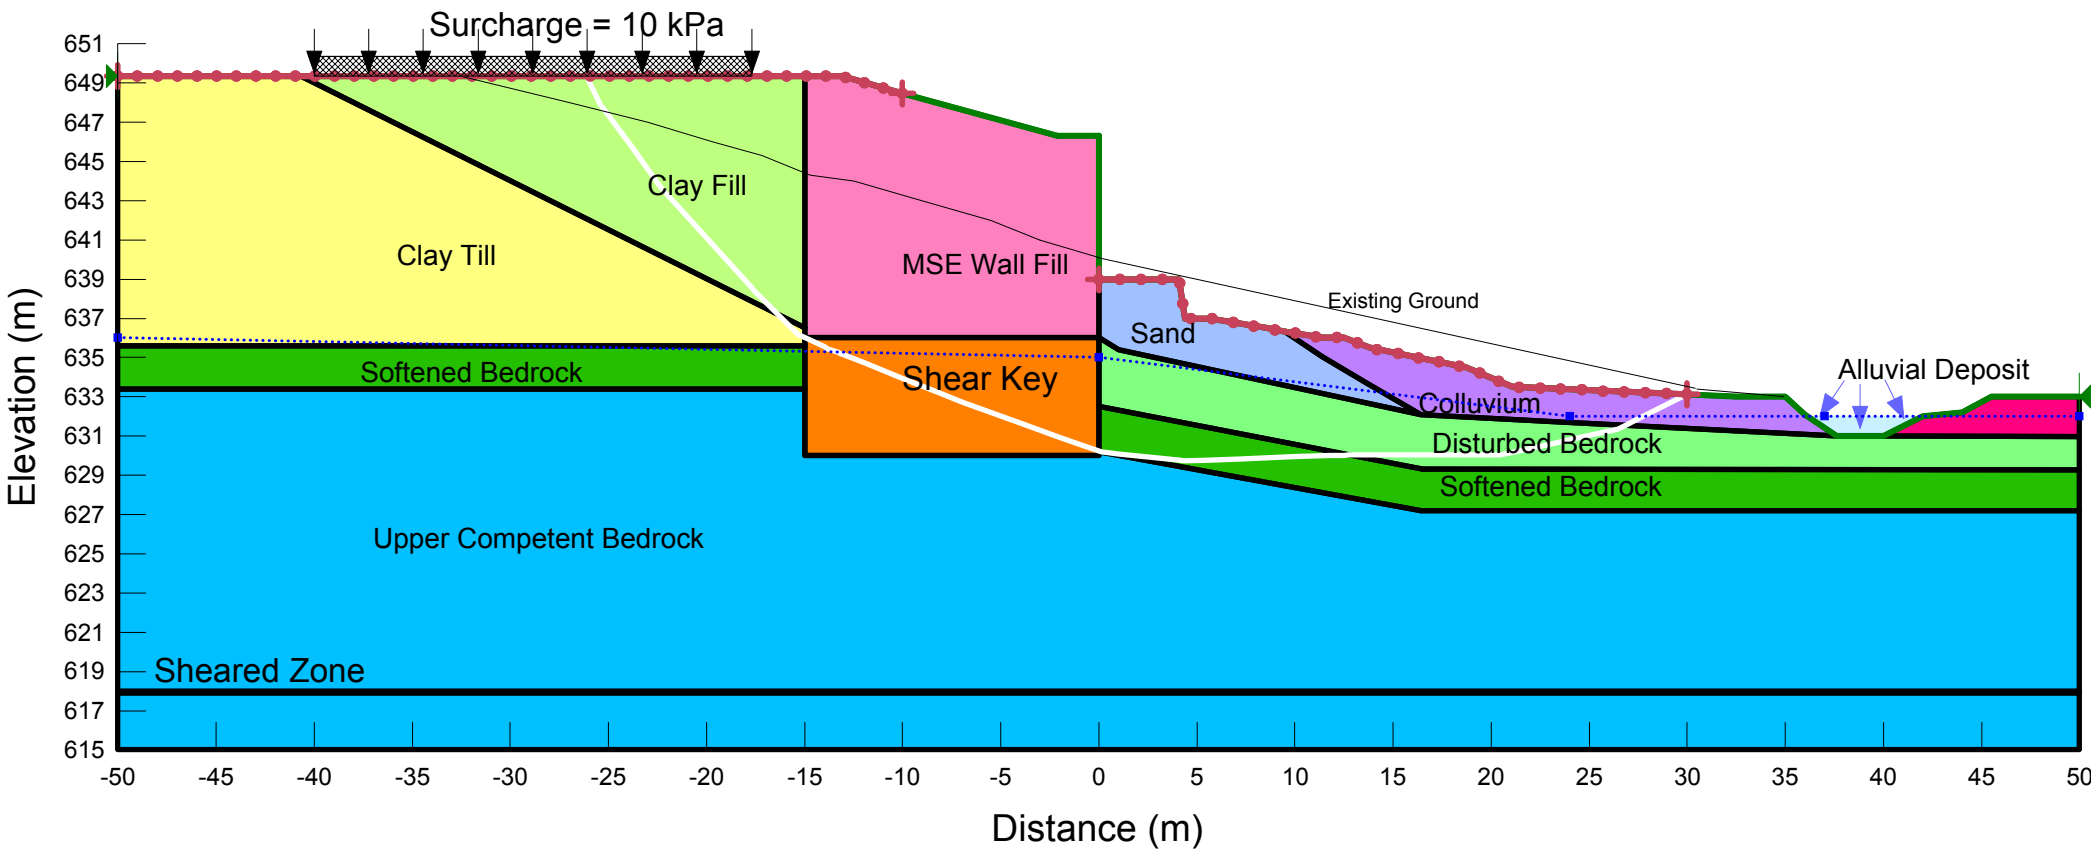
B2
 LT
 15 m MSE Wall at 636 m
 15 m Shear Key at 630 m
 3 m embedment
 GWT Increased

Shear keys are required to provide a stable foundation for the Mechanically Stabilized Earth (MSE) walls (see Appendix E Geotechnical Report). Four shear keys will be installed, one under each MSE wall that extends into the slope of the ravine. These shear keys will require excavation into the slope and subsurface until bedrock or stable material is reached in order to provide a solid foundation for the walls.

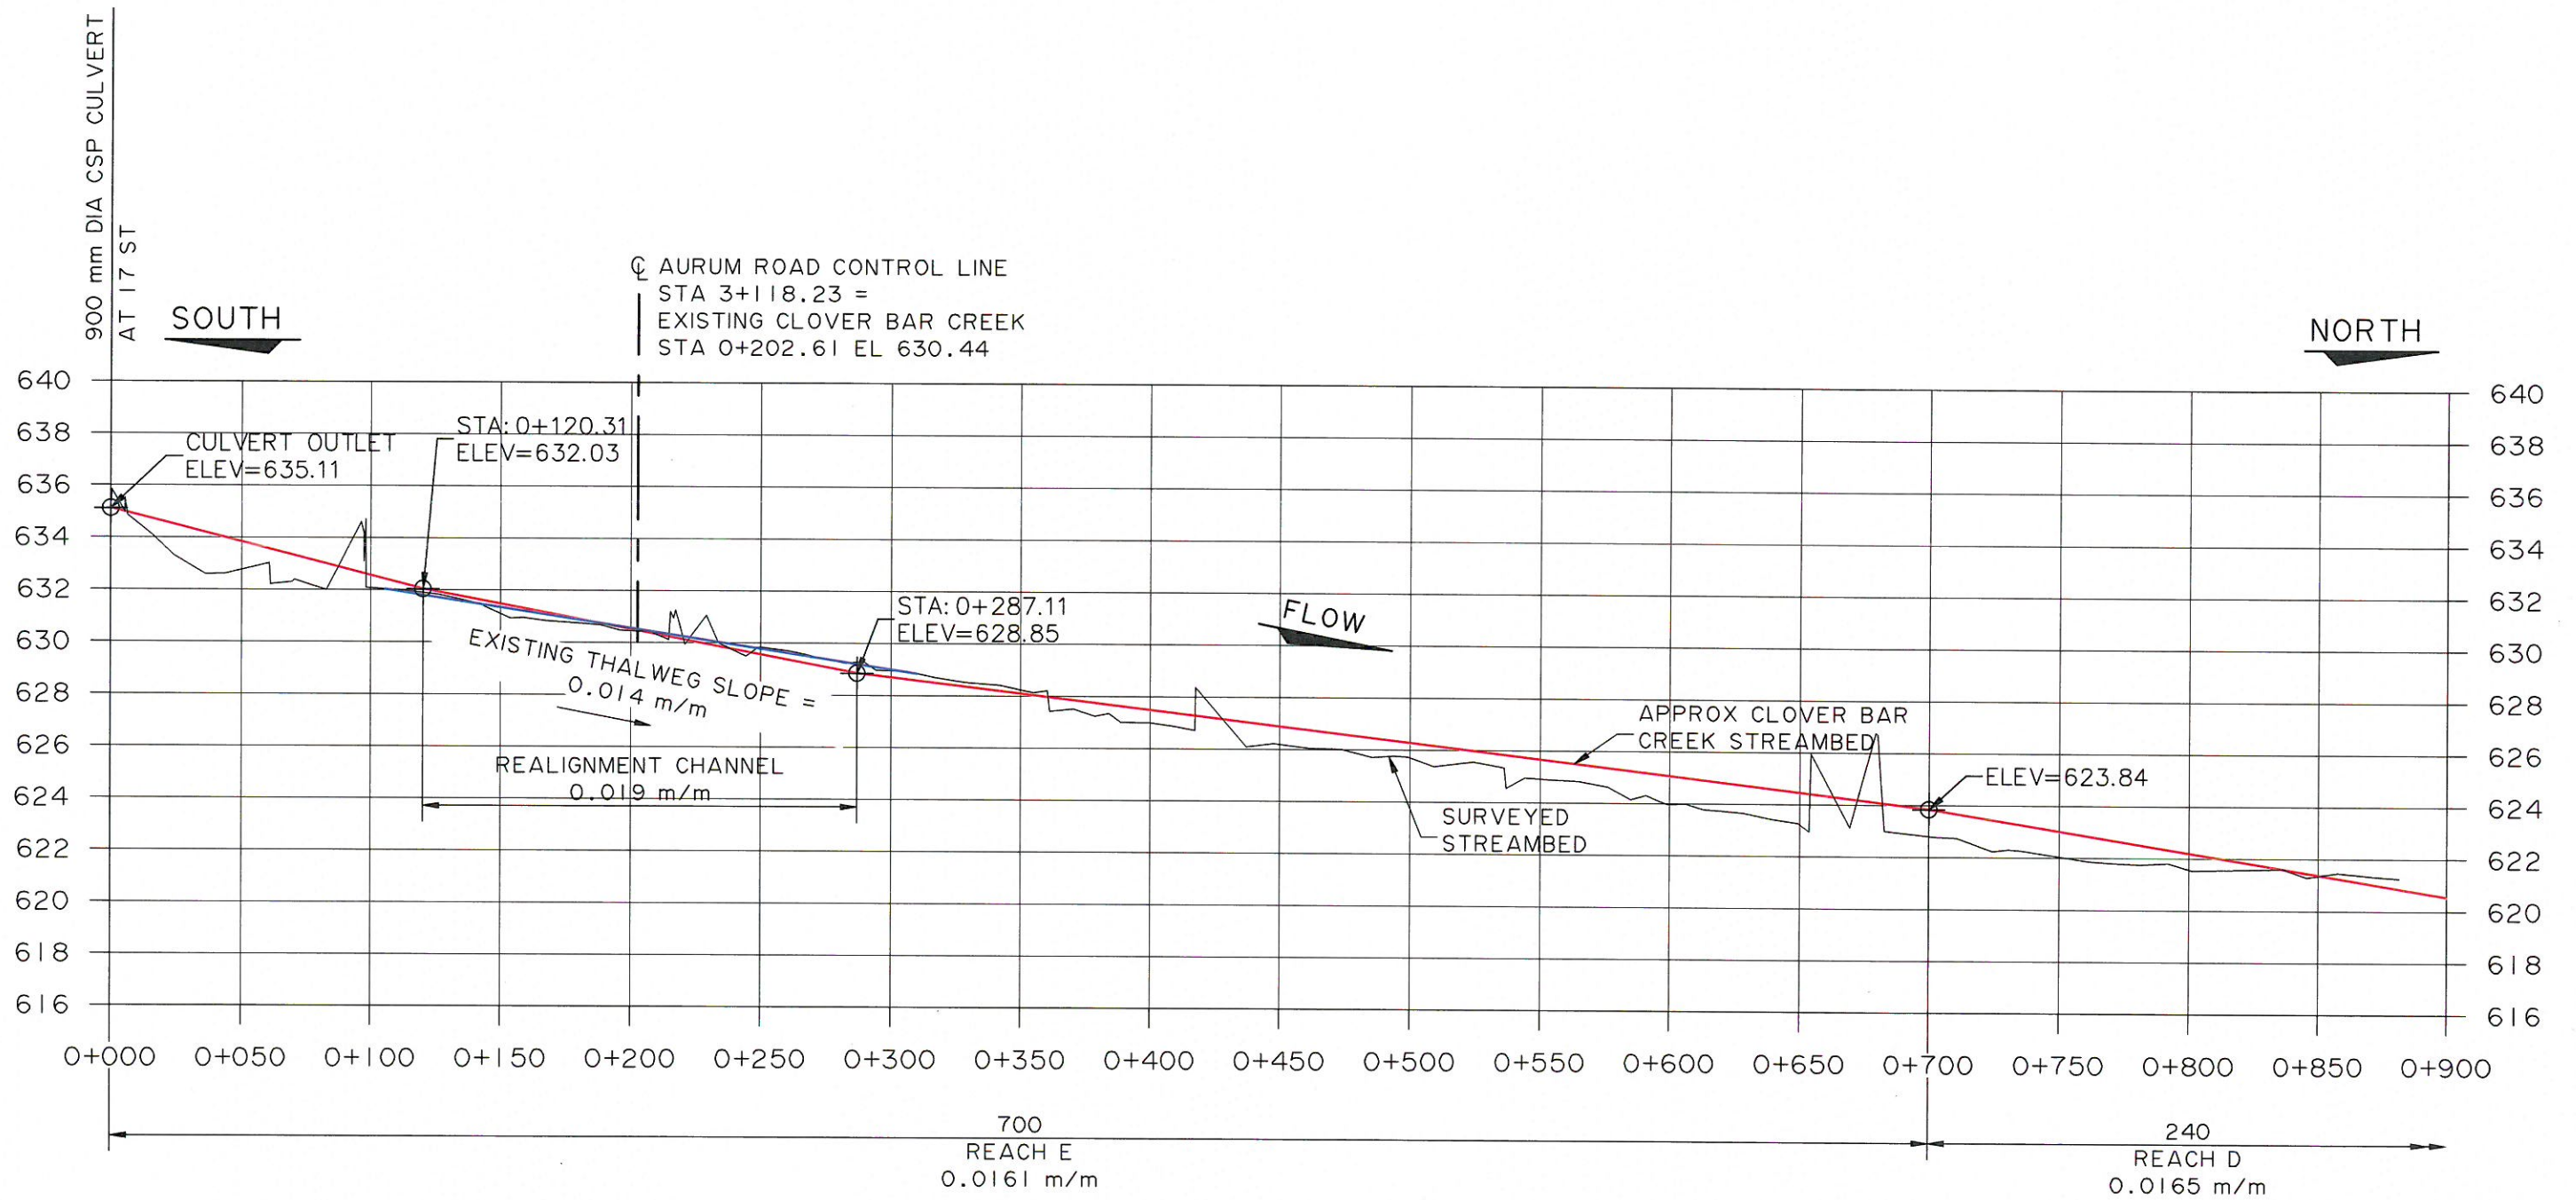
CLOVER BAR CREEK PROFILE
