**Environmental Impact
Assessment Report for 199 St
NW Road Widening at
Wedgewood Creek within 5-
52-25-W4M and 6-52-25-W4M,
Edmonton, Alberta**

Prepared for:
Riverview Owners Group Ltd.

Prepared by:
Stantec Consulting Ltd.

May 2015 (Revised June 2016)
110219229

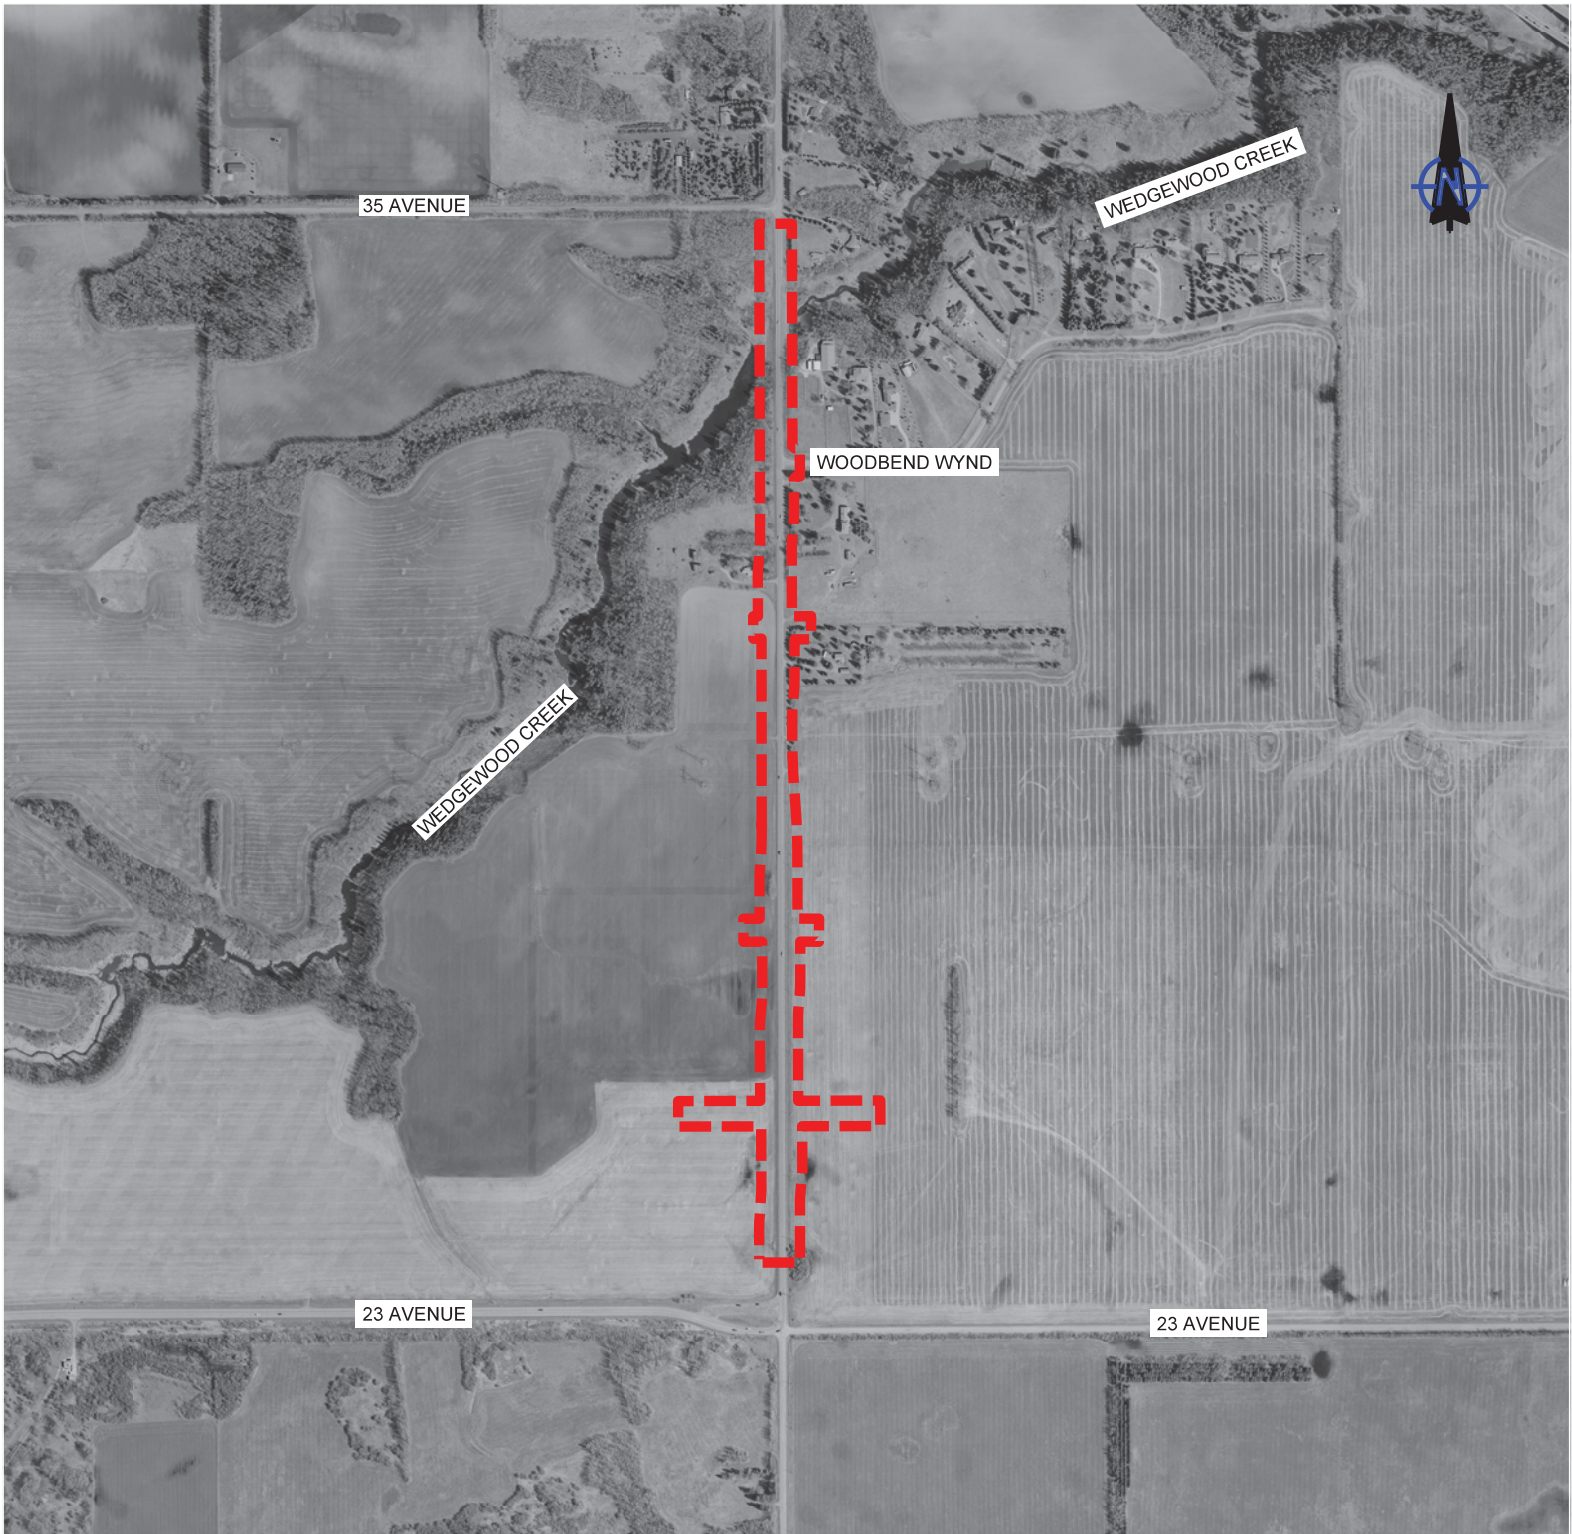
Figure 2.0

This report summarizes the design process on the development of the Arterial Roadway Conceptual Plan for 199 Street between 23 Avenue and 35 Avenue.

199 STREET 35th AVENUE TO 23rd AVENUE DEVELOPMENT CONCEPT PLAN

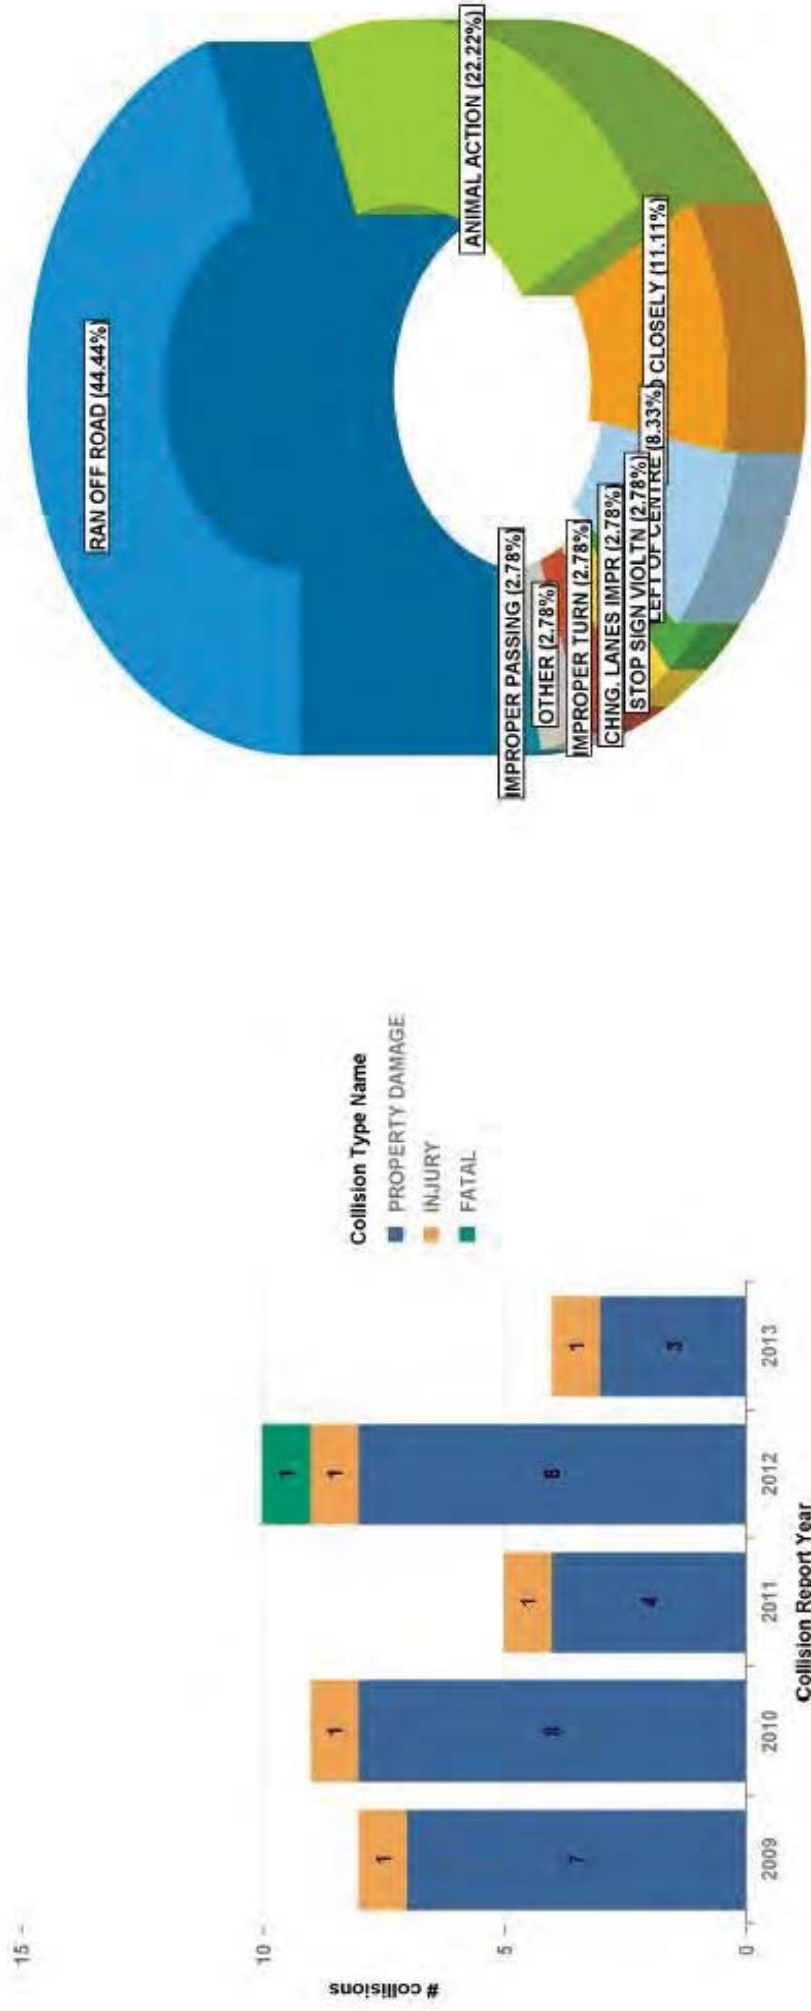
Figure 5 – Collision Breakdown by Severity and Cause

Reference: Figures clipped from the City of Edmonton collision report (February 27, 2014)
