This report presents the results of the subsurface investigations made on the site of the proposed road upgrading in Edmonton, Alberta. The objective of the investigation is to determine the existing subsoil conditions along the proposed road alignment and to provide geotechnical recommendations for the roadway development, underground utility installation and wildlife crossing construction based on the soil data retrieved. Authorization to proceed with the investigation was received from Petrea Chamney of Stantec in February 2015. Field work for the project was completed in April 2015. Environmental and previous land use issues are beyond the scope of this report.

RIVERVIEW HEIGHTS ESTATES LTD. C/O QUALCO
 199 STREET
 CROSSING AT WEDGEWOOD CREEK
 Figure No. SK-1
 Title PLAN - WEDGEWOOD CREEK CULVERT INSTALLATION UNDER 199 STREET DESIGNED CULVERT ALIGNMENT

**Erosion and Sediment Control
Report 199 Street Wedgewood
Creek Crossing – North of
Woodbend Wynd, South of 35
Avenue**

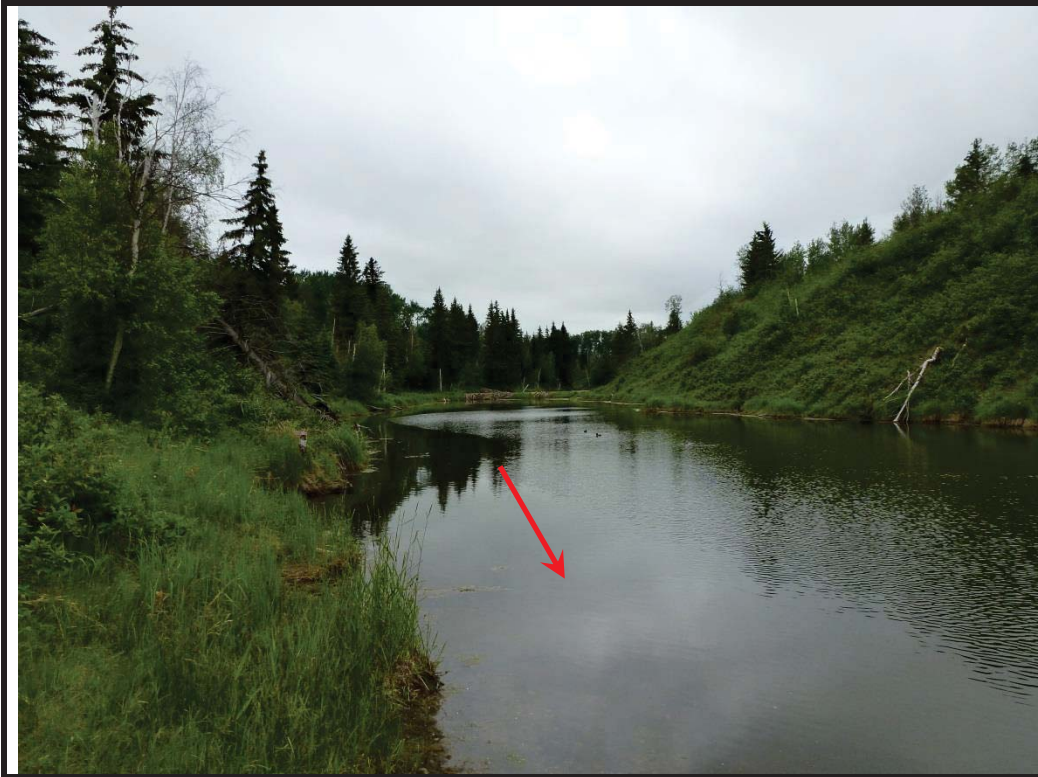
Photo 17: Looking upstream at channel and banks upstream of existing culvert.

Note: Ponding water due to beaver dam.

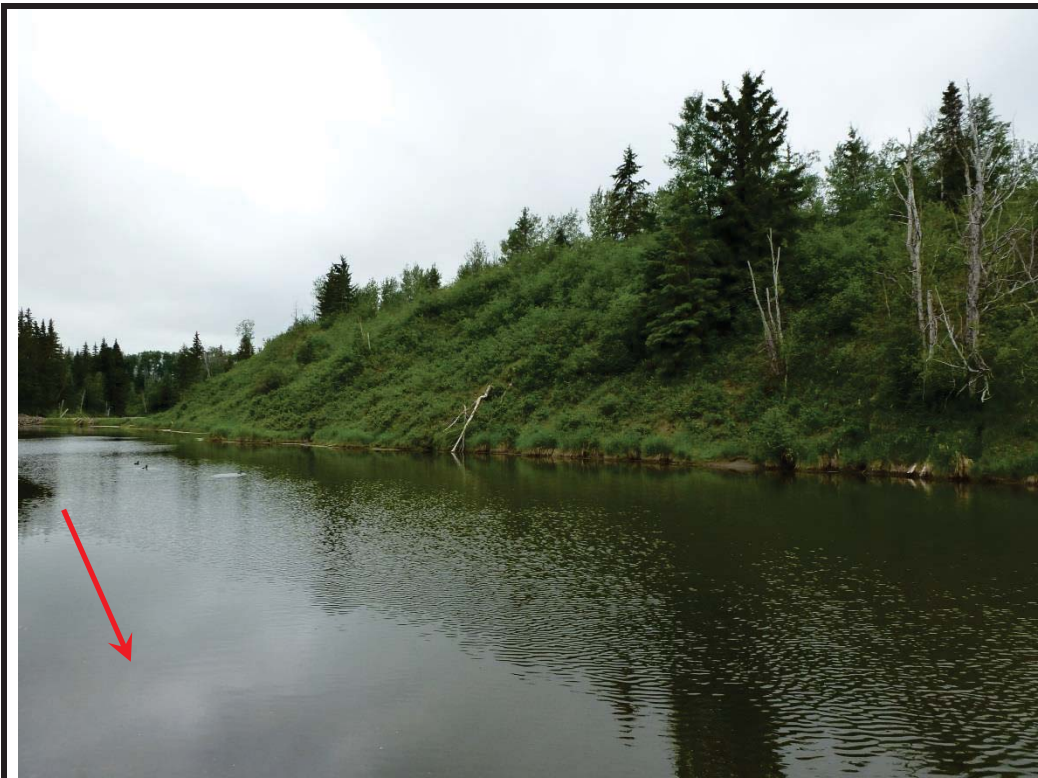
Photo 18: Looking upstream at channel and banks upstream of existing culvert.

Note: Ponding water due to beaver dam.

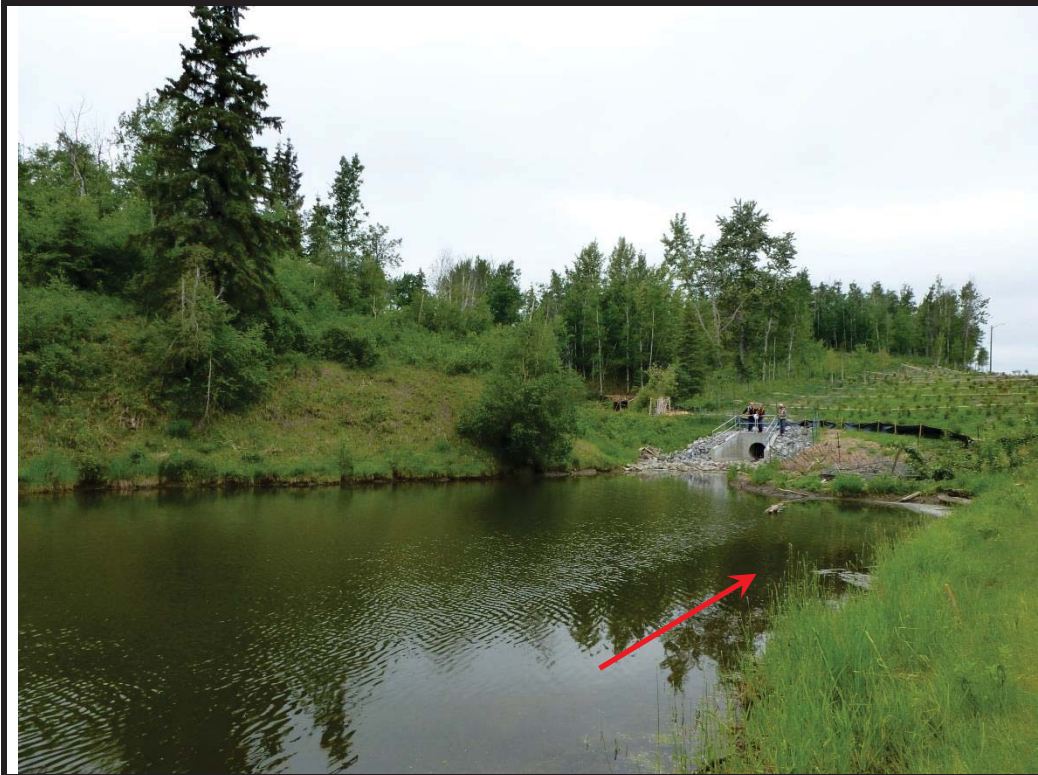
Photo 19: Looking from upstream to downstream at area U/S of existing culvert

Note: Ponding water due to beaver dam

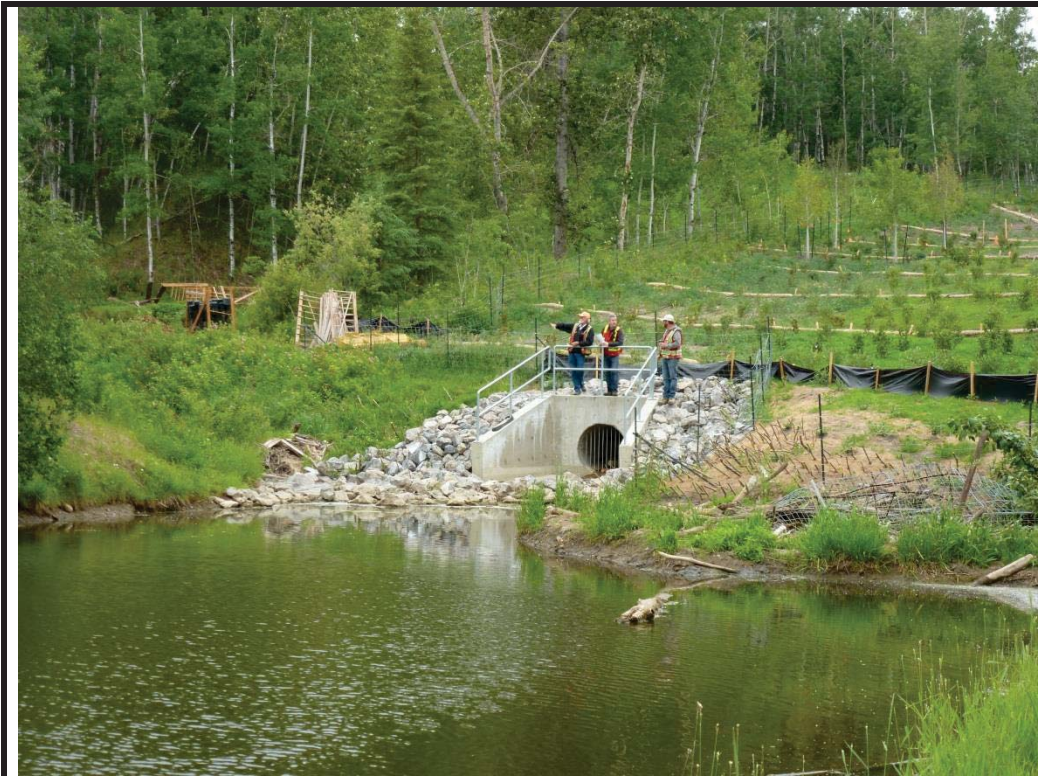
Photo 20: : Looking from upstream to downstream at area U/S of existing culvert

Note: Ponding water due to beaver dam

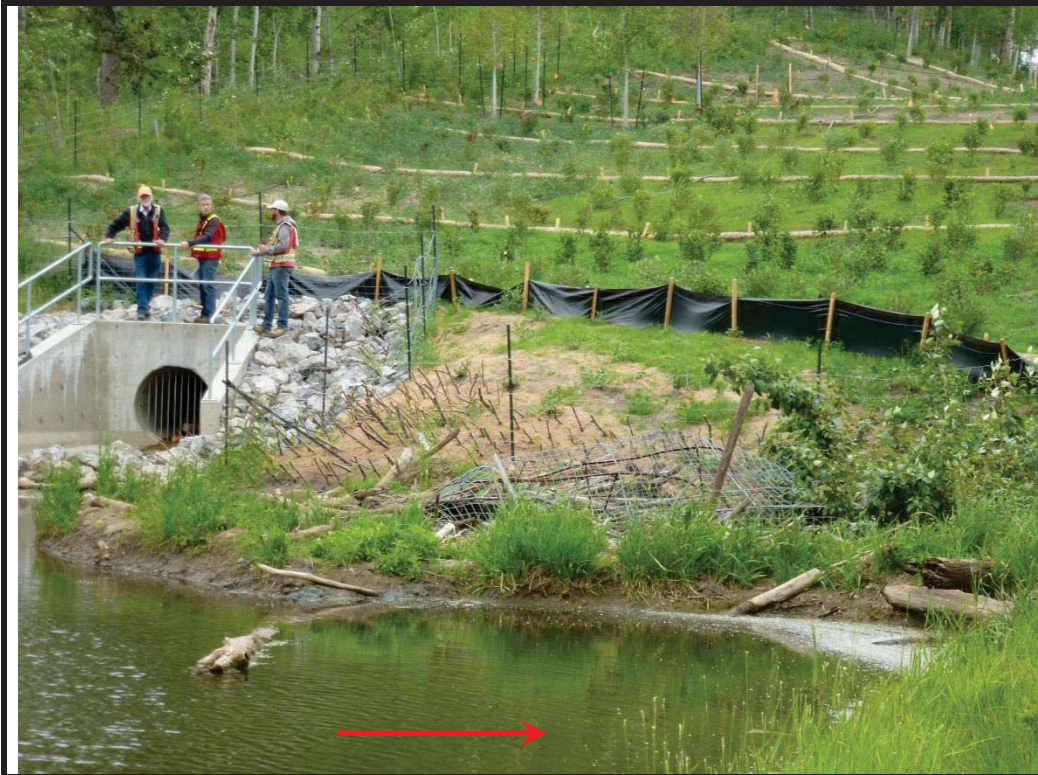
Photo 21: Looking from upstream to downstream at area U/S of existing culvert

Note: Ponding water due to beaver dam and erosion control measures along facing upstream (west) sideslope.

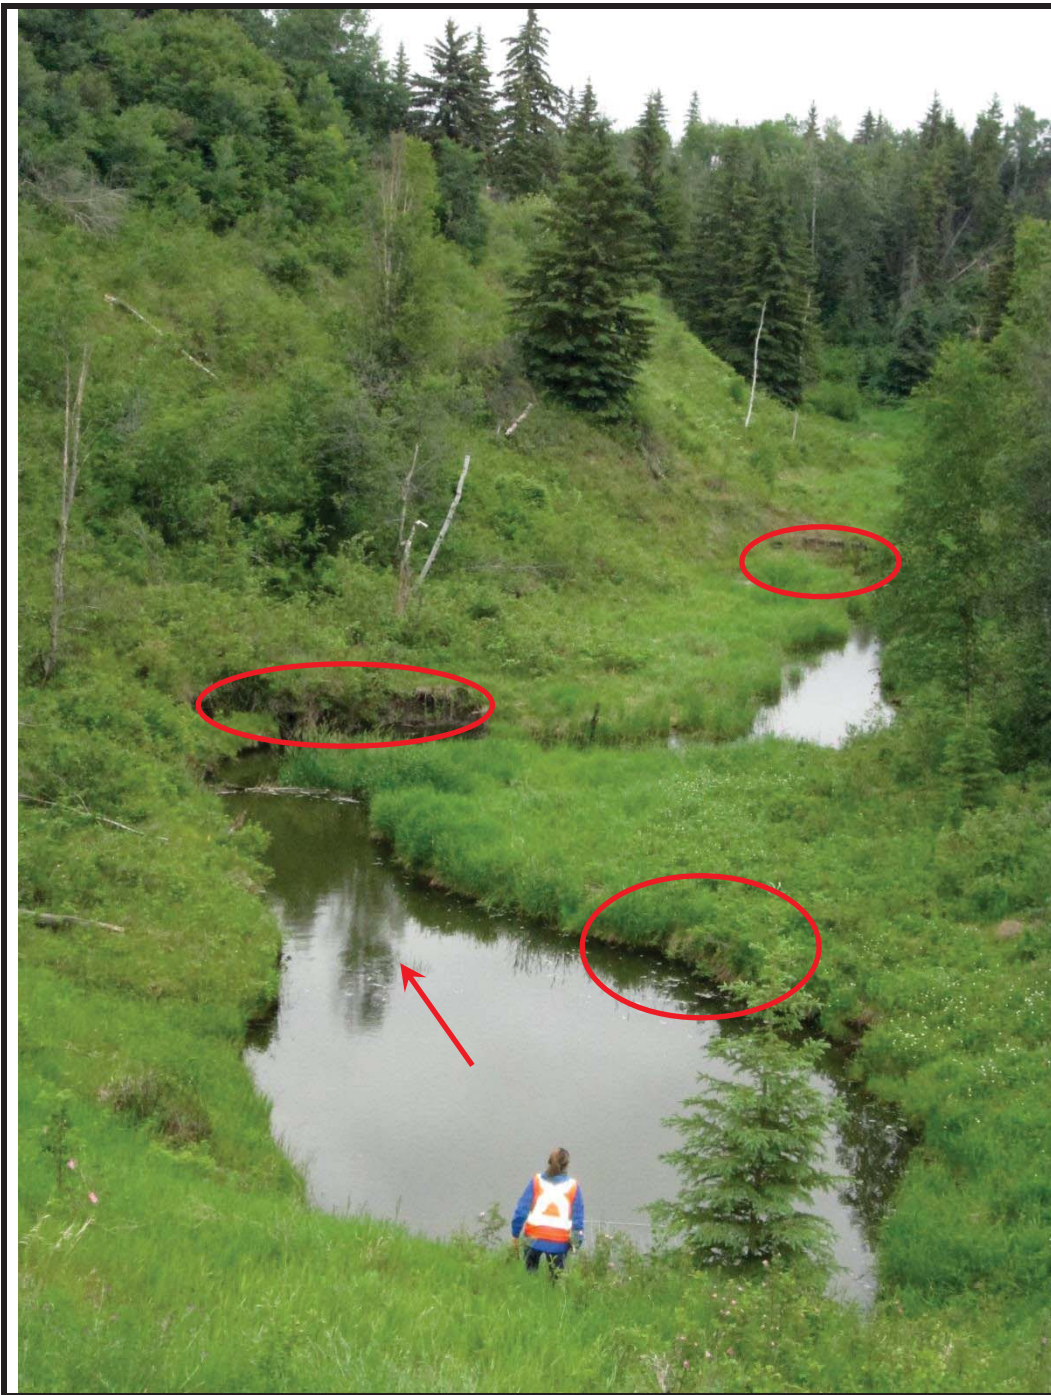
Photo 25: Looking downstream (east) from existing culvert downstream end.
Note: size and meander pattern of channel banks lateral erosion.

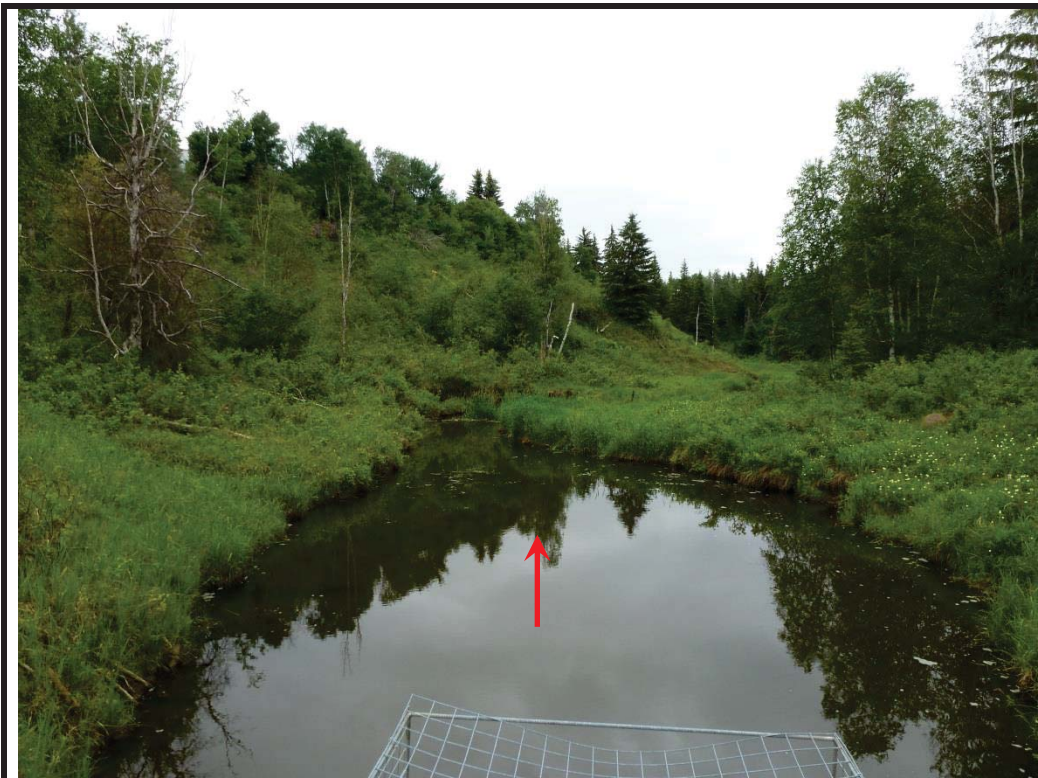
Photo 27: Looking downstream (east) from existing culvert downstream end.
Note: scour hole and water ponding (due to beaver dam)

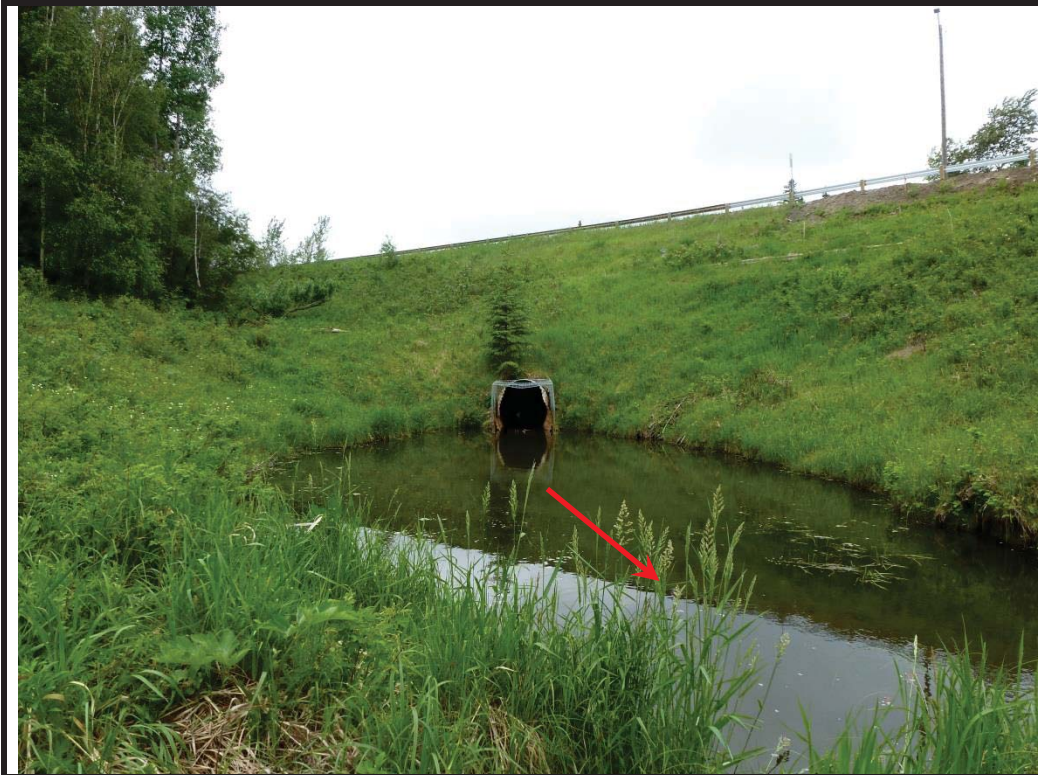
Photo 28: Looking upstream at downstream end of existing culvert
 Note: scour hole and water ponding (due to beaver dam)

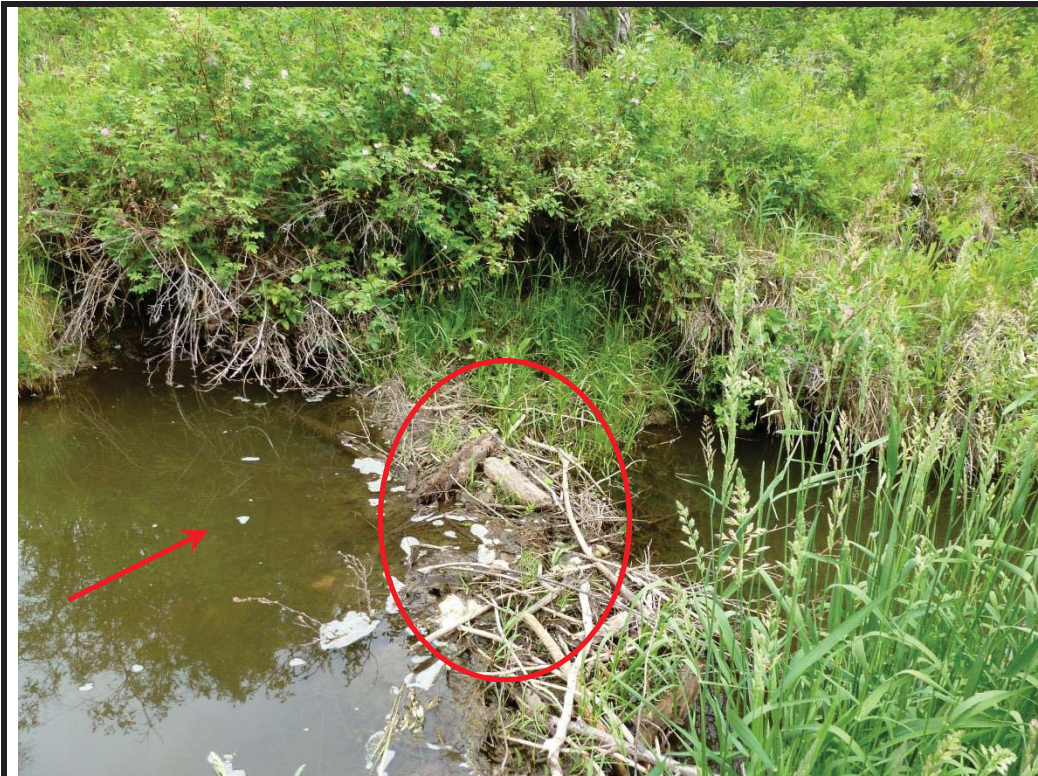
Photo 29: Looking at beaver dam approximately 25 m downstream of downstream end of culvert

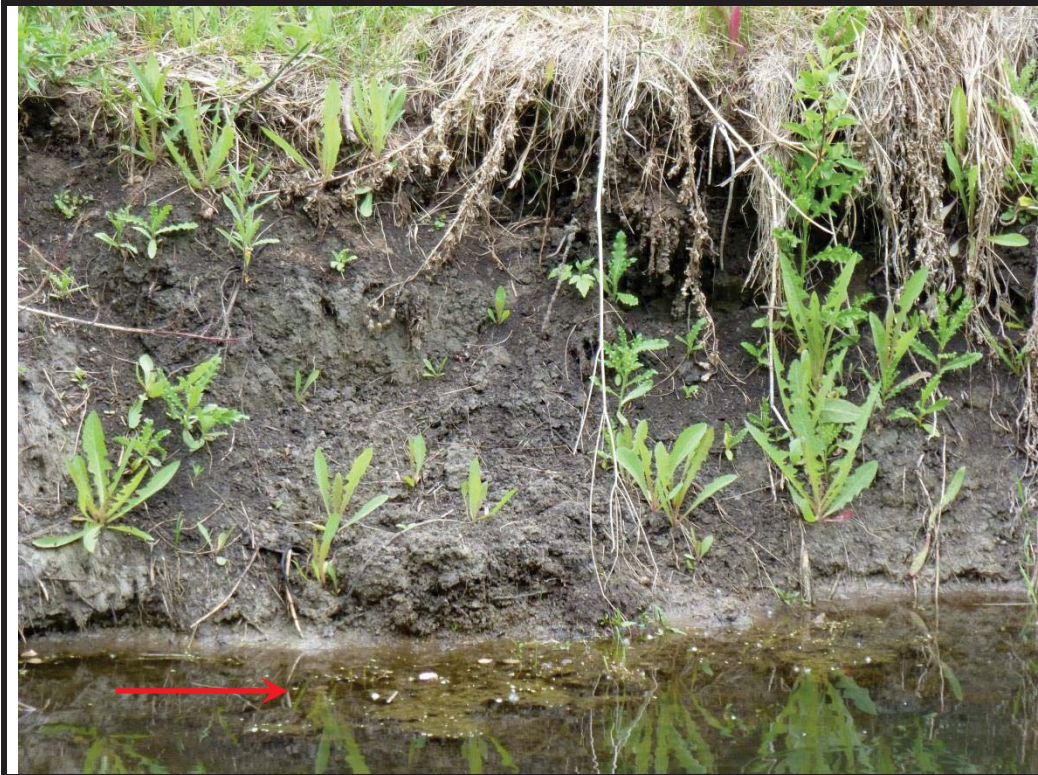
Photo 30: Looking downstream at left (north) bank material downstream of existing culvert.

Note: Lateral bank erosion

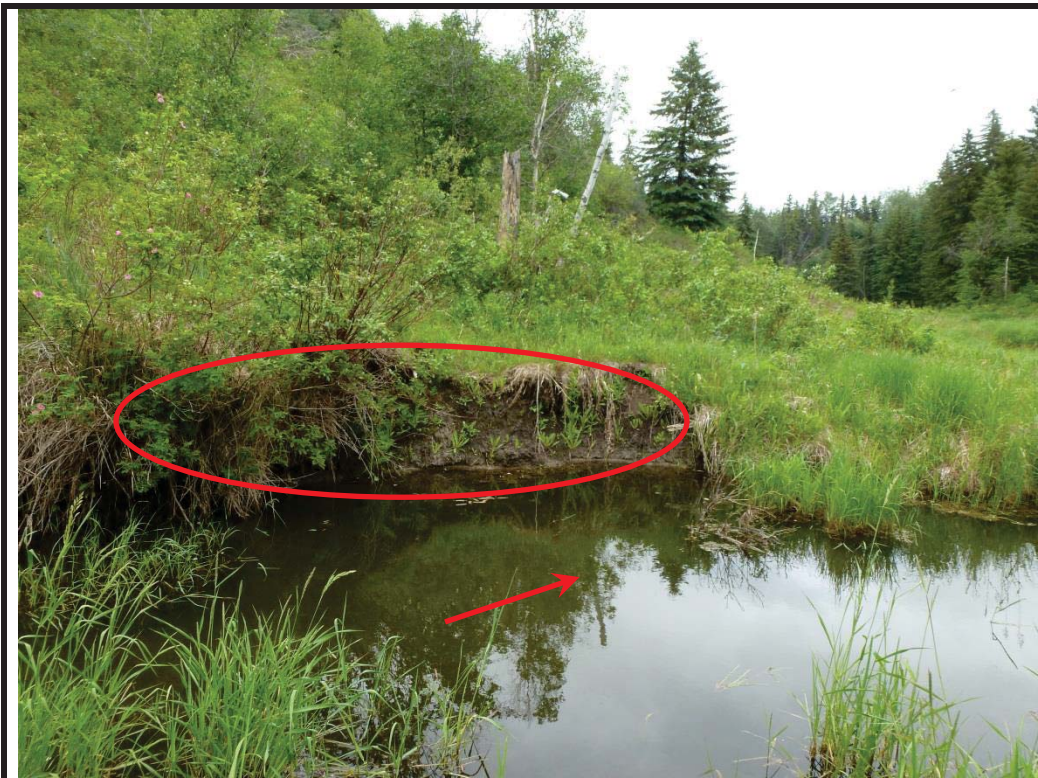
Photo 31: Looking downstream at left (north) bank material downstream of existing culvert.

Note: Lateral bank erosion

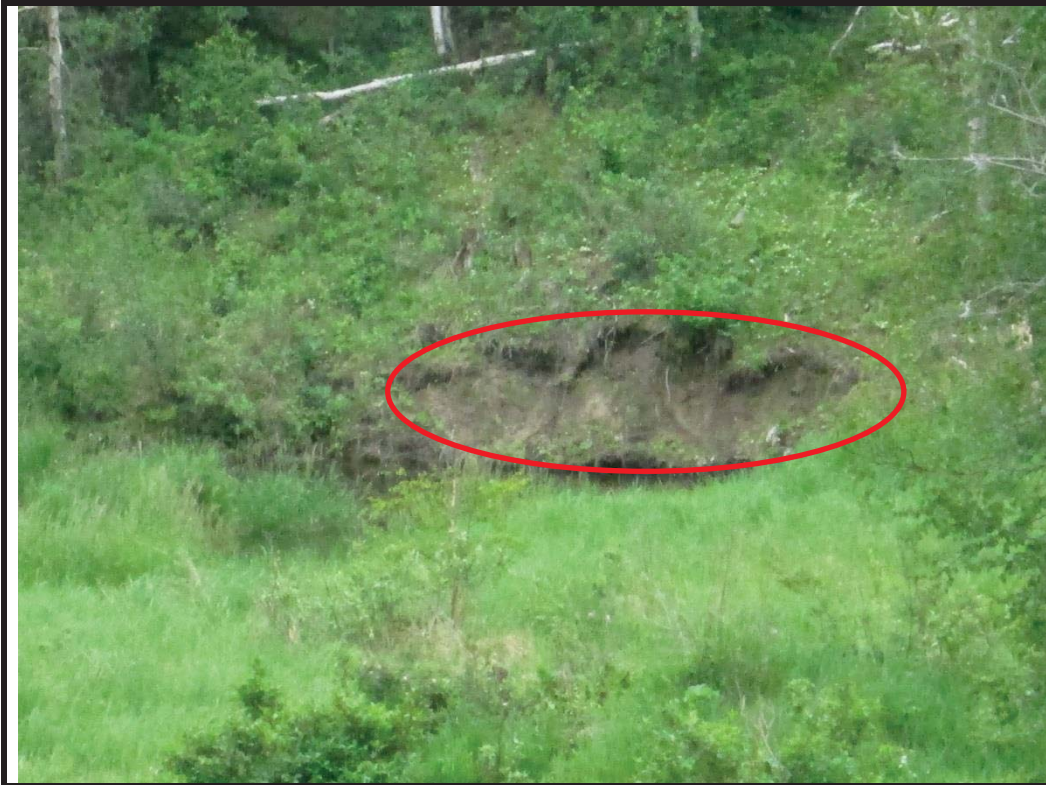
Photo 32: Looking downstream at left (north) bank material downstream of existing culvert.

Note: Lateral bank erosion

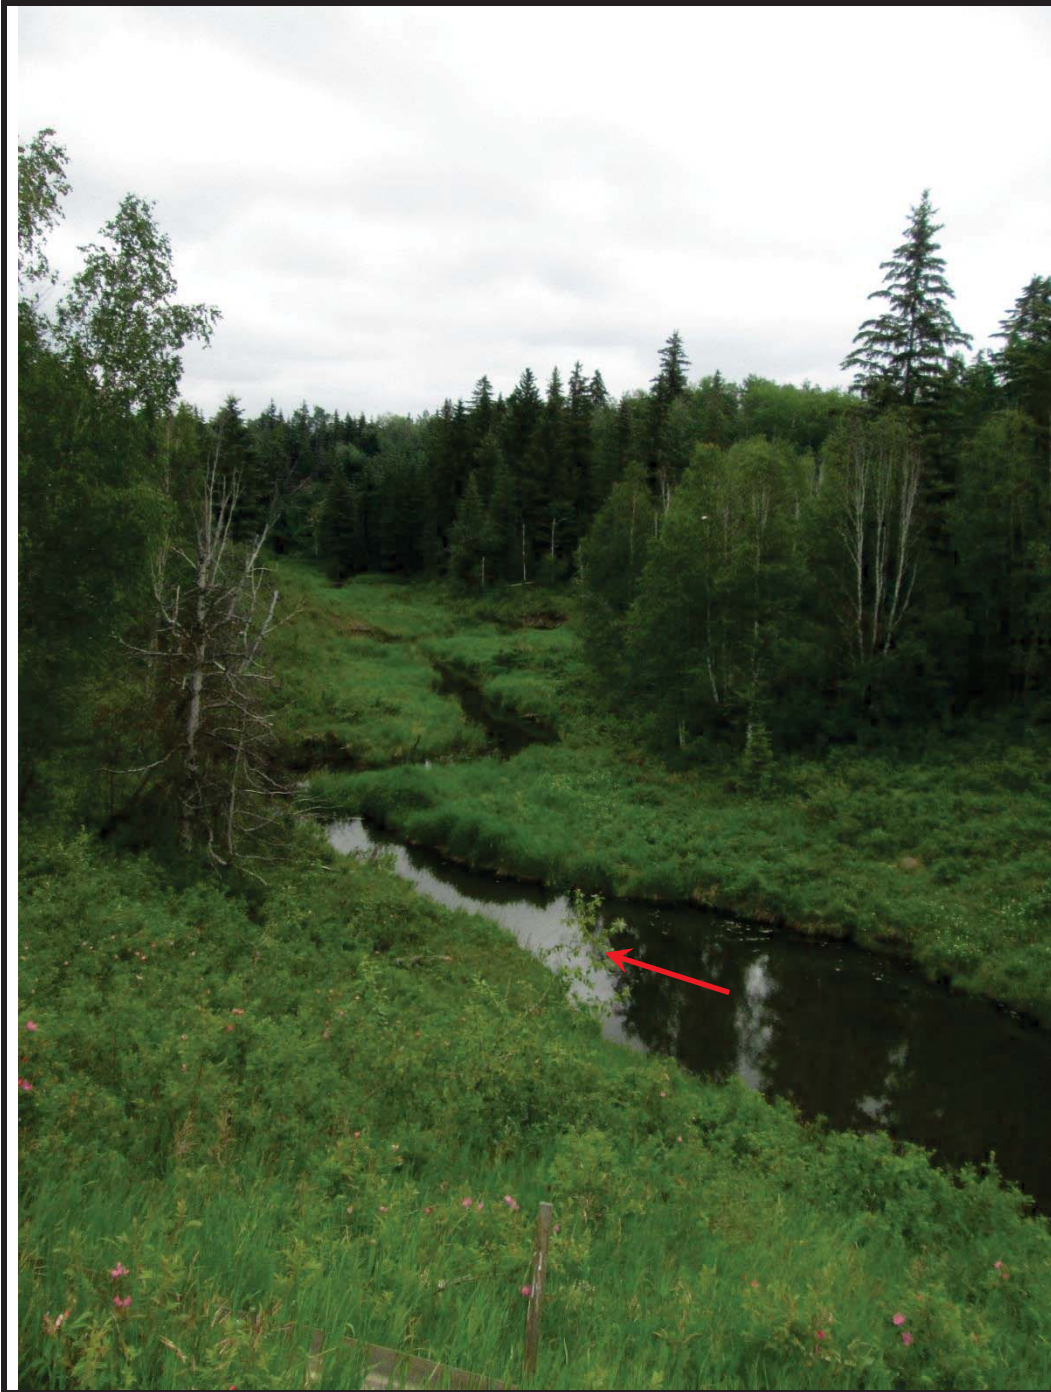
Photo 34: Looking downstream (east) from existing culvert downstream end.
Note: size and meander pattern of channel

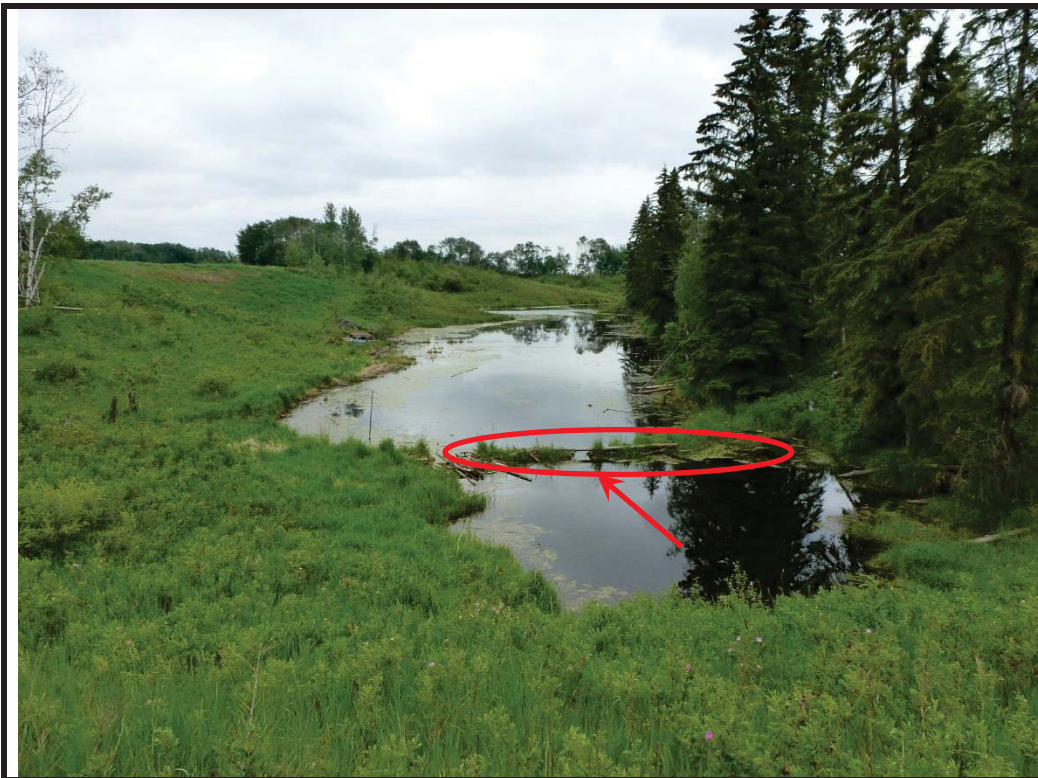
Photo 35: Looking downstream at Wedgewood Creek from 215 Street crossing
Note: Beaver dam

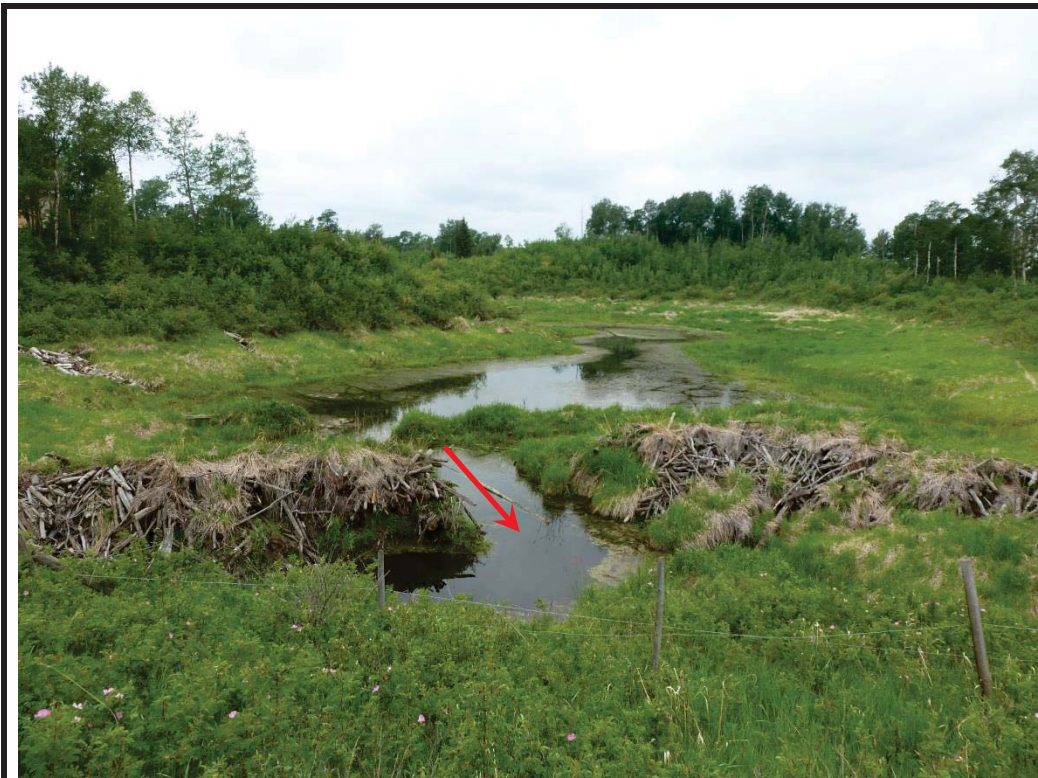
Photo 36: Looking upstream at Wedgewood Creek from 215 street crossing
Note: Removal of beaver dam

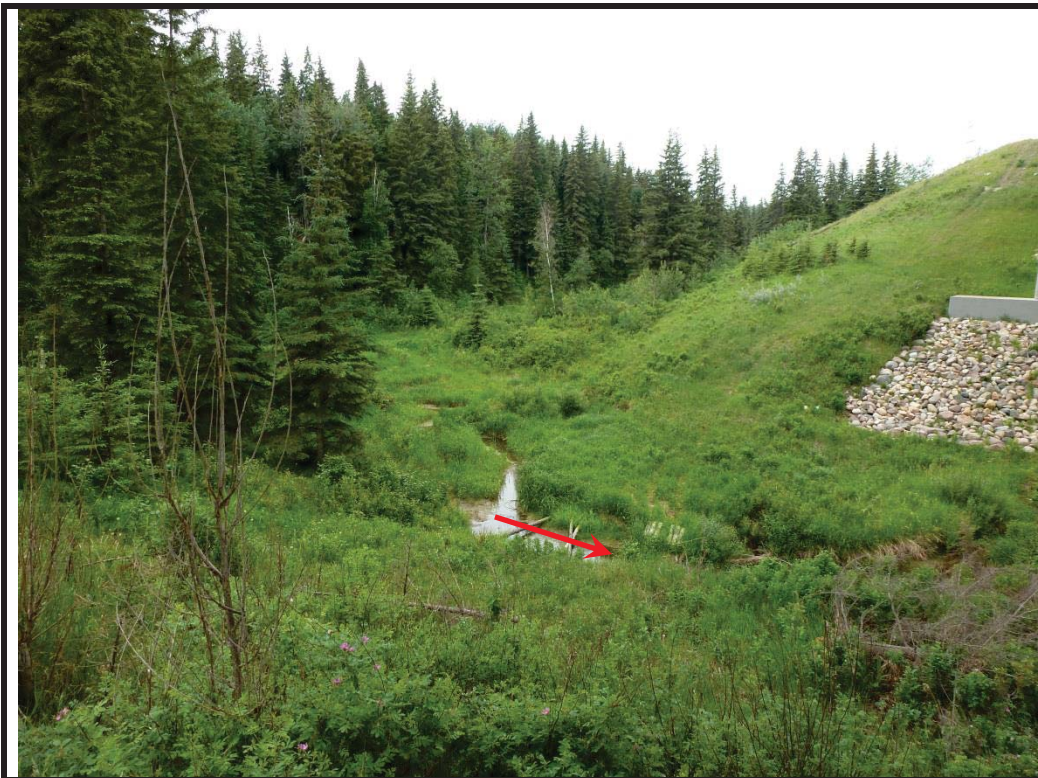
Photo 37: Looking upstream at Wedgewood creek from right (south) bank under Anthony Henday crossing. Note: size of creek

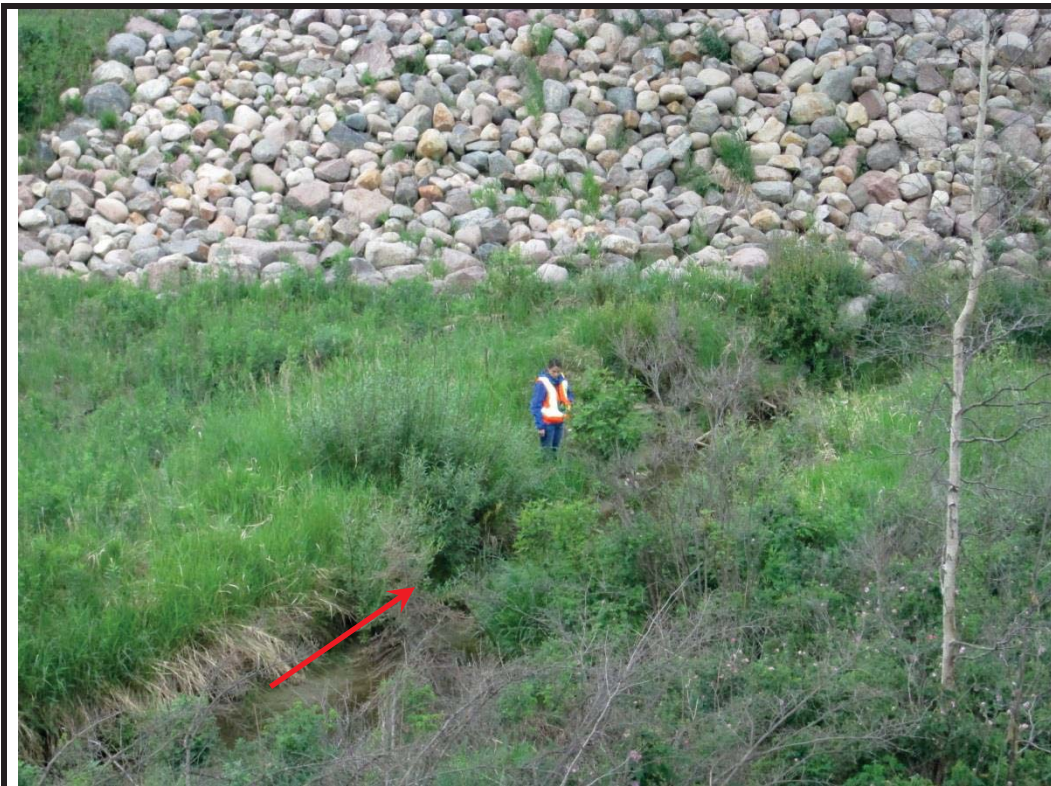
Photo 38: Looking downstream at Wedgewood creek from right (south) bank under Anthony Henday crossing. Note: size of creek

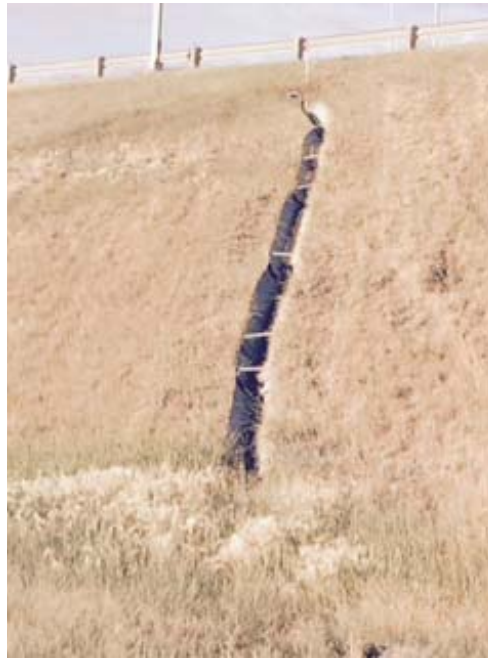
B.2 CONCRETE SPILLWAY CHANNEL

A concrete channel could be used to convey the overflow runoff. It should be noted that with the steep roadway embankment this channel would be very difficult to construct. As well this is typically a smooth surface which does not provide for any further energy dissipation. Due to the construction difficulty and costs this option is not recommended.

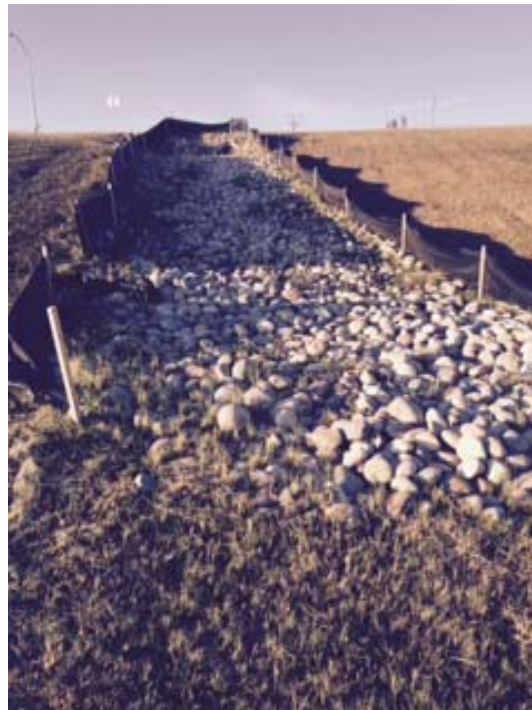
B.6 OVERFLOW CHANNEL INTERFACE AT ANIMAL PATH

As noted above the rock rip rap is the recommended alternate for the overflow channel surface. If there is a concern for where the animals may need to cross the rock rip rap, the Tufstone and grass within the animal path area will provide a smoother surface for the animals to navigate.
