**Sanitary Grit Residuals
Treatment Facility
Environmental Impact
Assessment Located within
Edmonton, Alberta**

Prepared for:
EPCOR Water Services Inc.

Prepared by:
Stantec Consulting Ltd.

November 2015
110146363

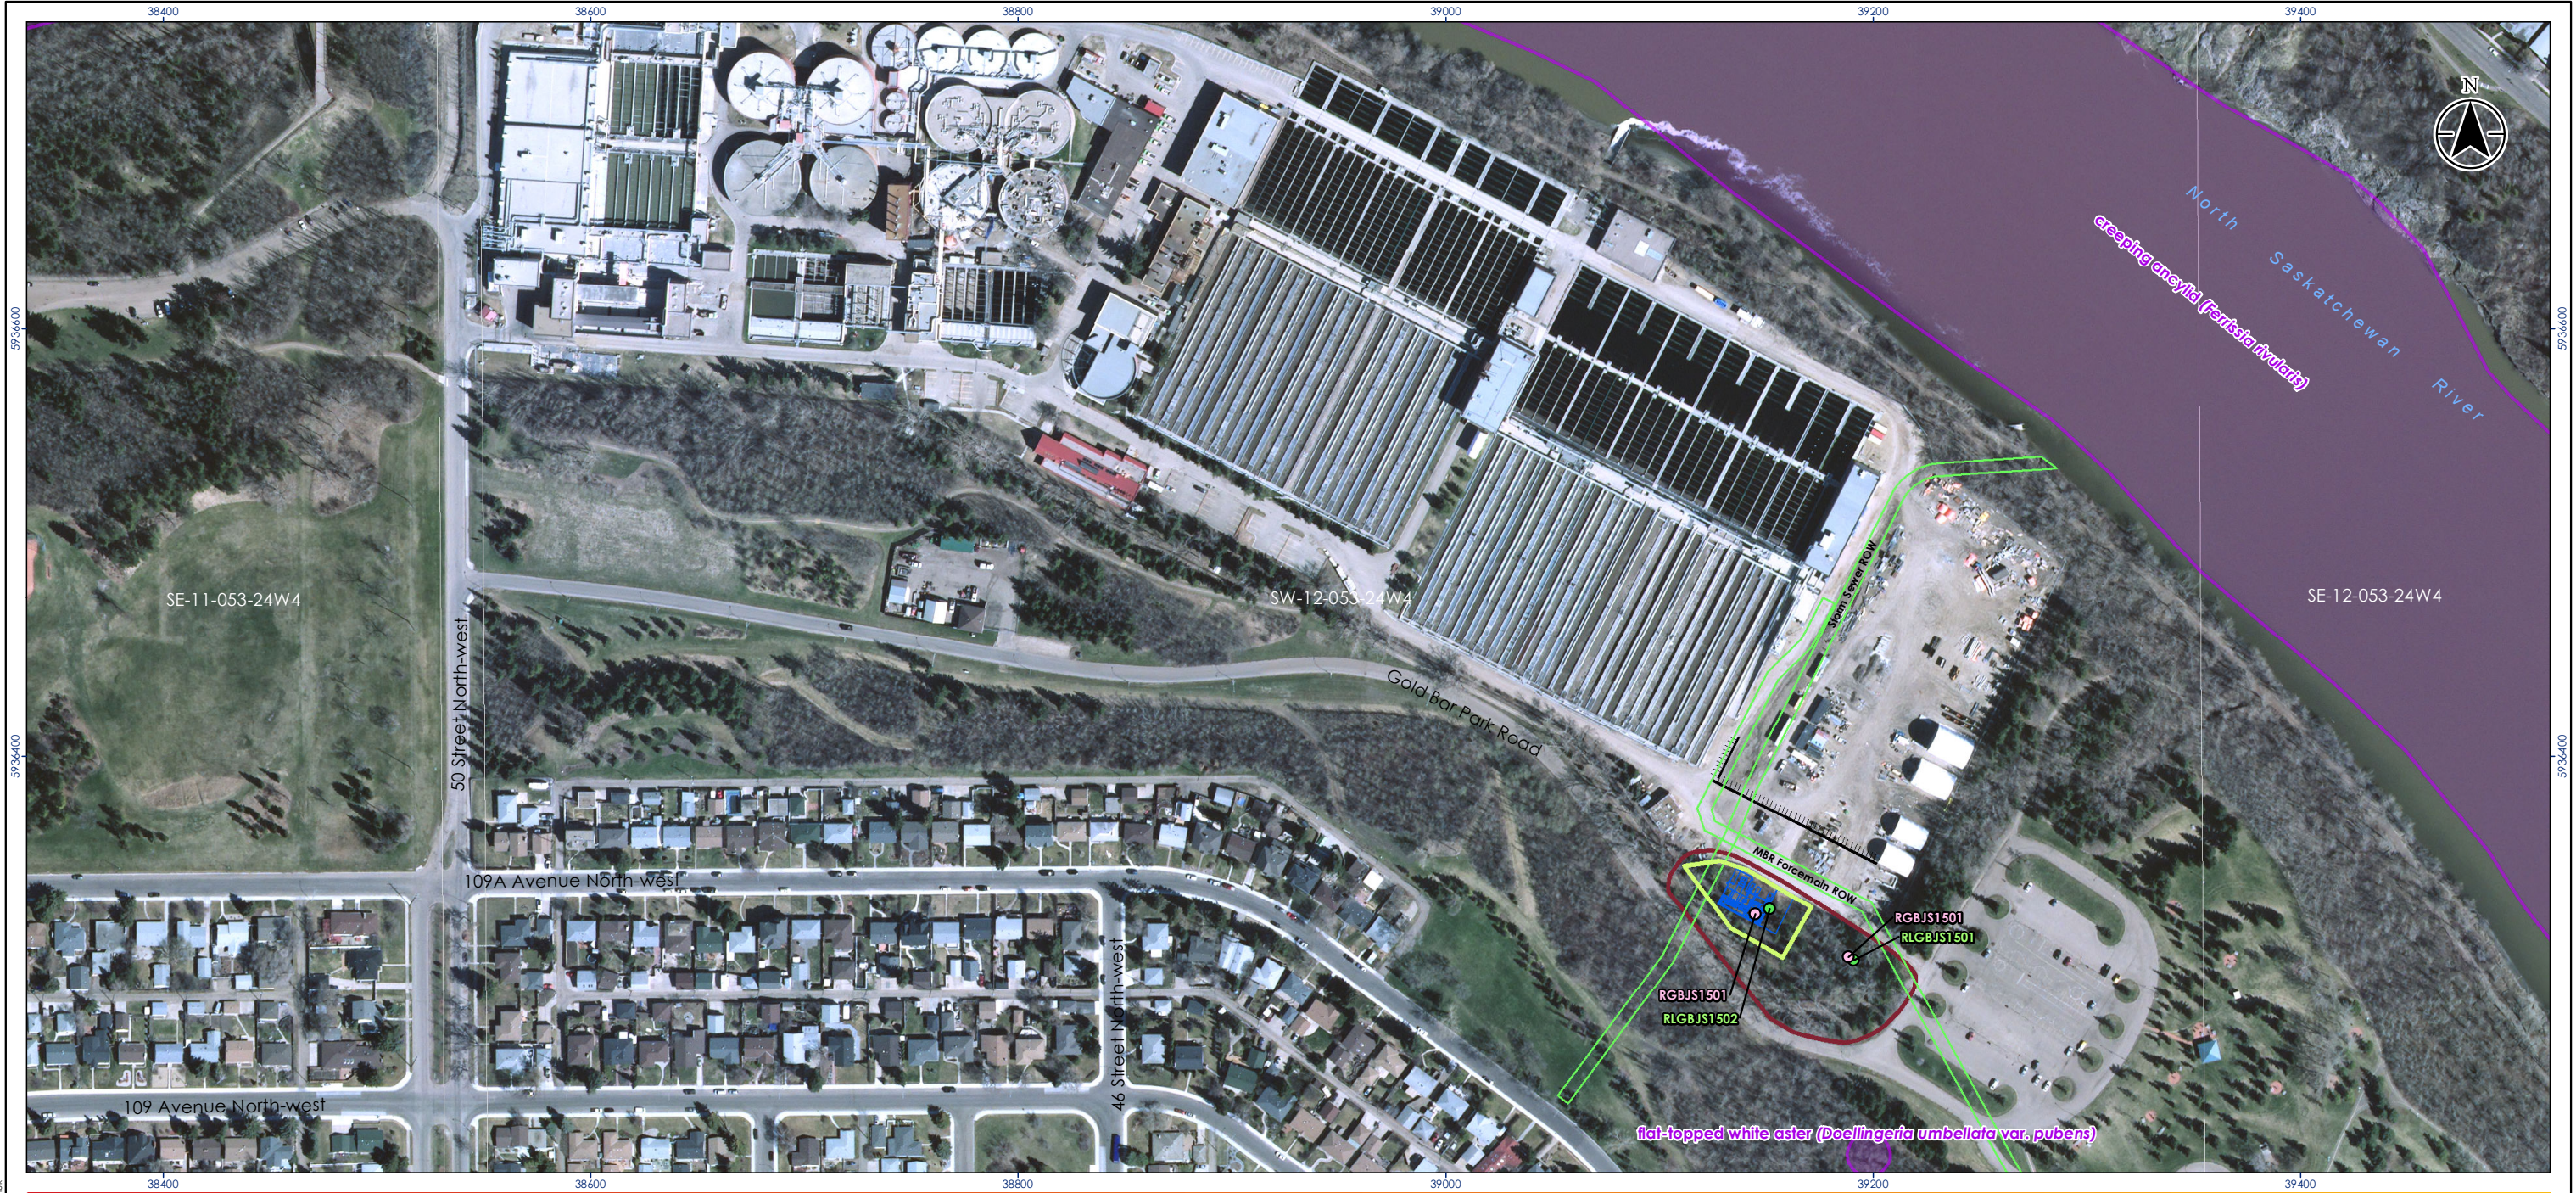
Title
Rare Plant Survey Locations

- Spring Rare Plant Survey
- Summer Rare Plant Survey
- Candidate Location Footprint
- Utility Right of Way
- ▨ Future Bioreactor Expansion
- ▭ Study Area
- ▭ Tree Clearing Extent
- ▭ ACIMS Occurrence
- ▭ ATS Quarter Section Grid

Historical occurrences of flat-topped white aster (*Doellingeria umbellata* var. *pubens*) have been found within 12-053-24 W4M (Figure 2, Appendix A). Flat-topped white aster has an S rank of S3 (AEP 2015a) and a status of *may be at risk* according to the Alberta Wild Species rank (Government of Alberta 2012). This species of forb is a perennial generally found in moist woodlands and swamp edges (Kershaw et al. 2001). Flat-topped white aster can be distinguished from the common variety by the presence of fine hairs.

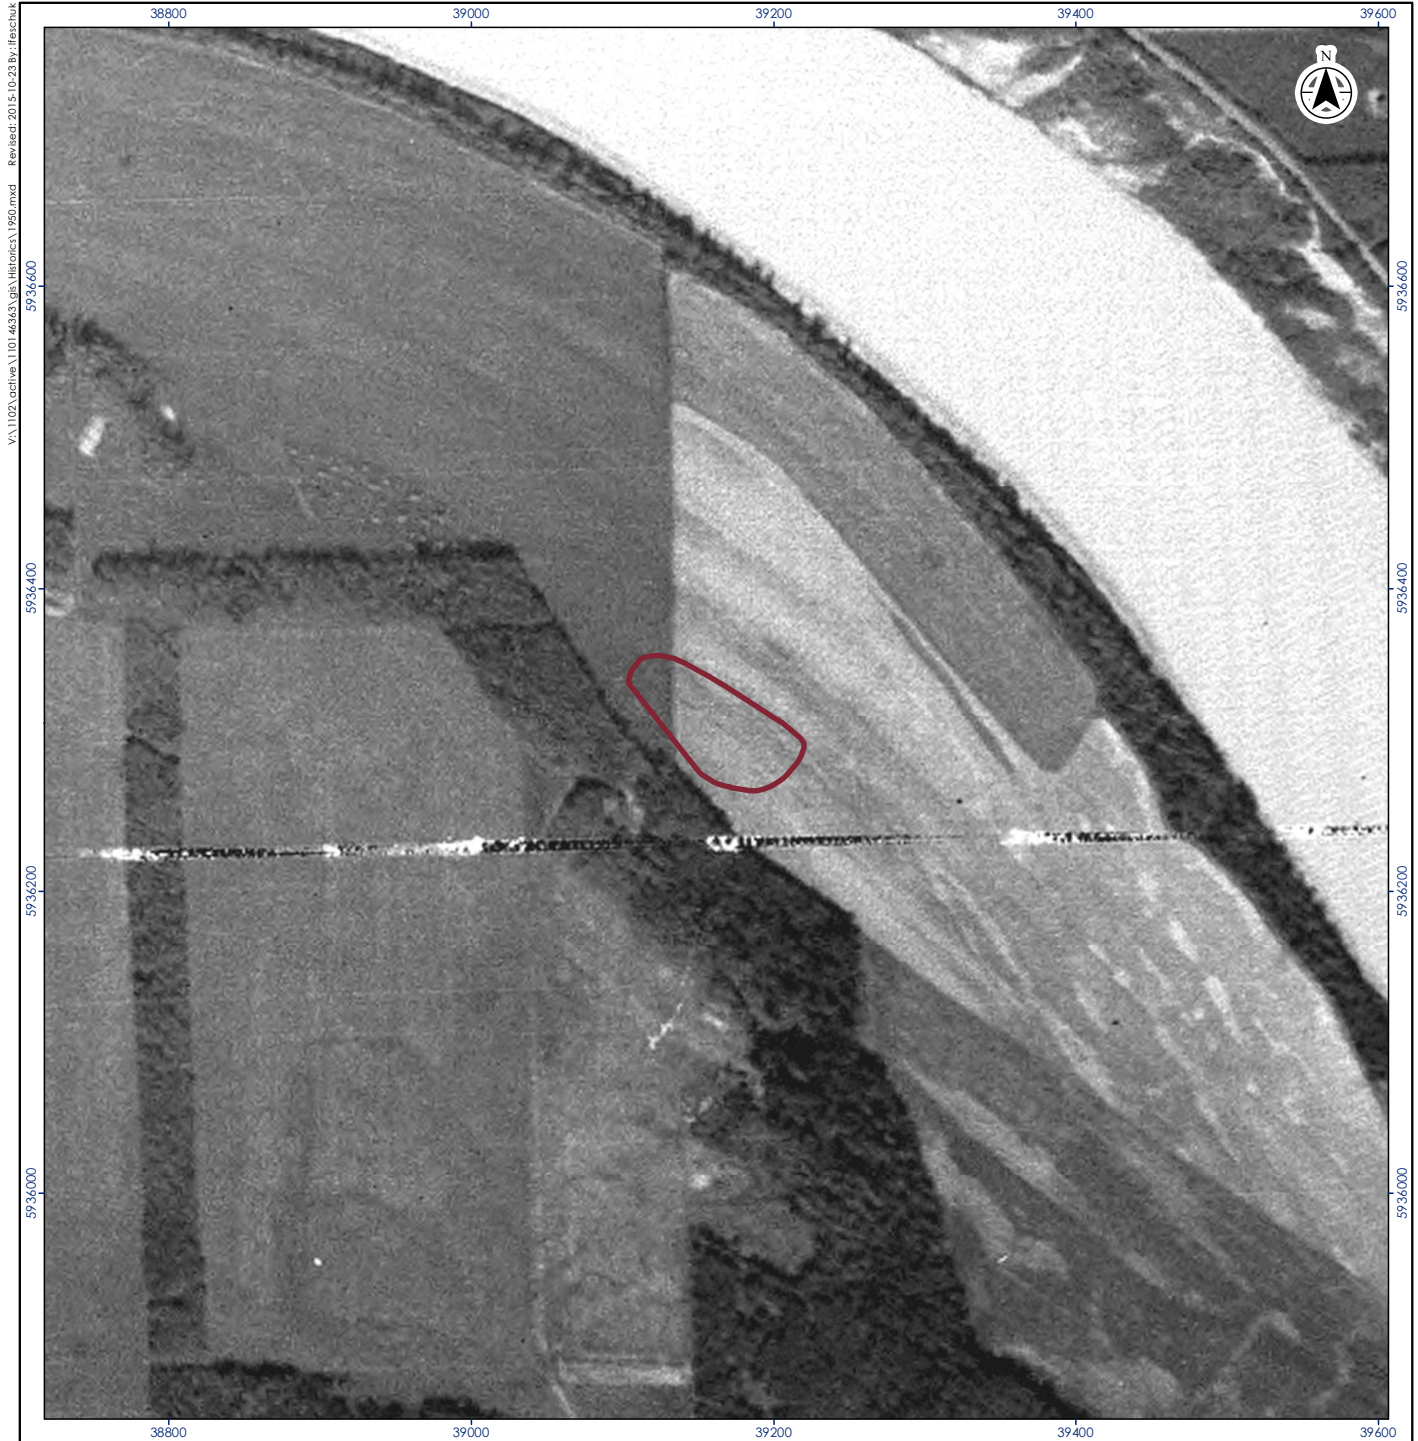
V:\1102\active\110146363\GIS\Hdnotes\1950.mxd Review: 2015-10-23 by: fteschuk

- Notes**
1. Coordinate System: NAD 1983 3TM 114
 2. Base features: Geogratis, ©Department of Natural Resources Canada. All rights reserved.
 3. Imagery: Alberta Environment and Parks, AS-134-108, 1950-08-20

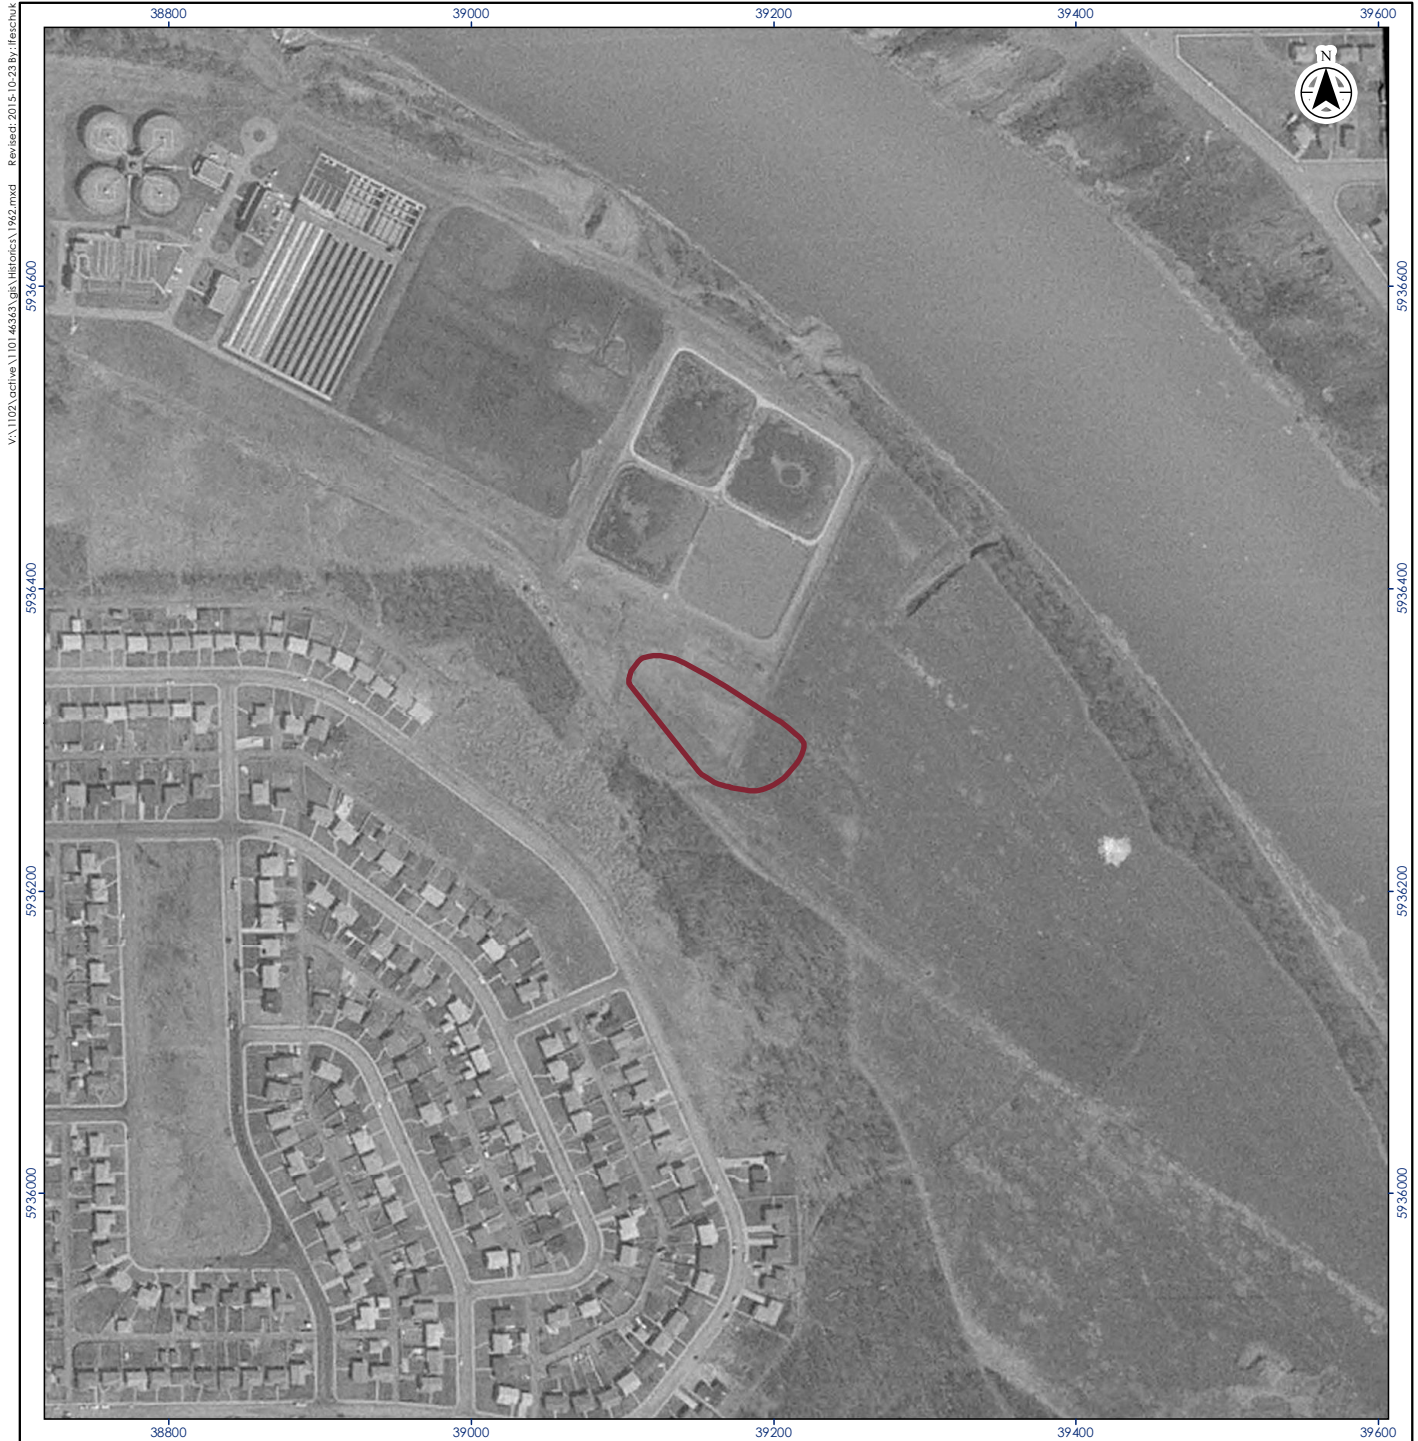
V:\1102\active\110146363\GIS\Historics\1962.mxd Review: 2015-10-23 by /feschuk

- Notes**
1. Coordinate System: NAD 1983 3TM 114
 2. Base features: Geogratis, ©Department of Natural Resources Canada. All rights reserved.
 3. Imagery: Alberta Environment and Parks, AS-818-151, 1962-05-08

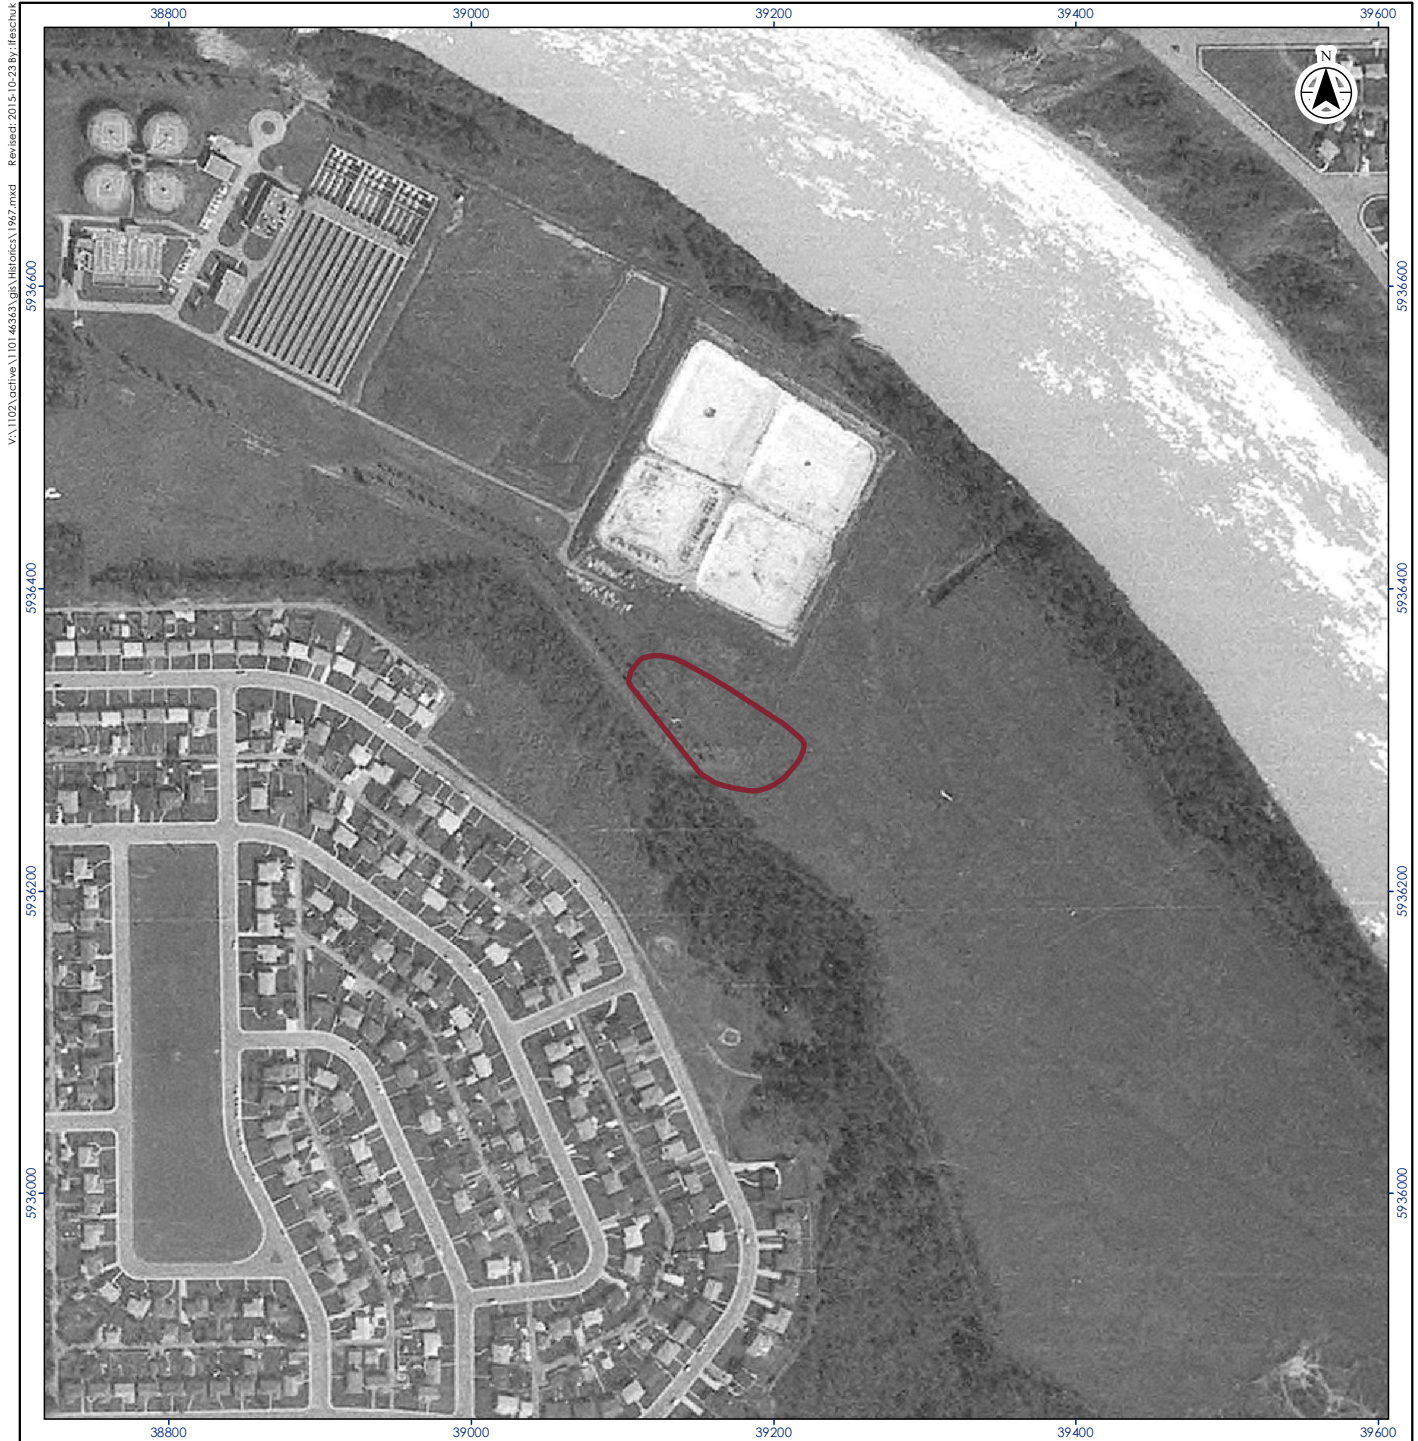
V:\1102\active\110146363\GIS\Hidotes\1967.mxd Review: 2015-10-23 by: feschuk

- Notes**
1. Coordinate System: NAD 1983 3TM 114
 2. Base features: Geogratis, ©Department of Natural Resources Canada, All rights reserved.
 3. Imagery: Alberta Environment and Parks, AS-979-260, 1967-08-15

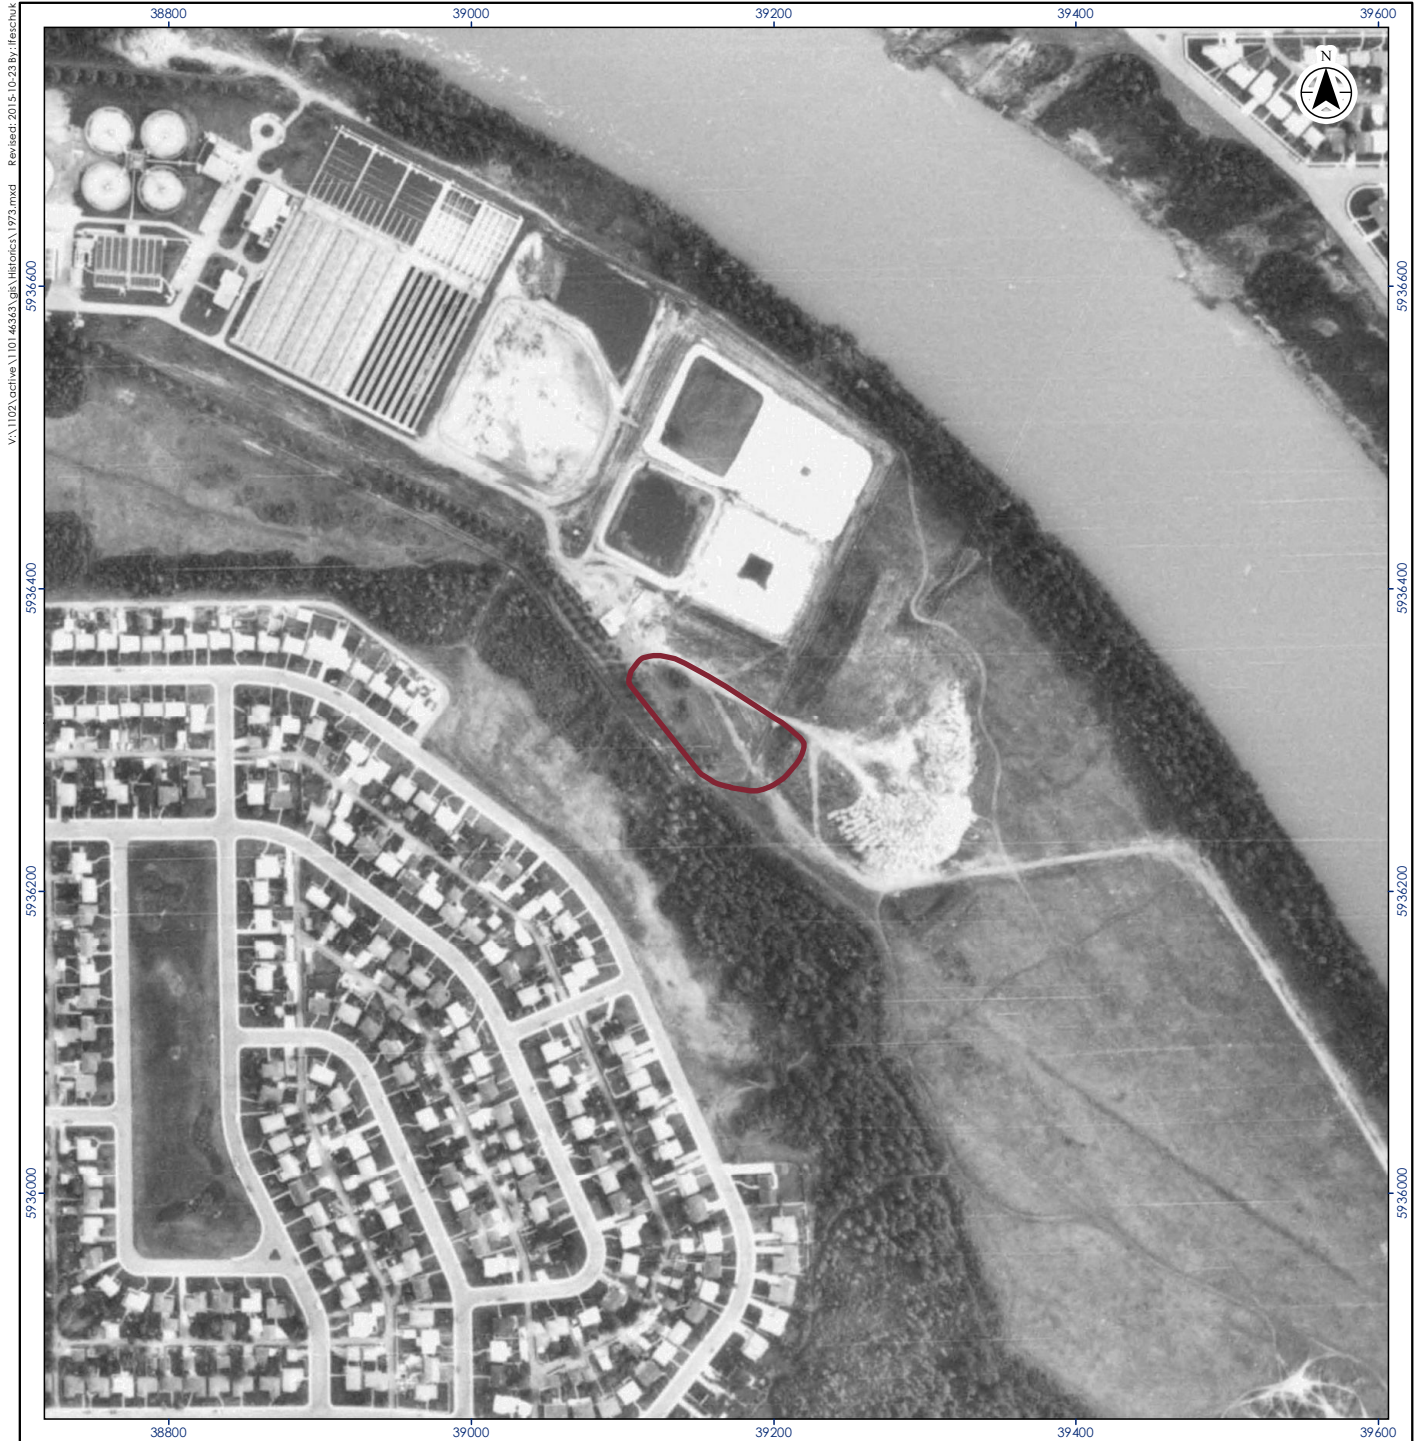
V:\1102\active\110146363\GIS\Hdnotes\1973.mxd Review: 2015-10-23 by /teschuk

- Notes**
1. Coordinate System: NAD 1983 31M 114
 2. Base features: Geogratis, ©Department of Natural Resources Canada, All rights reserved.
 3. Imagery: Alberta Environment and Parks, AS-1279-31, 1973-07-06

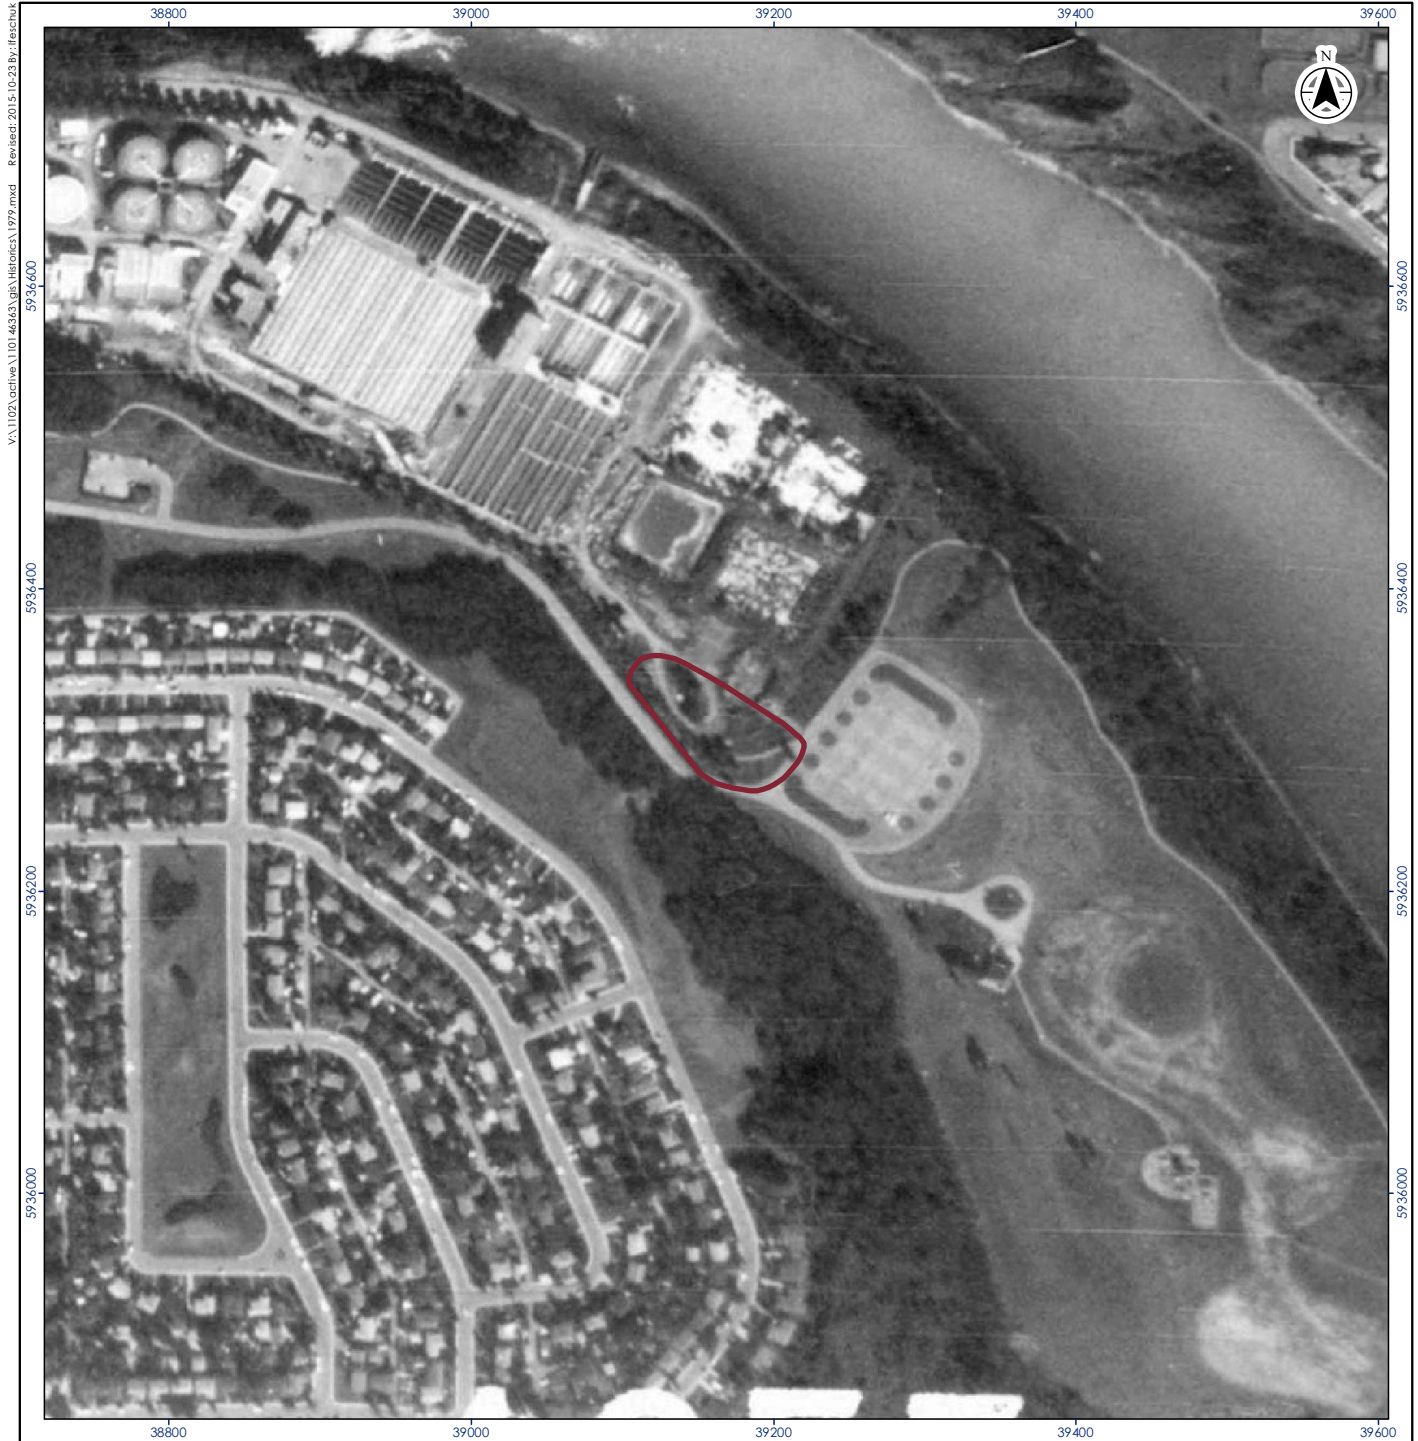
V:\1102\active\110146363\GIS\Hidotes\1979.mxd Review: 2015-10-23 by: fteschuk

- Notes**
1. Coordinate System: NAD 1983 3TM 114
 2. Base features: Geogratis, ©Department of Natural Resources Canada, All rights reserved.
 3. Imagery: Alberta Environment and Parks, AS-1955-30, 1979-09-01

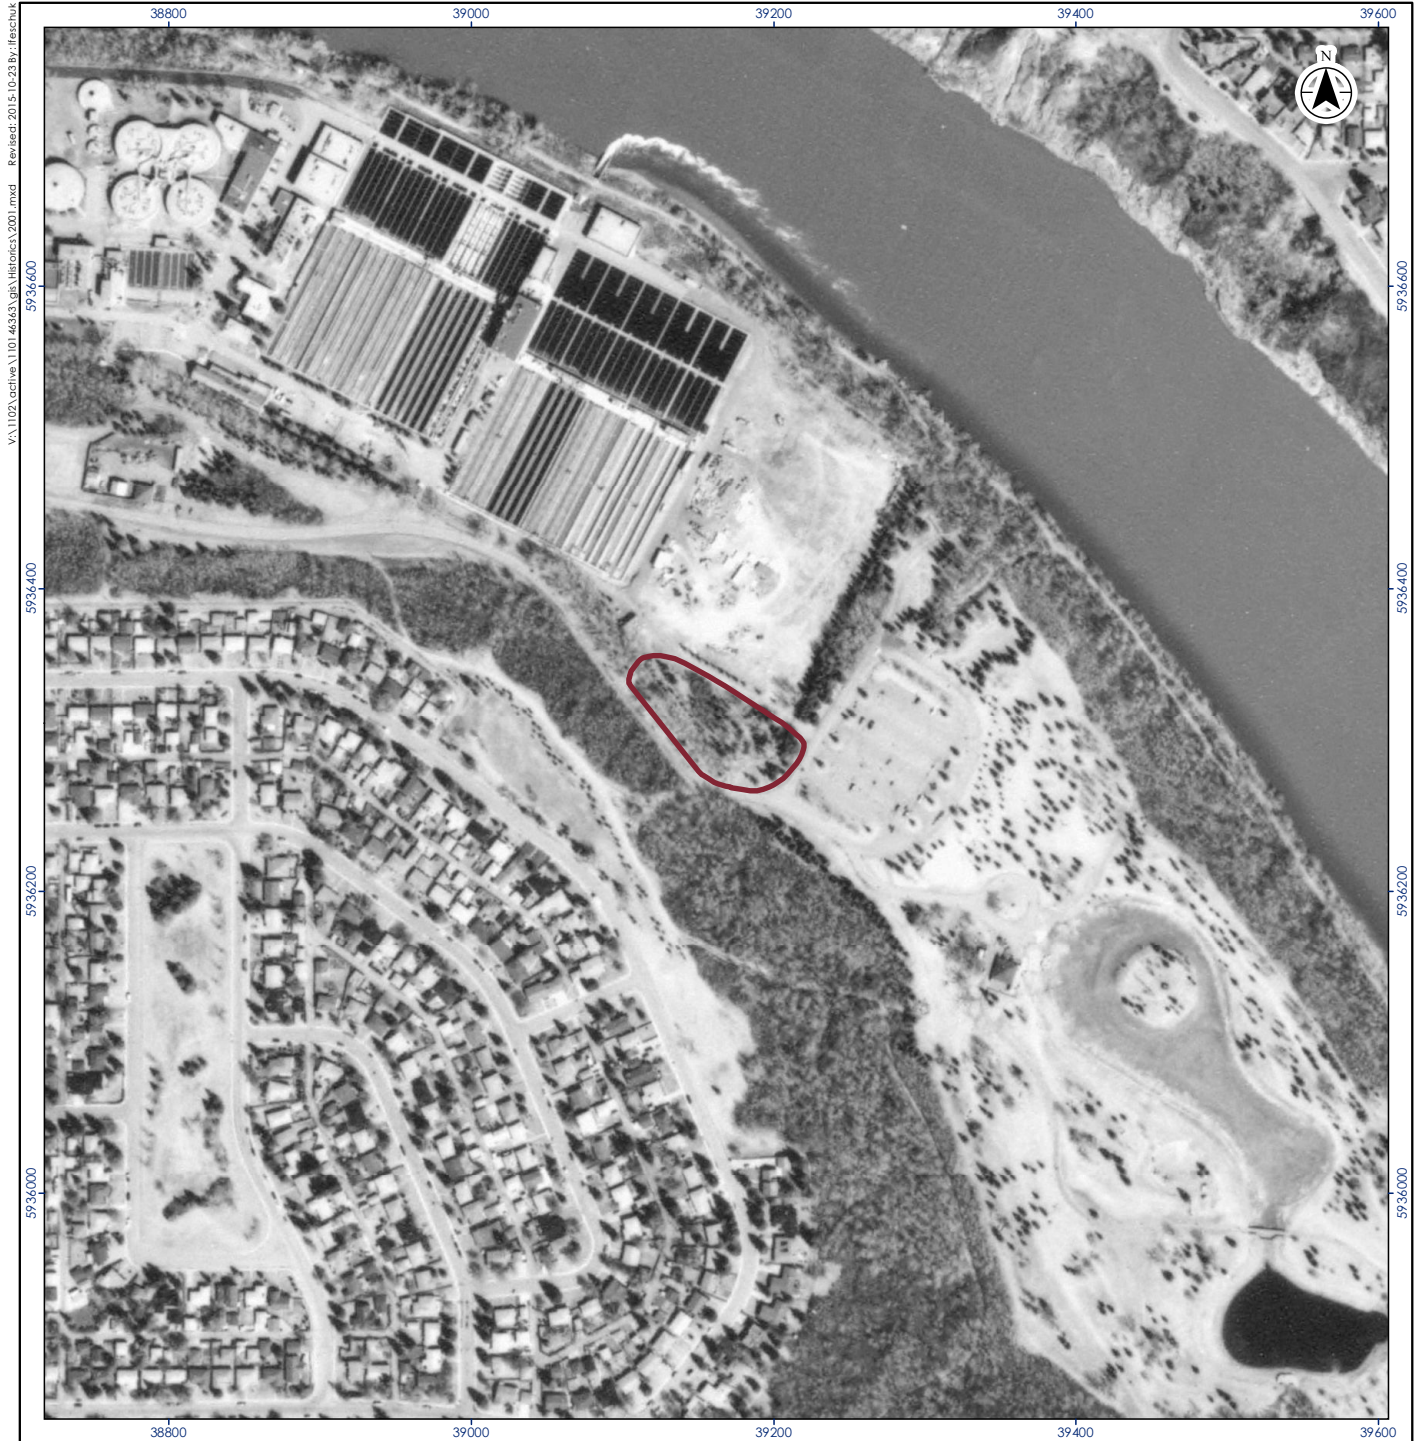
V:\1102\active\110146363\GIS\Hidotes\2001.mxd Review: 2015-10-23 by /teschuk

- Notes**
1. Coordinate System: NAD 1983 3TM 114
 2. Base features: Geogratis, ©Department of Natural Resources Canada, All rights reserved.
 3. Imagery: Alberta Environment and Parks, ED2001-233, 2001-04-29

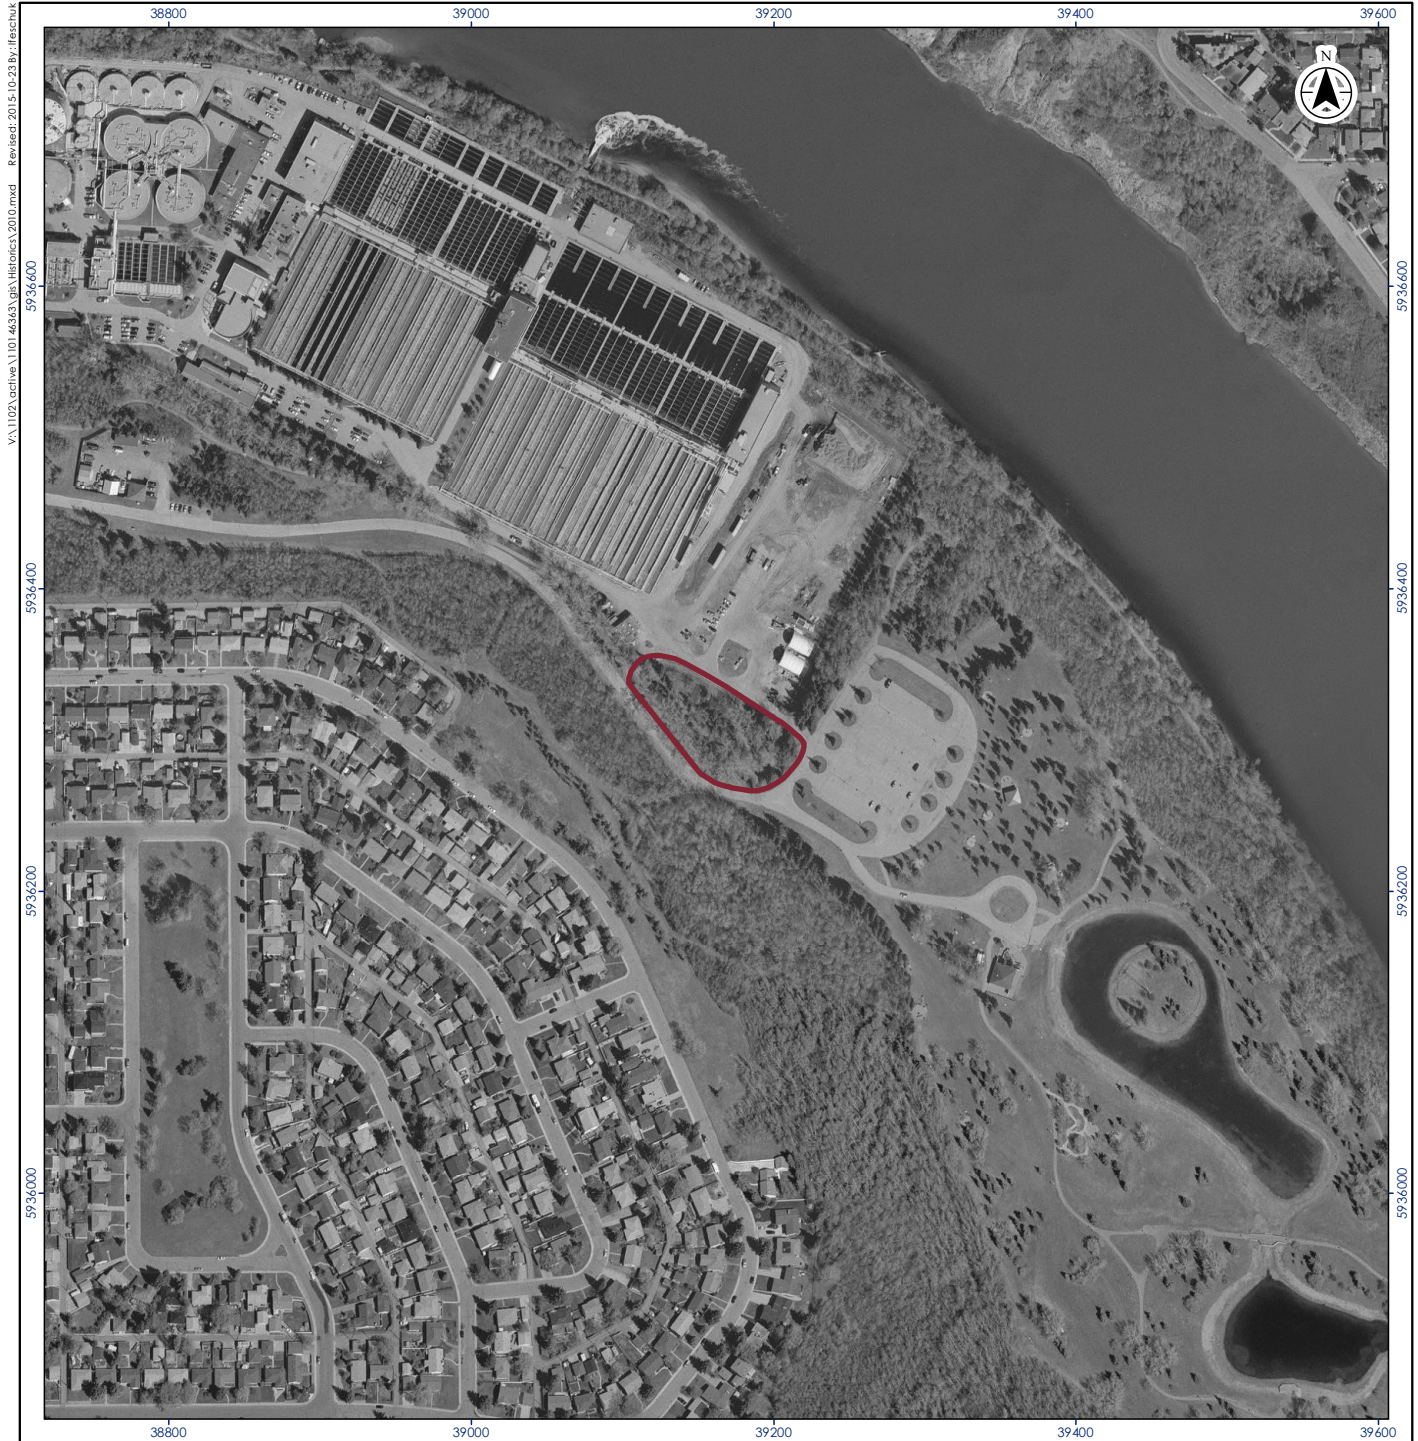
V:\1102\active\110146363\GIS\Hidotes\2010.mxd Review: 2015-10-23 by /teschuk

- Notes**
1. Coordinate System: NAD 1983 3TM 114
 2. Base features: Geogratis, ©Department of Natural Resources Canada, All rights reserved.
 3. Imagery: City of Edmonton, Transportation, 2010

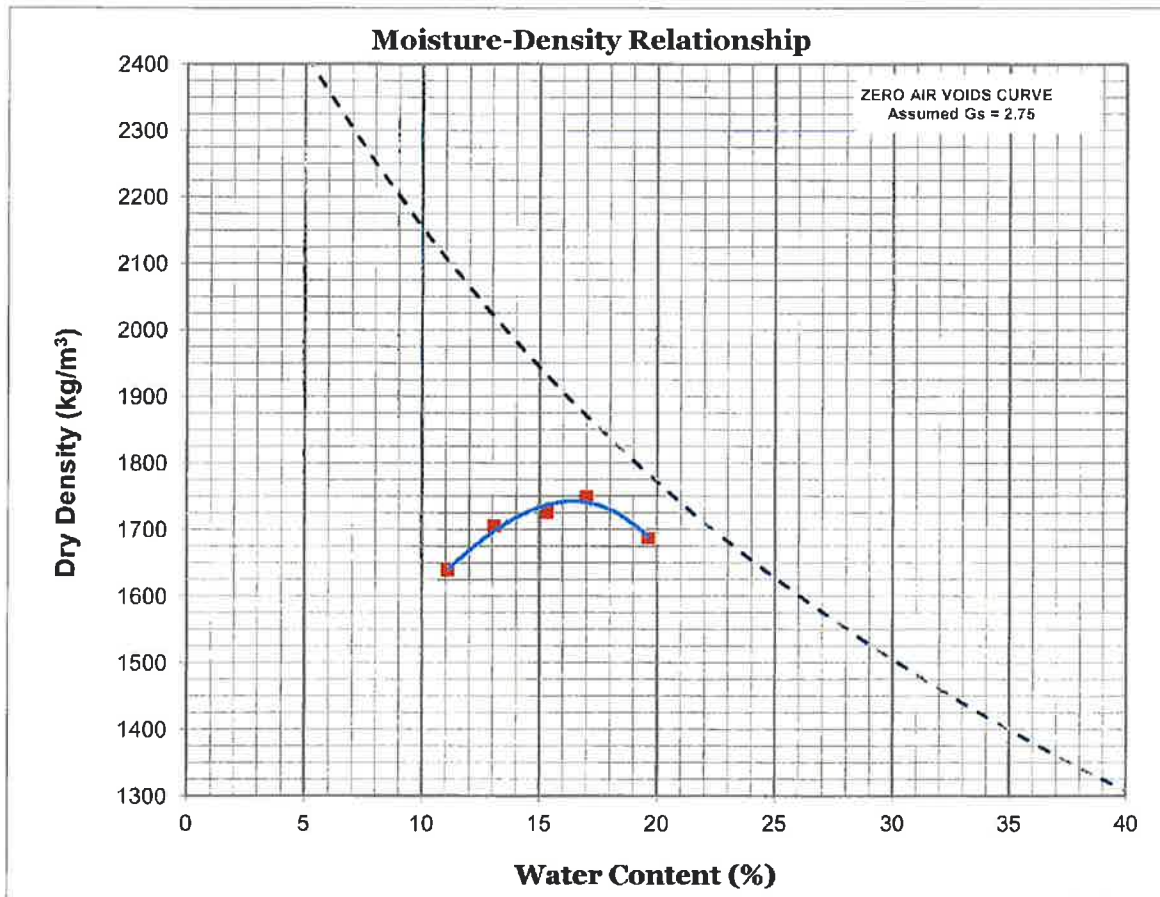
1	2	3	4	5
1640	1706	1726	1749	1688
11.1	13.1	15.4	17.0	19.7

Source of Sample: 1.3FT - 6.1FT
Soil Description: SILT AND CLAY, TR SAND, TR GRAVEL
Date Tested: August 31, 2015
Maximum Dry Density: 1745kg/m³
Optimum M.C.: 16.2%
Natural M.C.: NA
Oversize Correction: 0.0%
