**River Valley Mechanized Access  
Environmental Impact Assessment**

**Final Report**

Project Number EP 629

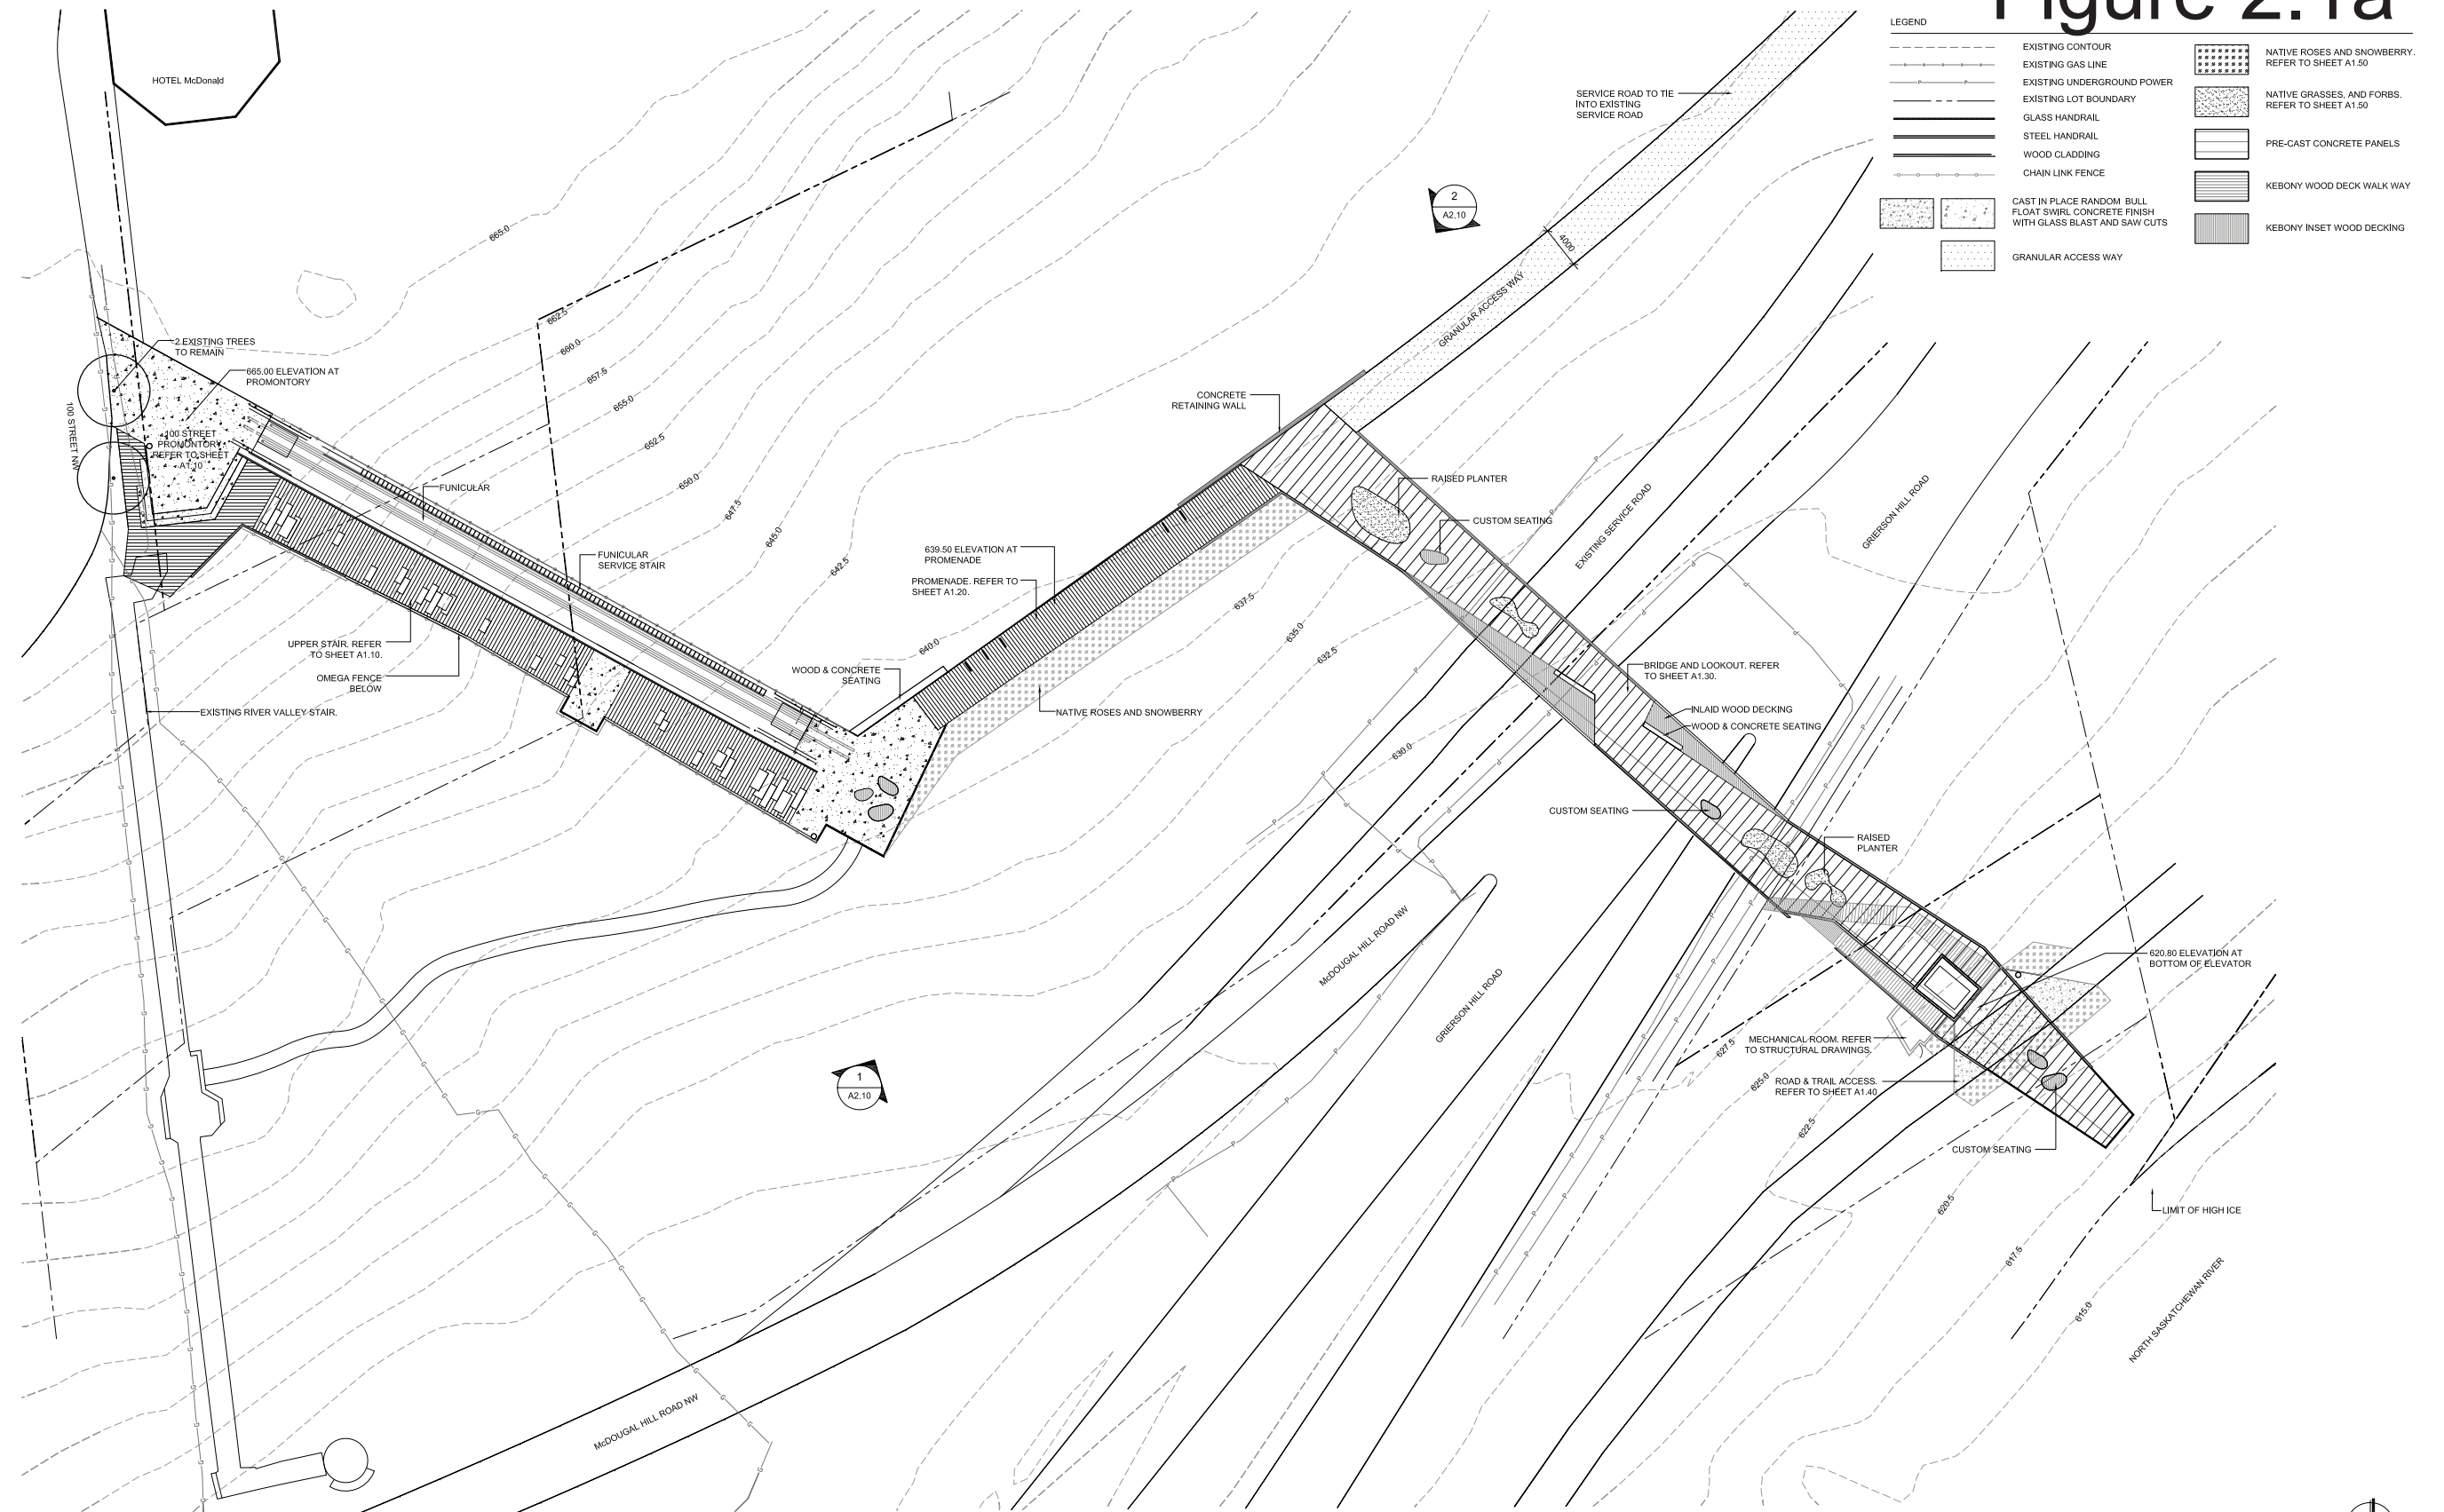
# Figure 2.1a

1 SITE DEVELOPMENT PLAN  
A1.00 SCALE: 1:300

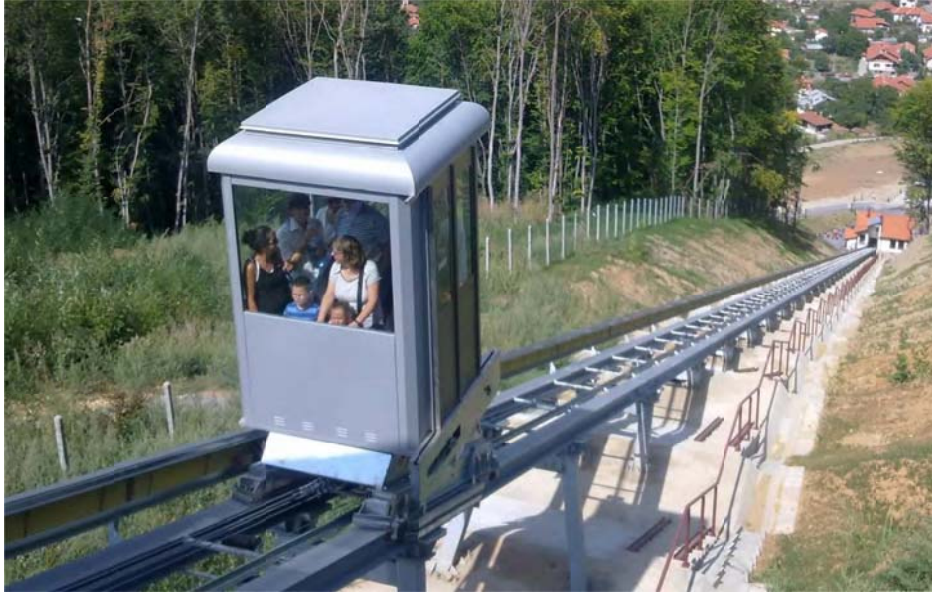
**Plate 2.4. Sample Funicular/Inclined Elevator System from Greece (DIALOG 2015b)**

- are safe,
- typically have long service lives,
- are not susceptible to strong winds,
- do not require an operator because they are passenger-controlled,
- are a low-energy option because they are only operated when needed.
- provide a closed compartment that will shelter passengers during operation; and
- are expected to perform better than other mechanized access systems in winter conditions.

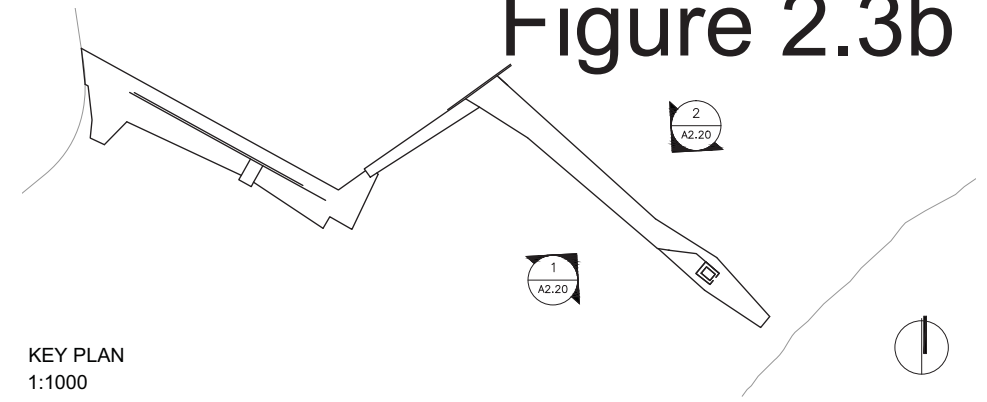
# Figure 2.3b

The trackway and an associated maintenance/emergency stair will be 3.8 m wide (DIALOG 2015b). The trackway will be elevated 1.2 m above grade for safety and operation reasons, and will be fenced off to deter tampering. A higher trackway would allow snow to accumulate on the slope below without impeding the funicular car. The trackway will be supported on piers founded on micropiles.

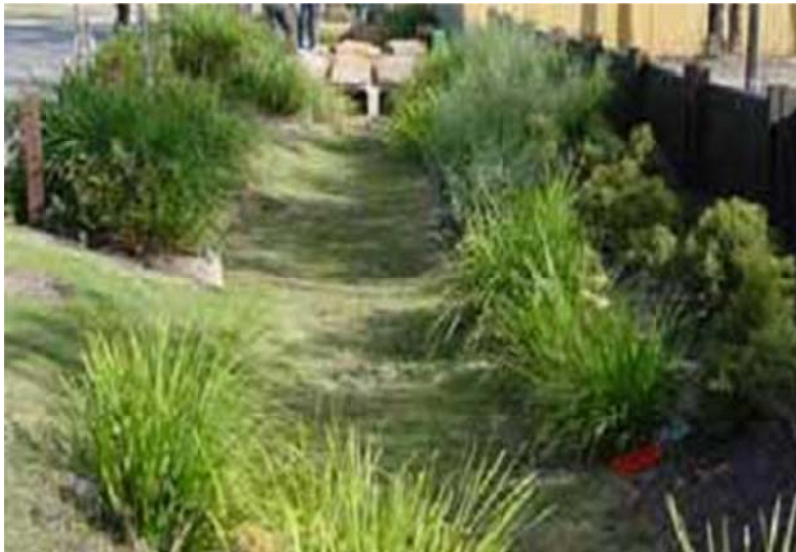
**Plate 2.10. Typical vegetated swale (Hatch Mott MacDonald 2015)**

A linear vegetated swale is proposed along the north edge of the promenade (Plate 2.10) (Drawings C1.01, C1.03 and C1.05 in Appendix A) (Hatch Mott MacDonald 2015). Swales are shallow channels designed to store and/or convey runoff and remove pollutants. They may be used as conveyance structures to pass the runoff to the next stage of treatment and can be designed to promote infiltration where solid and groundwater conditions allow. For the proposed RVMA project, surface water flows from the adjacent north slope will flow into this swale feature. The promenade surface will have a 2% slope towards the swale so that surface flows from the promenade will be directed away from the southern edge to the north and collected in the swale.

The swale channel is proposed to be broad and shallow and covered by dense vegetation to reflect the landscaping of the area (Hatch Mott MacDonald 2015). Planting with native grasses, to slow down flows and trap particulate pollutants collected off the surface. As noted above, the swale will contain a buried “French drain” to collect and remove the surface water collected by the swale. The swale and the drain will sit on an impermeable layer to manage the potential for water to migrate through the slope and saturate the ground immediately below the swale. The swale drain will be connected to outfall pipes along its length to allow the collected flow to daylight below the promenade structure and help mitigate the build-up of groundwater behind the promenade’s north supporting wall. Construction of the outfall pipes (Drawing C1.03 in Appendix A) will require cut and cover with a mini-excavator in a 2.0 m wide construction footprint (S. Brown, *pers. comm.*). A toe drain will also be supplied at the promenade north support wall to manage the natural flow of water that does locally occur (Hatch Mott MacDonald 2015).
