Date:	May 17, 2024	File:	2020-3858
To:	Achyut Adhikari	Page:	Page 1 of 183
From:	Erica Graham, M.Sc., P.Biol.		
Project:	Wellington Bridge Replacement		
Subject:	Environmental Impact Assessment: Update

Wellington Bridge Replacement Environmental Impact Assessment

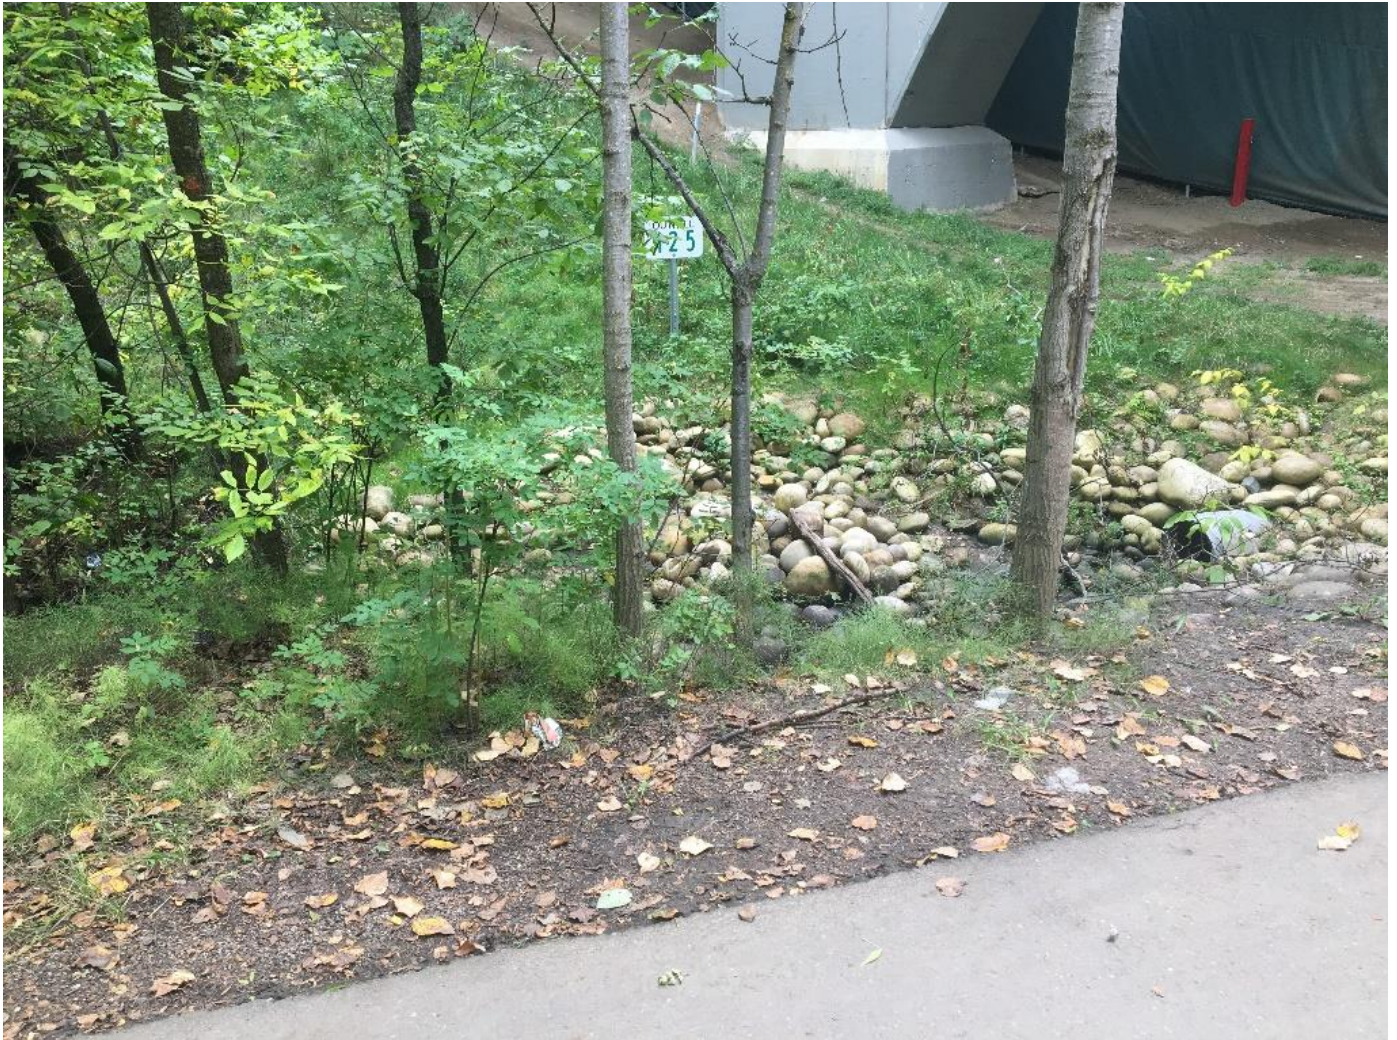
Figure 3-3
Outfall 125 in Unnamed Watercourse

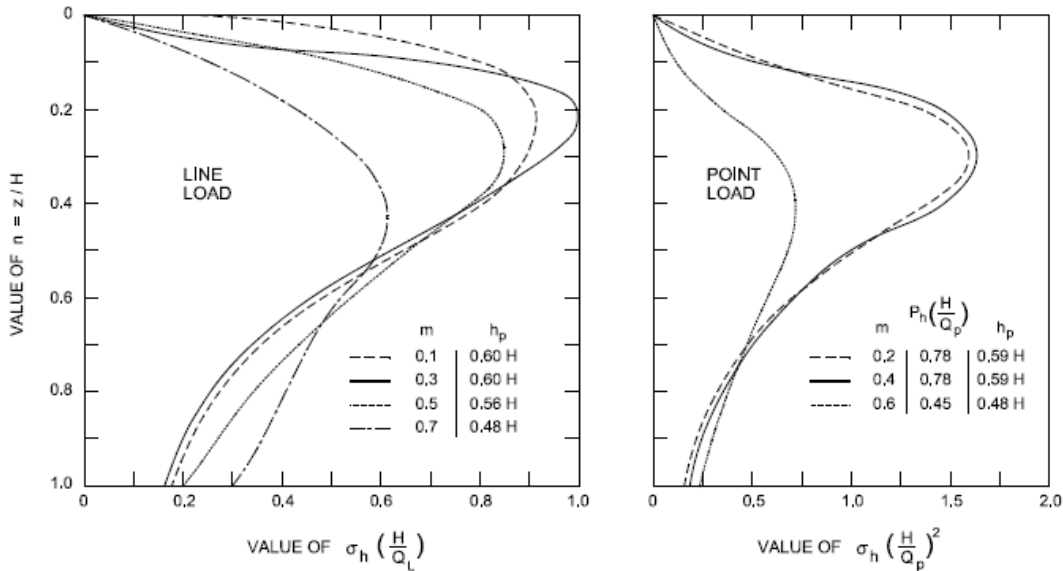
PRESSURES FROM LINE LOAD Q_L
(BOUSSINESQ EQUATION MODIFIED BY EXPERIMENT)

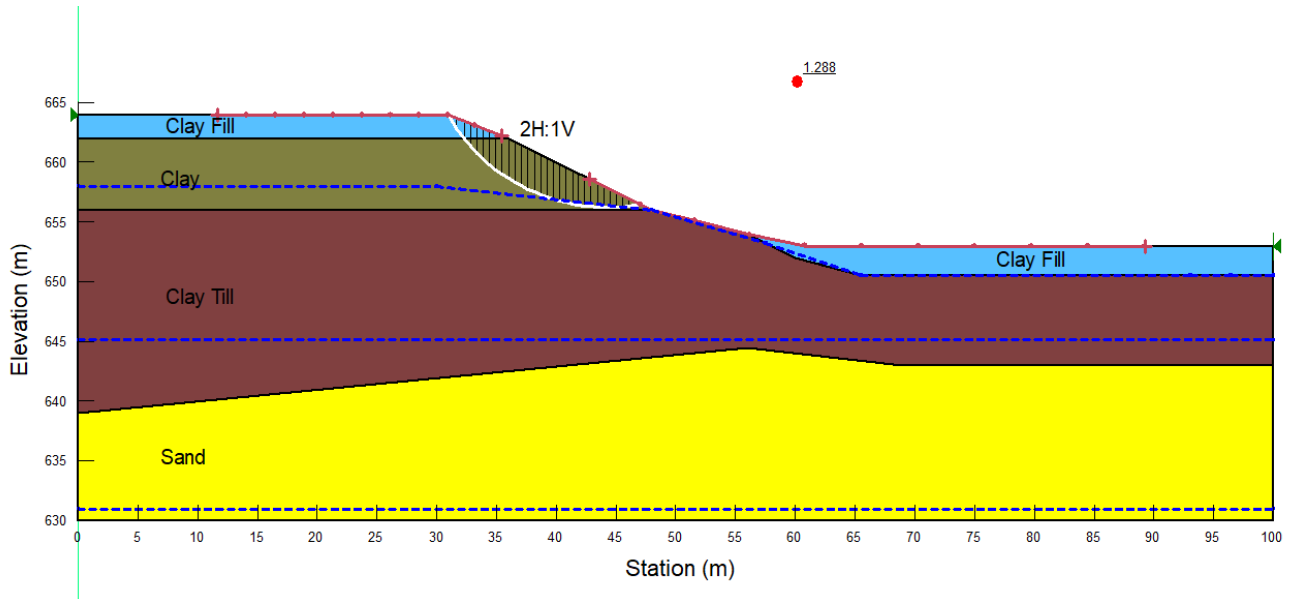
**FIGURE 6.2
CROSS-SECTION A-A WEST HEADSLOPE ALONG BRIDGE CENTRELINE –
BACKANALYSIS**

Figure 6.2 indicates that current factor of safety (FS) of the headslopes is about 1.3. It is likely that the clay fill placed at the base of the slope at the bridge location contributed to the overall stability of the slope. Therefore, the current headslopes do not meet the long-term FOS for bridge headslopes (i.e. a FOS of 1.5).

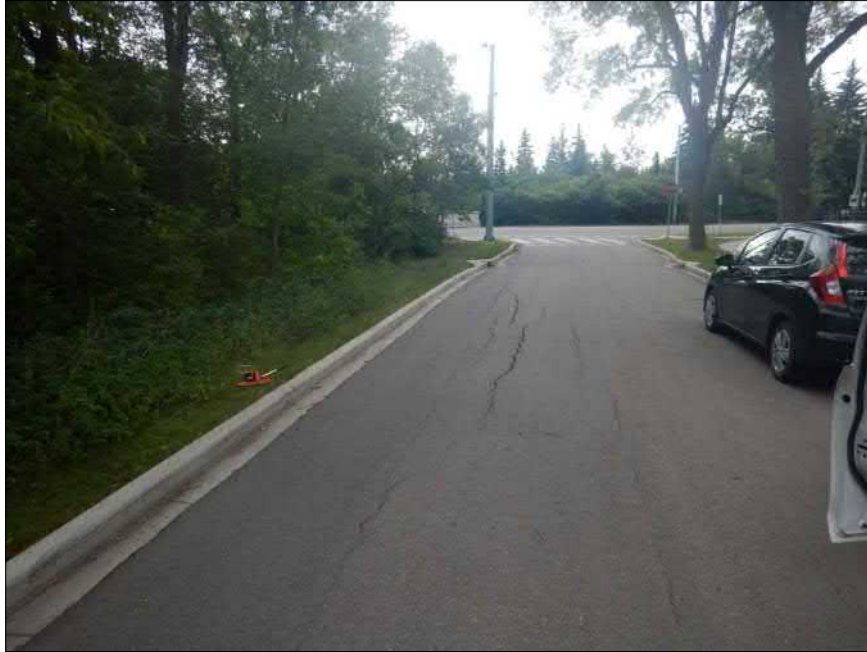
PHOTO 1 CATCH BASIN AND CRACKING ON CHURCHILL CRESCENT LOOKING SOUTH TOWARDS 102 AVENUE

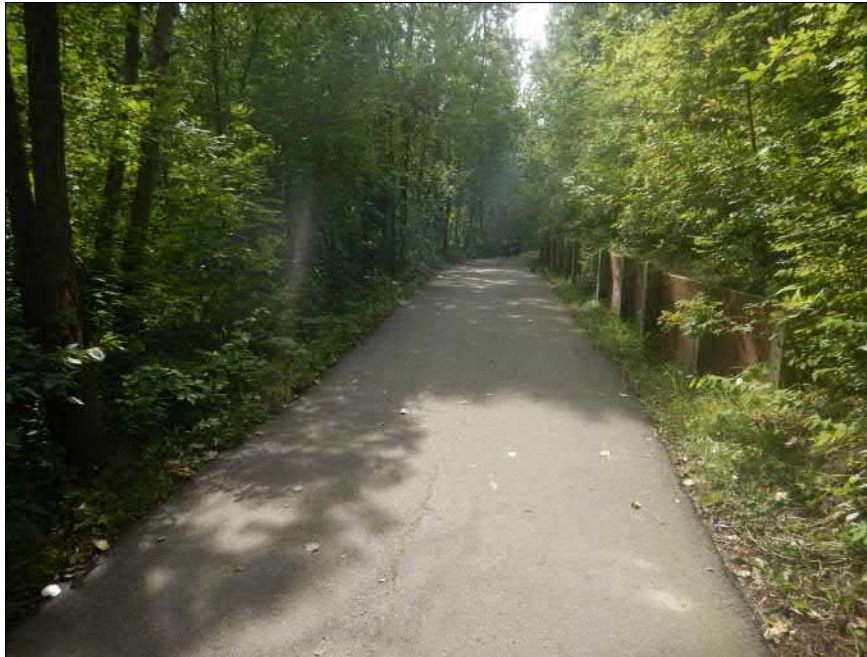
PHOTO 2 TIMBER RETAINING WALL ALONG WEST SIDE OF MULT-USE TRAIL TOWARDS SOUTH

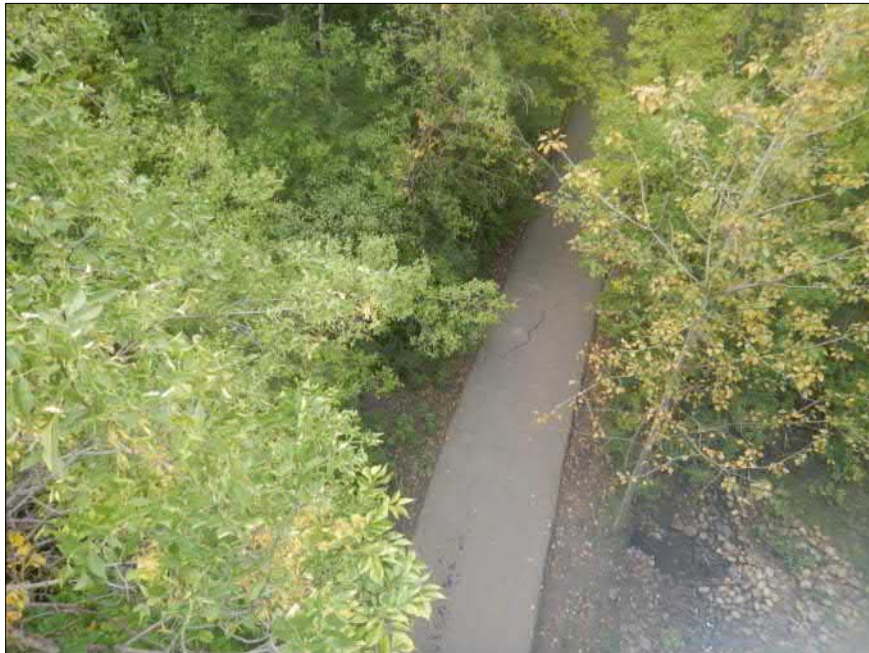
PHOTO 4 SURFACE CRACKING ON MULTI-USE TRAIL BETWEEN RETAINING WALL AND BRIDGE

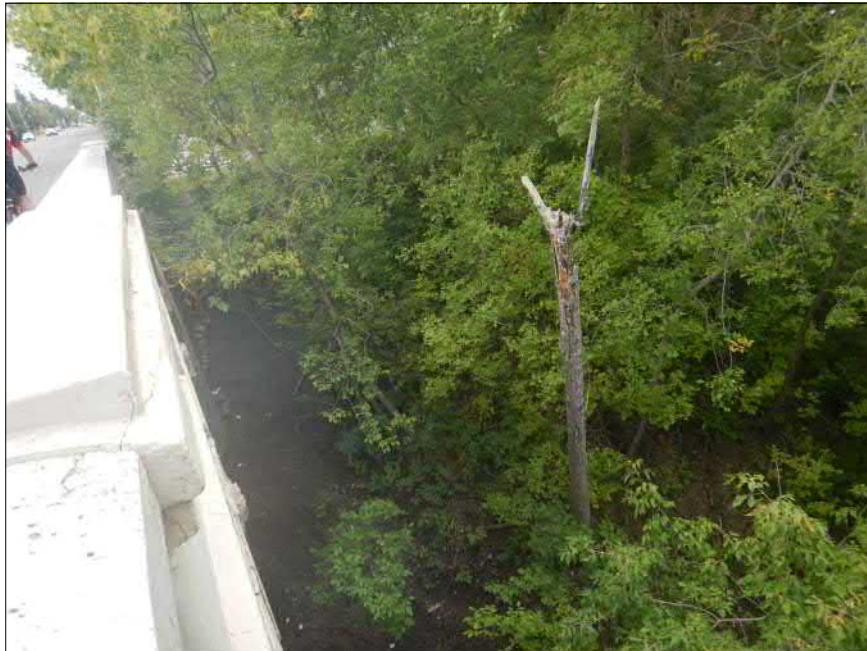
PHOTO 6 EROSION ON WEST RAVINE SLOPE NORTH OF BRIDGE

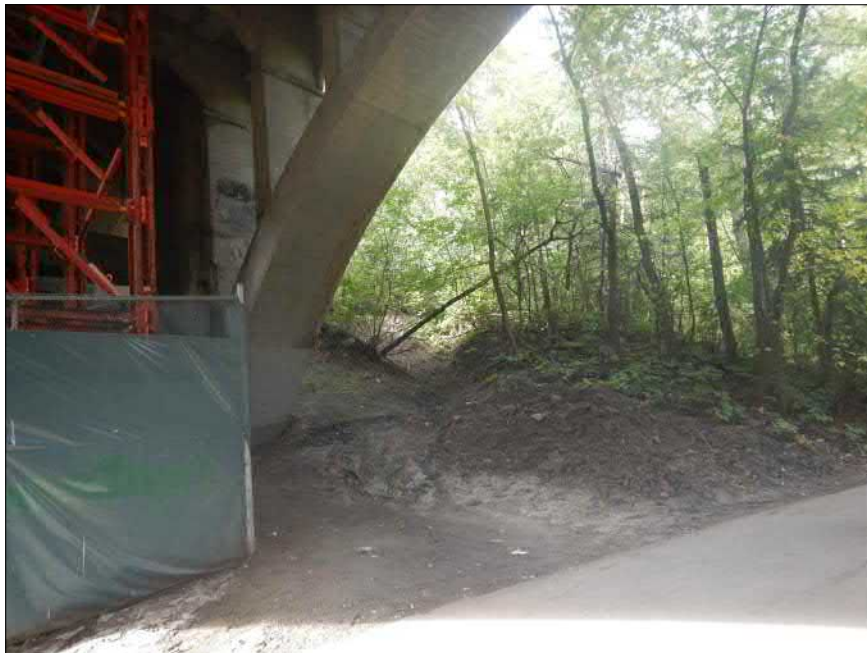
PHOTO 8 EROSION ON WEST RAVINE SLOPE NORTH OF BRIDGE

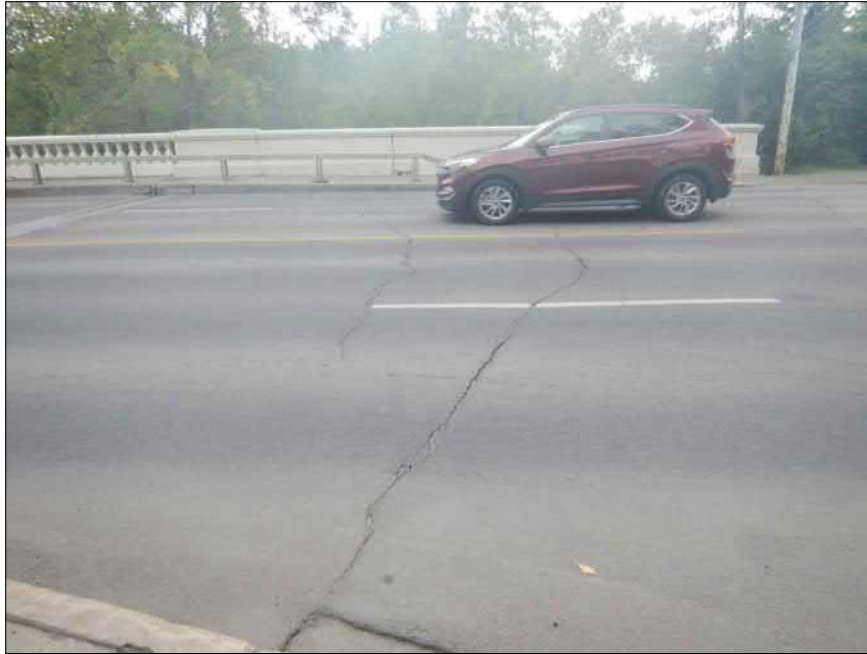
PHOTO 9 DIAGONAL CRACKING ON 102 AVENUE IN WEST ABUTMENT AREA

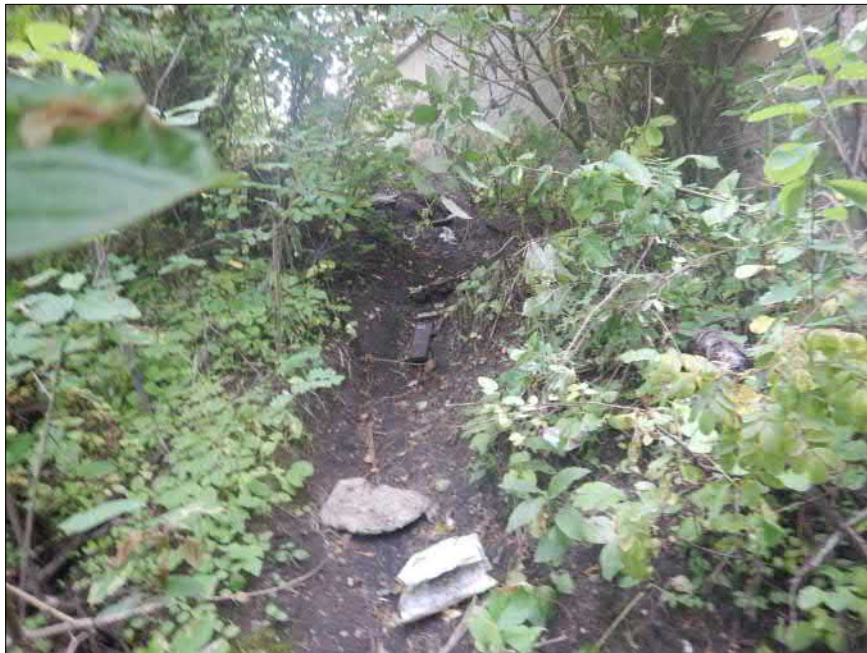
PHOTO 10 EROSION ON EAST RAVINE SLOPE NORTH OF BRIDGE

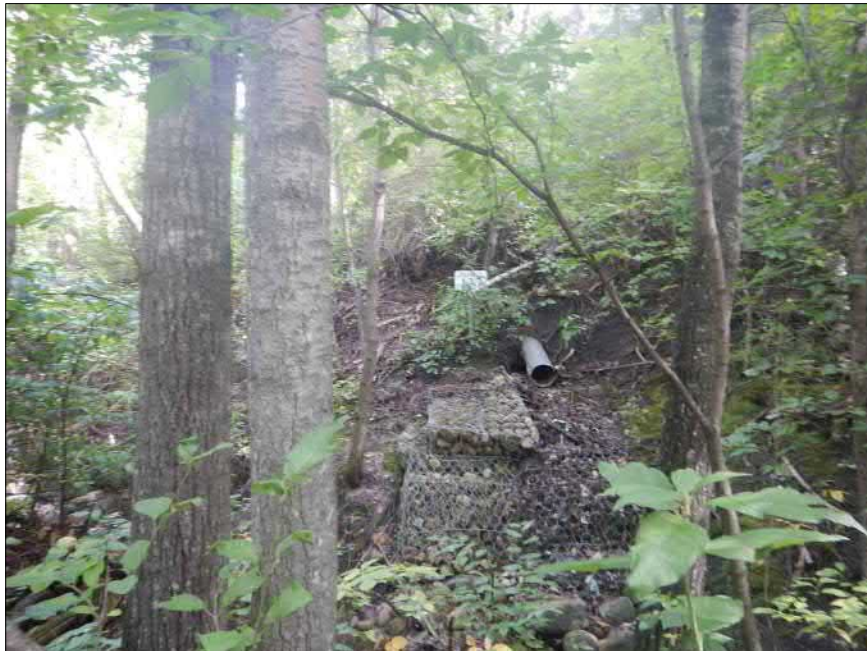
PHOTO 12 OUTFALL ON EAST RAVINE SLOPE SOUTH OF BRIDGE

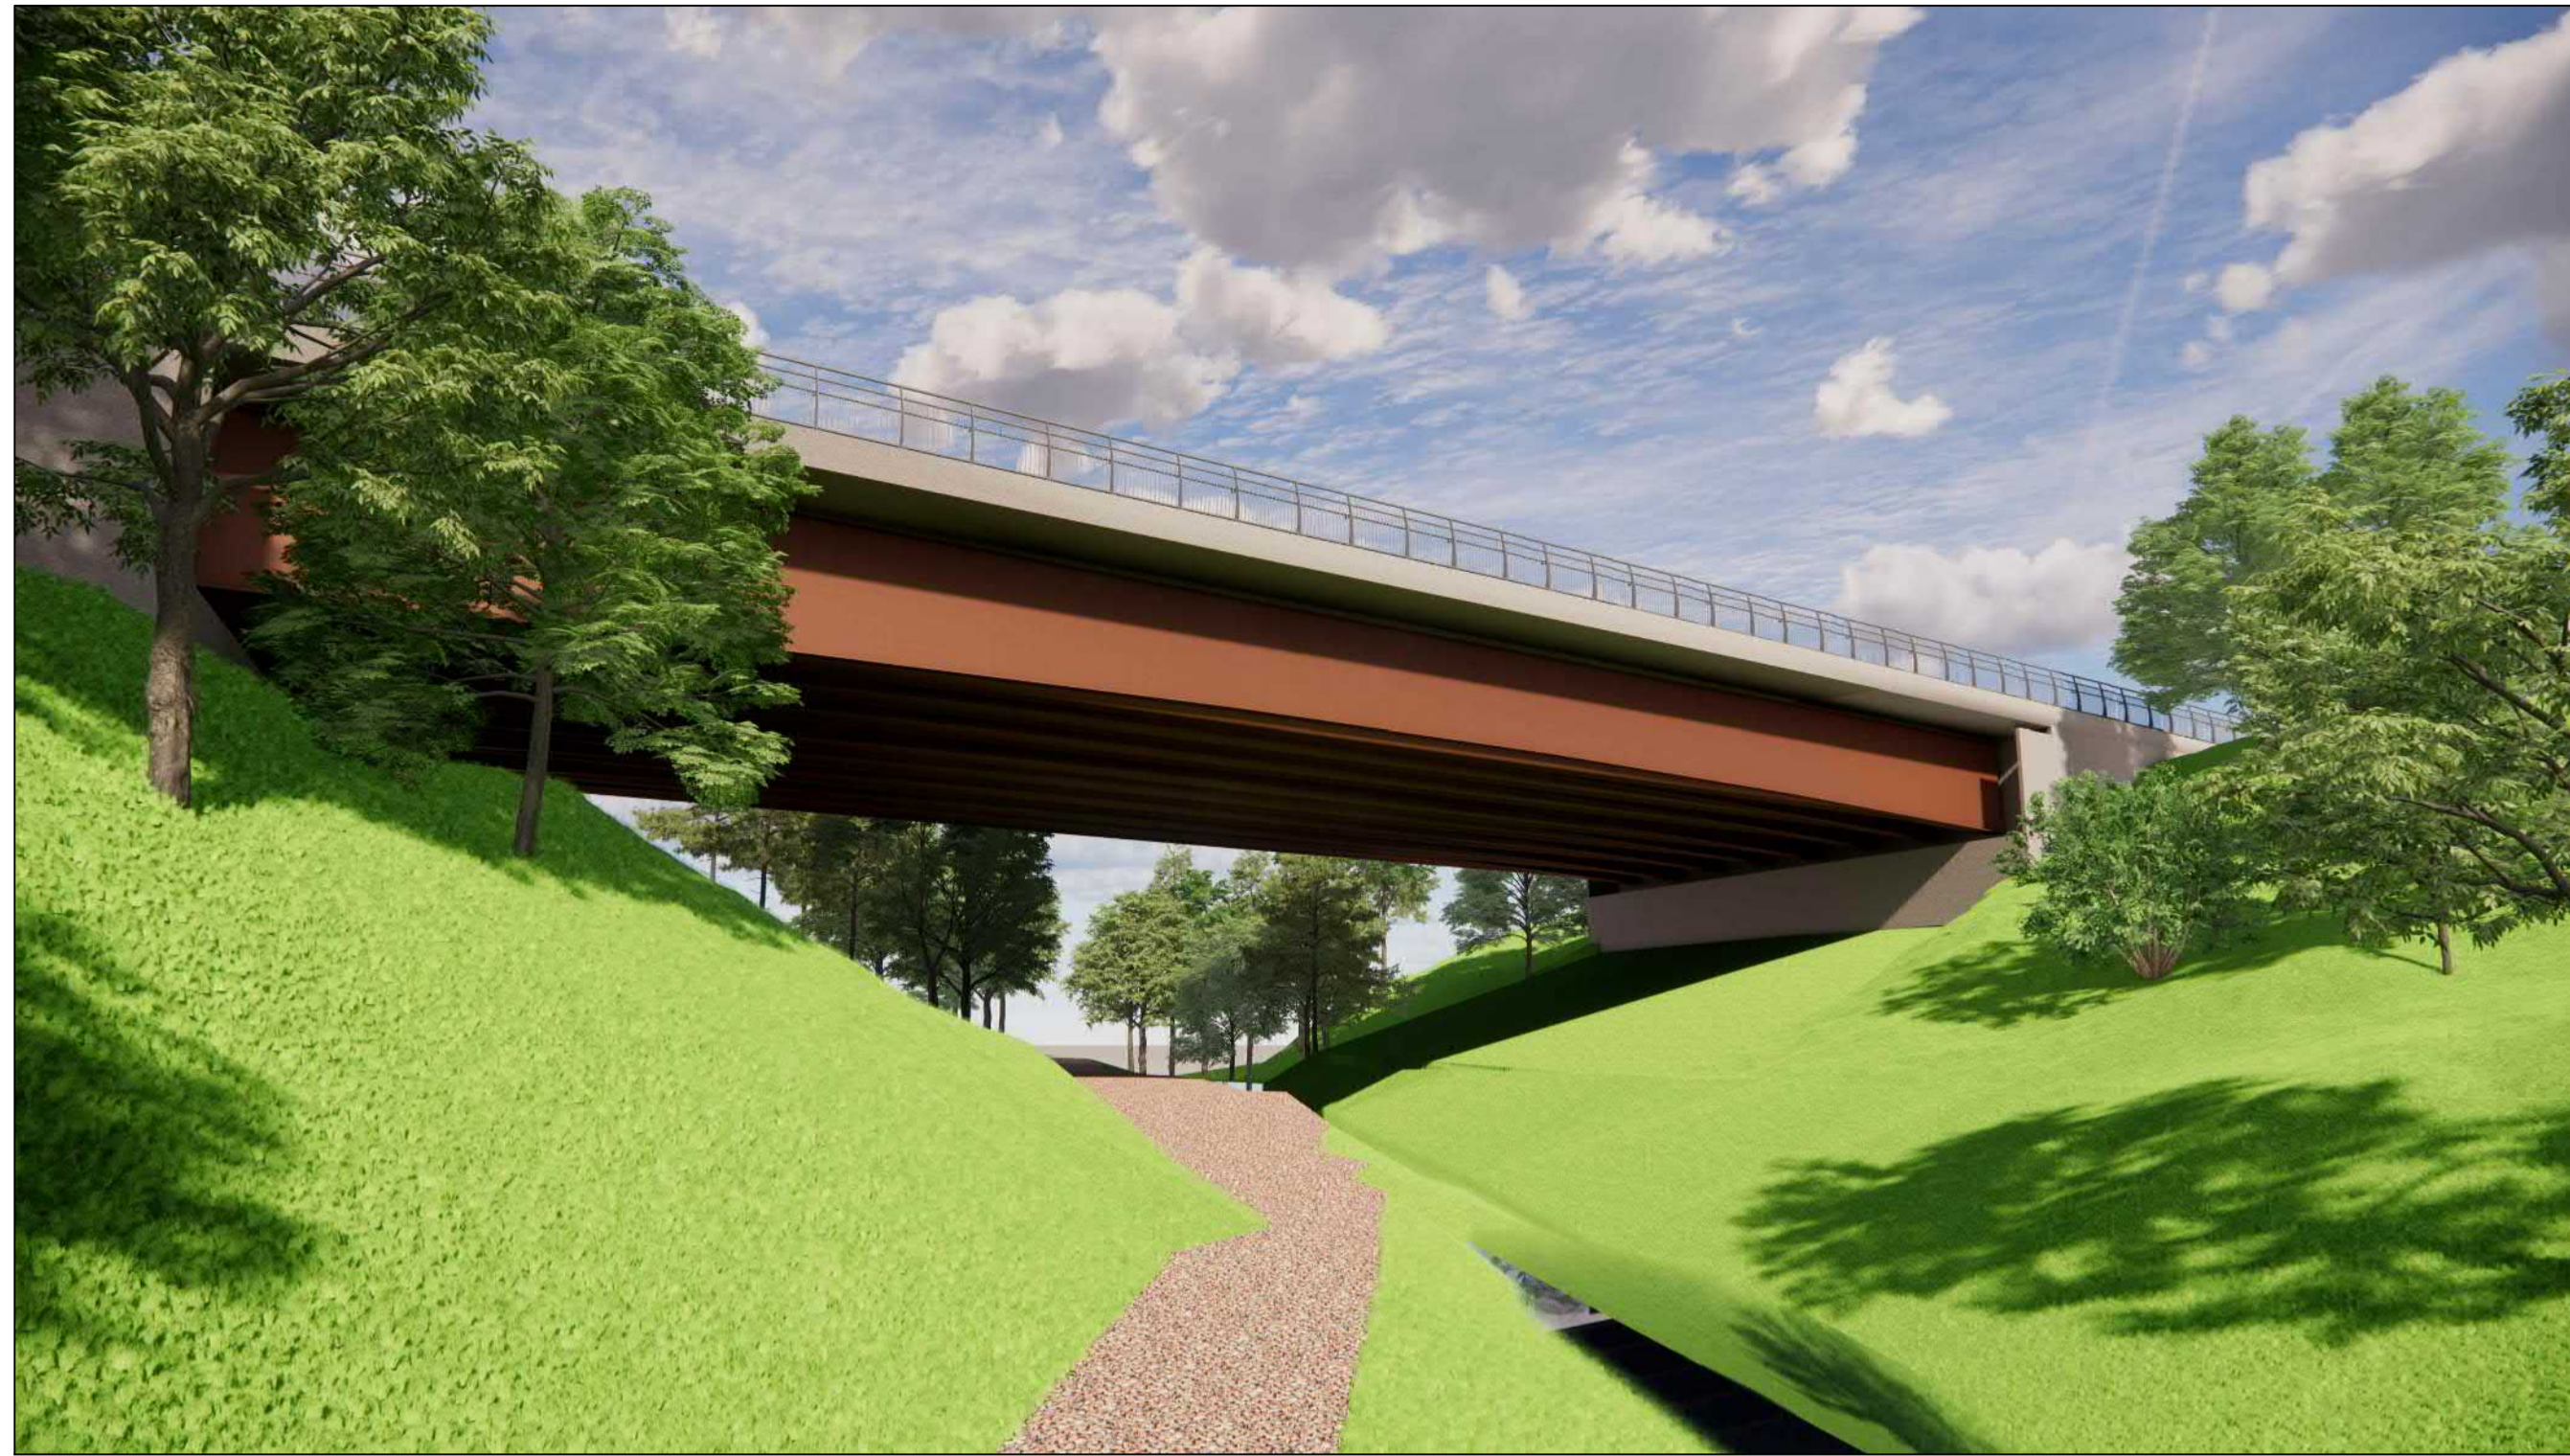
PHOTO
STEEL GIRDER OPTION

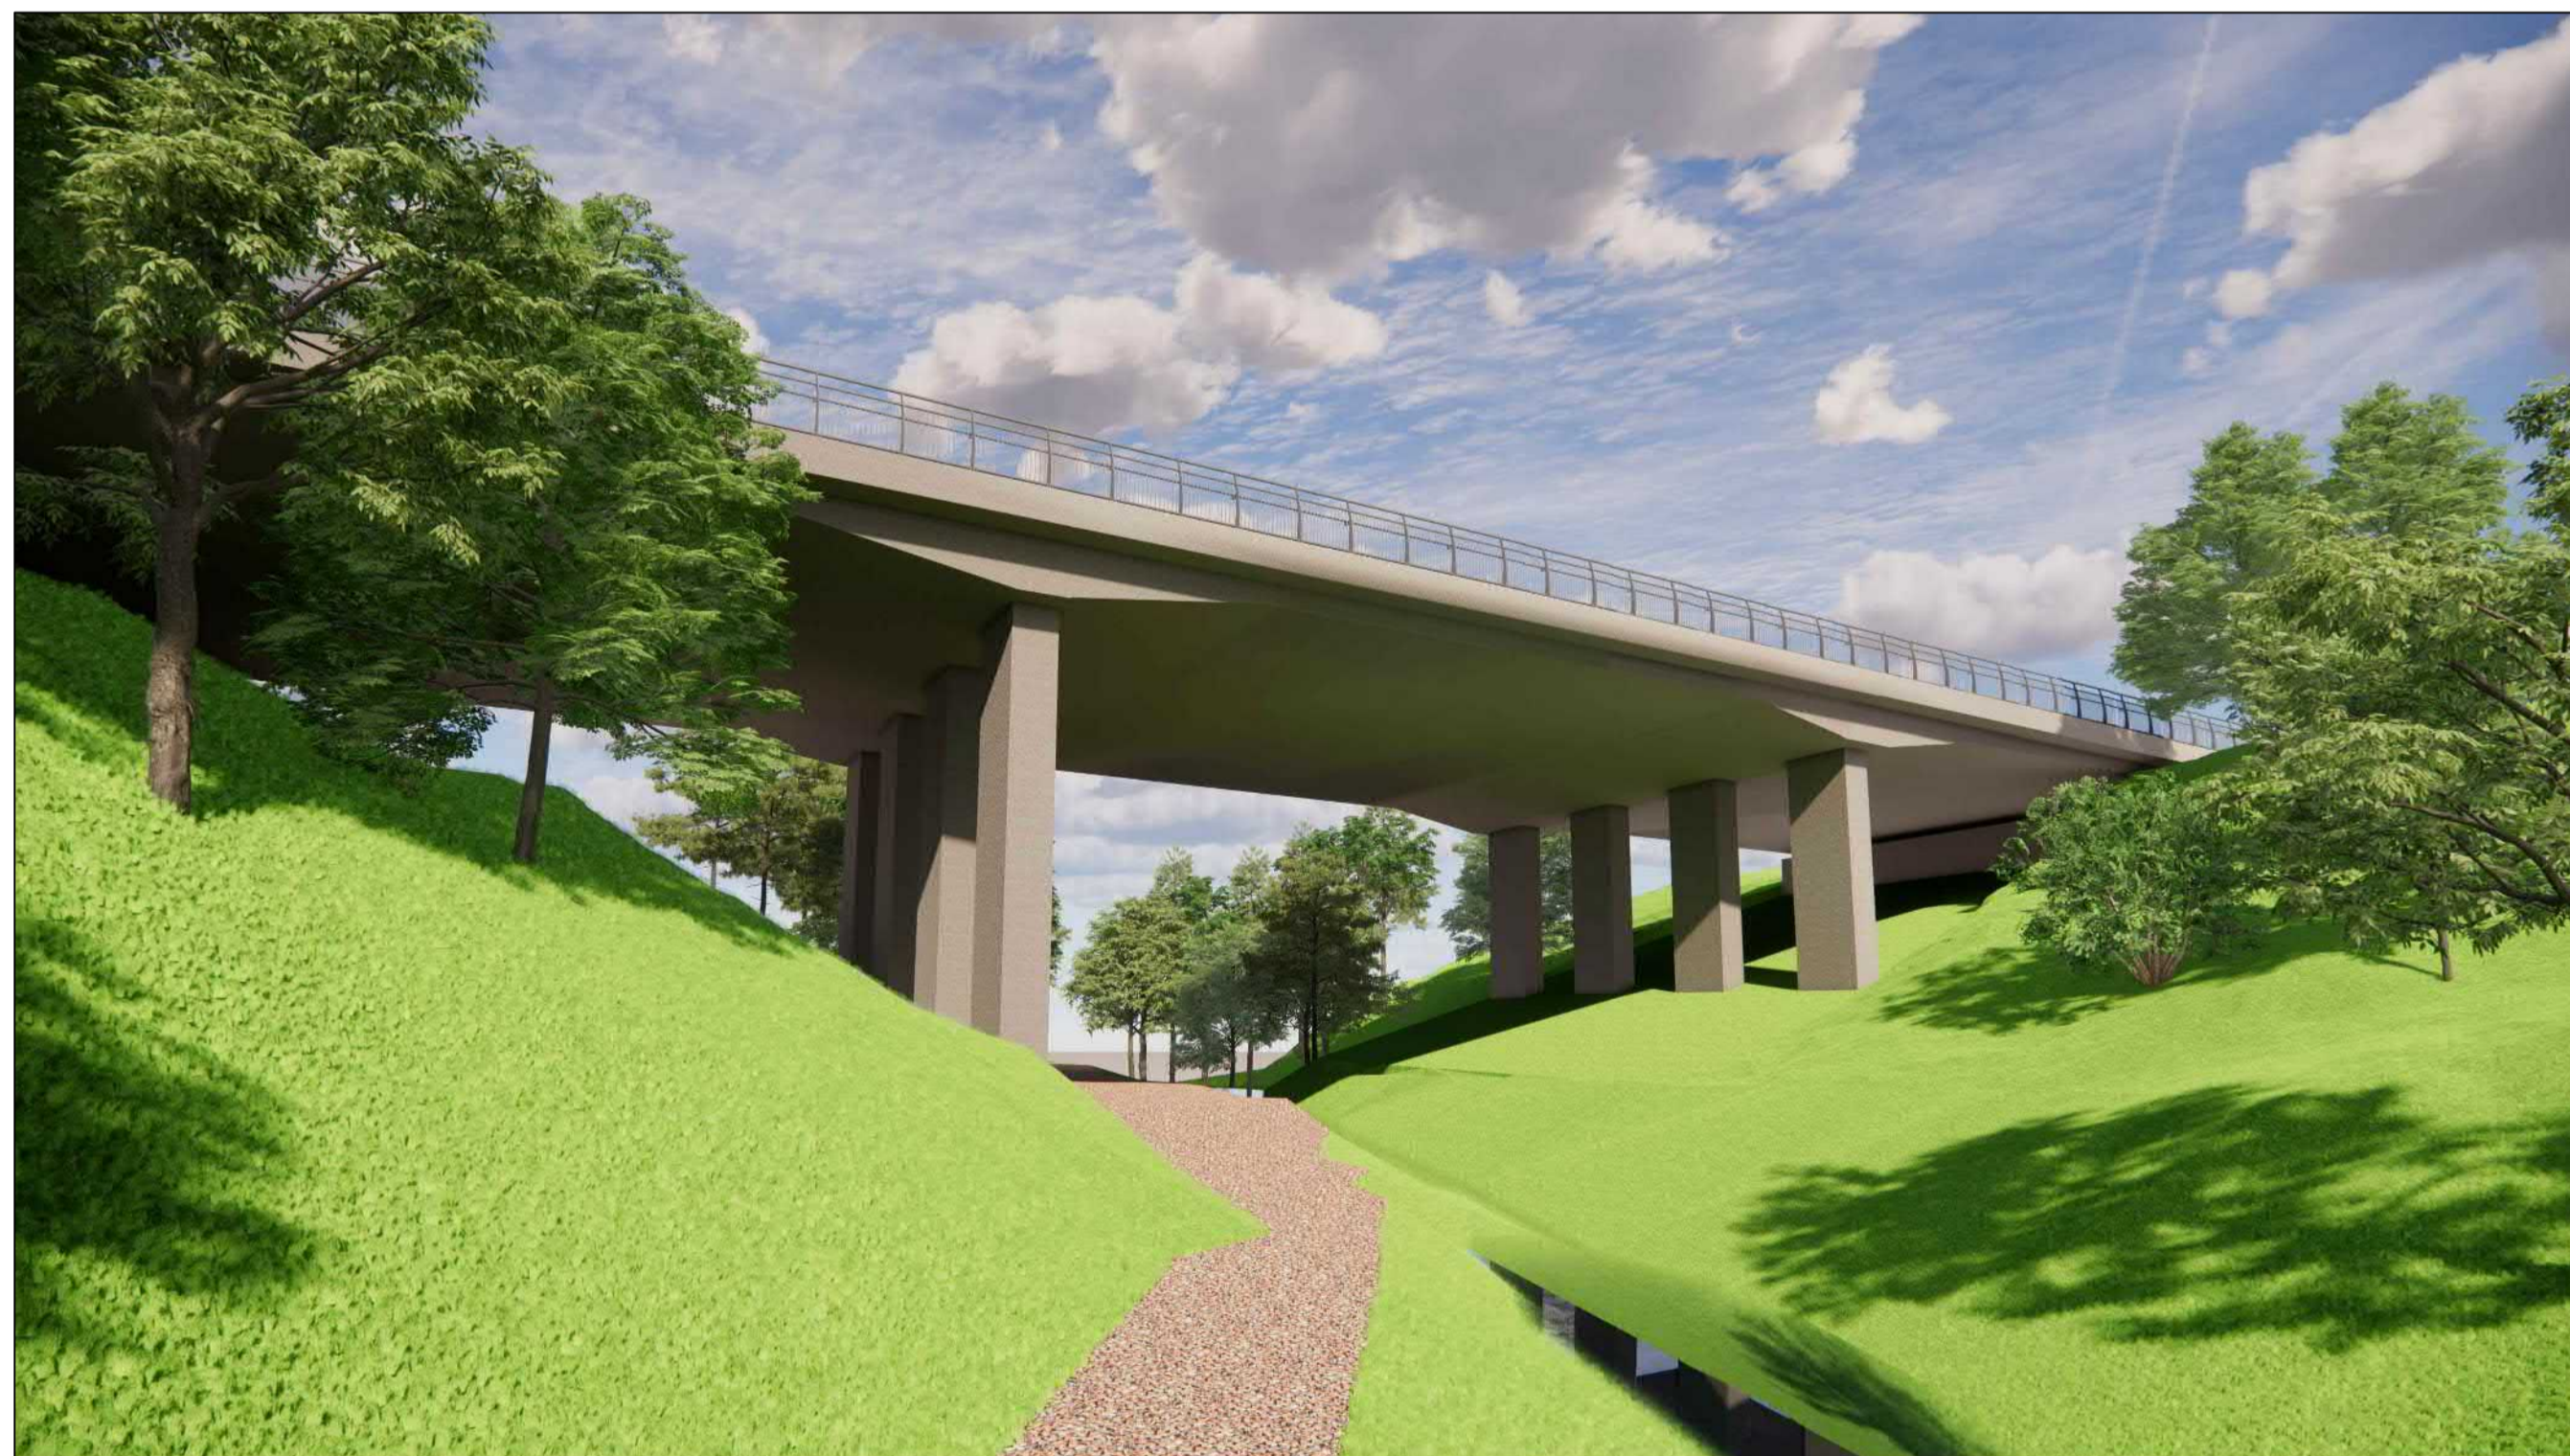
PHOTO
THREE SPAN HAUNCHED CONCRETE GIRDER OPTION
