7.2 Trees on Public & Private Property

October 29, 2024, Urban Planning Committee

2024 PARKALLEN INFILL CASE STUDY

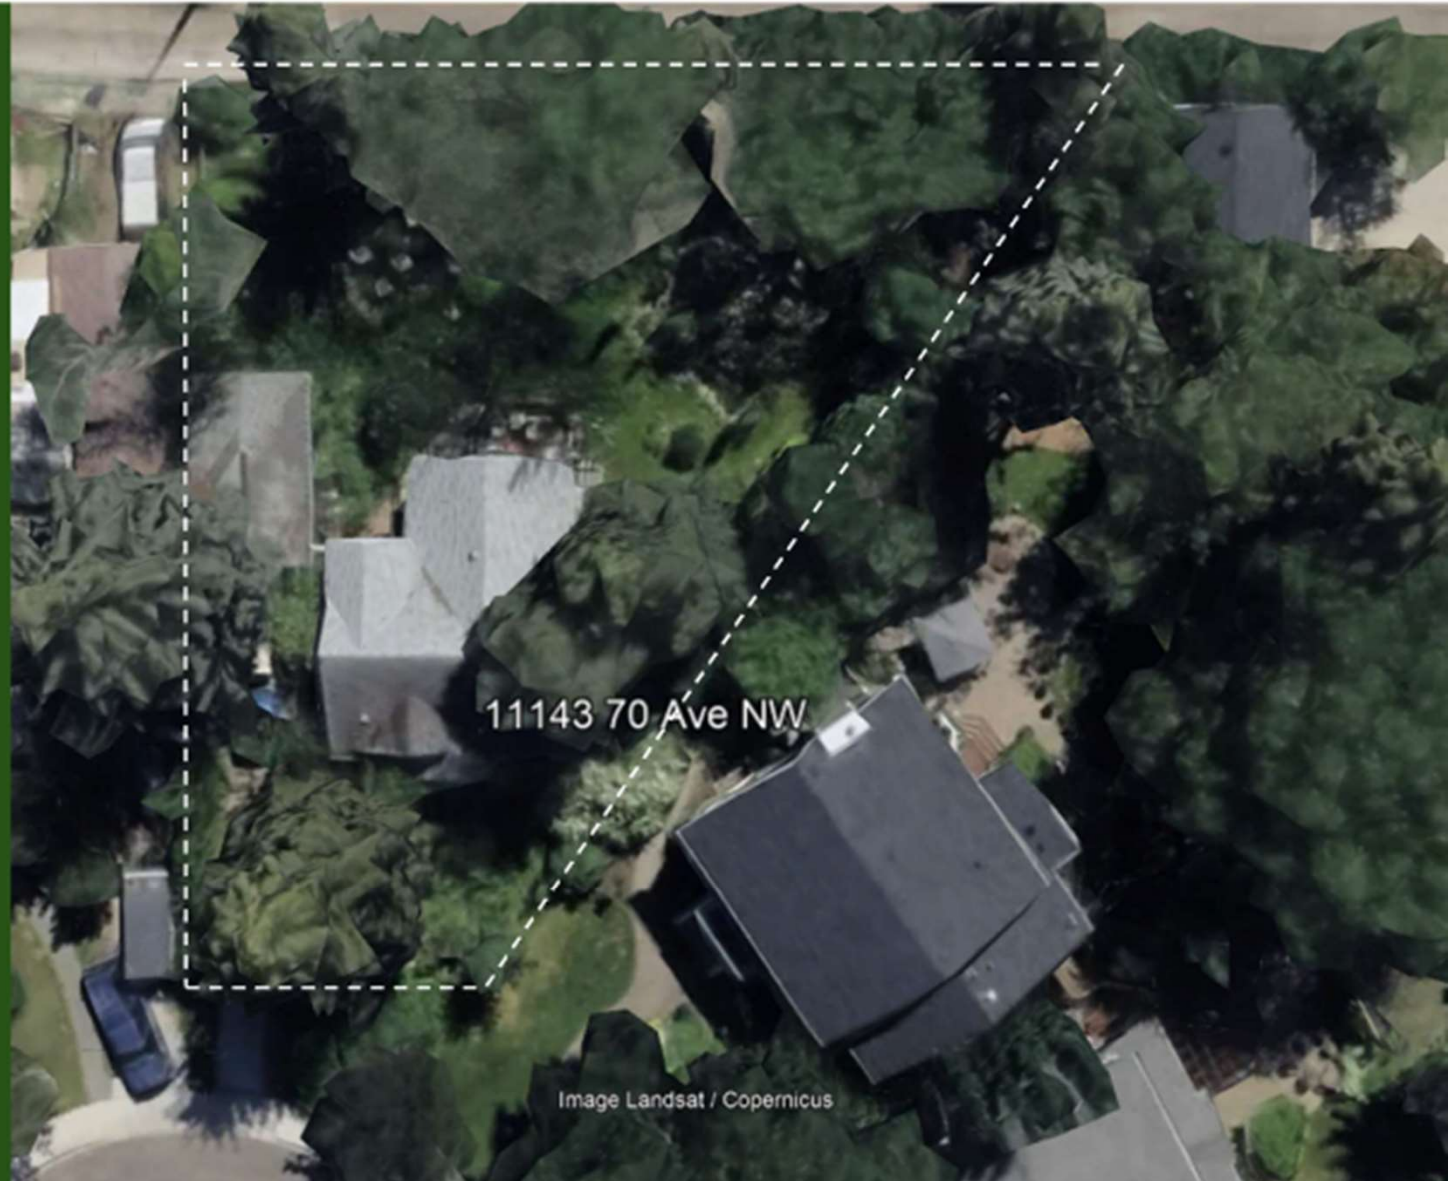
PRE-DEVELOPMENT SITE
at 11143 70 Avenue

Mature Site
80% Vegetation
&
Under Built!

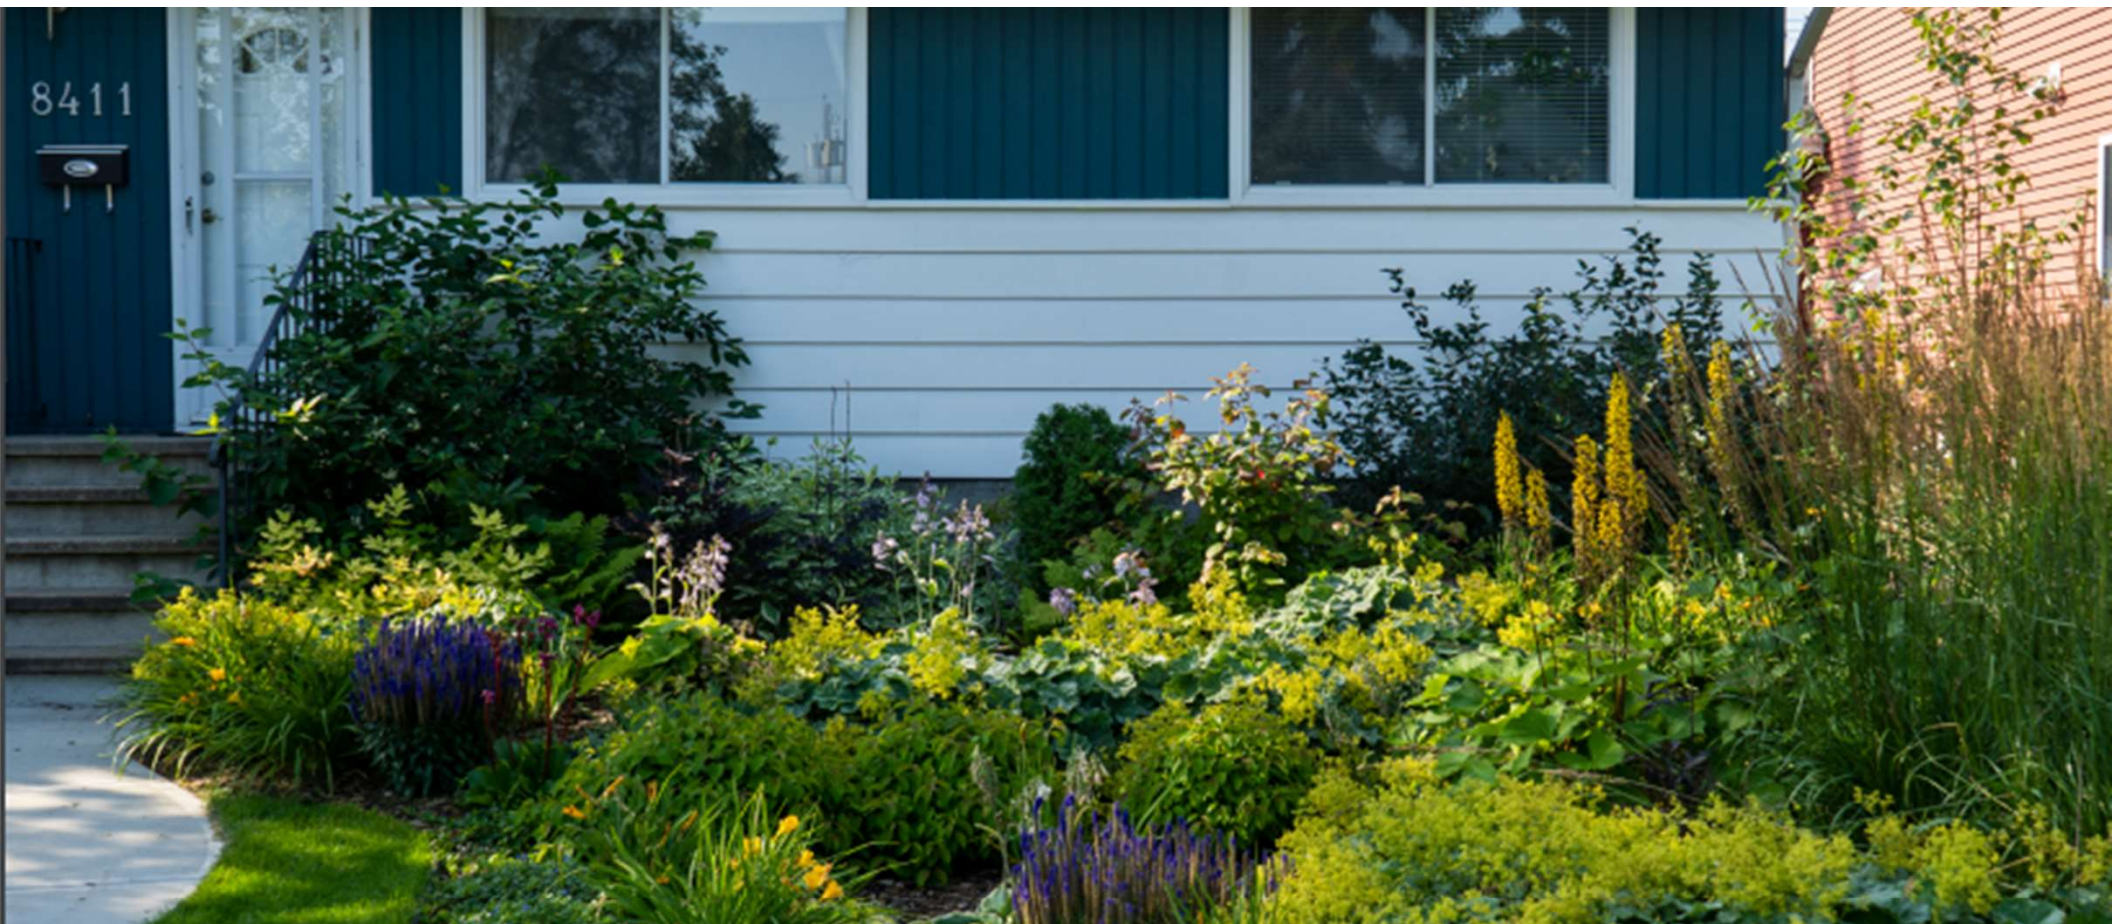
Rain Gardens for Resilience – Designed by Jan Hardstaff for ALIDP, 2017

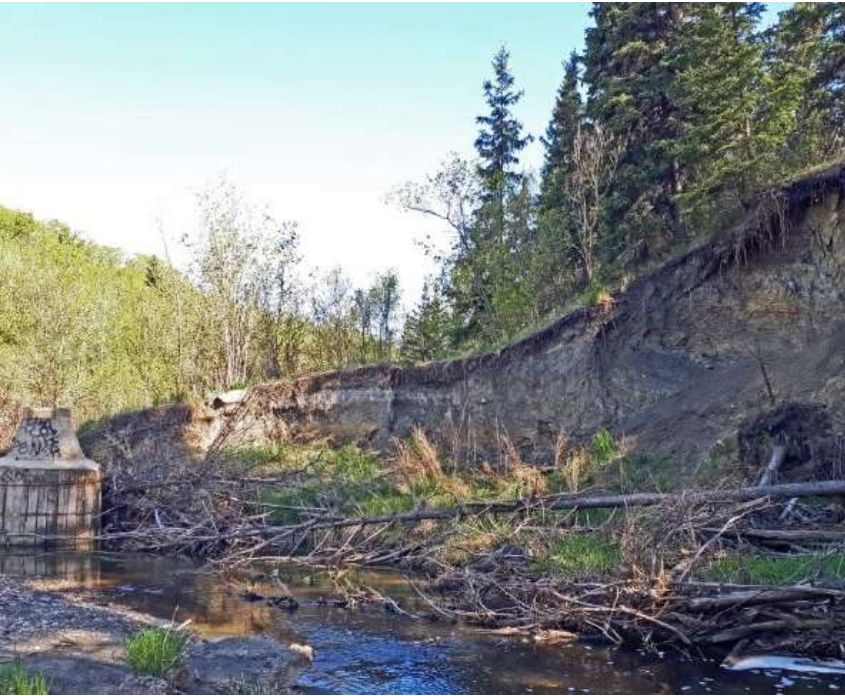
Erosion of Millcreek Ravine, 2024 that is related to increased development imperviousness and increasing impacts of climate change & extreme rainfall events. Further damage must be mitigated.

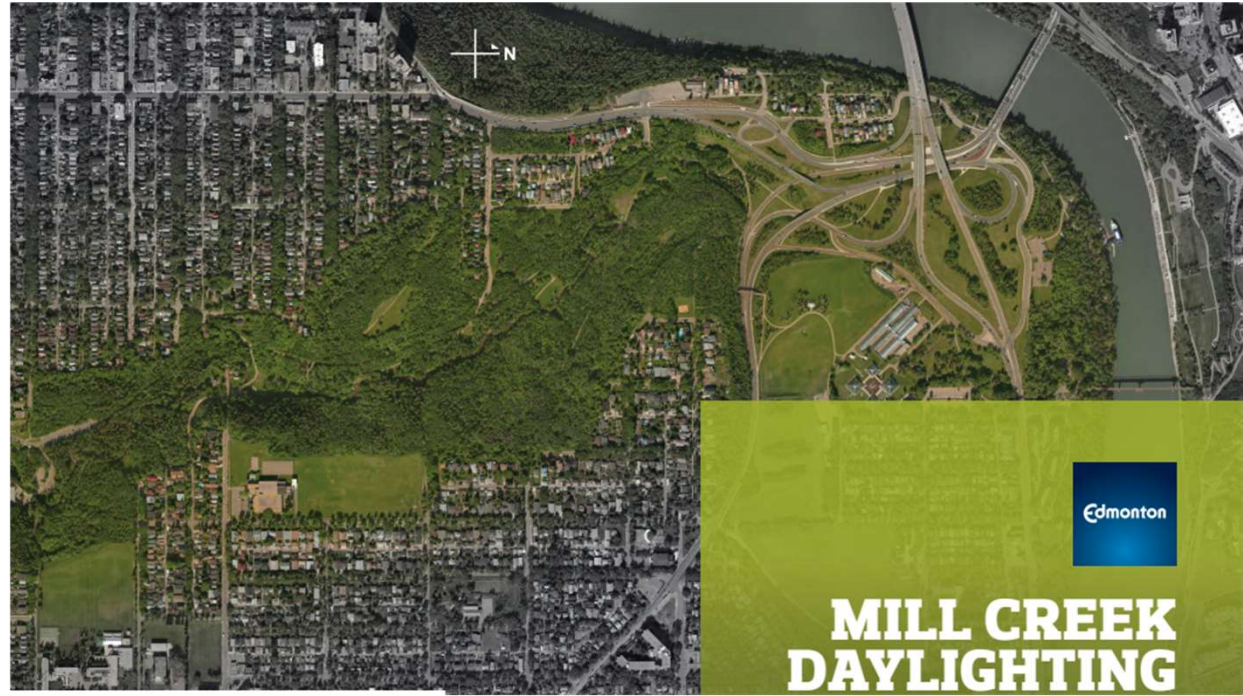
Proposal to daylight Millcreek Ravine to restore its ecological function and provide green infrastructure.
