Date:	August 8, 2024	File:	2020-3858
To:	Achyut Adhikari	Page:	Page 1 of 19
From:	Erica Graham, M.Sc., P.Biol.		
Project:	Wellington Bridge Replacement		
Subject:	Environmental Impact Assessment: Update

1.1 Project Background

Wellington Bridge is a three-span concrete arch bridge that carries traffic along 102 Avenue over Ramsey Ravine in Edmonton, AB. The bridge was constructed in 1932; it is now in poor condition and has reached the end of its service life. Since 2014, the bridge has been supported by a temporary shoring system to maintain vehicular traffic until the bridge is replaced. In 2020, the City of Edmonton (the City) retained Associated Engineering Alberta Ltd. (Associated) to undertake the preliminary design, detailed design, and construction services to replace Wellington Bridge, including a shared-use path.

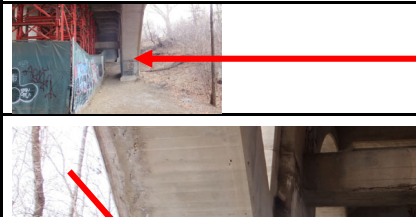
<21.0	
3	NW Pier	Graffiti and covering paint	~40 m ²	Weathered, thick (many layers), cracking, easy to sample

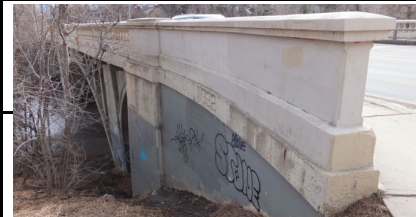
<23.5	
4	W Abutment	Graffiti and covering paint	~75 m ²	Weathered, thick (many layers), cracking, easy to sample	 	<23.1	
5	SE Pier	Graffiti and covering paint	~40 m ²	Weathered, thick (many layers), cracking, easy to sample

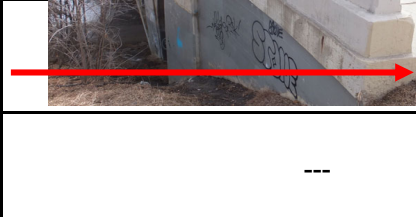
<23.3 / <22.87	
7	W. Abutment	Concrete material (typical)	Entire structure	Variable condition, some area quite weathered / degraded, non-friable
