Date: May 17, 2024 **File:** 2020-3858
To: Achyut Adhikari **Page:** Page 1 of 183
From: Erica Graham, M.Sc., P.Biol.
Project: Wellington Bridge Replacement
Subject: Environmental Impact Assessment: Update

Wellington Bridge Replacement Environmental Impact Assessment

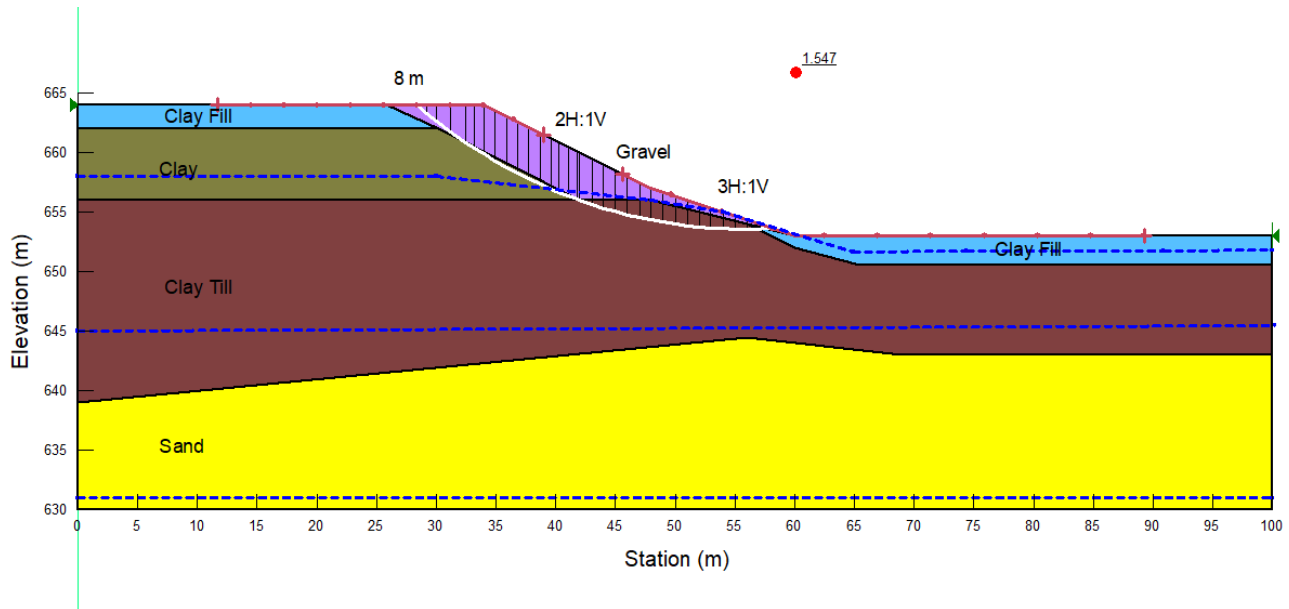
**FIGURE 6.4
CROSS-SECTION A-A WEST HEADSLOPE ALONG BRIDGE CENTRELINE –
NEW HEADSLOPE CONFIGURATION WITH 8 m WIDE GRAVEL WEDGE**

An additional analysis was conducted to determine possible measures to increase the FS of the slope to the required value. As shown in Figure 6.4, replacing the face of the headslope down to the top of the clay till at an elevation of approximately 656 m and back for a distance of at least 8 m from the slope crest with an approved crushed gravel would result in a calculated FS of about 1.5; therefore this can be considered a preliminary suitable option for the stabilization of the new bridge headslopes.

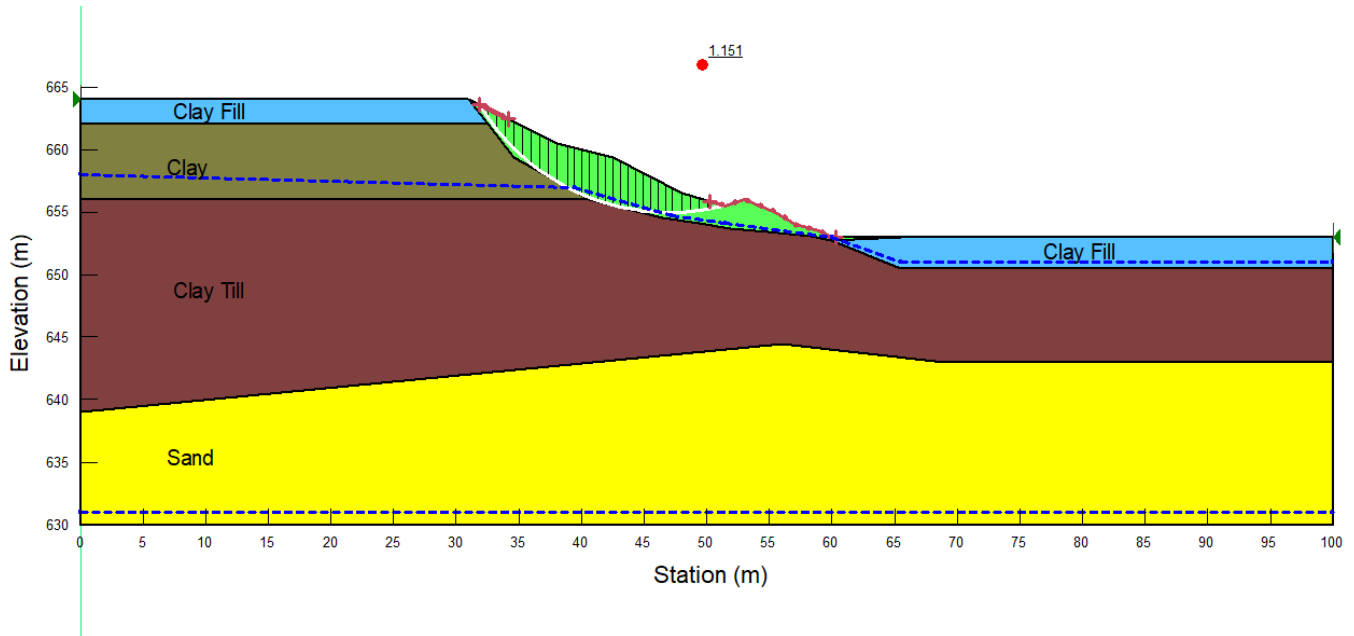
**FIGURE 6.5
WEST HEADSLOPE ALONG NORTH EDGE OF BRIDGE- BACKANALYSIS**

Figure 6.5 shows that current factor of safety (FS) of the slope immediately to the north of the bridge is about 1.15, indicating that the slope is likely creeping with risk of potential future movements. The face of this slope is considered to feature a surface of weaker colluvium material (as shown in light green) that has been caused by surficial slope movements and erosion.

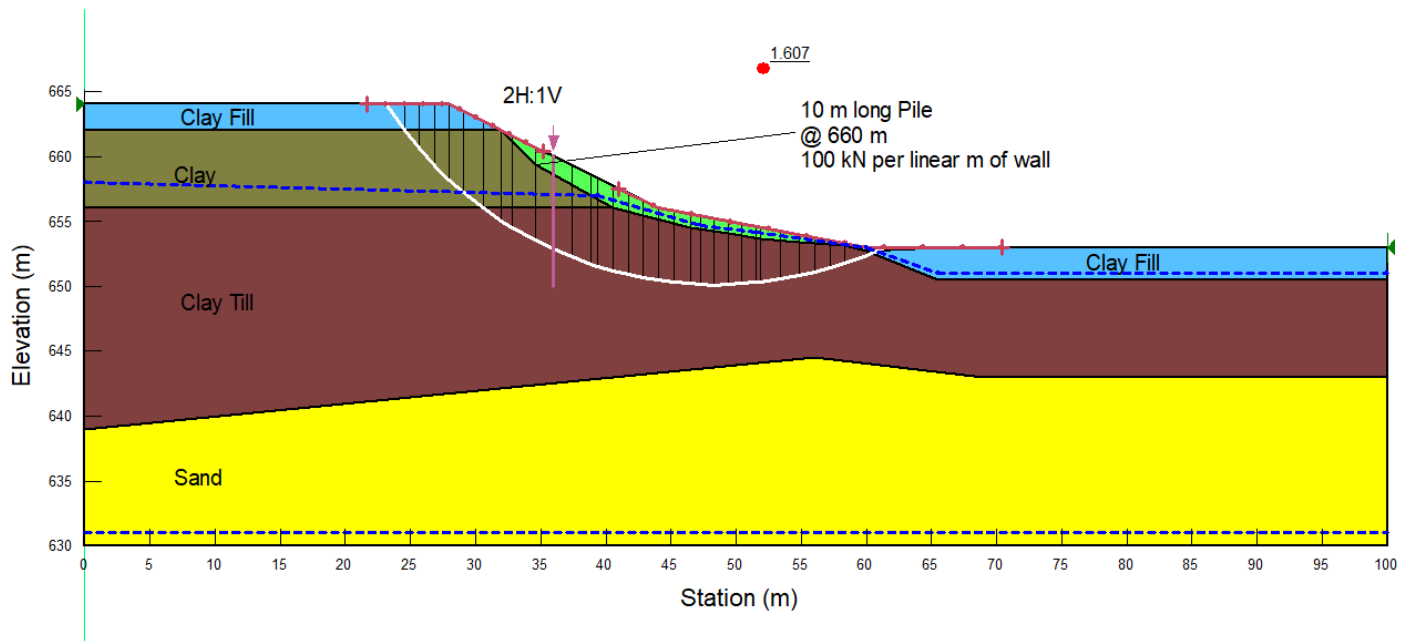
**FIGURE 6.7
WEST HEADSLOPE ALONG NORTH EDGE OF BRIDGE –
NEW HEADSLOPE CONFIGURATION WITH PILE WALL**

Figure 6.7 illustrates the analysis results for the stability of the slope considering the installation of a pile wall (likely a tangent cast-in-place reinforced pile wall) that is at least 10 m deep from a surface elevation of approximately 660 m. This wall would need to sustain an unfactored shear force of at least 100 kN per m of wall length to achieve a FS of 1.5 or greater. If considered, the wall should be extended northward a distance of about 10 m from the north edge of the new bridge alignment to shelter the bridge from future movements. The configuration of the pile wall will need to account for the presence of the outfall structure on the north side of the bridge.

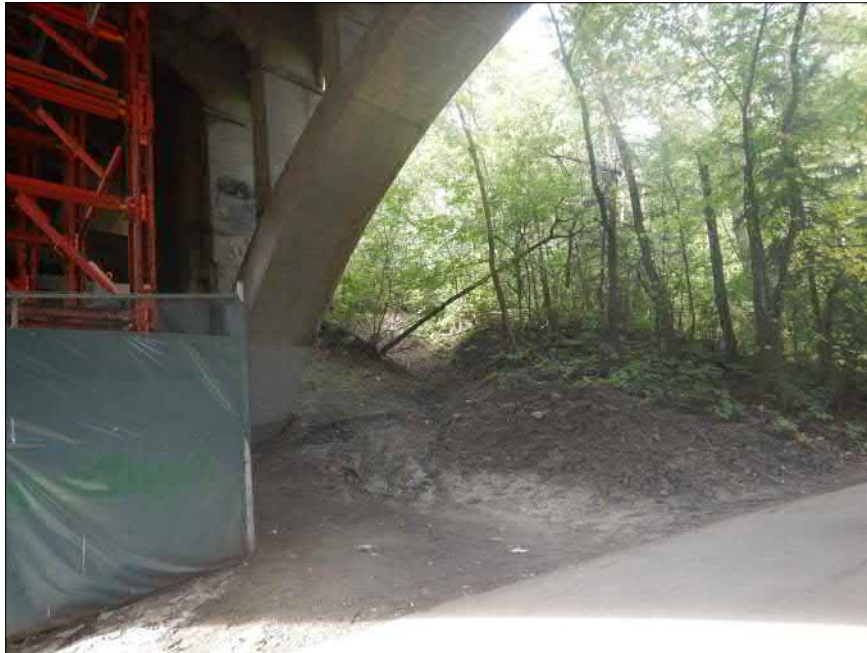
PHOTO 8 EROSION ON WEST RAVINE SLOPE NORTH OF BRIDGE
