102 Avenue Corridor Evaluation

City of Edmonton
Final Report
November 2024

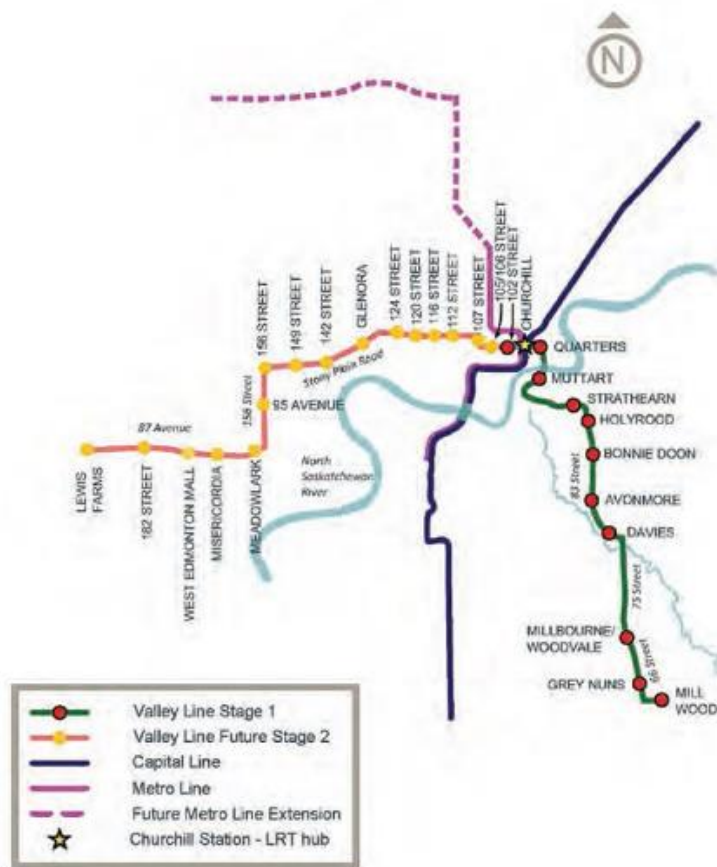
Figure 2.1: Edmonton LRT Network Plan for Valley Line LRT (Stage 1 Booklet, September 2016)

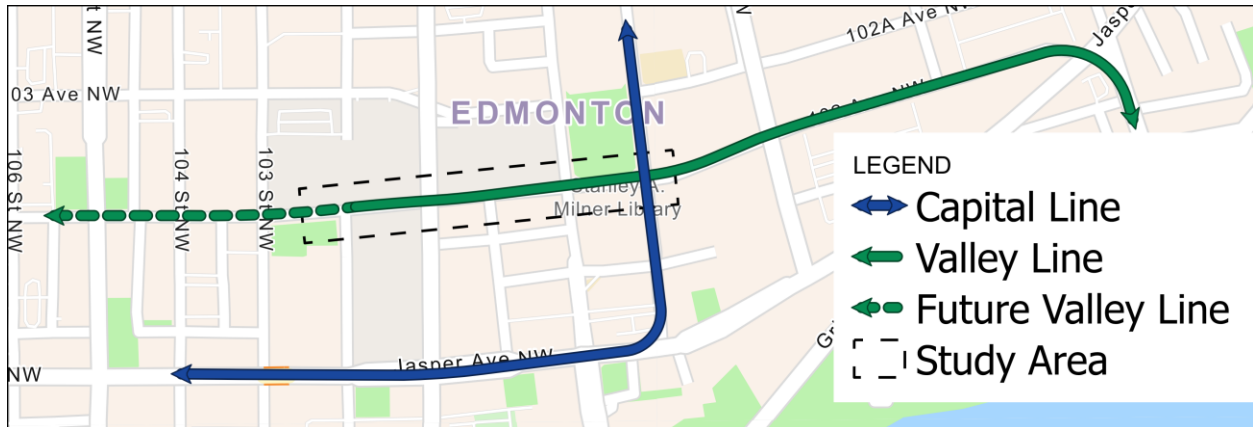
Figure 2.2: Study Area along 102 Avenue

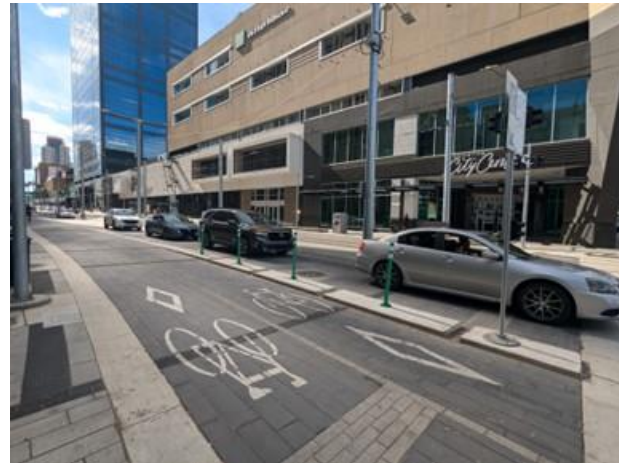
Oct 2016
Source: Google Street View

Jun 2024

Figure 2.3: Before and After Comparison of 102 Avenue at 100 Street

102 Avenue previously operated as a minor arterial road, with 4 total lanes of through-traffic (2 in each direction), plus a left-turning lane at most intersections (see Figures 2.3 and 2.4 below). The cross section has changed substantially for vehicles, as there is now only a single eastbound lane for the full length of the study area. The right-of-way that was previously available for vehicular traffic has now been allocated for transit, bicycles and some areas for improved pedestrian open space.

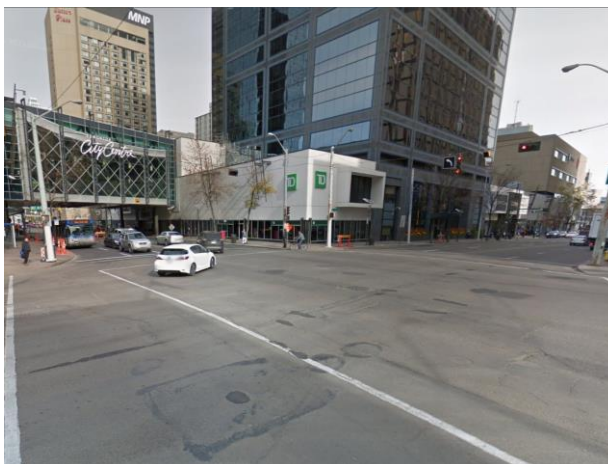
Figure 2.4: Before and After Comparison of 102 Avenue at 101 Street

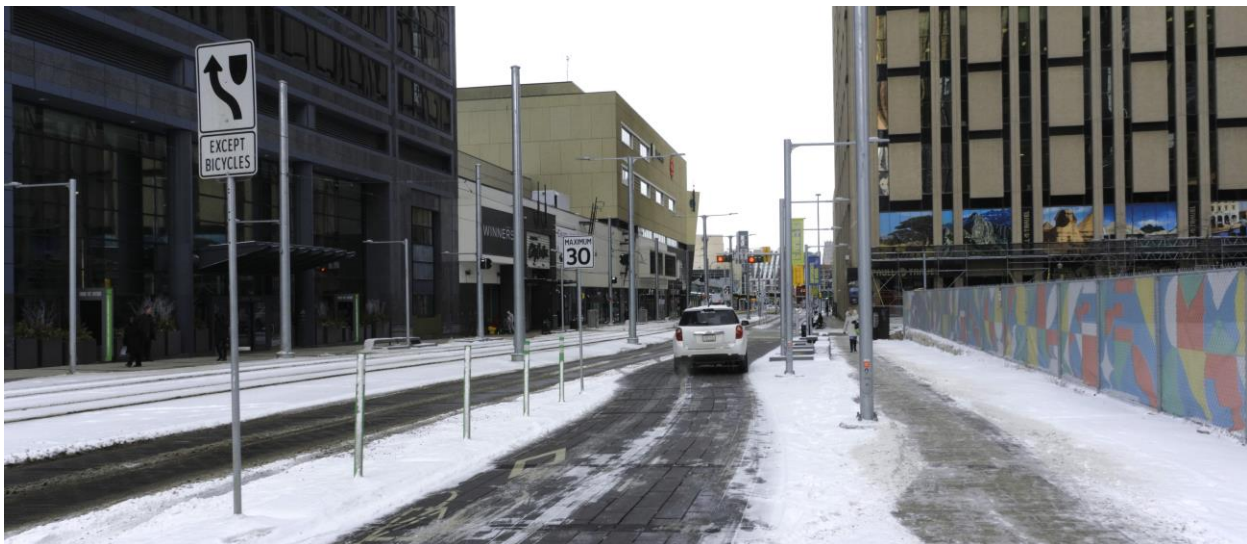
Figure 3.3: A car driving in the bicycle lanes after a fresh snowfall (ISL Engineering)

The figure above, captured by ISL during a site visit, depicts some of the concerns expressed by survey participants.

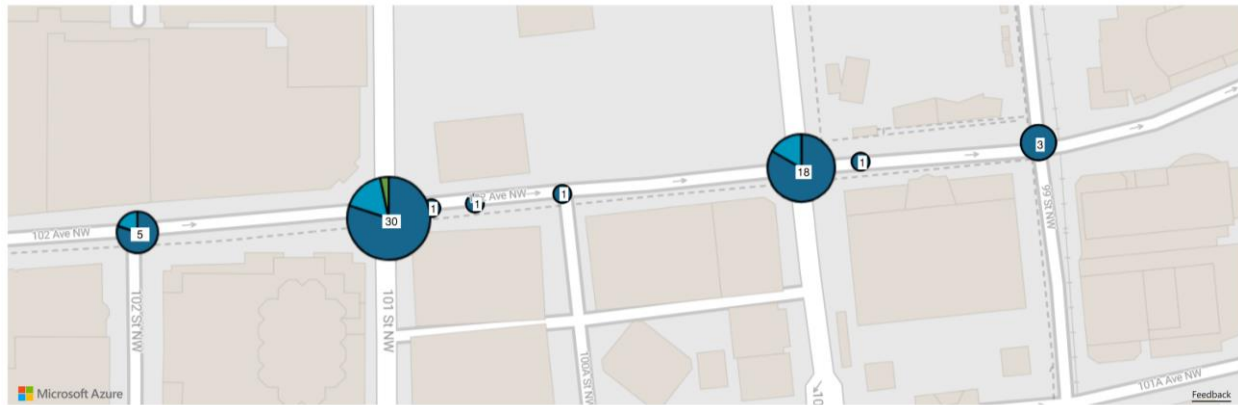
Figure 5.1: Locations of all reported collisions

The figure above shows that the majority of events have occurred at 100 Street and 101 Street, and correlates with the expected higher number of vehicles and road users at these locations.

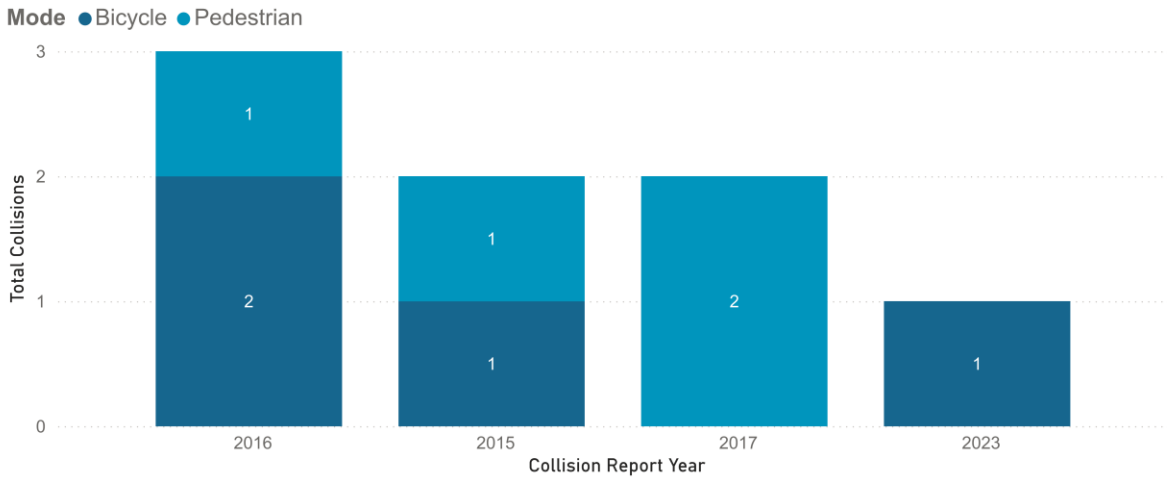
The years between 2018 and 2021 are outside the scope of this report. The 102 Avenue corridor was closed to the public due to construction. There were no active mode collisions in 2022.

Figure 5.3: Active Mode Related Collisions by Year

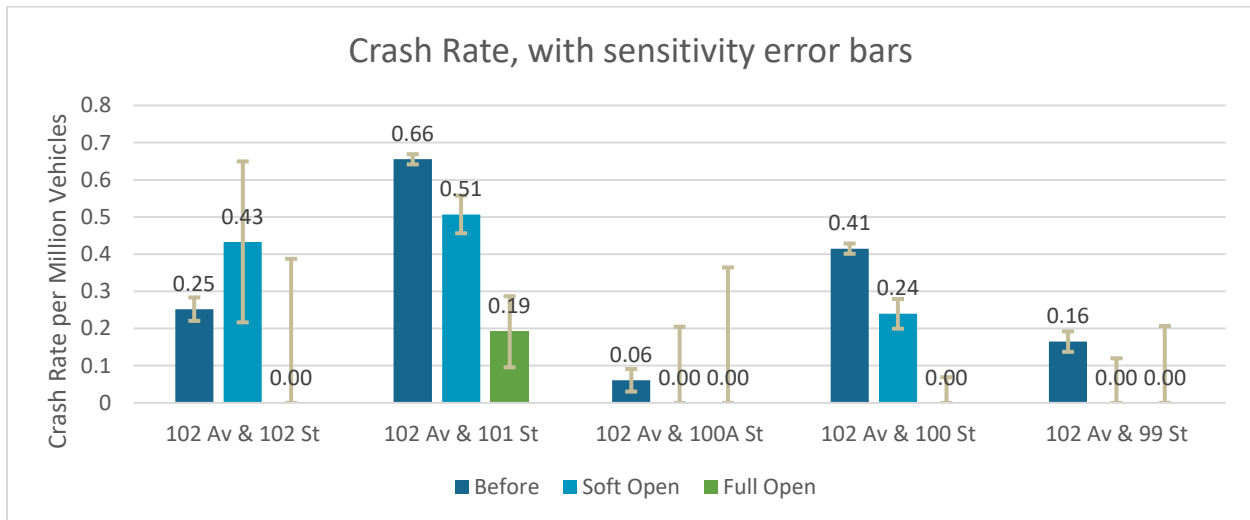
Figure 5.5: Intersection Crash Rate (per million vehicles) in each analysis period

As explained previously, using the total number of collisions introduces bias due to the short duration of the after period (since the LRT has not yet been operational for a full year) and the changes in traffic volumes between time periods. Figure 5.5 addresses this bias by dividing the collisions at each location by the typical daily volume of traffic entering the intersection. This figure also includes some “sensitivity” error bars, which depict the range of crash rates that would result as *if* one more or one fewer collision occurred in each time period.

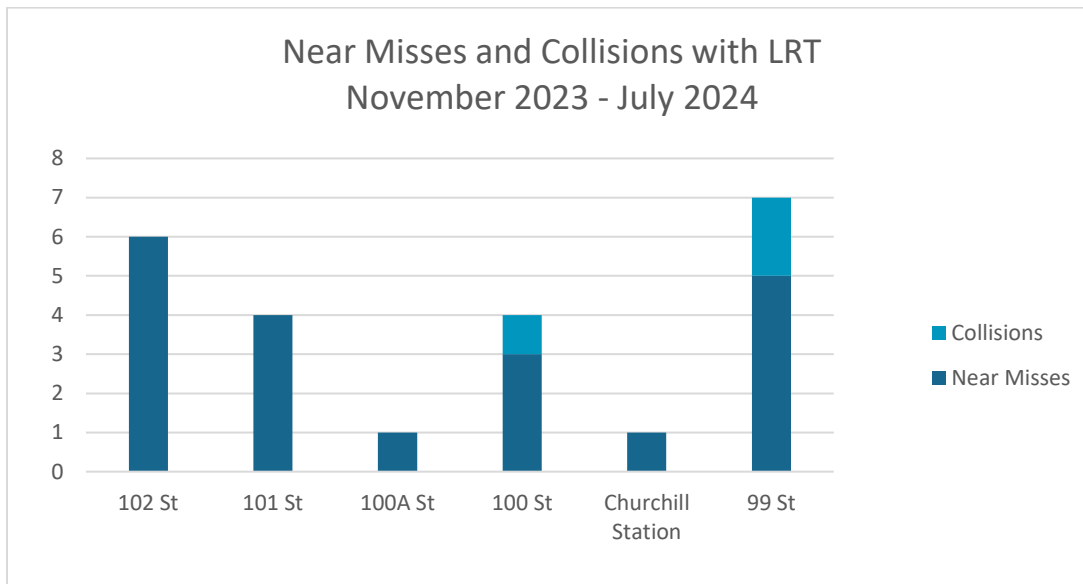
Figure 5.7: Near Misses and Collisions with LRT along 102 Avenue – November 2023 through July 2024

Figure 5.7 shows the number of near misses and collision events reported by TransEd for the Full Opening period (November 2023 through July 2024). This chart demonstrates that the intersections with 102 Street and 99 Street are the most prominent locations for LRT-related events. Table 5.1 and Figure 5.8 provide a breakdown of where and what type of events occurred as well as how they have changed over time.

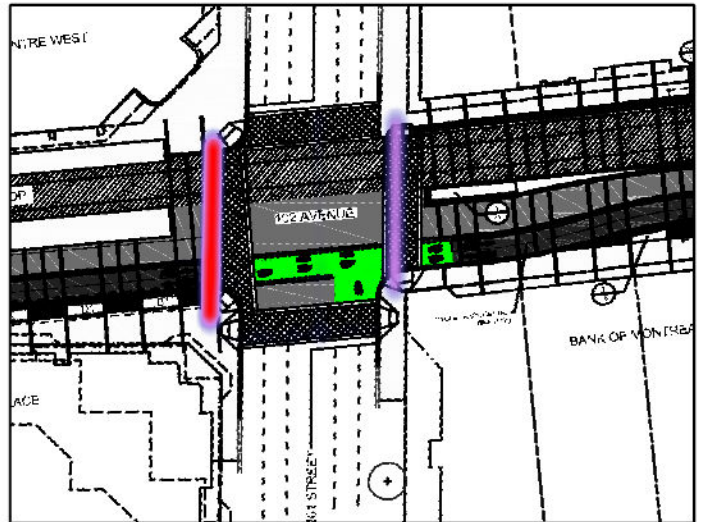
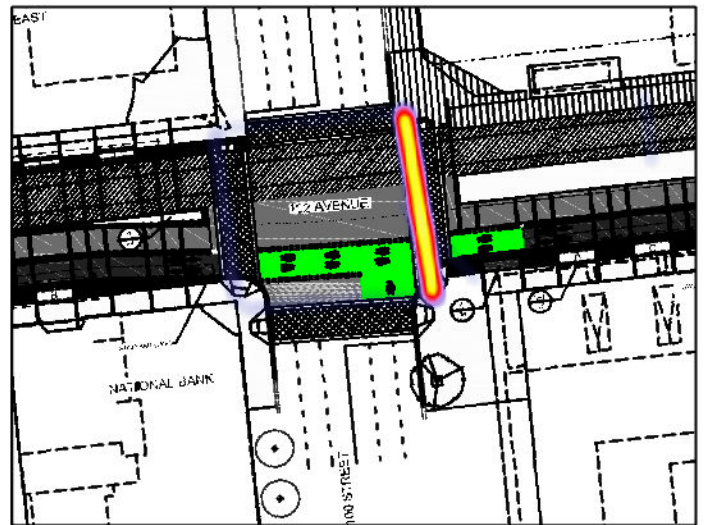
TITLE
HEATMAP OF RIGHT-OF-WAY VIOLATIONS
LUNCH HOUR

As part of recording near miss events, the trajectory or travel path of the road users was recorded. This data was used to give clearer detail on where within each intersection that unsafe acts are most prominent. The following pages provide heatmaps for the total number of events during each observation period, with subset figures for each study area. Cool colours, such as purple and blue, demonstrate a low number of events, while hotter colours (red, orange, yellow and white) show increasing numbers of near miss and unsafe acts.

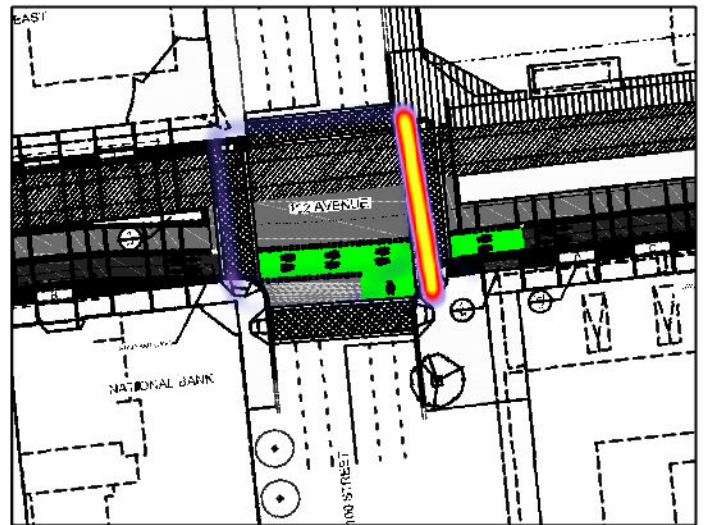
TITLE
HEATMAP OF RIGHT-OF-WAY VIOLATIONS
EARLY PM RUSH HOUR

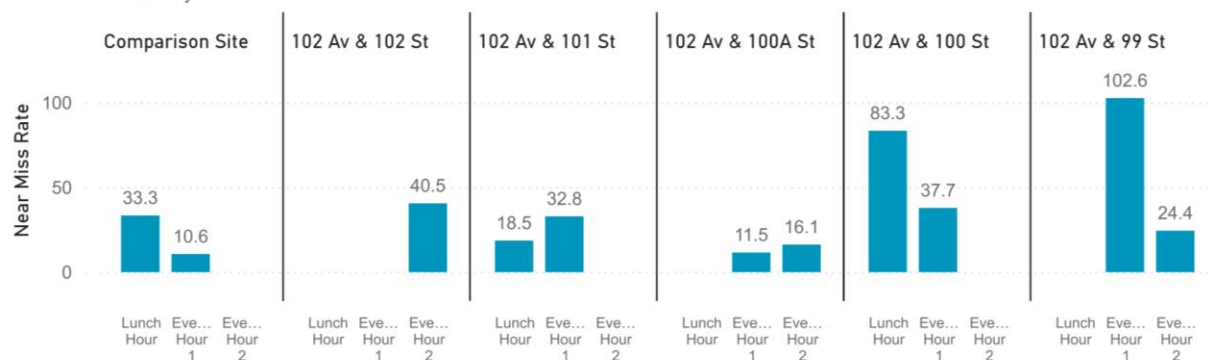
Figure 5.15: Near Miss Rate for Bicycle Users (periods with 0 counts had no near-misses involving cyclists)

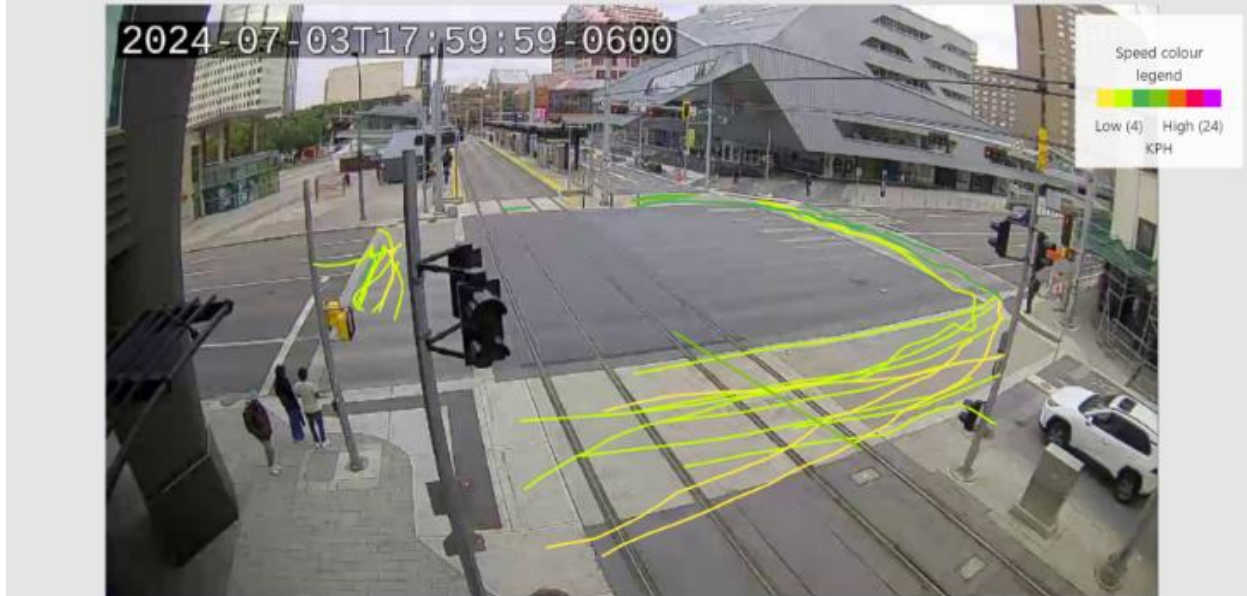
Figure 5.18: Computer-aided trajectory assessment of active mode users at 102 Avenue and 100 Street
