Mill Creek Trestle Bridge (B034) and Culvert under 76 Avenue (B038) Replacement

City of Edmonton | 16307
Environmental Impact Assessment

March 2025

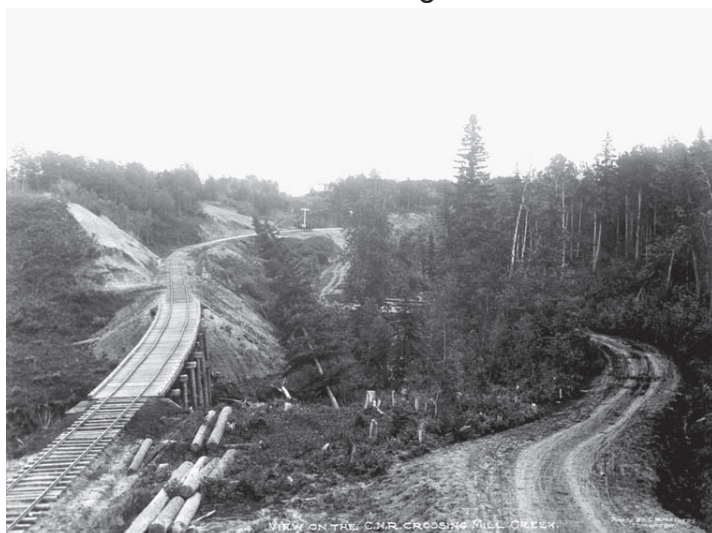
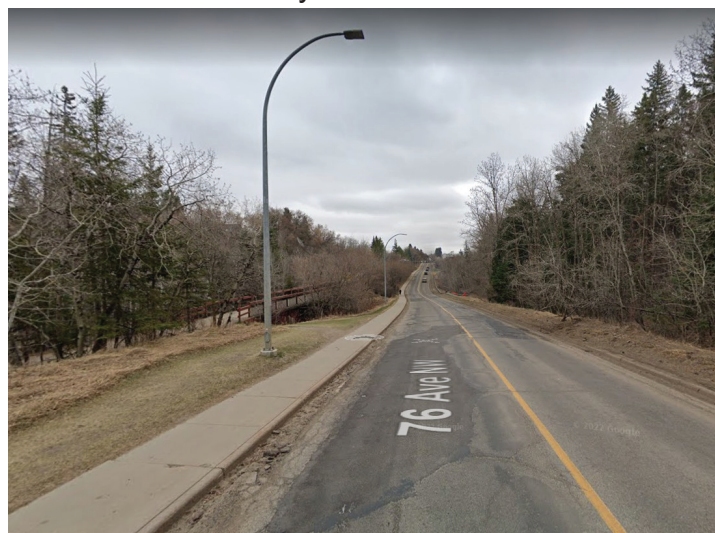
Figure 1: Archival and contemporary photographs of development area

The Mill Creek Trestle Bridge is one of three built in the Mill Creek ravine in 1902 CE as part of the Yukon and Pacific Railway. The construction of this railway included significant cut and fill earth works at both abutments of the structure. Further disturbance was caused by the construction of the 76th Avenue crossing of Mill Creek which is located immediately to the south of the trestle

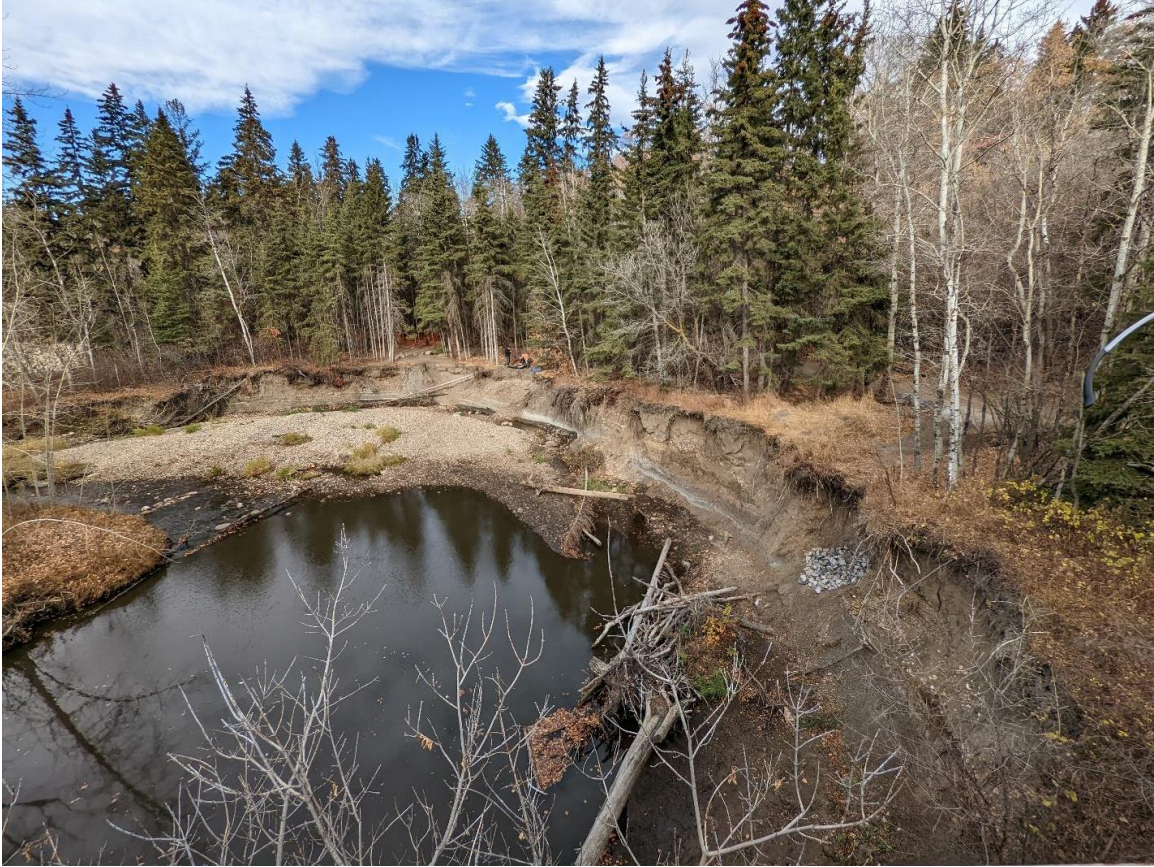
Figure 4: Mill Creek immediately north of the trestle bridge, showing the area recommended for rehabilitation and stabilization of the cut bank. Note the presence of preserved bedded river terrace deposits in the cut bank. From Law and Tweedie (2022).
