# Edmonton Bike Park Environmental Impact Assessment

FINAL REPORT

**Prepared for:**  
Edmonton Mountain Bike Alliance

Project 2420

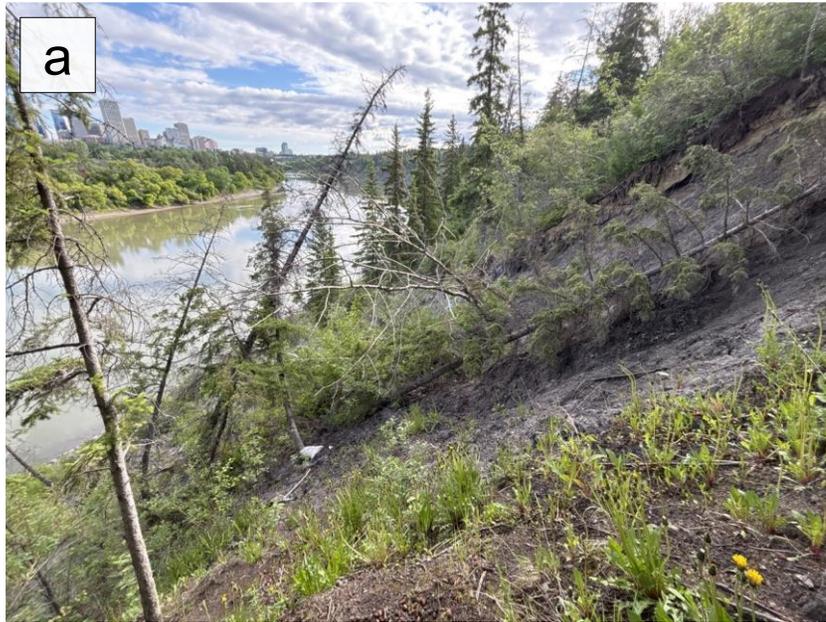
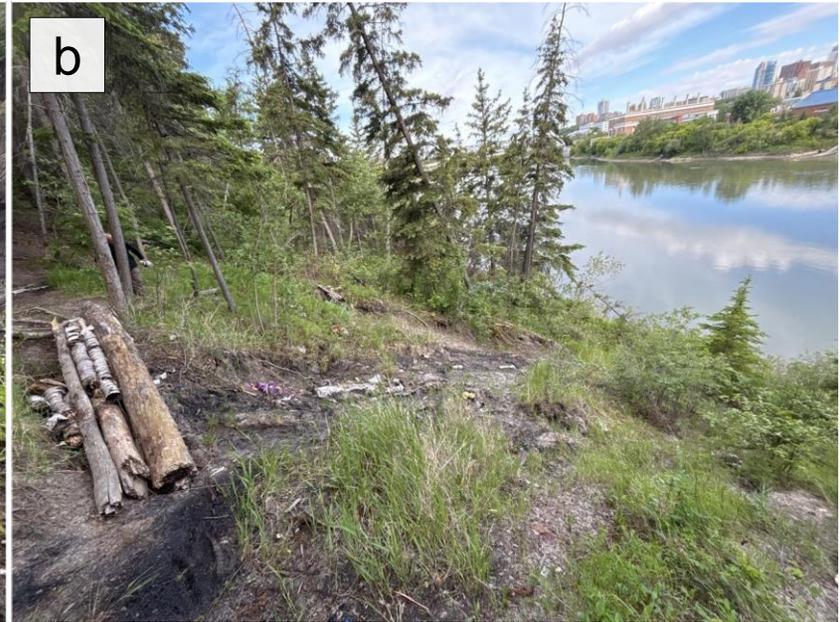
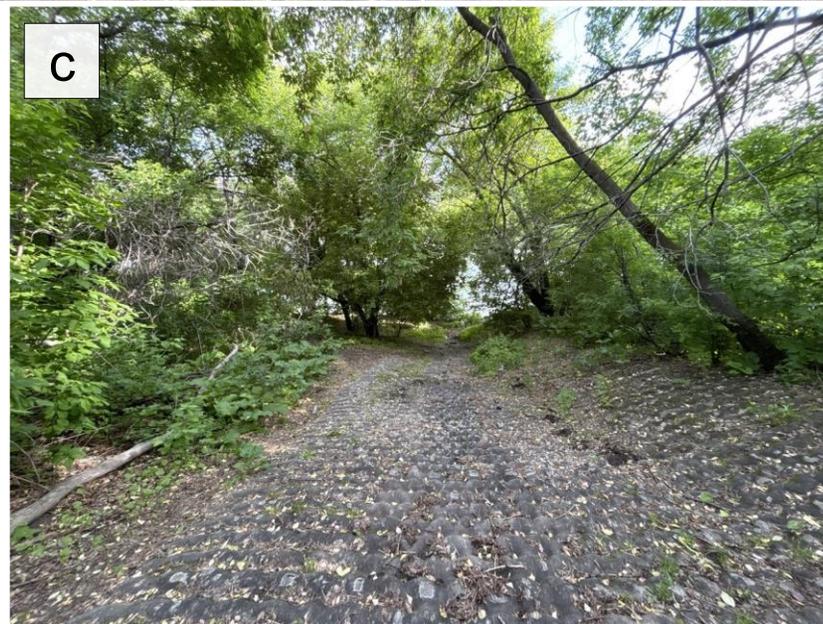
Photo 2. Bank slumping (a and b) and existing erosion protection installed along the river bank (c) directly to the east of the proposed bike park.

Several areas of bank instability were noted east of the proposed bike park during the field reconnaissance conducted on June 17, 2024. These areas were characterized by vegetation that had been uprooted and/or was leaning due to apparent bank sliding or movement (Photo 2a and 2b). One of these areas (location b on Map 7) was located immediately downslope of the seep described in Section 2.4. No signs of major slope instability were observed within the proposed footprint of the bike park; however, Thurber (2018b) notes that the river valley wall in this location is subject to slow, seasonal creep movement, and in some areas, more intensive creep movement within the surficial colluvial deposits and weathered bedrock could develop into shallow landslides over time.

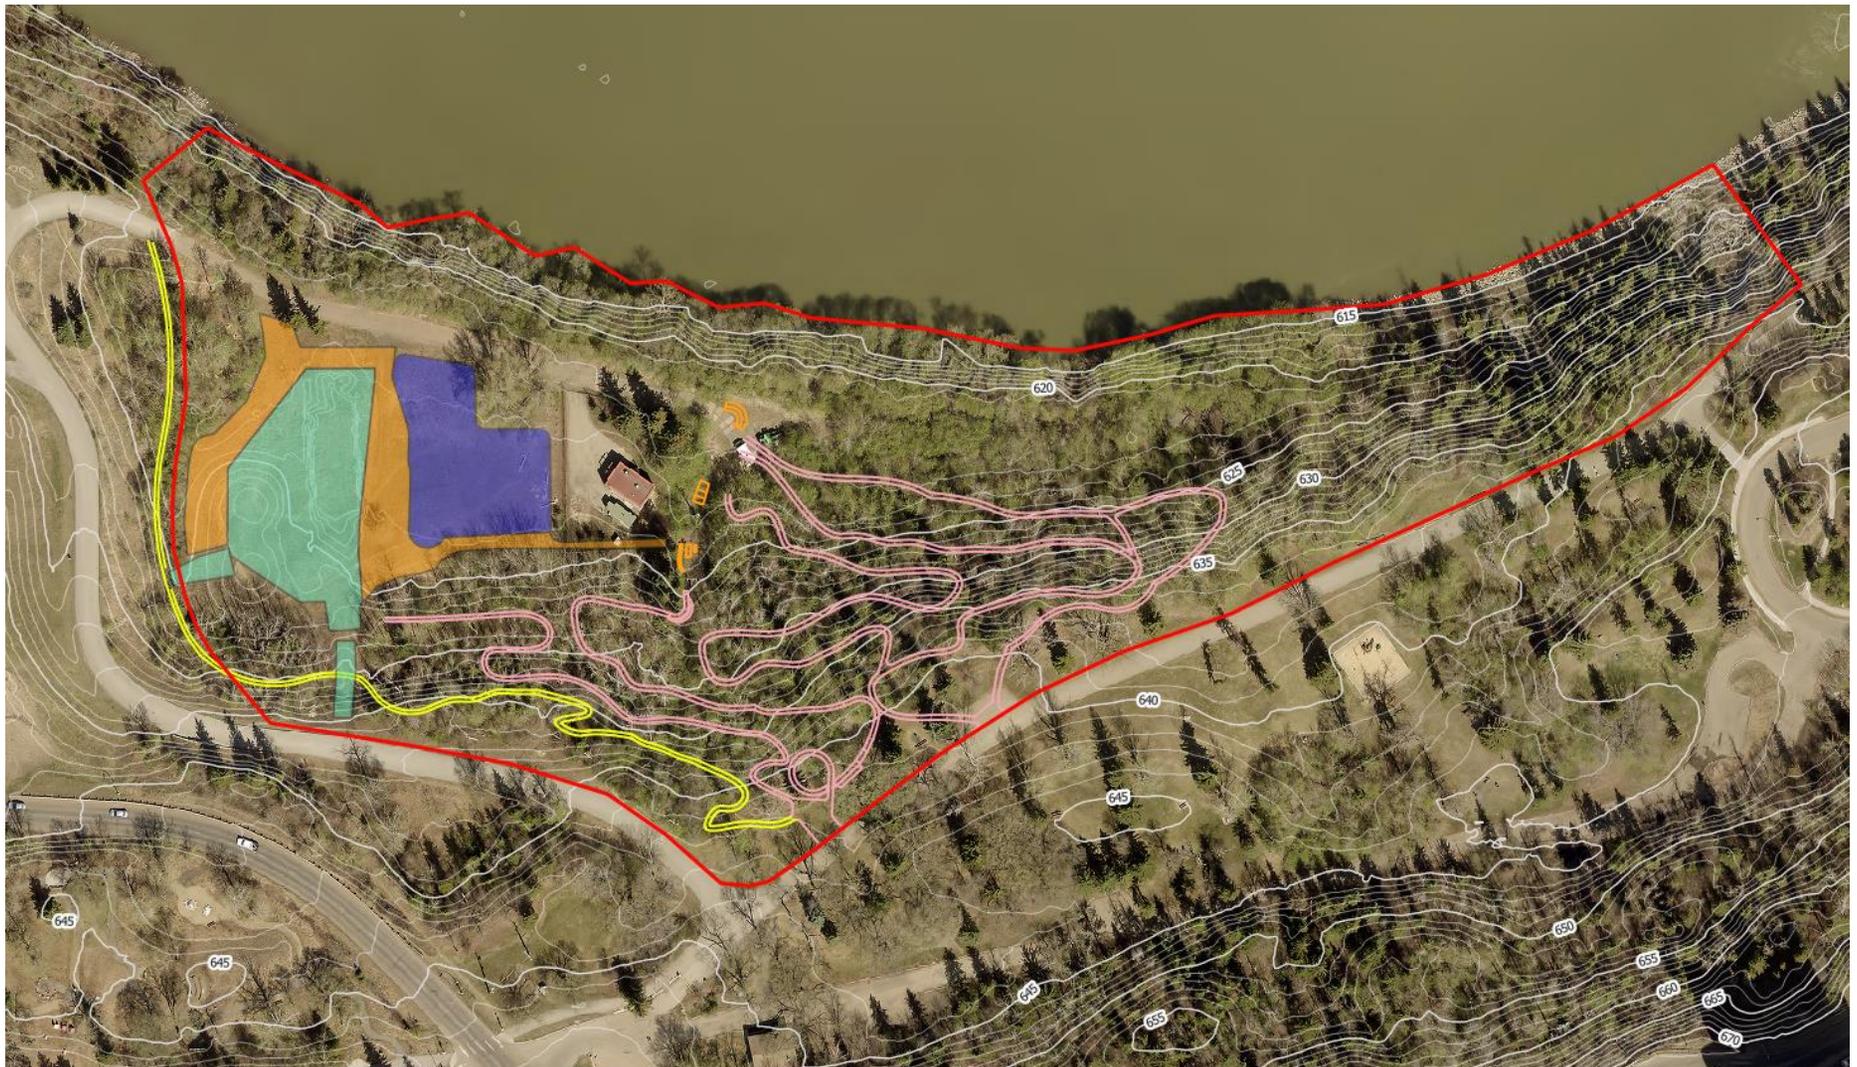
Map 11. Concept design for the Edmonton Bike Park, showing the four distinct design elements that will be integrated into the facility. Note that the locations of the flow trails is proposed and preliminary, and subject to change as part of on-the-ground geotechnical and environmental consultation during the construction phase.

**Jump Park:** The jump park will be located on the site of the former wastewater treatment plant, and will utilize existing elevated location as the start platform for all jump lines. The park will be built-up from the existing ground elevation, with minimal excavation. Removal of hazard trees is planned, as identified and required by City of Edmonton Urban Foresters.

**Skills Areas:** The skills areas will be located within the western and central portions of the bike park, and will contain built features (e.g., rock garden, teeter totter, etc.) that will promote skill development. The majority of the features associated with the skills loop will be located within the former wastewater treatment facility. Additional built features will be located at the exit of the flow trails located east of the Walterdale Pump Station. The skills features will be built and placed in already cleared and impacted areas. As such, excavation and vegetation removal will be limited.

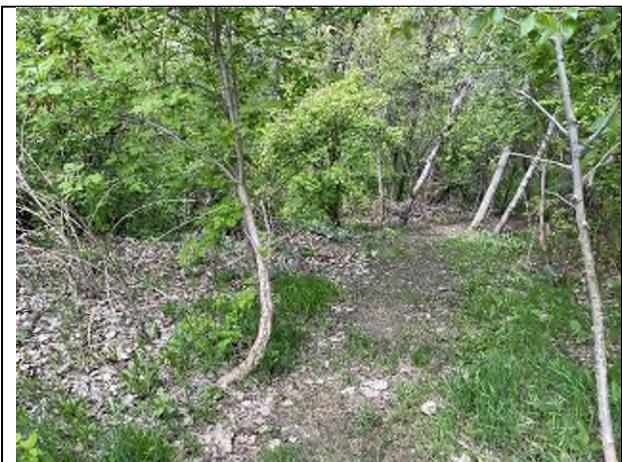
Picture 1: small leaning trees at top of slope

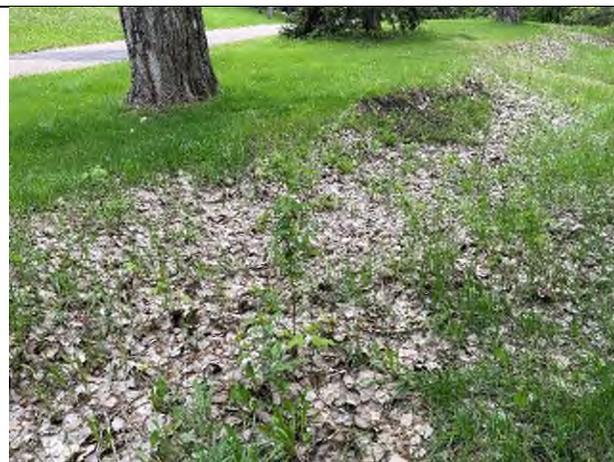
Picture 2: minor old scarp at top of slope

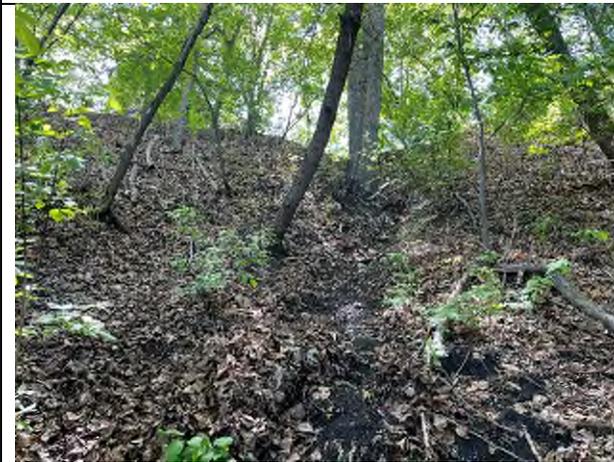
Picture 5: small erosion gully

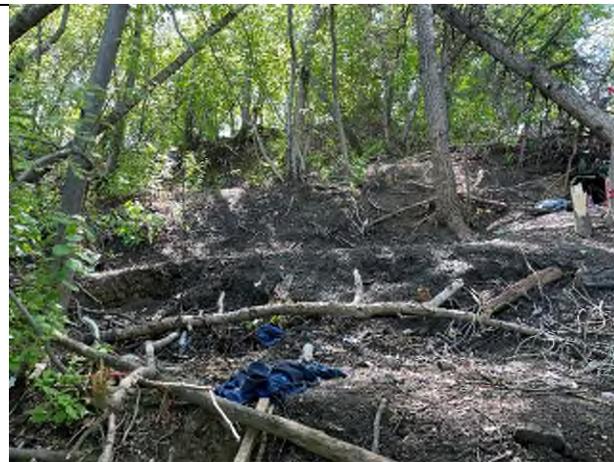
Picture 8: slope scarred by human activity

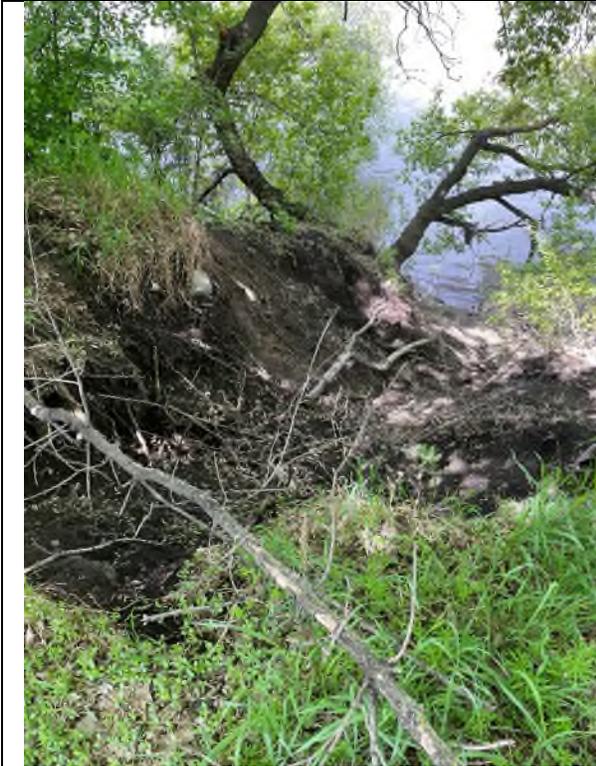
Picture 13: erosion at toe of slope along river

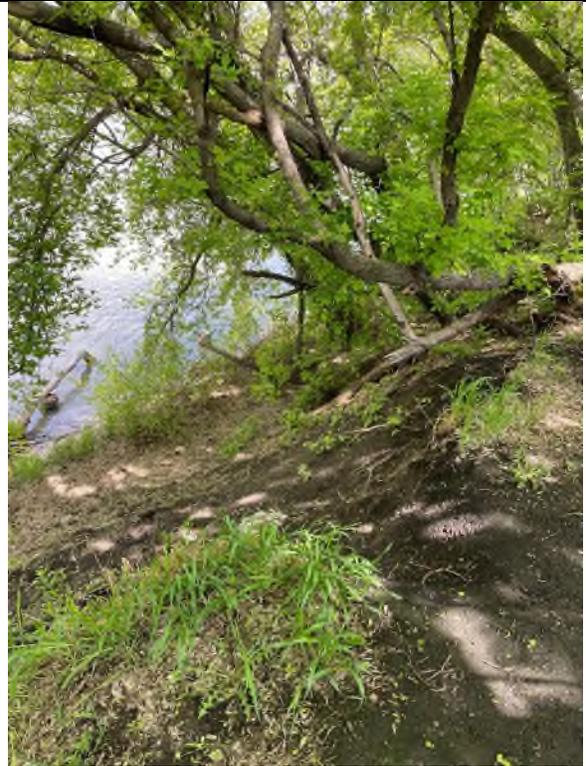
Picture 14: toe of slope, leaning trees/bare soil

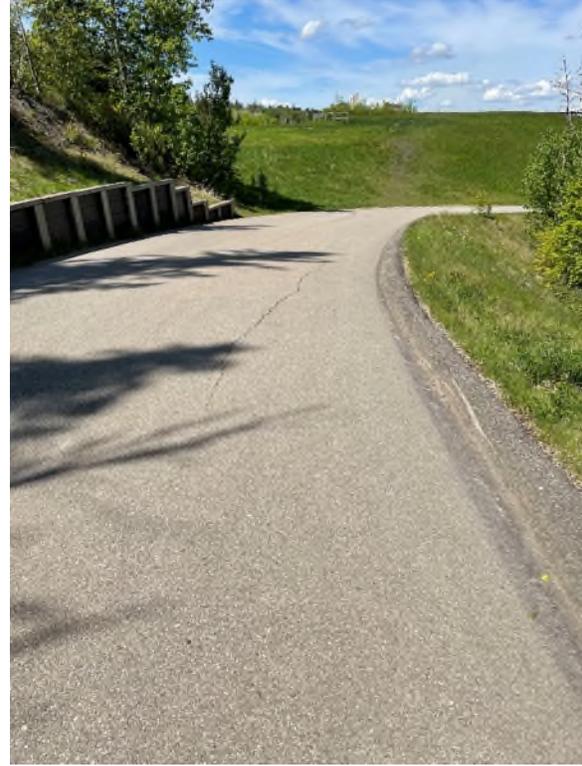
Picture 18: Service road crack S of terrace area

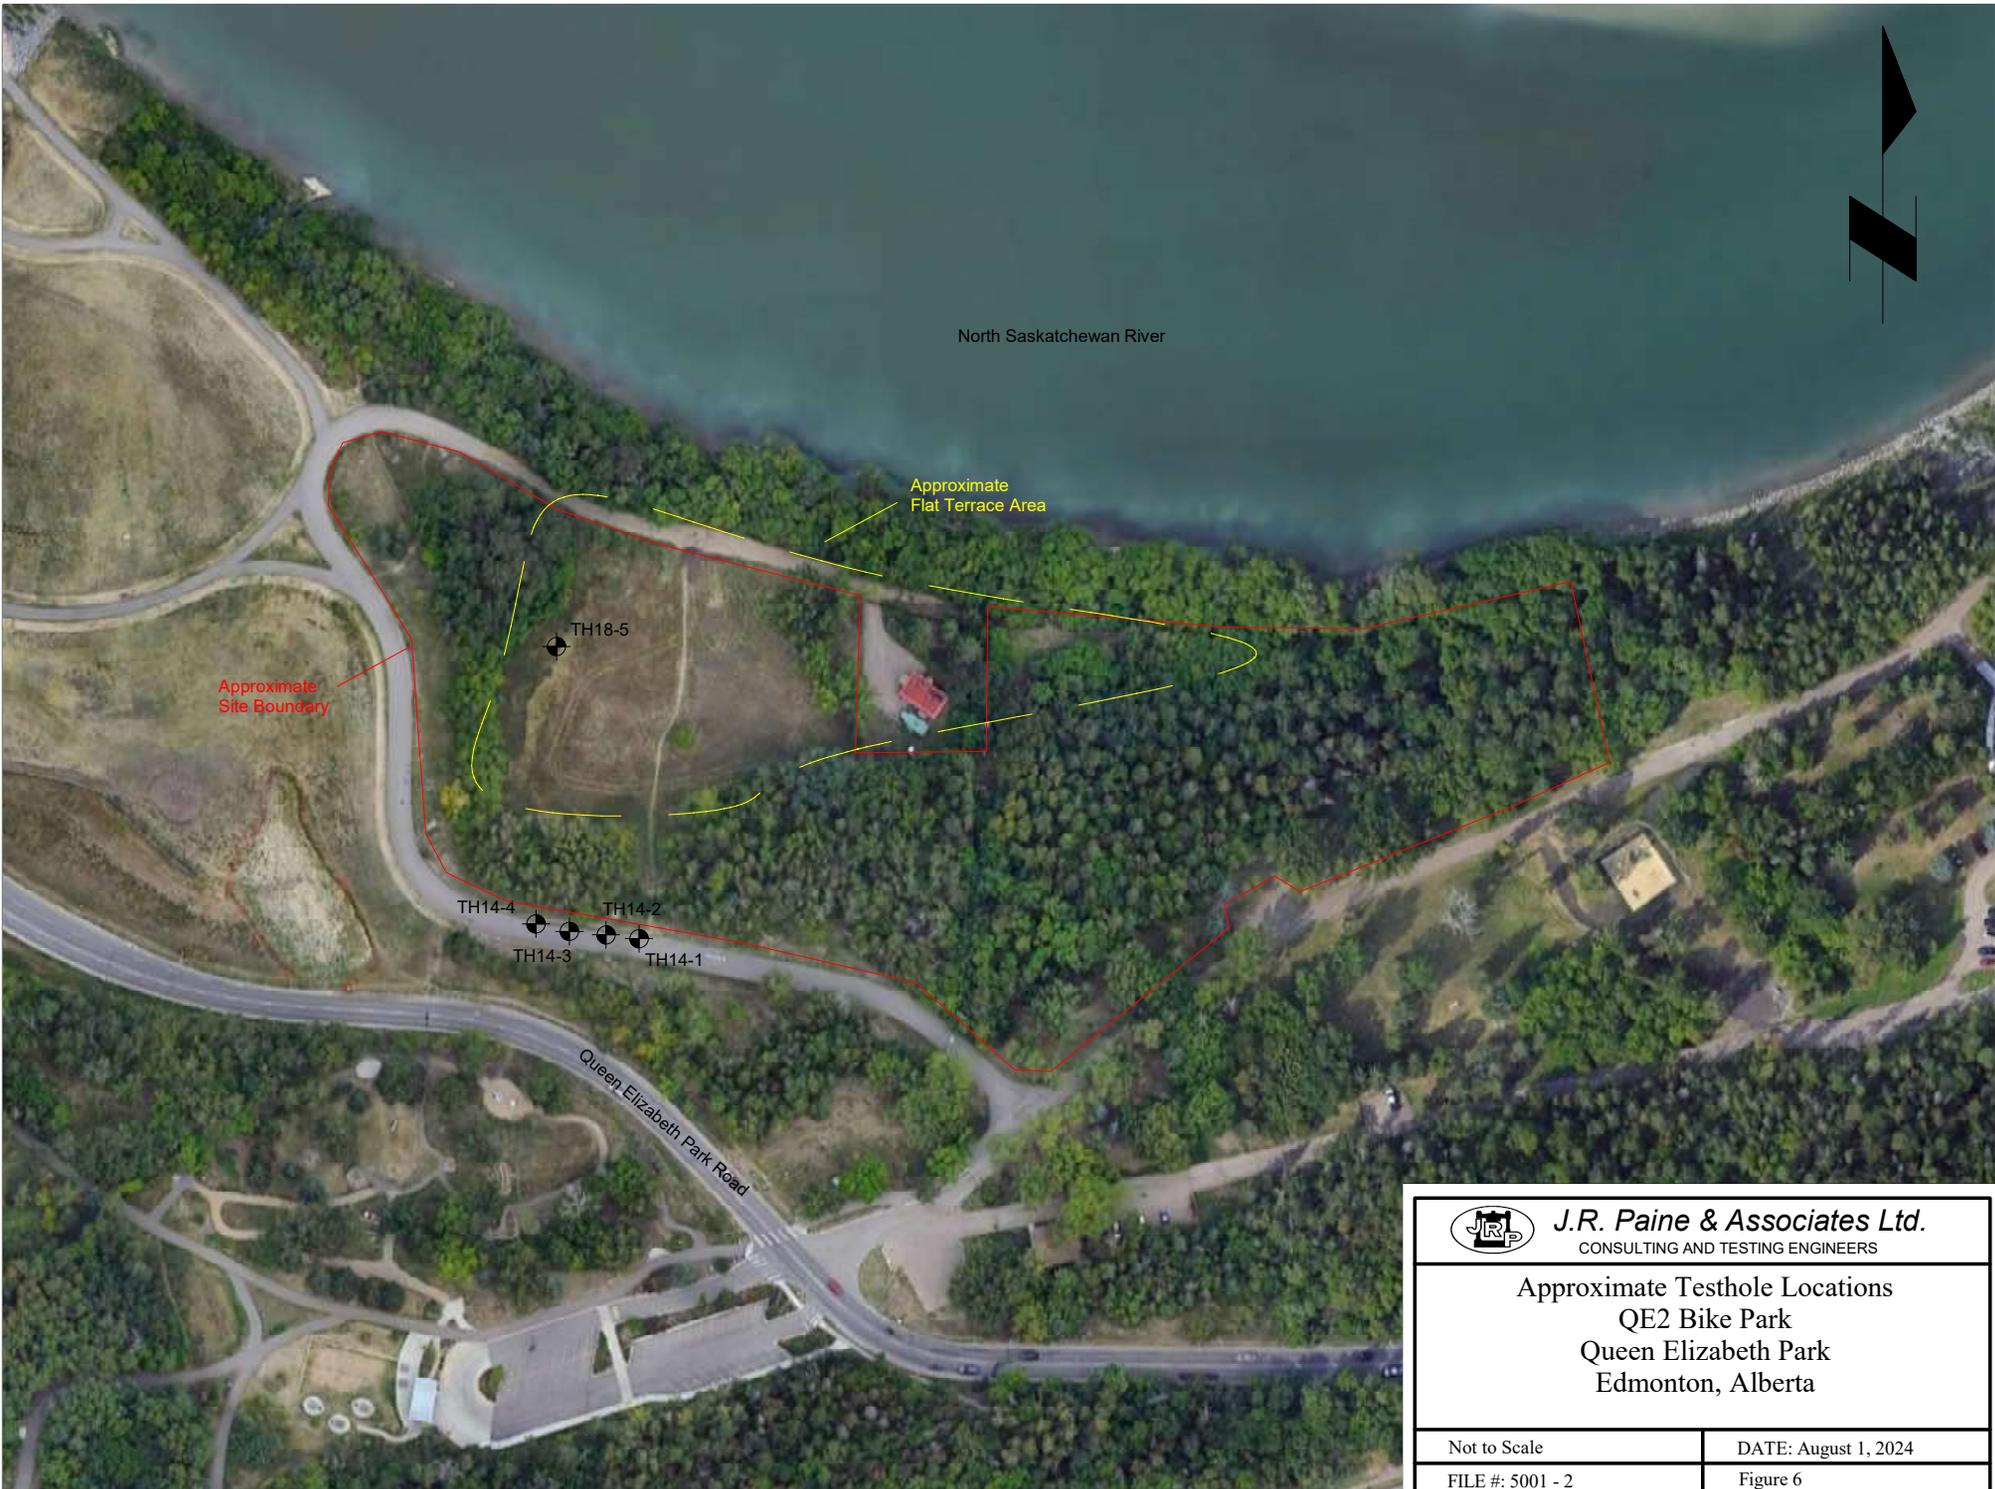
Approximate Testhole Locations  
QE2 Bike Park  
Queen Elizabeth Park  
Edmonton, Alberta

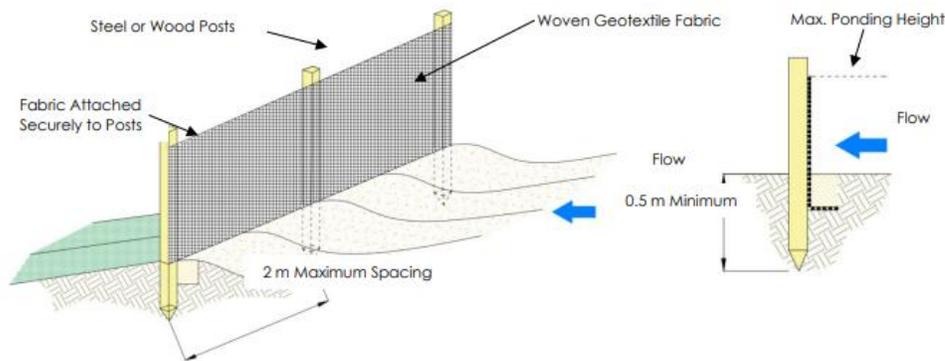
Figure 10. Silt fence installation

Silt fencing is a perimeter control type BMP used to intercept sheet flow runoff and used in conjunction with other BMPs. Typical silt fencing comprises a geotextile fabric anchored to posts driven into the ground. Silt fencing promotes sediment control by filtering water that passes through the fabric and increases short term retention time, allowing suspended sediments to settle. Silt fences will be placed parallel to slope contours in order to maximize ponding efficiency. Barrier locations are informally chosen based on site features and conditions (e.g., soil types, terrain features, sensitive areas, etc.), design plans, existing and anticipated drainage courses, and other available erosion and sediment controls. Typical barrier sites are catch points beyond the toe of fill or on side slopes above waterways or drainage channels. Silt fences should not be used for wide low flow, low-velocity drainage ways, for concentrated flows, in continuous flow streams, for flow diversion, or as check dams. To ensure it is properly anchored, silt fencing will be installed in backfilled trenches. The perimeter around stockpiled materials will be controlled using silt fencing or straw bale barriers to prevent any runoff from leaving the laydown areas. Proper installation and frequent inspection and maintenance is required for effective silt fence use.
