Mill Creek Ravine Pedestrian Bridge Replacements (B304-314)- Environmental Impact Assessment

City of Edmonton | 15616
Final Report

August 2020

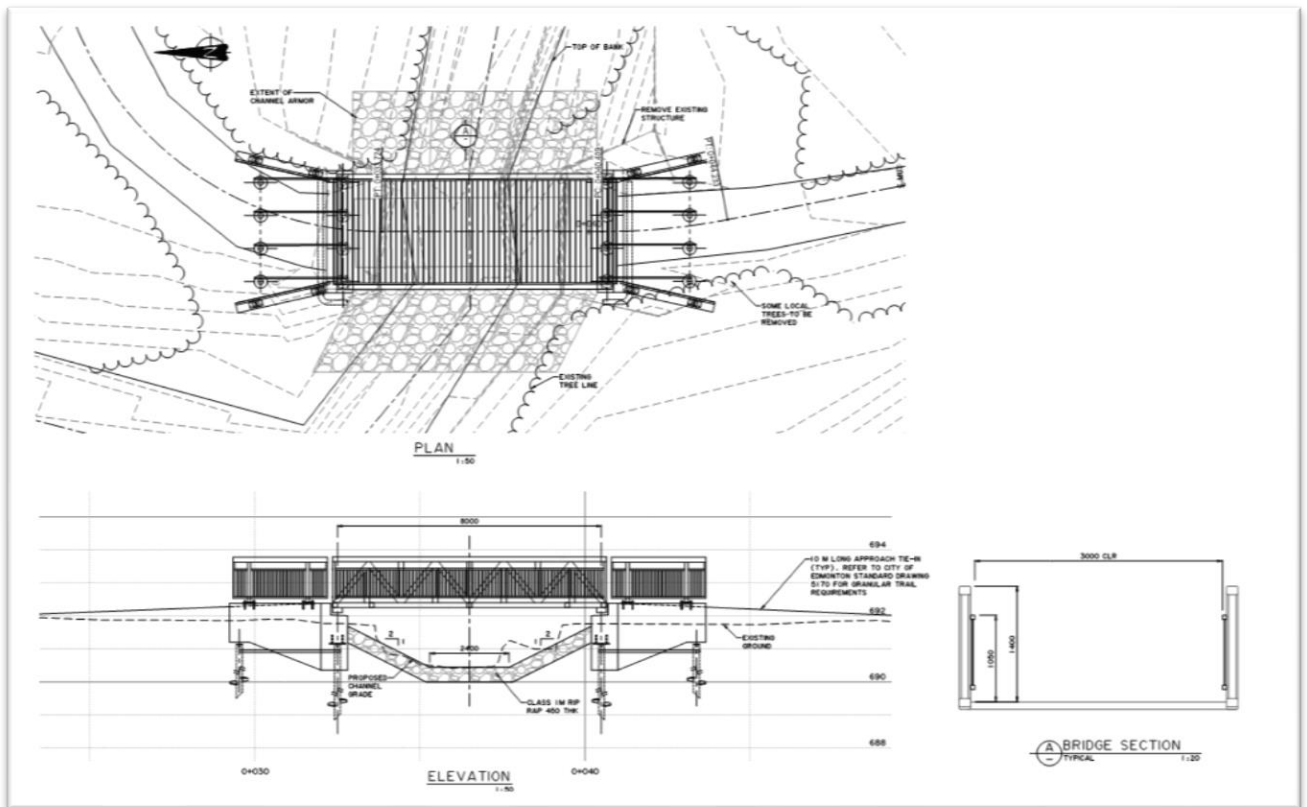
Figure 2.2: Typical Bridge Replacement General Arrangement (ISL 2020b)

ISL evaluated the three scenarios and recommended proceeding with Option 3, complete replacement of substructures and superstructures with prefabricated bridges. The existing bridges do not have adequate load carrying capacity, so Option 1 was not further considered. Of the two full replacement options, replacement with a prefabricated bridge was found to have a lower capital cost and a lower net present value. Additionally, this option is considered a lower maintenance bridge type. The typical bridge drawing is provided below in Figure 2.2 for an example of the changes, showing the removal of the existing bridge, channel armoring, alteration to approaches and typical tree removal (ISL 2020b).

- Installation of temporary bridges for access (potentially utilizing the existing bridge decks where possible);
- Completing any required earthworks (grading, removal of existing abutments, etc.);
- Installation of foundation piles;
- Casting abutments and wing walls;
- Erecting trusses and bridgeworks;
- Installation of timber decking and bridge railing;
- Completing backfill and earthworks; and
- Removing the temporary bridge.

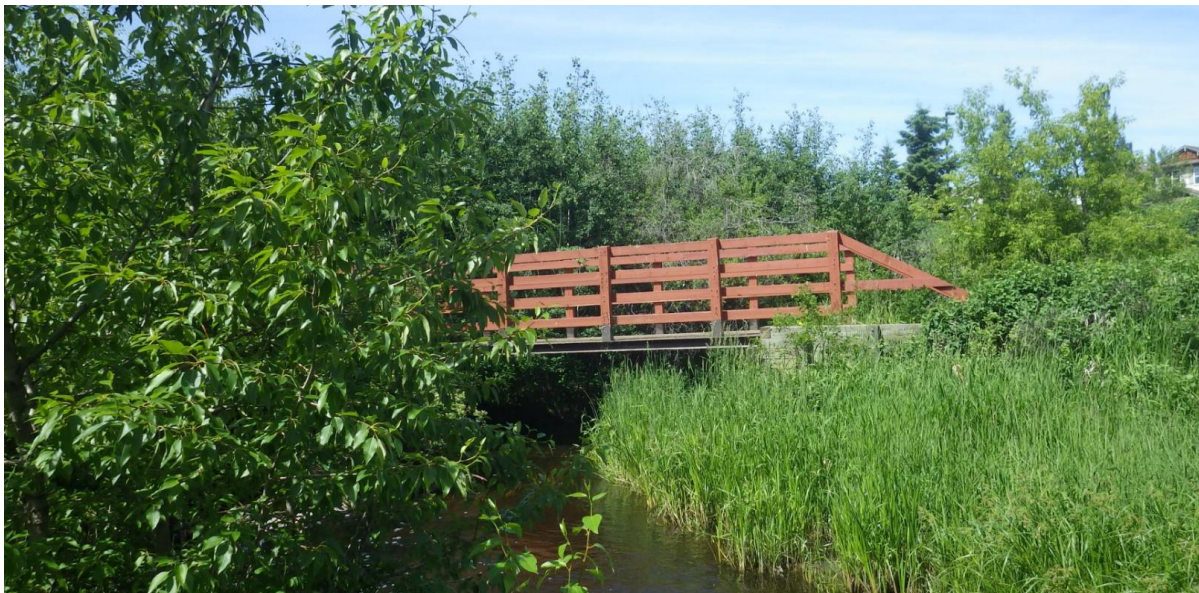
Figure 4.8.1: Bridge B314, showing contrast to the natural environment that surrounds it (June 26, 2020).

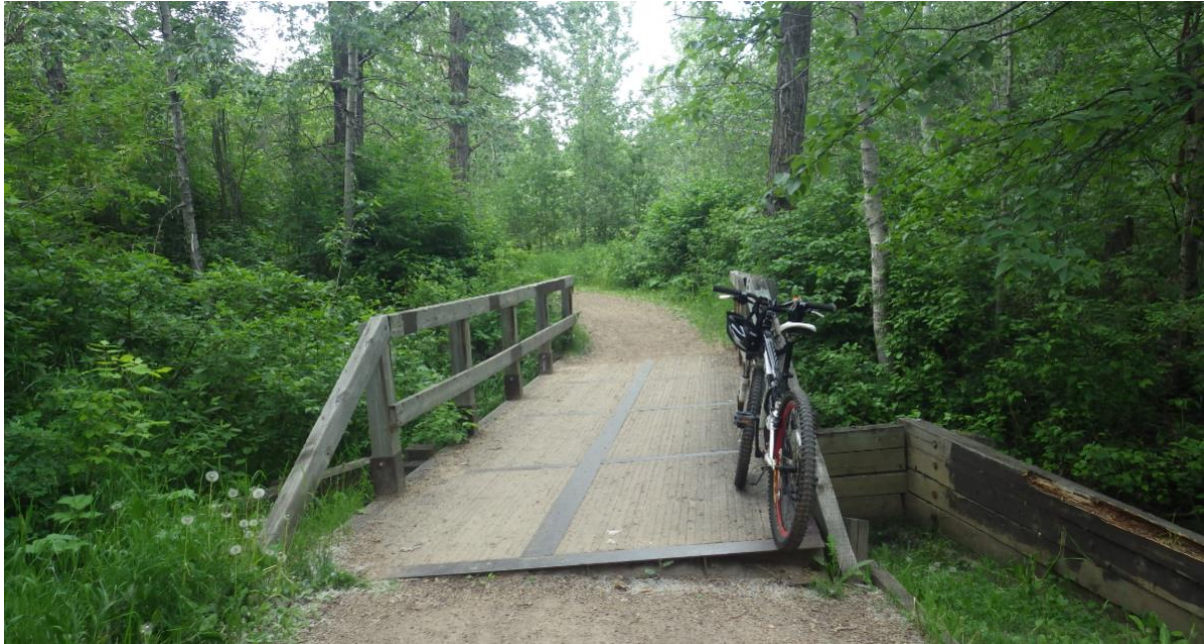
The bridges are visually showing their age, with most chipping paint and many with visible decay and hazardous tripping gaps, which detract from the visual resource value (Figure 4.8.2).

Figure 4.8.2: Bridge B309, Showing Visual Signs of Age and Deterioration (June 26, 2020).

Bridge ID	Substructure	Superstructure	Handrail
B304	Rotten timber. Fill settlement and/or pile frost-jacking, wingwalls pulled apart, fill spilling out of backwalls	Minor surface corrosion on the steel beams on the rig mat, Portion of rig mat below grade.	Failing coating
B305	Rotten timber. Fill settlement and/or pile frost-jacking, wingwalls pulled apart, fill spilling out of backwalls	Minor surface corrosion on the steel beams on the rig mat, Portion of rig mat below grade.	Failing coating
B306	Rotten timber. Fill settlement and/or pile frost-jacking, wingwalls pulled apart, fill spilling out of backwalls	Minor surface corrosion on the steel beams on the rig mat	Partially painted
B307 (two span structure)	Rotten timber, wingwalls pulled apart, frost-jacking	Minor surface corrosion on the steel beams on the rig mat	Isolated patches of paint
B308	Rotten timber. Fill settlement and/or pile frost-jacking, wingwalls pulled apart, fill spilling out of backwalls	Minor surface corrosion on the steel beams on the rig mat, Portion of rig mat below grade.	Partially painted

B309	Rotten timber. Fill settlement and/or pile frost-jacking, wingwalls pulled apart, fill spilling out of backwalls	Minor surface corrosion on the steel beams on the rig mat, Portion of rig mat below grade.	Isolated patches of paint
B310	Frost-jacking/settlement, fill spilling out below backwalls and wingwalls	Minor surface corrosion on the steel beams on the rig mat	Partially painted
B311	Frost-jacking/settlement, fill spilling out below backwalls and wingwalls	Minor surface corrosion on the steel beams on the rig mat	Failing coating
B312	Frost-jacking/settlement, fill spilling out below backwalls and wingwalls	Minor surface corrosion on the steel beams on the rig mat	Rail extends beyond bridge
B313	Frost-jacking/settlement, fill spilling out below backwalls and wingwalls	Minor surface corrosion on the steel beams on the rig mat	Good
B314	Absence of rock on headslopes	Minor surface corrosion on the steel beams on the rig mat	Good

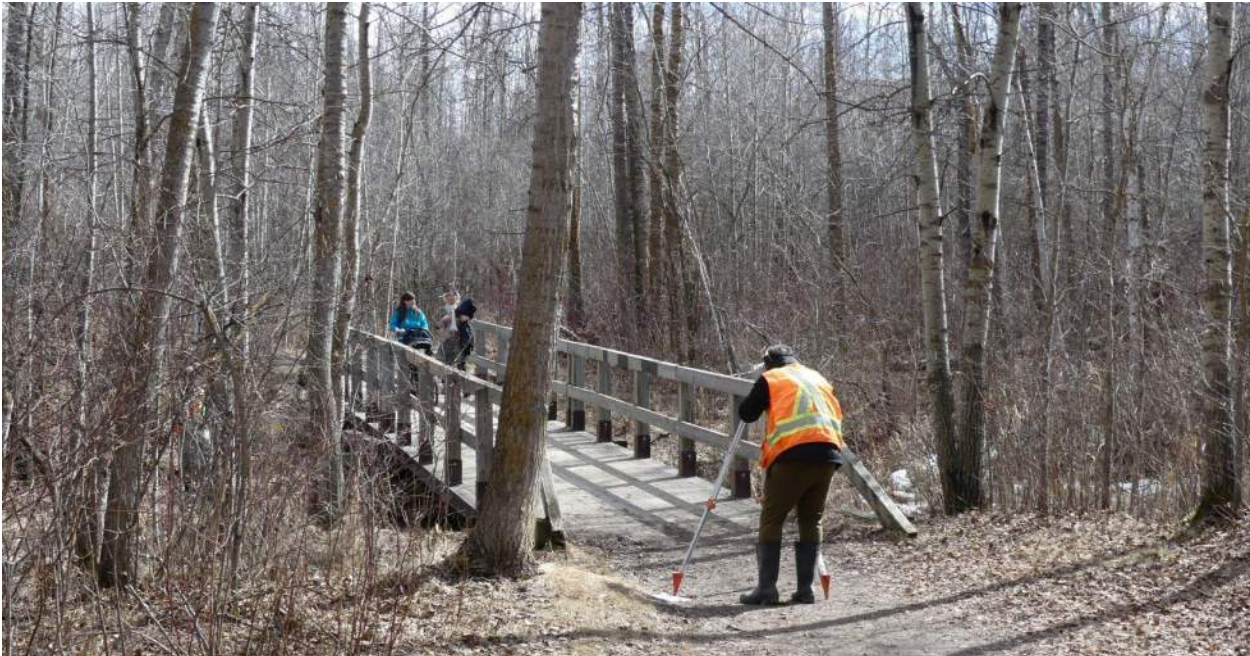
Photo B-1 (File No. P1000891) – Representative photograph of typical bridge structure and adjacent riparian habitat.

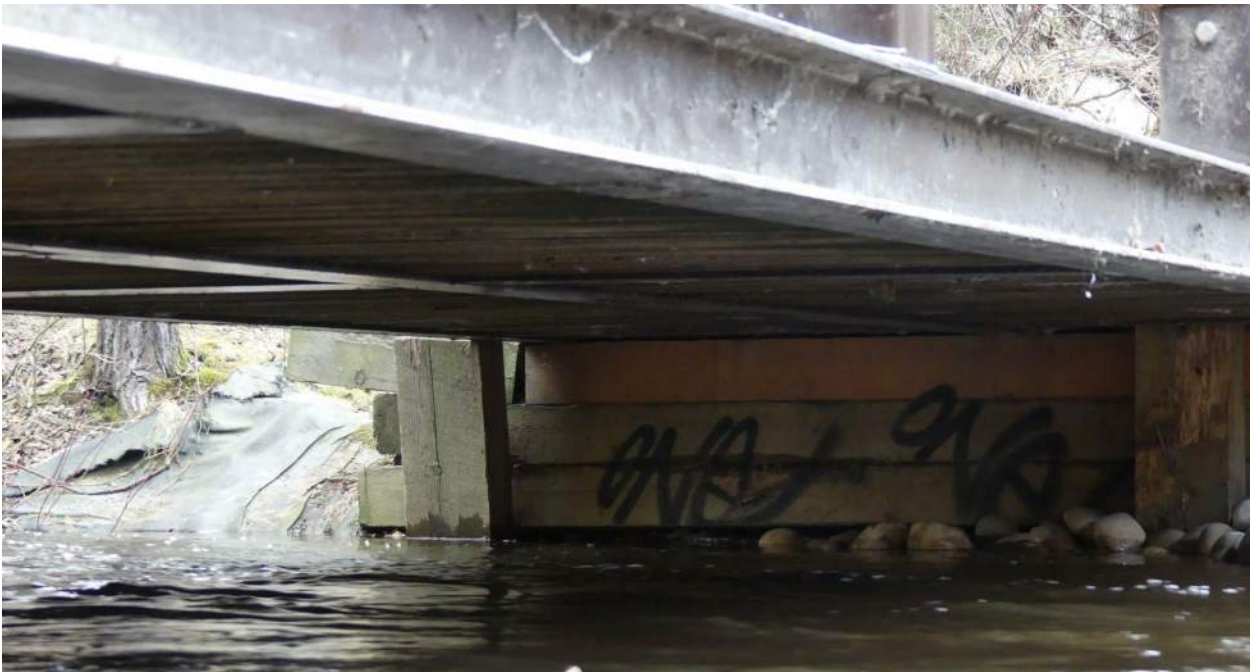
Photo B-2 (File No. P1000911) – Representative photograph of typical bridge underside. No evidence of cliff or barn swallow nesting was observed.

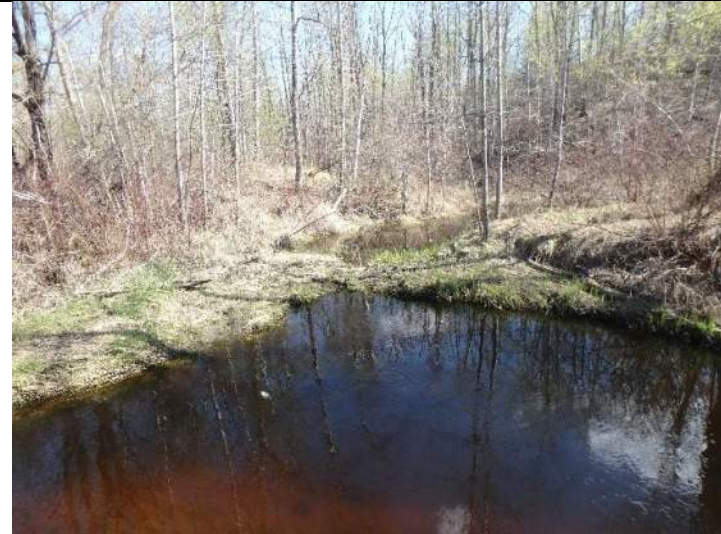
Plate 6: View showing backwater effect caused by large woody debris, upstream of site

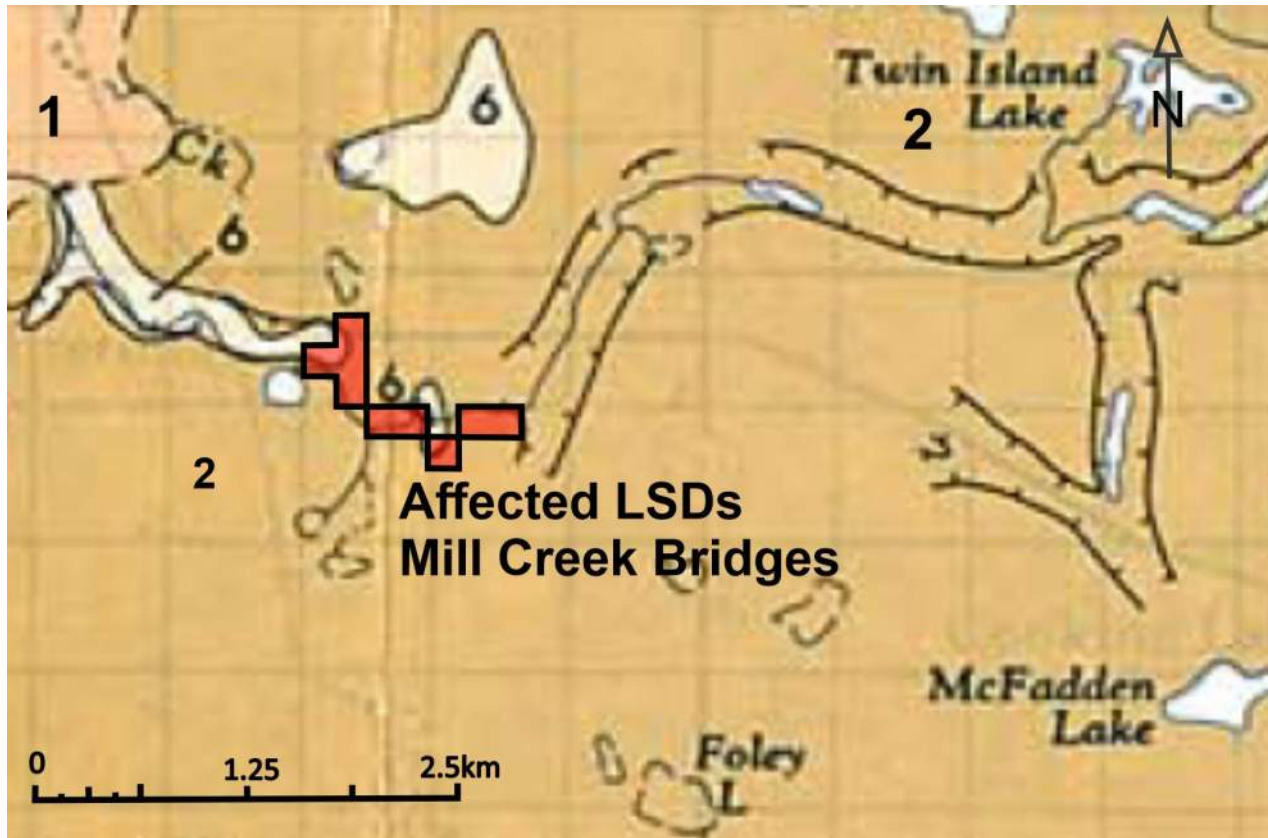
Figure 2: Surficial Geology of the Mill Creek Pedestrian Bridges Project.
