Environmental Impact Assessment Pursuant to Bylaw 7188

Riverside Trail Realignment

Final Report

Project Number EP-893
September 2020

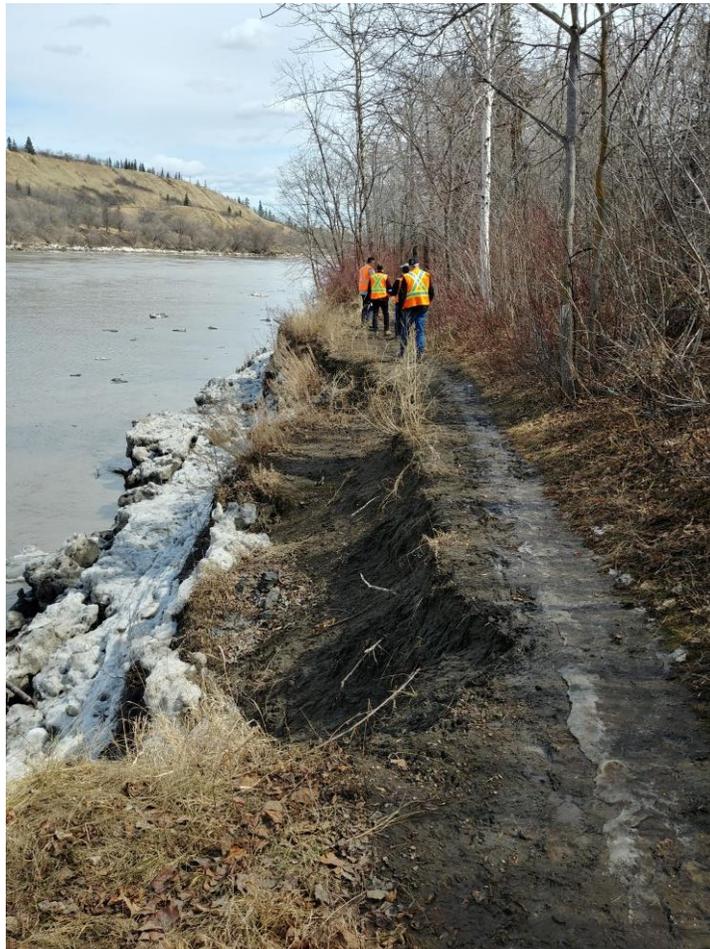
Plate 1.1. Slumping of the south bank of the NSR along Riverside Trail (Location 1) (22 April 2020).

The City of Edmonton proposes to realign and rehabilitate portions of Riverside Trail where slumping along the south bank of the North Saskatchewan River (Plates 1.1 and 1.2) has created safety concerns. Riverside Trail is a granular trail located in the River Valley Riverside Neighbourhood, adjacent the Riverside Golf Course in the North Saskatchewan River Valley (Figure 1, Appendix A). In 2017, EDA Planning + Urban Design Inc. completed the Riverside Trail Rehabilitation Feasibility Study - Conceptual Plan for rehabilitation of two slumping sections (Locations 1 and 6, Figure 2; Appendix A) of Riverside Trail with the preferred concept option being trail realignment for those two locations. In 2019, an additional geotechnical assessment was completed for the entire length of Riverside Trail. That assessment identified five (5) additional high-risk slumping areas on the riverbank. In total, seven (7) areas were identified as needing rehabilitation or realignment due to slumping and unsafe conditions along an approximate 700 m section of Riverside Trail (Figure 2, Appendix A). Along that same section of trail, three (3) additional low spots in the trail were identified for upgrading during a team site reconnaissance on 22 April 2020 (Plate 1.3) (Figure 2, Appendix A).

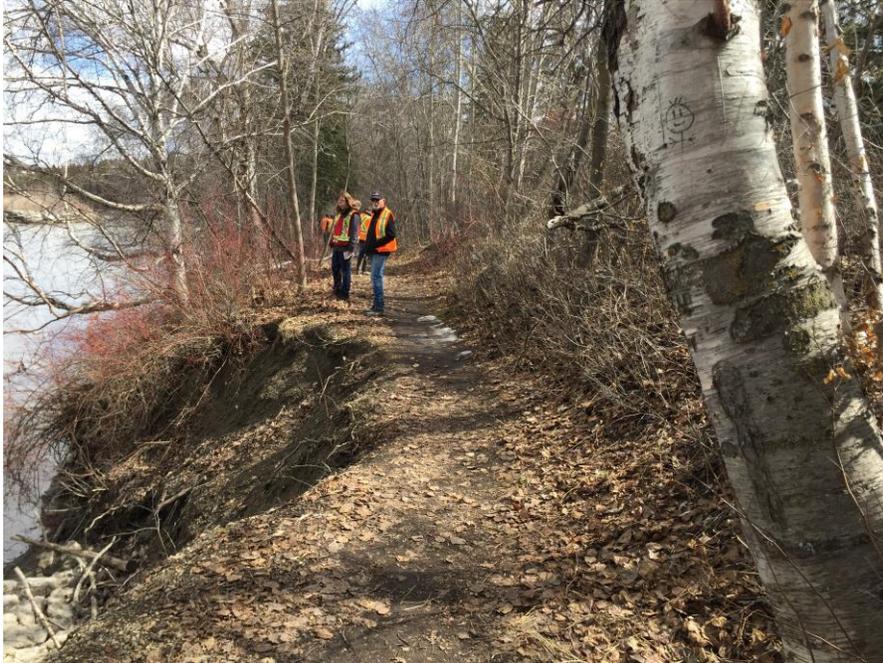
Plate 1.2. Slumping of the south bank of the NSR along Riverside Trail (Location 6) (22 April 2020).

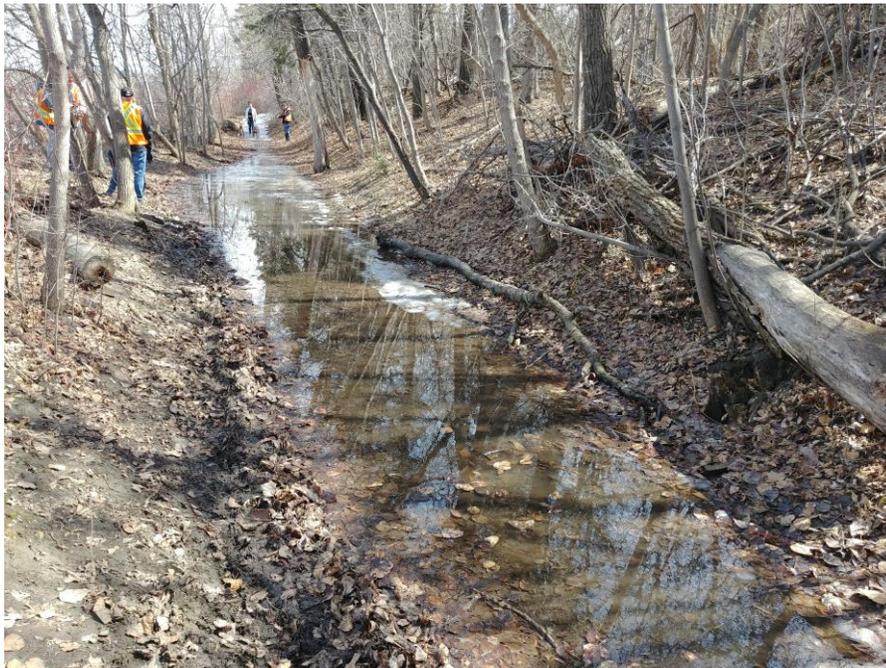
Plate 1.3. A low area in the trail identified for upgrading (Upgrade Location 1) (22 April 2020).

Trail upgrading of three low spot areas (Figure 2, Appendix A) will comprise clearing, scarifying and compaction the existing 1.5 m trail prior to placement of filter fabric and geogrid on the existing trail surface followed by the addition of 150 mm of granular material. Trail edges will be rehabilitated/graded as needed to ensure surface drainage does not flow over the top-of-bank toward the river.

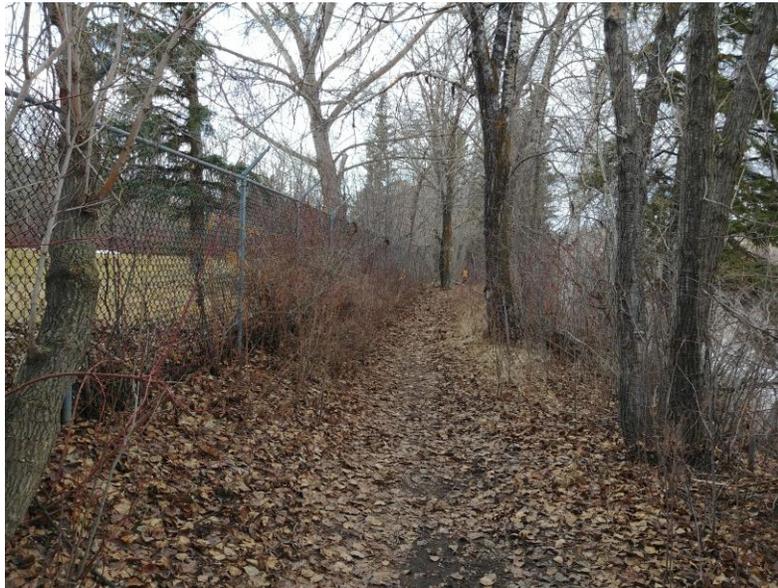
Plate 3.1. Mixed Deciduous - Mixed Shrubs plant community along Riverside Trail (22 April 2020).

The plant community in the immediate vicinity of Riverside Trail was typical of a Mixed Deciduous - Mixed Shrubs forest in the NSRV. The forest canopy was a mature overstorey, typically 10 - 20 m in height, dominated by balsam poplar (*Populus balsamifera*) and trembling aspen (*Populus tremuloides*), with lesser amounts of white spruce (*Picea glauca*), white birch (*Betula papyrifera*), Manitoba maple (*Acer negundo*), mountain-ash (*Sorbus aucuparia*) and other ornamental species. The understorey canopy was composed of a dense shrub layer 1 - 4 m in height and a herbaceous layer comprised mostly of forbs with a few grass and sedge species also present. Shrubs included Saskatoon (*Amelanchier alnifolia*), beaked hazelnut (*Corylus cornuta*), buckbrush (*Symphoricarpos occidentalis*), Wood's rose (*Rosa Woodsii*) and prickly rose (*Rosa acicularis*). Forbs included star-flowered Solomon's-seal (*Maianthemum stellatum*), wild sarsaparilla (*Aralia nudicaulis*), northern bedstraw (*Galium boreale*), Canada anemone (*Anemone canadensis*), red and white baneberry (*Actaea rubra*), and wild lily-of-the-valley (*Maianthemum canadense*). Species observed immediately within the slump locations and along trail edges comprised more weed and non-native species compared to the surrounding forest and included common dandelion (*Taraxacum officinale*), Kentucky bluegrass (*Poa pratensis*) and smooth brome (*Elymus repens*). Common buckthorn (*Rhamnus catharticus*), a prohibited noxious weed, was observed scattered throughout this community. Canada thistle, a provincially listed noxious weed, was also observed at slump locations 1 and 6 during a site familiarization visit in 2017 (Spencer Environmental 2017).

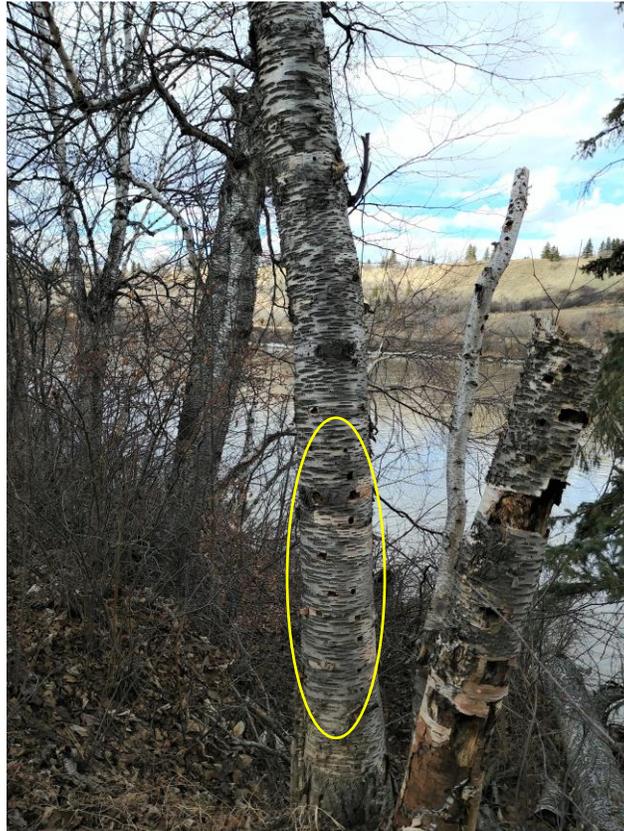
Plate 3.2. Example of a wildlife tree with many cavities along Riverside Trail (22 April 2020)

Review Comment	Response Approach	EIA Report Section Reference
	<p>local study area (Plate 3.2) and are expected to occur in the expanded study area owing to the mature age of the forest in this portion of the river valley.” These trees ranged in DBH as noted above and exhibited varying numbers and sizes of cavities as is typical of mature riparian forest habitat along the NSR.</p> <ul style="list-style-type: none"> • The site reconnaissance level of site visit as required by the EIA ToR did not include a detailed survey of each wildlife tree in the study area. If a detailed survey of wildlife trees is required, this would result in a scope change. 	
<p>Mitigation: mitigation measures to avoid, minimize tree removal including avoidance of habitat or matured tree species, potential retention of trees, options to reduce the potential width of trail in certain locations if feasible to protect tree species. Identification of construction best practices to minimize impact on the riverbank and tree species within the periphery. Selection of native species that is also suitable for the bank stabilization is preferred .</p>	<ul style="list-style-type: none"> • These mitigation measures have been added to Section 5.2.2.1. of the EIA. • Tender will require contractor to manually clear trail alignment with on-site trail adjustments made to avoid any larger trees of value. 	Section 5.2.2.1

The NSRV is a regional biological corridor that is critical for wildlife movement and ecological processes within Edmonton and the surrounding areas (City of Edmonton 2007). Major wildlife corridors provide cover and resources, connecting large areas of habitat at a regional scale and can support a high diversity of species. Although the Riverside Trail exists within a relatively narrow band of forest located between the Riverside Golf Course and the NSR, the habitat that is present consists of mature riparian mixedwood forest and is contiguous with larger areas of natural habitat both upstream and downstream along the NSR. Because of the high degree of habitat complexity and ecological connectivity, this Riverside Trail area is expected to support use by an abundance of native wildlife species and to function as an important wildlife movement corridor. Several wildlife trees (i.e., trees with visible nests or cavities) were observed scattered throughout the local study area (Plate 3.2) and are expected to occur in the expanded study area owing to the mature age of the forest in this portion of the river valley.

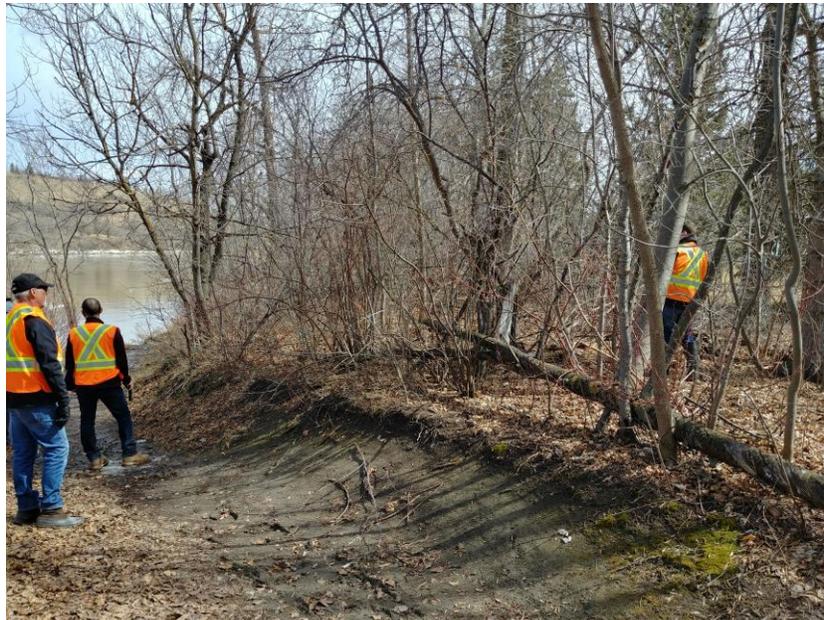
Plate 4.1. Vegetation to be cleared for trail realignment (3.5 m wide) at Location 1 (22 April 2020).

The majority of tree/vegetation removal for the proposed project will be completed by the City of Edmonton Forestry Department in fall/winter 2020/21 before construction begins in spring 2021 (May). Some selective vegetation removal may need to be completed by the contractor in consultation with City Forestry once construction begins. Vegetation removal will be minimal (approximately 962 m²) for trail rehabilitation (Plate 4.1). No vegetation will need to be cleared for guardrail construction (Plate 4.2).

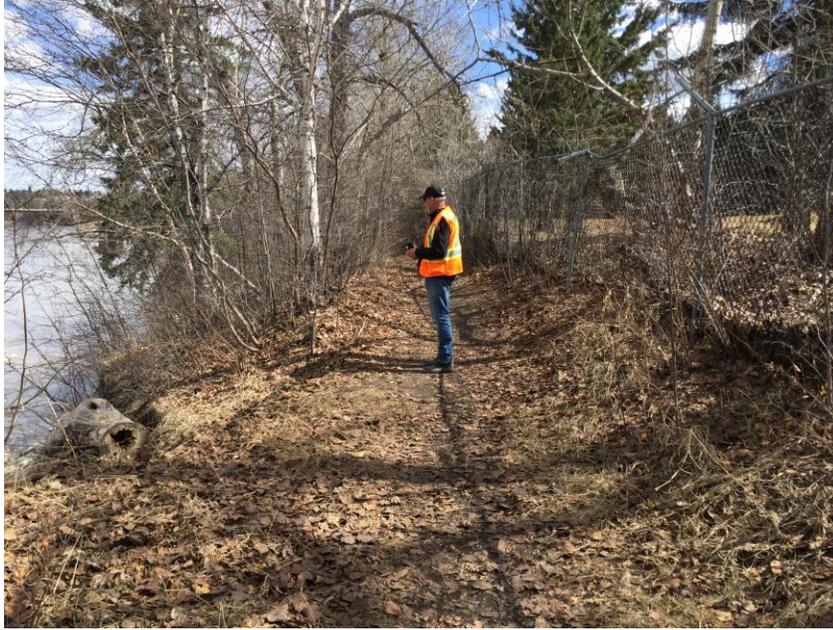
Plate 4.2. Location 5 where a guardrail is proposed, devoid of significant vegetation cover (22 April 2020).

New wooden guardrails, ranging in length from 10 m to 25 m, are proposed for trail locations 4, 5, 6 and 7 along the downslope edge of the granular trail (Appendix G). Guardrails will be constructed on screw piles drilled at least 3 m below the ground surface to avoid seasonal frost heave and will be 1.2 m in height.

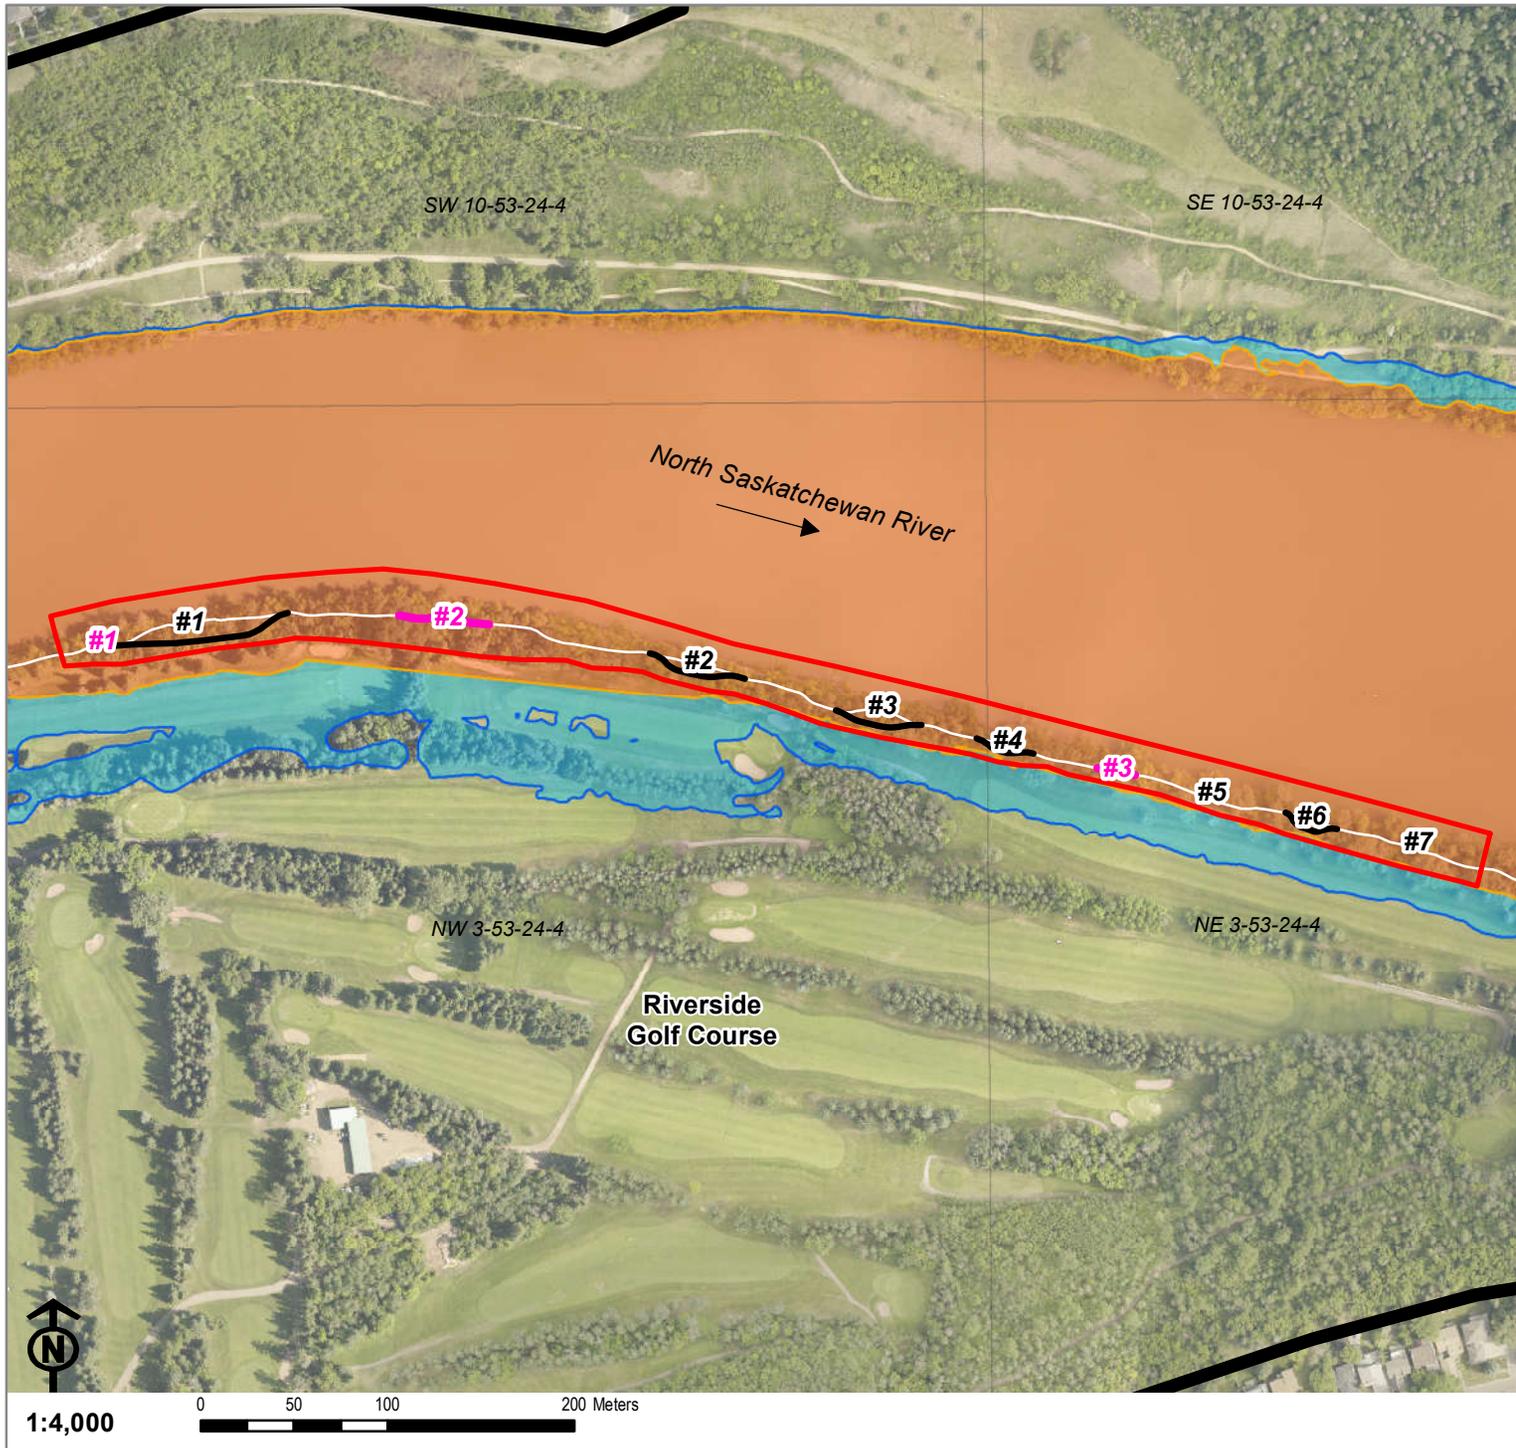
Figure 4.
Flood Hazard Mapping
Riverside Trail
Realignment
and Upgrading

The existing Riverside Trail in the local study area is entirely located in the flood hazard area (1:100 year flood) of the NSR, and, as a result, will experience occasional flooding as it currently does (Figure 4, Appendix A). In order to reduce the risk of ongoing trail damage and erosion from flooding at the slump locations, the proposed trail realignments are located at a relatively higher elevation compared to the existing trail and are located as far back from the top-of-bank as possible given the limitations of the adjacent golf course boundary. While infrequent river flooding is expected to result in continued bank erosion in the project area, realignment of the trail at the slumped locations is expected to improve the integrity of the trail over the short-term and reduce the amount of sediment generated at these locations. The impact to river water quality from trail erosion would be negligible.

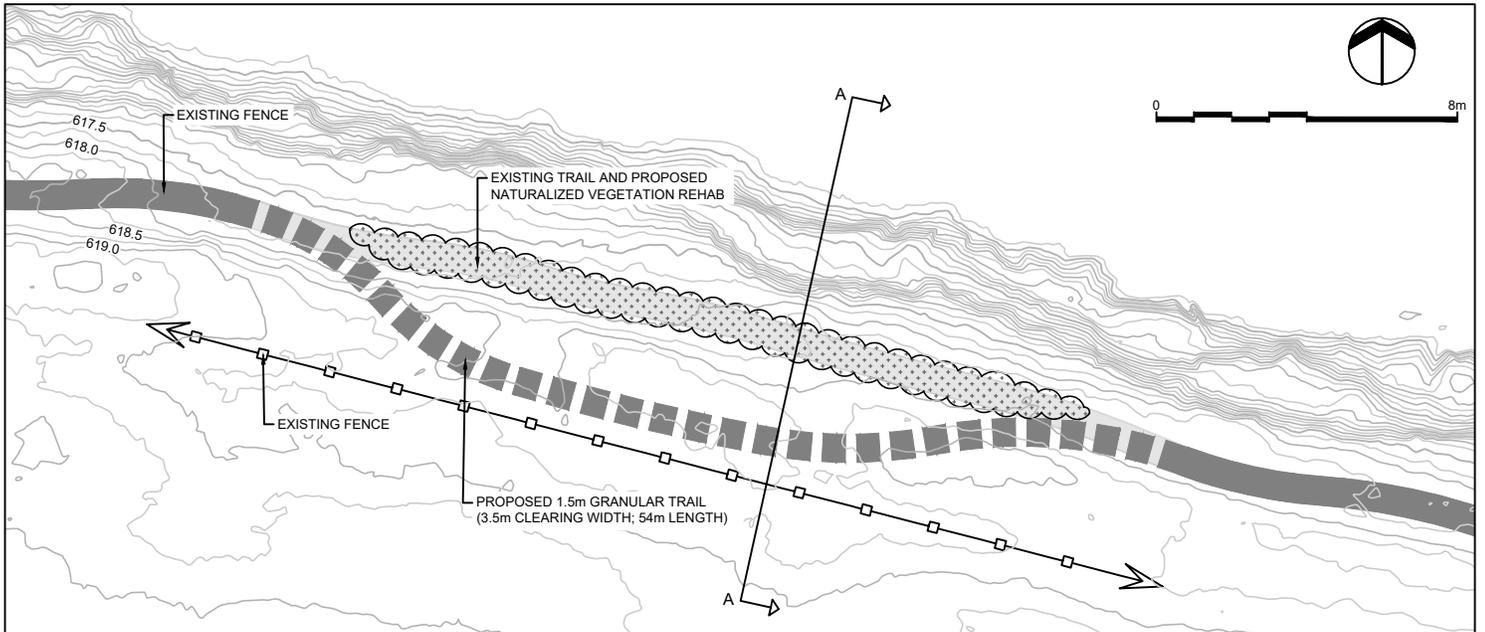
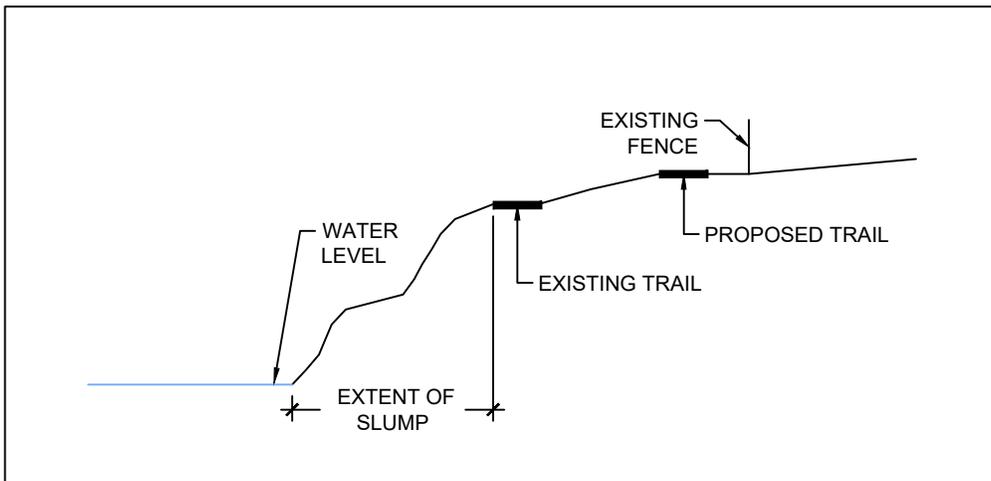
LOCATION 2 OPTION: TRAIL RELOCATION TO AVOID SLUMPING BANK
THURBER SITE 7

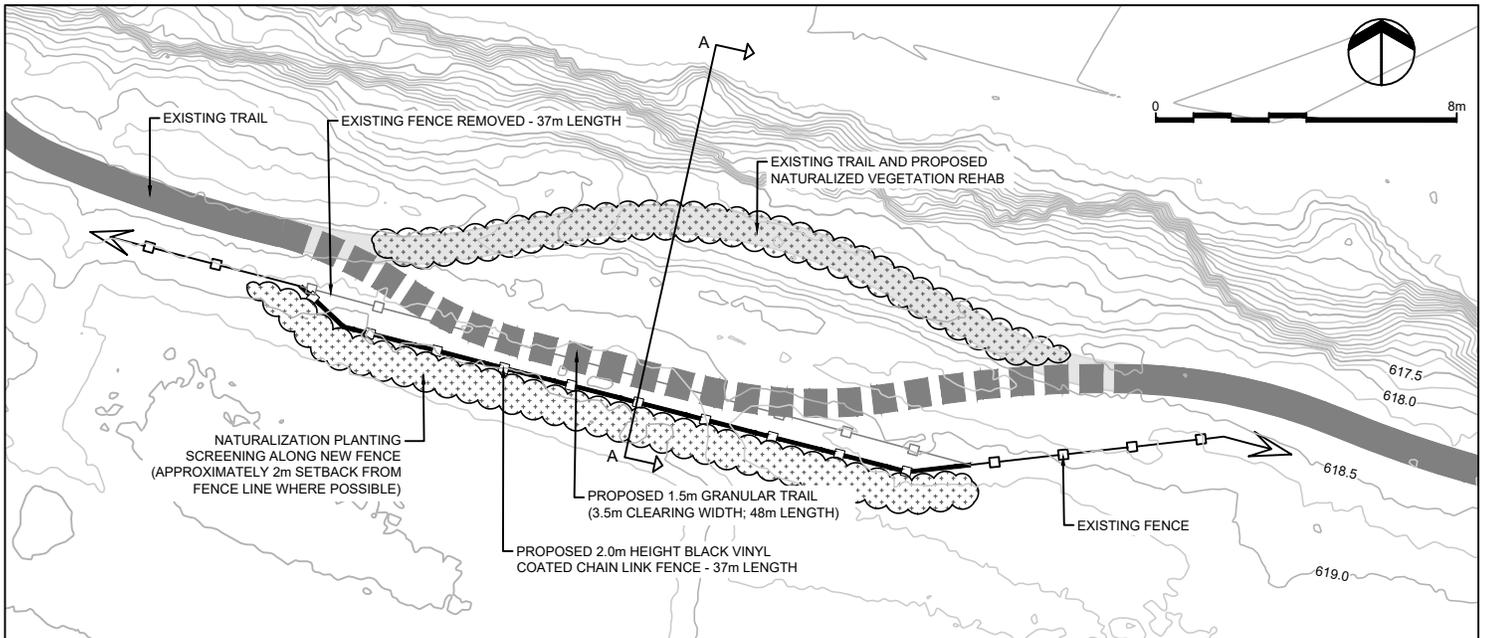
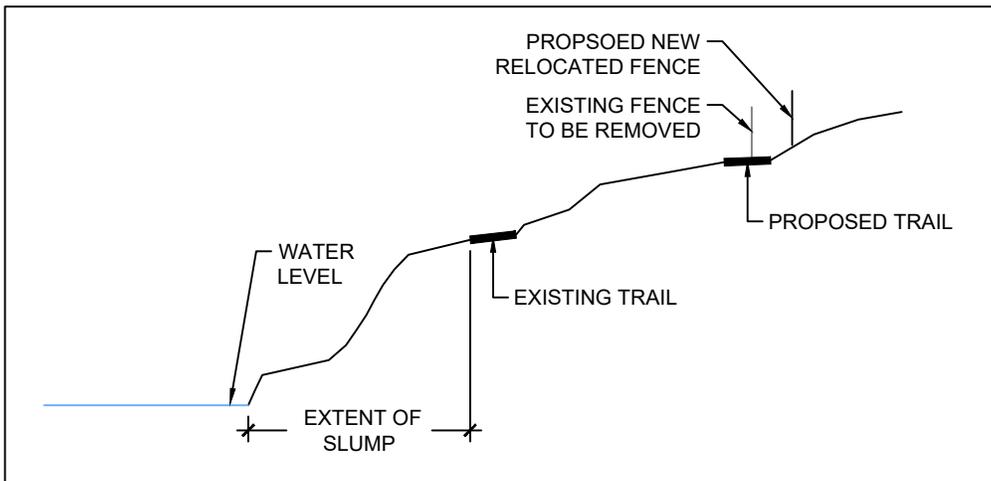
RIVER SIDE TRAIL RE-ALIGNMENT

LOCATION 3 OPTION: TRAIL RELOCATION TO AVOID SLUMPING BANK

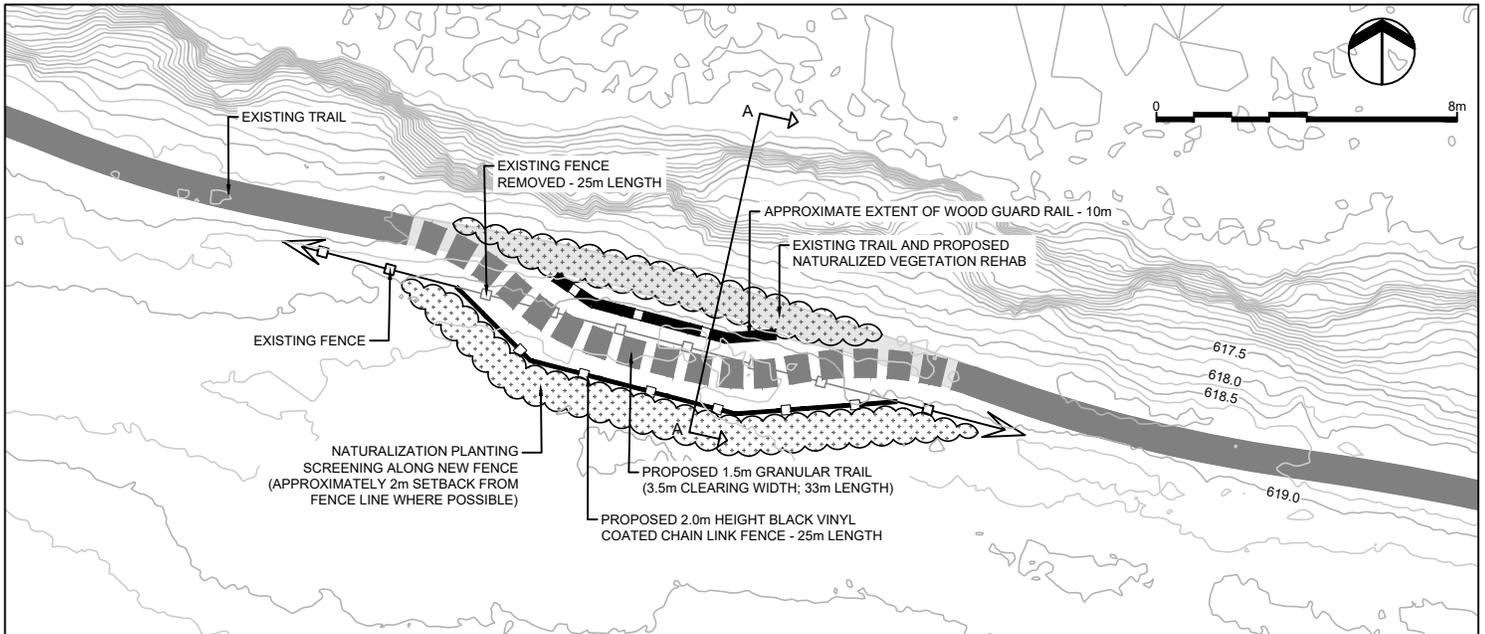
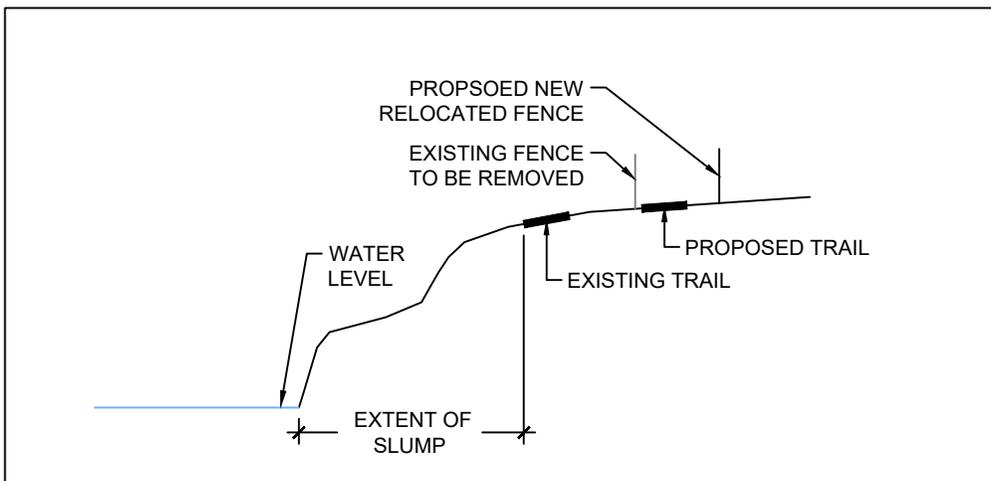
RIVER SIDE TRAIL RE-ALIGNMENT

LOCATION 4 OPTION: TRAIL RELOCATION TO AVOID SLUMPING BANK

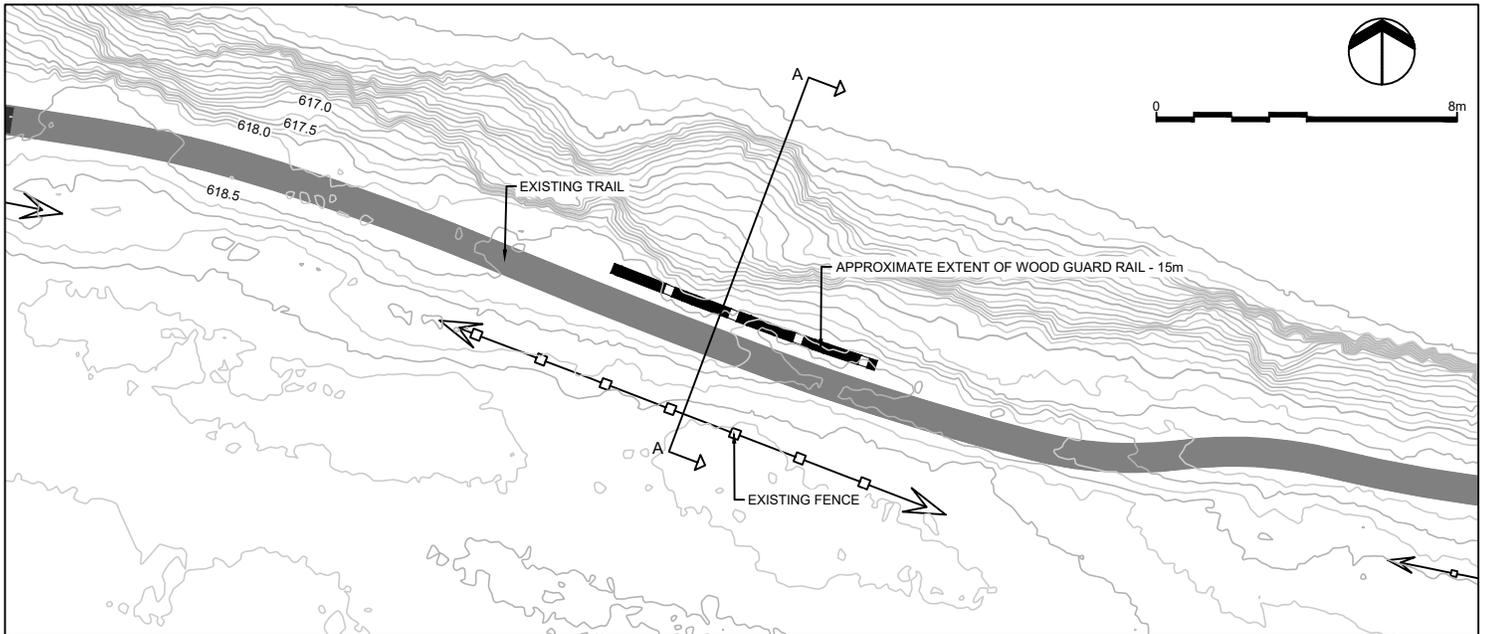
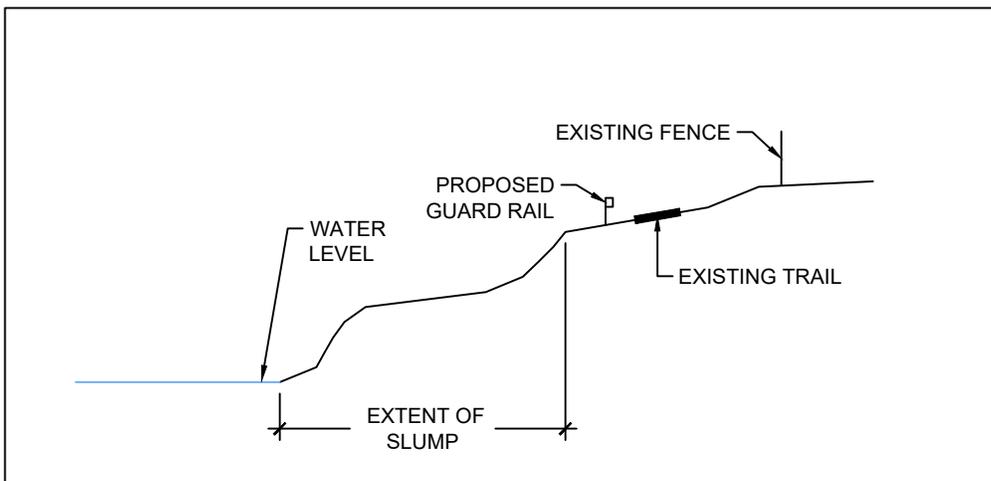
RIVER SIDE TRAIL RE-ALIGNMENT

LOCATION 5 OPTION: TRAIL RELOCATION TO AVOID SLUMPING BANK

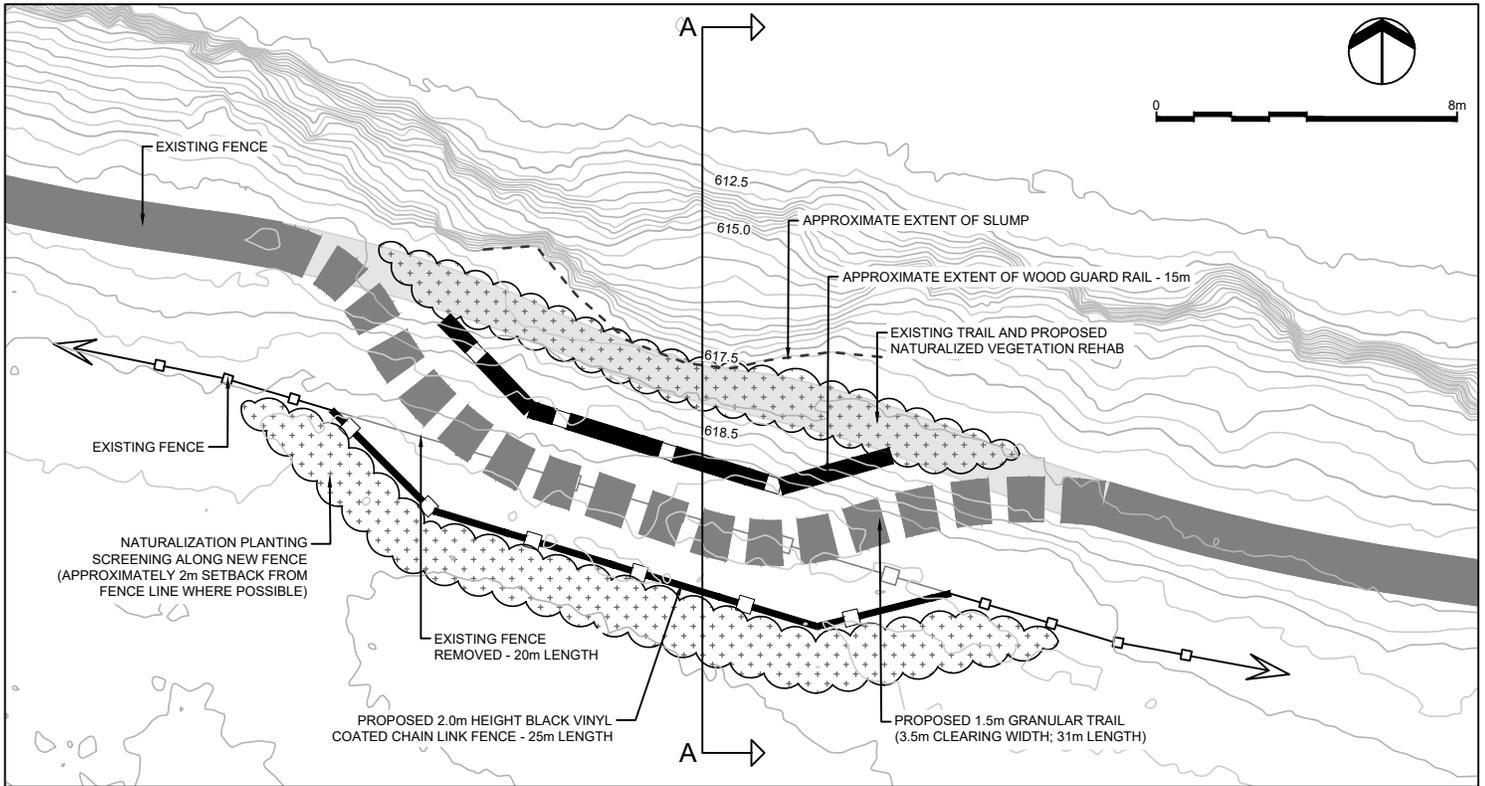
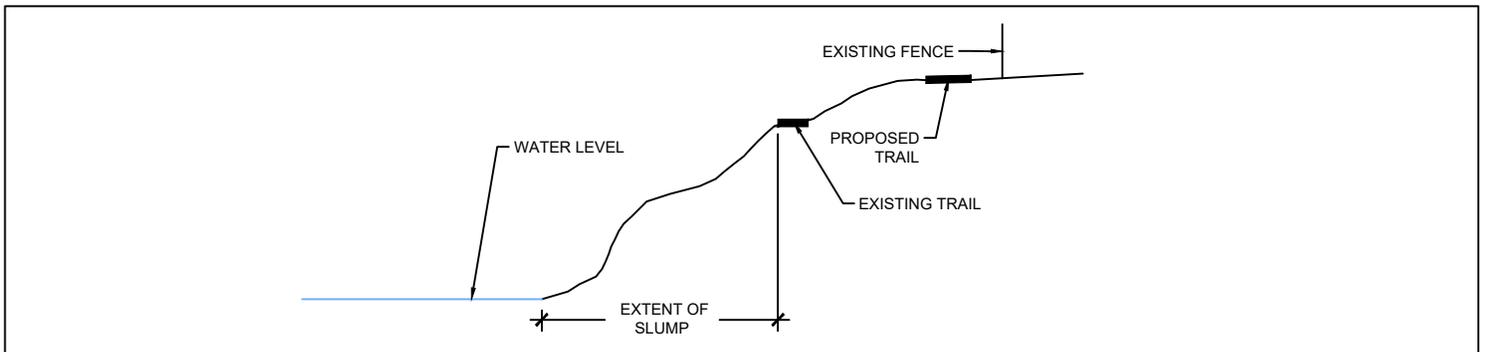
RIVER SIDE TRAIL RE-ALIGNMENT

LOCATION 6 OPTION: TRAIL RELOCATION TO AVOID SLUMPING BANK

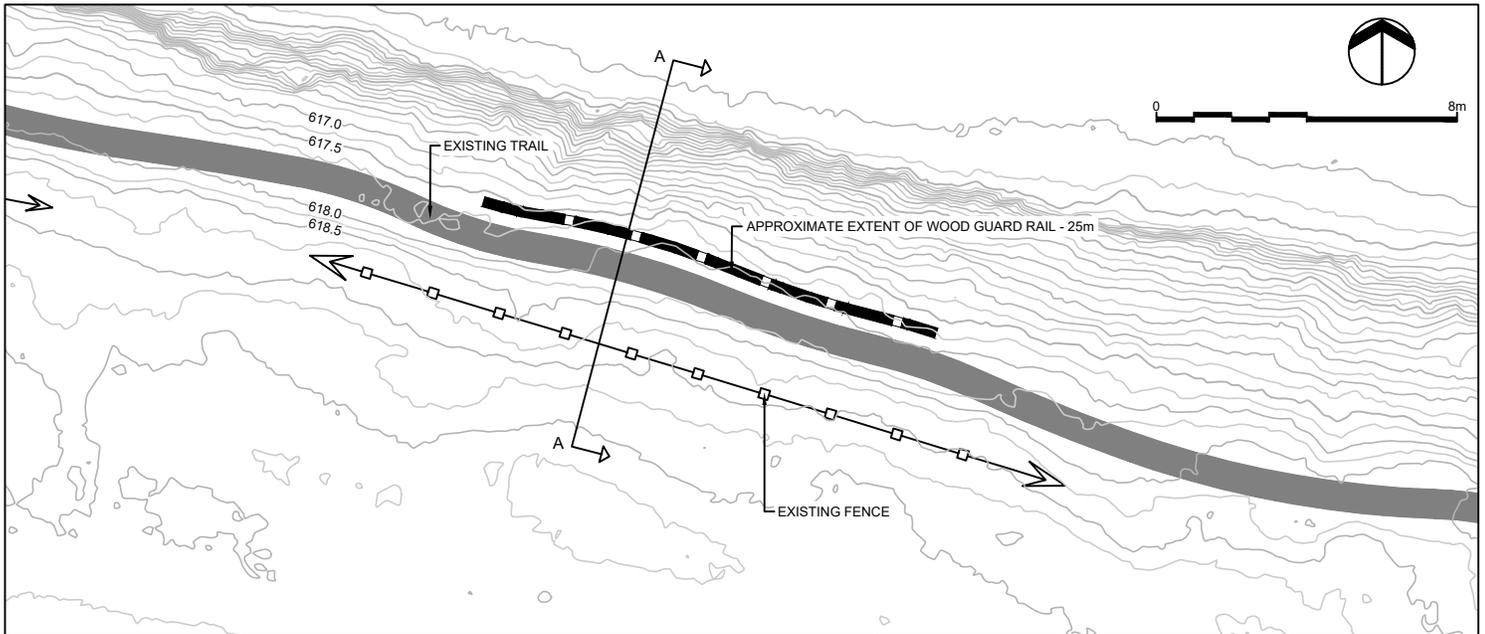
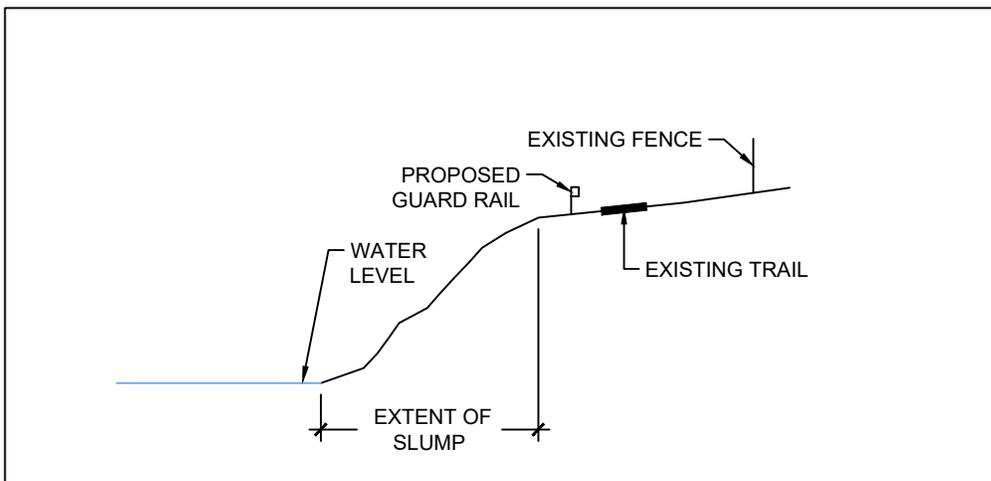
RIVER SIDE TRAIL RE-ALIGNMENT

LOCATION 7 OPTION: PROPOSED GUARD RAIL

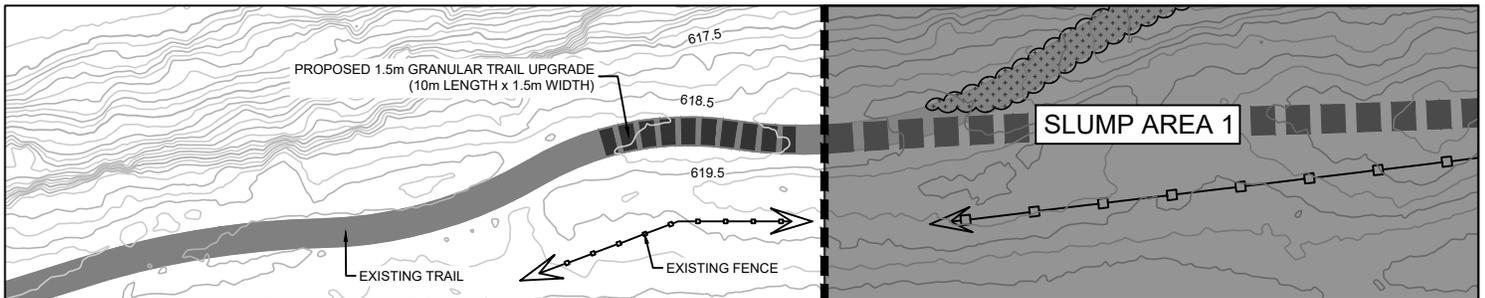
LOW AREA IN TRAIL LOCATION 1 - 10m LENGTH X 1.5m WIDTH

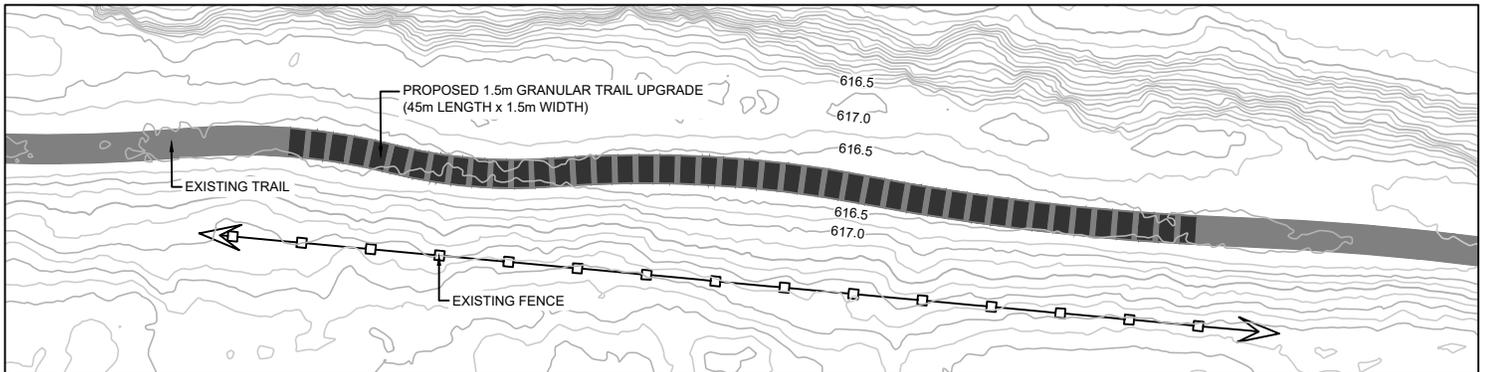
LOW AREA IN TRAIL LOCATION 2 - 45m LENGTH X 1.5m WIDTH
THURBER SITE 6

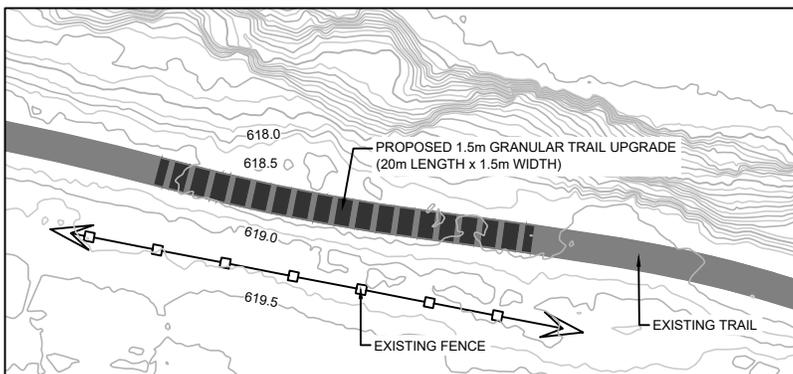
LOW AREA IN TRAIL LOCATION 3 - 20m LENGTH X 1.5m WIDTH

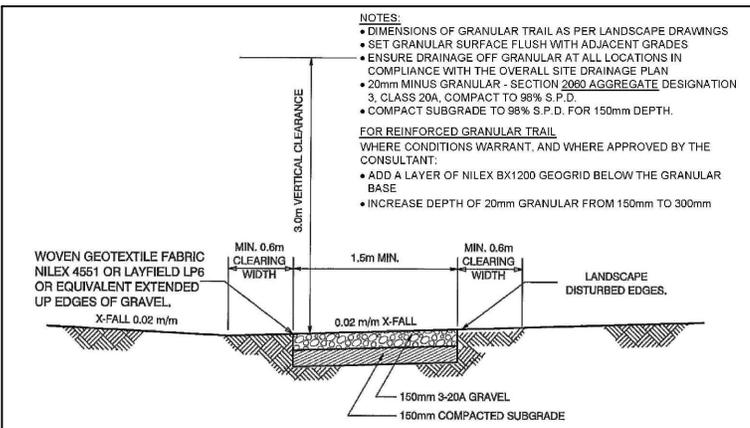
PROPOSED GRANULAR TRAIL DETAIL
