On April 7, 2019 - attempts were made to report an excavation failure and property damage to a 311 Agent.

On April 16, 2019 this is what the excavation failure and damage to adjacent property and building looked like.

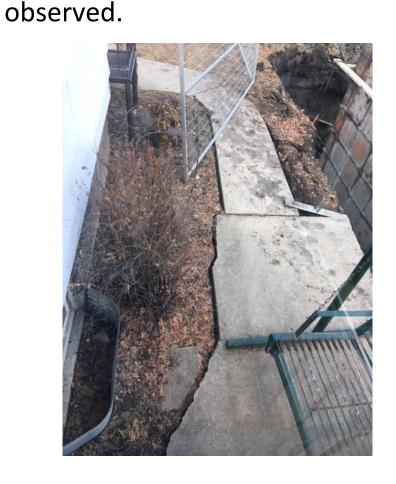
Movement of the sidewalk is

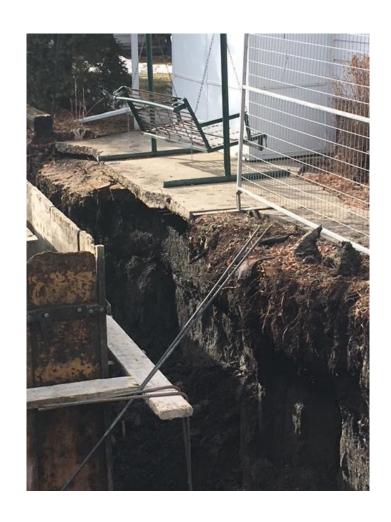
Sloughing of excavation walls is also observed.

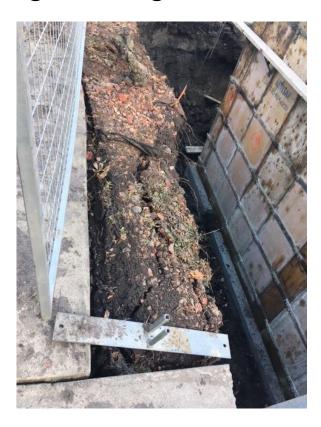
Fencing is no longer secure

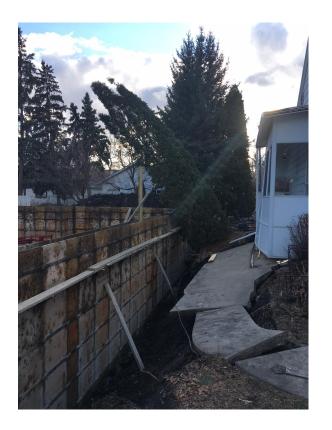
Failure continues and a tree falls over

"Was informed that the site conditions had deteriorated. . . . The whole north side of the north neighbour's property alongside his house is beginning to fail . . . a 30 foot high cedar tree is similarly leaning towards the excavation. This entire section of soil could fail completely at any moment.

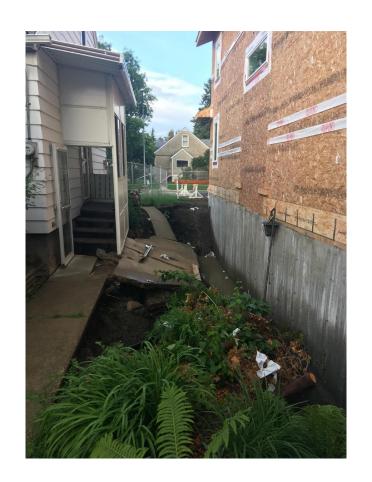
This July 9, 2019 photo shows the concrete slab is in the same place. Backfilling is still not done and there is water accumulation in the excavation.
