Environmental Impact Assessment Pursuant to Bylaw 7188

111 Street and Blackmud Creek Pedestrian Bridge Replacement Final Report

Project Number EP-861
December 2020

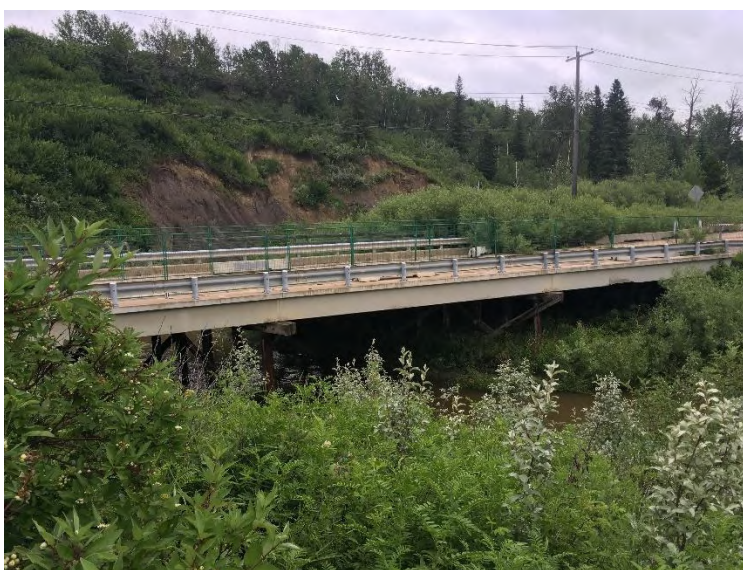
Plate 1.1. View to northeast (upstream) of pedestrian bridge crossing Blackmud Creek (24 July 2019)

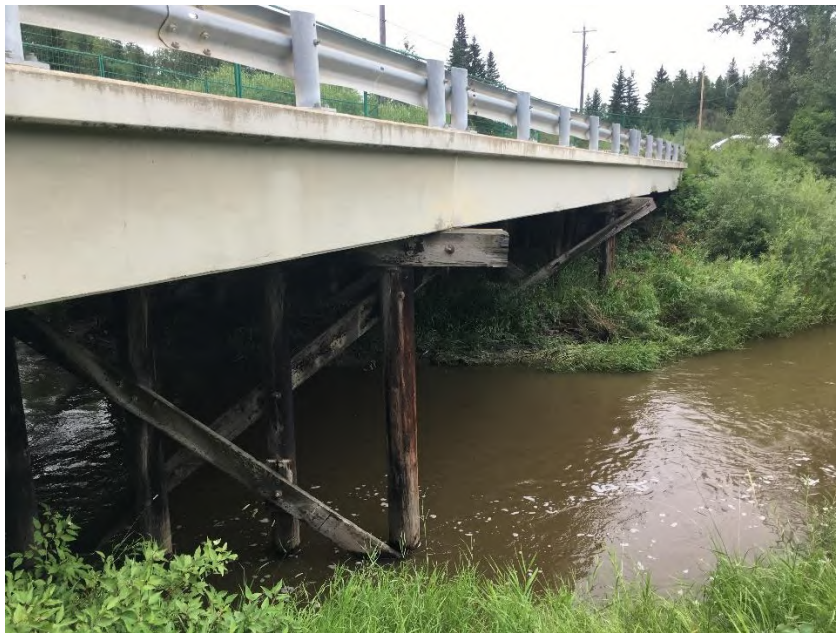
Plate 1.3. View to northwest of upstream side of the pedestrian bridge and treated timber pilings structures (24 July 2019)

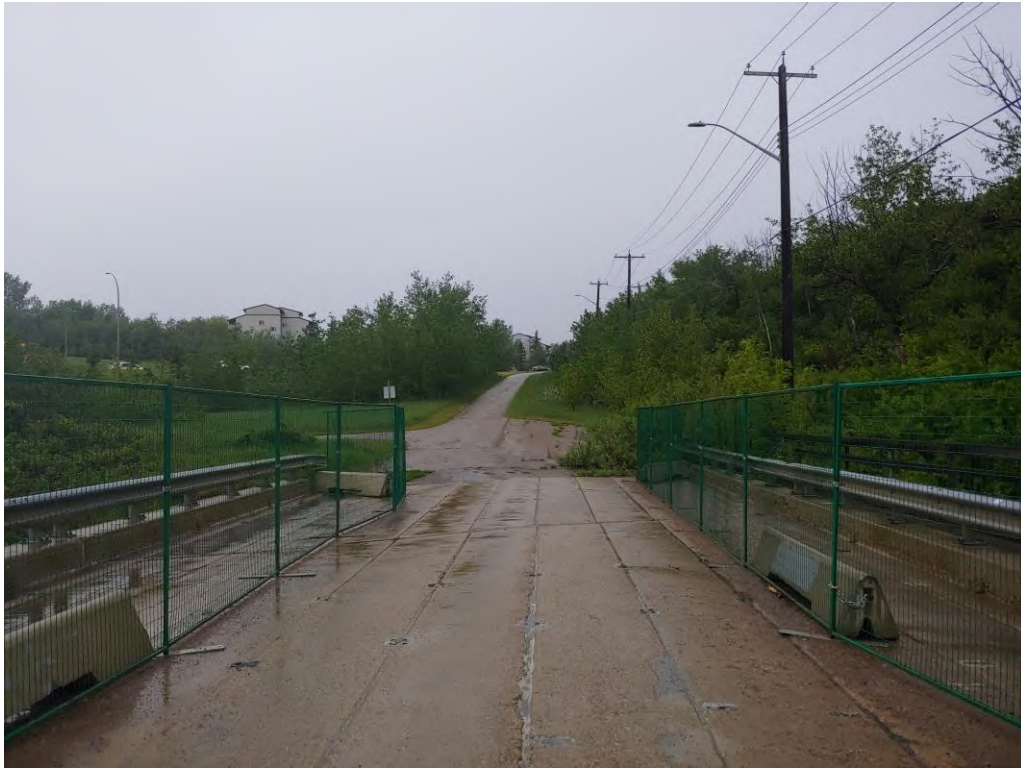
Photo 1 – View of 111st pedestrian bridge (looking north).

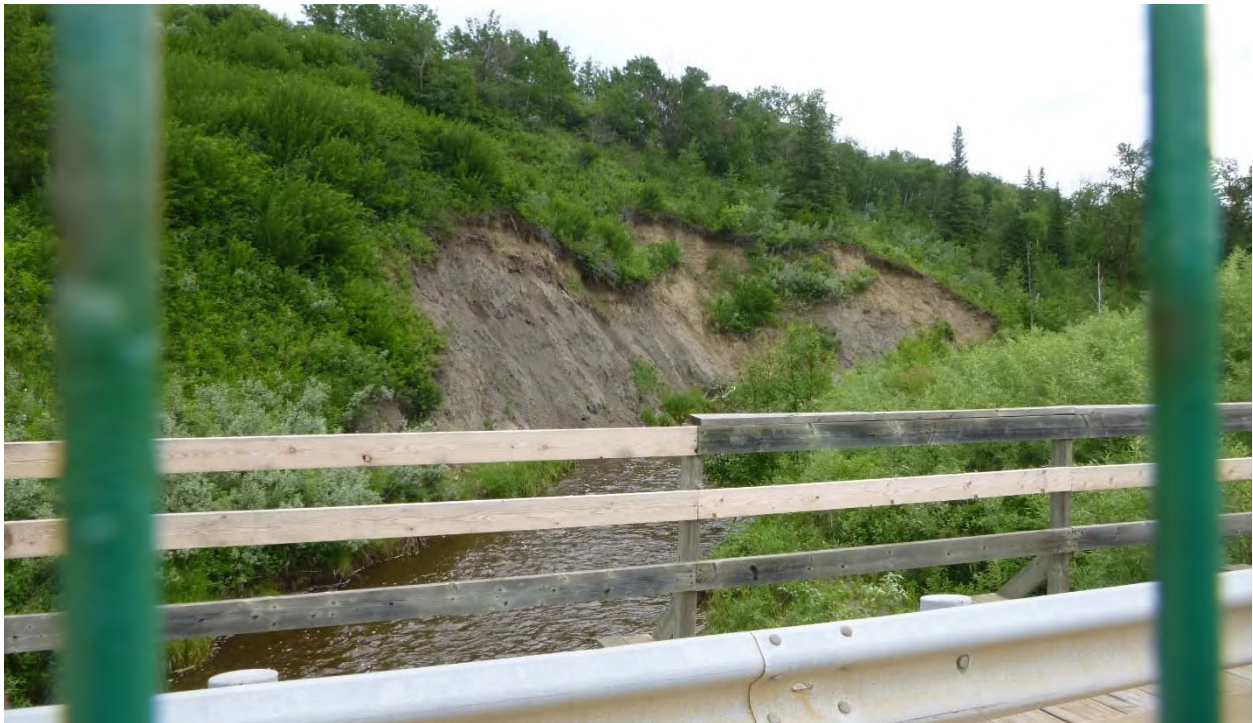
Plate 2. Bedrock of the Horseshoe Canyon Formation just east of the existing bridge, Z1.

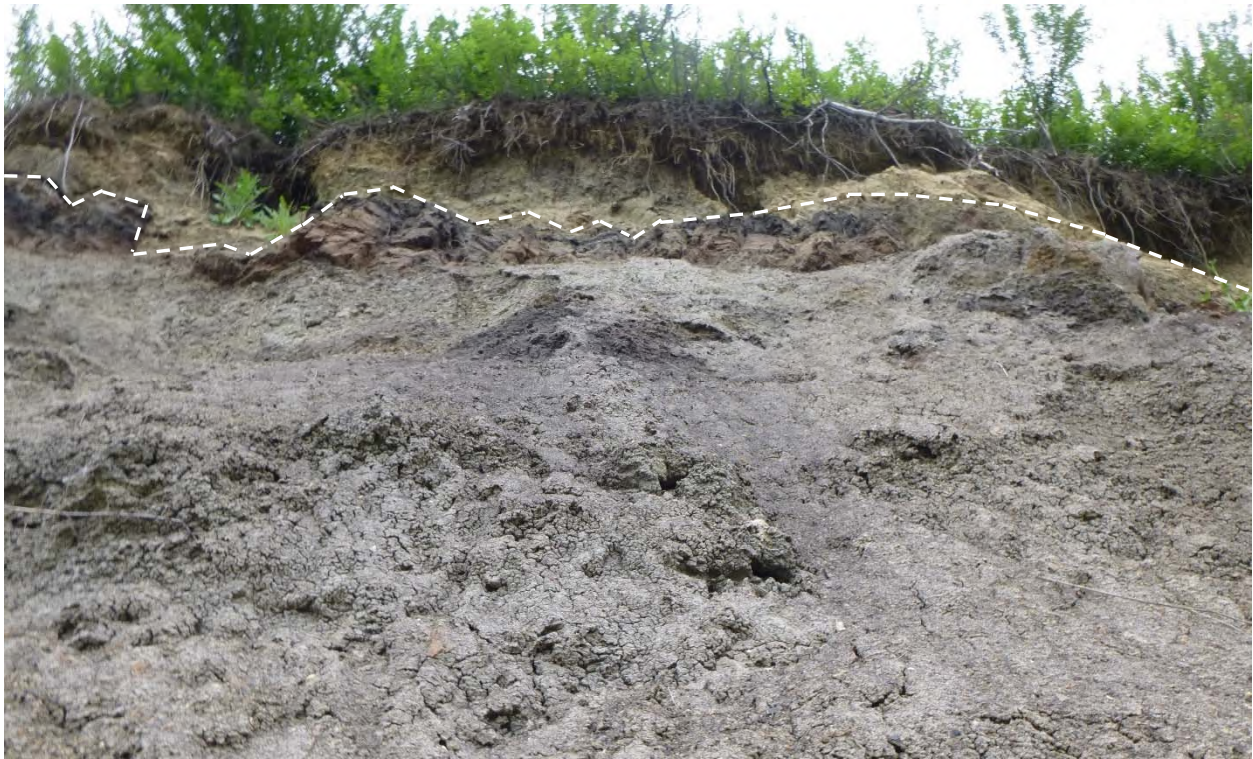
Plate 3. Bedrock of the Horseshoe Canyon Formation overlain by glaciolacustrine silt, Z1.

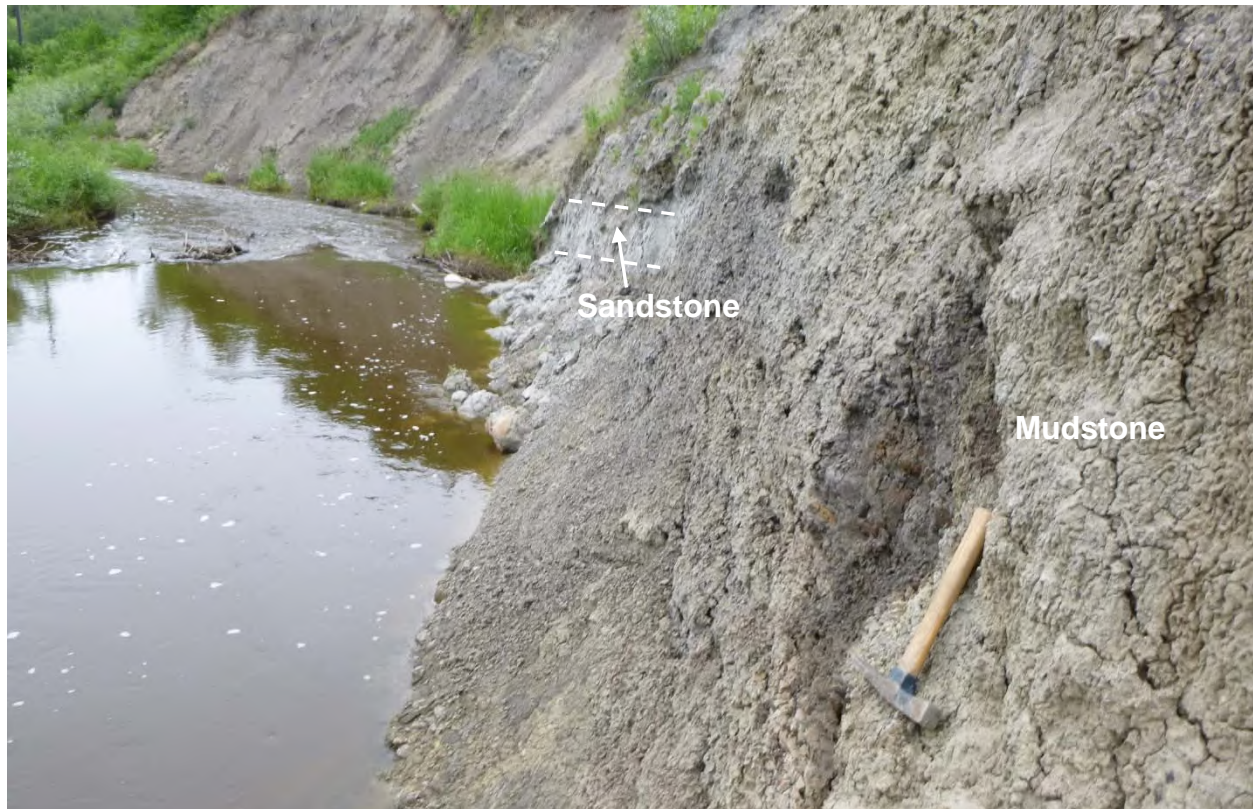
Plate 5. Crumbly dark grey mudstone and interbedded siltstone, Z1.

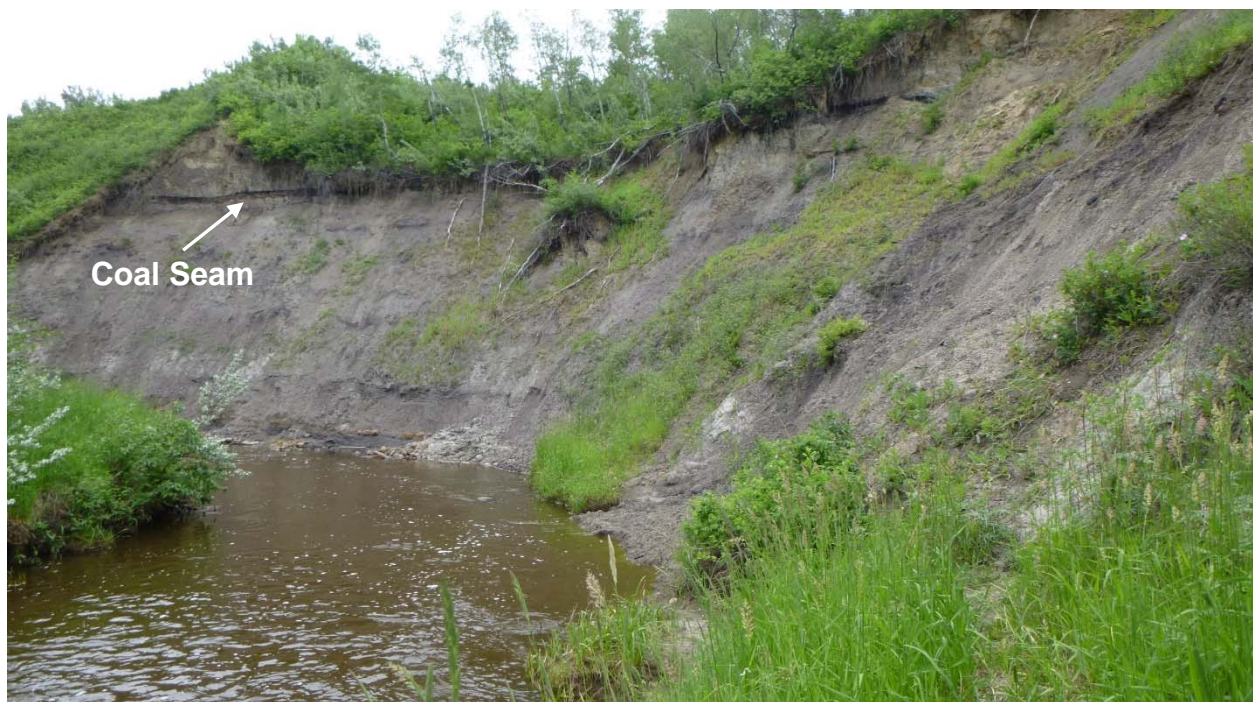
Plate 6. Coal seam at the top of the exposure, Z4 and Z5.

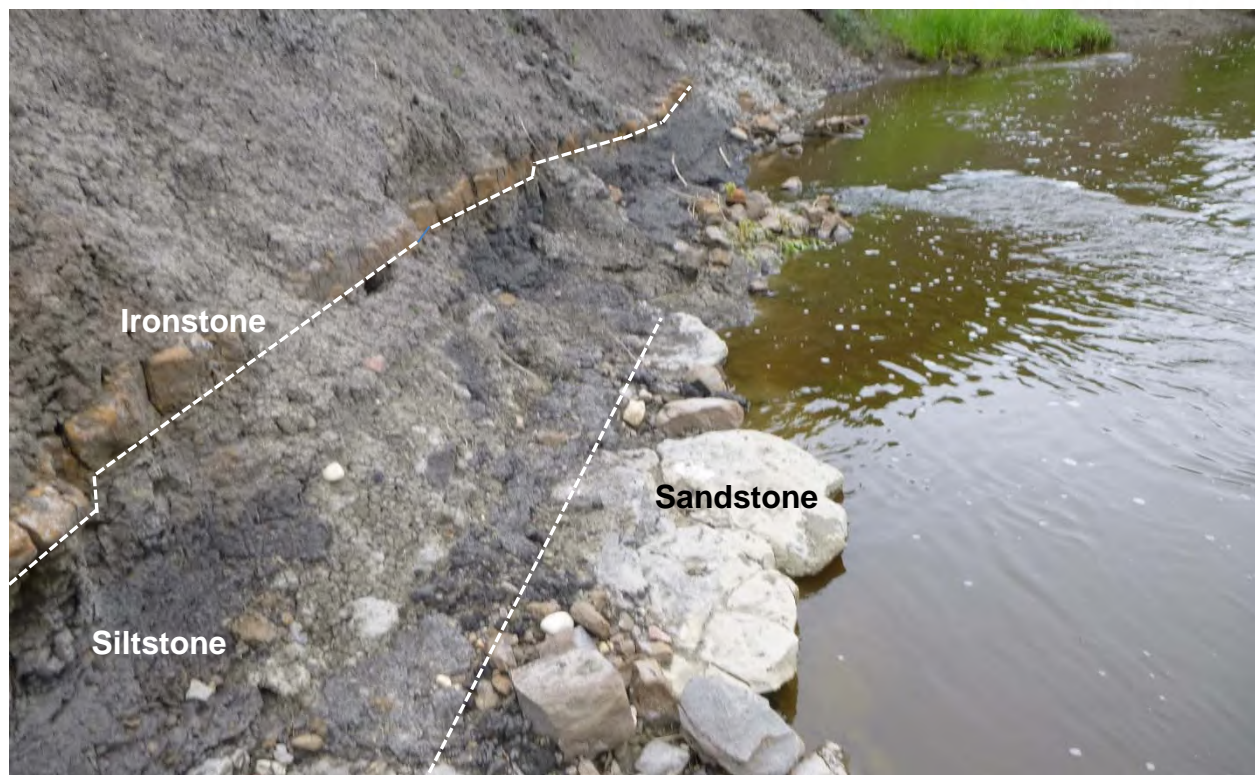
Plate 7. Indurated grey sandstone, grey dark grey siltstone and blocky ironstone, Z5.

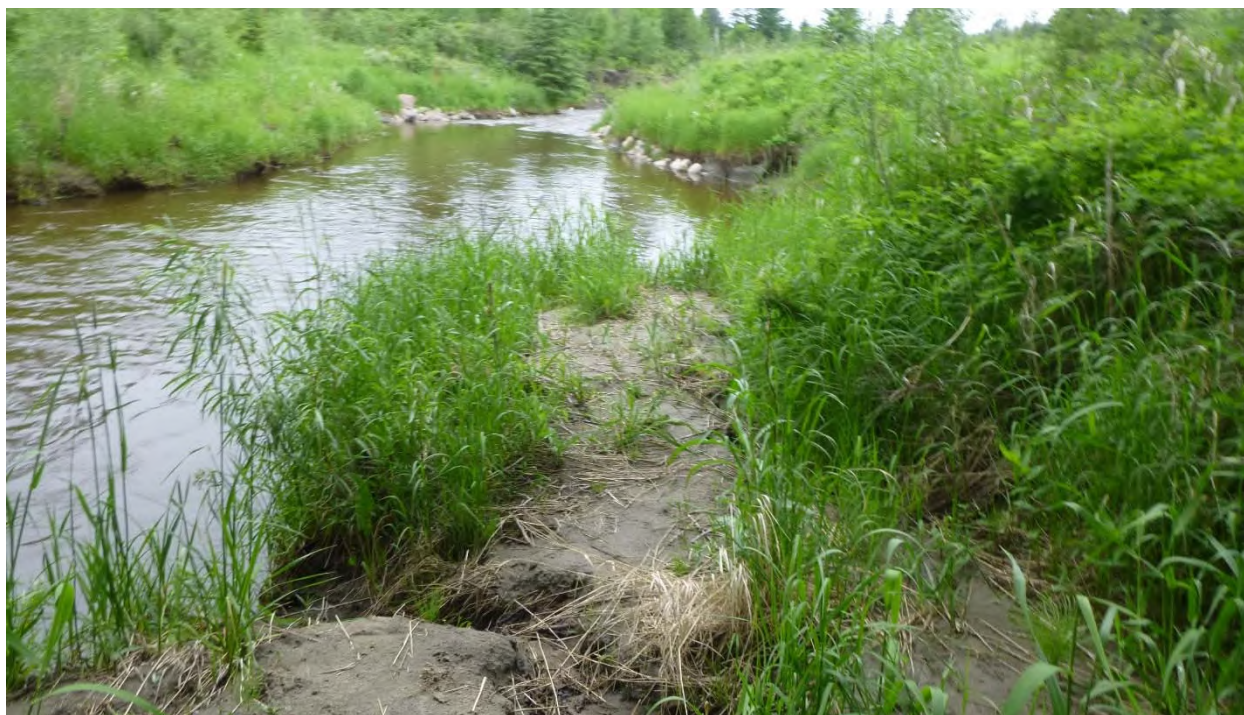
Plate 10. Modern river alluvium of silt and sand, Z2.

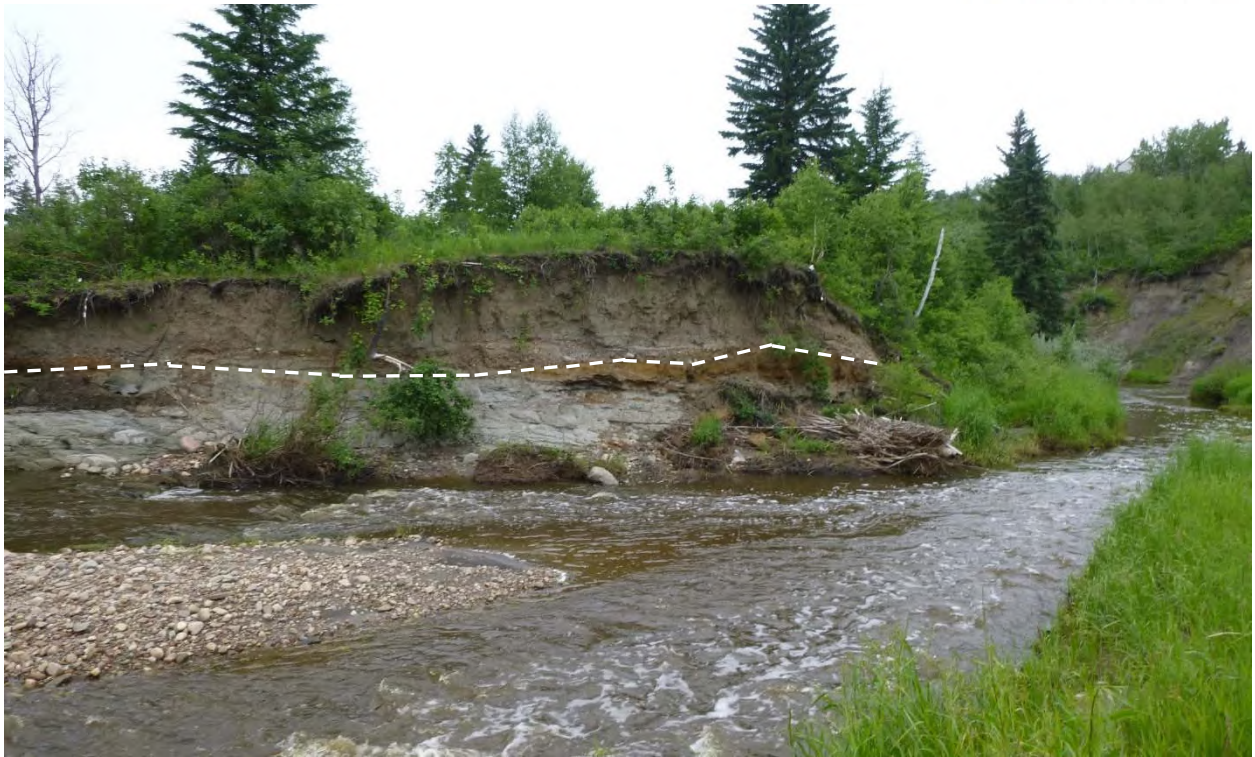
Plate 11. Holocene alluvial deposits of gravel and silt overlying bedrock, Z3.
