GEC Architecture

EIA Amendment
Fort Edmonton Park
Steam Train Re-location

September 2018

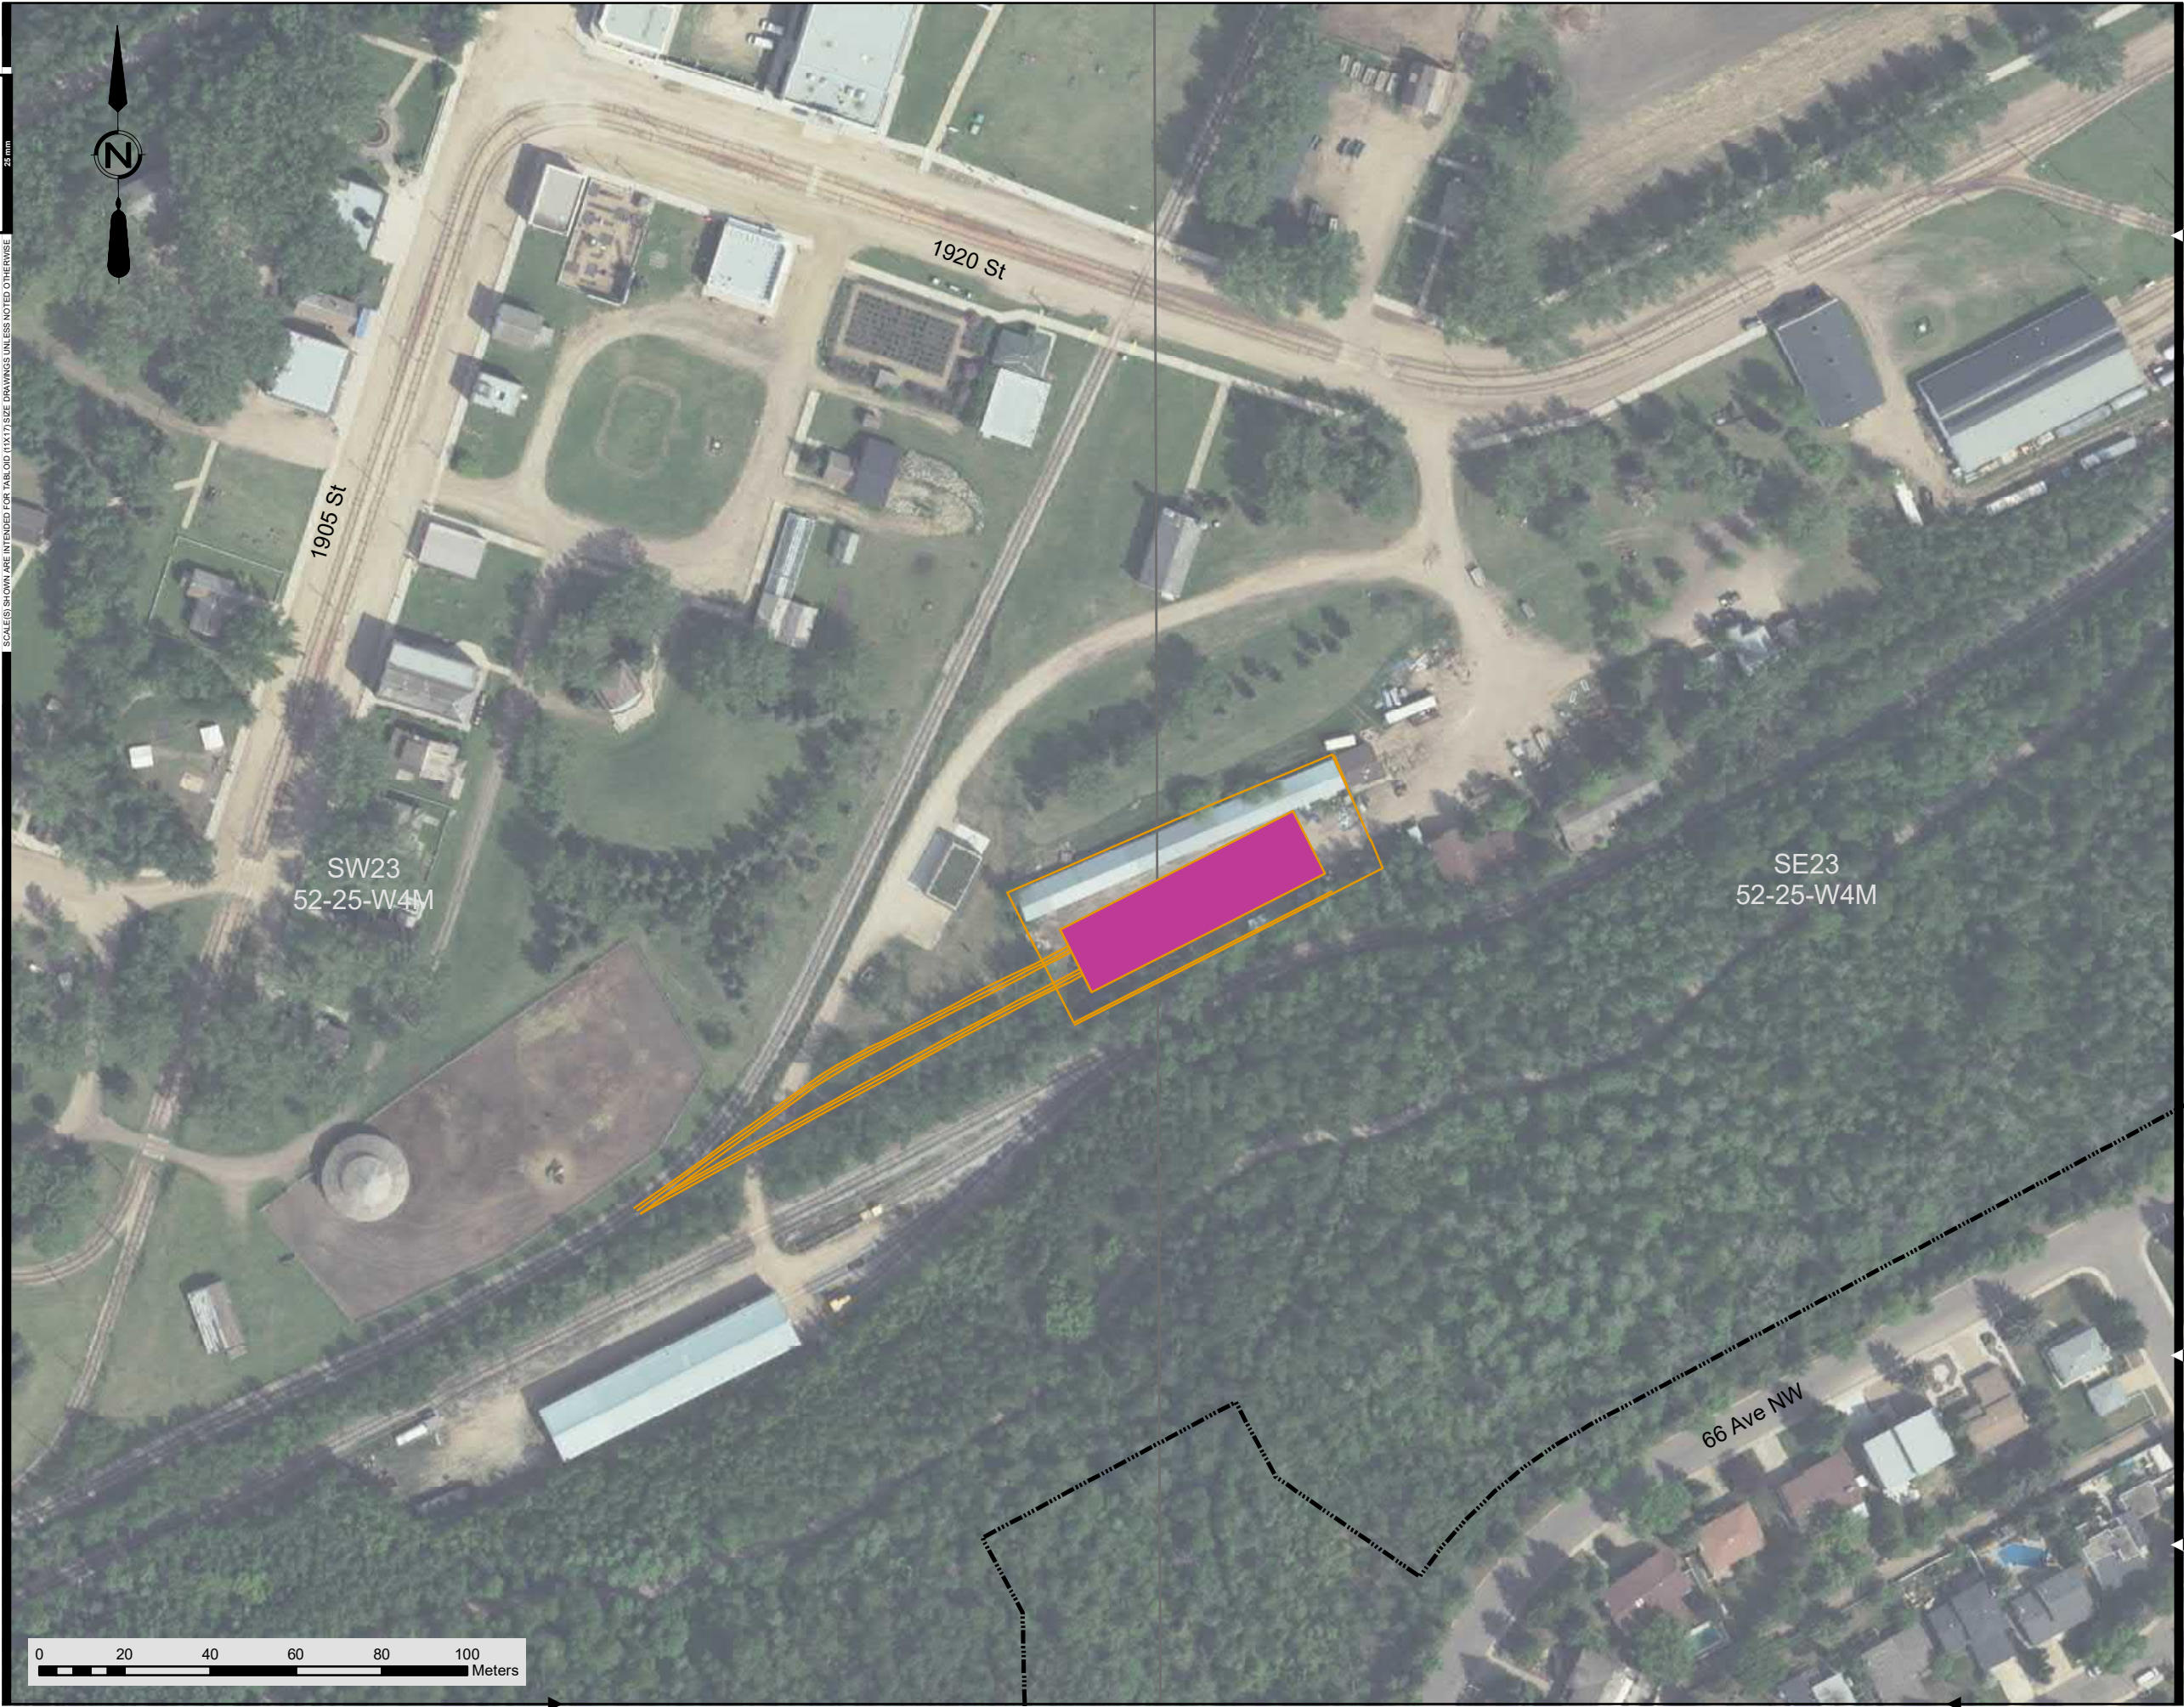
The project will involve re-locating the train barn to the existing maintenance yard and installing new tracks that will connect to the existing steam train tracks to the west (**Figure 2-1**). The train barn will serve as a maintenance building for train servicing and train storage. It will be approximately 9.5 m in height with a footprint of 950 m² and it will be constructed using a slab foundation on grade with perimeter beams and piles. Within the train barn, two maintenance pits, including a 49.77 m² inspection pit and a 11.81 m² wheel pit, will be constructed below grade. An existing fuel tank storage building will be relocated to the southeast corner of the new site. In addition, two sets of single tracks, constructed using steel rails and wooden ties, will connect the train barn to the existing steam train tracks. The existing main loop track will be re-aligned slightly to accommodate the new sets of tracks. Both sets of tracks will be approximately 80 m in length and 2.5 m in width. A detailed design drawing of the project site plan is shown on **Figure 2-2**.

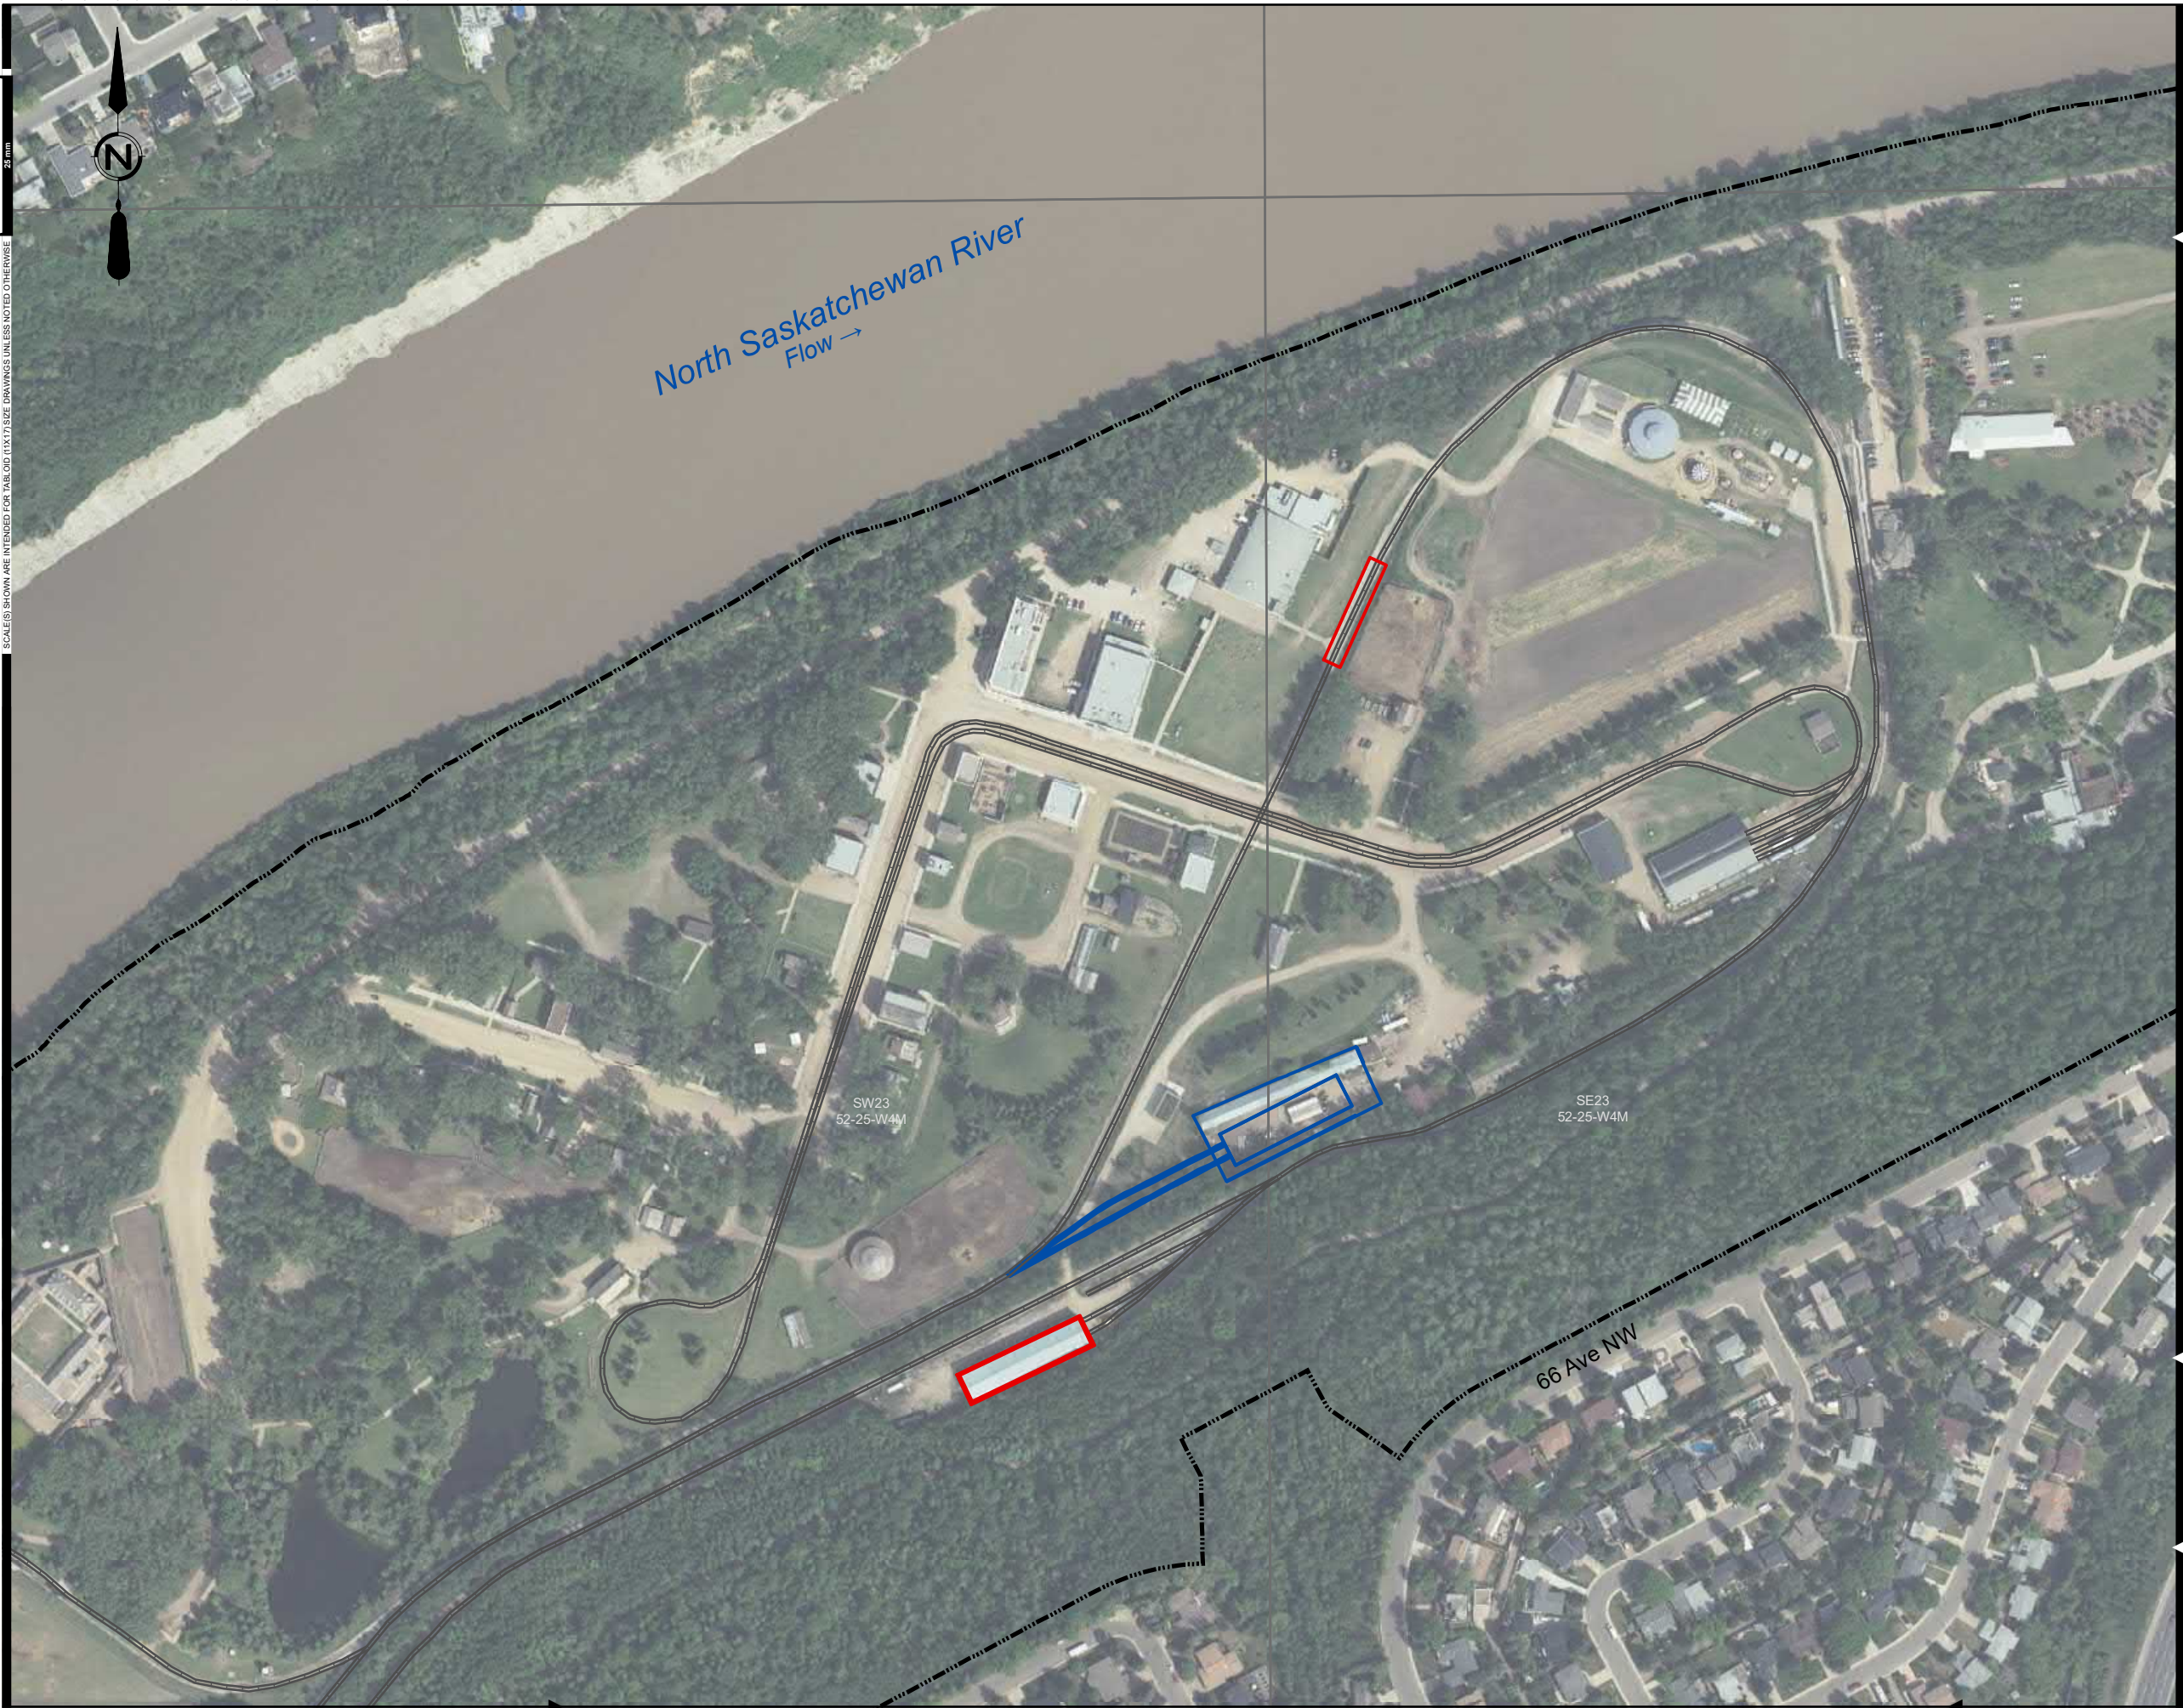
Two options were considered to meet the needs for updating and replacing the existing steam train building. The first option considered was to construct a new pre-engineered train barn at the existing site while using a temporary structure for train storage and maintenance until the new train barn was completed (Figure 3-1). However, the existing steam train site is not serviced and would require construction of utilities, as well as, stabilization of the embankment, and remediation work, which would be costly and involve potentially significant impacts to the environment. In addition, it was determined that a larger building would be required to allow for proper maintenance of the steam train in accordance with building code and Occupational Health & Safety standards and the current site does not provide sufficient space. The second option involved construction of a new pre-engineered train barn with tie in tracks at the site of a current maintenance yard located approximately 100 m northeast of the existing steam train location (Figure 3-1).

The maintenance yard is on low grade gravel and contains a tin storage shed, a fuel storage tank building, four wood sheds, two sea cans and, various pieces of equipment. West of the maintenance yard, where the proposed tracks will be located, there is a small naturally treed area and an open grassy area that have been previously fragmented by the existing steam train tracks and a service road. Ultimately, the second option of re-locating the steam train was selected as it can safely accommodate the size of building that is required for the new building as well as potential future expansions, it is fully serviced, and the steam train and its contents can remain in place until the new structure is completed.

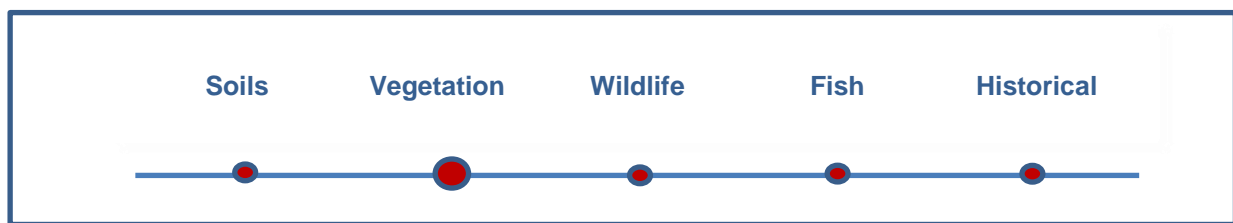
7.2.2 Train Tracks

Two sets of single tracks, constructed using steel rails and wooden ties, will connect the train barn to the existing train tracks within FEP. Both sets of tracks will be approximately 80 m in length to the train barn. Permanent tree removal and vegetation clearing is required through a forest stand mapped as Class B and C sensitivity habitats. Approximately 520 m² of Class C and 126 m² of Class B sensitivity habitats will be cleared for the construction and installation of the train tracks (**Figure 7-1**). Additionally, the re-alignment activities of the main loop track may involve handling and removal of creosote-treated ties. Excavation is not anticipated for the construction of the tracks; however, if creosote-treated ties need to be removed they will need to be disposed of at an appropriate waste management facility.

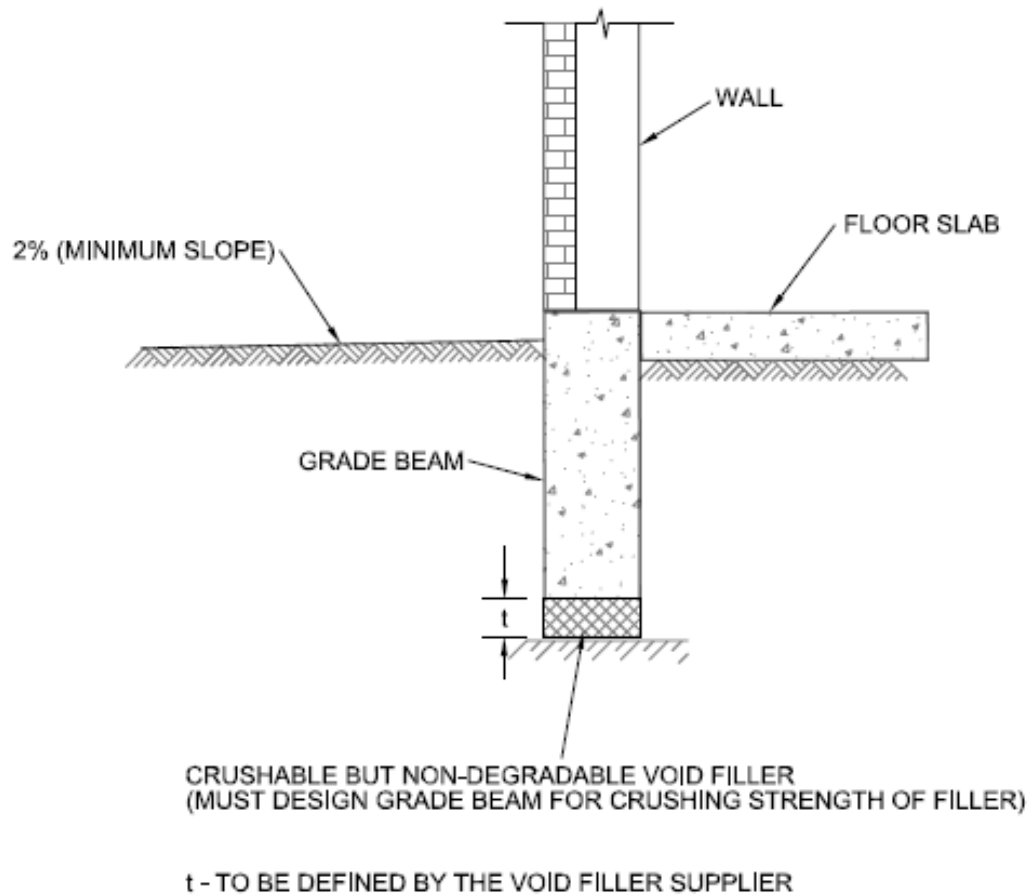
FIGURE 6.1

The recommended construction procedures for preventing heave under the grade beam are through use of a crushable non-degradable void form material (such as Beaver Plastics Frost Cushion) as shown in Figure 6.1. The grade beam must be designed in accordance with the crushing strength of the void filler used and the piles must be able to resist the resulting uplift load.

TYPICAL UNINSULATED GRADE BEAM
BASE OF GRADE BEAM ABOVE ZONE OF SEASONAL VOLUME CHANGE

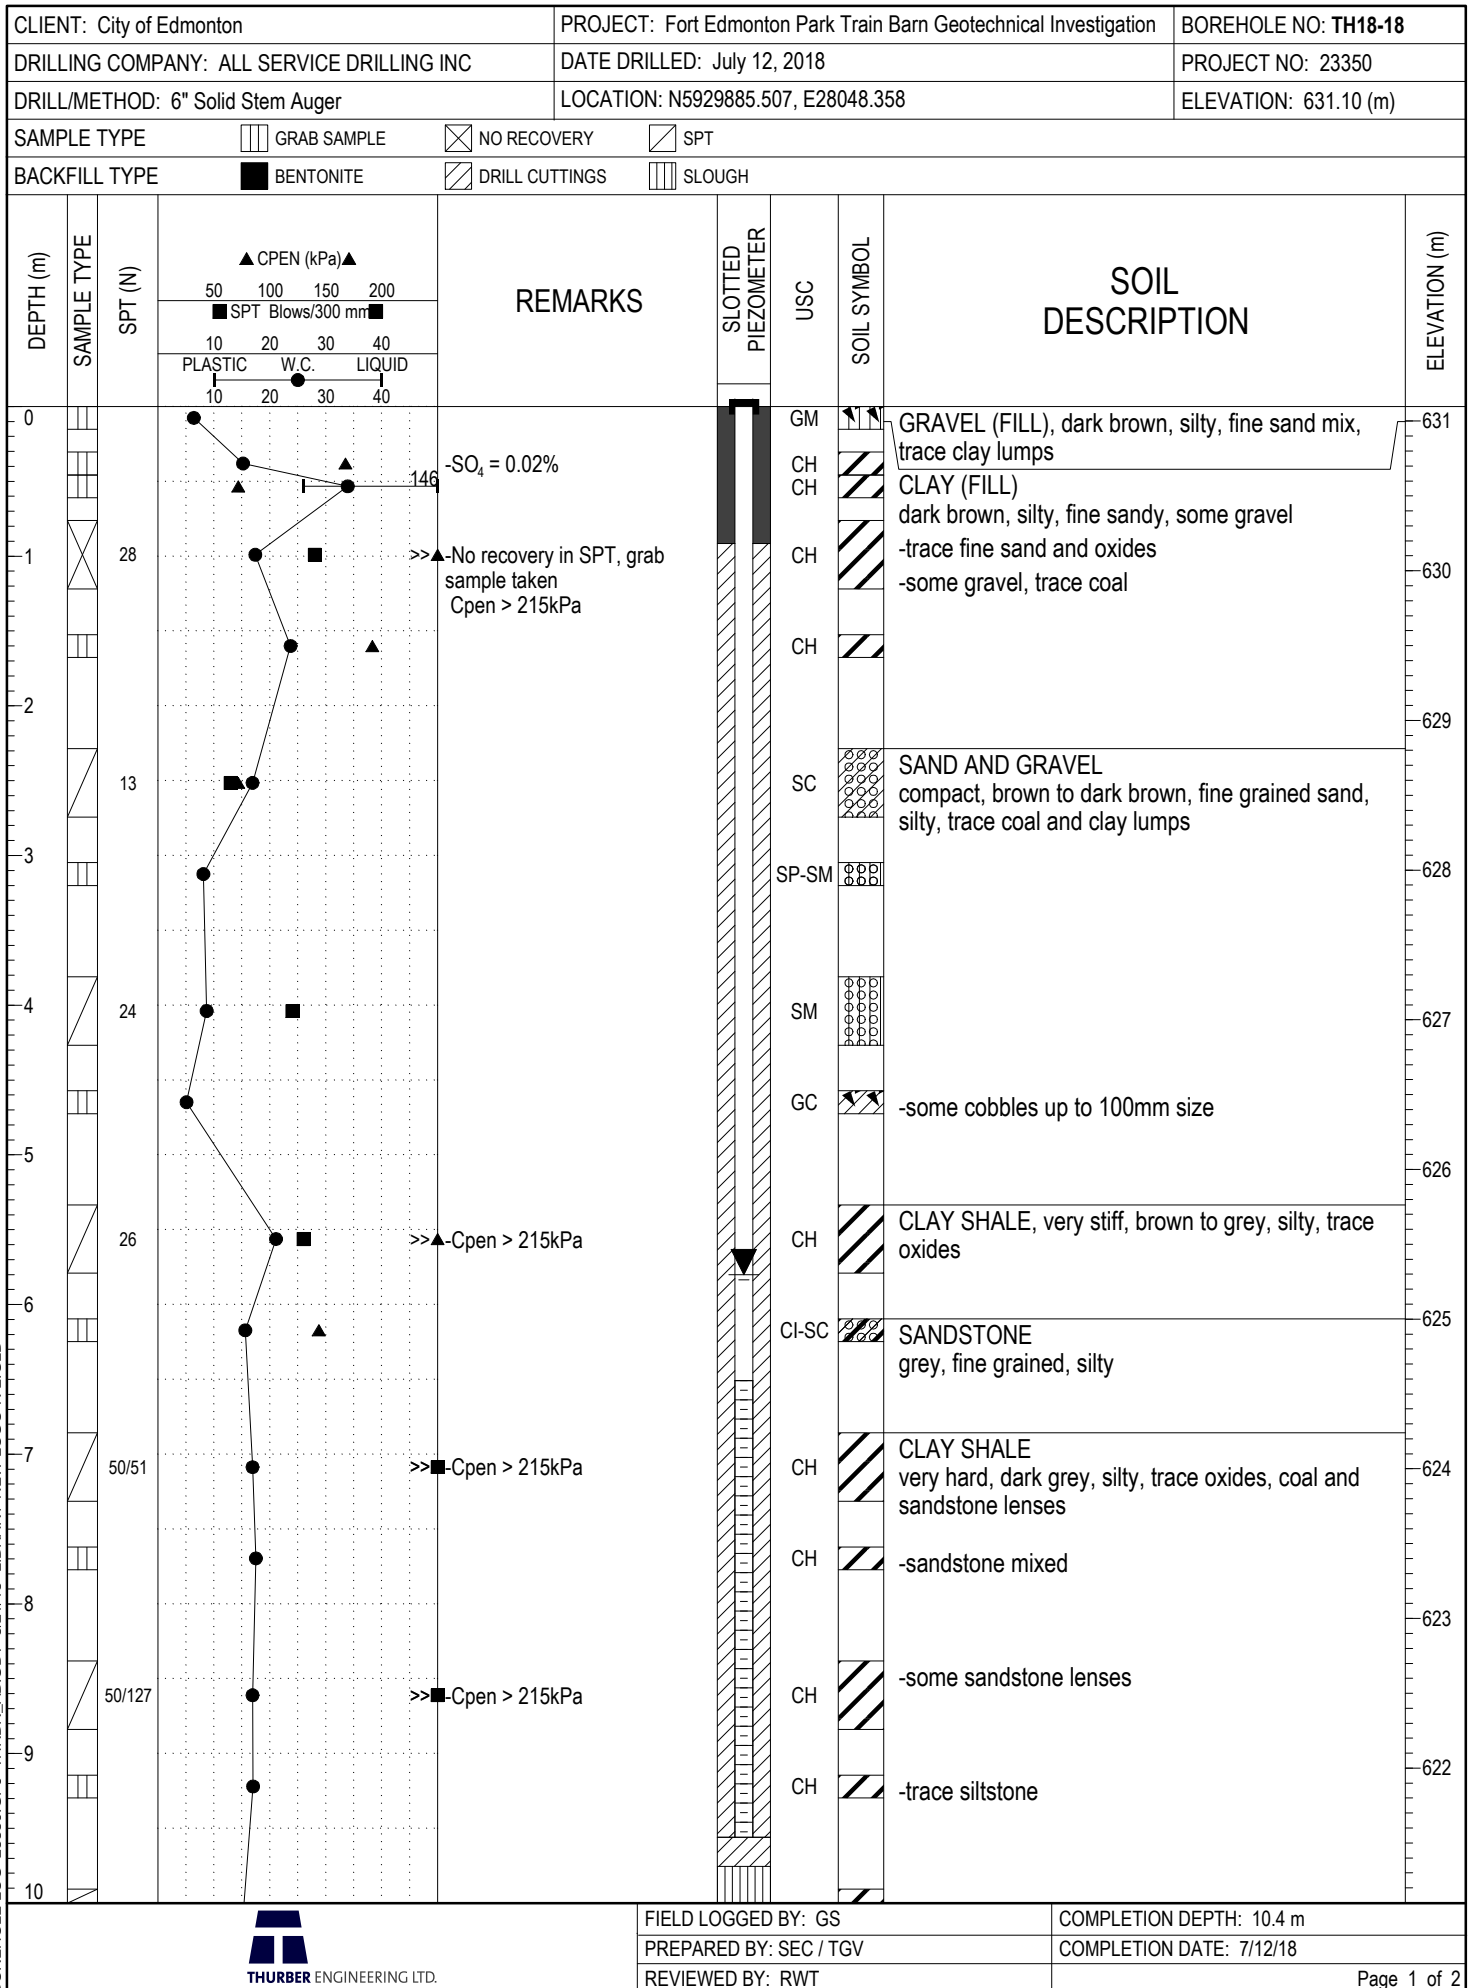
CLIENT: City of Edmonton			PROJECT: Fort Edmonton Park Train Barn Geotechnical Investigation			BOREHOLE NO: TH18-18		
DRILLING COMPANY: ALL SERVICE DRILLING INC			DATE DRILLED: July 12, 2018			PROJECT NO: 23350		
DRILL/METHOD: 6" Solid Stem Auger			LOCATION: N5929885.507, E28048.358			ELEVATION: 631.10 (m)		
SAMPLE TYPE			<input type="checkbox"/> GRAB SAMPLE <input checked="" type="checkbox"/> NO RECOVERY <input checked="" type="checkbox"/> SPT					
BACKFILL TYPE			<input checked="" type="checkbox"/> BENTONITE <input checked="" type="checkbox"/> DRILL CUTTINGS <input type="checkbox"/> SLOUGH

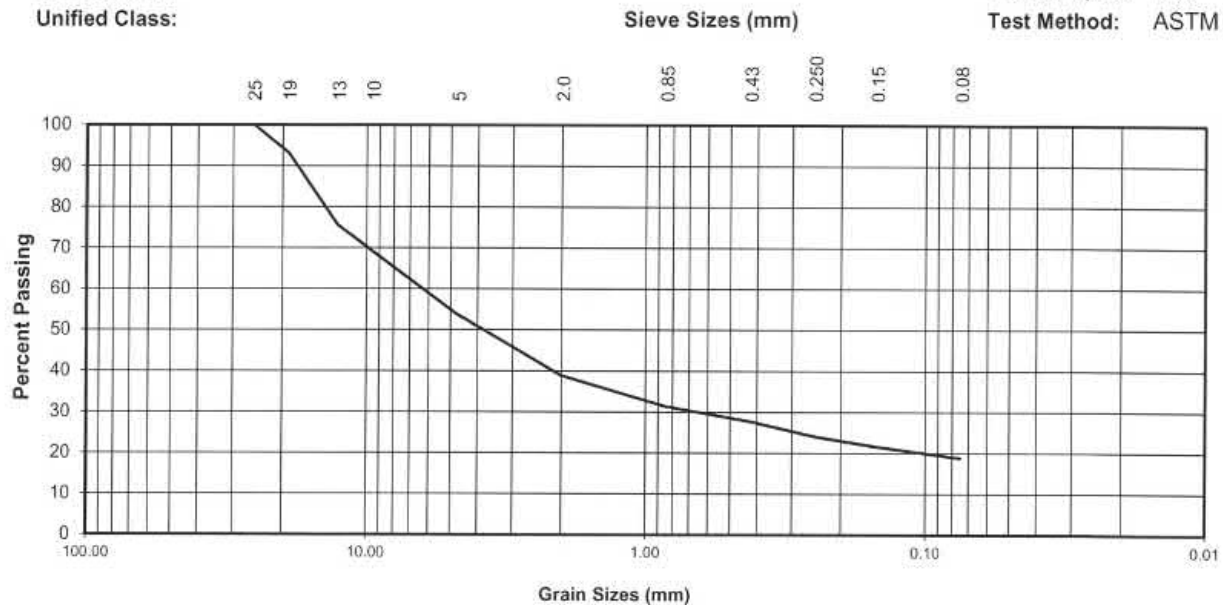
Sieve No.	Opening (mm)	Percent Passing	Gradation Limits	
			Max	Min
1.0 ins	25.4	100.0		
3/4 ins	19.1	93.1		
1/2 ins	12.7	75.6		
3/8 ins	9.53	69.2		
#4	4.75	53.8		
#10	2	38.8		
#20	0.85	31.3		
#40	0.425	27.7		
#60	0.25	24.1		
#100	0.15	21.6		
#200	0.075	18.8

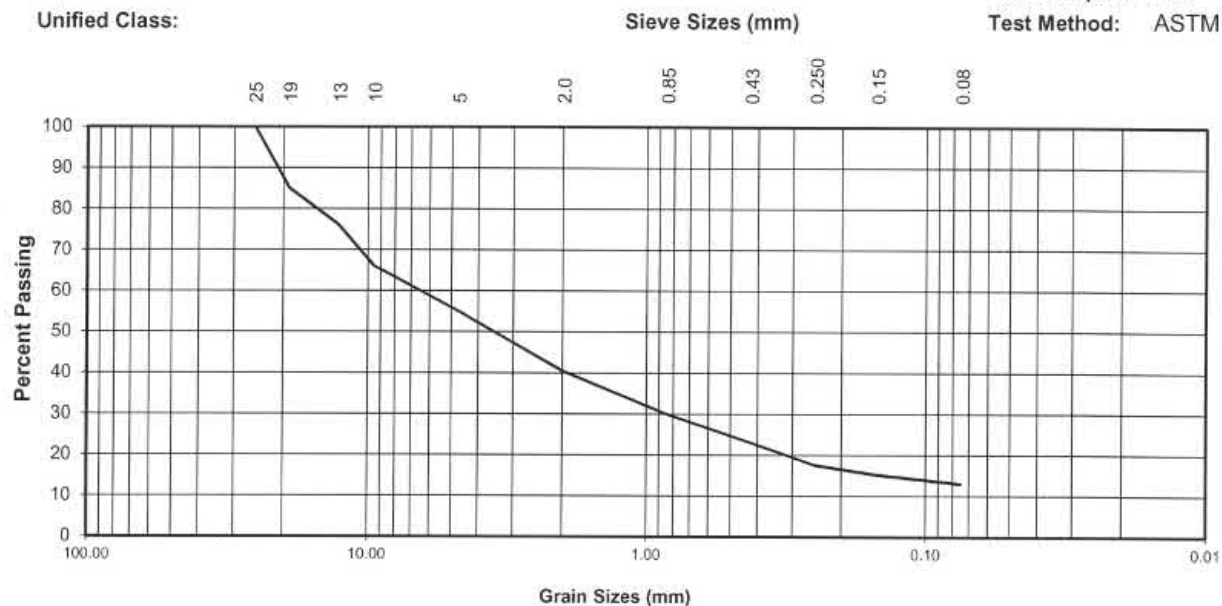
Client: COE**Project:** Fort Edmonton Train Barn Replacement**SIEVE ANALYSIS REPORT****Project No.:** 23350**Date:** 20-Jul-18**Sample Source:** TH18-17 P7 @ 12.5 - 14.0 ft.**Material Type:****Specification:****Unified Class:****Date Tested:** 20-Jul-18**Sampled by:** N/A**Date Sampled:** N/A**Test Method:** ASTM C 136

Sieve No.	Opening (mm)	Percent Passing	Gradation Limits	
			Max	Min
1.0 ins	25.4	100.0		
3/4 ins	19.1	85.0		
1/2 ins	12.7	76.0		
3/8 ins	9.53	66.1		
#4	4.75	55.1		
#10	2	40.4		
#20	0.85	30.0		
#40	0.425	23.1		
#60	0.25	17.6		
#100	0.15	15.2		
#200	0.075	13.0

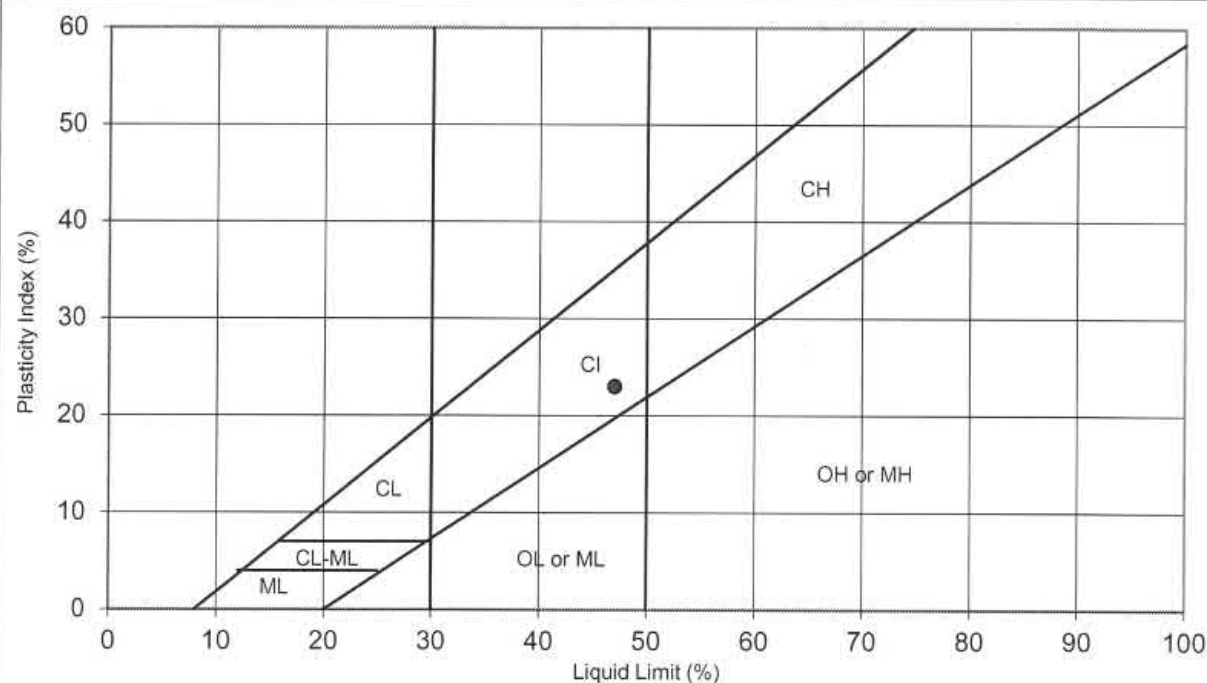
Liquid Limit:	47
Plastic Limit:	24
Plasticity Index:	23
USC Classification:	CI

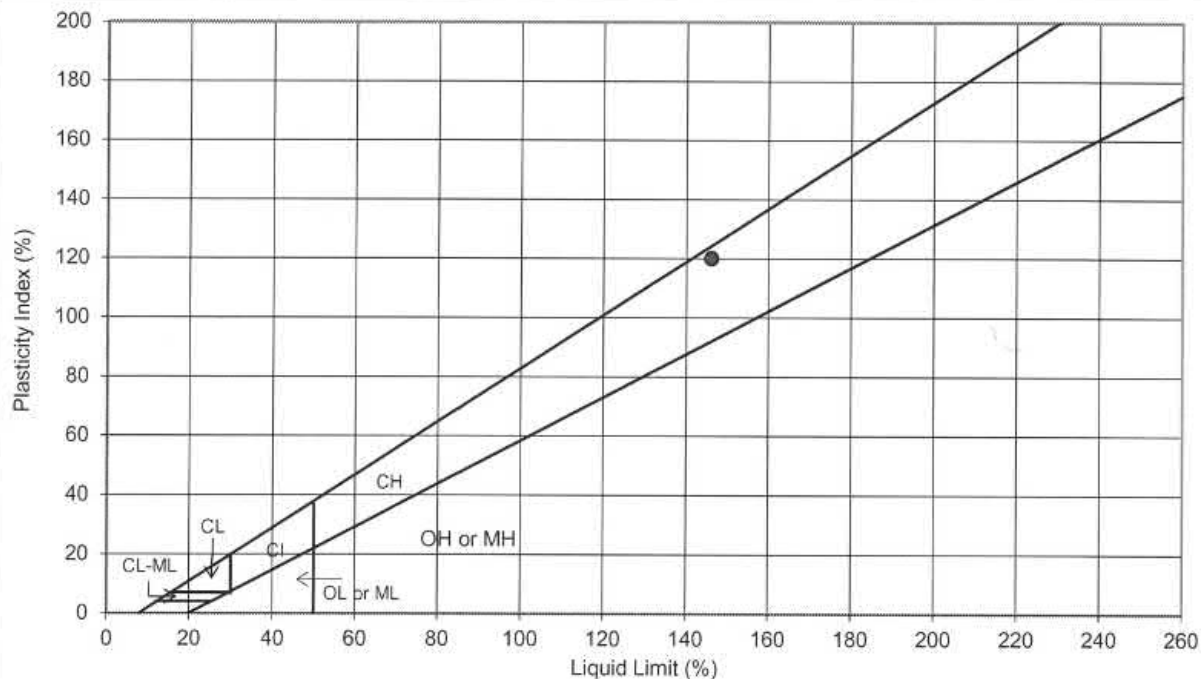
Liquid Limit: 146
Plastic Limit: 26
Plasticity Index: 120
USC Classification: CH

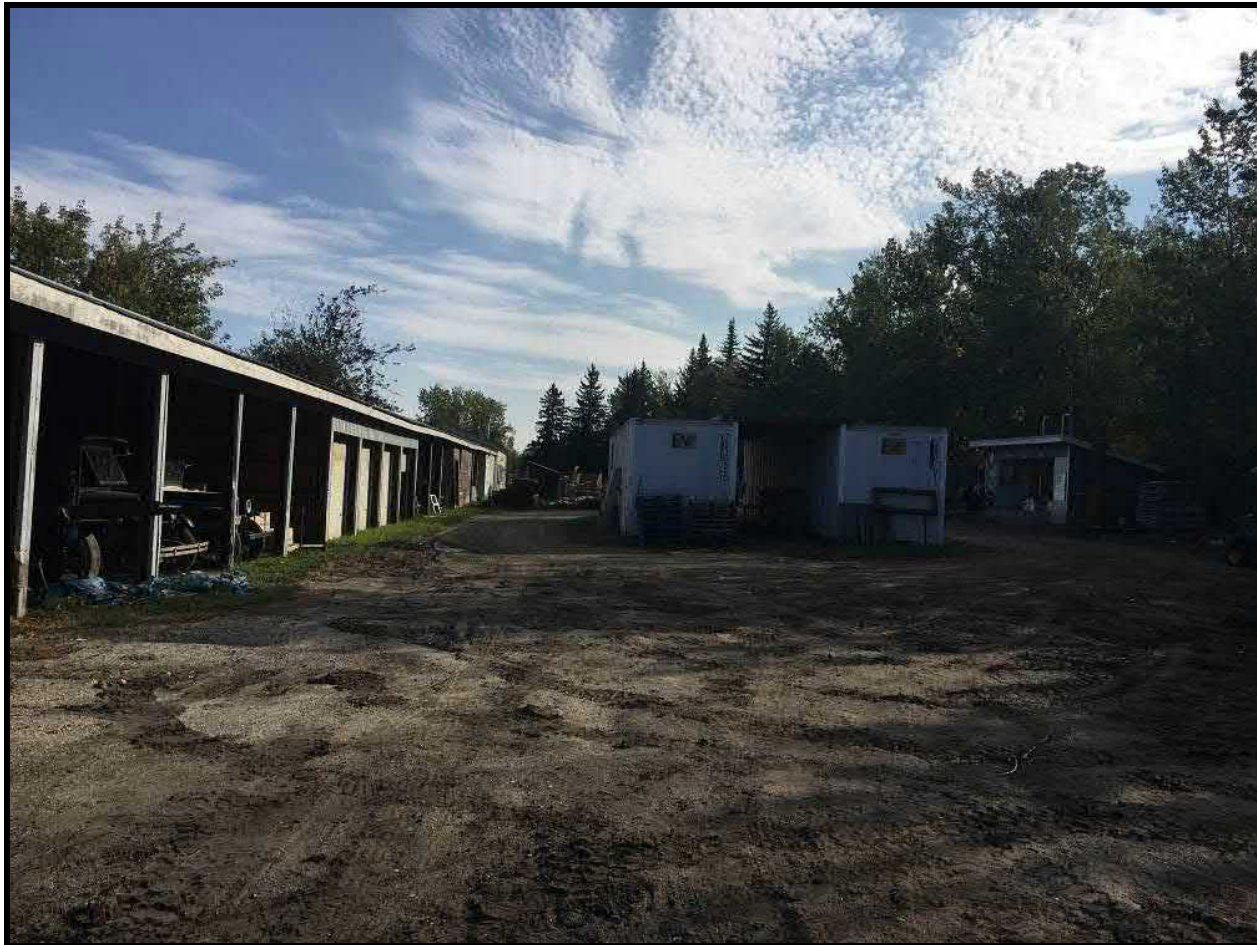
Photograph 1: The northeast portion of the Property, including the main storage building, intermodal containers, and AST shed (September 7, 2018).

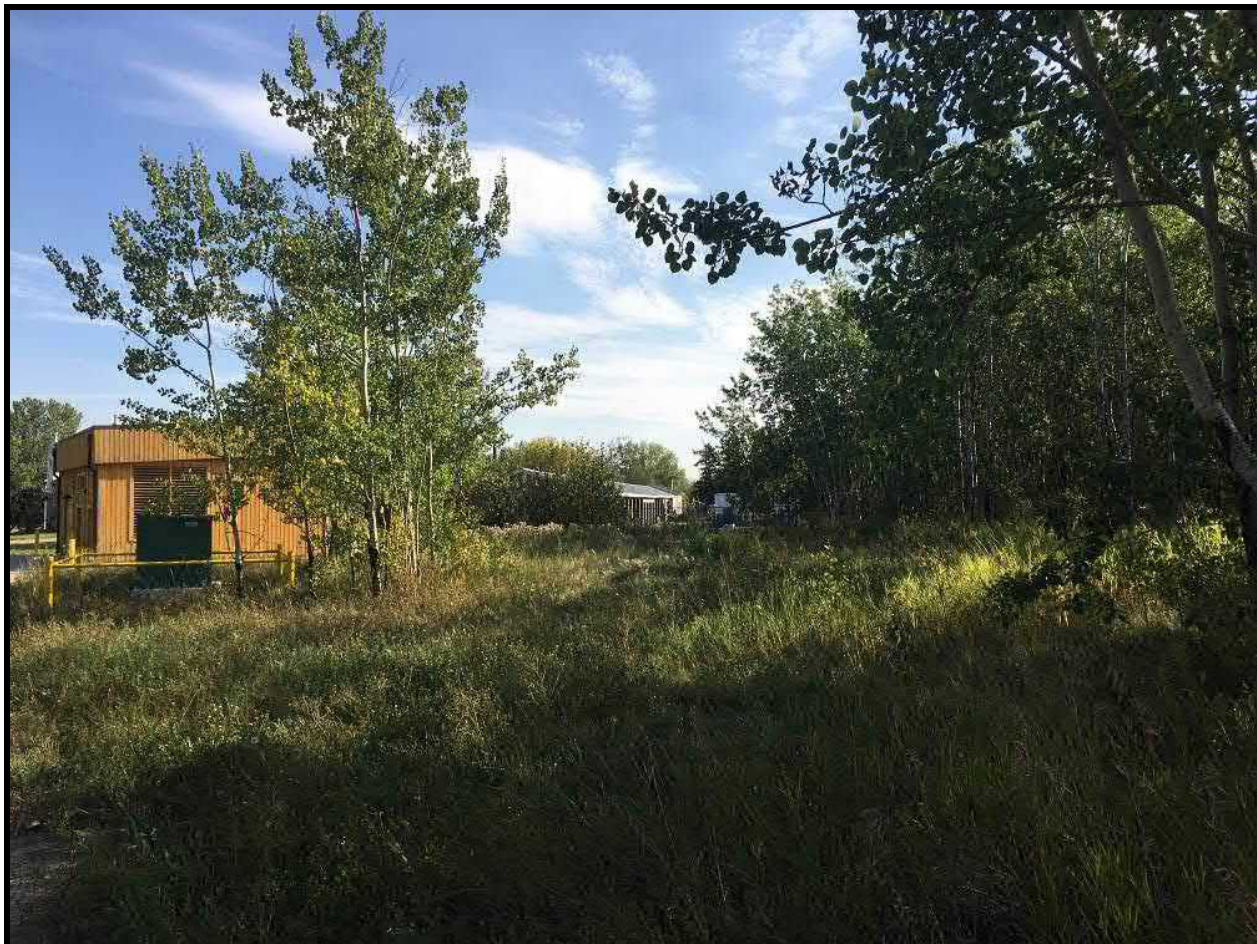
Photograph 2: A transformer and pump station in the vicinity of the southwest portion of the Property, facing northeast (September 7, 2018).

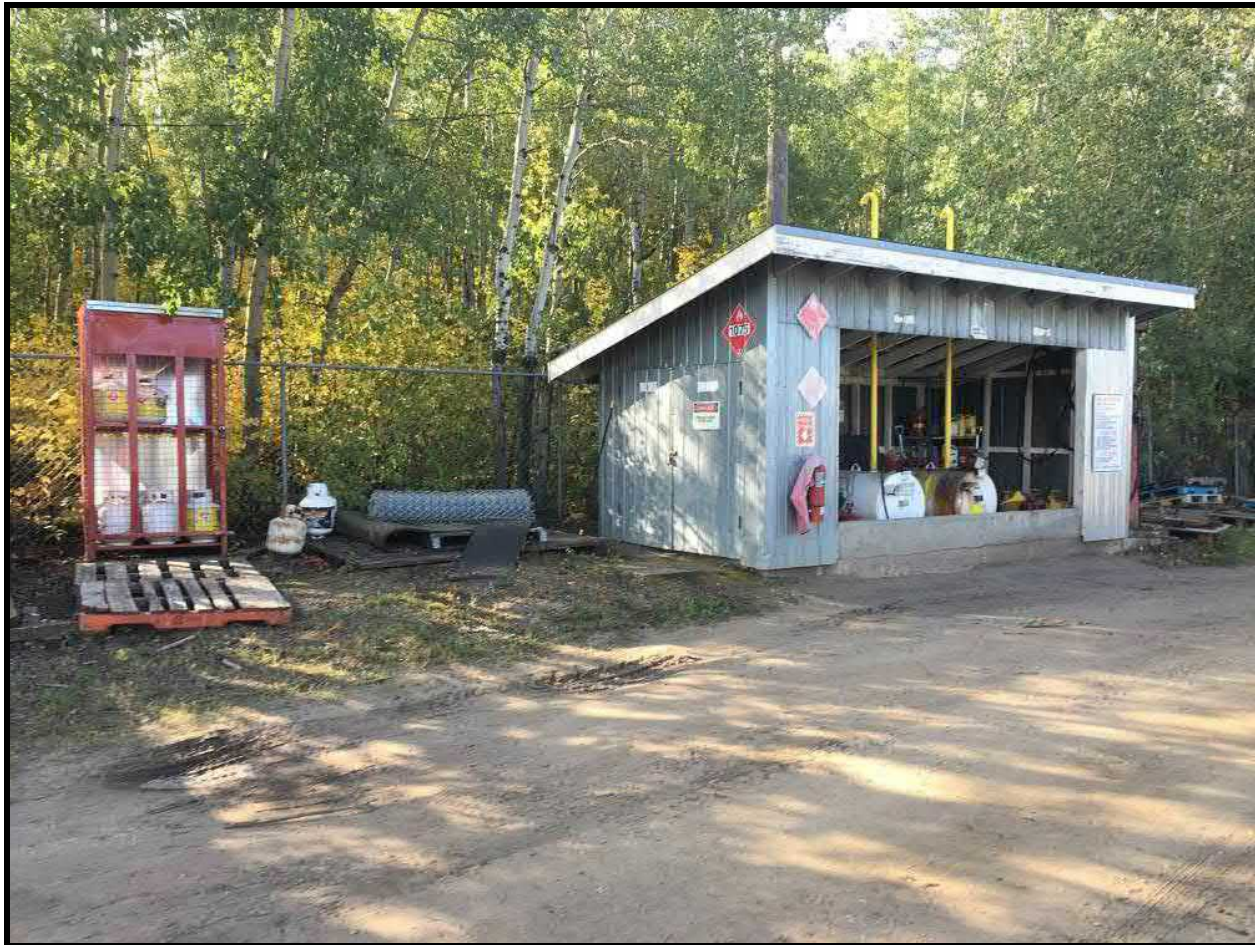
Photograph 3: AST and propane tank storage on the northeast portion of the Property (September 7, 2018).

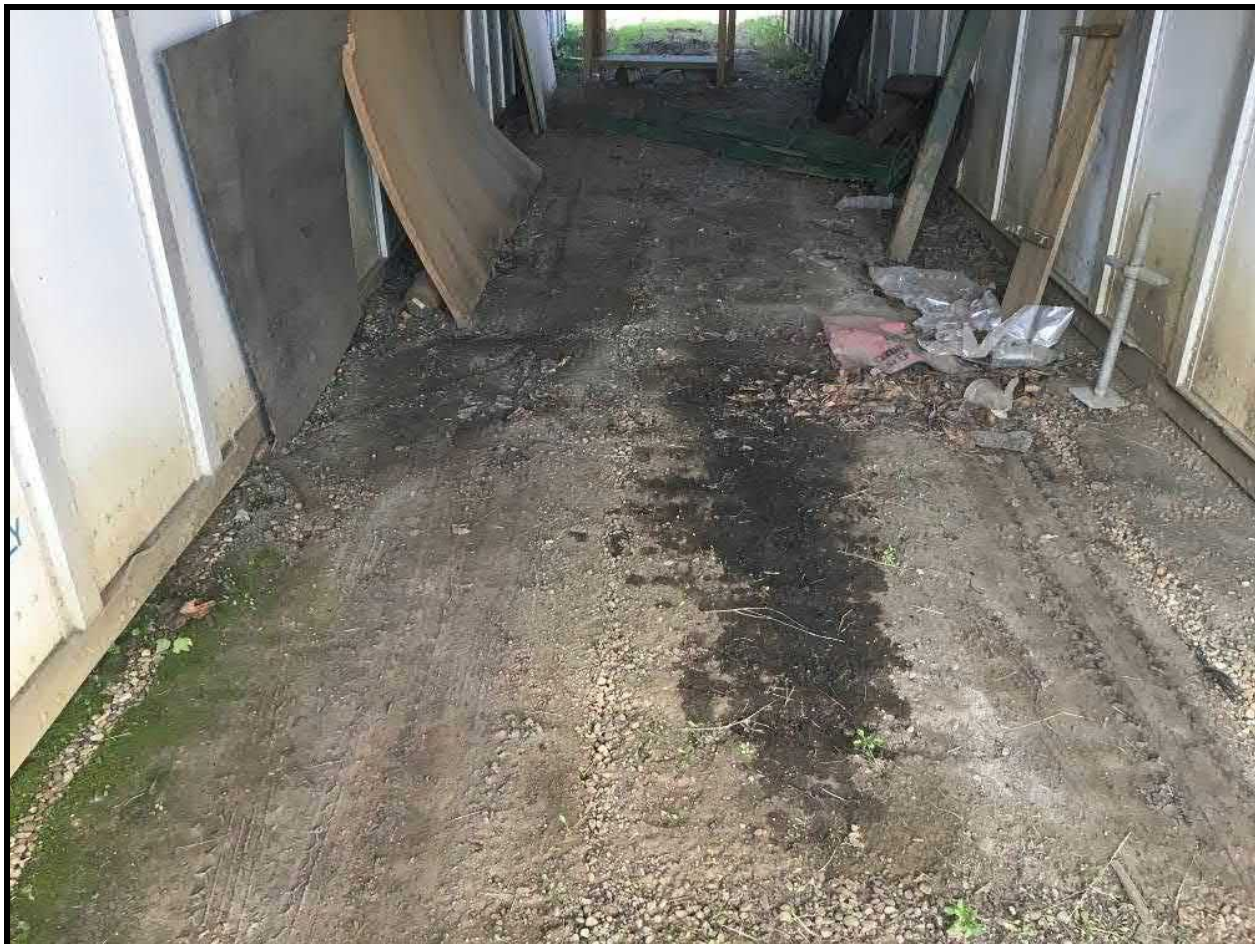
Photograph 4: Staining on the northeast portion of the Property, between two intermodal storage containers (September 7, 2018).

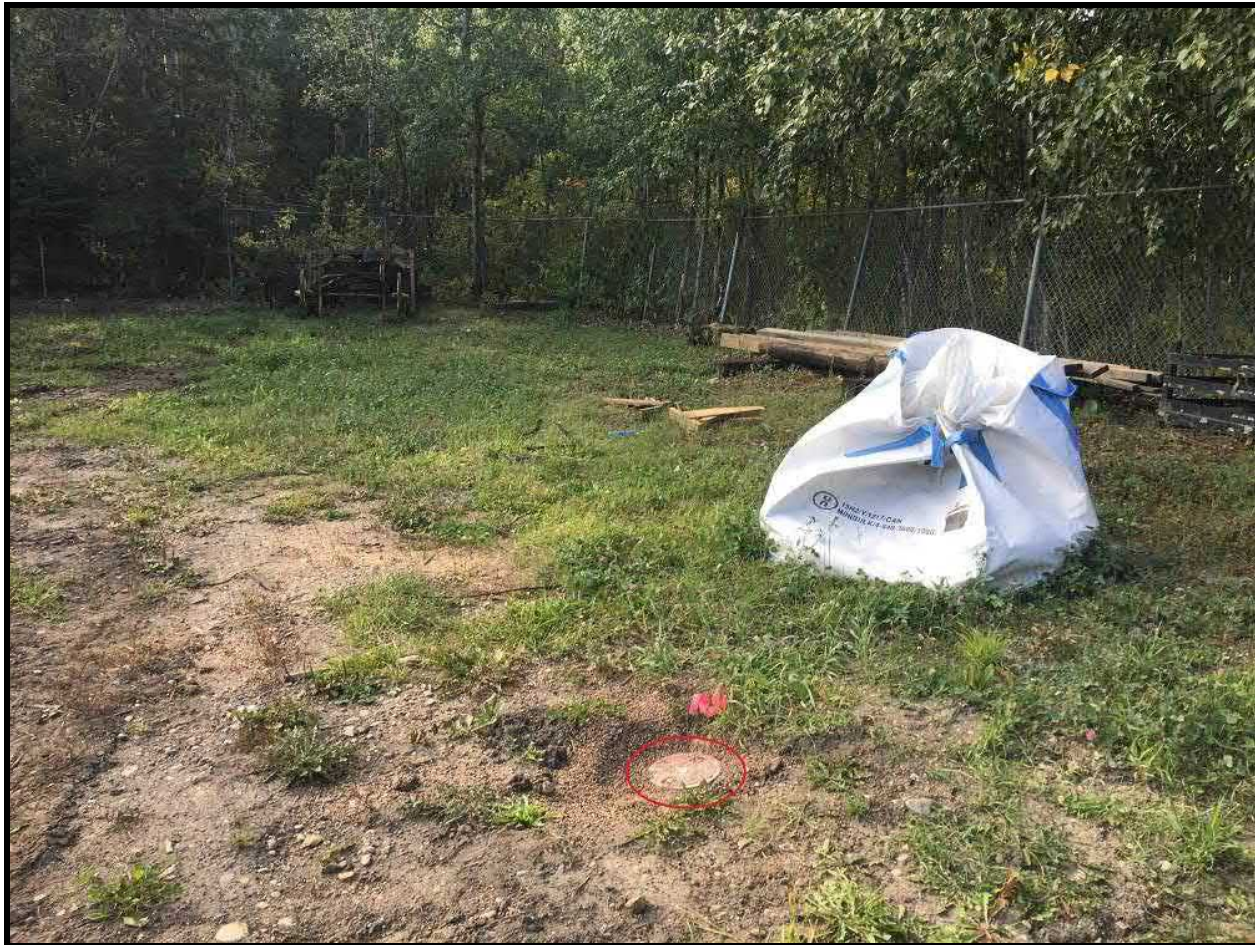
Photograph 5: A groundwater monitoring well (marked in red) and soil bag on the central portion of the Property (September 7, 2018).
