GEC Architecture

EIA Amendment
Fort Edmonton Park
Steam Train Re-location

September 2018

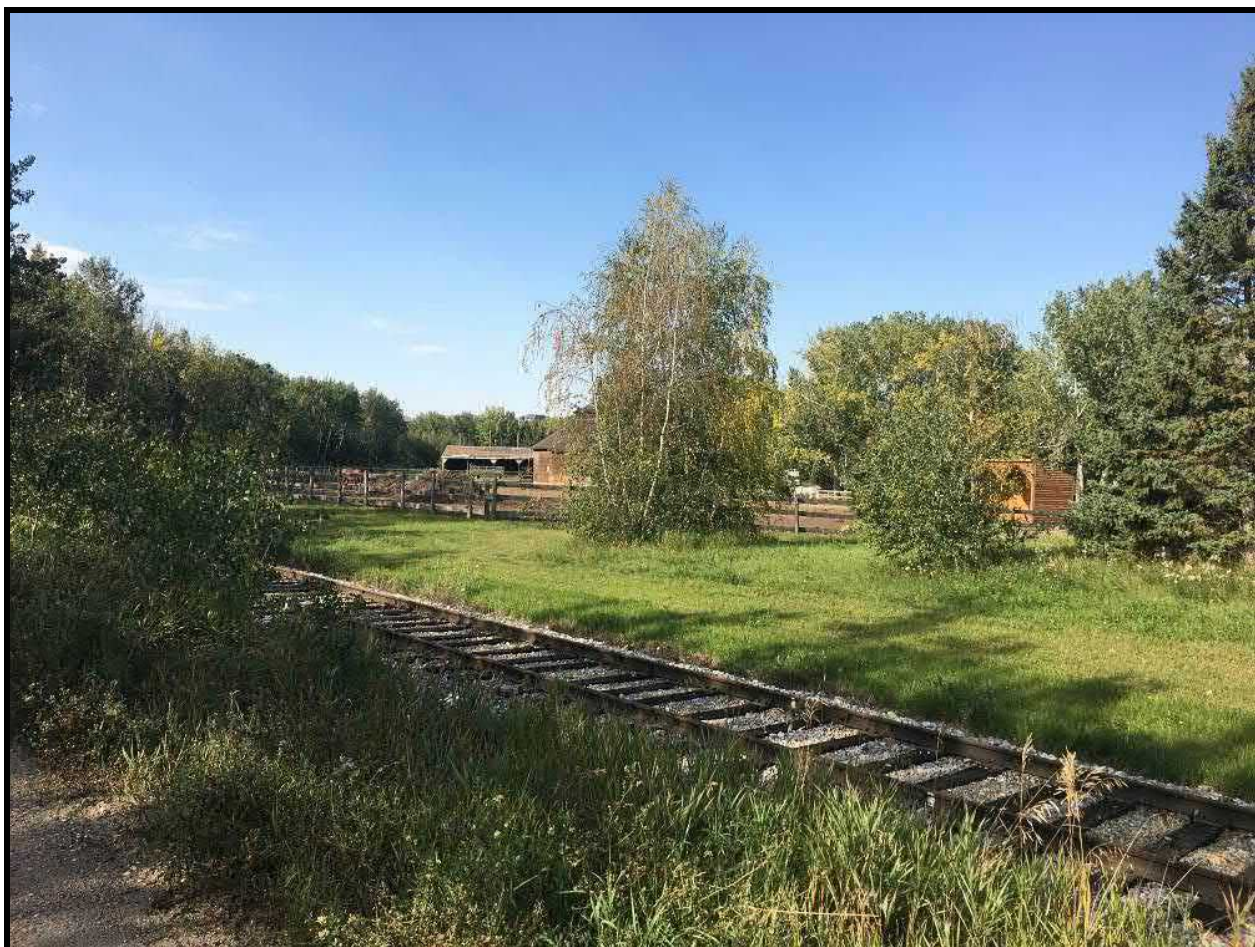
Photograph 6: The rail line that intersects the southwest portion of the Property (September 7, 2018).

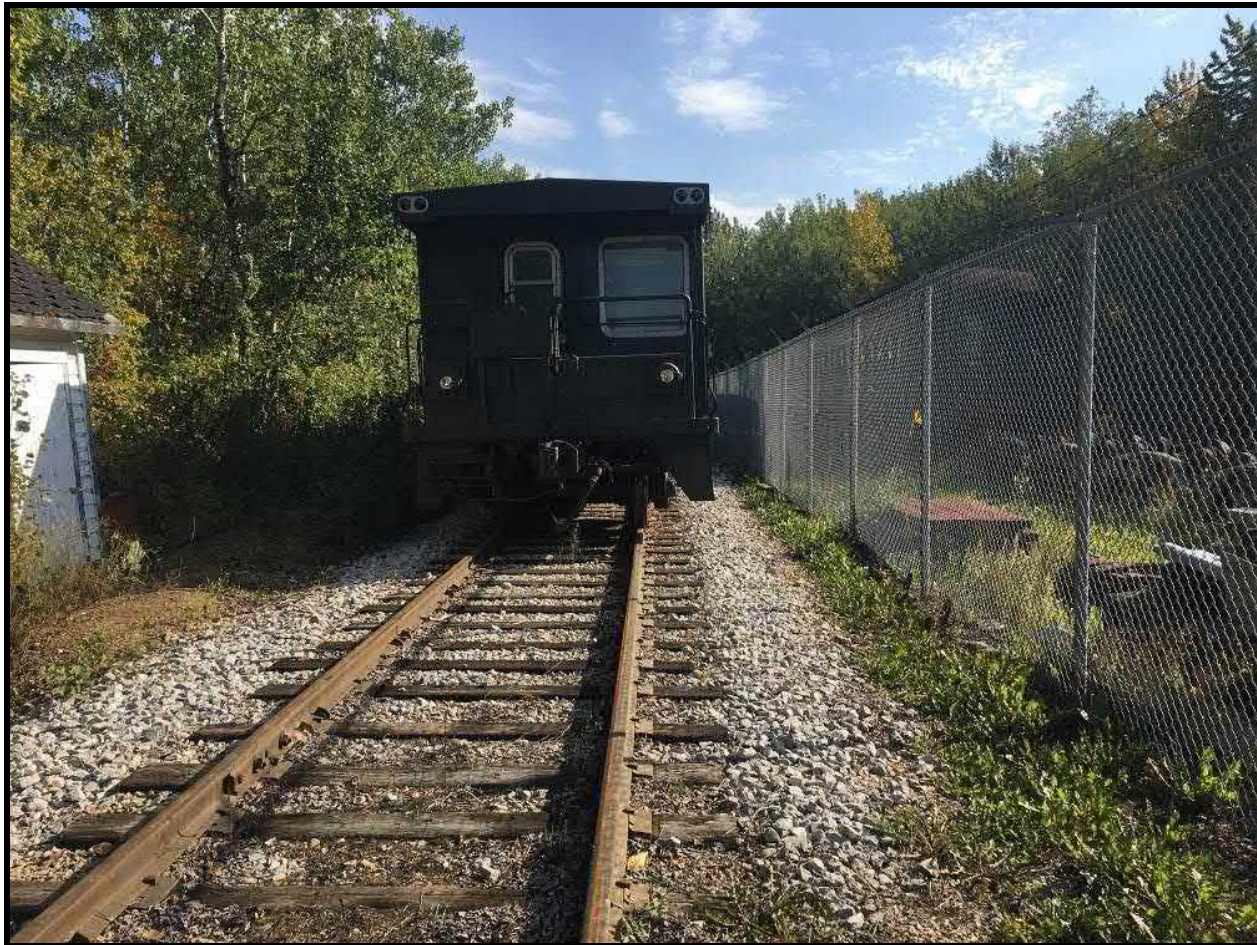
Photograph 7: The rail line present to the south of the Property (September 7, 2018).

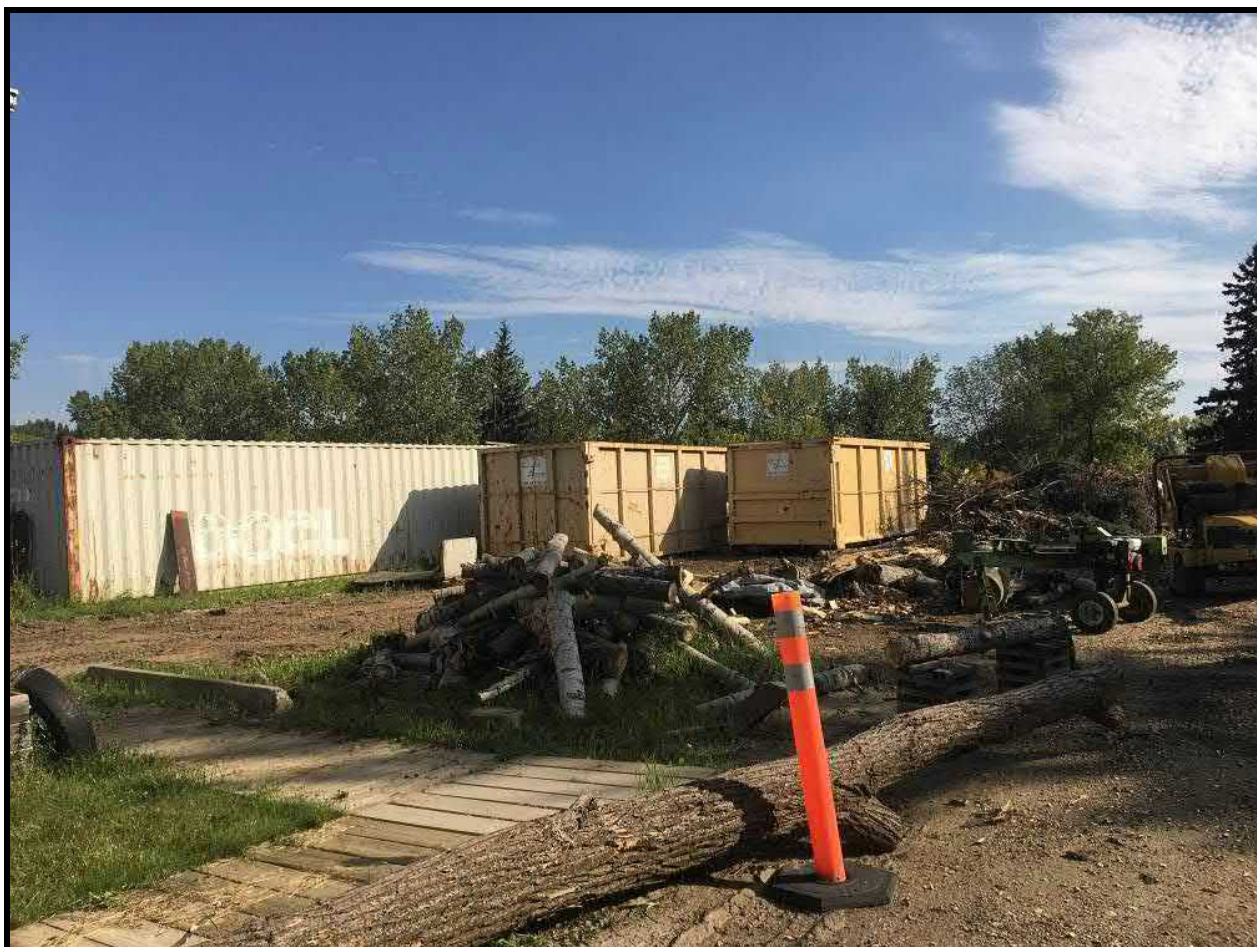
Photograph 8: Intermodal containers and wood waste storage area to the east of the Property (September 7, 2018).
