## Edmonton Composting Facility Renewal Business Case

City Operations Department | Waste Services Branch  
City of Edmonton

Project Number: OP-002318

Date published: December 21, 2018

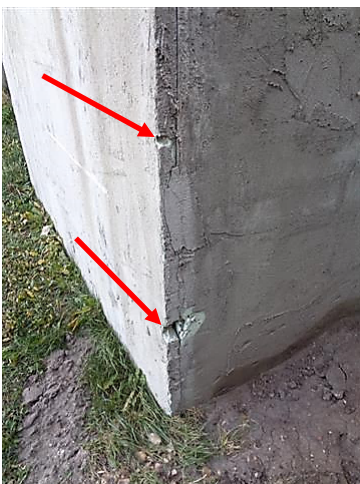
View of damaged foundation insulation and parging on the southwest corner of the Tipping Building

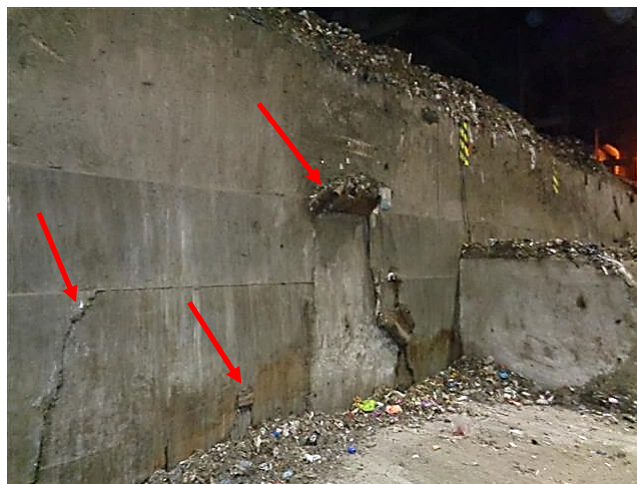
View of typical damaged and torn metal plating on the push wall in the tipping area.

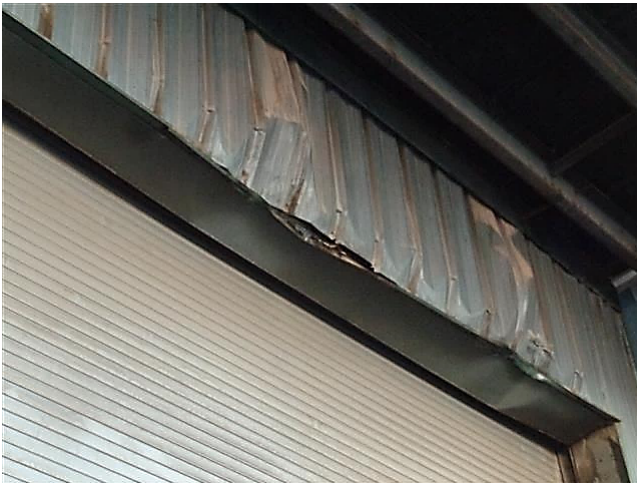
View of damaged metal cladding at overhead doors on the west elevation of the Tipping Building

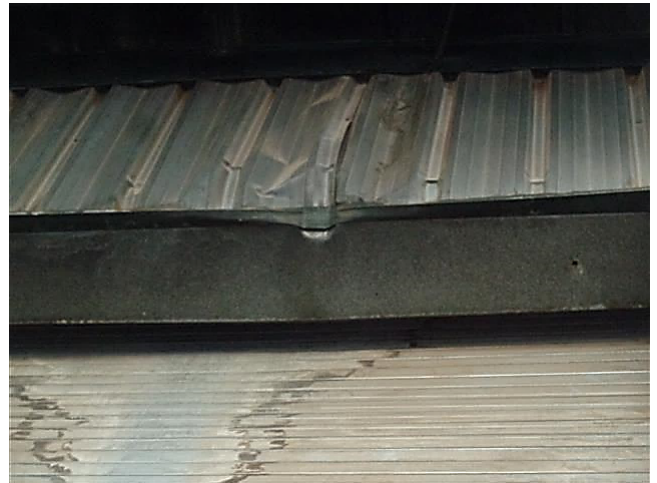
View of damaged metal cladding at overhead doors on the west elevation of the Tipping Building

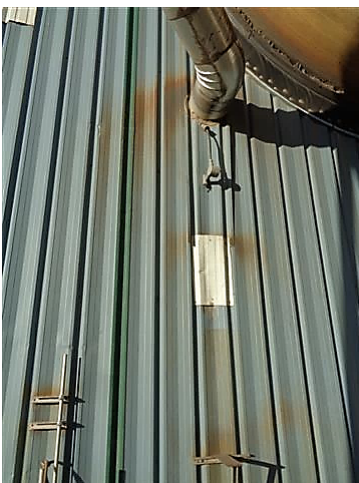
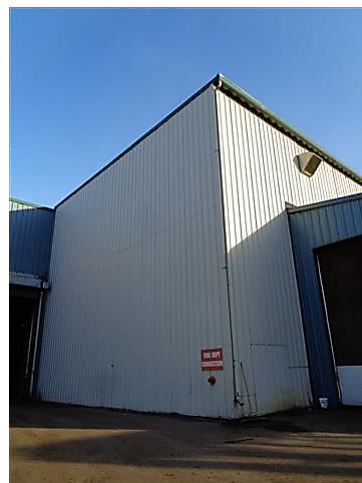
View of stained exterior metal cladding on east elevation of the Tipping Building

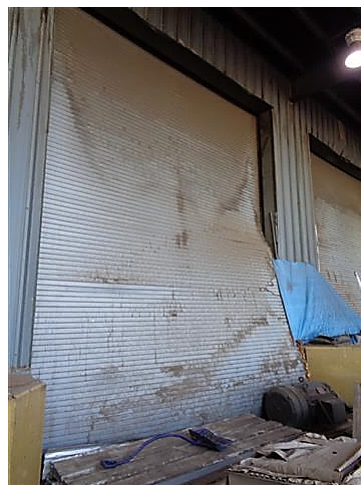
View of non-functioning damage to overhead doors on the west elevation of the Tipping Building

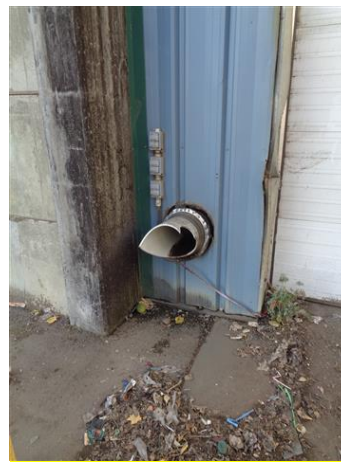
View of damaged rain leader on the east corner of the Tipping Building

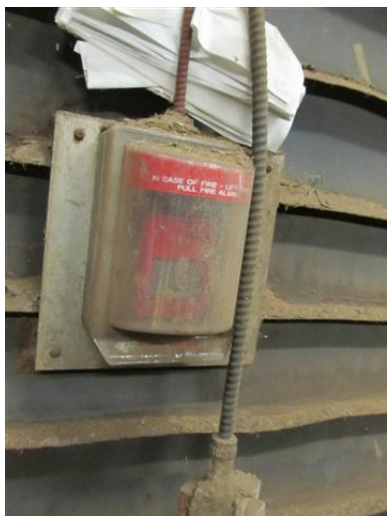
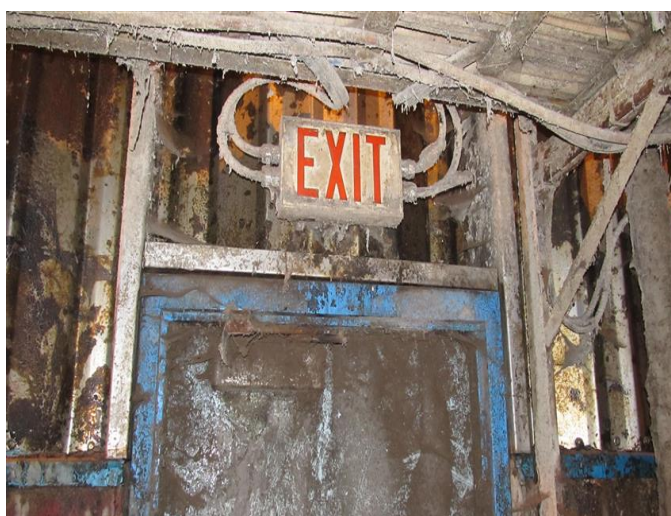
South Download Pull-station requiring cleaning    Finishing Building typical exit sign requiring cleaning

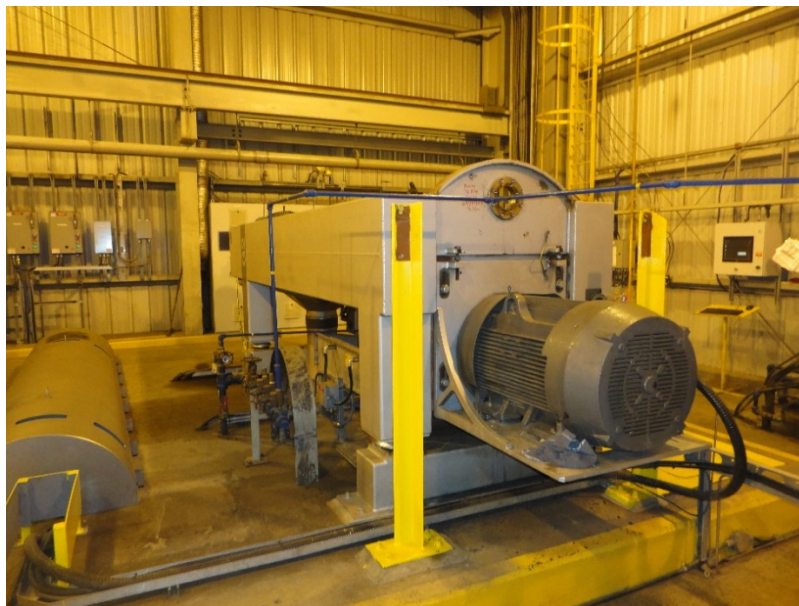
One (1) centrifuge 10-F-3, known as Centrifuge C, is type G2, also manufactured by Alpha Laval and was added in 2014. The G2 is a newer model of similar design and functionality to the DS706. It has a rated capacity of 65 m<sup>3</sup>/hr, but is understood to have major leakage when operated beyond 50m<sup>3</sup>/h.

Picture 3-1 (left) View of Centrifuge C with lid removed (bottom left) for annual maintenance.

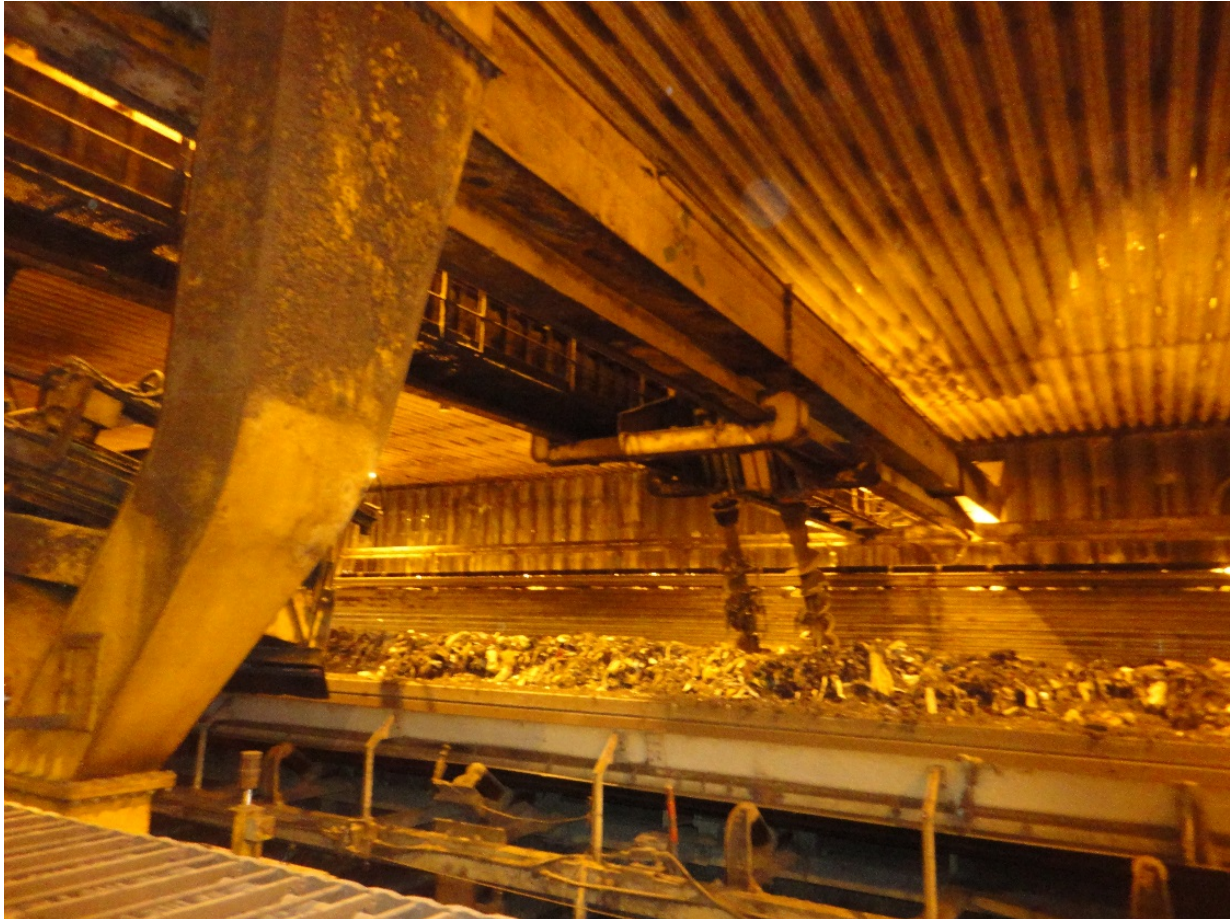
**Picture 3-3 - Turner assembly showing the rotating screws (right), bridge (top) and conveyor track (bottom left)**

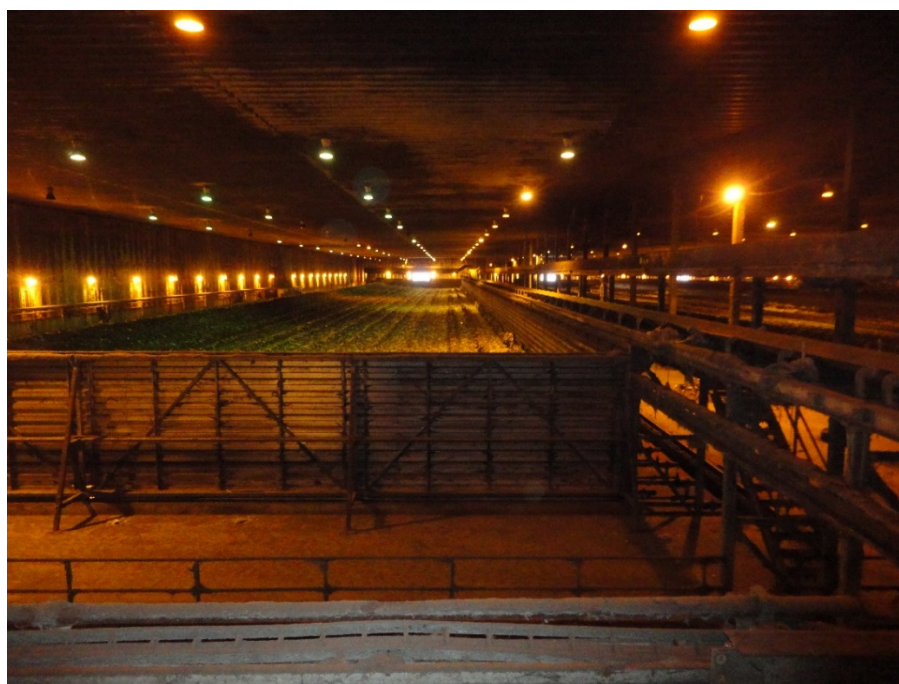
**Picture 3-4 - Aeration bay showing "lines" from Turner productivity**

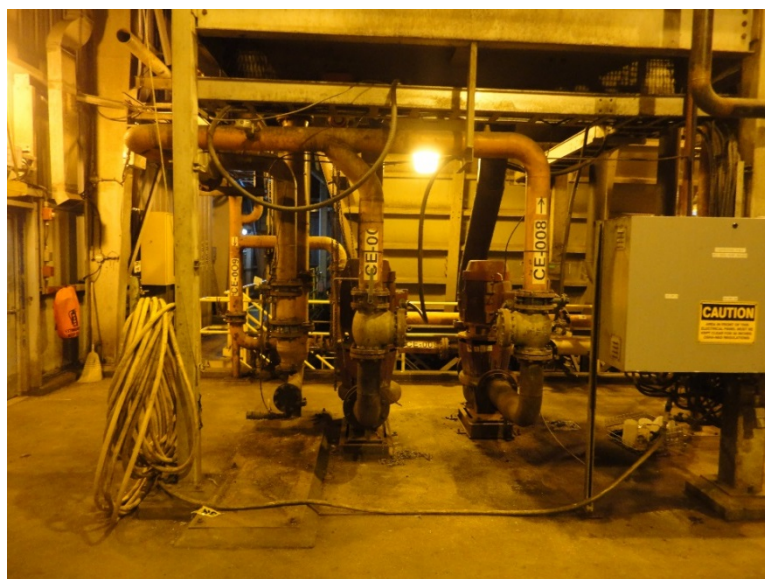
Water extracted from the biosolids via the centrifuges is recirculated with two centrifugal pumps 10-P-8A and 10-P-8B with an estimated capacity of 225 m<sup>3</sup>/h. Manufacturer is unknown.

Picture 3-7 – Centrate Pumps

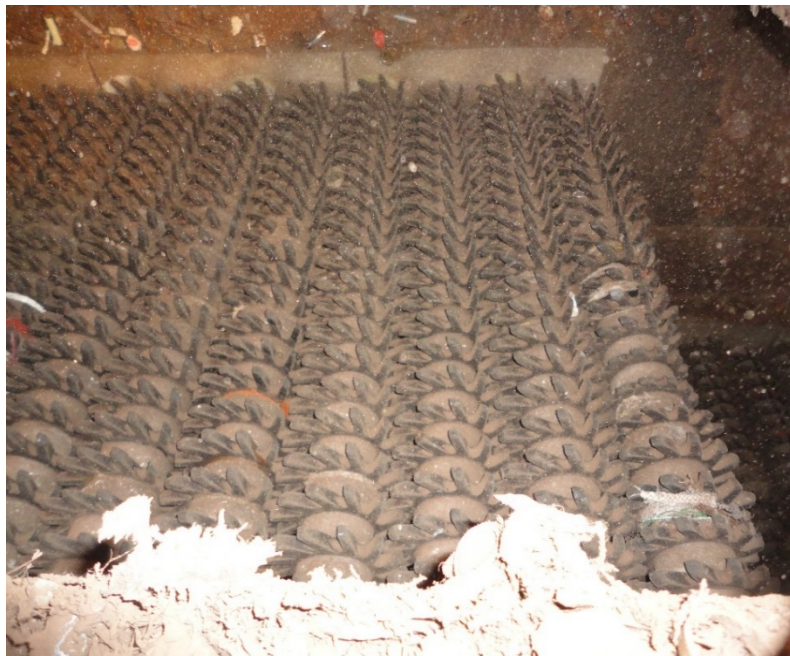
It is understood that the Trommel screen was replaced in 2015. All shafts and stars on the star screens were replaced in 2016. No immediate or short-term replacement of screens is anticipated.

**Figure 3-11 - Stars from screen YM-107**
