# Environmental Impact Assessment Pursuant to Bylaw 7188

## Horsehills Road Over Horsehills Creek (B130) Bridge Replacement

### Final Report

**Project Number EP-882**  
February 2021

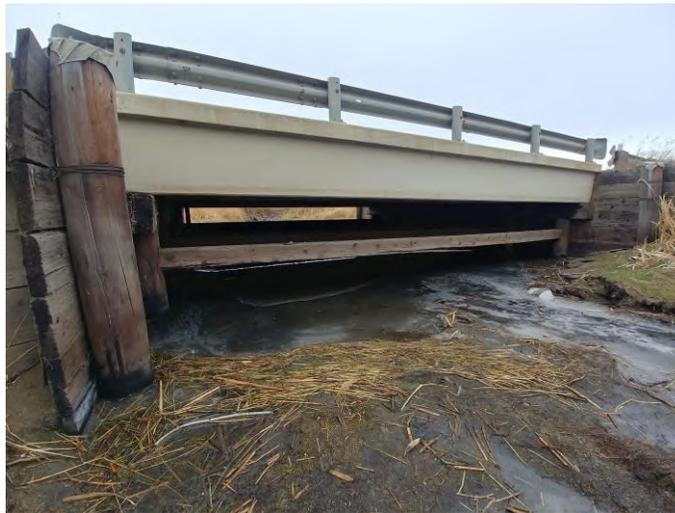
**Plate 1.1. Horsehills Road over Horsehills Creek (B130) with single span girder supported by wooden pile abutments (27 October 2020).**

The Horsehills Road over Horsehills Creek Bridge (B130) (the bridge) is located in the northeast corner of Edmonton, north of Manning Drive (SW 17-54-23-W4M) (Figure 1, Appendix A). Built in 1971, the existing bridge is an 8.5 m long single span girder bridge supported by treated, vertical wooden pile abutments (Plate 1.1). It supports two lanes of traffic and has a posted speed limit of 50 km/h. Due to the poor condition of the existing structure, the City of Edmonton (the City) is proposing to replace the bridge in the same footprint (Figure 2, Appendix A). The City has retained MPA Engineering Ltd. (MPA) to provide engineering services for replacement of Horsehills Road bridge and the adjacent roadway approaches.

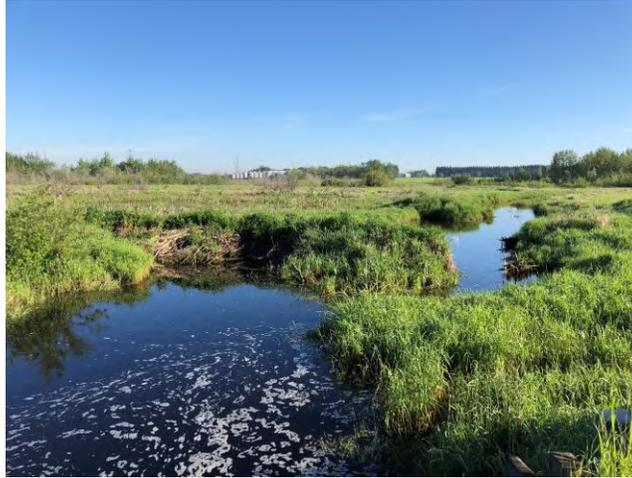
**Plate 3.6. View to north of Horsehills Creek, beaver dam and dense natural vegetation from bridge B130 (19 June 2020).**

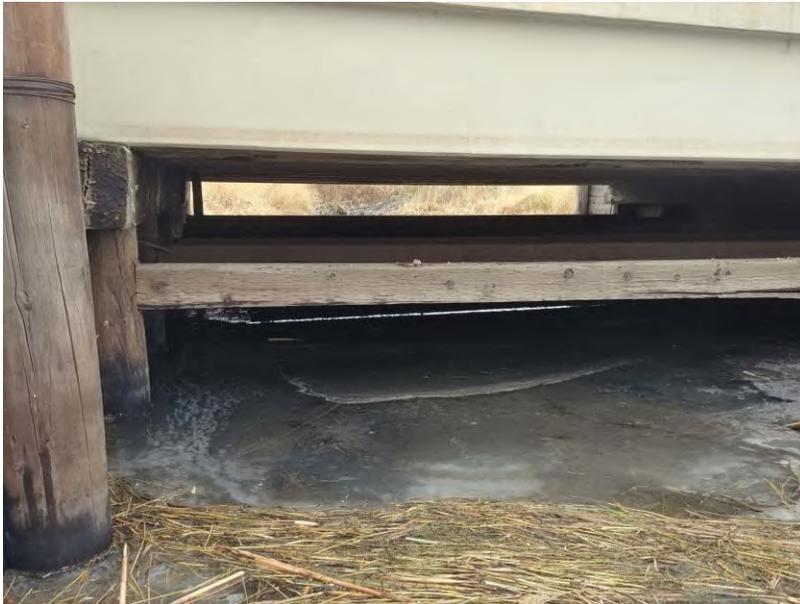
**Plate 3.7. View to south under existing bridge with wooden struts (27 October 2020).**

The existing bridge does have a relatively low clearance with a calculated openness ratio of 1.37, however, movement under the bridge by large-sized animals is impeded by the presence of several wooden struts across the width of the bridge and creek channel and high water levels at some times of the year (Plate 3.7). The Horsehills Creek corridor is relatively wide and level and permeable to wildlife movement in the local study area and so it is likely that most large-, medium- and small-sized animals cross over the surface of the two-lane, local Horsehills Road when travelling through the area north of Manning Drive.

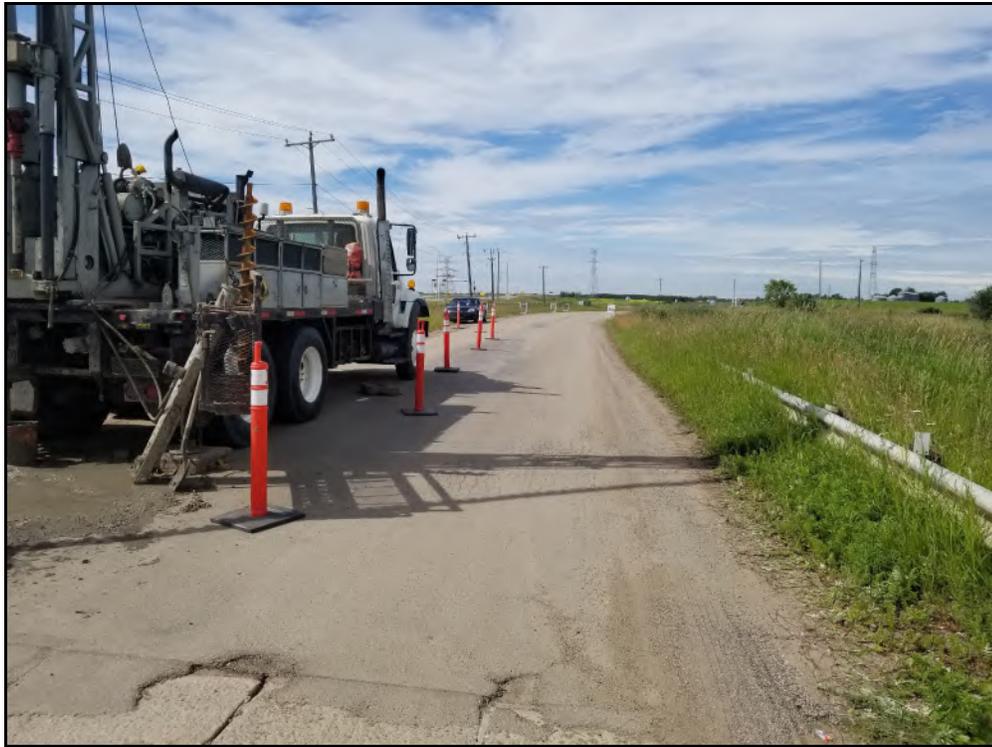
**Photograph 1:** Facing west from the bridge location. Drilling rig can be seen set up at Borehole 20-01.

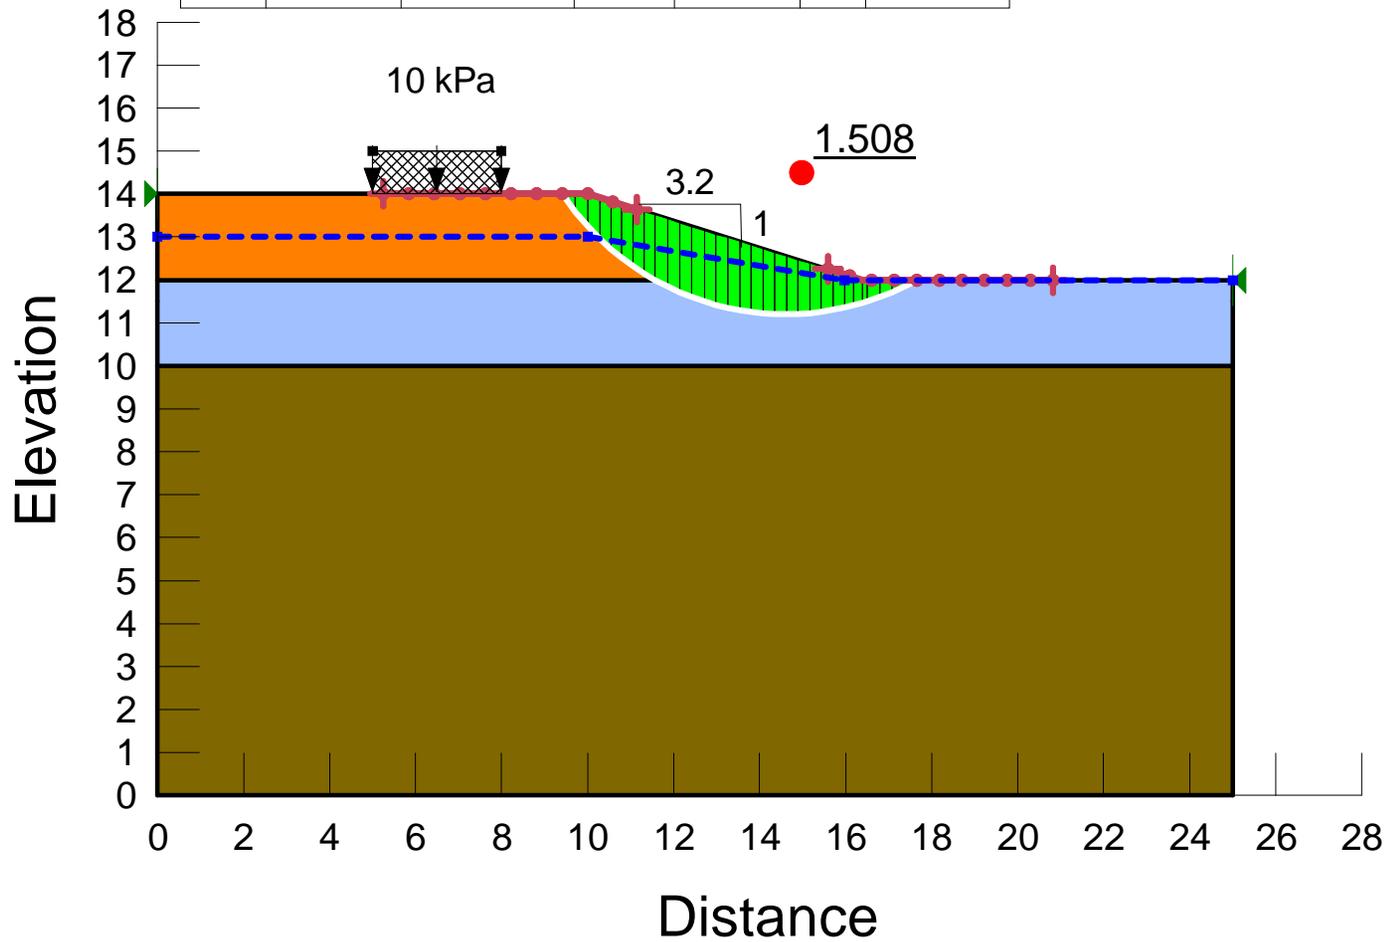
Color	Name	Model	Unit Weight (kN/m <sup>3</sup> )	Cohesion' (kPa)	Phi' (°)	Piezometric Line
Orange	Clay Fill	Mohr-Coulomb	18.5	2	25	1
Brown	Lower Clay	Mohr-Coulomb	18	4	25	1
Blue	Upper Clay	Mohr-Coulomb	17.5	1	23	1

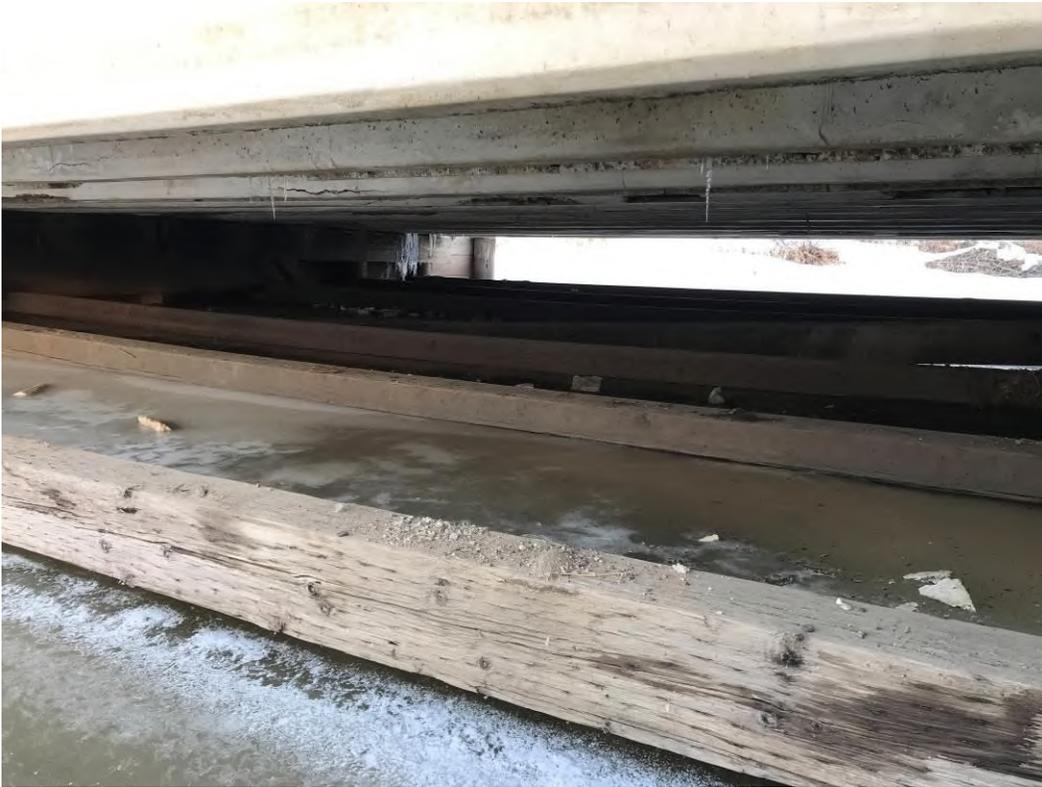
Underside of Bridge

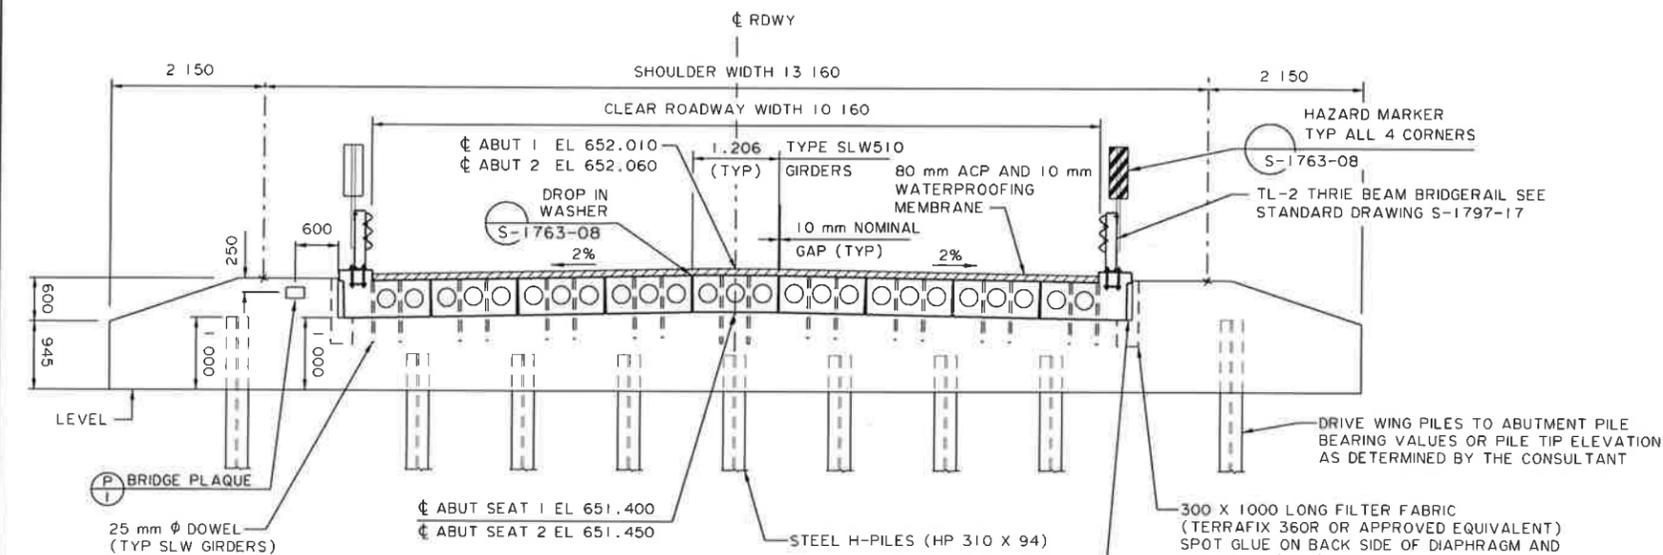
**ABUTMENT ELEVATION**

ALL DIMENSIONS 1:50 IN MILLIMETRES

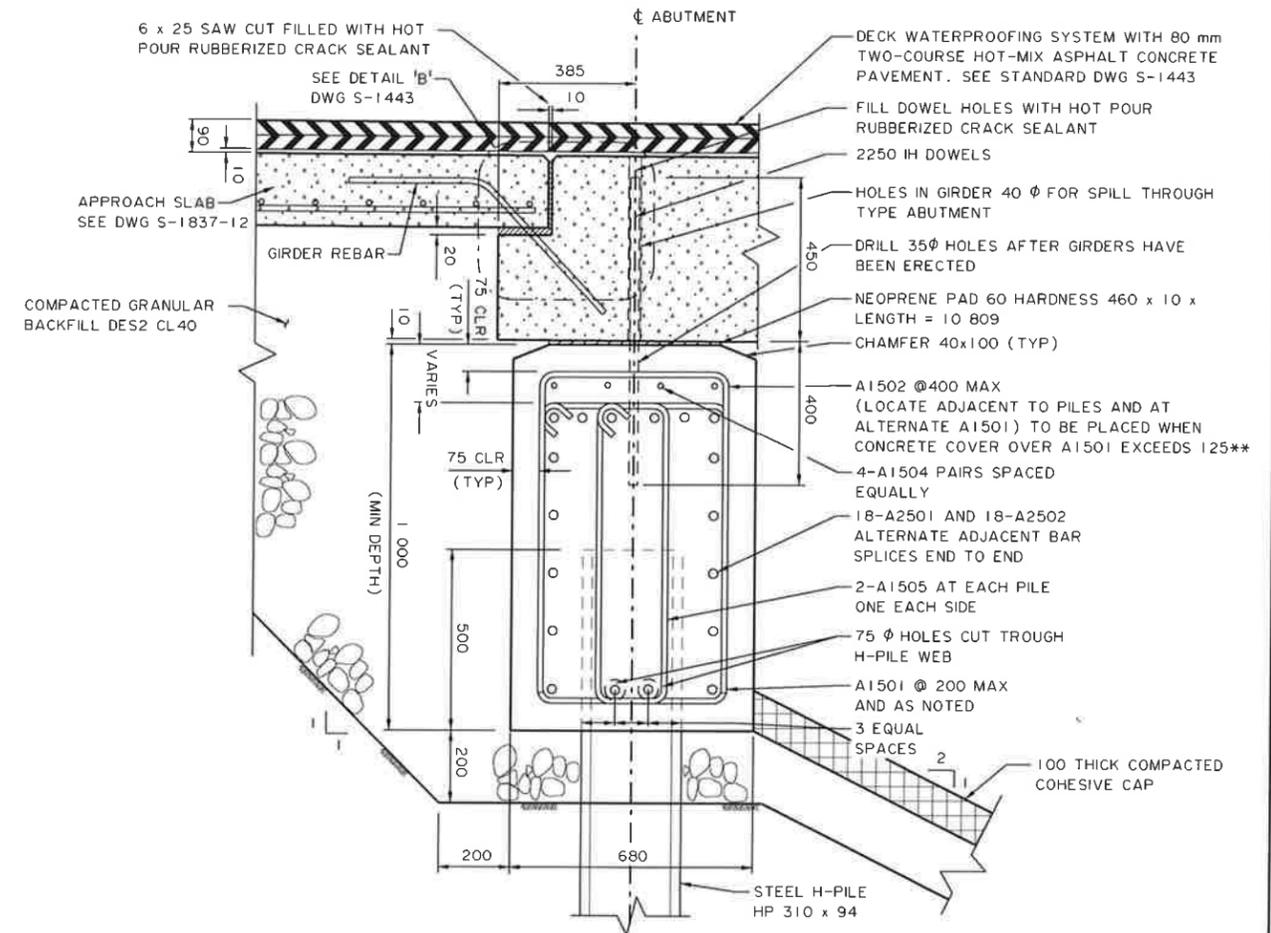
**B ABUTMENT SECTION**

ALL DIMENSIONS 1:50 IN MILLIMETRES (ON SQUARE) LOOKING EAST

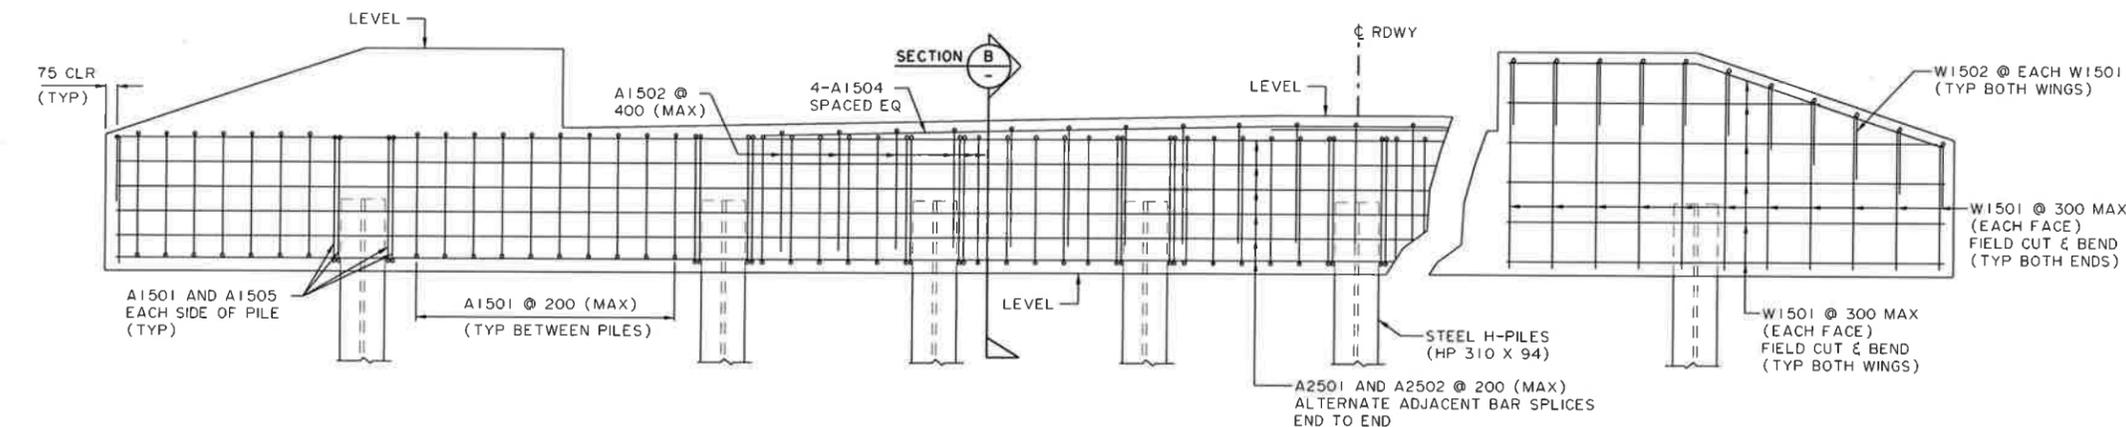
**ABUTMENT REBAR ELEVATION**

ALL DIMENSIONS 1:10 IN MILLIMETRES

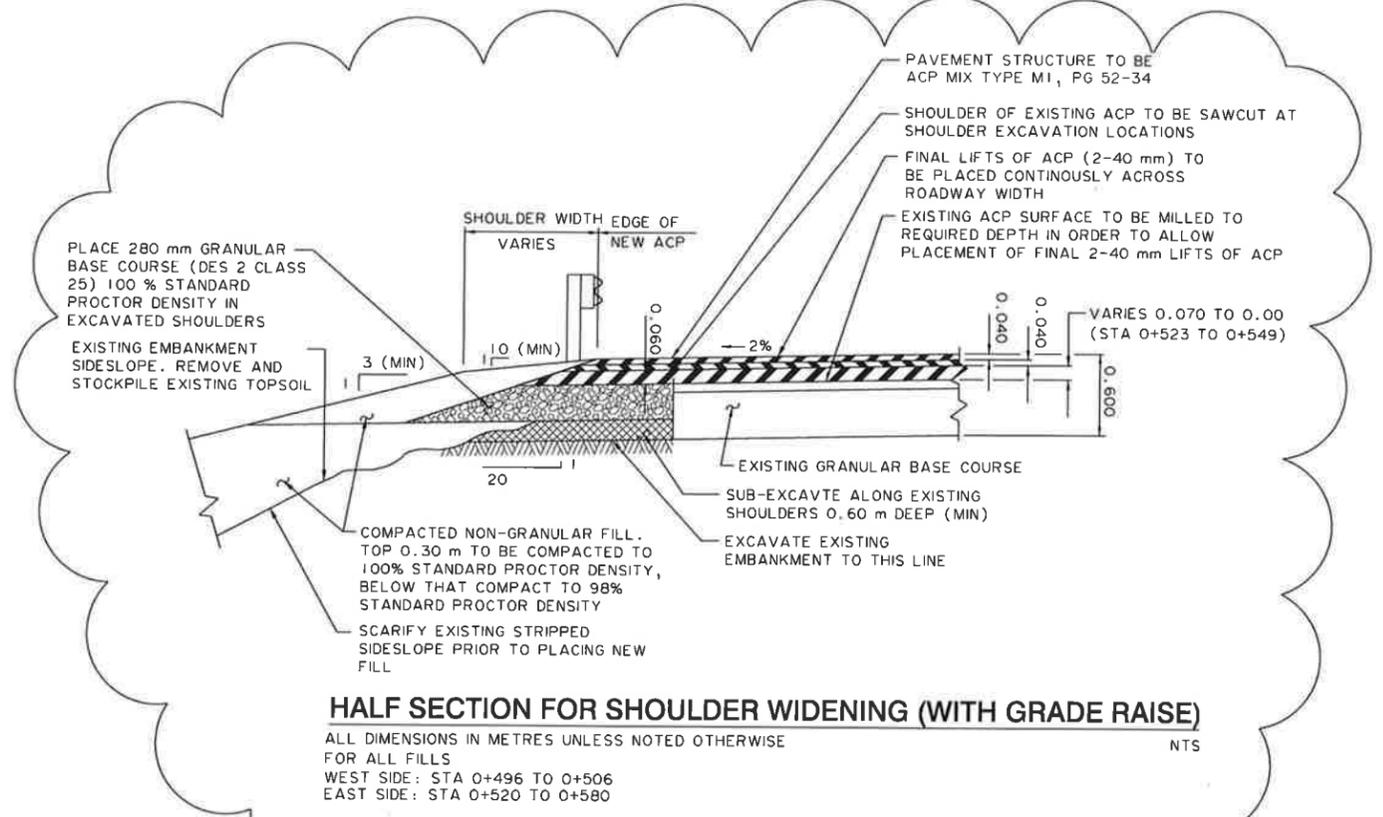
**HALF SECTION FOR SHOULDER WIDENING (WITH GRADE RAISE)**  
ALL DIMENSIONS IN METRES UNLESS NOTED OTHERWISE  
FOR ALL FILLS  
WEST SIDE: STA 0+496 TO 0+506  
EAST SIDE: STA 0+520 TO 0+580  
NTS

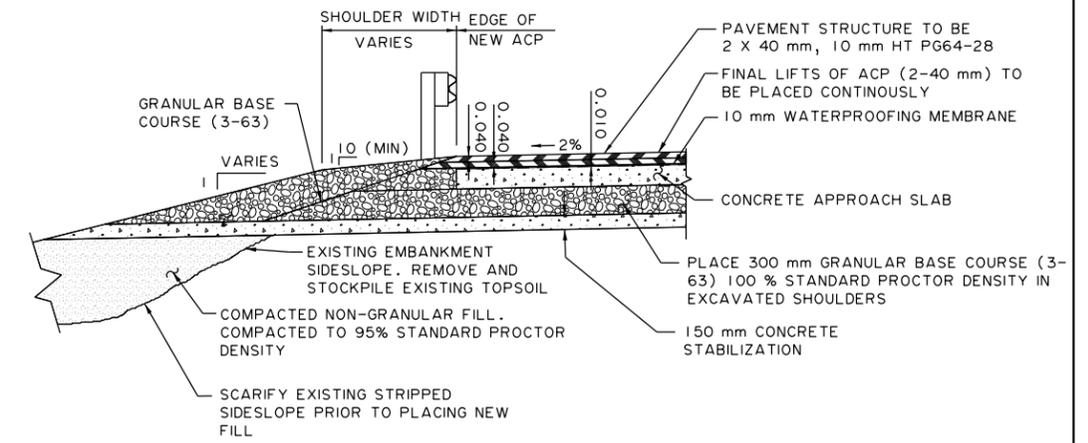
**HALF SECTION THROUGH CONCRETE APPROACH SLAB**  
ALL DIMENSIONS IN METRES UNLESS NOTED OTHERWISE NTS
