# Leduc Annex – Gravel Roads Condition Assessment and Maintenance Program Review

Final Document Prepared on August 19, 2020

Project Report: 126265

## IBI Group

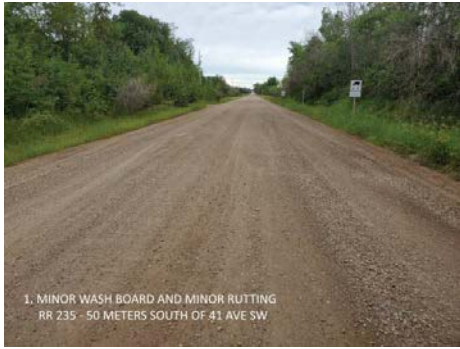
# 1. Other - Other

Item No.	Description	Detail	Location	Quantity	Unit	Completion Date
1	W, Rut	Minor washboard and minor rutting- 50 meters south of 41 AVE SW.	On map.			
2	W	Minor washboard - 400 meters south of 41 AVE SW.	On map.			
3	LG	Loose gravel - 700 meters south of 41 AVE SW.	On map.			
4	W, LG	Minor washboard, loose gravel - 900 meters south of 41 AVE SW.	On map.			
5	P, DB	Pothole, fallen tree on west shoulder - 1000 meters south of 41 AVE SW.	On map.			
6	W, Rut	Washboard and rutting - 1200 meters south of 41 AVE SW.	On map.			
7	Rut	Rutting - 1400 meters south of 41 AVE SW.	On map.			
8	W, Rut, DB	Minor washboard, minor rutting, fallen trees west shoulder - 1600 meters south of 41 AVE SW.	On map.			
9	DB	Fallen trees west shoulder - 2000 meters south of 41 AVE SW.	On map.			
10	AM, Rut, DB, R	Add material, rutting, rough road and fallen branches west shoulder - 2800 meters south of 41 AVE SW.	On map.			
11	W	Washboard - 3100 meters south of 41 AVE SW. Intersection of TWP RD 510.	On map.

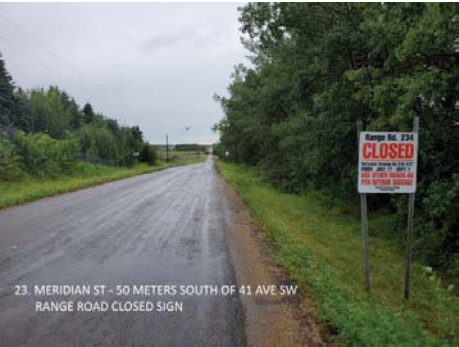
23. MERIDIAN ST - 50 METERS SOUTH OF 41 AVE SW  
RANGE ROAD CLOSED SIGN

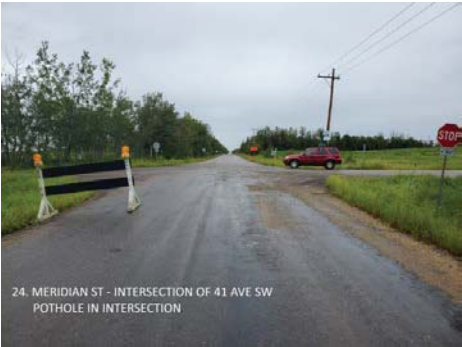
24. MERIDIAN ST - INTERSECTION OF 41 AVE SW  
POTHOLE IN INTERSECTION

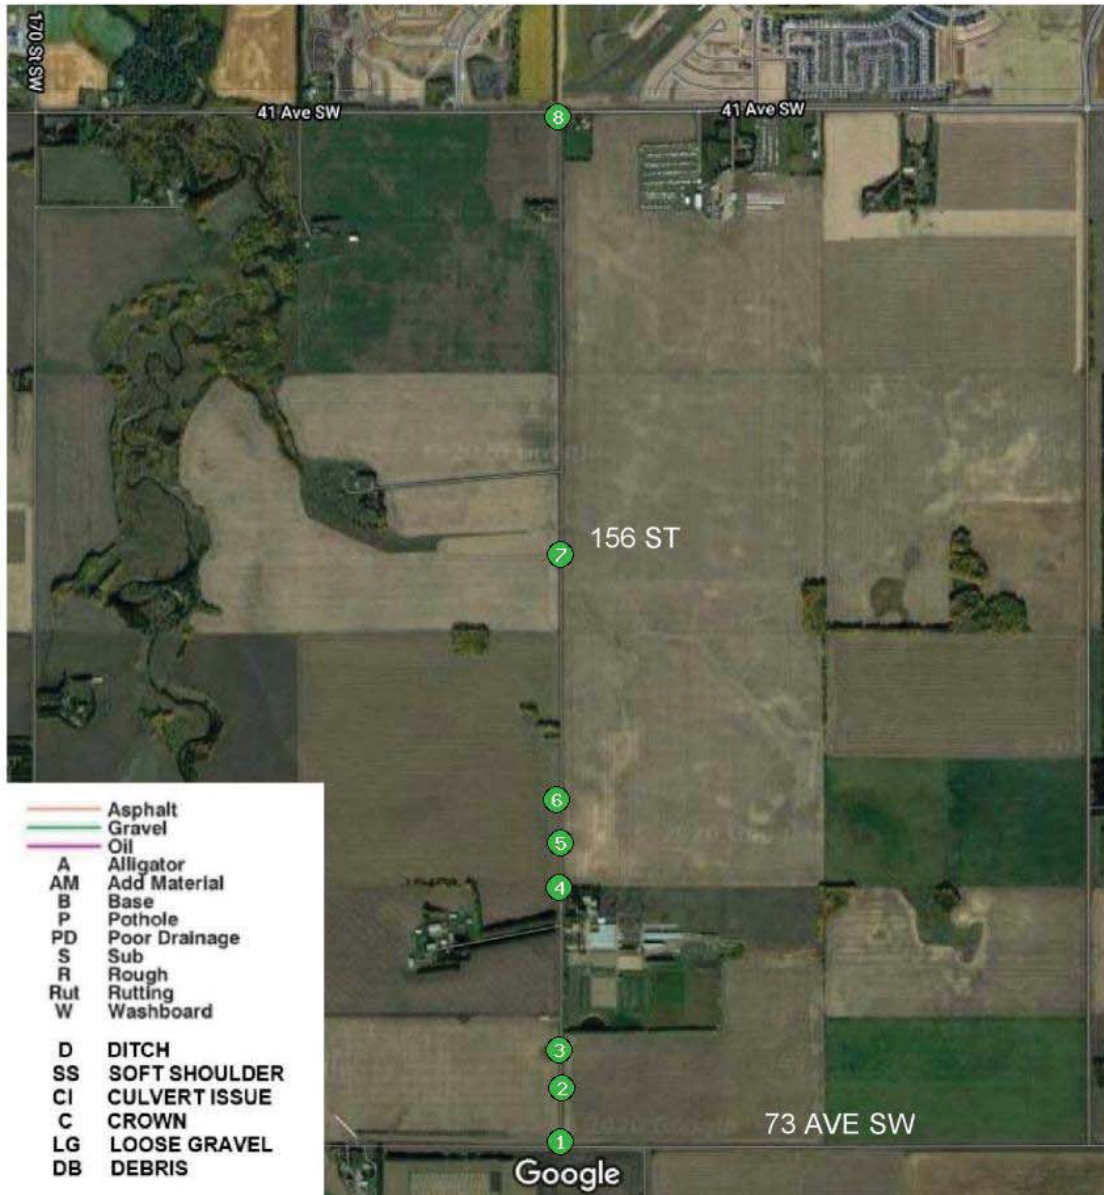
**156 ST FROM 73 AVE SW TO 41 AVE SW**

Item No.	Description	Detail	Location	Quantity	Unit	Completion Date
1	Repairs, Rut, R, P	COE repair work taking place at intersection. 50 meters north of intersection rough road, rutting and potholes.	Intersection of 73 AVE SW and 156 ST			
2	Rut, W	Rutting, minor washboard.	200 meters north of 73 AVE SW.			
3	Rut, W	Rutting west shoulder, washboard.	300 meters north of 73 AVE SW.			
4	W	Washboard.	800 meters north of 73 AVE SW.			
5	Rut, P, W	Rutting, potholes, washboard.	900 meters north of 73 AVE SW.			
6	Rut, R	Rutting, rough road.	1000 meters north of 73 AVE SW.			
7	CI	Culvert repairs.	1800 meters north of 73 AVE SW.			
8	Rut	Rutting east shoulder.	3150 m north of 73 AVE SW. Intersection of 41 AVE SW.

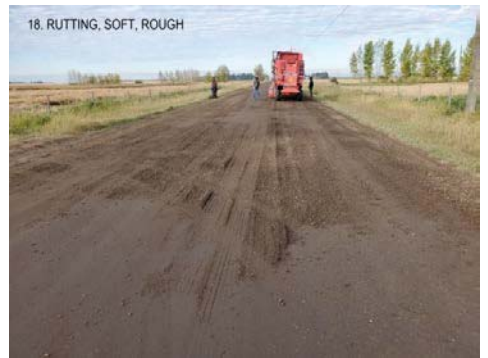
# 17. Other - Other

17	Rut	Rutting (North)				
18	Rut	Bad rutting, soft conditions.				
19	Rut	Rutting, soft conditions				
20	Rut, W	Rutting, washboard at RR254S Intersection				
21		RR 253N Intersection, condition fair

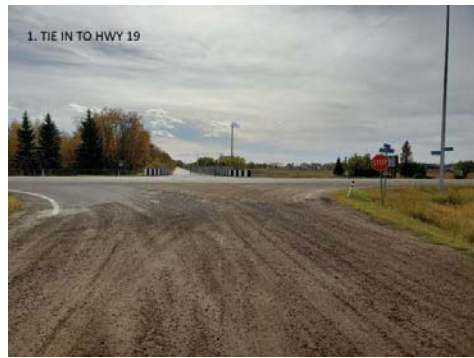
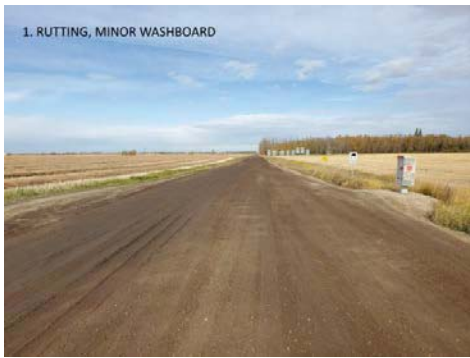
# 1. Other - Other

Item No.	Description	Detail	Location	Quantity	Unit	Responsibility
1	Rut, W	Minor rutting and washboard. Tie in to Hwy 19 and first 350 meters.				
2	Rut	Minor rutting. Overall good condition.				
3	Rut	Minor rutting. Overall good condition				
4	Rut, SS, D	Rutting, soft shoulder and double ditch east shoulder of road.				
5	Rut, SS, D	Rutting, soft shoulder and double ditch east side of road.				
6	Rut, SS, D	Rutting east and west, Soft shoulder east and west, Minor double ditch west.				
7	Rut	Minor rutting. Overall road condition good.				
8	AM	More clay, add material if needed. Overall condition fair.				
9	Rut	Rutting at east entrance to field. Overall condition good.				
10	Rut, SS	Rutting, soft shoulder east.				
11	P, AM	Minor potholes. Add material if required. Overall condition fair.				
12	P, AM	Minor potholes, Add material if required. Overall condition fair.				
13	Rut, P, D	Minor rutting, minor potholes, silt in ditches on both side. Minor double ditch (west)

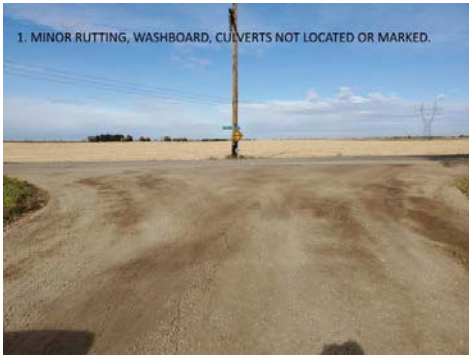
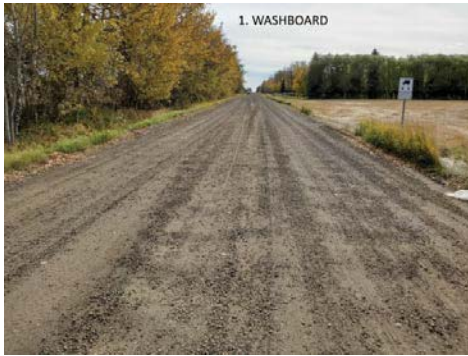
# 1. Other - Other

Item No.	Description	Detail	Location	Quantity	Unit	Responsibility
1	Rut, W	Minor rutting, wasboard, no culverts marked.				
2	Good.	Road condition good.				
3	Good.	Road condition good.				
4	Good.	Start of cold mix overlay. Road condition good.				
5	Good.	Road condition good.				
6	Good.	End of cold mix overlay. Road condition good.				
7	Good.	Road condition good.				
8	Good.	Road condition good.				
9	Good.	Road condition good.				
10	W	Minor washboard. Road condition fair. Tie in to HWY 19.

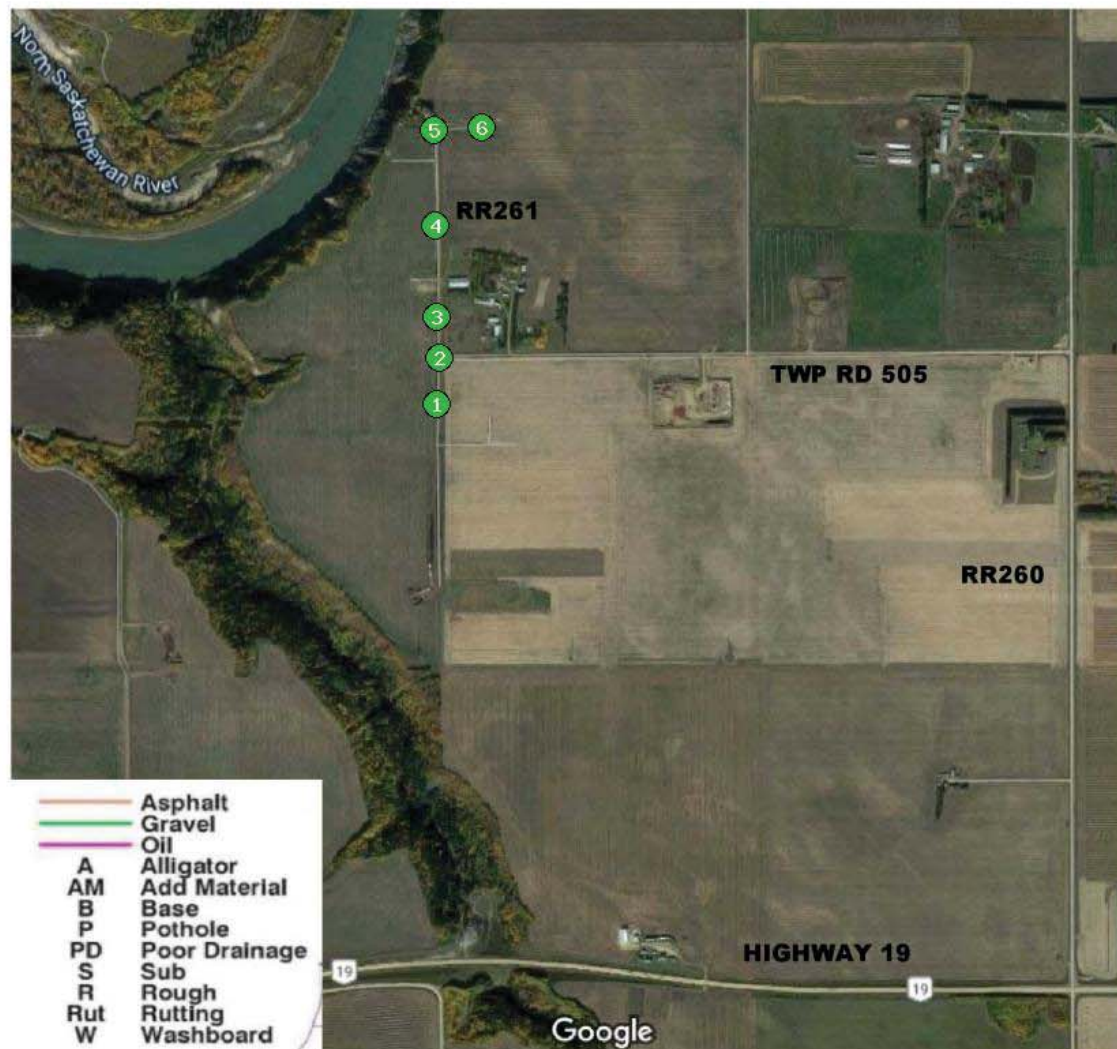
**RR261 BETWEEN TWP RD 510 AND HIGHWAY 19**

Item No.	Description	Detail	Location	Quantity	Unit	Completion date
1	RUT, AM	Rutting, ponding, poor road conditions south of TWP RD 505, add material.				
2	RUT	Minor rutting at intersection of TWP RD 505.				
3	GOOD	Road condition good.				
4	GOOD	Road condition good.				
5	RUT	Minor rutting at intersection.				
6	RUT	Minor rutting, end of road.

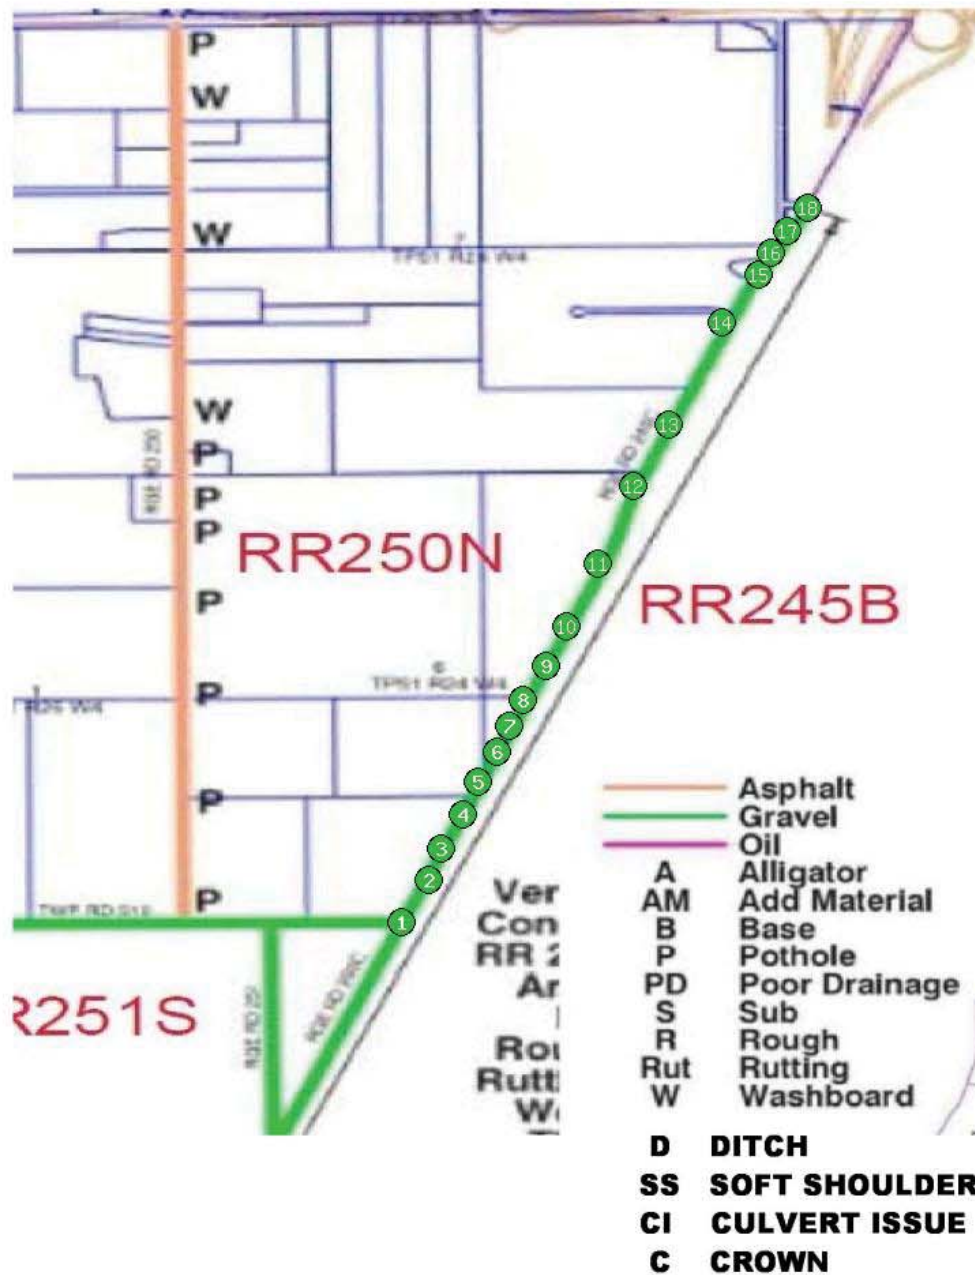
RR245B

Item No.	Description	Detail	Location	Quantity	Unit	Responsibility
1	Rut, D	Minor rutting in intersection and east shoulder. Debris in east ditch may cause drainage issues, should be removed. New culverts installed.				
2	SS, Rut, D	Rutting, Soft shoulder (East), Minor double ditch (East)				
3	Rut, SS, D	Rutting, soft shoulder, minor double ditch				
4	Rut	Rutting				
5	Rut, SS	Rutting, soft shoulder (East)				
6	SS, Rut	Soft shoulder, rutting (West)				
7	Rut	Rutting (West)				
8	Rut	Rutting (East)				
9	Rut, W	Rutting and washboard at dressage studio entrance				
10	Rut, SS	Rutting and soft shoulders				
11	Rut	Rutting				
12	Rut, SS	Rutting and soft shoulder (East) at Marty RV Entrance				
13	Rut, P	Rutting, pothole at RV north entrance				
14	Rut	Rutting at 50 Ave SW				
15	Rut	Rutting north of bridge, rutting at turnaround				
16	Rut	Rutting				
17	Rut, D, Fence	Rutting on road and ditch, Fence opened in two places, cars cutting through and rutting ditch. Fence should be closed.

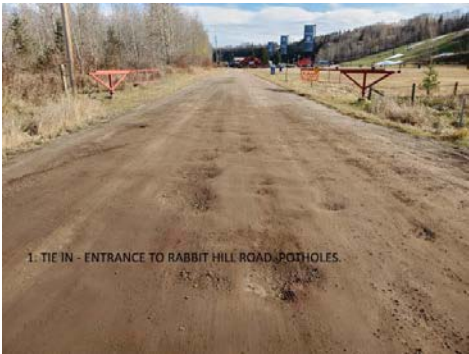
# 1. Other - Other

Item No.	Description	Detail	Location	Quantity	Unit	Completion Date
1	P	Entrance to Rabbit Hill. Potholes.				
2	P	Shalom Water Ski Entrance. Potholes.				
3	P, W	Potholes, minor washboard forming.				
4	W, P	Major washboard forming. Potholes. Some cold mix and gravel in this section.				
5	W, P	Major washboard, potholes.				
6	W, P	Washboard, potholes, eroding shoulders, water runs off ditch over road.				
7	W, P	Washboard, potholes, poor road conditions. Start of oil section of road.

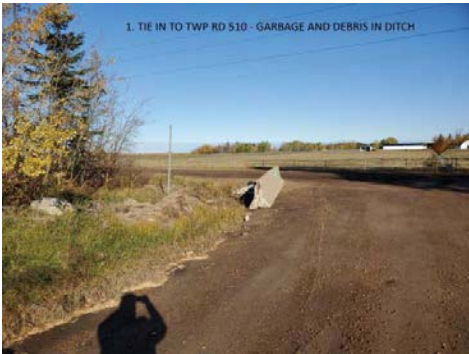
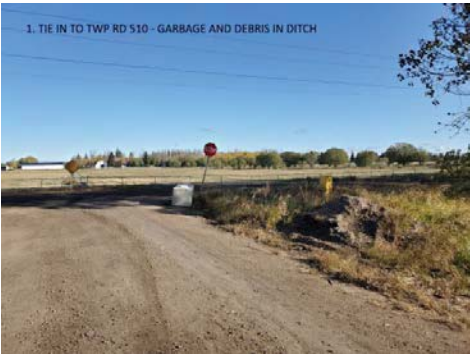
# 1. OtMer - OtMer

Item No.	Description	Detail	Location	Quantity	Unit	Responsibility
1	D	Tie in to TWP RD 510, Garbage and debris in ditch may cause drainage issues.				
2	RUT	honor rutting.				
3	RUT, P	honor rutting, PotHole				
4	GOOD	Road condition good.				
5	RUT	Tie in to RR245C, rutting at intersection.

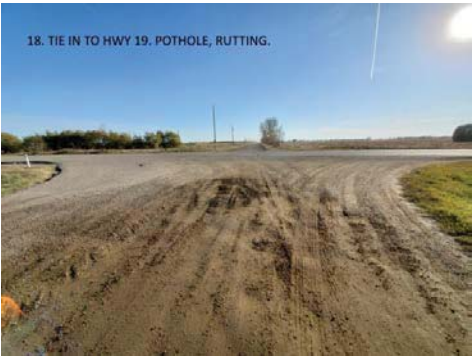
18. TIE IN TO HWY 19. POTHOLE, RUTTING.

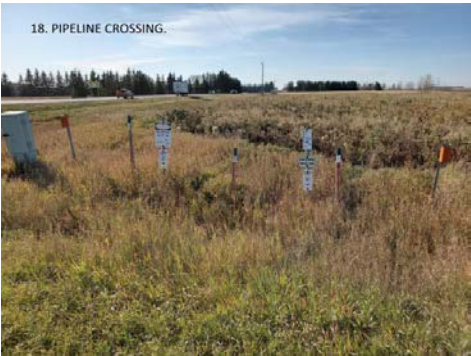
18. PIPELINE CROSSING.

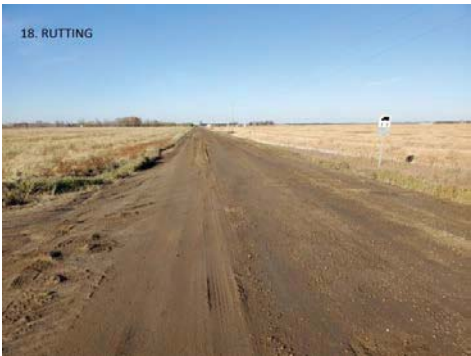
18. RUTTING

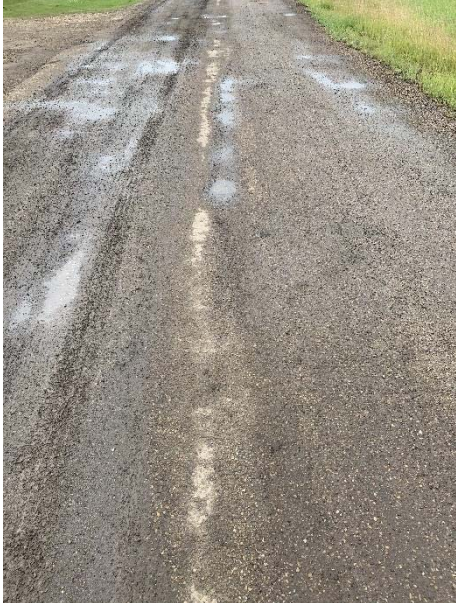
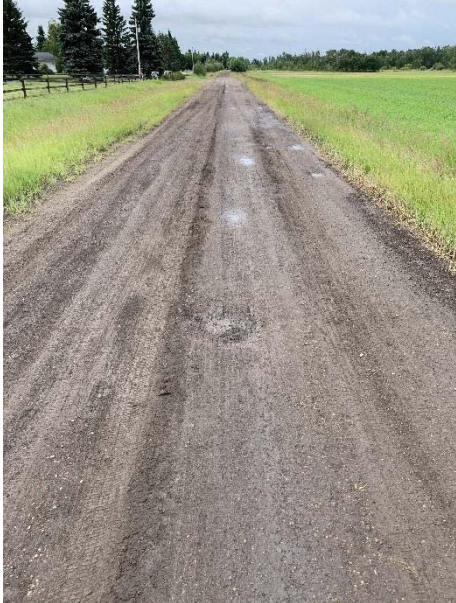
<p>1. In-situ asphalt (oiled) roadway surfacing, some ponding on roadway surfacing, some instances of minor pot holes. Slight washboarding/ corrugations. Approximately 25 metres south of TWP Rd 511A.</p>	<p>2. In-situ asphalt (oiled) roadway surfacing, slight to moderate rutting or channelling, some minor to moderate potholes. Approximately 75 metres south of TWP Rd 511A.</p>

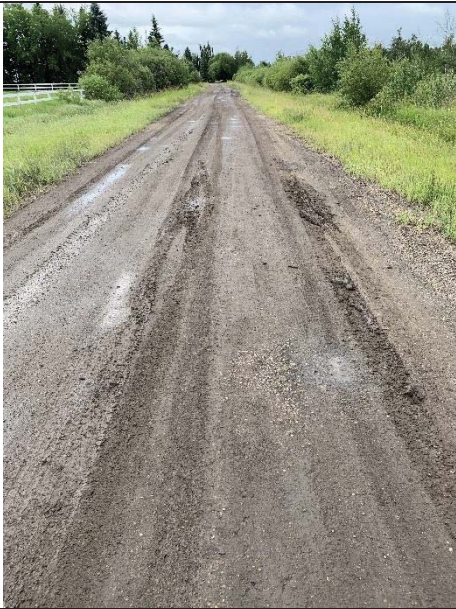
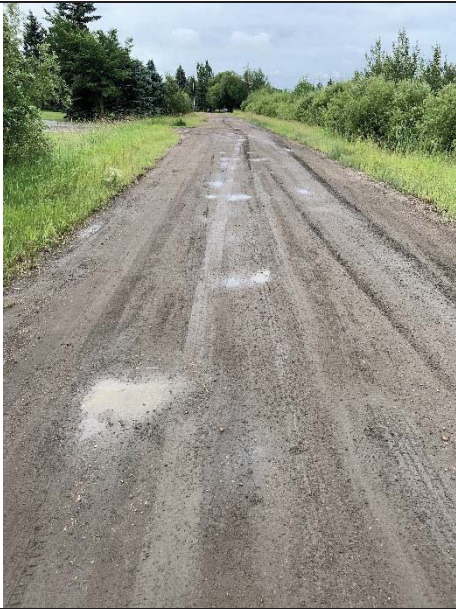
<p>7. In-situ asphalt (oiled) roadway surfacing. Slight rutting occurring, lack of a roadway crown leading to minimal ponding. Tracked mud and gravel on roadway surfacing. Roadway surfacing lacking, some areas of subgrade soil exposed. Approximately 450 metres south of TWP Rd 511A.</p>	<p>8. In-situ asphalt (oiled) roadway surfacing. Slight rutting occurring, slight to moderate potholes, tracked mud and gravel on roadway surfacing. Roadway surfacing lacking, some areas of subgrade soil exposed. Approximately 500 metres south of TWP Rd 511A.</p>

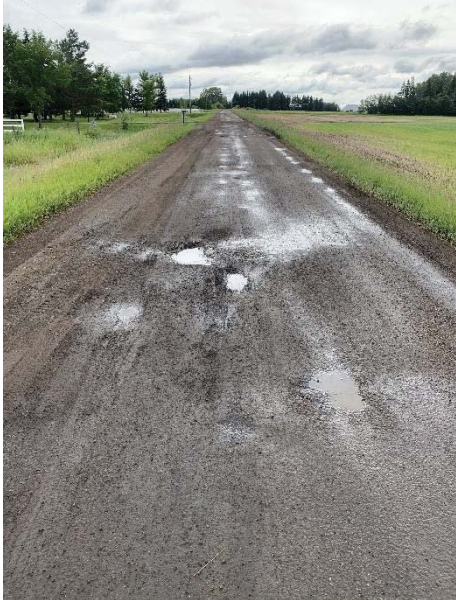
<p>7. In-situ asphalt (oiled) roadway surfacing. Slight to severe potholes with many instances, slight rutting or channeling, lack of a roadway crown. Approximately 375 metres east of 91 Street and TWP Rd 511A intersection.</p>	<p>8. In-situ asphalt (oiled) roadway surfacing. Slight to moderate potholes, many instances. Slight alligator cracking and ponding water from lack of roadway crown. Approximately 480 metres east of 91 Street and TWP Rd 511A Intersection.</p>
