HANGAR 11 - BLATCHFORD

- HISTORIC BUILDING RECORD
- HISTORIC BUILDING CONDITION ASSESSMENT
- CONSERVATION PLAN

December 20, 2019

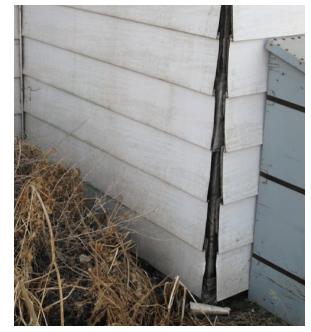
Fig. 31

The exterior of the building is clad in prefinished white steel siding, arranged in a horizonal shiplap configuration with green painted galvanized steel flashings at the coping. Flashings are generally found to be uneven and discontinuous, with signs of corrosion visible where the outer paint layer has worn away (Figures 31 & 32). There is no evidence of any remaining original wood siding.

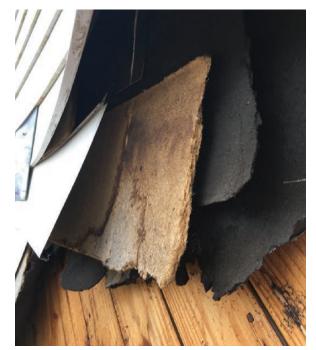
Fig. 37

Some areas of flashing were missing entirely, such as at wall corners and roof junctions (Figure 33). Rust staining was observed in some of the corners, where flashings have failed (Figures 33 & 34). Large sections of siding were found to be missing or separating from the sheathing on the west and south elevations, exposing the interstitial layers of the assembly (Figures 35-37).

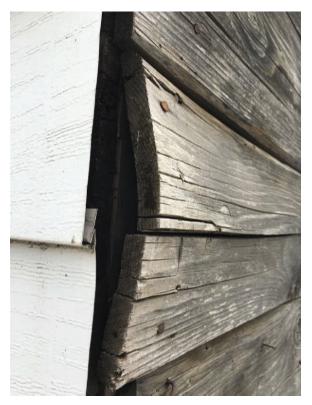
Fig. 42

Smaller sections of siding were observed to be missing on all four sides of the building, with visible discontinuities in the air barrier system (Figures 38-41). Deterioration of the pine sheathing boards was noted at several locations where corner junctions are exposed (Figures 42 & 43) and it is likely that similar degradation of the wood is occurring beneath the surface where the exterior envelope is compromised.

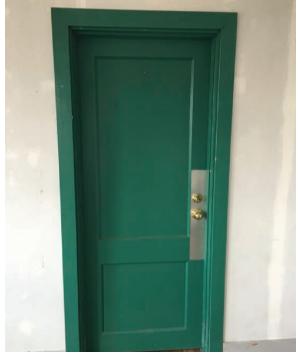
Fig. 96

The interior doors are typically of solid wood panel construction, with similar knob-type locksets and glazed lites in the offices (Figures 92-96). Overall, they are in good condition with limited wear and only local damage to frames, panels and glazing (Figure 97).

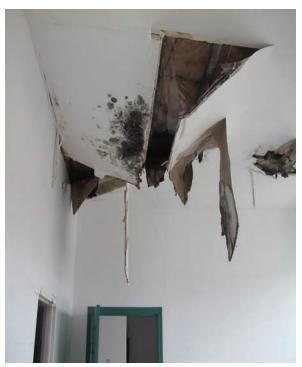
Fig. 109

The worst conditions were found on the west ancillary wing, where portions of ceilings have broken free and collapsed and floor finishes are heavily damaged (Figures 104 - 109).

- Remove water saturated batt insulation, vapour barrier & finishes at underside of flat roofs, exterior walls and west wing, down to bare floor deck (see Section 7.2.2 SP-05, SP-06, SP-07)
- Abate and dispose of all remaining non-structural interior partitions, drop ceilings, deteriorated floor and wall finishes in ancillary wings, and remove all redundant building services (see Section 7.2.3 CP-07);
- Abate and dispose of ceiling panels in hangar (see Section 7.2.3 CP-15);
- Full replacement of interior floor, ceiling and wall finishes, non-original millwork and equipment (see Section 7.2.3 CP-16).
- Refurbish wood flooring in east ancillary wing, as well as south half of second floor in west wing; locally replace missing or damaged floor boards as needed (see Section 7.2.3 - CP-24)

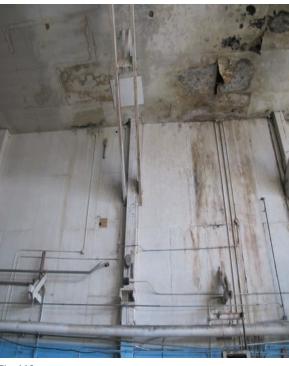
Fig. 110

Wall and ceiling finishes in the central hangar space are also generally defective from excessive wetting, fungal contamination and moisture damage primarily on the east and west sides (Figures 111 - 120).

- Strip existing paint from interior hangar walls, replace deteriorated wall panels with matching plywood panels, paint 1 coat primer, 2 coats acrylic latex enamel (see Section 7.2.3 CP-10);
- Refurbish wood flooring in east ancillary wing, as well as south half of second floor in west wing; locally replace missing floor boards as needed (see Section 7.2.3 CP-10).

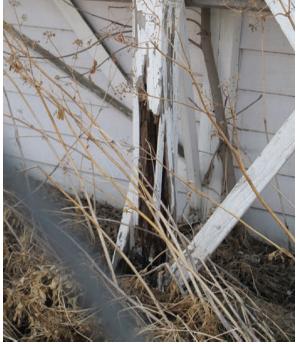
Fig. 150

The exterior wood fire escapes are currently located at all four corners of the property and are currently accessed from all upper floors of the ancillary wings. They are presently in a defective state, with significant portions showing signs of structural distress and material loss/decay, posing a high safety and security risk to the property (Figures 150 - 153).
