HANGAR 11 - BLATCHFORD

- HISTORIC BUILDING RECORD
- HISTORIC BUILDING CONDITION ASSESSMENT
- CONSERVATION PLAN

December 20, 2019

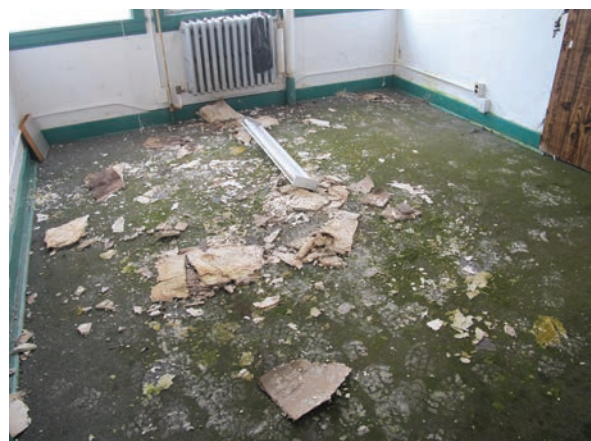
Fig. 6

There is vegetation that is actively growing, in moss form, in several of the carpeted rooms (Figures 6 & 7).

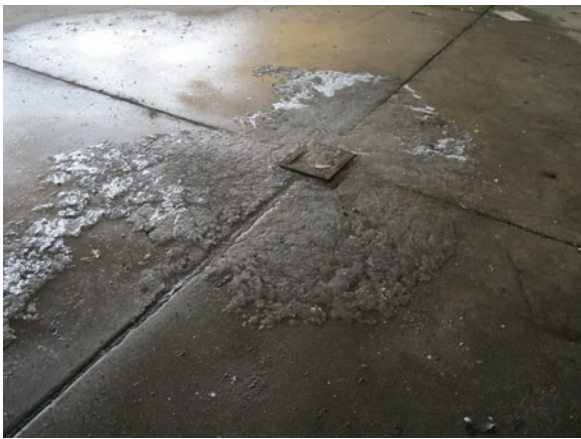
Fig. 15

Ponding, as well as ice patches, were noted in several locations on the slab in the central open space (Figures 15 & 16). Black fungal growth was observed on the ceiling panels and walls, which is an indicator of prolonged high moisture levels.

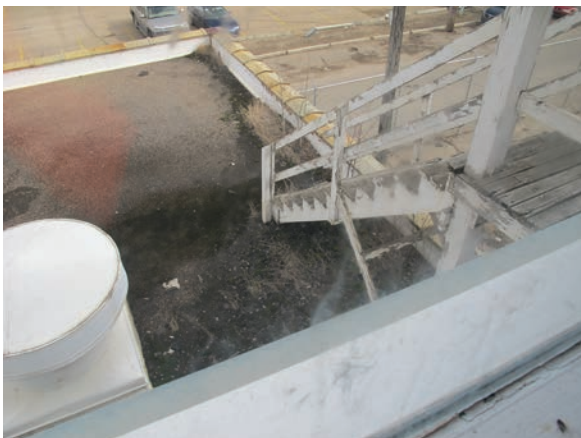
Fig. 17

The low flat roofs of the east and west additions were partially observed from adjacent upper floors (Figures 17 & 18). These roofs appear to be in fair to poor condition, with several uneven surfaces causing differential drying-out patterns, particularly on the northeast corner roof where patches of vegetation were also seen along the perimeter.

- Full replacement of the roofing system, carried out from an operating budget until further decision is made regarding the future adaptive reuse and conservation of the building (see Section 7.2.2 - SP-03 and SP-04).
- Replacement of all flashings and tie-ins, including flashing at all stacks and roof penetrations. Roof drains are of contemporary design and should be replaced (see Section 7.2.2 - SP-04).
- Install insulated roofing assembly from the exterior side of the hangar, so as allow for the exposure of the wood trusses from the interior.

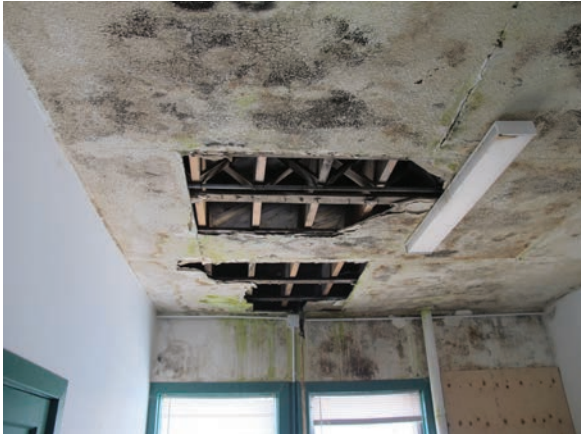
Fig.19

Visible black staining of the ceiling and floor joists, decking and cross-bridging was observed in several of the rooms where ceiling finishes have collapsed, suggesting potential subsurface degradation of the wood elements (Figures 19 & 20).

- Provide temporary bracing as required adjacent to any interior floor areas exhibiting signs of distress, such as sagging, deflection or excessive water saturation. Remove the existing deteriorated sections of floor and reframe with new infill floor structure (see Section 7.2.2 - SP-02).
- Where found to be in a state of disrepair, existing wood members should be examined with a view to conservation, even in part, using moisture-expelling epoxy consolidants (see Section 7.2.3 - CP-01).
- Remove existing deteriorated sections of floor on the west ancillary wing and infill with new wood floor structure (see Section 7.2.3 - CP-08).
- See Appendix E for additional structural recommendations by RJC.

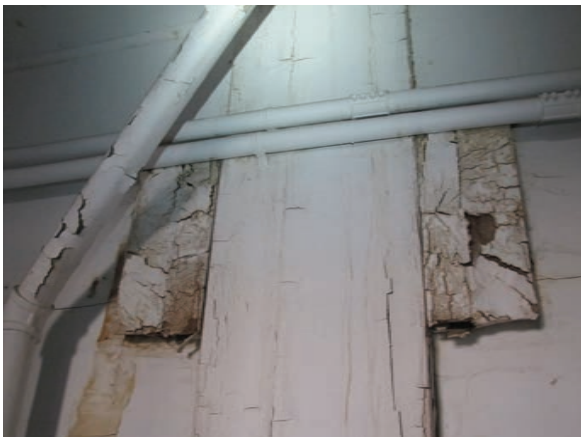
Fig. 27

Several of the truss ends were exposed in the office wings through the interior walls and were found to be generally close to saturation, the ends physically damp to the touch and resulting in visible wood decay (Figures 27 & 28) as were several posts in the hangar space (Figures 29 & 30). It is highly probable that the majority of wood members have moisture content well above equilibrium levels for the material.

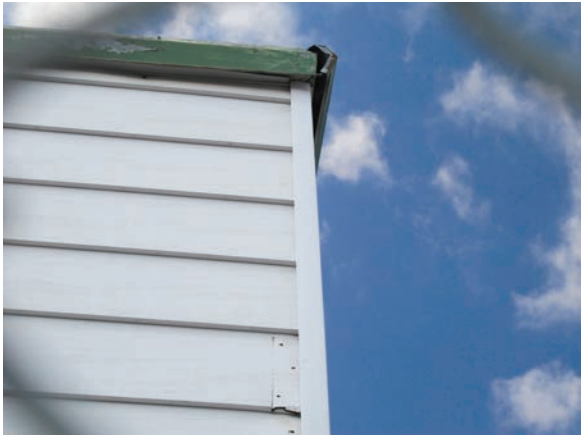
Fig. 31

The exterior of the building is clad in prefinished white steel siding, arranged in a horizontal shiplap configuration with green painted galvanized steel flashings at the coping. Flashings are generally found to be uneven and discontinuous, with signs of corrosion visible where the outer paint layer has worn away (Figures 31 & 32). There is no evidence of any remaining original wood siding.

- Full replacement of the exterior cladding and air barrier system (see Section 7.2.3 - CP-17).
- Replacement of all flashings and transition membranes, including flashings at wall openings (see Section 7.2.2 - SP-15; Section 7.2.3 - CP-17).

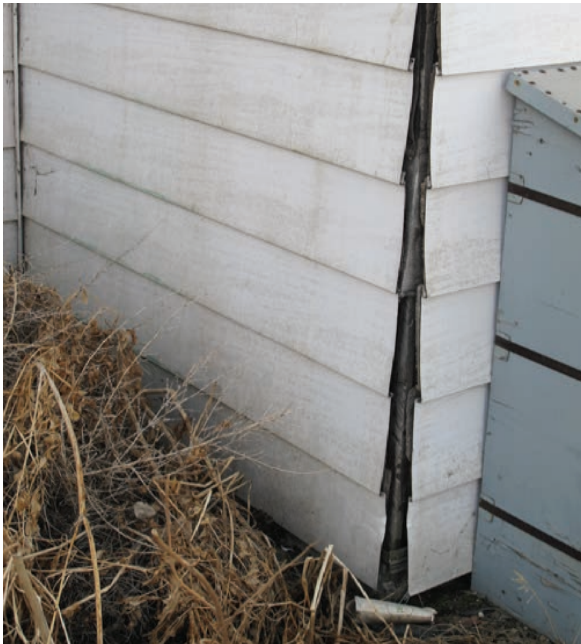
Fig. 33

Some areas of flashing were missing entirely, such as at wall corners and roof junctions (Figure 33). Rust staining was observed in some of the corners, where flashings have failed (Figures 33 & 34). Large sections of siding were found to be missing or separating from the sheathing on the west and south elevations, exposing the interstitial layers of the assembly (Figures 35-37).

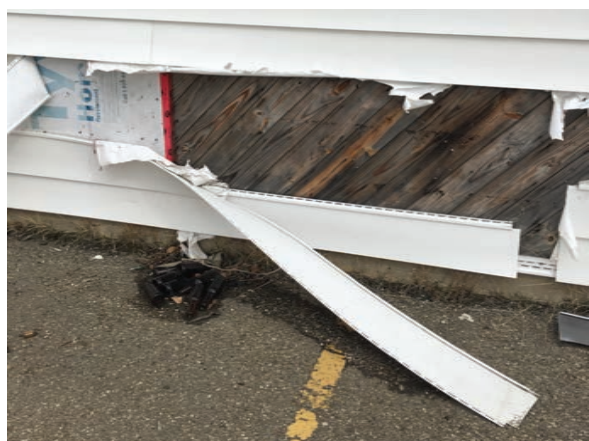
Fig. 38

Smaller sections of siding were observed to be missing on all four sides of the building, with visible discontinuities in the air barrier system (Figures 38-41). Deterioration of the pine sheathing boards was noted at several locations where corner junctions are exposed (Figures 42 & 43) and it is likely that similar degradation of the wood is occurring beneath the surface where the exterior envelope is compromised.

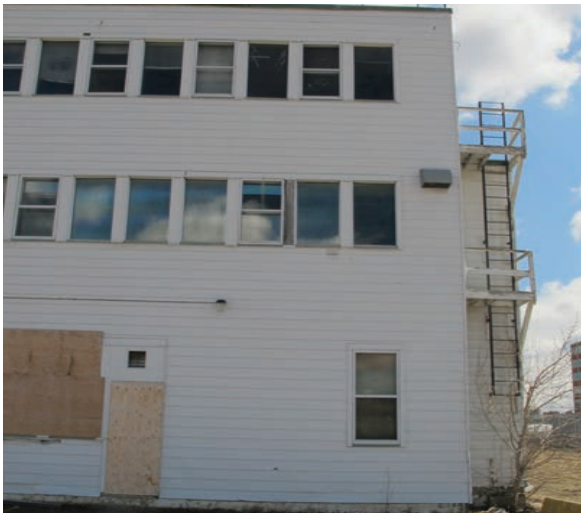
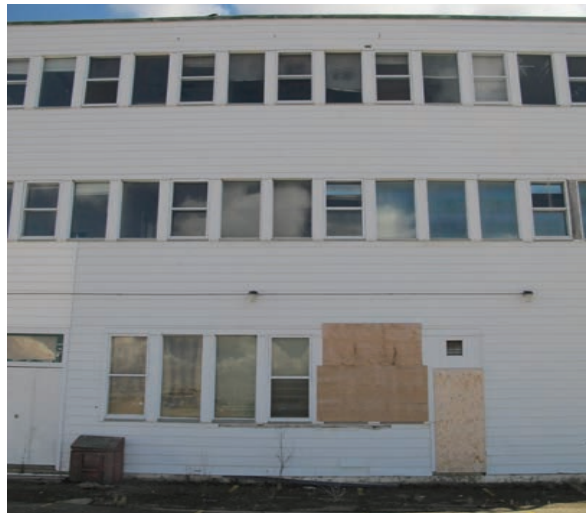
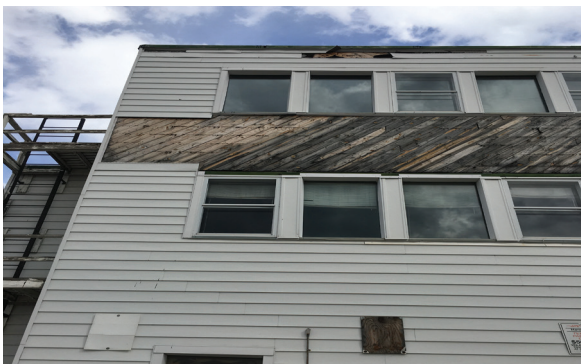
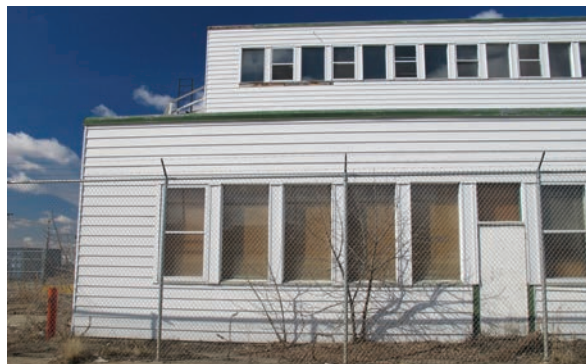
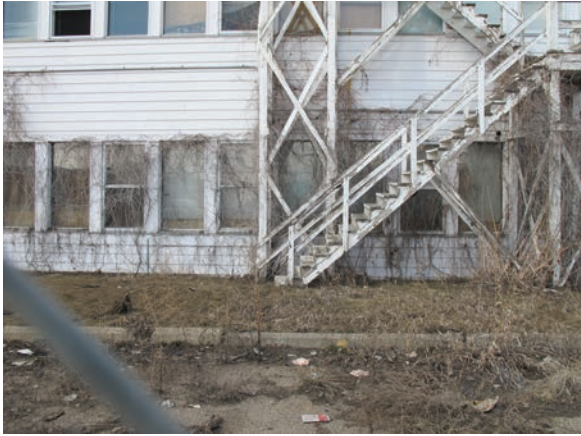
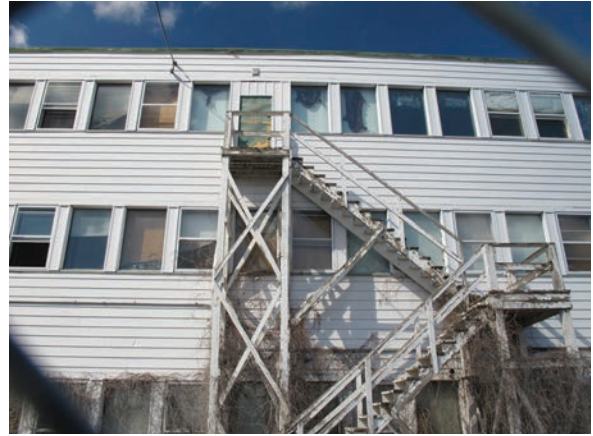
The condition of the existing windows was visually reviewed from the interior spaces, as well as externally from ground level. Contemporary double-glazed aluminium windows and interior storms have been installed at the exterior of the building and appear to be in generally fair condition (Figures 44-49).

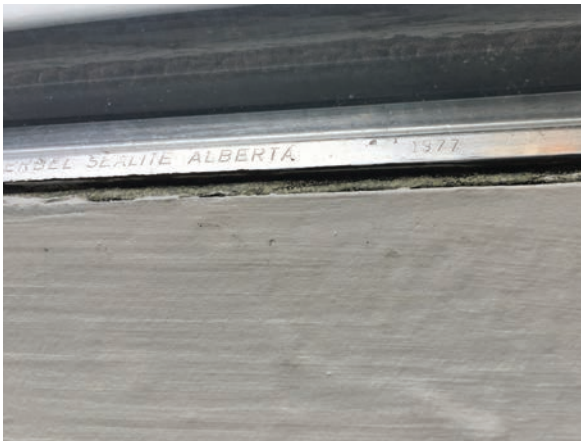
Fig. 50

As noted earlier in this report, the original exterior windows have been replaced and the current ones likely date from 1977, as per the manufacturer's etched inscription on the spacer bars (Figure 50). Several units were found to have broken glass and/or damaged screens (Figures 51-53), and condensation was observed on the glazing on the third floor of the east and west wings (Figure 54).

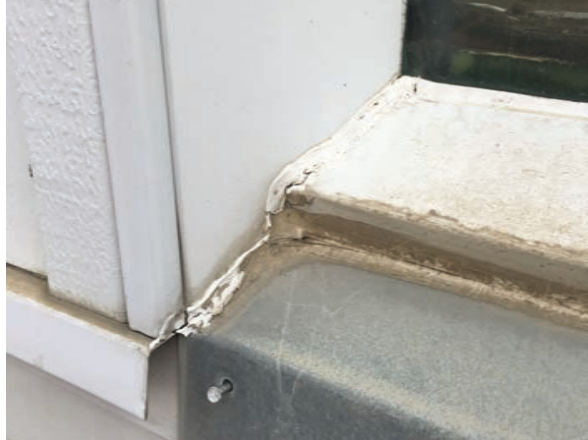
Fig. 55

Perimeter sealant joints appear to be in poor condition overall, and are exhibiting age-related distress in the form of adhesion failure, cracking and debonding (Figures 55 & 56). Several of the join sealants were found to contain asbestos. Some of the frames contain flaking/peeling paint and visible signs of deterioration between the panes (Figures 57-60).

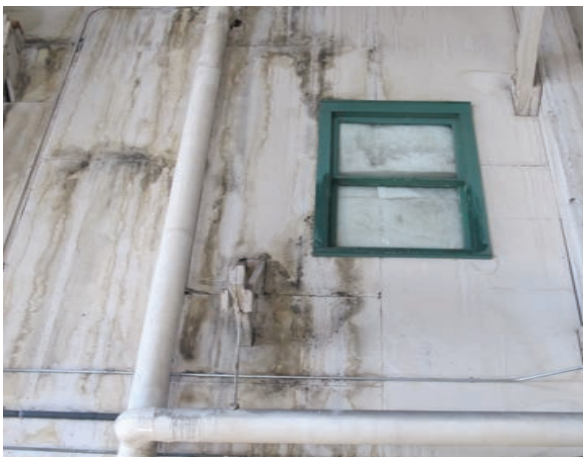
Fig. 64

Some areas show uneven paint build-up, suggesting the frames were locally touched up rather than fully repainted (Figure 64). No signs of visible wood decay were observed, however some minor consolidation of the wood should be expected once the paint layers have been stripped and the bare wood exposed, particularly in areas where active roof leaks are occurring directly above.

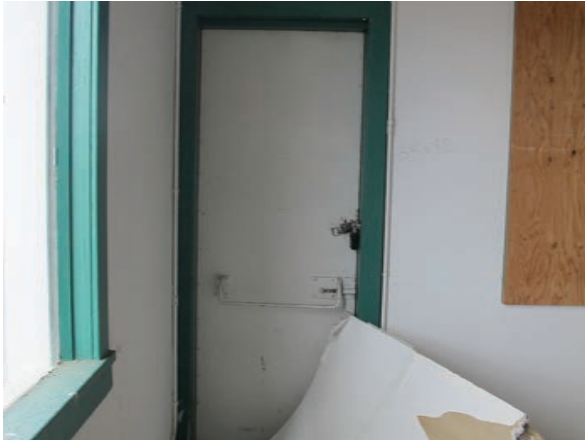
Fig. 70

The exterior doors are typically of a combination of solid wood panel and plywood construction, with knob-type locksets at man doors and makeshift push bars at exit doors (Figures 70 & 71). It is uncertain whether they are insulated.

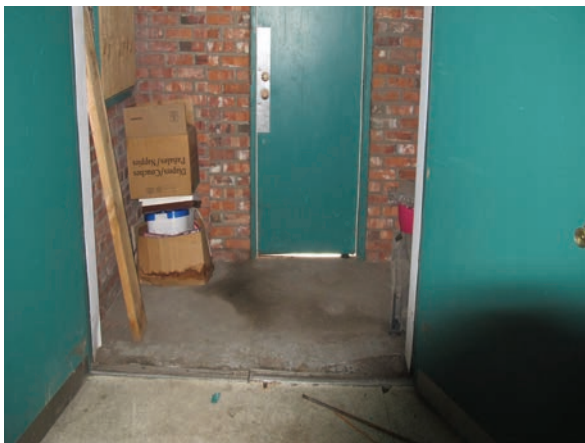
Fig. 72

Nearly all the exterior doors were non-operational at the time of review, thus door/hardware functionality and the presence/condition of weather stripping could not be observed apart from limited visual access. Rubber seal gaskets were noted at the jambs and headers of the southeast entrance door, however no bottom seal was apparent in this location, as a significant amount of daylight penetration could be seen at the threshold (Figure 72).

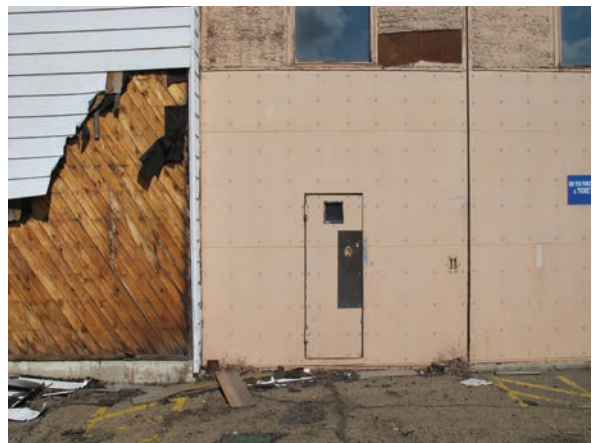
Fig. 73

The north man door, which presently serves as the primary access to the hangar space, is of wood frame and plywood construction, with mechanically fastened sheet steel cladding that is consistent with the appearance of the rolling hangar doors (Figure 73). The door itself is in poor condition, with delamination of the sheet steel at the edges revealing visible degradation of the underlying wood. This condition is typical of the hangar doors, where wood edges are exposed to view and deterioration observable (Figures 74-79).

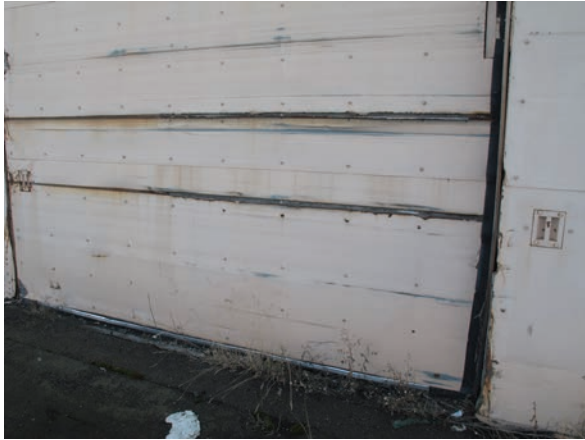
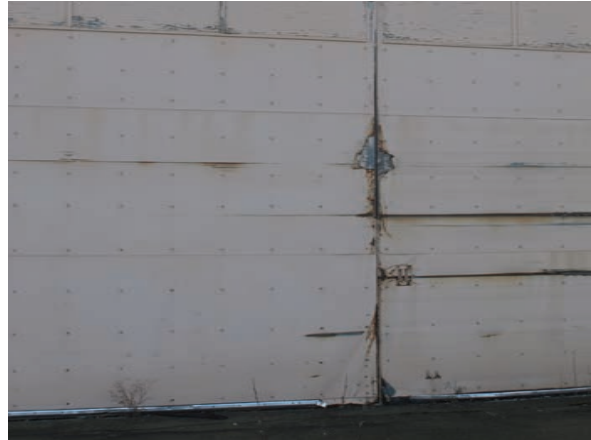
The painted sheet cladding on both the north and south main doors is heavily worn and corroding at the edges, surficial wear marks and fasteners (Figures 80 & 81), with some sections missing or damaged at the south facing doors (Figures 82 & 83). Above the cladding, the upper door sections are arranged in a three-over-three plywood panel layout with flat trim pieces at the panel joints (Figure 84). The plywood here is also in poor condition, with flaking and blistering paint revealing sections of deteriorated plywood, most likely the result of prolonged moisture trapping beneath the paint surface (Figures 85 & 86).

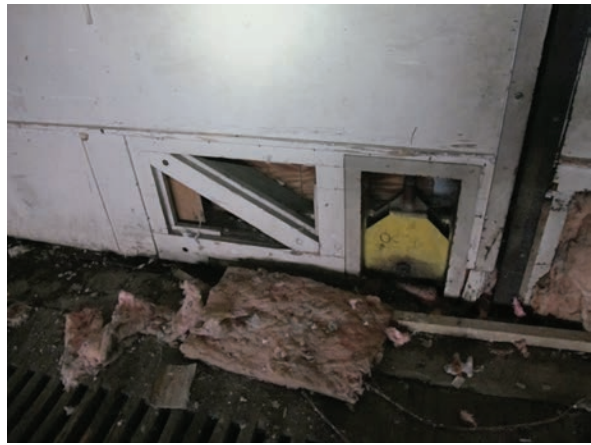
Fig. 87

From the interior side of the hangar doors, cut-outs in the cladding provided a limited view of the inner wood-laminated structural frame and steel rollers (Figure 87). From what could be directly observed at the cut-outs, framing appears to be in fair to poor condition with signs of wear and some cracking and checking of the wood in evidence

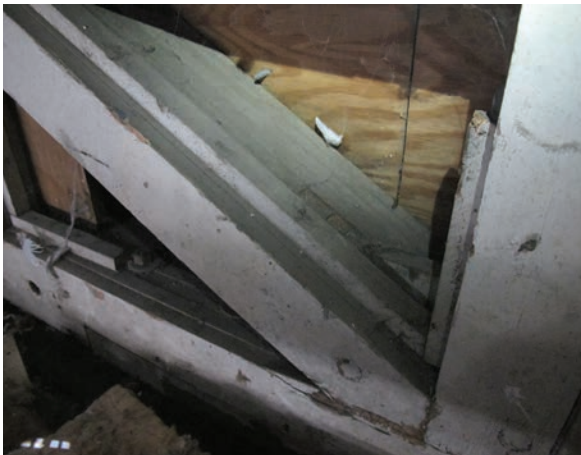
Fig. 88

(Figure 88). Loose bits of batt insulation were also present, suggesting that the doors are insulated (Figure 89).

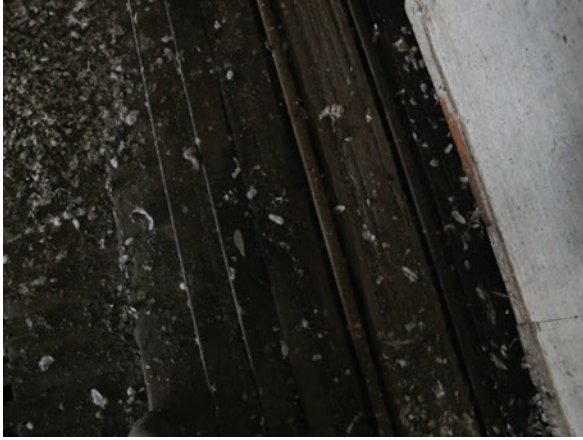
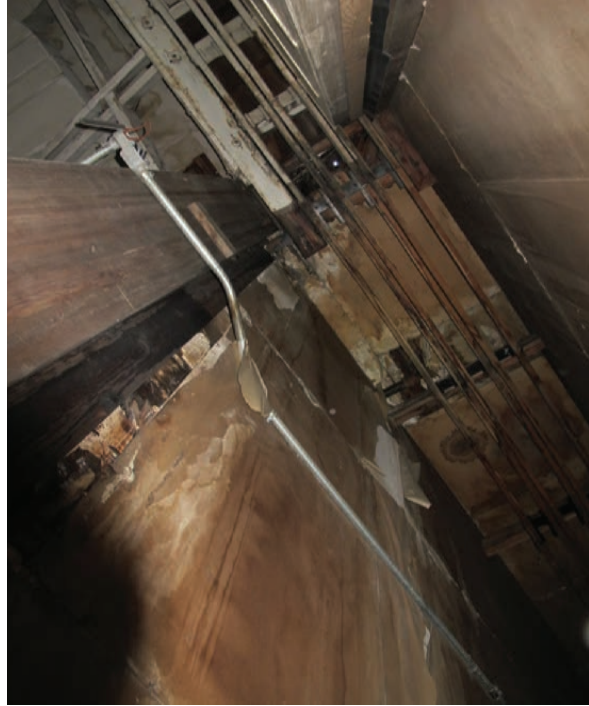
Door tracks are ceiling mounted and constructed in wood, with bottom wood tracks and steel runners embedded in the floor (Figures 90 & 91). Tracks are generally still intact, though the present functionality of the roller system is not certain. The floor-embedded tracks were wet and punky to the touch and likely compromised.

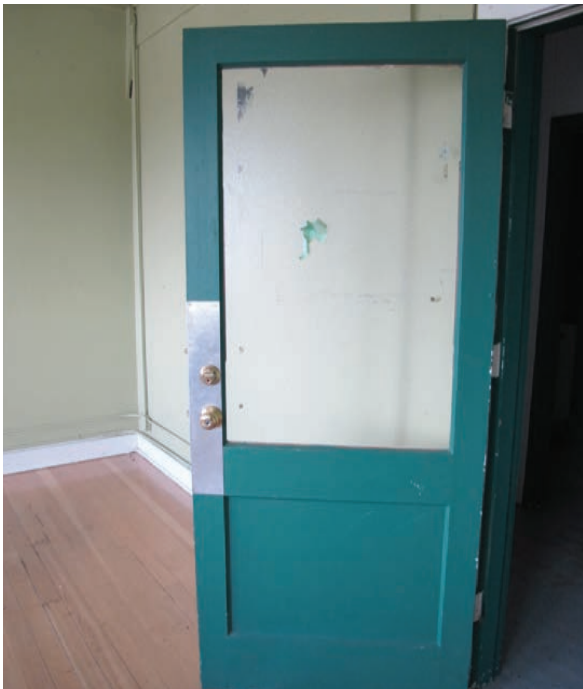
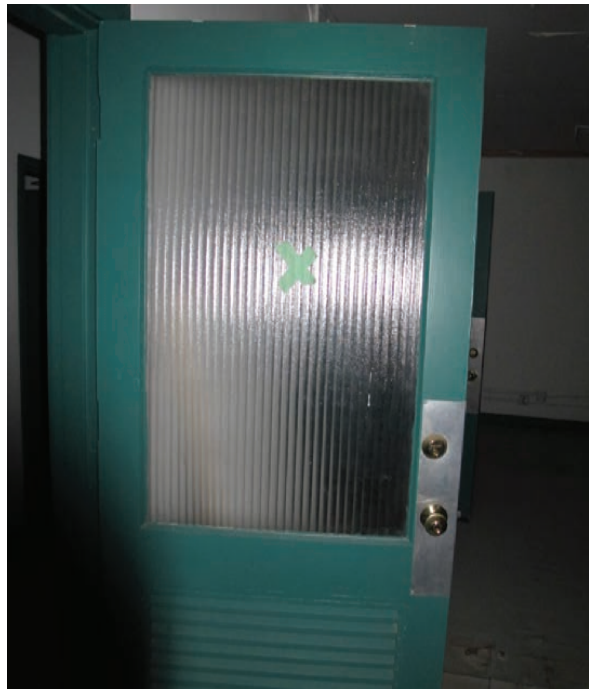
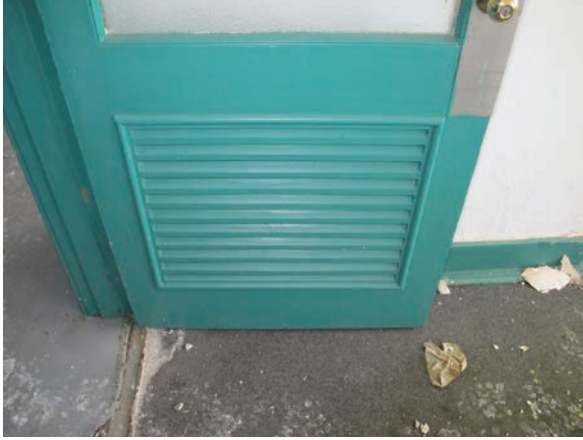
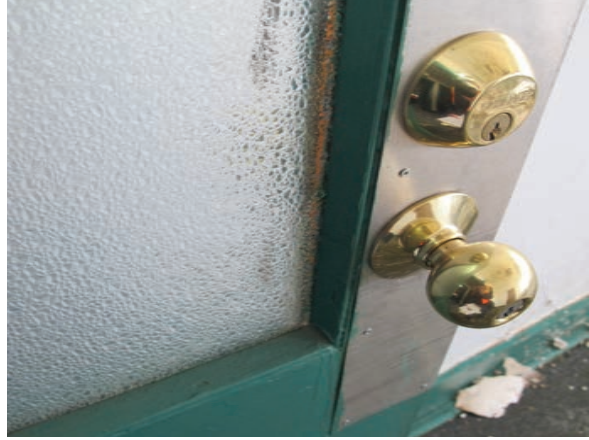
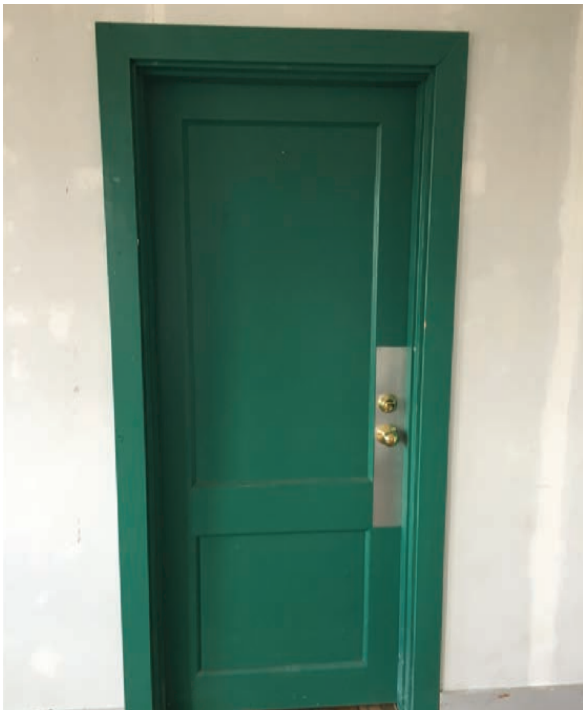
The interior doors are typically of solid wood panel construction, with similar knob-type locksets and glazed lites in the offices (Figures 92-96). Overall, they are in good condition with limited wear and only local damage to frames, panels and glazing (Figure 97).

- Retain, or salvage and reuse, interior wood panel doors. Strip doors to bare wood surface and repaint. (see Section 7.2.3 - CP-29).

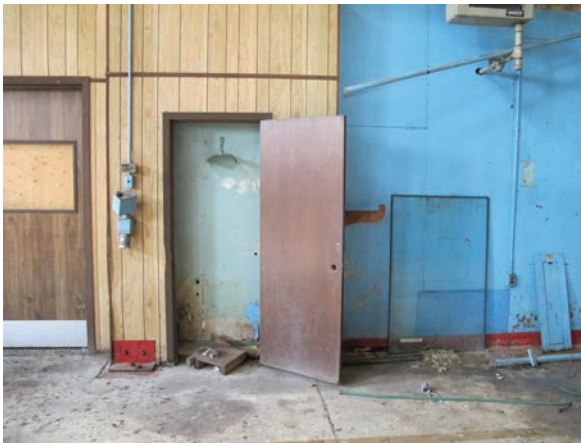
Fig. 98

Interior wall, floor and ceiling finishes are heavily damaged overall as a result of deterioration from water damage, unconditioned environmental impacts (freeze/thaw), deferred maintenance and general building neglect. Apart from the wood swing doors, casings, and frame structure, much of the existing interior fabric is beyond repair, showing signs of physical distress from moisture damage as well as a high probability of contamination from mould and fungal spores (Figures 98 - 103).

- Strip existing paint from interior hangar walls, replace deteriorated wall panels with matching plywood panels, paint 1 coat primer, 2 coats acrylic latex enamel (see Section 7.2.3 - CP-10);
- Refurbish wood flooring in east ancillary wing, as well as south half of second floor in west wing; locally replace missing floor boards as needed (see Section 7.2.3 - CP-10).

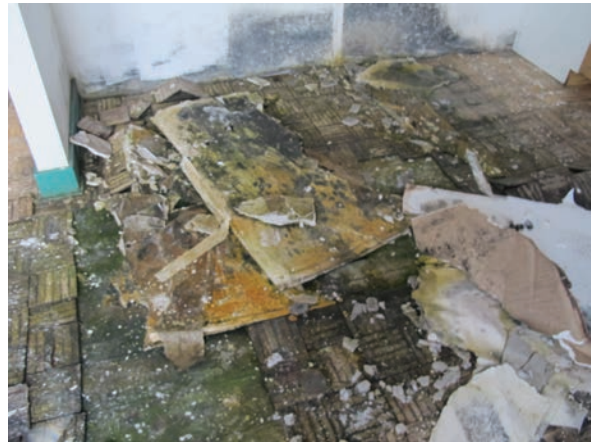
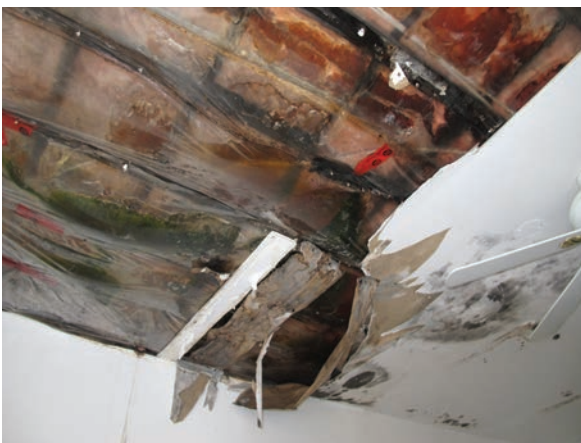
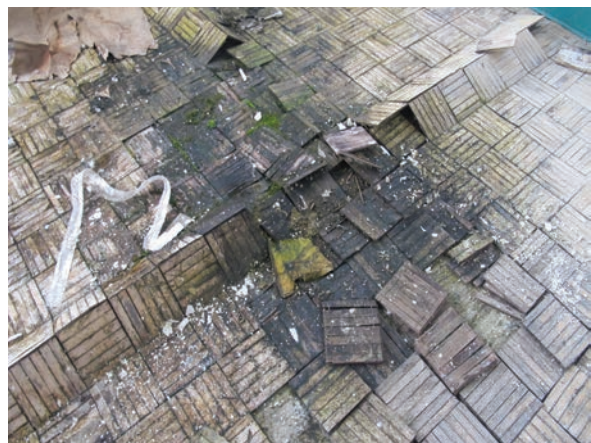
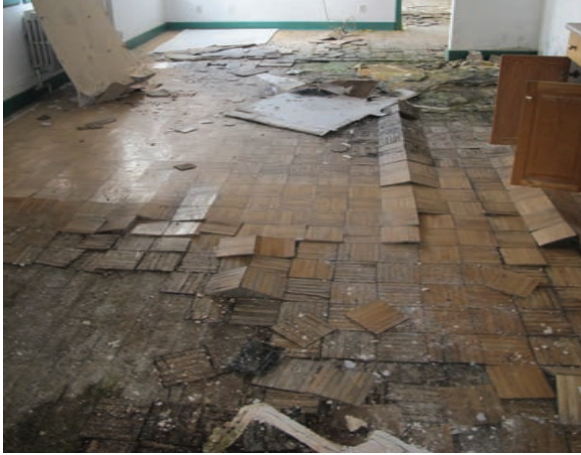
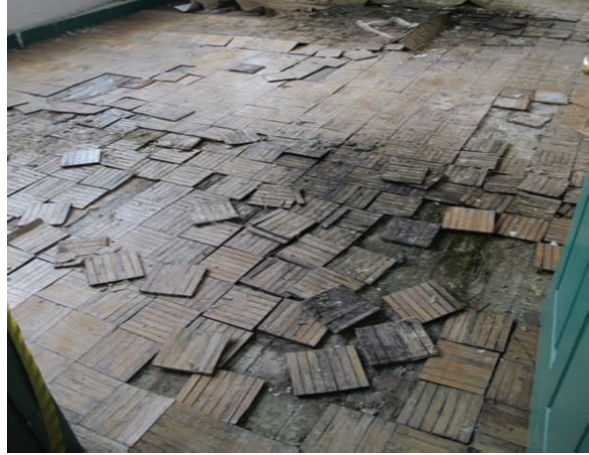
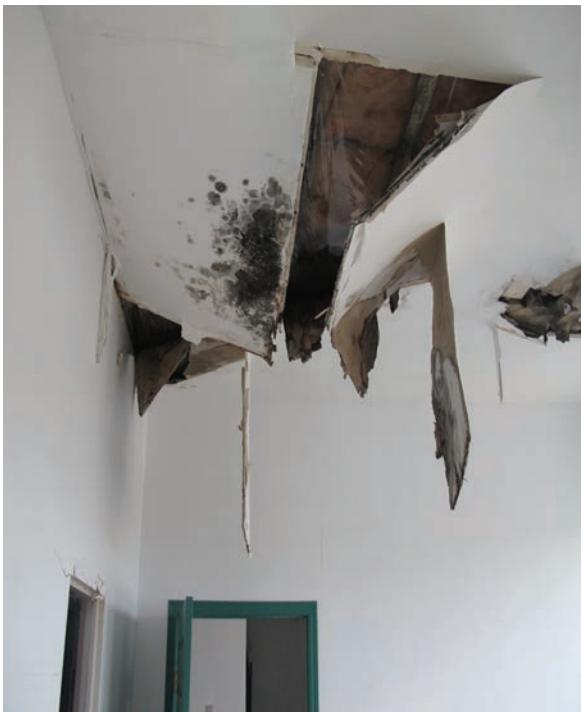
The worst conditions were found on the west ancillary wing, where portions of ceilings have broken free and collapsed and floor finishes are heavily damaged (Figures 104 - 109).

- Remove water saturated batt insulation, vapour barrier & finishes at underside of flat roofs, exterior walls and west wing, down to bare floor deck (see Section 7.2.2 - SP-05, SP-06, SP-07)
- Abate and dispose of all remaining non-structural interior partitions, drop ceilings, deteriorated floor and wall finishes in ancillary wings, and remove all redundant building services (see Section 7.2.3 - CP-07);
- Abate and dispose of ceiling panels in hangar (see Section 7.2.3 - CP-15);
- Full replacement of interior floor, ceiling and wall finishes, non-original millwork and equipment (see Section 7.2.3 - CP-16).
- Refurbish wood flooring in east ancillary wing, as well as south half of second floor in west wing; locally replace missing or damaged floor boards as needed (see Section 7.2.3 - CP-24)

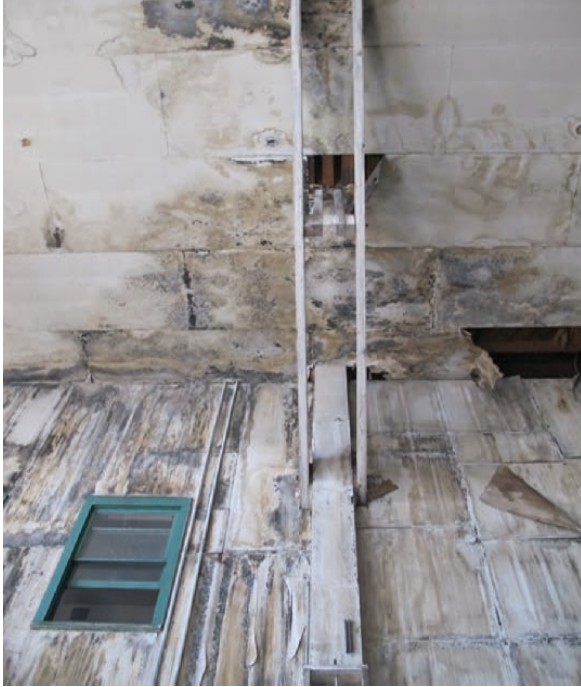
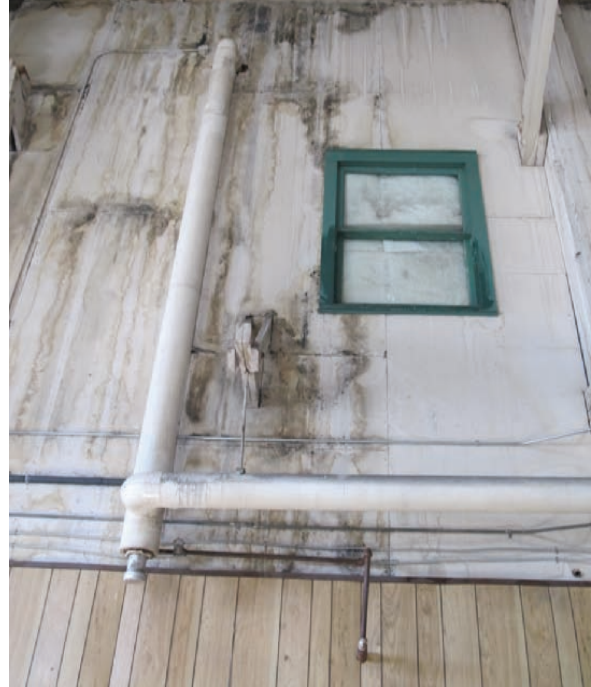
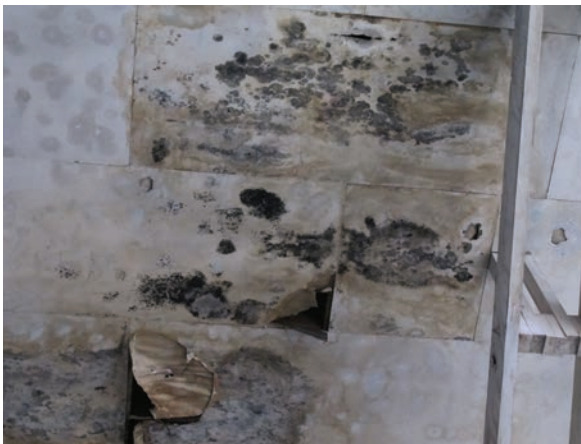
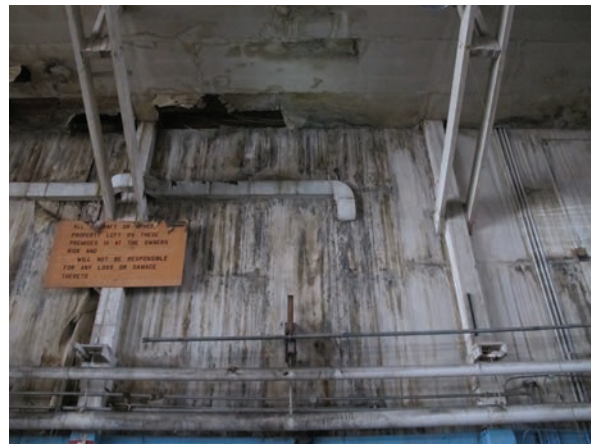
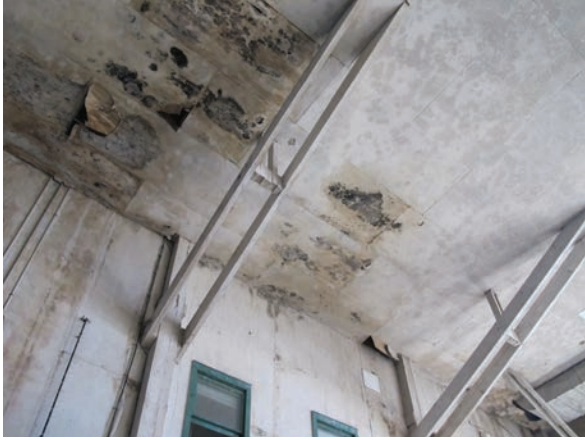
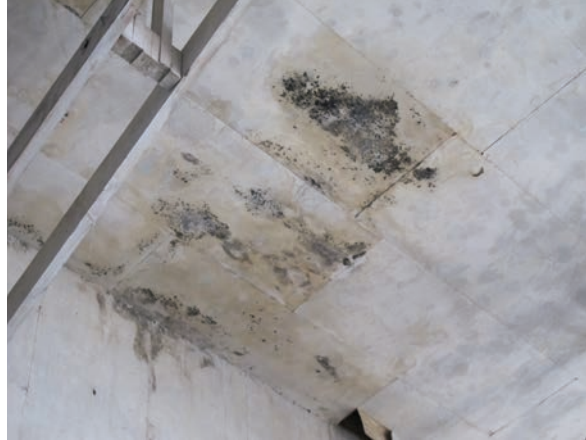
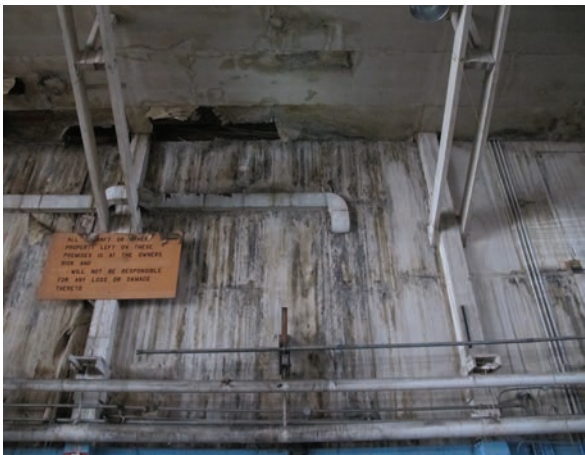
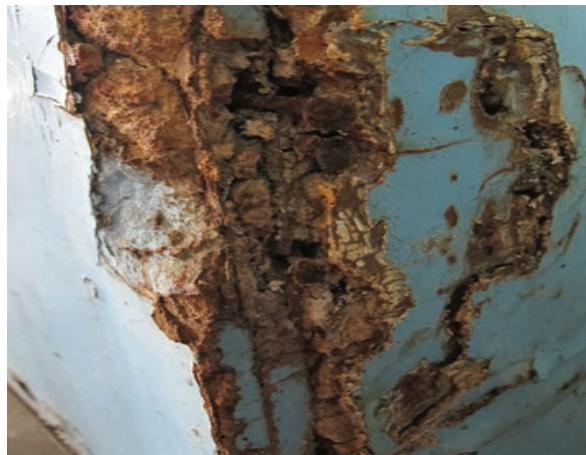
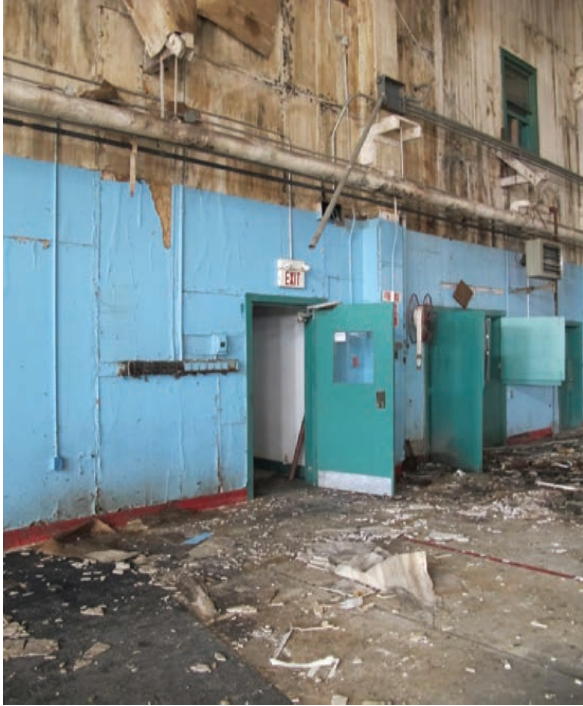
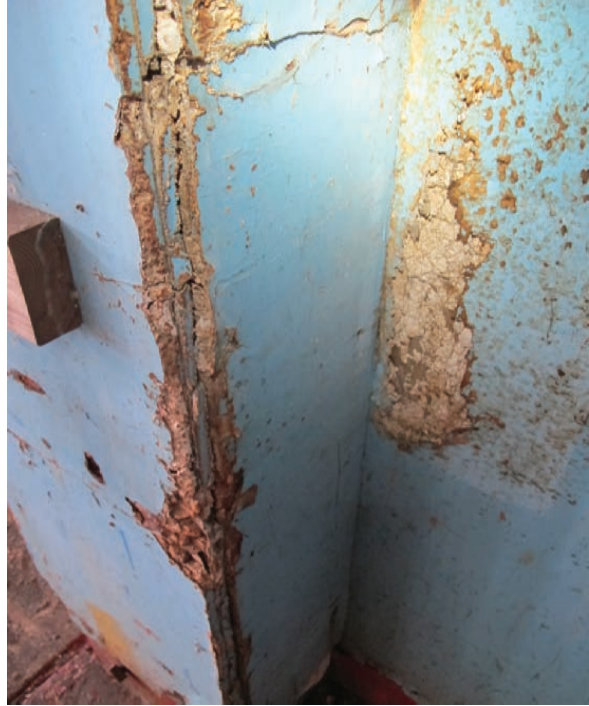
Wall and ceiling finishes in the central hangar space are also generally defective from excessive wetting, fungal contamination and moisture damage primarily on the east and west sides (Figures 111 - 120).

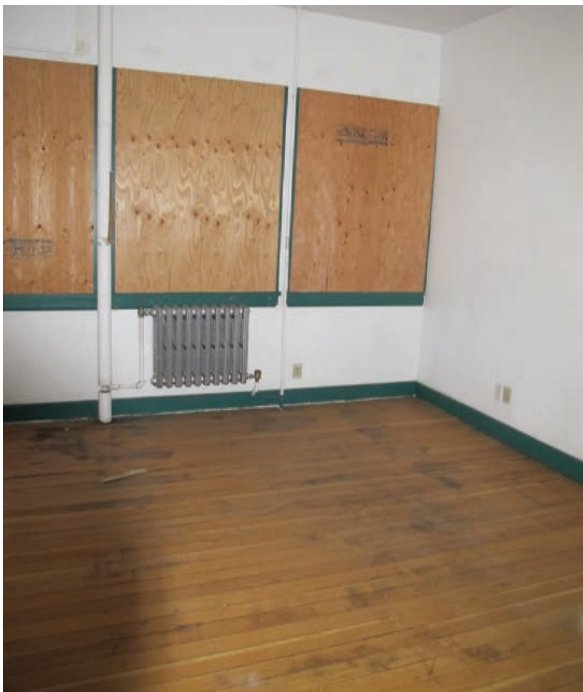
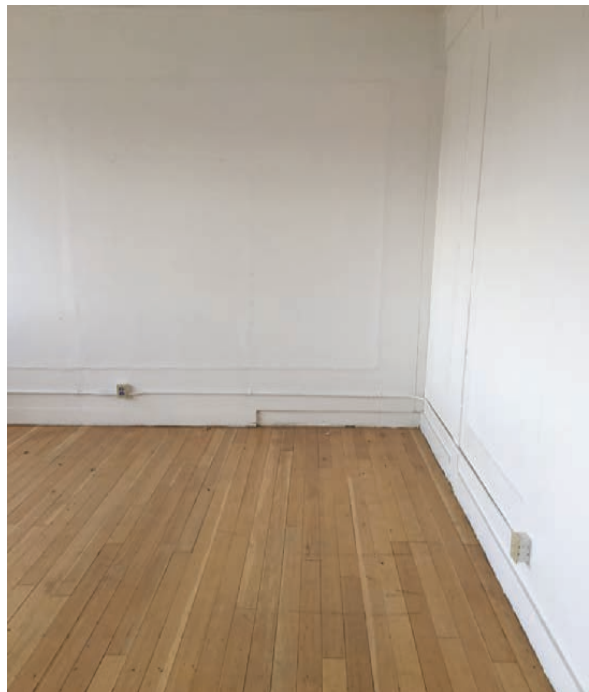
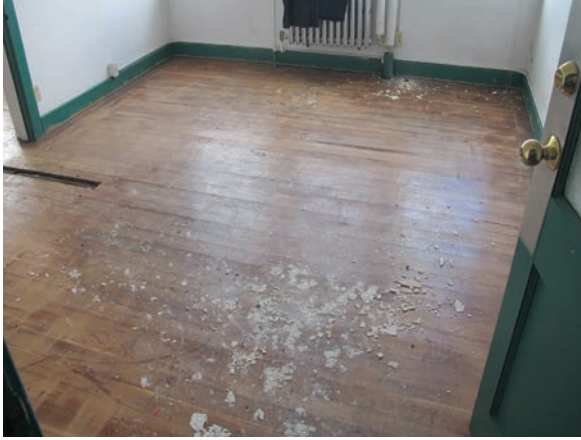
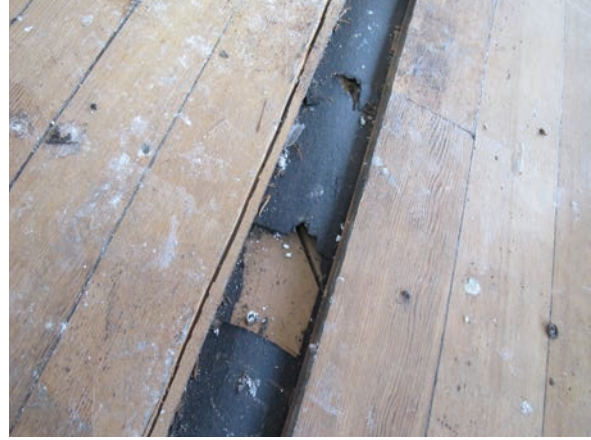
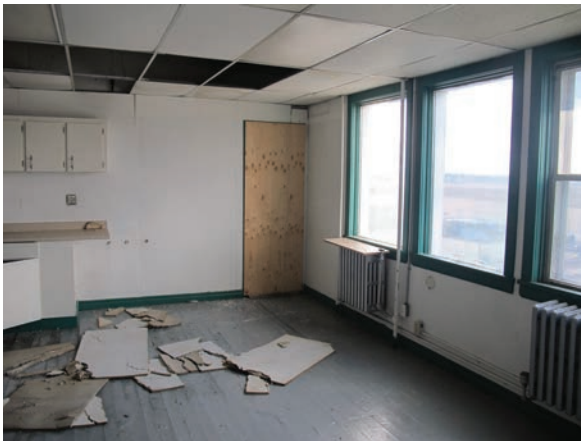
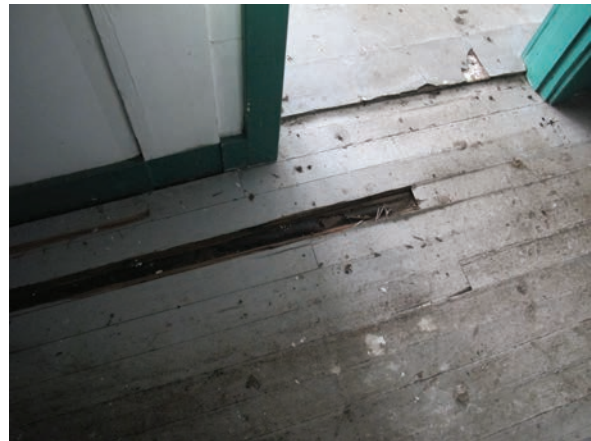
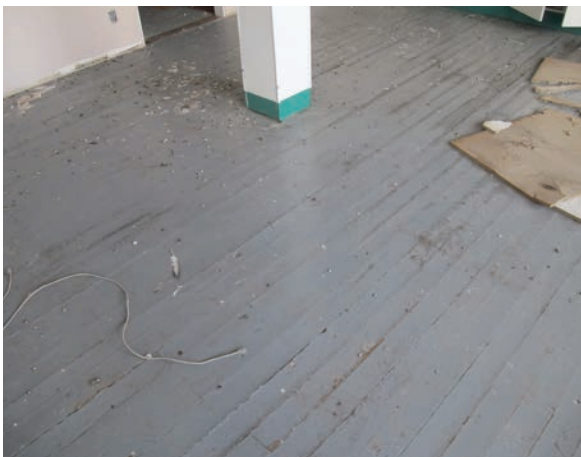
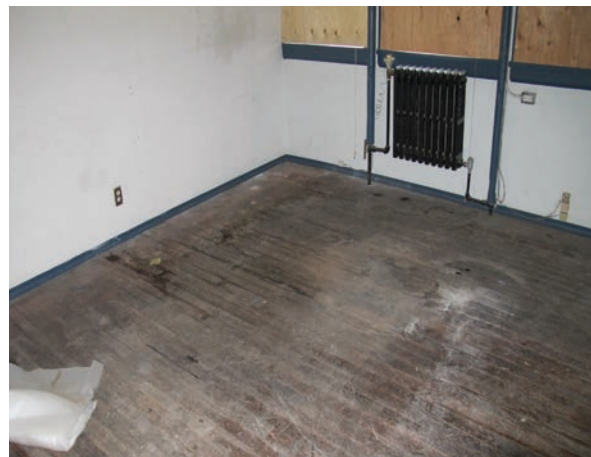
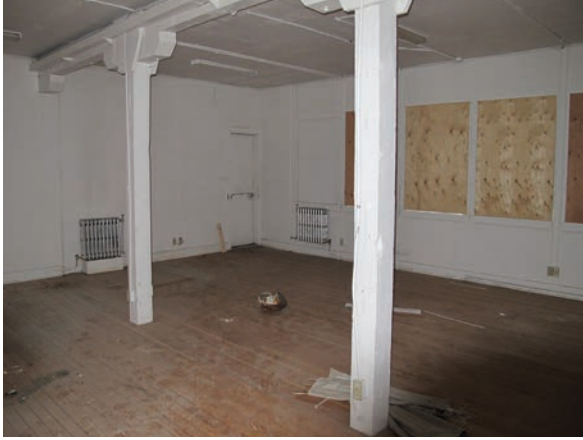
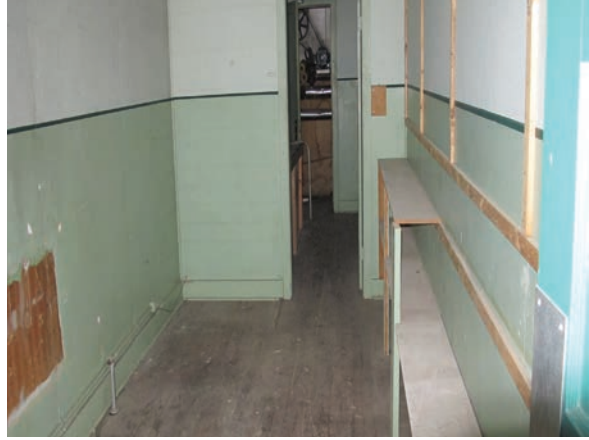
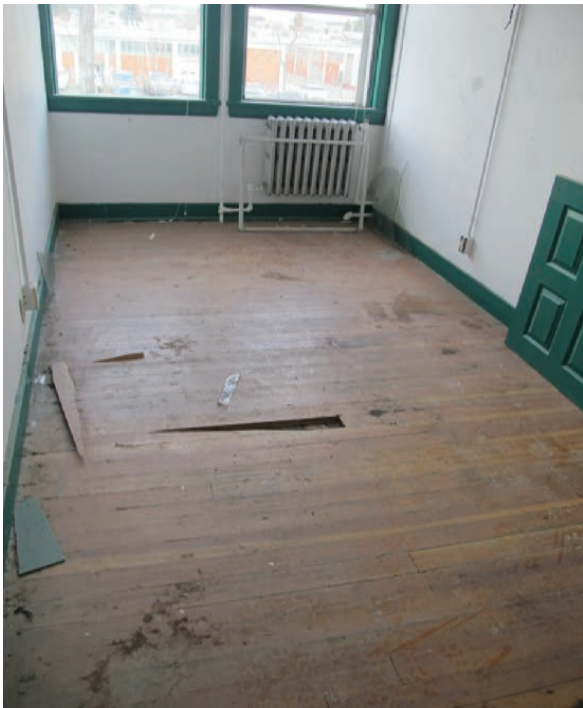
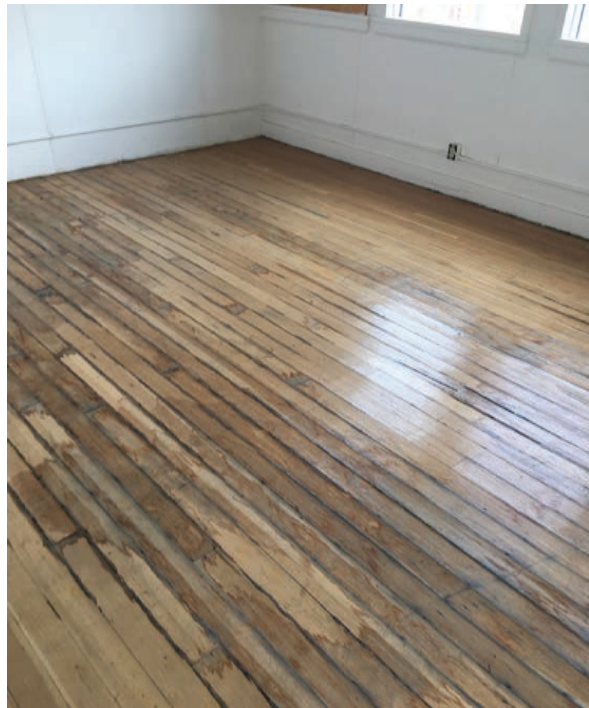
Floor finishes are generally in fair to good condition on the east ancillary wing, as well as the southern part of the west wing (second floor), with some areas exhibiting local water damage, staining and missing/damaged floor boards (Figures 121 - 132).

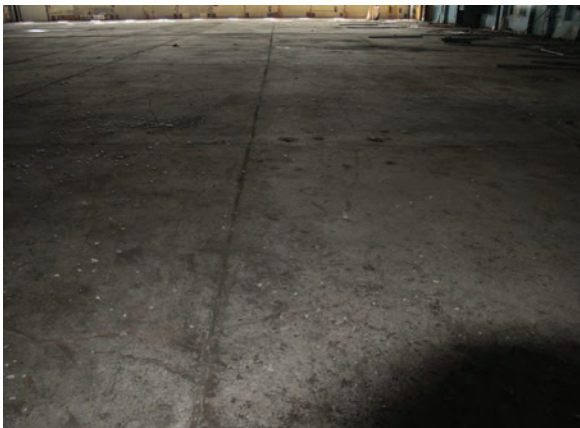
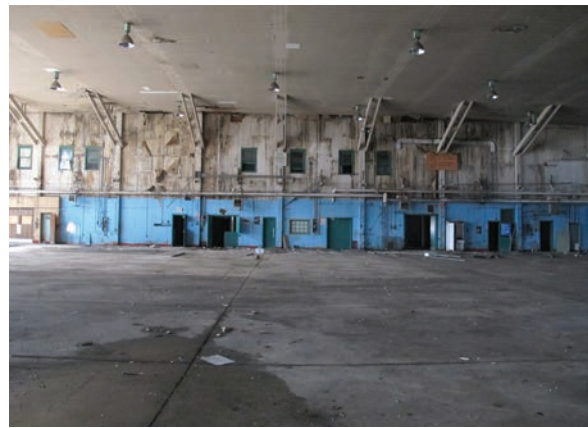
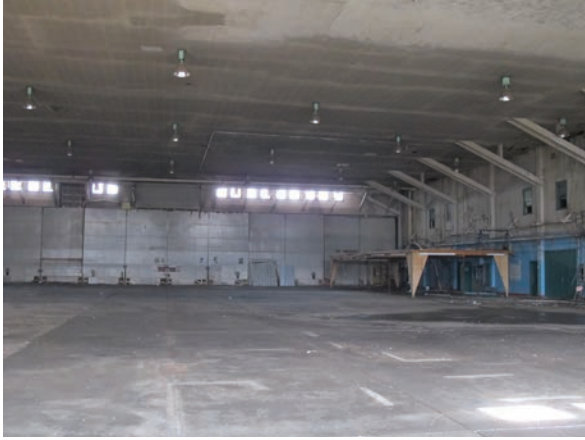
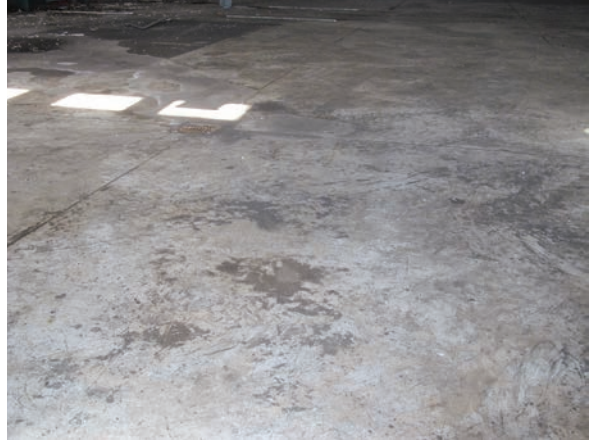
The concrete floor slab in the hangar space was found to be in good condition generally, with limited cracking and other signs of movement (Figures 133-136).

- Remove laminated wood embeds from ground floor concrete slab. Either replace in kind with pressure-treated wood, or patch with concrete and make good surfaces (see Section 7.2.3 - CP-20).
- Patch saturated areas of plywood subfloor with new pressure-treated plywood (see Section 7.2.3 - CP-21).
- Remove embedded wood trench drain and replace with new industrial steel trench drain cover plate to match (see Section 7.2.3 - CP-22).
- Provide local patch repairs to concrete floor where cracking or surficial damage has occurred (see Section 7.2.3 - CP-24).
- Clean existing floor slab, lightly polish and seal w/ clear penetrant (see Section 7.2.3 - CP-05).

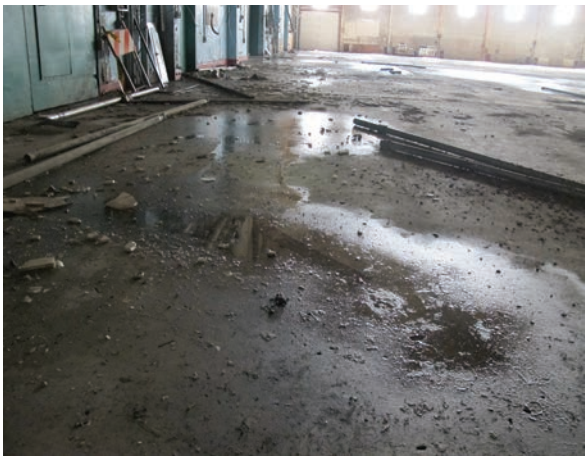
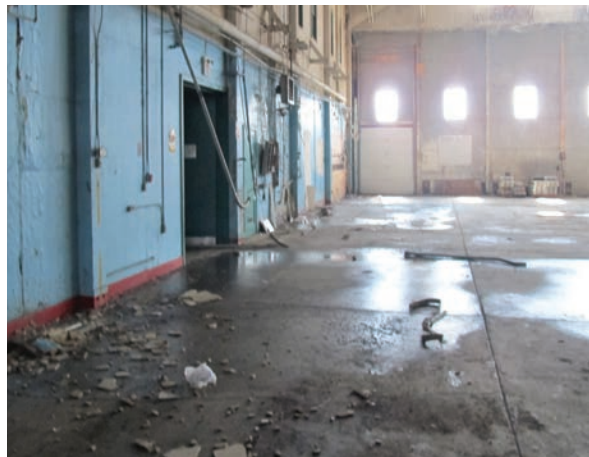
Large sections of the floor were actively damp (Figures 137 & 138), with local ice patches and water ponding where active roof leaks have formed on the east and west sides (Figure 139).

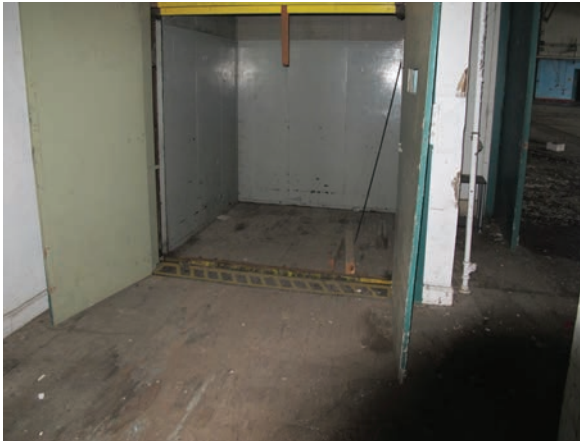
Fig. 146

The freight elevator is located on the west ancillary wing and was visually reviewed at ground level (Figure 146). The inner cab walls, floor, doors and closing gate are built in wood frame construction, with the cab interior lined in painted sheet steel.

- Option 1: Replace existing freight elevator with functioning elevator system (see Section 7.2.3 - CP-04).
- Option 2: Refurbish cab walls, floor doors and closing gate, and reinstate as a non-functional historic artefact (see Section 7.2.3 - CP-04).
