HANGAR 11 - BLATCHFORD

- HISTORIC BUILDING RECORD
- HISTORIC BUILDING CONDITION ASSESSMENT
- CONSERVATION PLAN

December 20, 2019

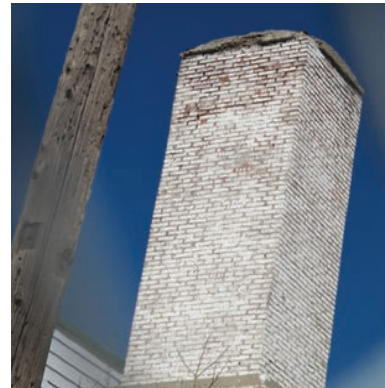
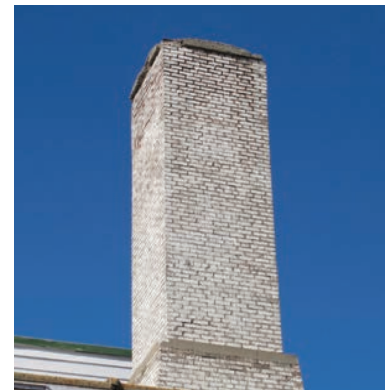
Flues, flue connections or chimney interiors were not reviewed. There is evidence of minor localized spalling of the brickwork towards the top portion of the chimney on the south face, as well as deteriorated mortar joints on all four sides (Figures 147 & 148).

- Strip the existing paint layer from the brickwork; rebuild loose, missing or damaged brick areas; 100% repoint mortar. Replace deteriorated capstone with new precast to match original size and profile (see Section 7.2.3 - CP-02);
- Provide all new base flashings for chimney stack (see Section 7.2.3 - CP-05);

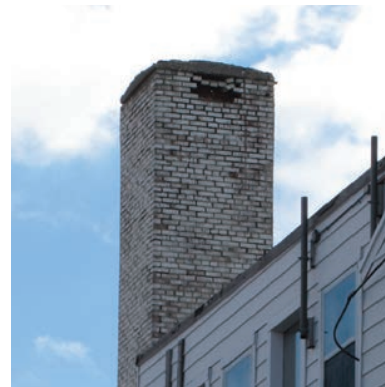
Fig. 149

Roughly ten bricks have dislodged and are missing from the top of the west face, with further header bricks in a similarly loosened condition above the hole (Figure 149).

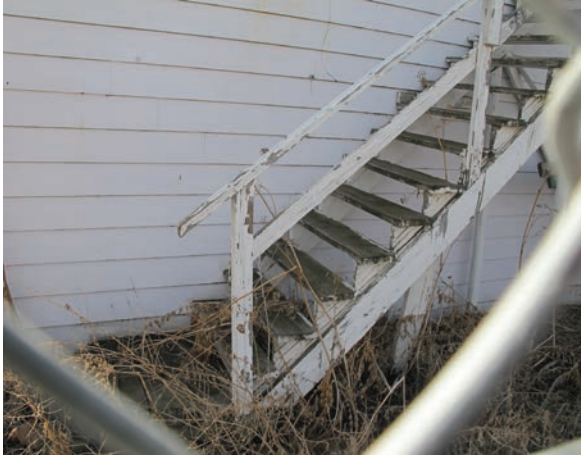
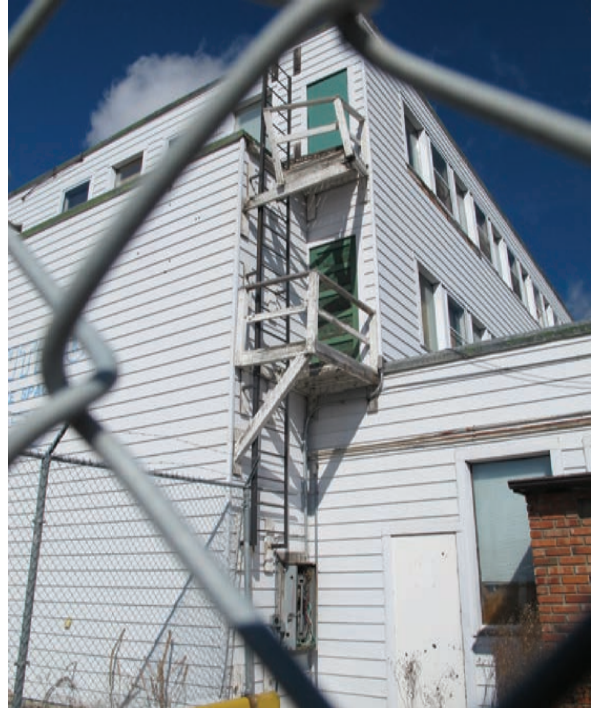
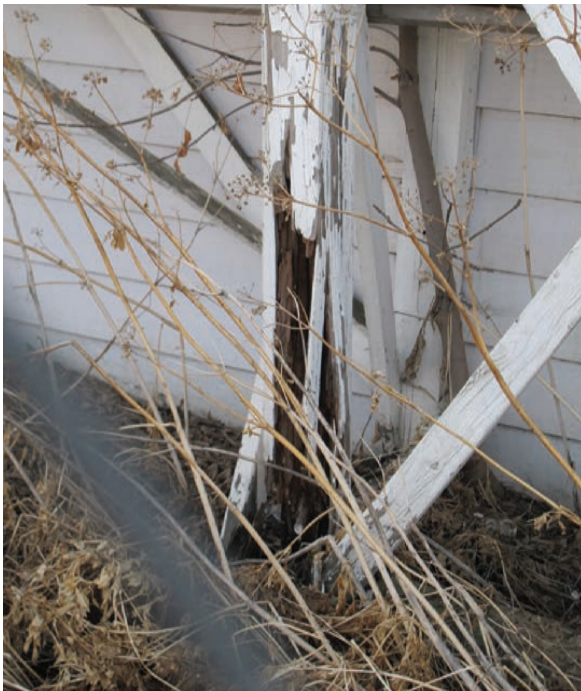
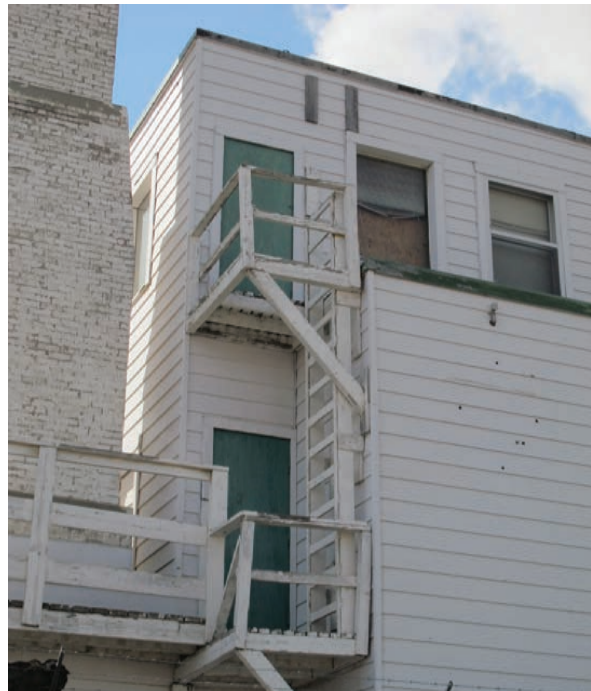
The exterior wood fire escapes are currently located at all four corners of the property and are currently accessed from all upper floors of the ancillary wings. They are presently in a defective state, with significant portions showing signs of structural distress and material loss/decay, posing a high safety and security risk to the property (Figures 150 - 153).

- Option 1 (rebuild): Abate and dispose of existing exterior wooden staircases and ladders and rebuild (4) existing exterior wooden staircases and (3) existing exterior wooden ladders to match (see Section 7.2.3 - CP-18);
- Option 2 (remove): Abate and dispose of existing exterior wooden staircases and ladders, and close in wall openings with new framed assembly (see Section 7.2.3 - CP-18).
