**City of Edmonton  
Valley Line Stage 1 – Light Rail Transit (LRT) Project  
Environmental Impact Screening Assessment Update**

**Final Report**

**Spencer Environmental  
Management Services Ltd.  
Edmonton, Alberta**

February 2015

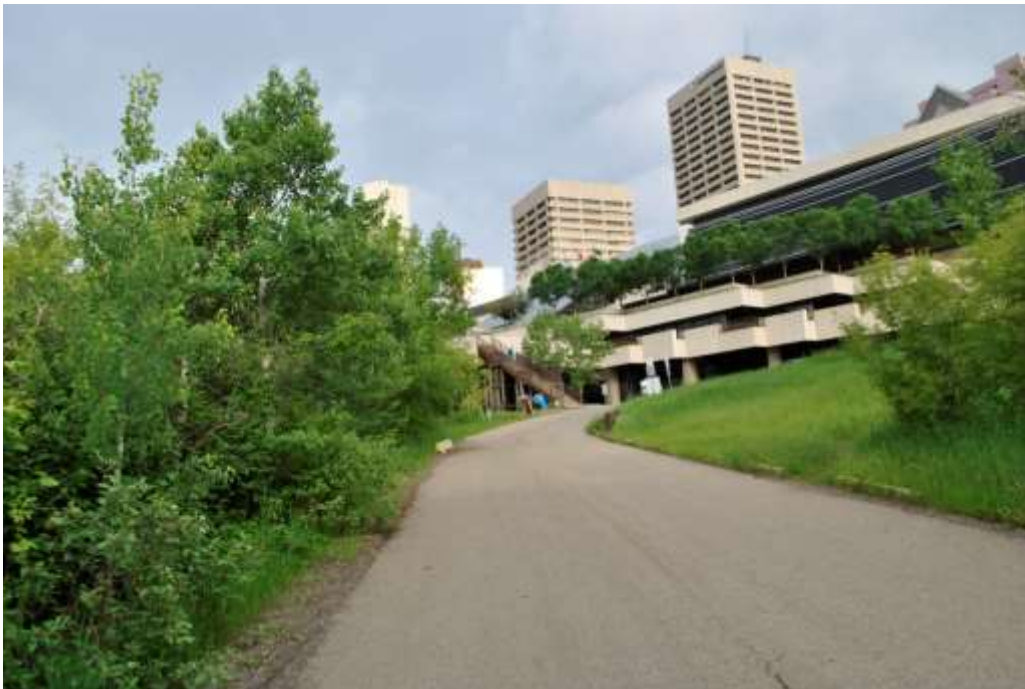
**Plate 2.1. Segment of proposed Louise McKinney Riverfront Park Construction Access Road using existing maintenance road, looking northeast.**

The proposed primary north valley construction access route enters LMRP from Grierson Hill Road near the Shaw Conference Centre, at the park main vehicle access point (Plate 2.1). From there, the access road travels southeast along the existing paved maintenance vehicle access, to the Riverfront Plaza, and then ties into an existing paved SUP (Figure 2.1b; Plate 2.2). The entire route follows existing asphalt, of variable width. Project Co will be required to design and construct the access road to the standard needed to carry out the work safely and without adversely affecting slope stability in the park. Based on the anticipated types of required construction equipment and the anticipated volume of traffic, Project Co is expected to upgrade the existing route. At a minimum, this is expected to involve some re-grading along the SUP to create a road base, and some preparatory work to assure a stable base. The road will have to accommodate two-way construction traffic and must fit within the corridor shown on Figure 2.1b. Temporary fencing may be installed to ensure safe separation of the route from public areas. The tight curves and narrow width of the existing access road from Grierson Hill to the Riverfront Plaza may be unable to accommodate large construction equipment. Thus, at this stage the City has not ruled out the need for Project Co to widen that route, which may require some clearing into adjacent natural vegetation.

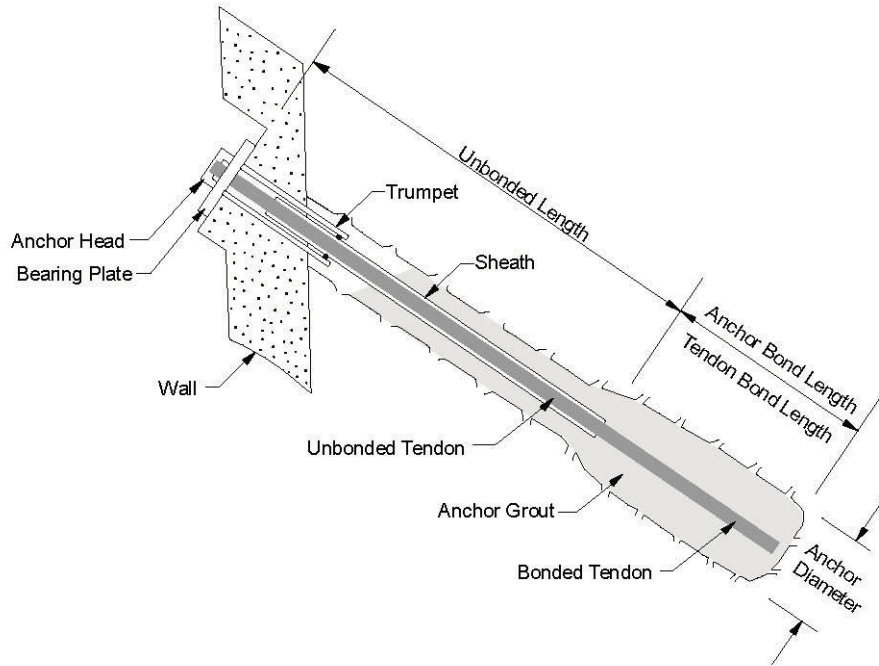
Figure 1 – Main Components of a ground anchor (FHWA, 1999)

Construction of a ground anchor involves the insertion of high strength steel element (bar or stand) into a predrilled hole that extends a certain design distance behind the excavation face. The hole is subsequently filled with cement grout (usually under pressure) and the steel member pre-tensioned. The pre-stressing force is transmitted to the retaining structure at the cut face via an anchorage system. Figure 2.3a shows a schematic diagram of the main components of a typical ground anchor. Figure 2.3b illustrates the construction sequence of one type of anchored retaining wall systems, namely, soldier piles and lagging.

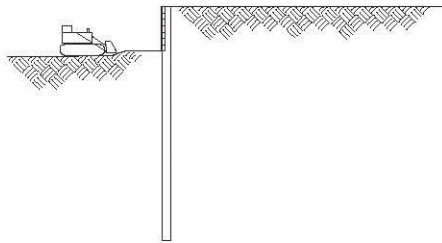
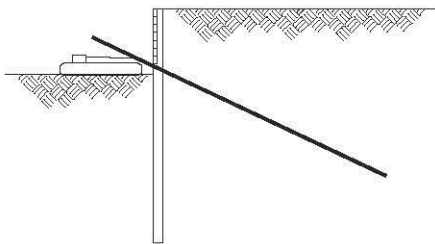
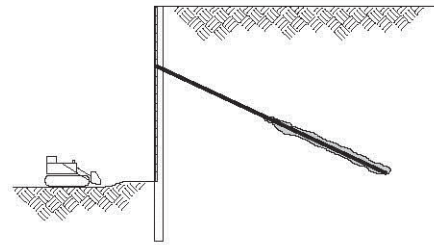
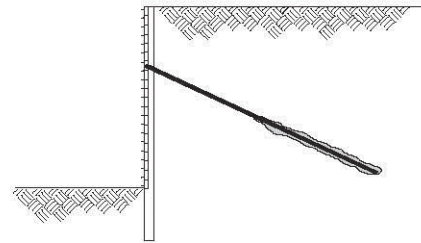
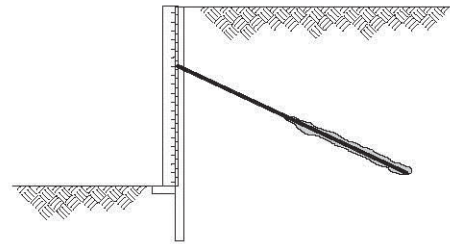
Figure 2.3b

STEP 1: Install soldier beam

STEP 4: Complete excavation

STEP 2: Excavate and install lagging

STEP 5: Install headed studs and prefabricated drainage

STEP 3: Install and test ground anchor

STEP 6: Pour cast-in-place facing

Figure 2 – Construction sequence for permanent soldier beam and lagging wall (FHWA, 1999)

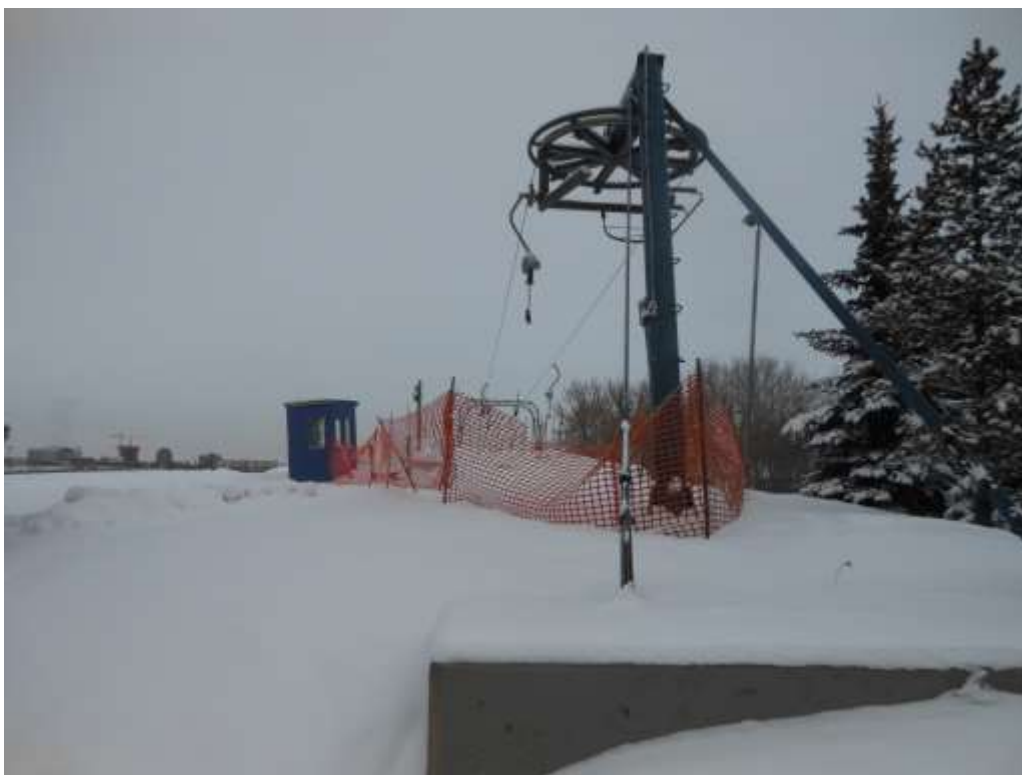
**Plate 2.6. Edmonton Ski Club return terminal bullwheel (foreground), operator shack (middle ground) and last tower (background) for the T-bar run, looking northwest (Jan. 2015)**

The 2013 EISA indicated that up to three Edmonton Ski Club lift towers must be relocated to accommodate a wider transportation corridor and the resulting changed grades north of Connors Road. Since then, studies of the effect of the project on the nearby ski runs have refined the City's understanding of the impact and of available and required mitigation means. As anticipated in 2013, Ski club infrastructure requires relocation at three locations, all of which can be undertaken within the 2013 delineated Project Area. However, at the third location, near the intersection of Connors Road and Cloverdale Hill Road, relocation of the T-bar return terminal bullwheel has implications for the associated downslope run. According to a specialist's report prepared for the City (BHA 2014), to maintain the minimum recommended unloading distance of 25 m between the relocated return terminal bullwheel and the last T-Bar tower there is a need to move the T-Bar tower slightly downslope and re-grade a small area to create a new suitable landing area. The existing operator shack shown in Plate 2.6 will also have to move further downslope, to be near the relocated return terminal bullwheel. Re-grading falls slightly outside the 2013 boundary and thus requires a small extension of the Project Area (Figure 2.1d) adding approximately 362 m<sup>2</sup> of additional land (Plate 2.6).

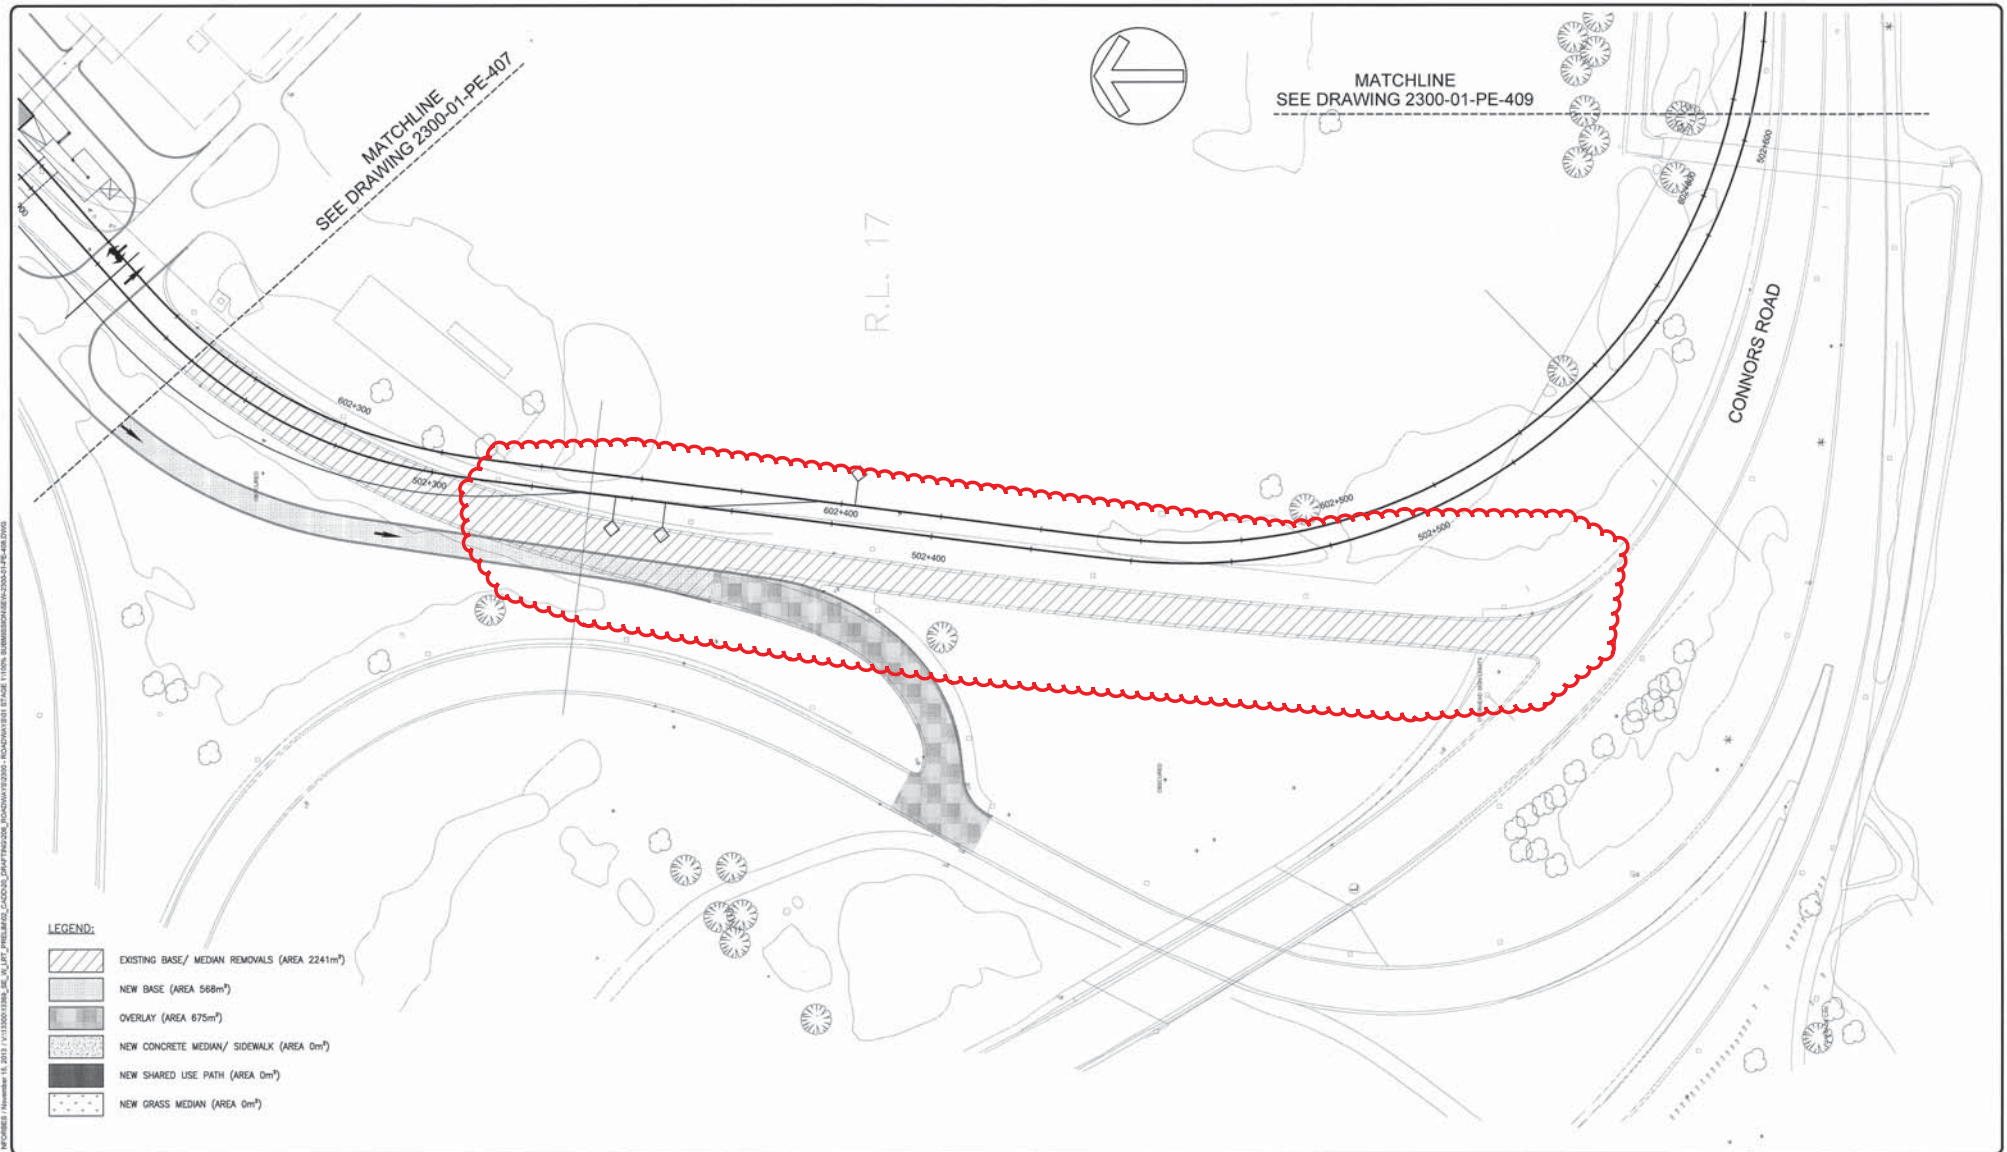
Figure 2.4 Muttart Access Road Partial Removal

- LEGEND:**
- EXISTING BASE/ MEDIAN REMOVALS (AREA 2241m<sup>2</sup>)
  - NEW BASE (AREA 568m<sup>2</sup>)
  - OVERLAY (AREA 675m<sup>2</sup>)
  - NEW CONCRETE MEDIAN/ SIDEWALK (AREA 0m<sup>2</sup>)
  - NEW SHARED USE PATH (AREA 0m<sup>2</sup>)
  - NEW GRASS MEDIAN (AREA 0m<sup>2</sup>)

As part of Valley Line LRT construction, the Muttart Access Road, connecting Connors Road northbound and 98 Avenue, and providing access to the conservatory grounds, will be permanently realigned to accommodate the LRT trackway and Muttart Stop. The need for realignment was covered in the 2013 EISA. As part of that realignment, closure/demolition of a 200 m long, one-way road connecting northbound Connors Road to the Muttart Access Road will be required (Figure 2.4). That connector road will be permanently removed as part of the Valley Line project. As 2013 EISA stated that the existing connector from Connors Road north would remain intact, this minor, permanent change in the road network was not fully assessed. The road removal involves approximately 2,070 m<sup>2</sup> of land. This project component differs from the others assessed in this update in that it requires no adjustments to the Project Area *and* most of the activities associated with removal would be the same as which these undertaken as part of the realignment of the access road, was covered in the 2013 EISA.

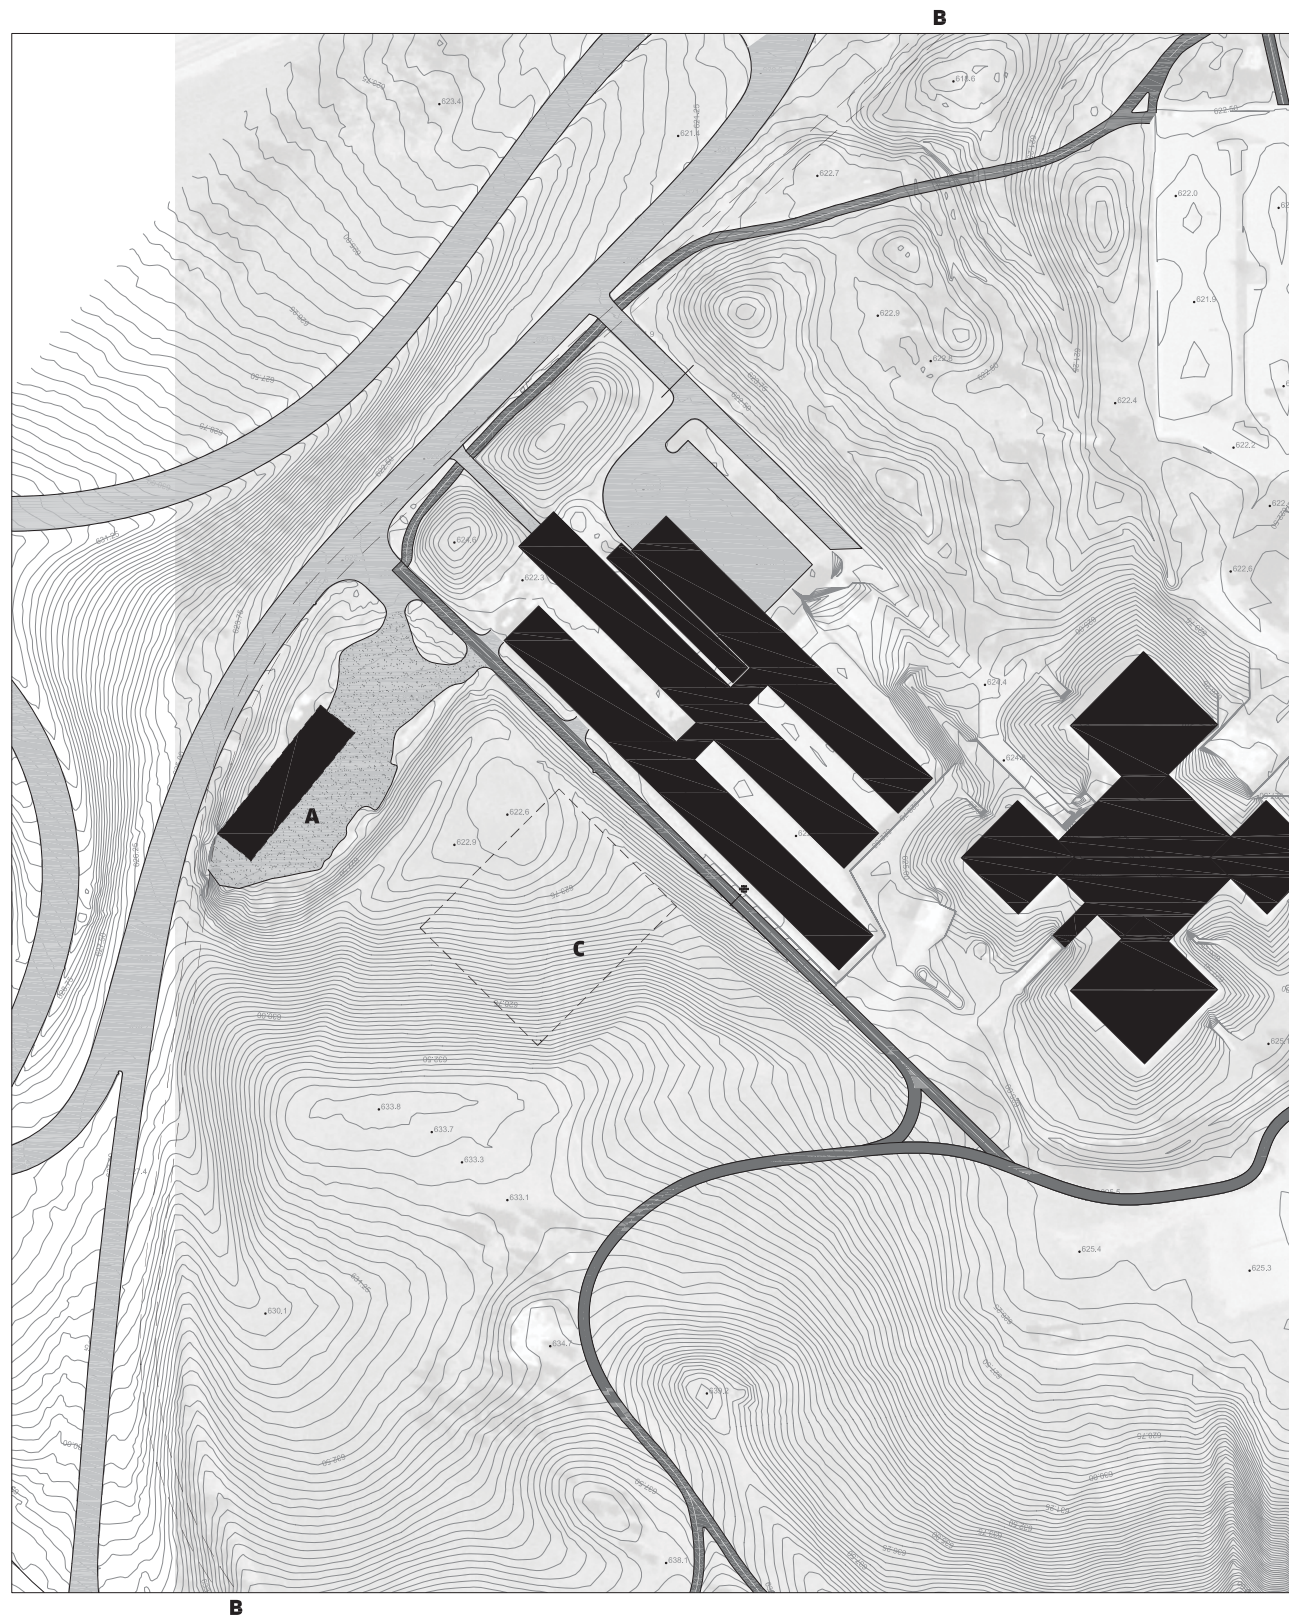
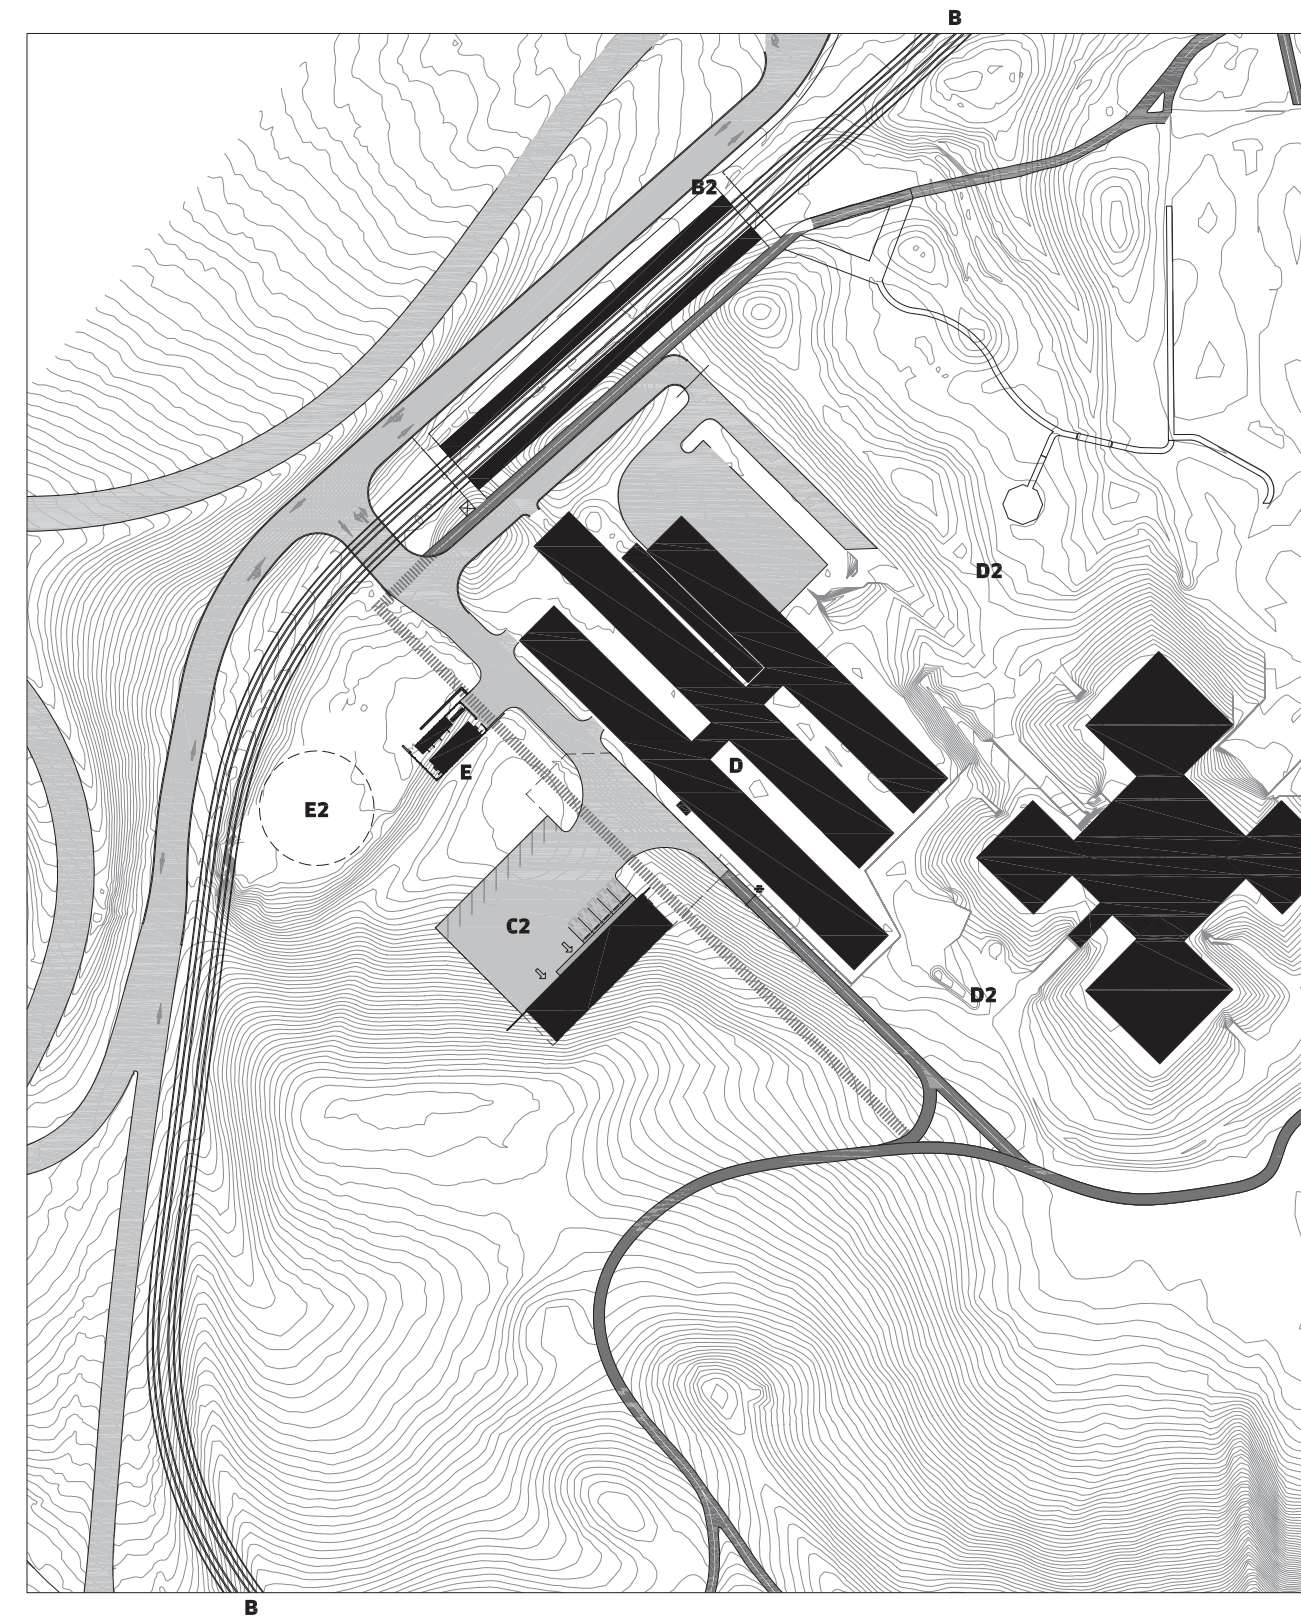
# Figure 2.5a

L.R.T. TRACK ALIGNMENT (at grade)

**PROJECT CONTEXT - EXISTING**  
SCALE 1:2000

**PROJECT CONTEXT - FUTURE**  
SCALE 1:2000

The new building is close to identical in size, shape and function as the building it is to replace. The replacement project includes re-establishment of essential ancillary facilities (a small number of parking stalls and delivery truck turn around). Much of the disturbance footprint shown in Figure 2.1d is temporary, required to accommodate the necessary re-grading (Plate 2.7) and will be returned to parkland following construction. The total project component footprint is 8,795 m<sup>2</sup>, of which approximately 5,966m<sup>2</sup> (68%) will be restored to turf and possibly other small landscaping features near the facility (i.e. planted beds). Lands to be disturbed consist entirely of manicured lawn and one SUP, situated along the existing west margin of the Muttart working greenhouses. Minor realignment of that SUP will be required. Construction activities associated with this project component will be undertaken by the City in summer and autumn of 2015, prior to commencement of general construction activities associated with the Valley Line.

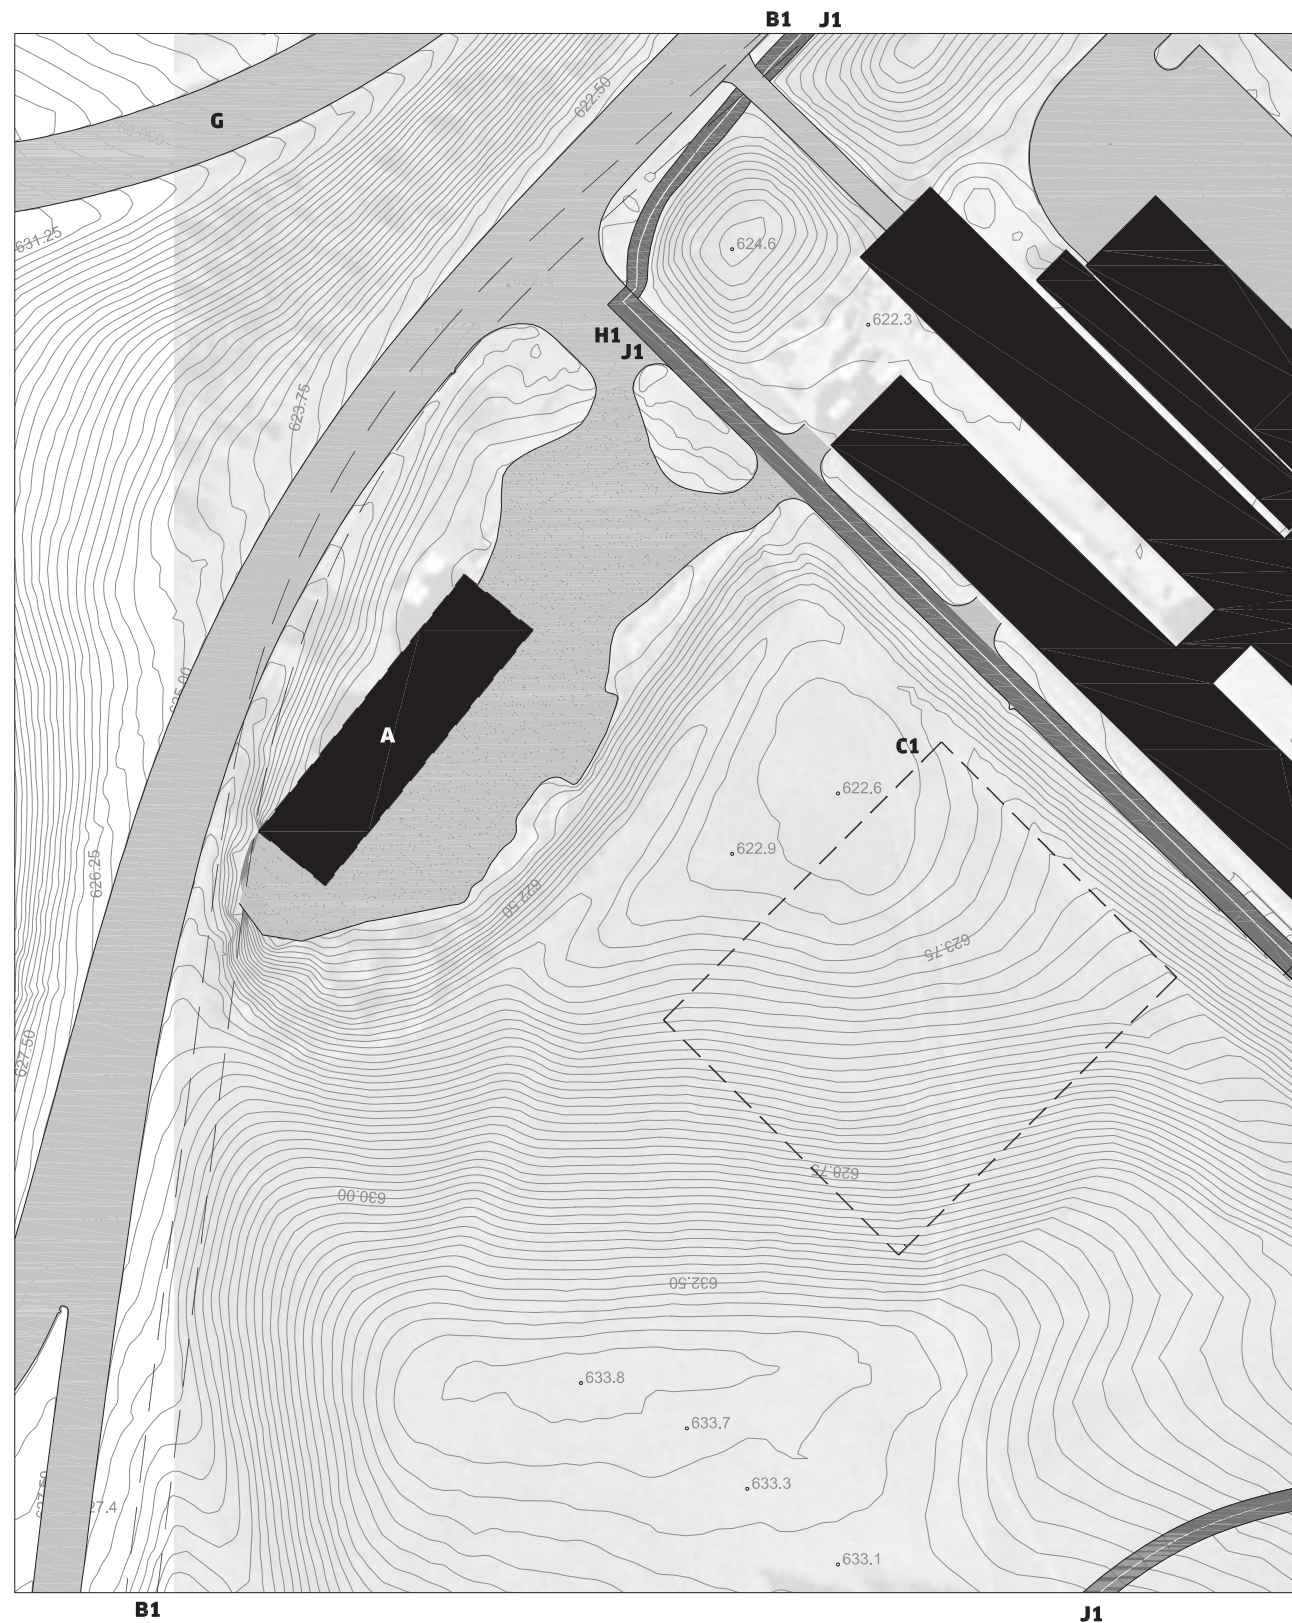
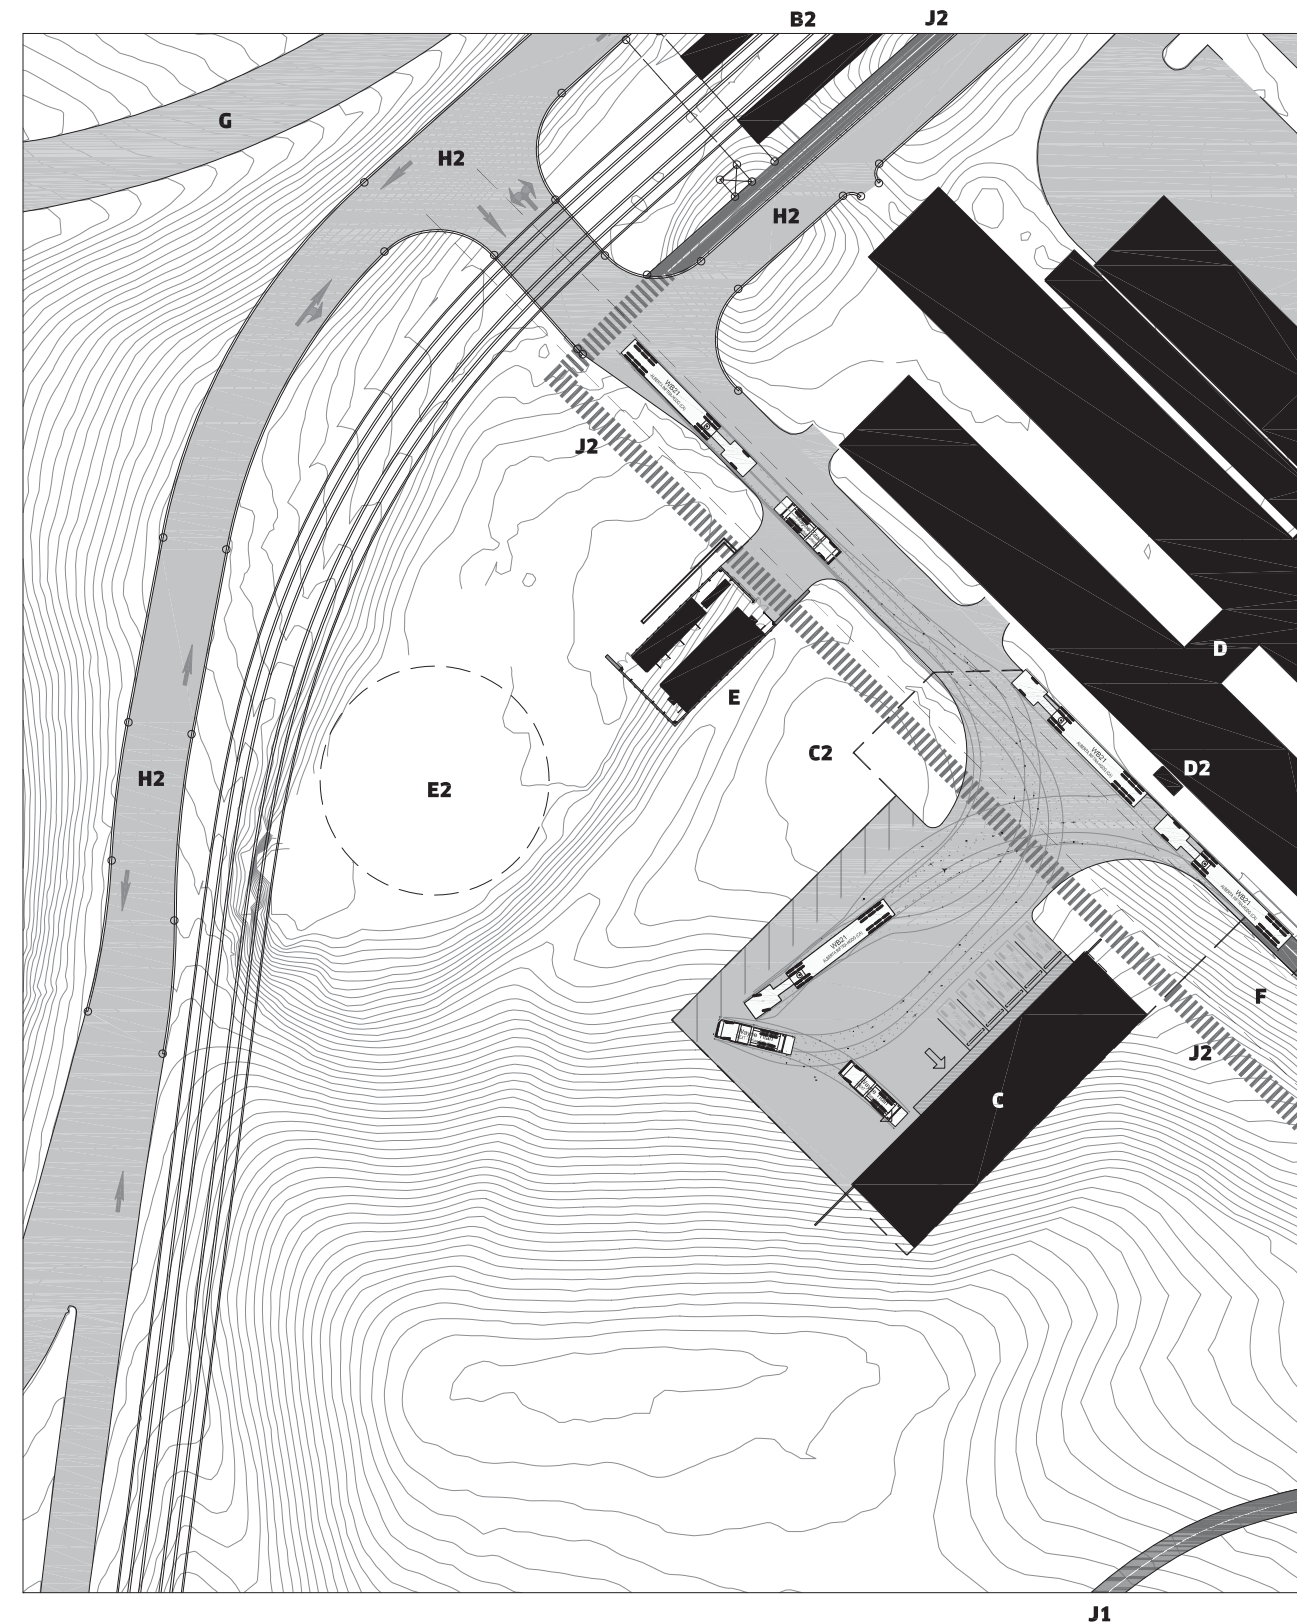
# Figure 2.5b

- A** Existing Storage Building.
- B1** Anticipated Valley-Line LRT alignment.
- B2** Valley Line LRT Stop.
- C** New Storage Building.  
= 502.8 m<sup>2</sup> or 5412.6 s.f.

**1** SITE CONTEXT PLAN - FUTURE  
SCALE 1:1000

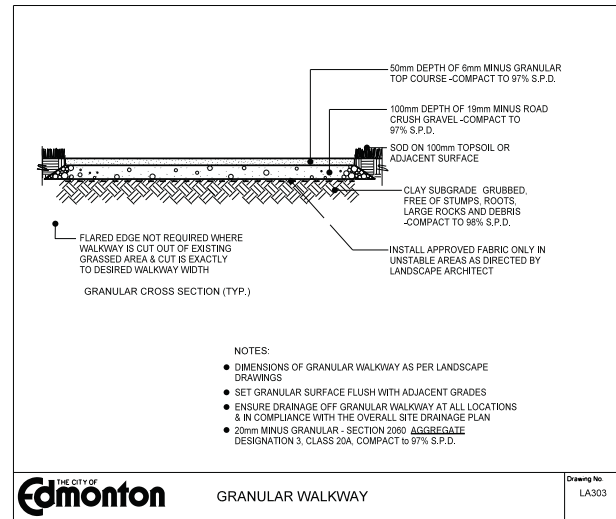
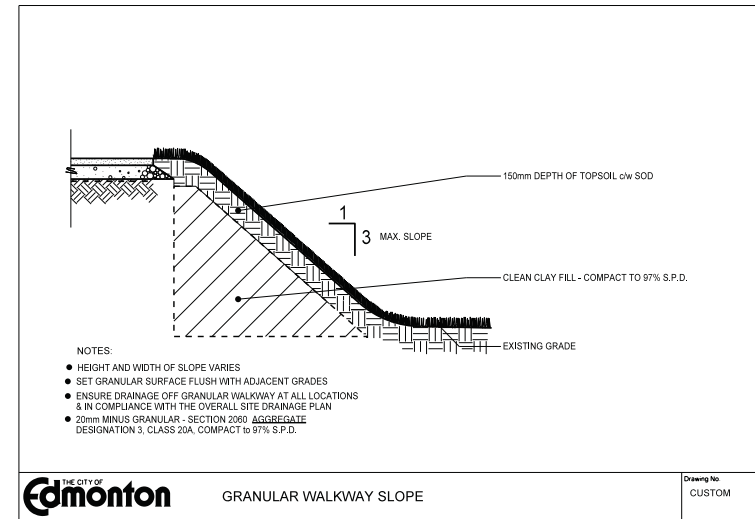
**Figure 2.6**

7. Build up the grade adjacent to existing trail to accommodate new trail construction. Construct 25.0 cubic m. base with clay fill adjacent to trail tapering down to existing grade. Maximum slope is 1:3. Refer to custom detail on this drawing.
8. Construct 30 sq. m. of 50mm depth granular paving c/w 150mm granular base on compacted clay sub-grade. Trail is 1.5m wide. Refer to detail LA302 on this drawing. Contact Community Project to arrange for compaction testing.
9. Install 10 sq. m. 100mm depth mulch adjacent to new trail through existing shrub bed. Ensure positive drainage
10. Install 20 sq. m. 150mm depth topsoil and sod adjacent to new trail. Ensure positive drainage.

**NOTE:**  
THIS SITE SURVEY IS OUT OF DATE AND MAY NOT BE ACCURATE. LAYOUT AND GRADING OF EXISTING SITE IS APPROXIMATE. NEW TRAIL IS TO BE LAID OUT IN THE FIELD. QUANTITIES MAY NEED TO BE ADJUSTED ACCORDINGLY.

Prior to commencement of Valley Line construction, to reduce the impact of the up to five years of construction on LMRP trails and facility use, the City will construct a short, temporary connector trail just west of the Project Area in the Chinese Gardens (Figure 2.1b; Plate 2.8). The temporary trail will connect the western portion of the primary north-south SUP to an established trail in the Chinese Garden, allowing pedestrians and cyclists to circulate through the broader network of park trails situated west of the main LRT project corridor and avoiding trail dead ends. The proposed temporary gravel trail will be approximately 1.5 m wide and 15 m in length. Design details and location are shown on Figure 2.6.

Construction drawings indicate that the trail will be sub-excavated to 150 mm depth, filled with compact clay and topped with gravel. Trail construction in this sloped area will involve grade changes. The grade adjacent to the existing trail will be raised using clay fill and will taper down to the existing grade with a maximum slope of 1:3 (Figure 2.6). Fill will be stabilized using 300-600 mm boulders installed at the bottom of the new embankment with one third of the boulders buried into the subgrade/topsoil. Topsoil and sod will be placed on disturbed soil adjacent to the new trail and positive drainage will be provided. The width of disturbed area will be approximately 2-3 m; total area of disturbance will be approximately 65 m<sup>2</sup>.

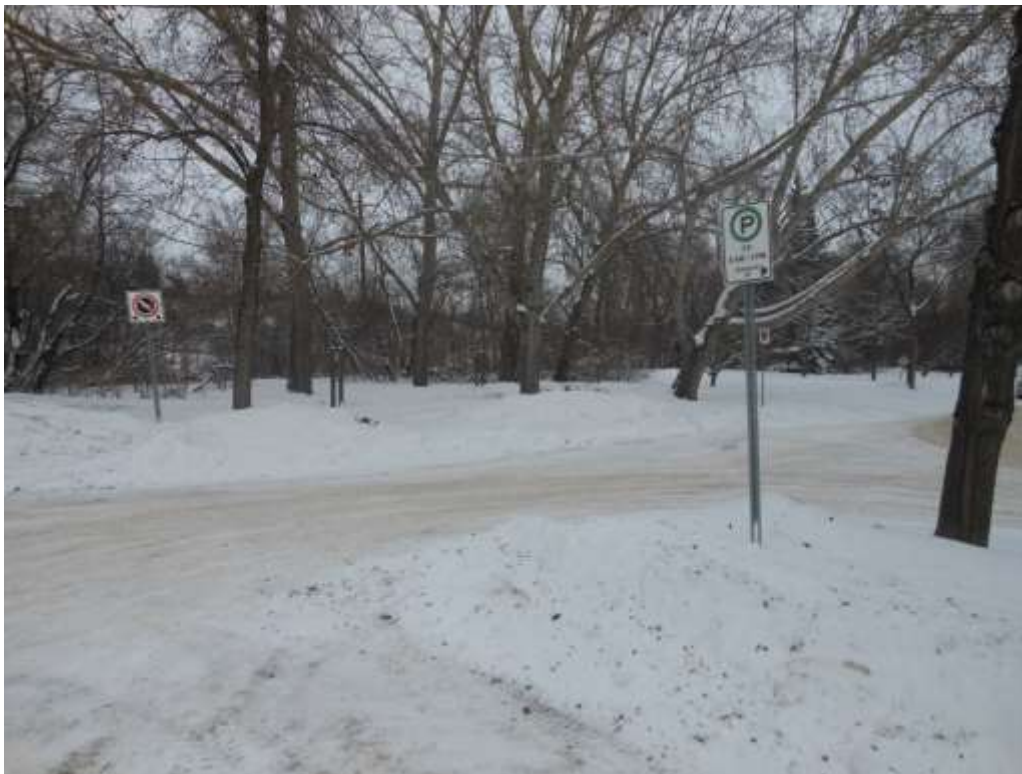
**Plate 2.10. Site of trail tie-in work required at HMEP and 98A Avenue, behind the no-stopping sign, see in the foreground (Jan. 2015).**

The 2013 EISA noted that LRT construction will disrupt portions of trails situated in HMEP in the vicinity of the south end of the new Tawatina Bridge crossing the NSR. It acknowledged the need to redevelop that area of the park and committed to providing a seamless tie-in to adjacent existing trails. During development of the 70% River Valley Landscape Drawings it became evident that the full area required for this work, particularly to appropriately tie-in to the existing east-west SUP at the north end of the HMEP parking lot, near 98A Avenue, was not captured by the 2013 EISA Project Area (Figure 2.9) (Plate 2.10, 2.11). This area has now been captured by both the landscape drawings that guide Project Co and by the revised Project Area boundary (Figure 2.7). The work area for this SUP tie-in will total 108 m<sup>2</sup> (Figure 2.9). Valley Line contract documents include specifications that limit Project Co work in this area to the work described in the landscape drawings; the added area will not be permitted to function as a general construction area.

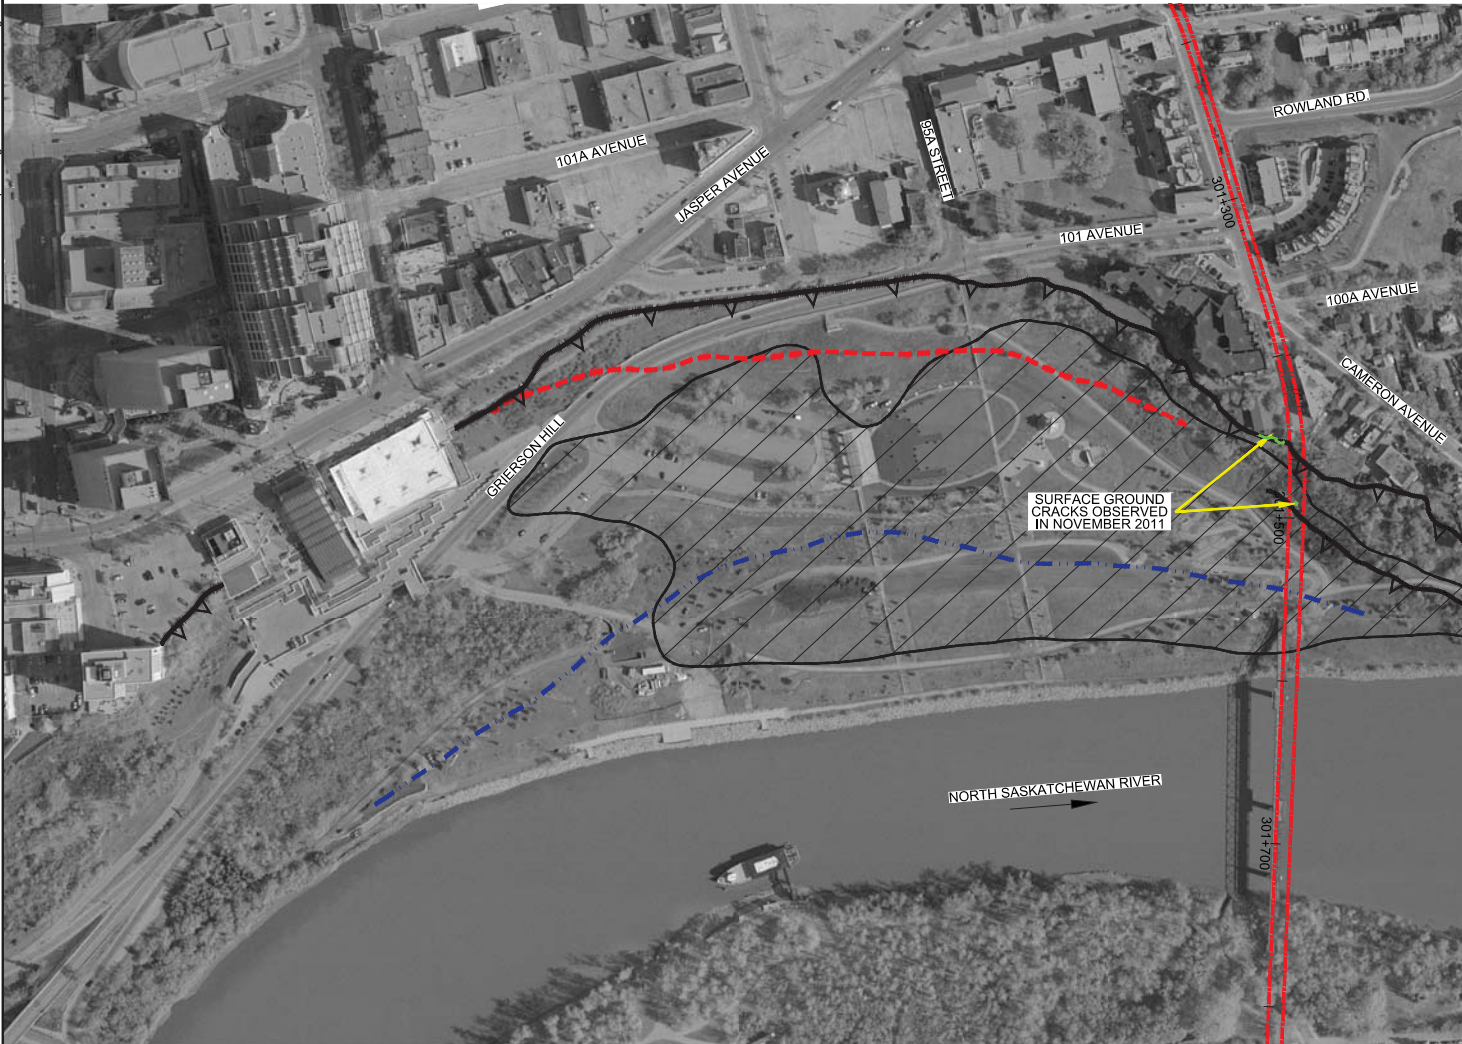
Figure 4.2

SLOPE CREST IN 1887 (BEFORE FAILURE)
-

TOE OF RIVERBANK IN 1887 (BEFORE FAILURE)
-

To assess groundwater conditions, Thurber Engineering (2014) installed standpipe piezometers in six of the boreholes drilled along the proposed access road alignment for groundwater level monitoring.

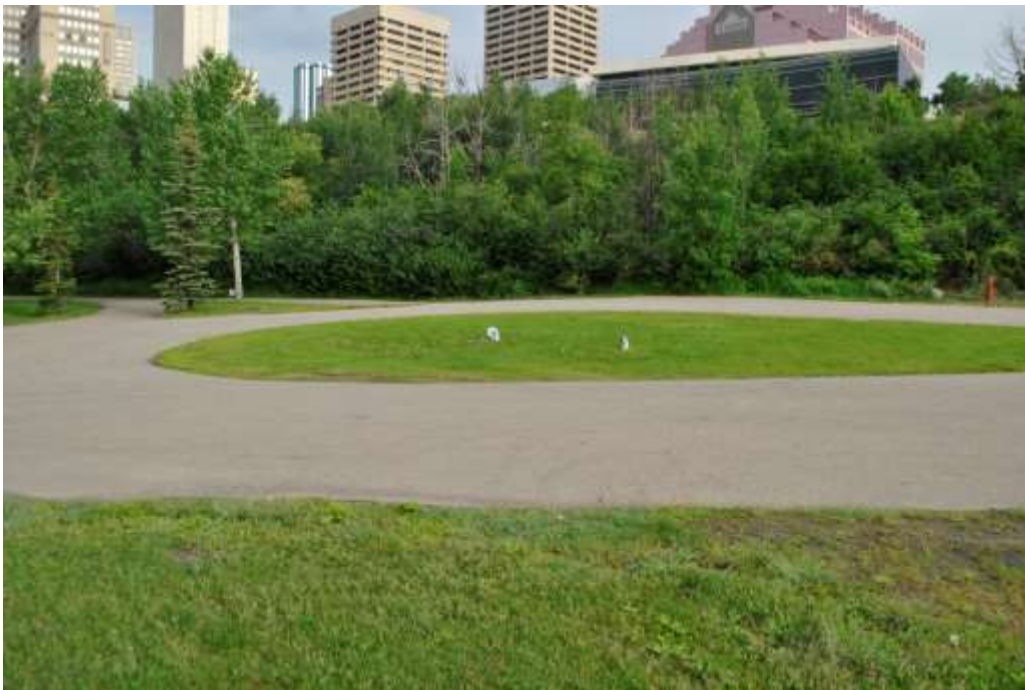
**Plate 4.9. Maintenance/service vehicle road turn-around, looking north (July 2014). This road does not provide vehicular park access or parking for the general public.**

- A paved maintenance/service vehicle road and turn-around that connects to the gravel east-west park maintenance road and recreational businesses and public washrooms. It also facilitates regular holding tank service. This road does not provide vehicular park access or parking for the general public (Plate 4.9)

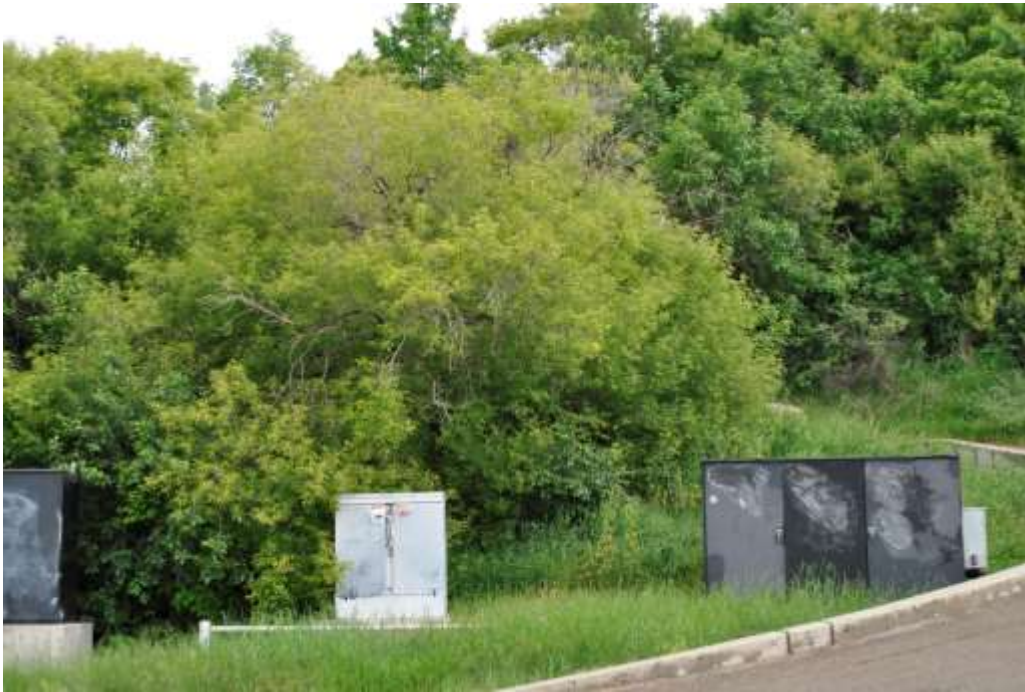
**Plate 4.15. Several utility panels/boxes are located along the vehicle access road turnaround, looking north.**

Multiple buried utility lines (and associated surface components) are present in the proposed construction access road project area (Appendix F). Several buried EPCOR electrical lines are within the project area including one running parallel with the Trans Canada SUP at the base of the slope, which terminates at an electrical panel near the east end of the Promenade. EPCOR lines also travel north, east and south and intersect with the project component area. Several utility panels/boxes are located along the vehicle access road turnaround (Plate 4.15). Two storm sewer lines are located across and adjacent to the entrance to the maintenance access road to the Riverfront Plaza building and two additional storm sewer lines are documented as running north/south across the valley slope east of the plaza building. A subsurface holding tank, an associated sanitary line and a monitoring cable are located west of the Riverfront Plaza building, with surface connections and the majority of the tank located in the grassed centre of the vehicle turn-around (Plate 4.16). This holding tank is anticipated to be replaced with a lift station and associated sanitary lines in 2015. One north-south water main and fire hydrant are situated immediately west of the Riverfront Plaza. An ATCO gas line is located under the west side of the vehicle access road to LMRP, within the project component lands. There are no identified overhead utilities. While some of the utility relocations required for the Valley Line are already underway, no relocation work has been undertaken in support of the proposed primary construction access road in LMRP.

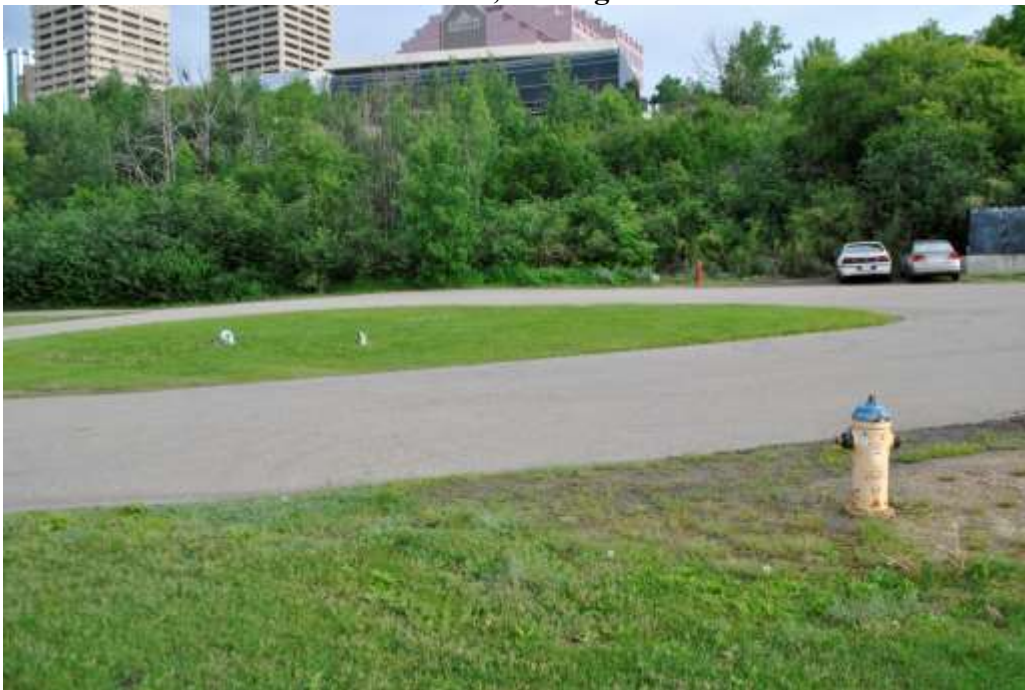
**Plate 4.16. A subsurface holding tank, an associated sanitary line and a monitoring cable are located west of the Riverfront Plaza building.**

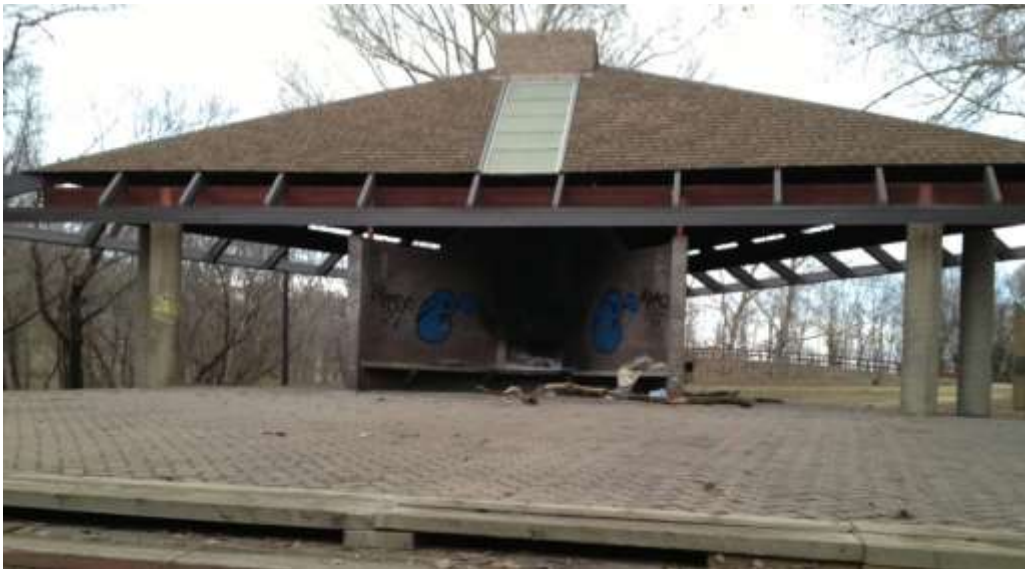
**Plate 5.8. The picnic shelter and hard surface appear to be in disrepair and public fireplaces installed as part of the picnic shelter structure have been boarded over (April 2013).**
