**City of Edmonton  
Valley Line Stage 1 – Light Rail Transit (LRT) Project  
Environmental Impact Screening Assessment Update**

**Final Report**

**Spencer Environmental  
Management Services Ltd.  
Edmonton, Alberta**

February 2015

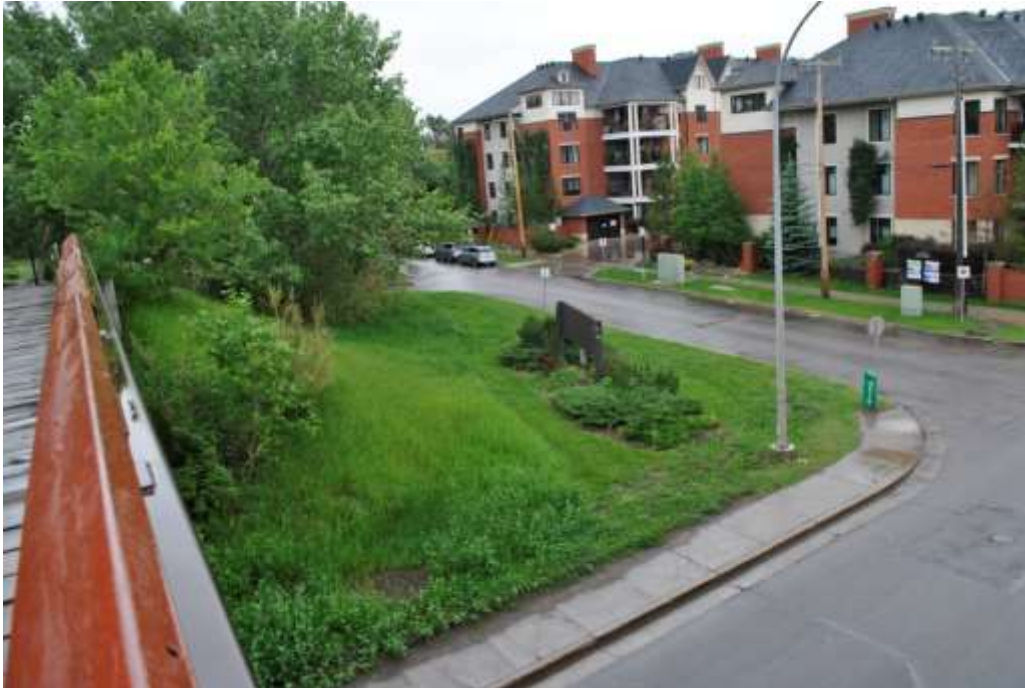
**Plate 6.1: Bridge abutment fill in the parcel to be added to the Project Area, looking northeast (June 2014).**

Soils in this parcel have likely been subject to past disturbance associated with the construction of the existing 98 Avenue Pedestrian Bridge and associated landscaping. The soils present appear to be fill material. A constructed embankment associated with the bridge abutment occupies much of the area (Plate 6.1). The Phase 1 ESA undertaken for the Valley Line LRT did not identify issues pertaining to soil contamination or slope stability for these lands (ConnectEd Transit Partnership 2013a). Geotechnical studies have not been undertaken as there is no intended infrastructure in this area.

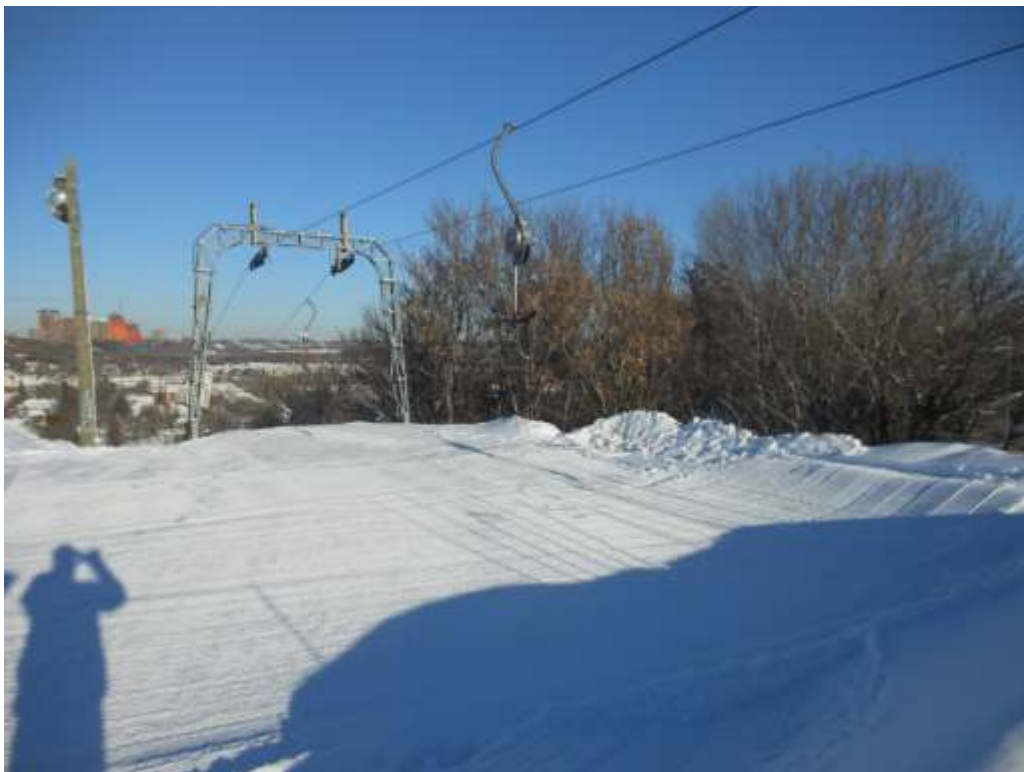
Plate 8.1. Sloping terrain of existing T-bar run to be re-graded. (Jan. 2015).

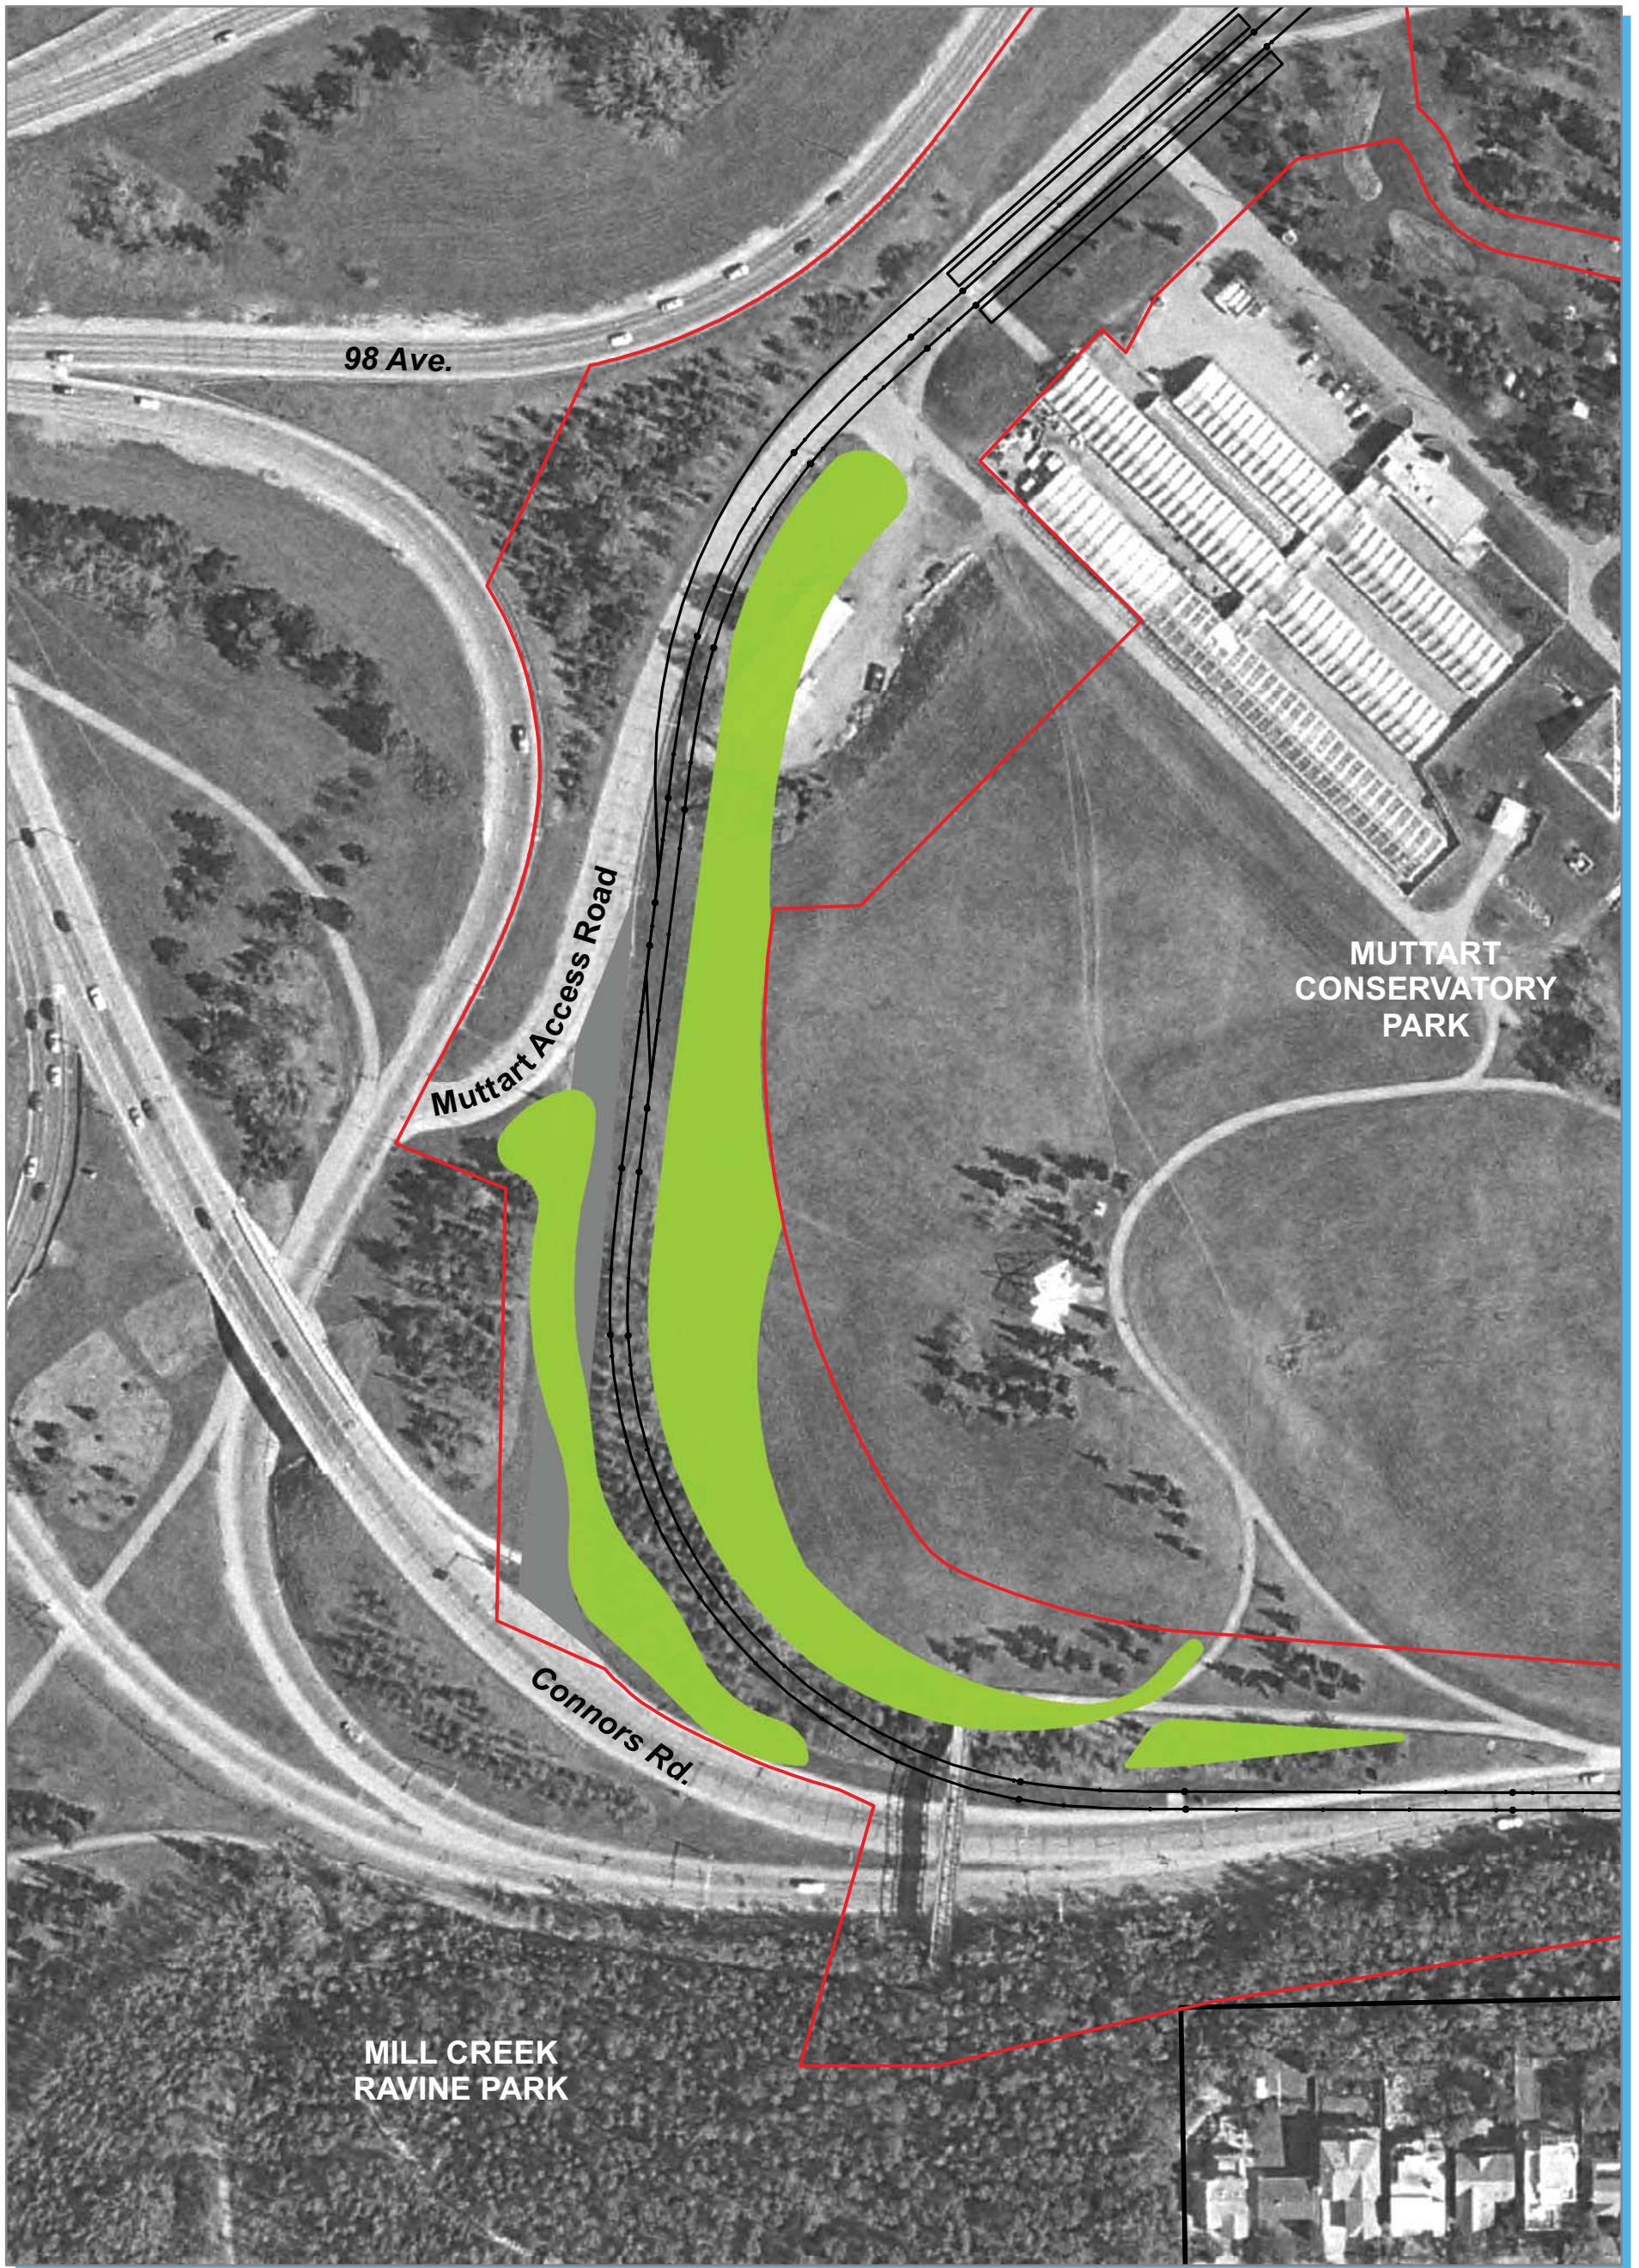
**Figure 9.1 Naturalization at Former Road Location**

Lands occupied by the connector road to be removed will be reclaimed to green space by Project Co as part of the larger landscaping efforts in the river valley. The vast majority of the right-of-way to be removed has been identified as a naturalization area (Figure 9.1), the remainder will be reclaimed to manicured lawn. Naturalization efforts will include installation of trees and shrubs and will be governed by the Naturalization requirements that are currently set out in the Project Agreement. The planned naturalization will assist in reducing the total hard surface area in the LRT/road right-of-way and will screen the LRT trackway from the realigned Muttart Access Road. Based on this, impacts to vegetation associated with this project component are rated as positive, minor, permanent and predictable.

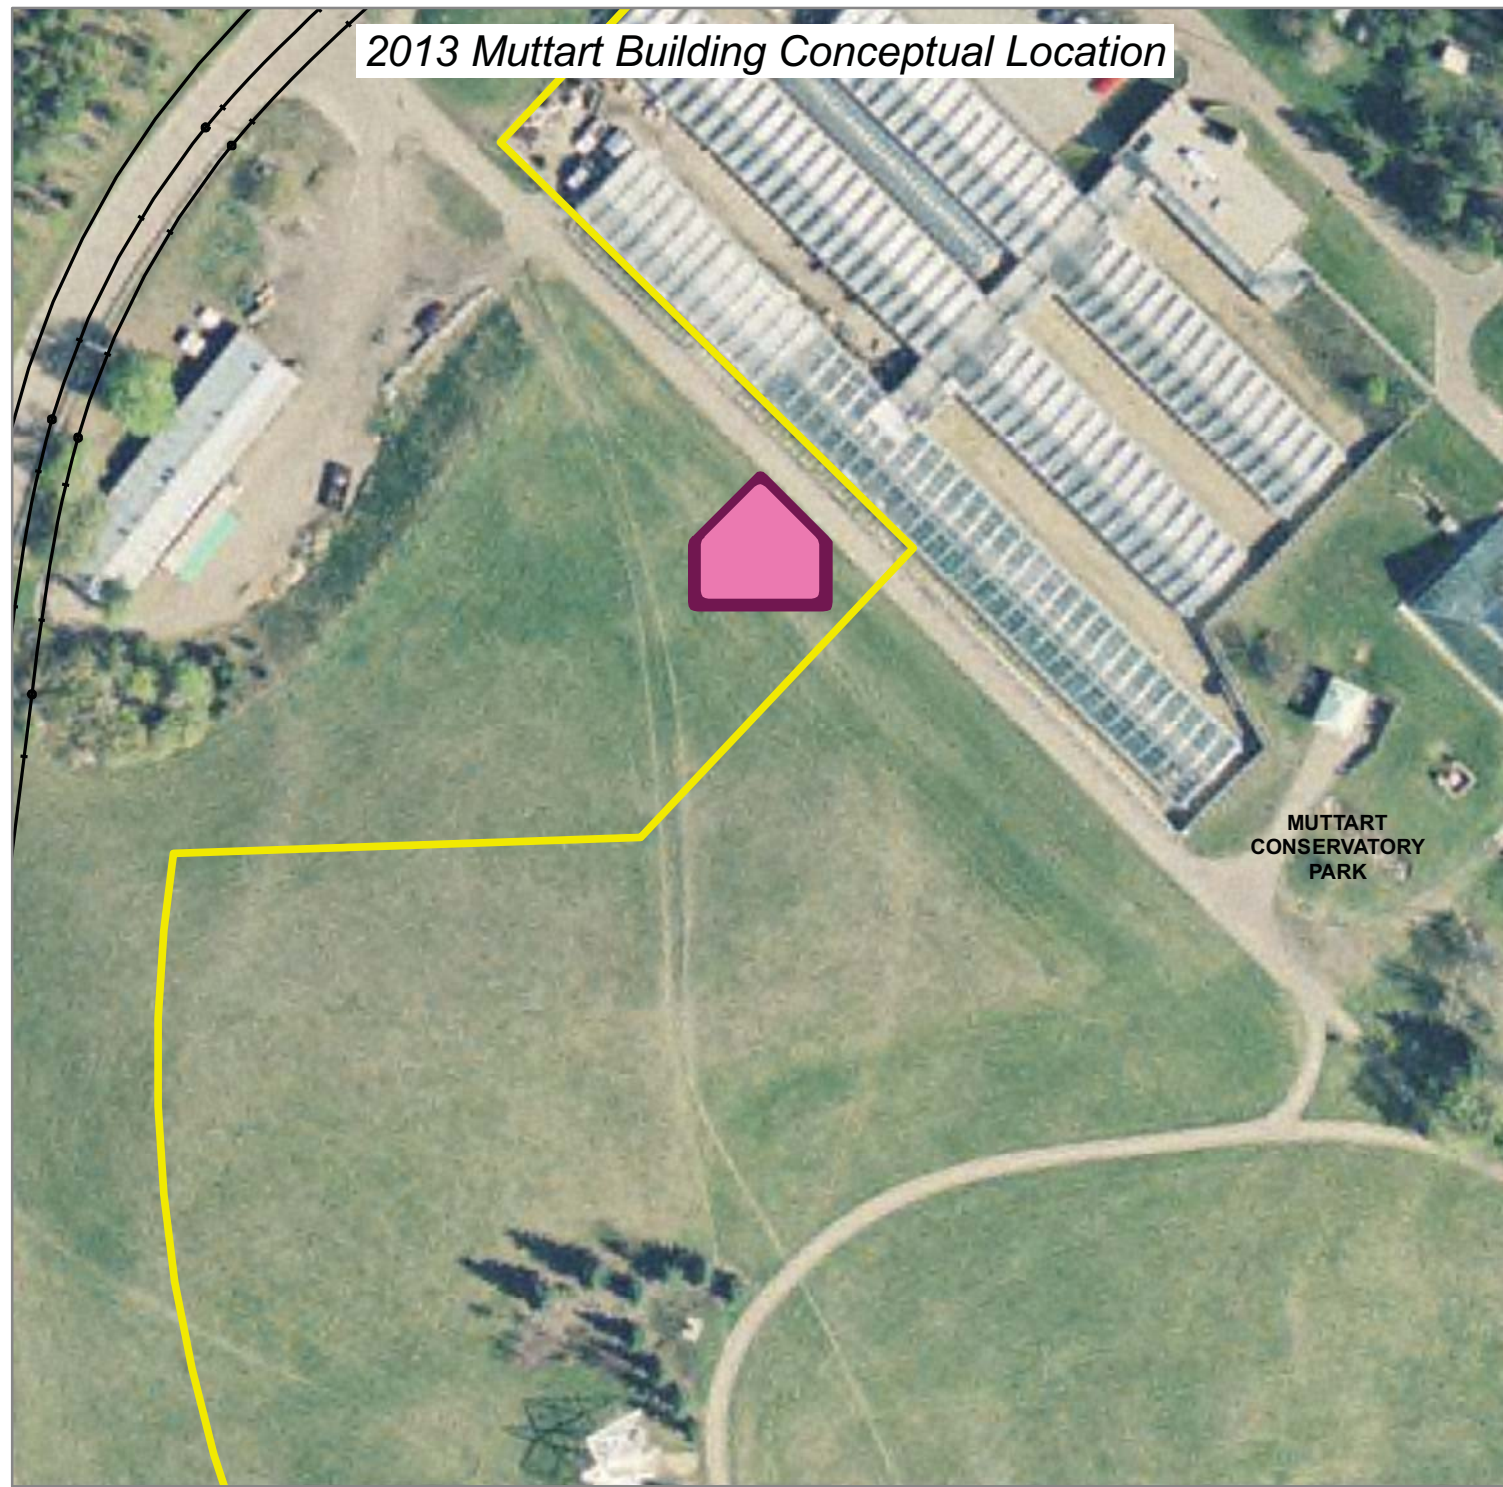
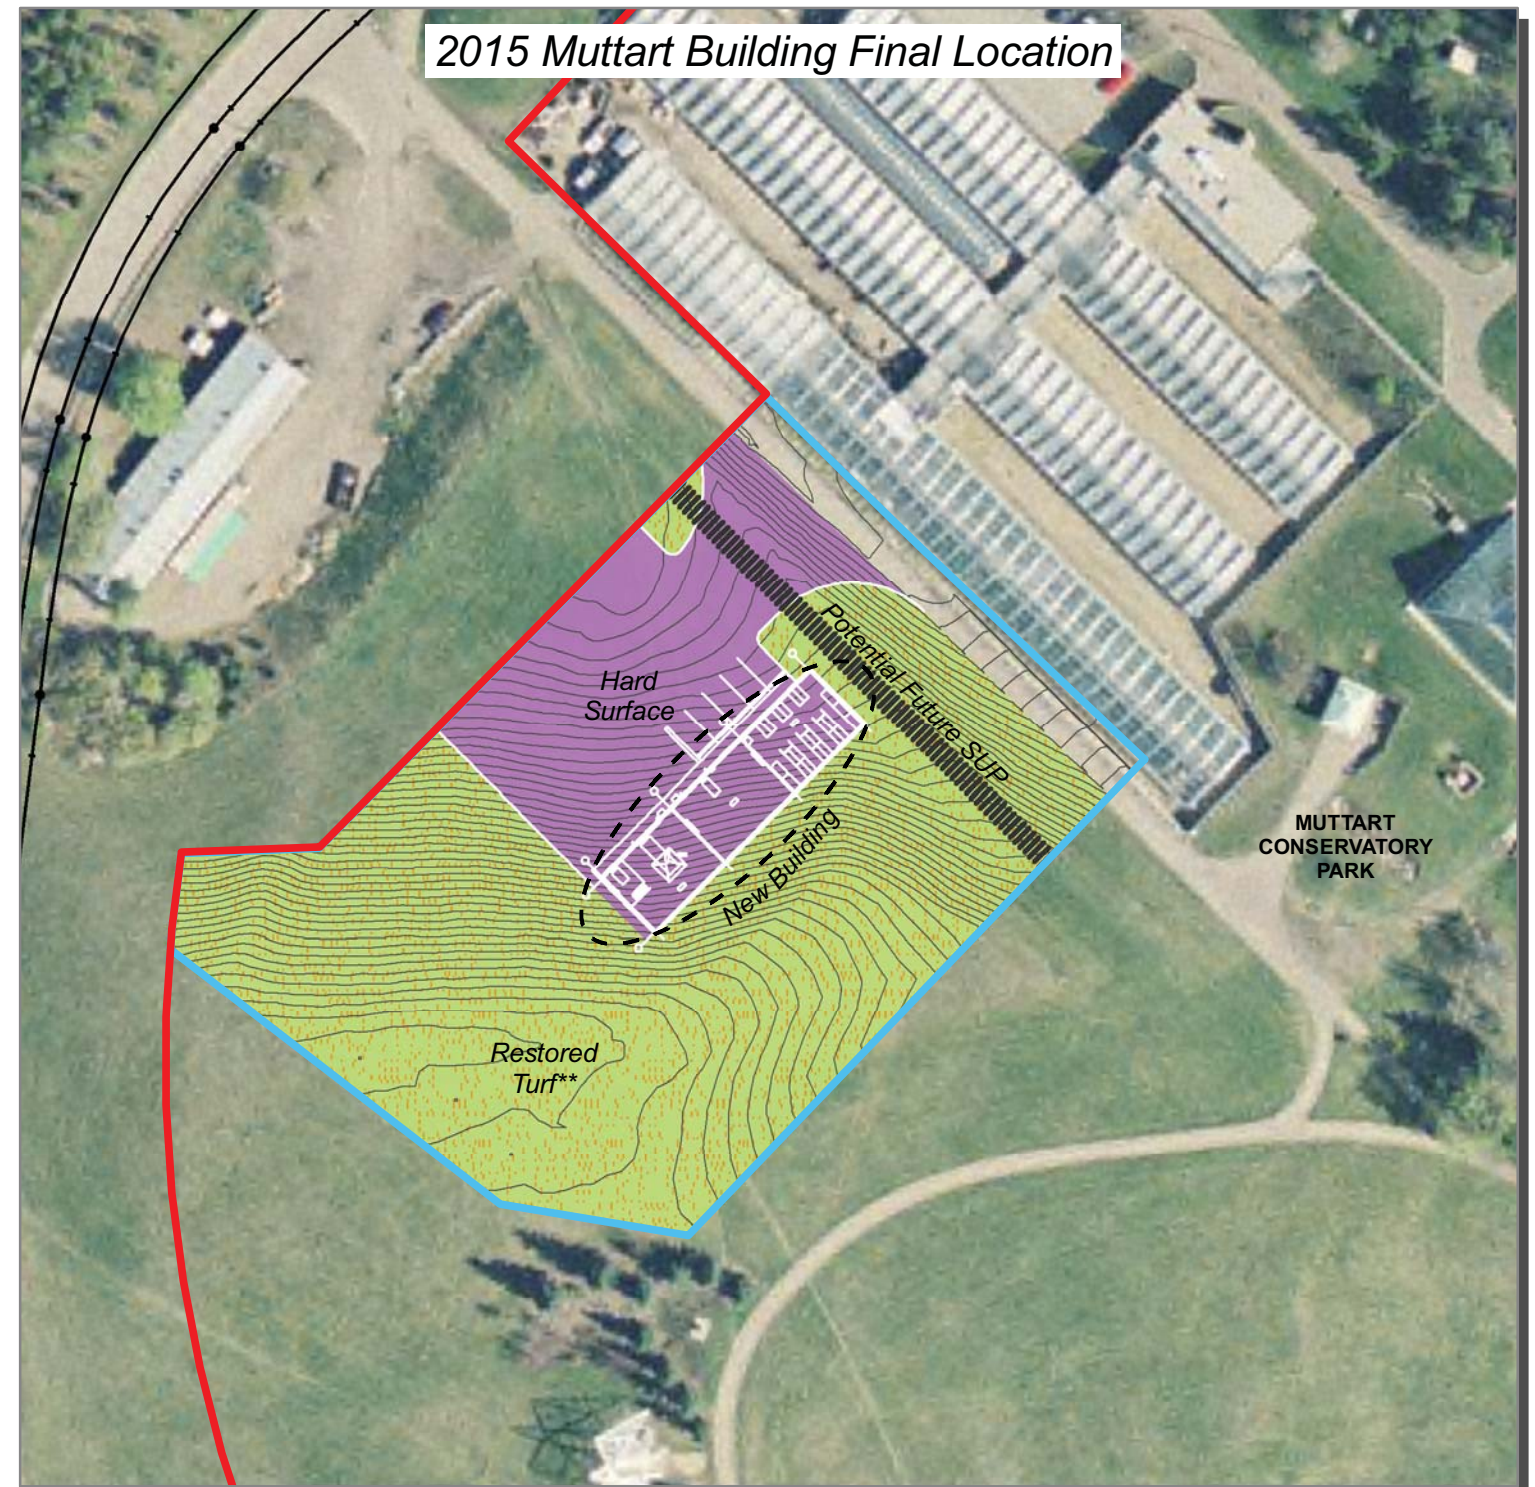
**Figure 10.1 Muttart Storage Building Replacement Site Plan**

The location of the replacement Muttart Conservatory Storage Building (MCSB) has shifted approximately 40 m to the southeast of its previously approved location (Figure 10.1). The new building, ancillary facilities (parking and access) plus the necessary site re-grading will disturb an additional area totaling 6,353 m<sup>2</sup> (0.64 ha). Lands to be disturbed consist entirely of manicured lawn and one SUP situated along the existing west margin of the Muttart working greenhouses. Minor realignment of the SUP will be required. Construction activities associated with this project component are planned to be undertaken by the City in summer and autumn of 2015.

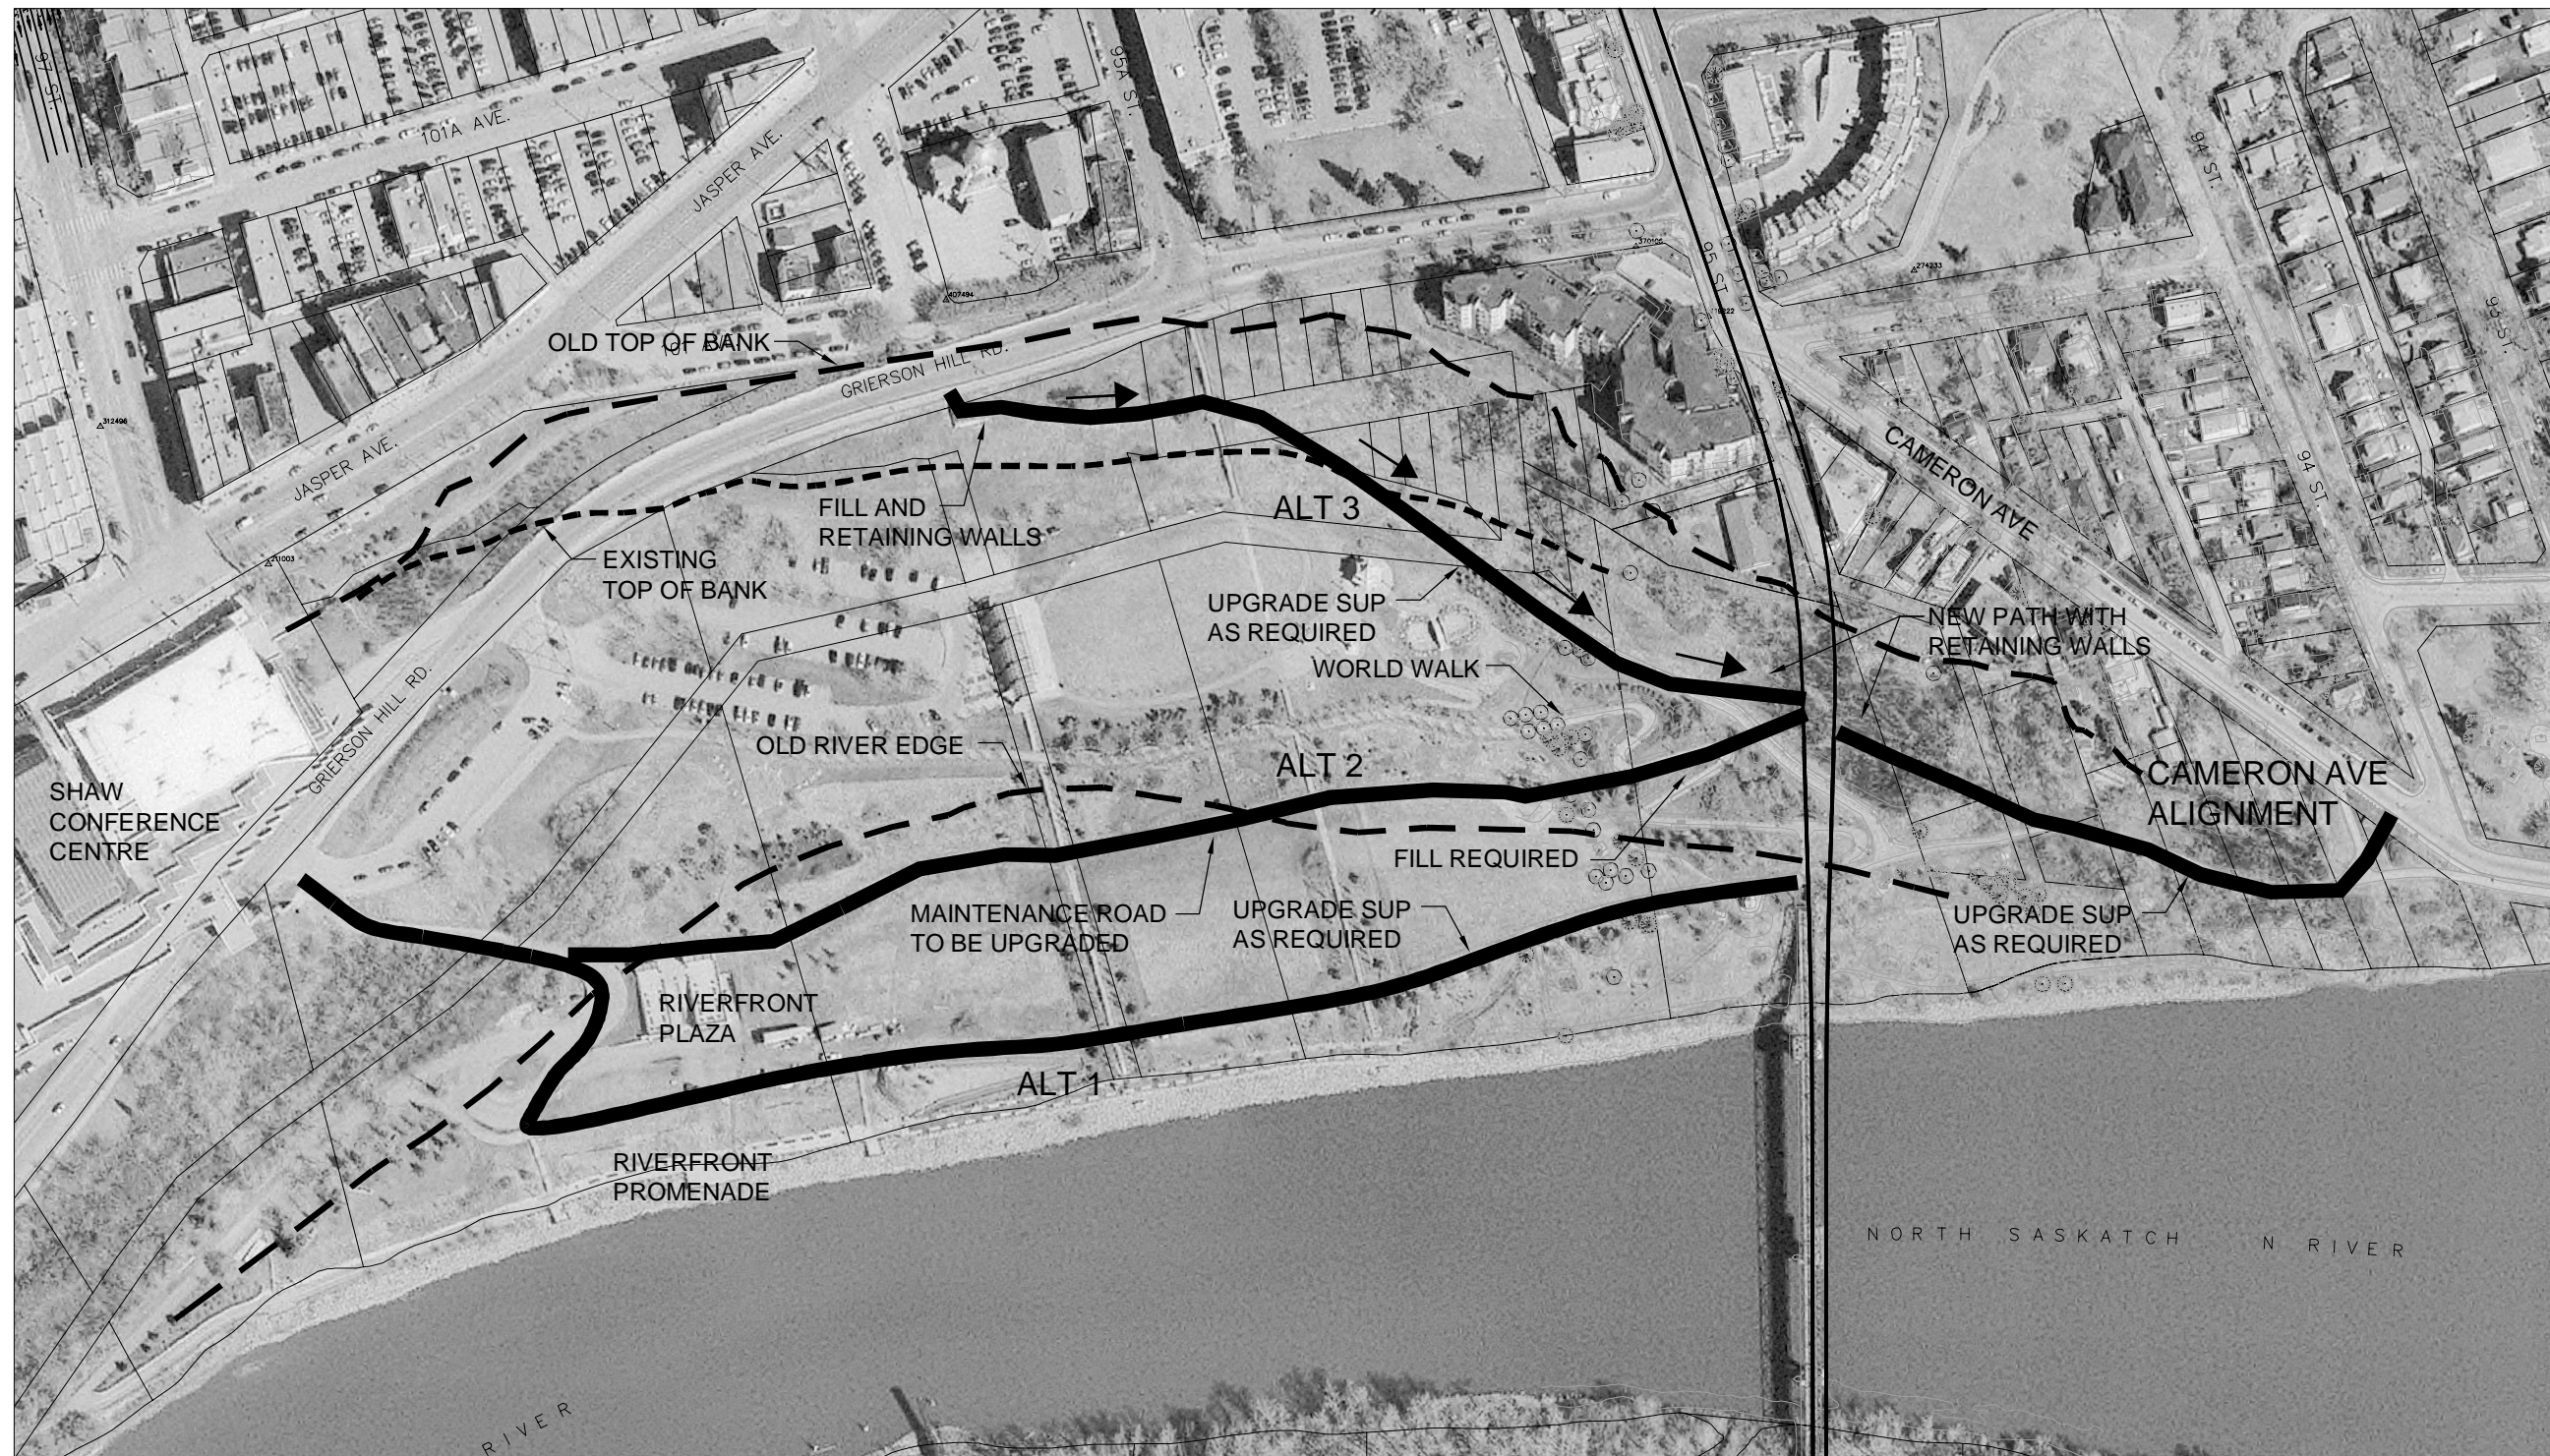
NORTH RIVER BANK ACCESS OPTIONS

If West Access Alignment 1 is determined to be unfeasible due to park and event restrictions than West Access Alignment 3 should be considered as a one way access to the site with the exit to Cameron Avenue. There is a higher geotechnical risk with this option due to placing the route along the top of the slope. The slope stabilizing and additional required retaining walls to access the portal site increase the costs of the option substantially.

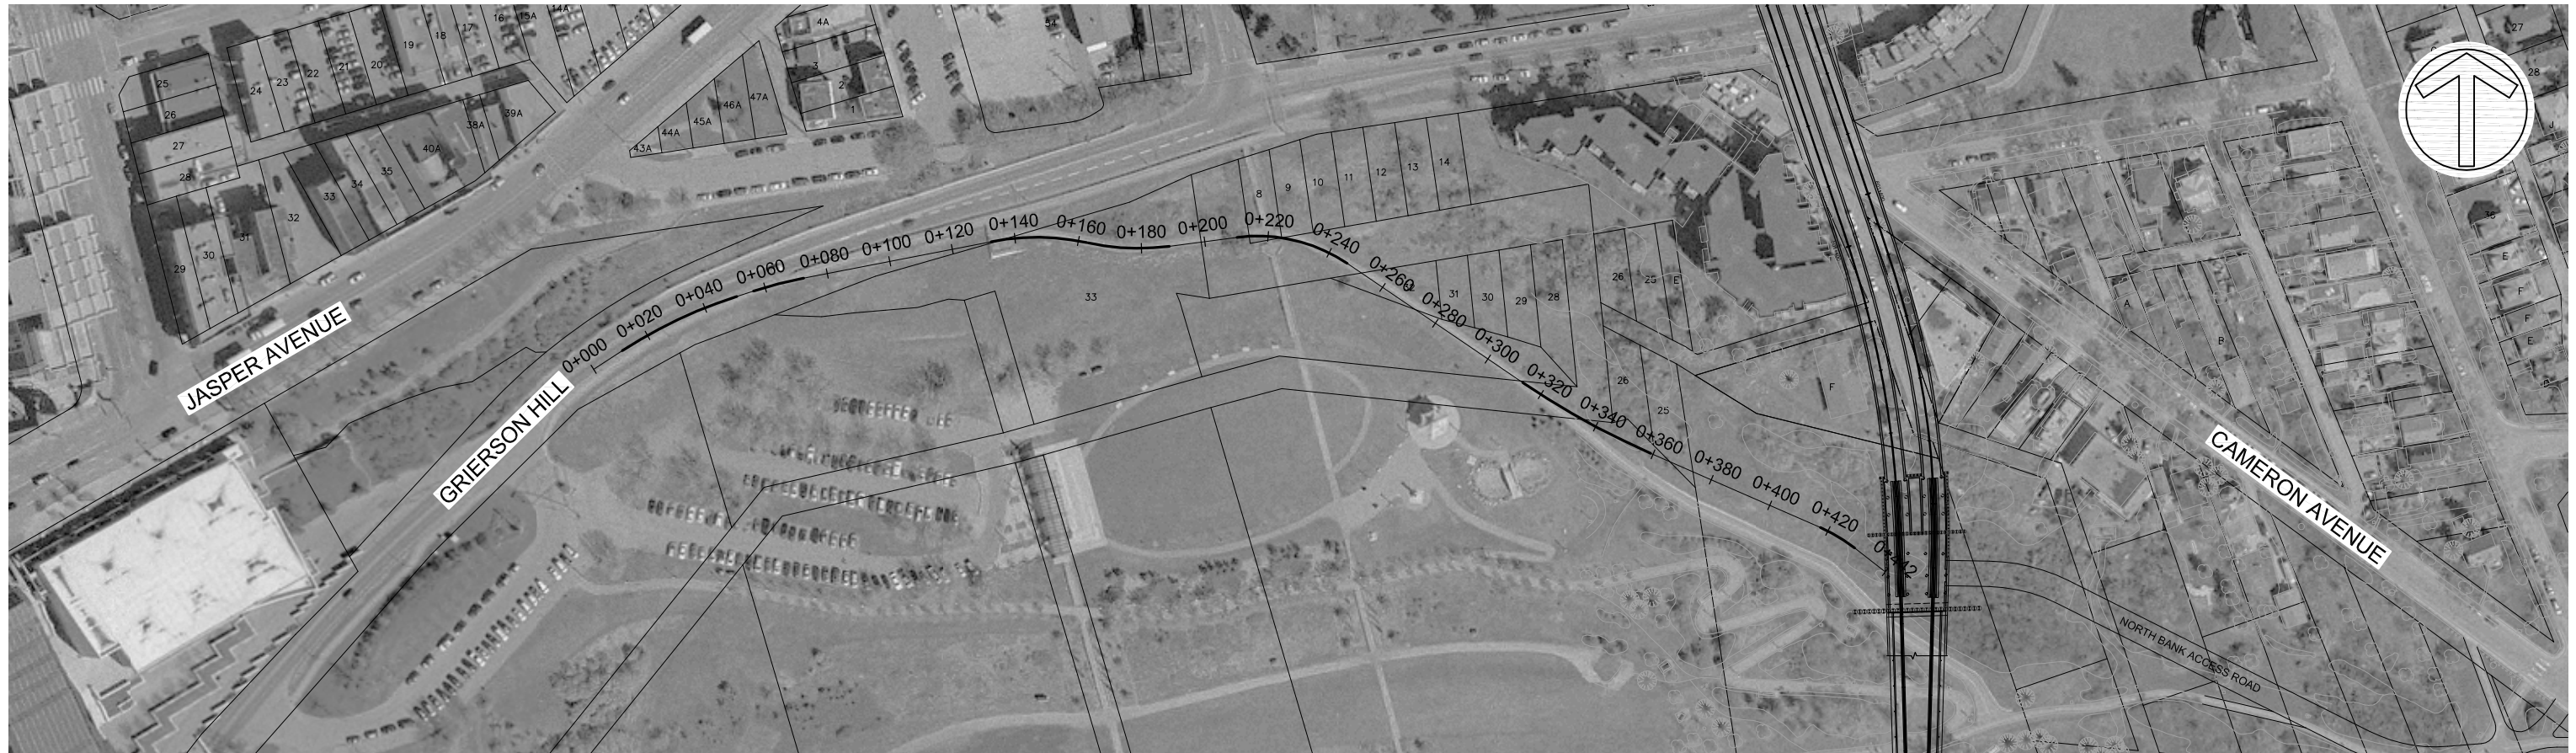
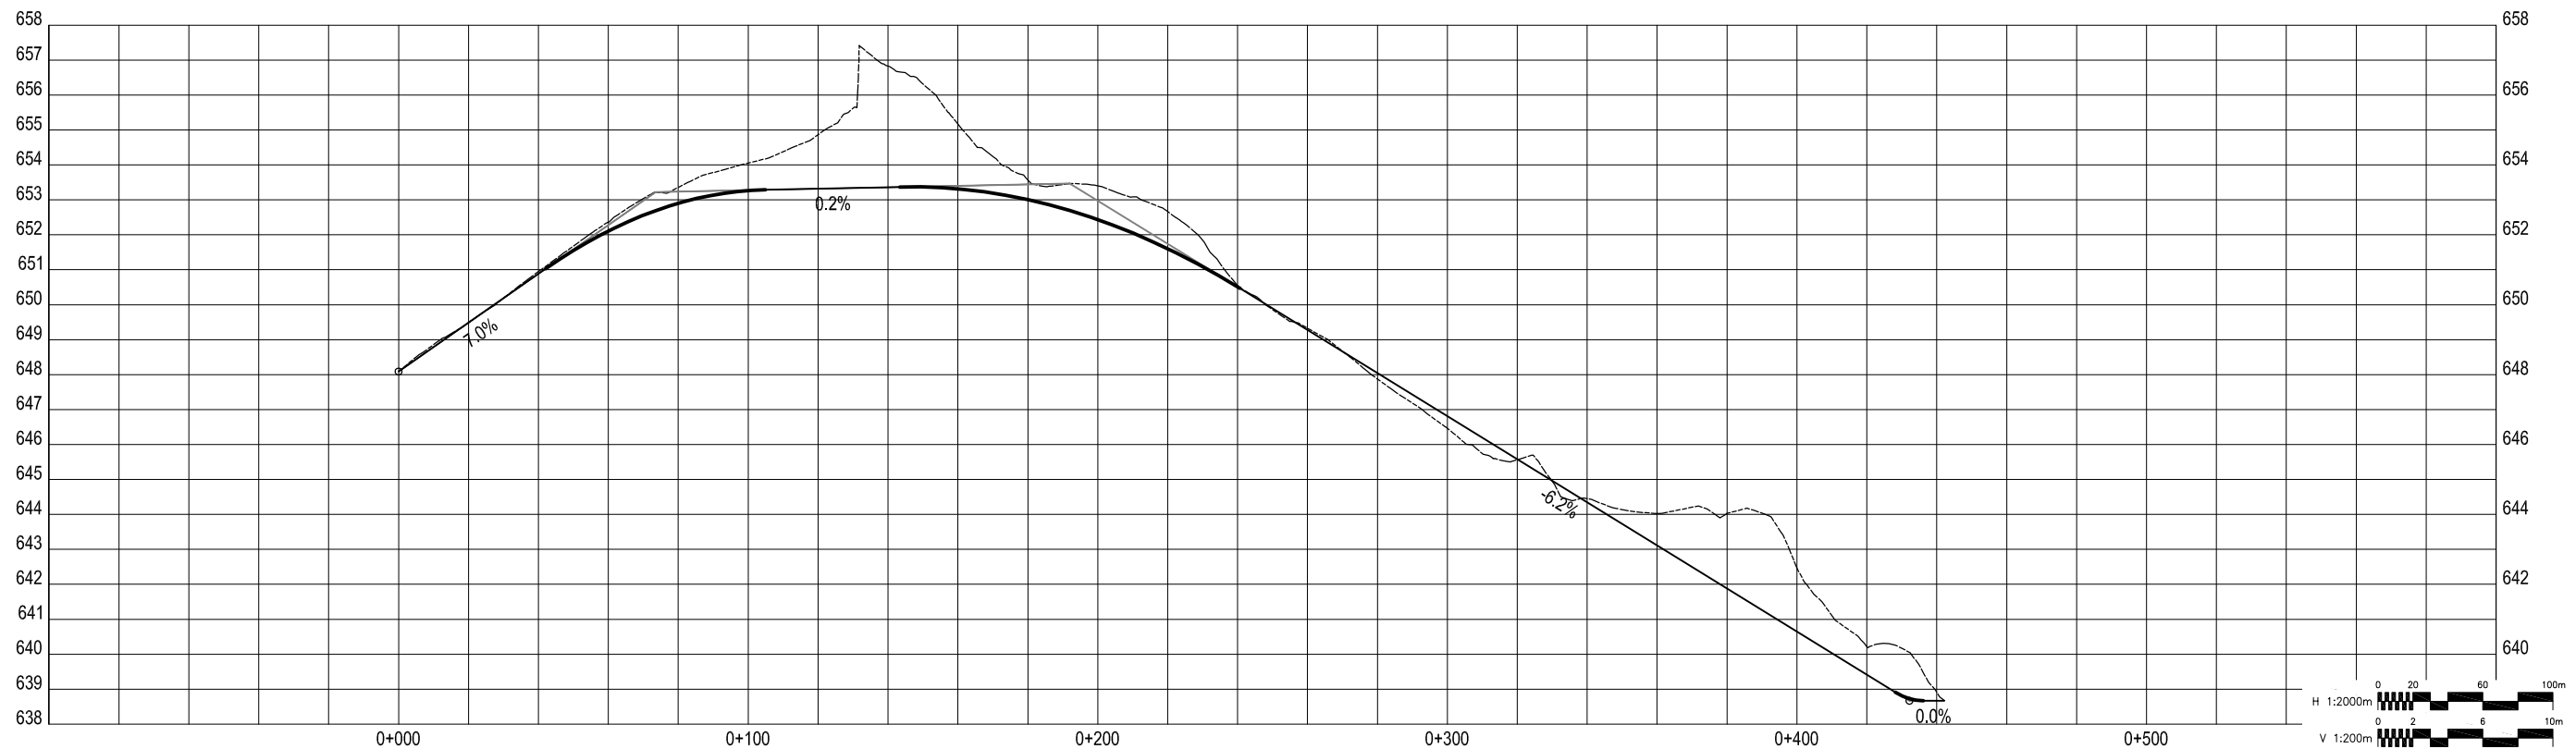
FIGURE 2

West Access Alignment 2 is from Grierson Hill along the existing maintenance road through Louise McKinney Park. At the east end of the existing maintenance road the access route would cross through the World Walk and over a Shared Use Path (SUP) on sufficient fill to meet the elevation of the tunnel portal. Access to the bridge site on the north bank would need to go through the portal site or use the Cameron Avenue access. Figure 2 shows the profile of the Alignment 2.
