**City of Edmonton  
Valley Line Stage 1 – Light Rail Transit (LRT) Project  
Environmental Impact Screening Assessment Update**

**Final Report**

**Spencer Environmental  
Management Services Ltd.  
Edmonton, Alberta**

February 2015

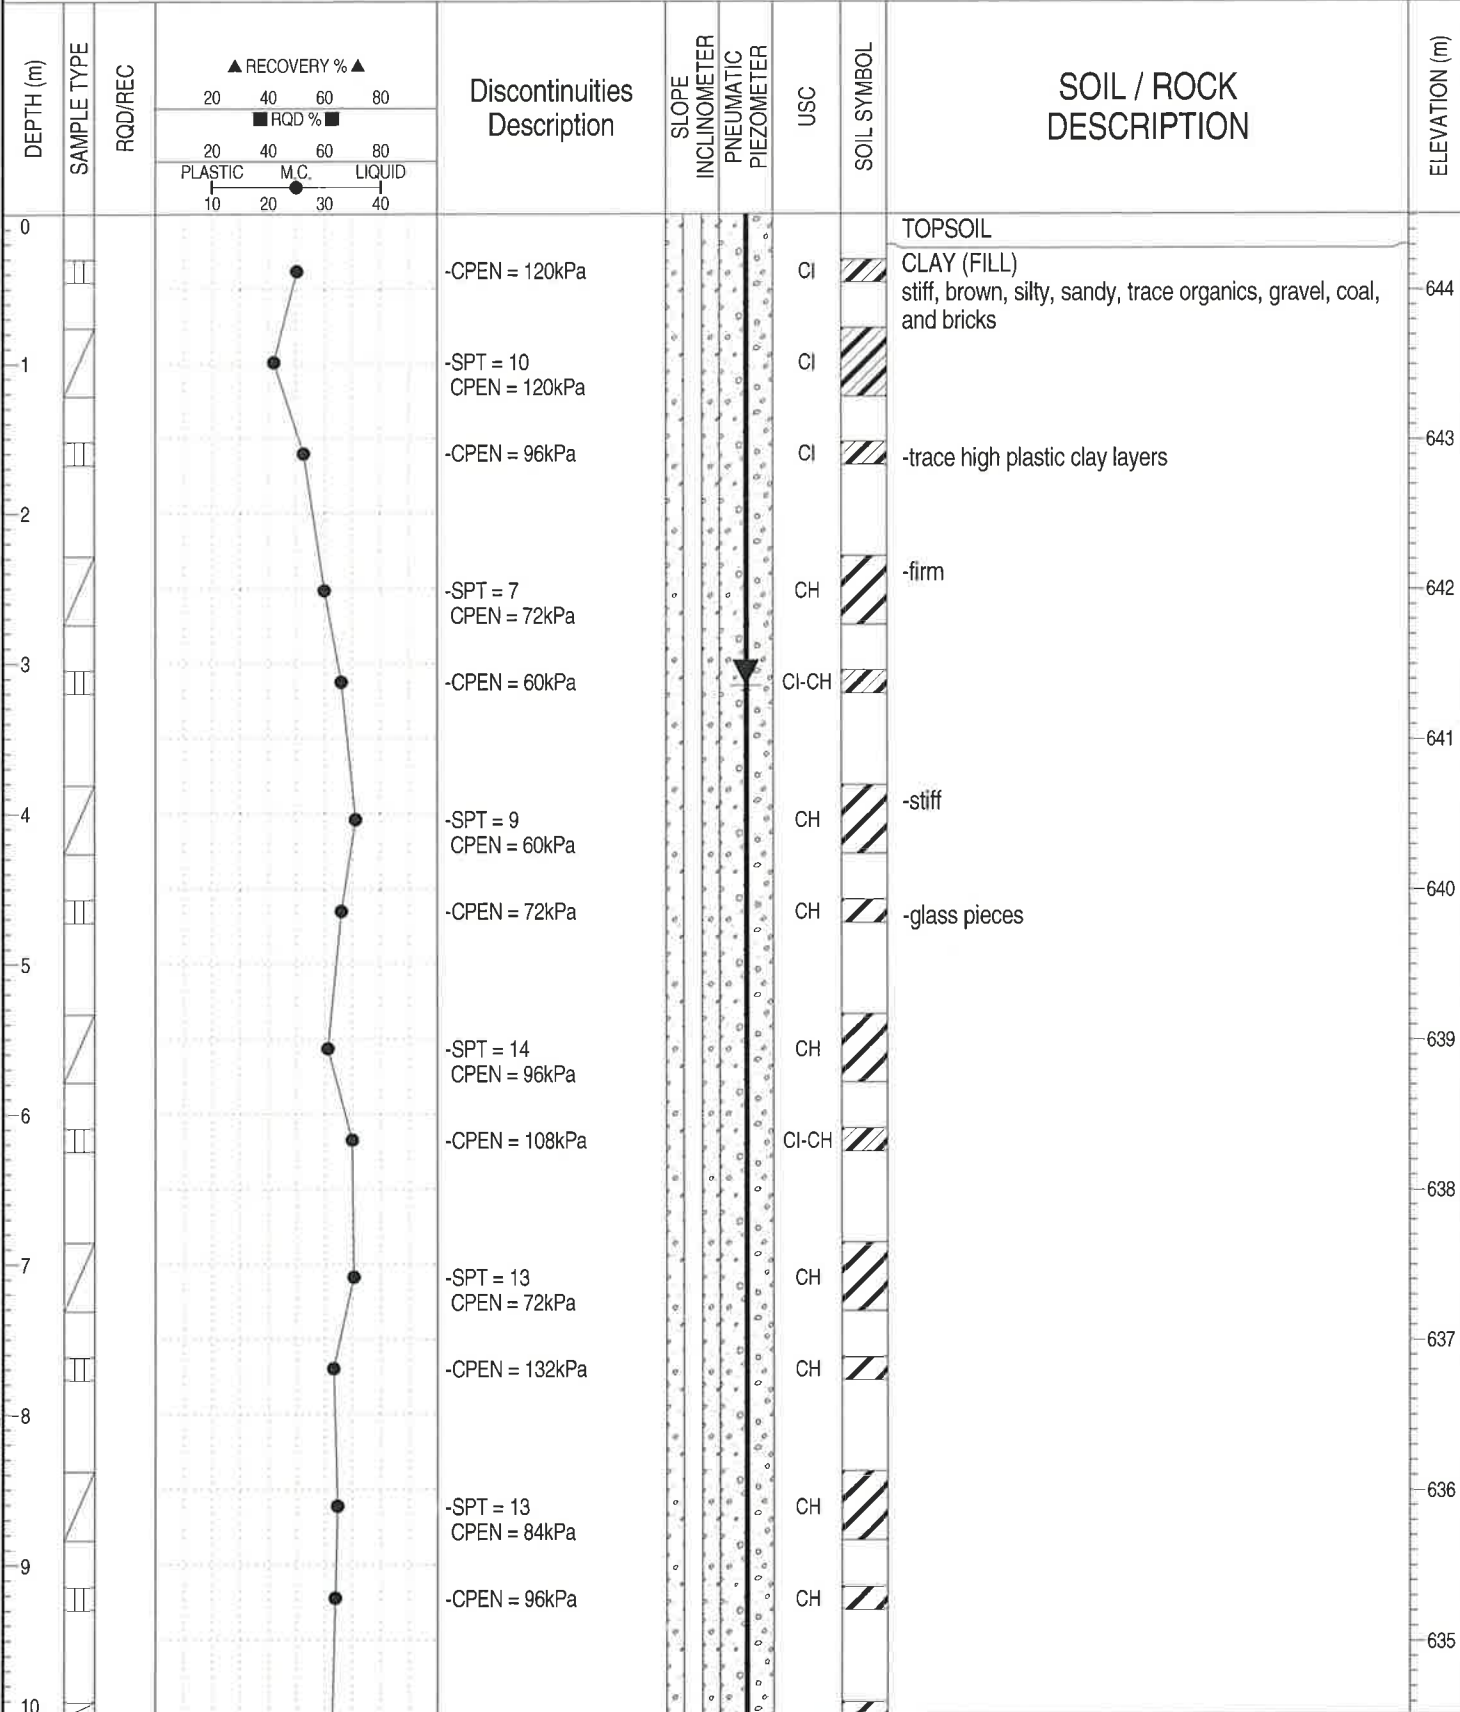
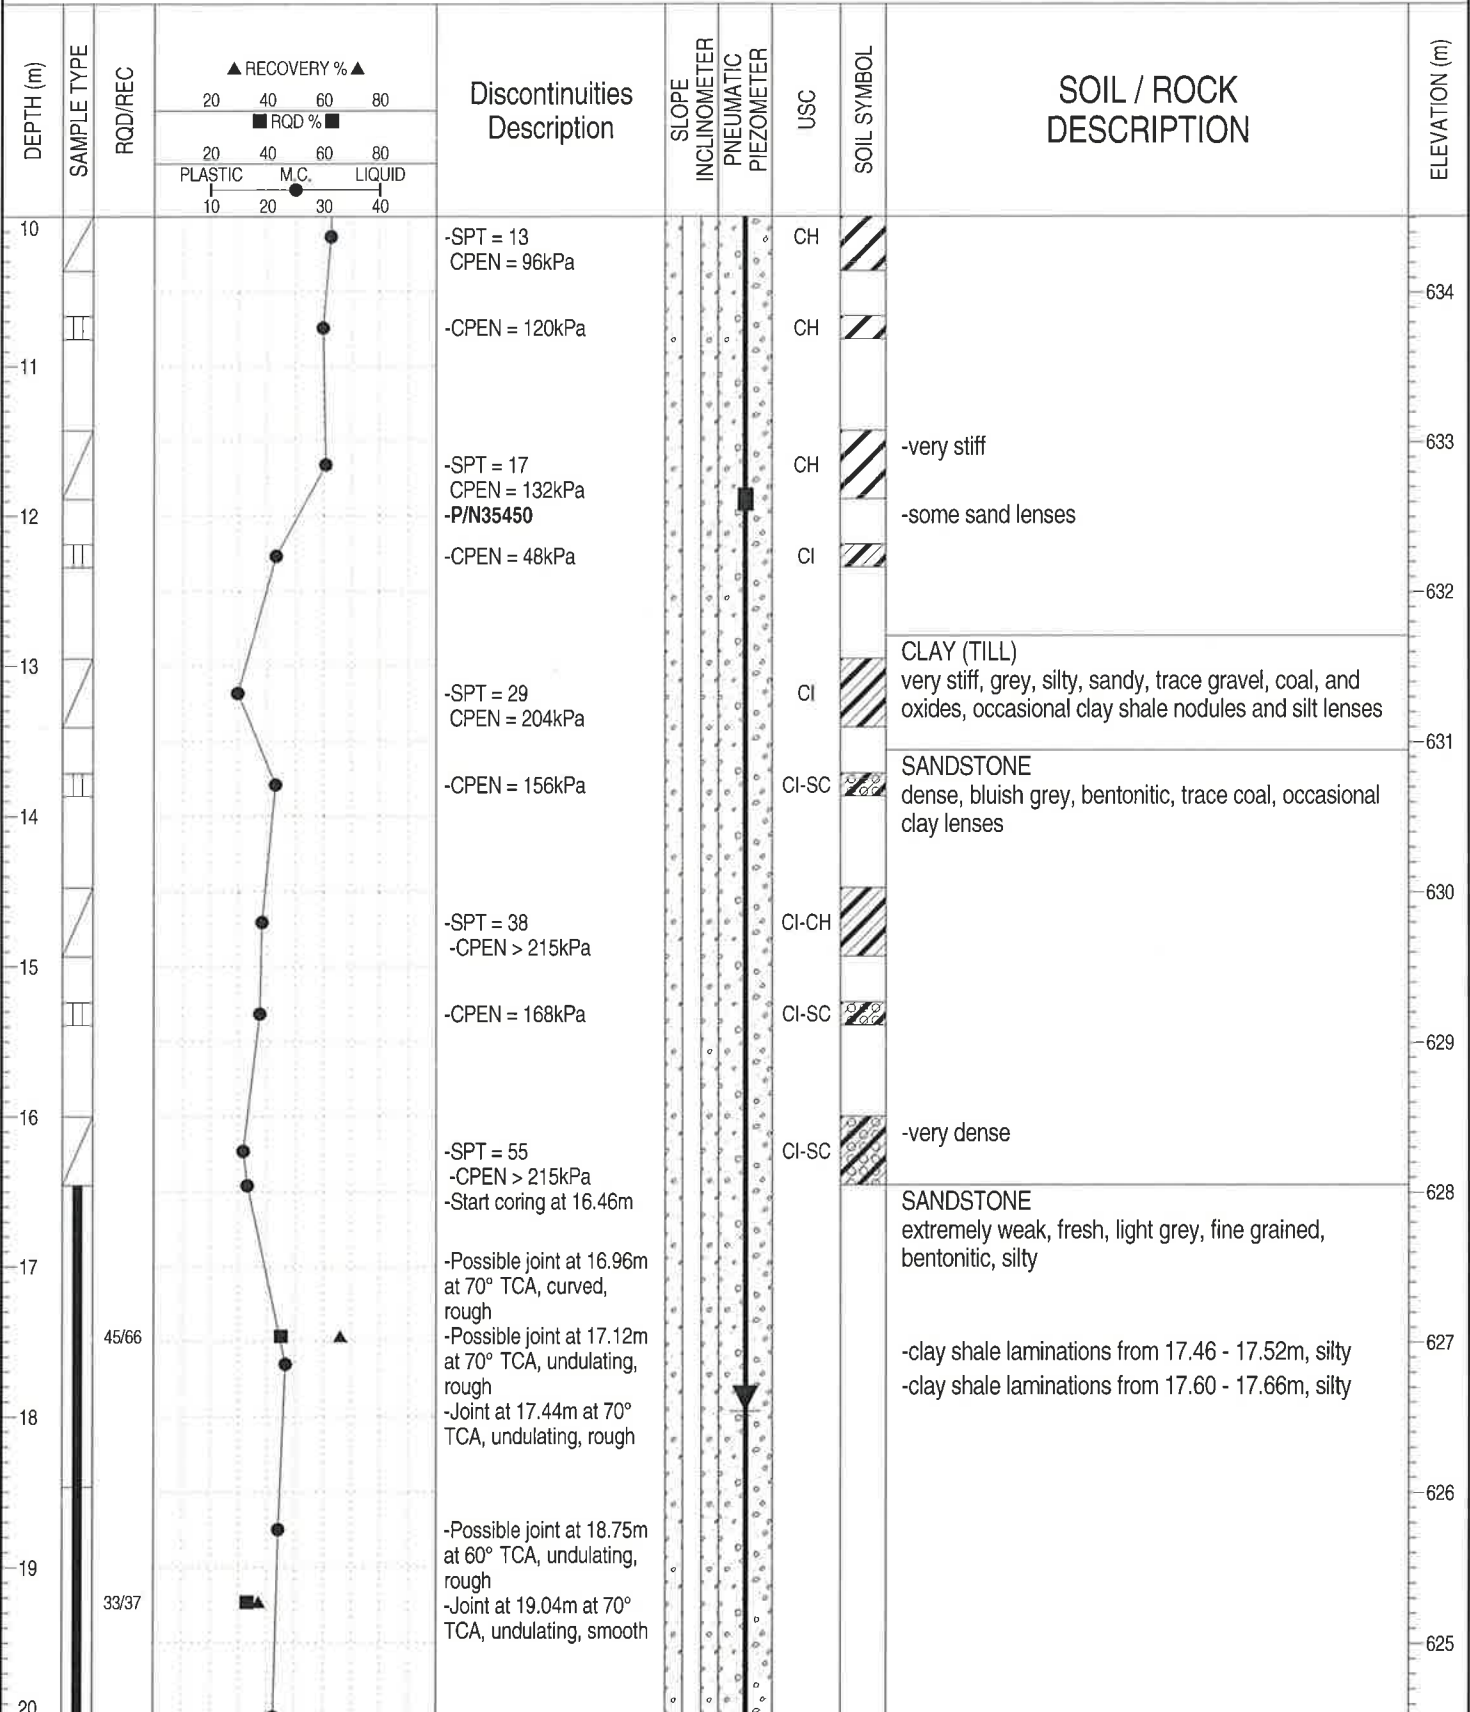
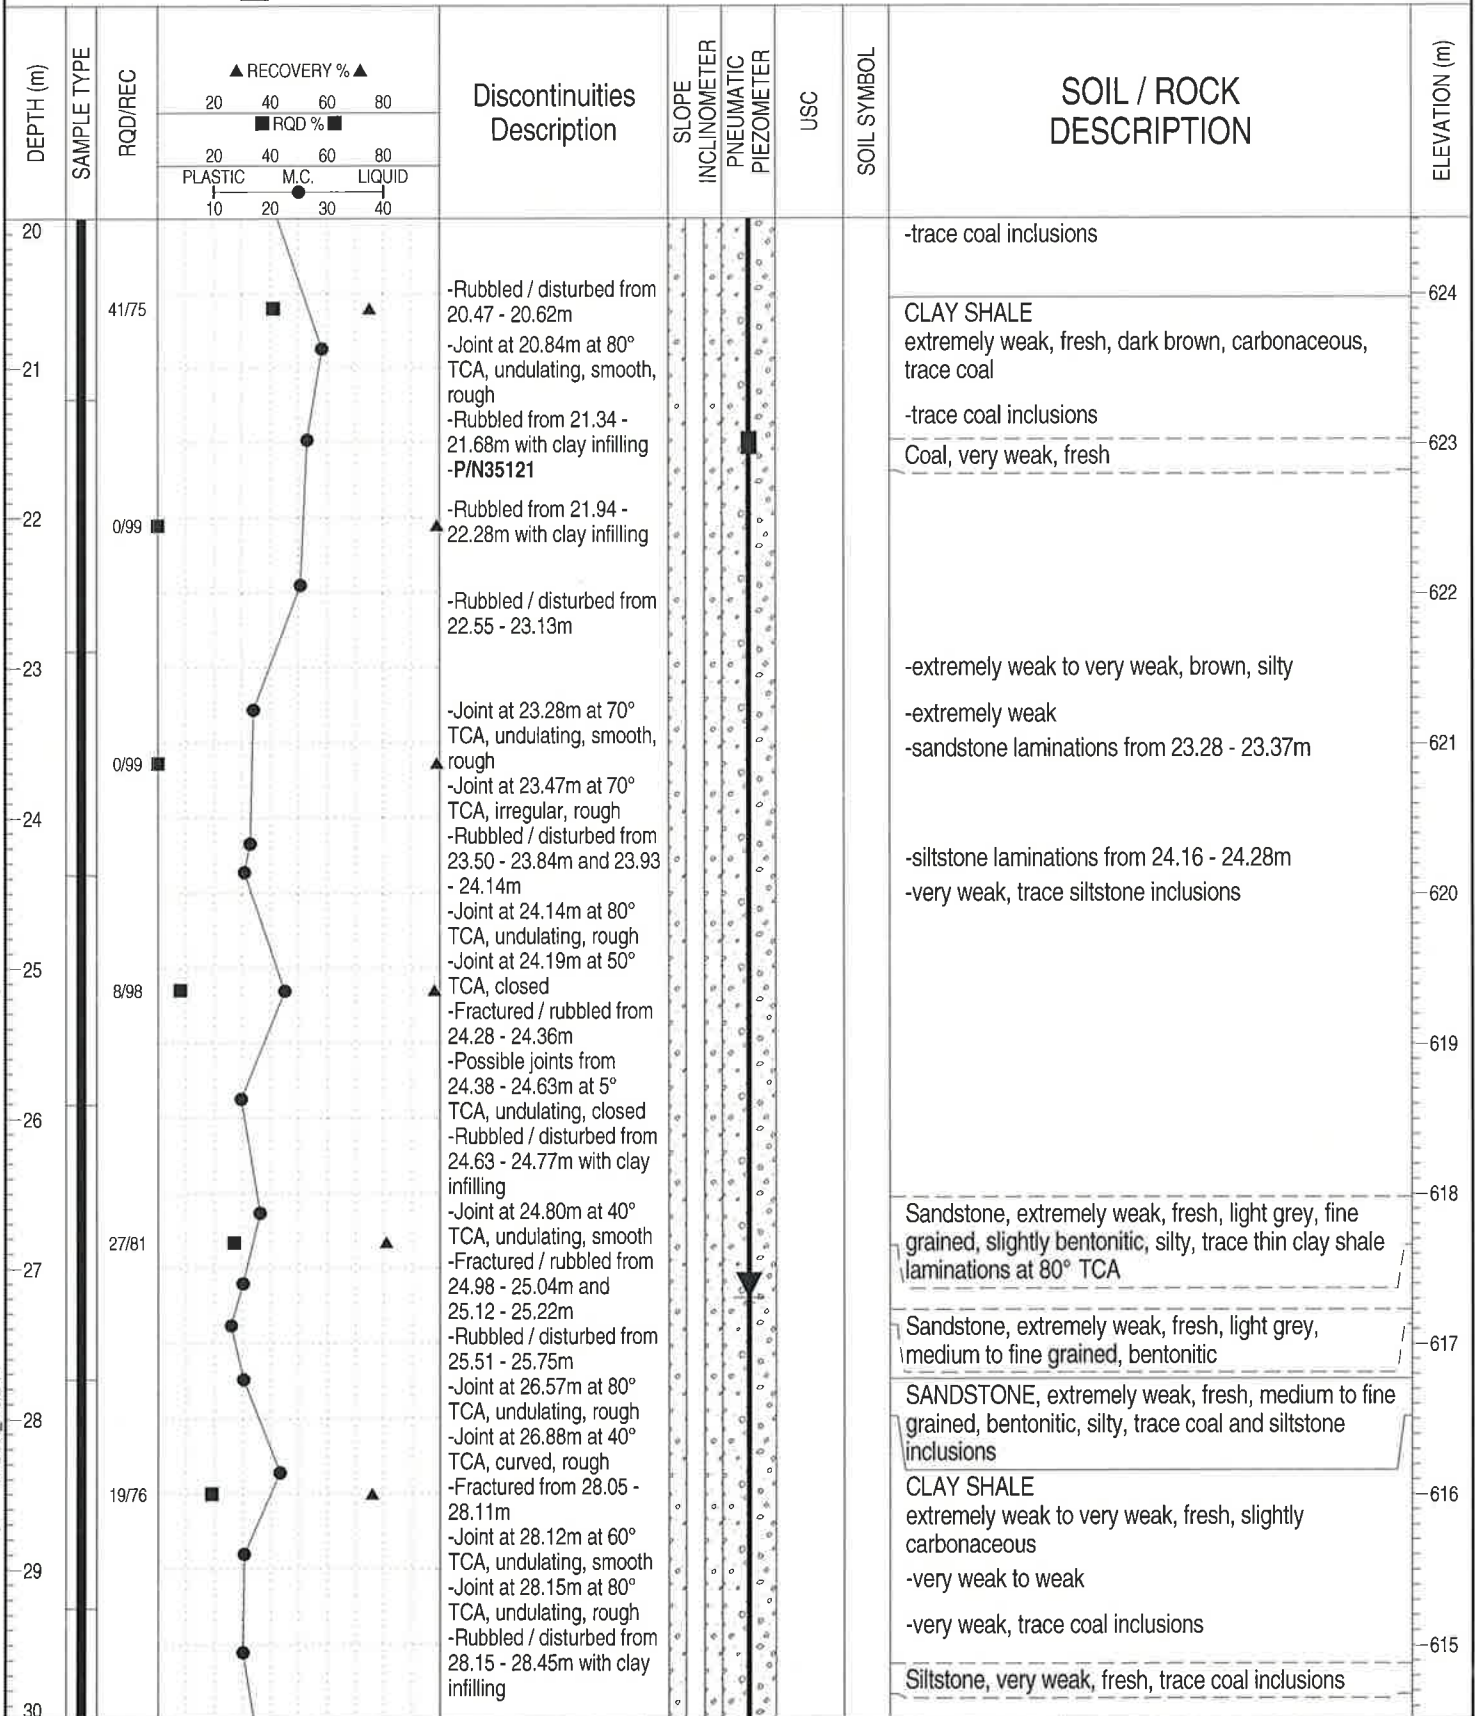
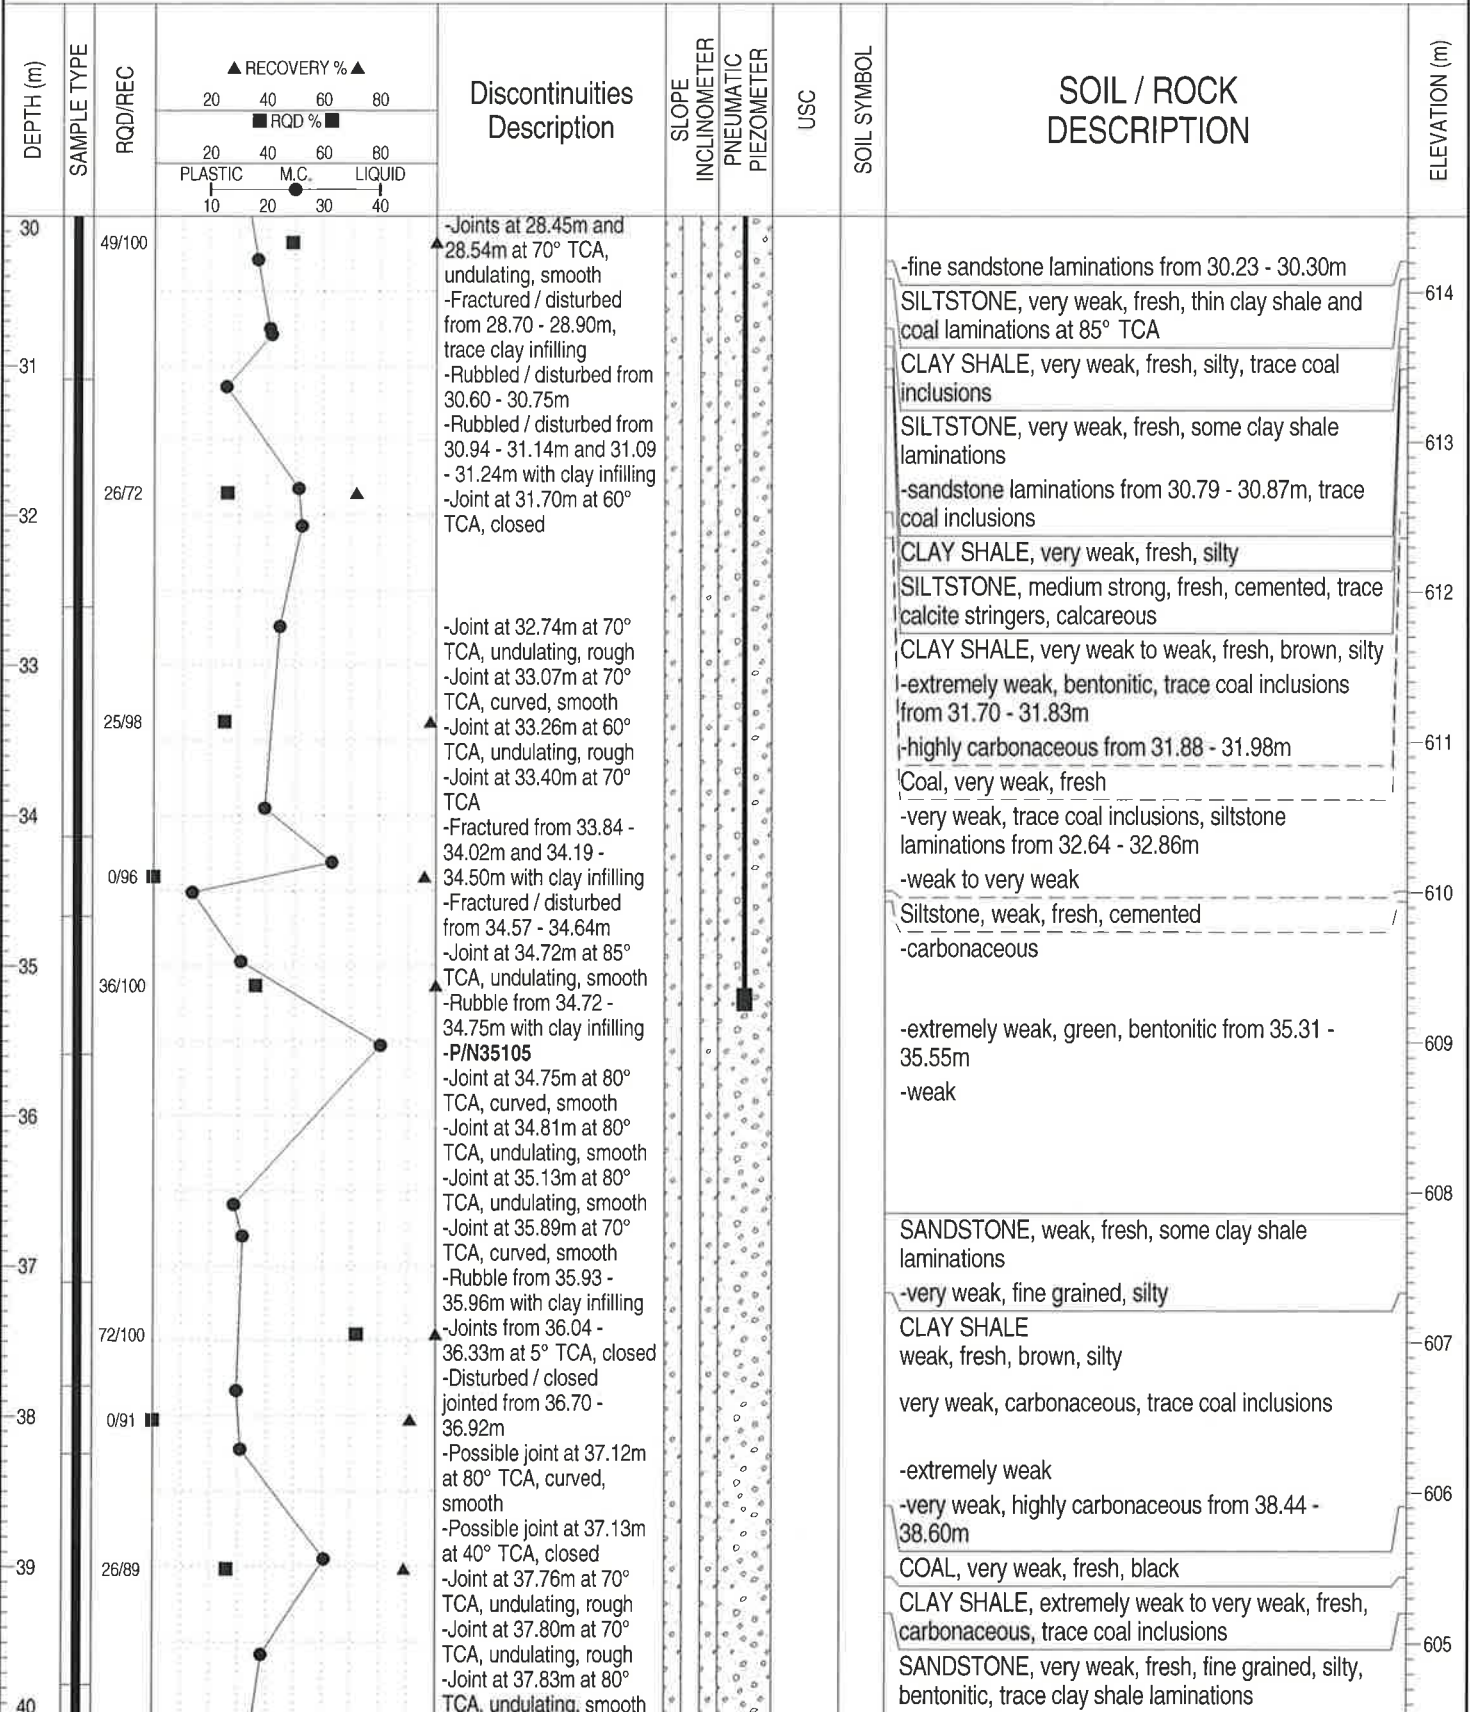
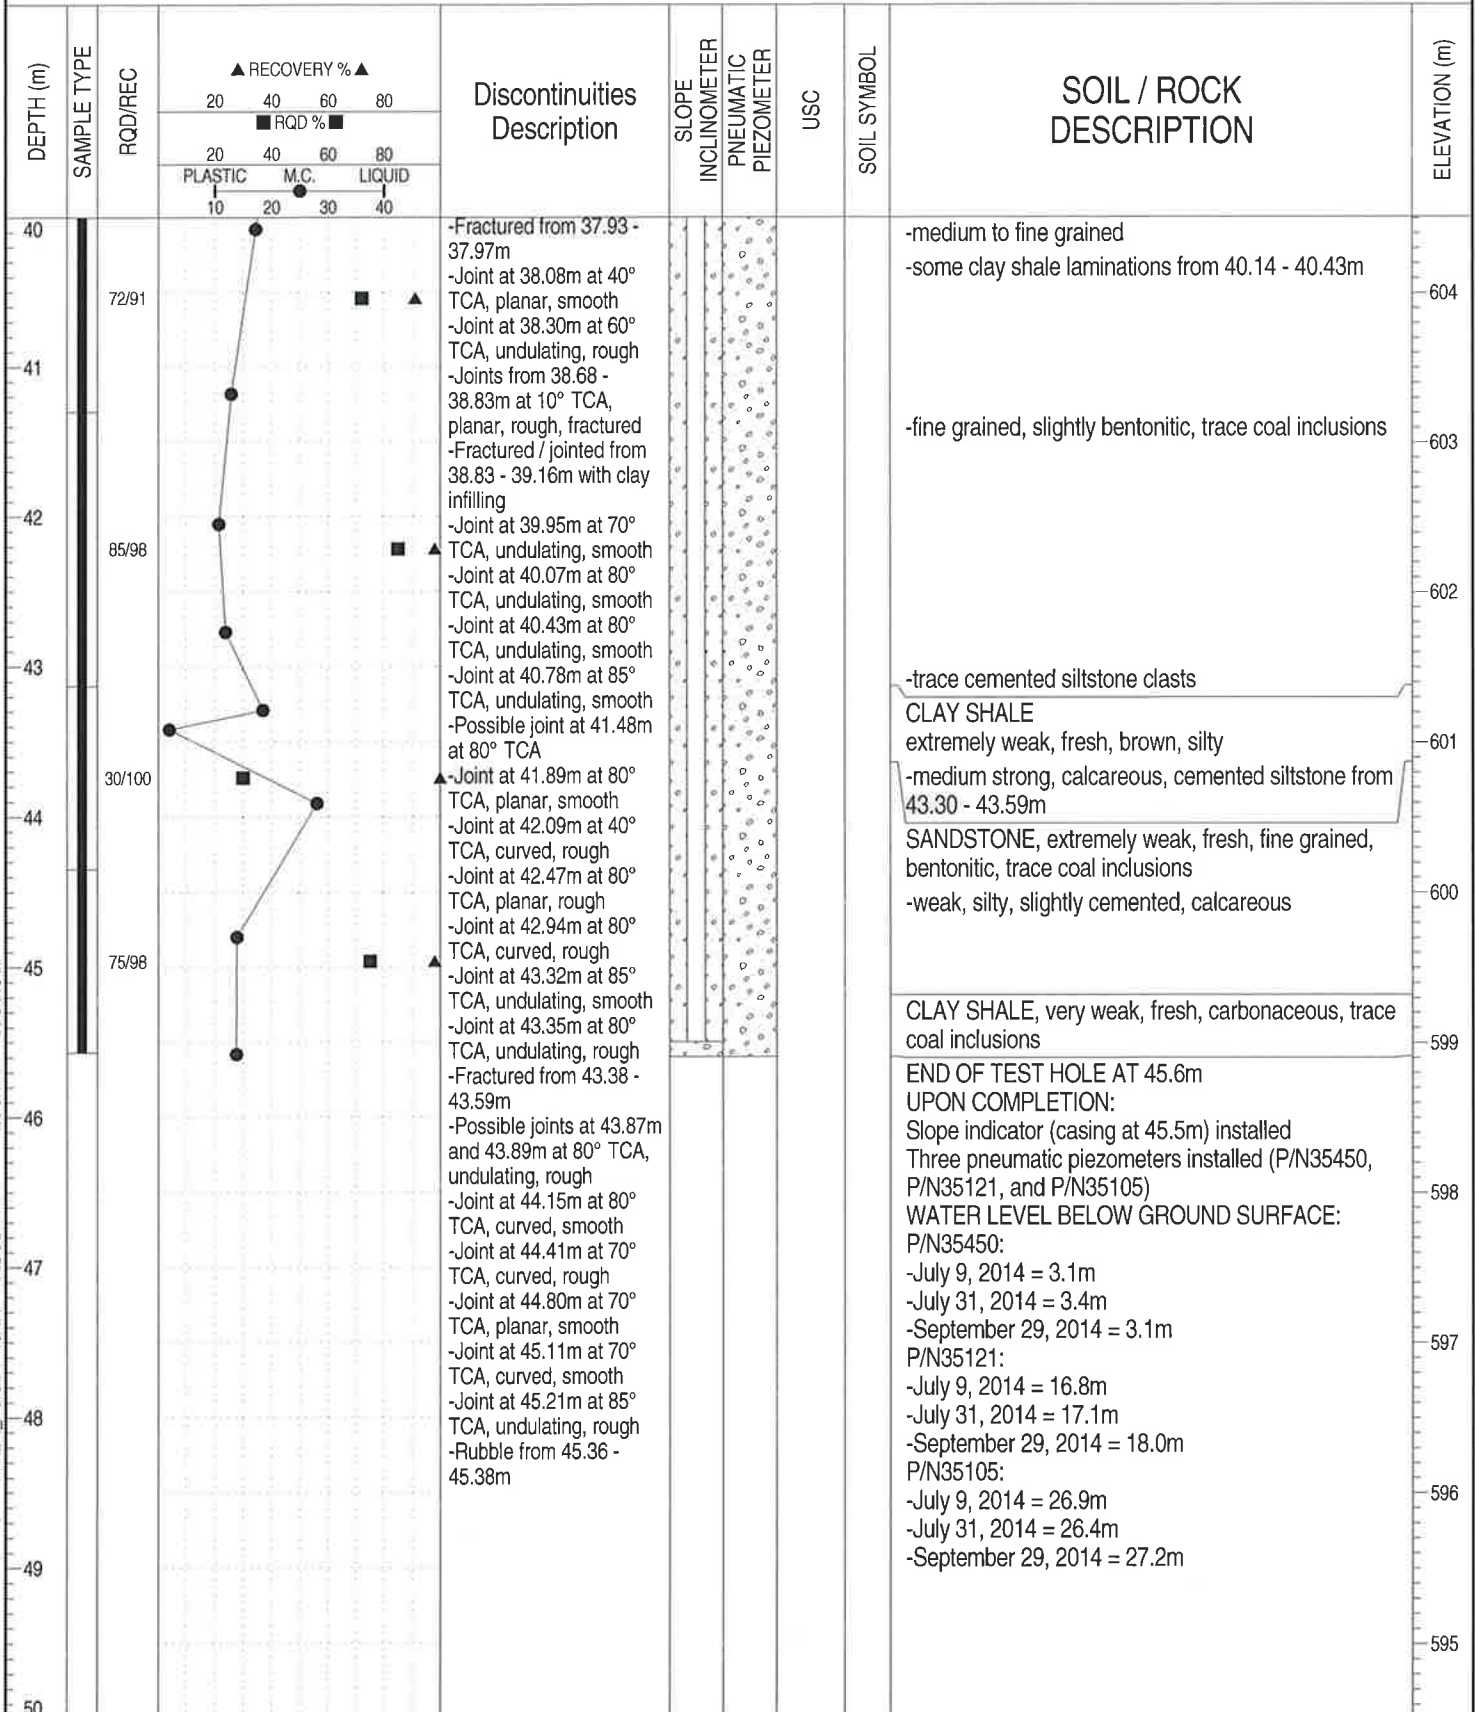
CLIENT: AECOM	PROJECT: EDMONTON SE LRT EXTENTION	BOREHOLE NO: S114-1
DRILLING COMPANY: Mobile Augers & Research Ltd.	DATE DRILLED: March 19, 2014	PROJECT NO: 19-5438-102
DRILL/METHOD: Core Truck / Solid Stem Augers	LOCATION: N5934499.95, E34488.92	ELEVATION: 644.51 (m)
SAMPLE TYPE	<input type="checkbox"/> GRAB SAMPLE <input checked="" type="checkbox"/> SPT <input type="checkbox"/> CORE	
BACKFILL TYPE	<input checked="" type="checkbox"/> GROUT

FIELD LOGGED BY: MW	COMPLETION DEPTH: 45.6 m
PREPARED BY: XW	COMPLETION DATE: 3/19/14
REVIEWED BY:

Layers of clay till were encountered beneath the clay in TH14-1 and beneath the fill in SI14-1. The thickness of till layers varied from 0.8 to 2.3 m. The clay till was medium plastic, silty, sandy, and contained traces of gravel, coal, and occasional sand lenses. The natural moisture content of clay till samples varied between 17 and 22 percent. The clay till was of very stiff consistency with SPT 'N' values between 18 and 29 blows per 300 mm of spoon penetration.

As noted earlier, slope inclinometers SI14-1 and SI14-2 were installed during the current investigation (refer to Drawing 19-5438-102-1AR) to monitor the movement of the Grierson Hill slide. Previously, four slope inclinometers were installed at the eastern end of the proposed construction access road as part of the geotechnical investigation for the LRT-VL project.

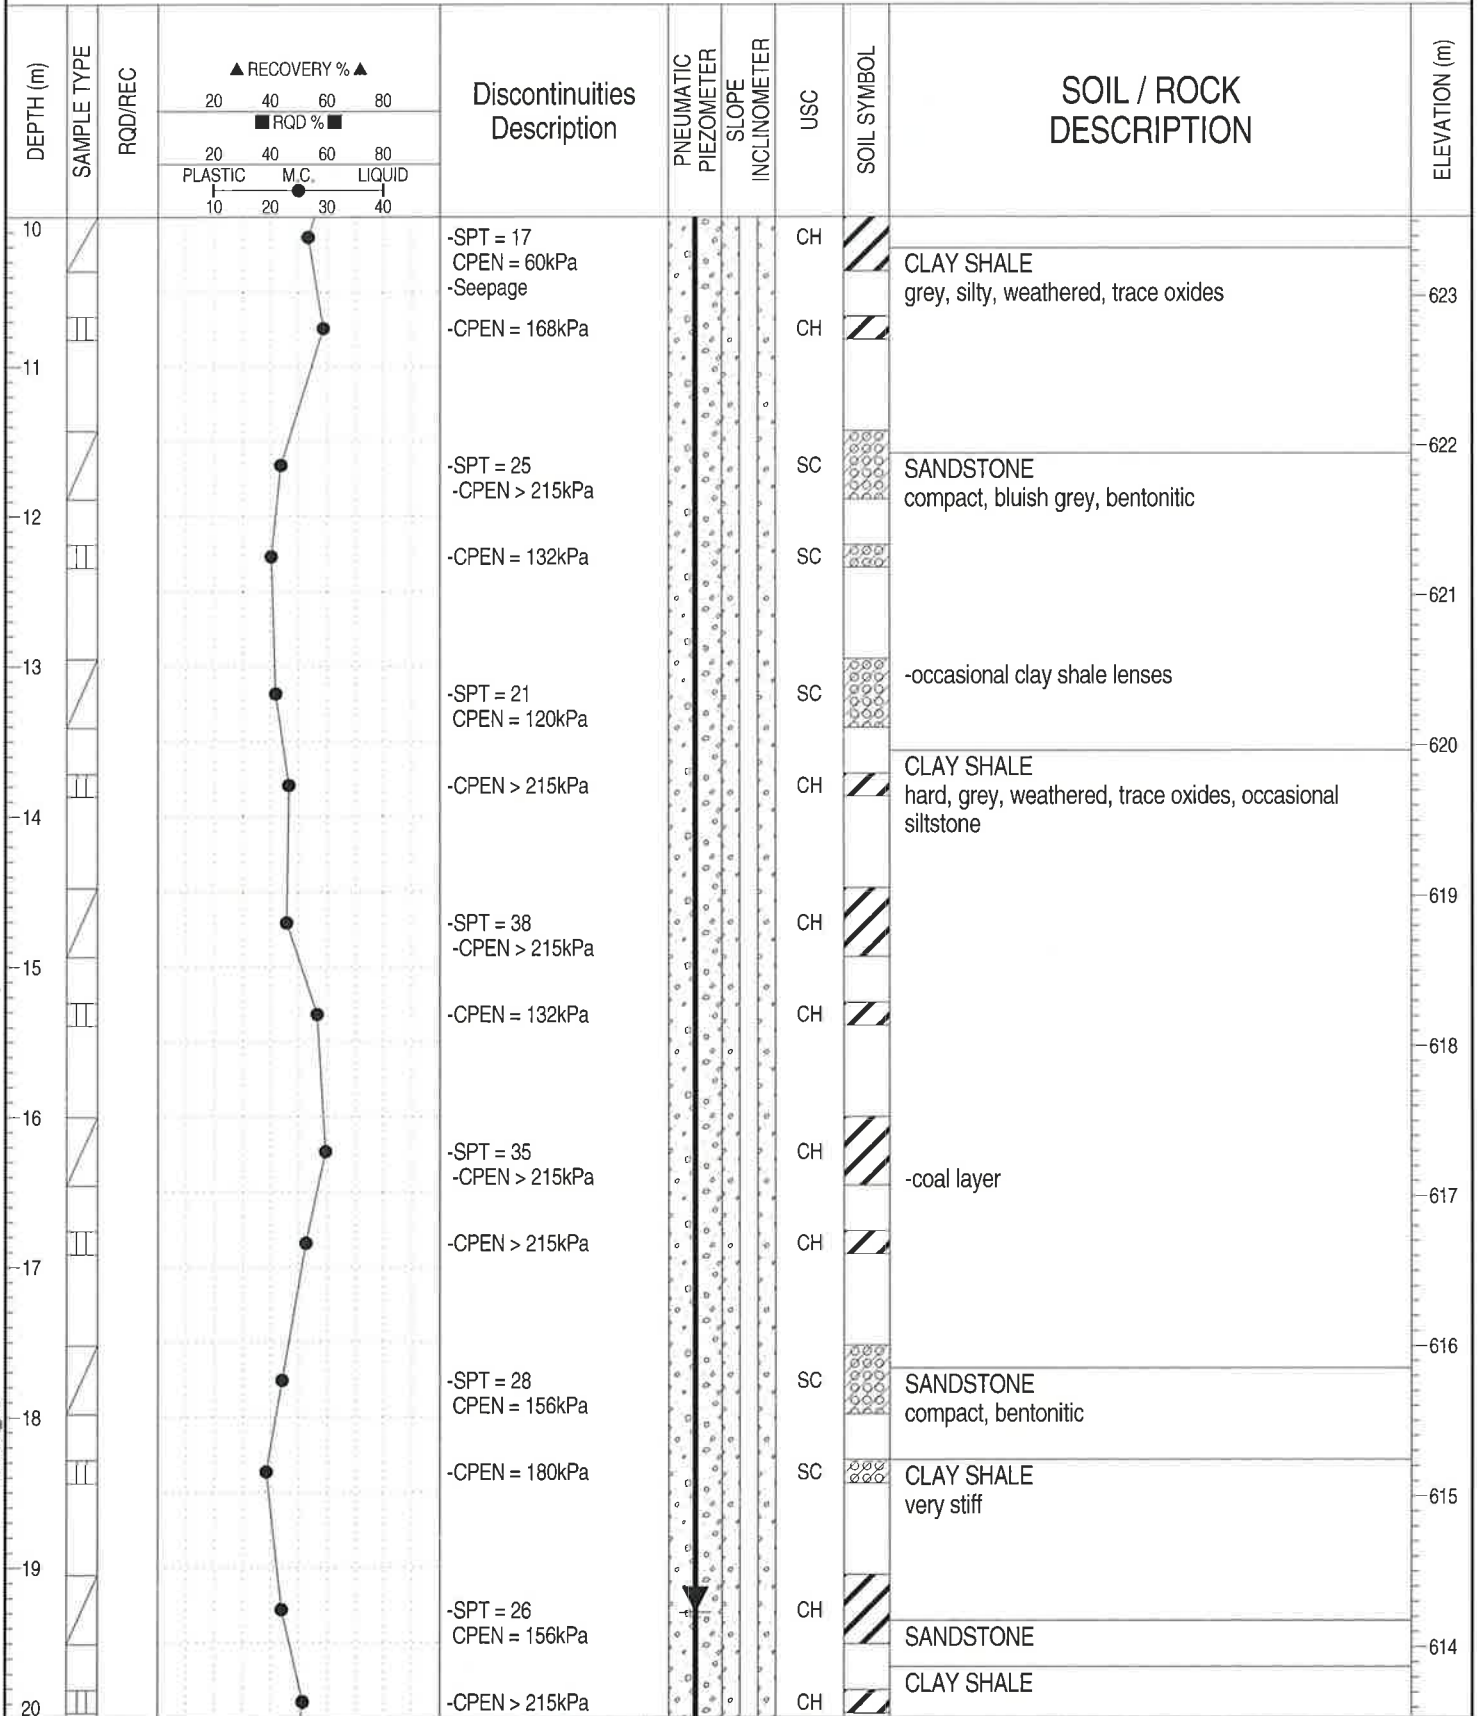
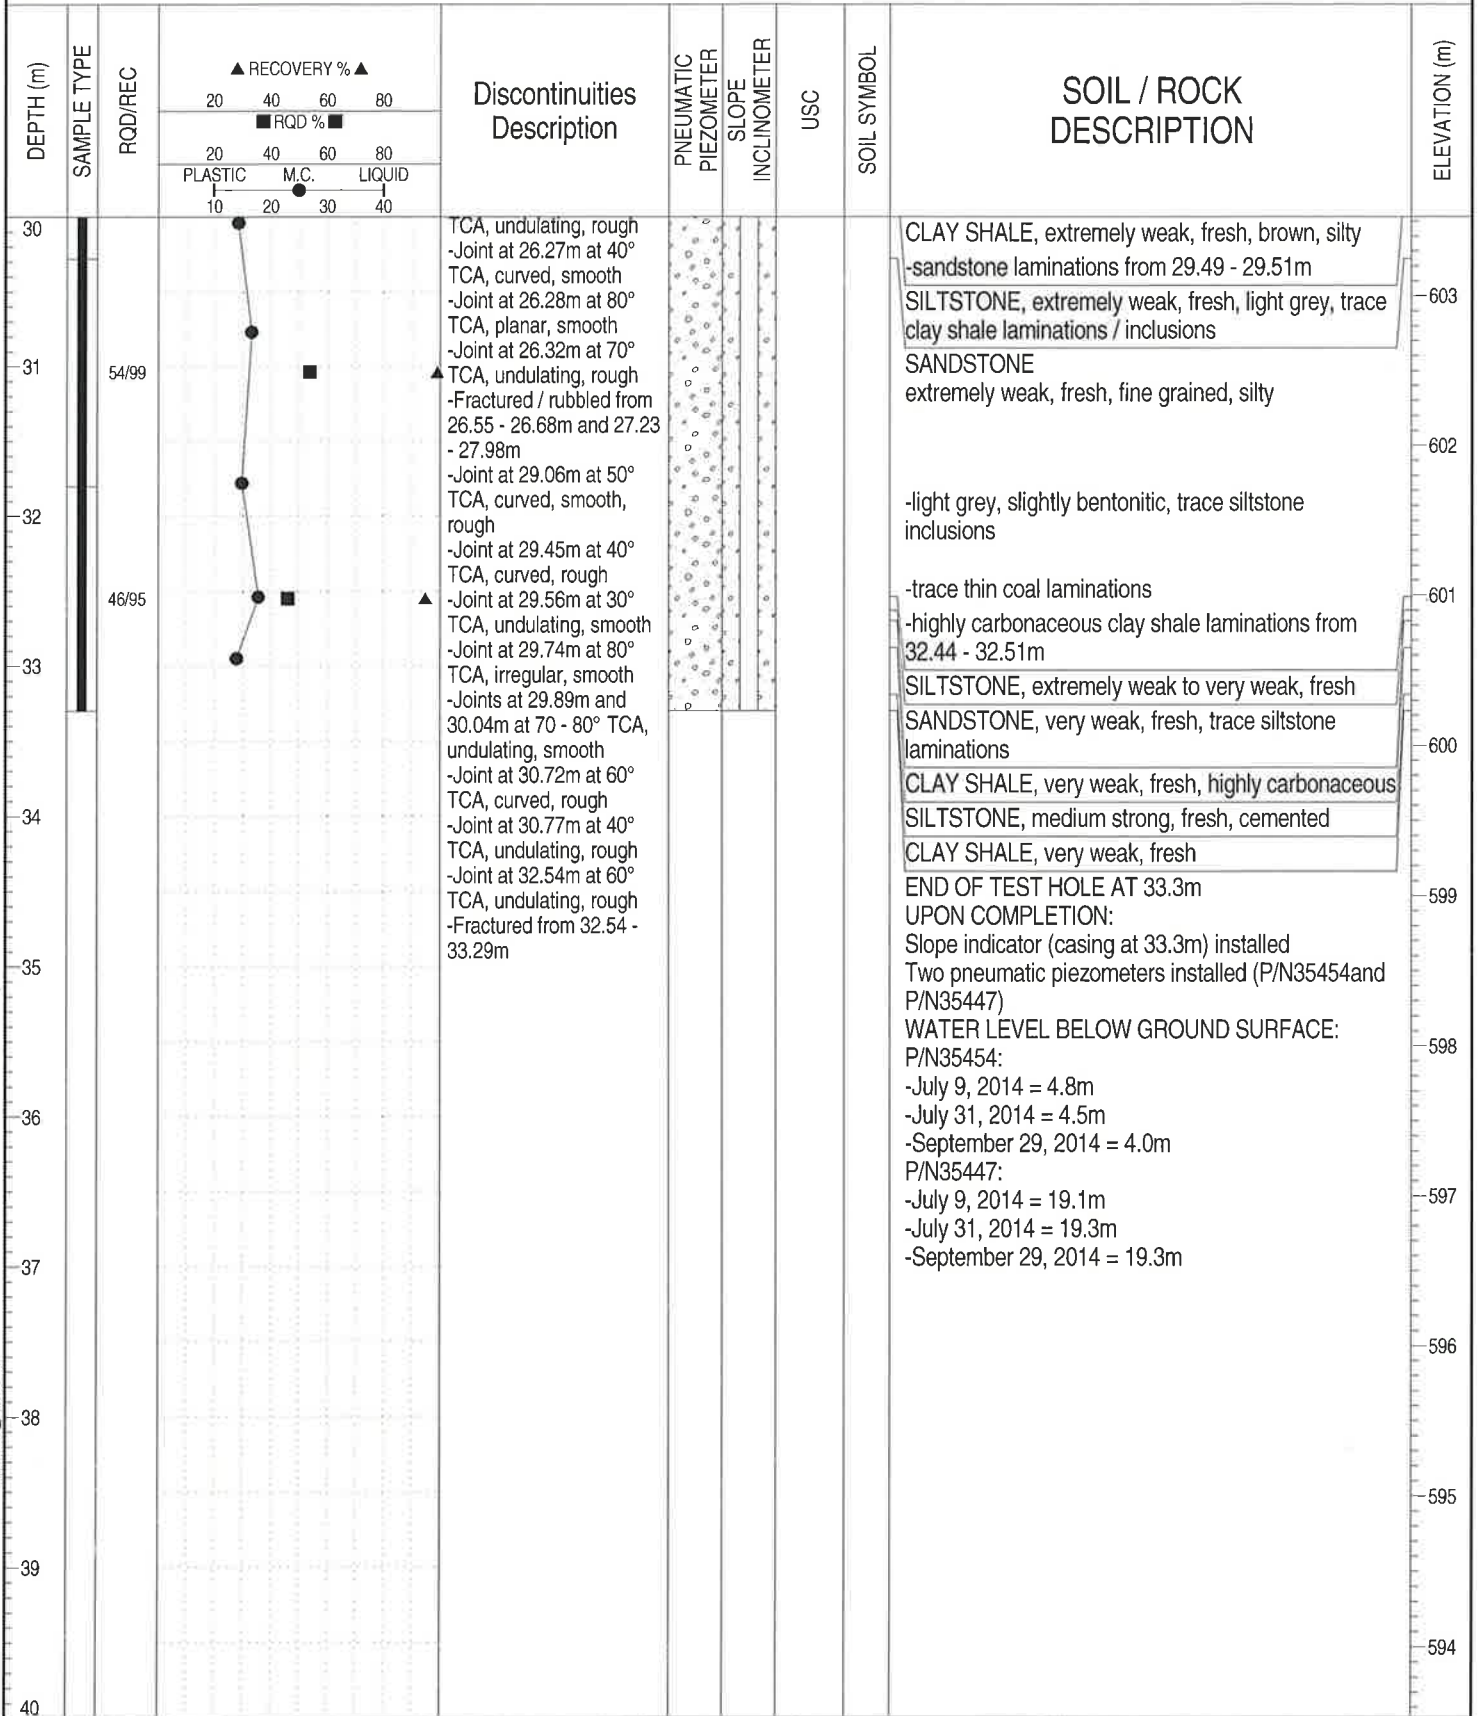
CLIENT: AECOM	PROJECT: EDMONTON SE LRT EXTENTION	BOREHOLE NO: SI14-2
DRILLING COMPANY: Mobile Augers & Research Ltd.	DATE DRILLED: March 17, 2014	PROJECT NO: 19-5438-102
DRILL/METHOD: Core Truck / Solid Stem Augers	LOCATION: N5934403.87, E34520.25	ELEVATION: 633.53 (m)

SAMPLE TYPE	<input type="checkbox"/> GRAB SAMPLE	<input type="checkbox"/> SPT	<input checked="" type="checkbox"/> CORE
BACKFILL TYPE	<input checked="" type="checkbox"/> BENTONITE	<input type="checkbox"/> GROUT

FIELD LOGGED BY: MW	COMPLETION DEPTH: 33.3 m
PREPARED BY: XW	COMPLETION DATE: 3/17/14
REVIEWED BY:

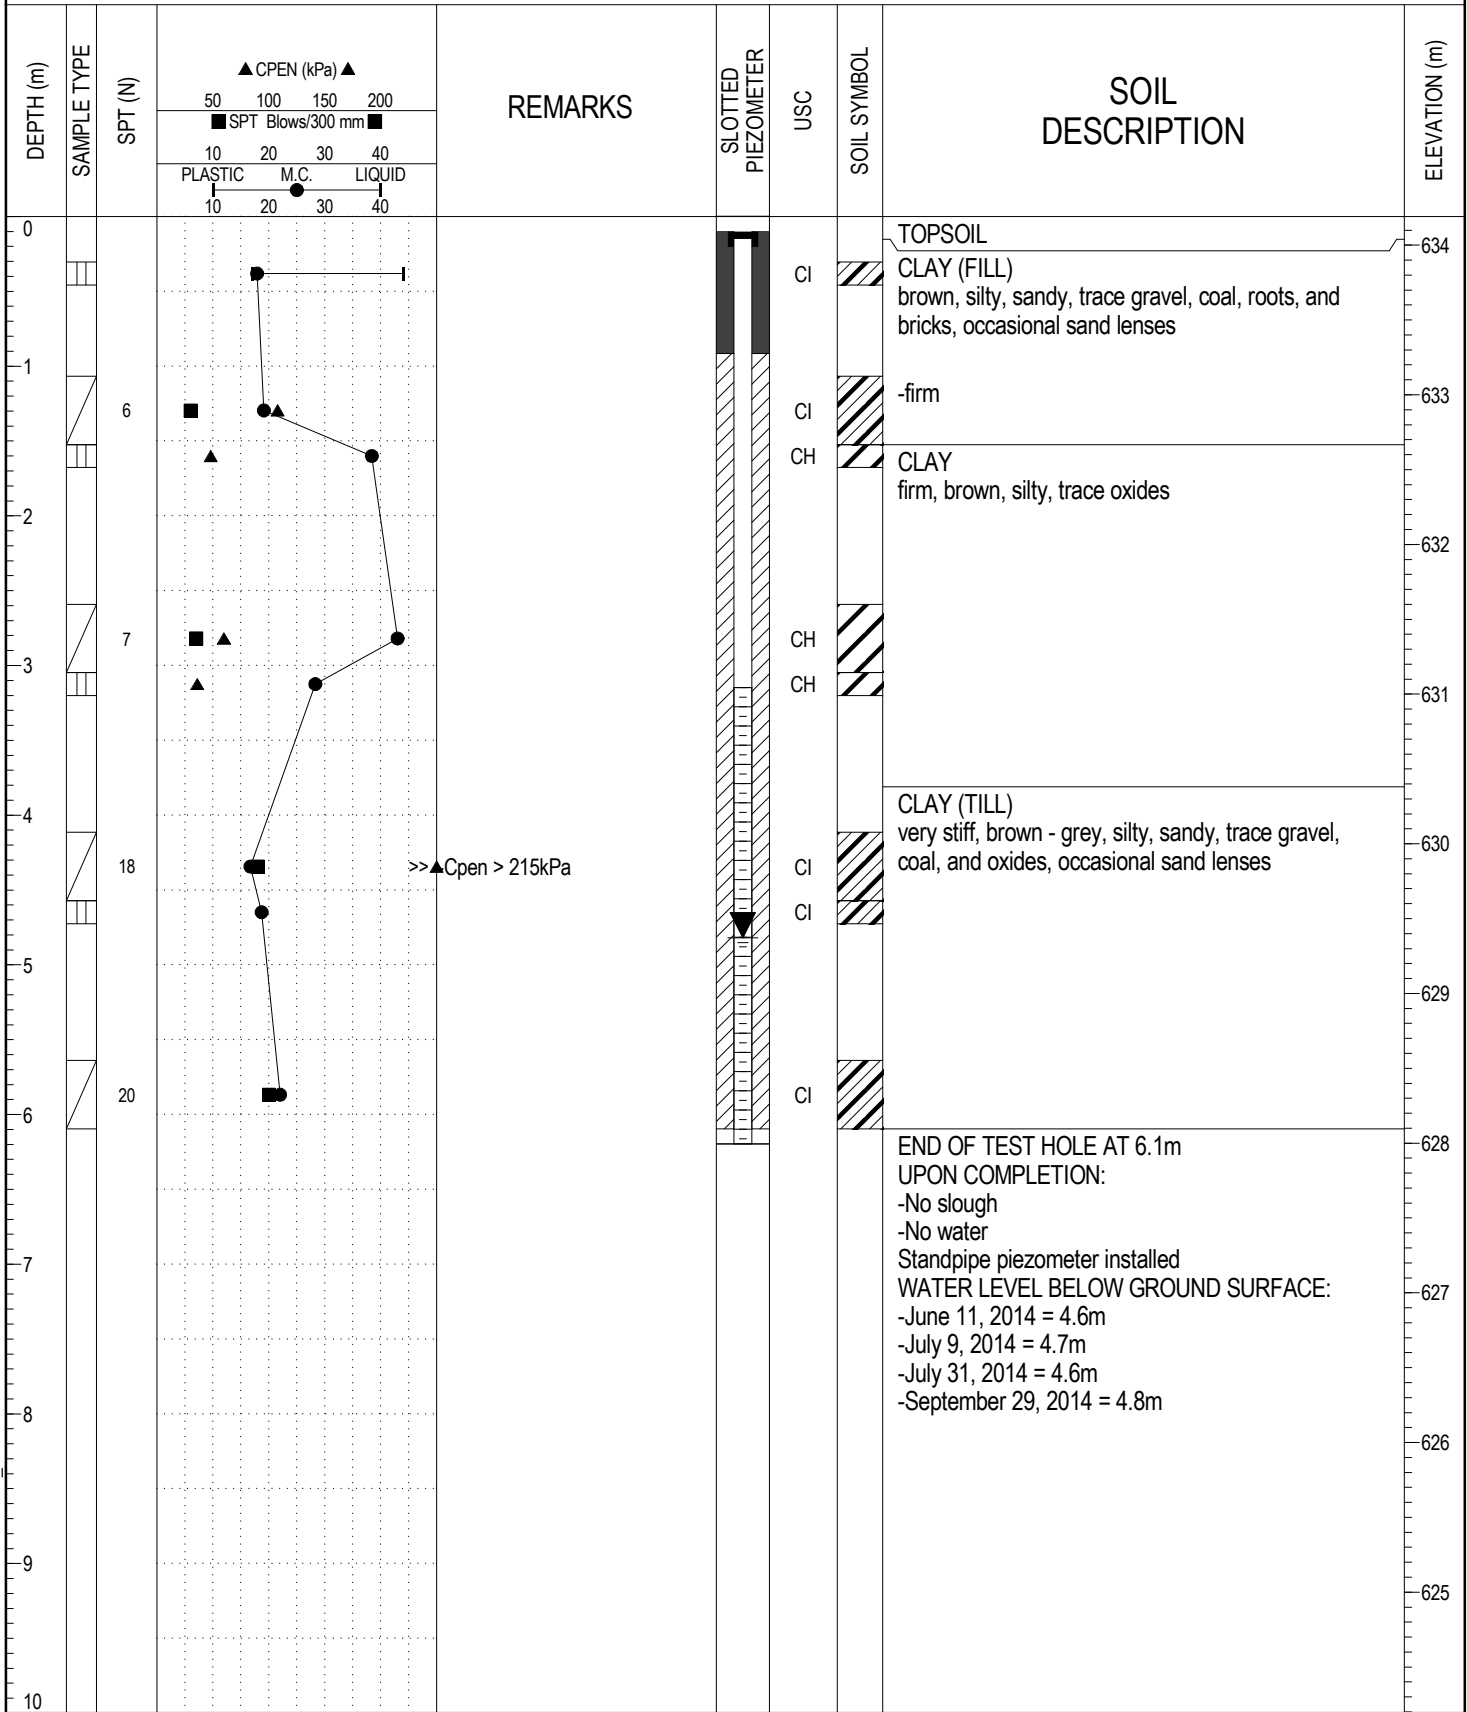
CLIENT: AECOM	PROJECT: EDMONTON SE LRT EXTENTION	BOREHOLE NO: TH14-1
DRILLING COMPANY: Mobile Augers & Research Ltd.	DATE DRILLED: March 24, 2014	PROJECT NO: 19-5438-102
DRILL/METHOD: M5 Truck / Solid Stem Augers	LOCATION: N5934370.75, E34212.54 3TM	ELEVATION: 634.19 (m)

SAMPLE TYPE	<input type="checkbox"/> GRAB SAMPLE	<input checked="" type="checkbox"/> SPT
BACKFILL TYPE	<input checked="" type="checkbox"/> BENTONITE	<input type="checkbox"/> DRILL CUTTINGS

A clay layer was encountered beneath the clay fill in TH14-1 at a depth of about 1.5 m below ground surface and had a thickness of about 2.3 m. The clay was brown, silty, contained trace oxides and was classified as high plastic. The natural moisture content of clay samples ranged from 28 to 43 percent. One SPT 'N' value of 7 blows per 300 mm penetration was recorded in the clay, indicating firm consistency.
