**City of Edmonton  
Valley Line Stage 1 – Light Rail Transit (LRT) Project  
Environmental Impact Screening Assessment Update**

**Final Report**

**Spencer Environmental  
Management Services Ltd.  
Edmonton, Alberta**

February 2015

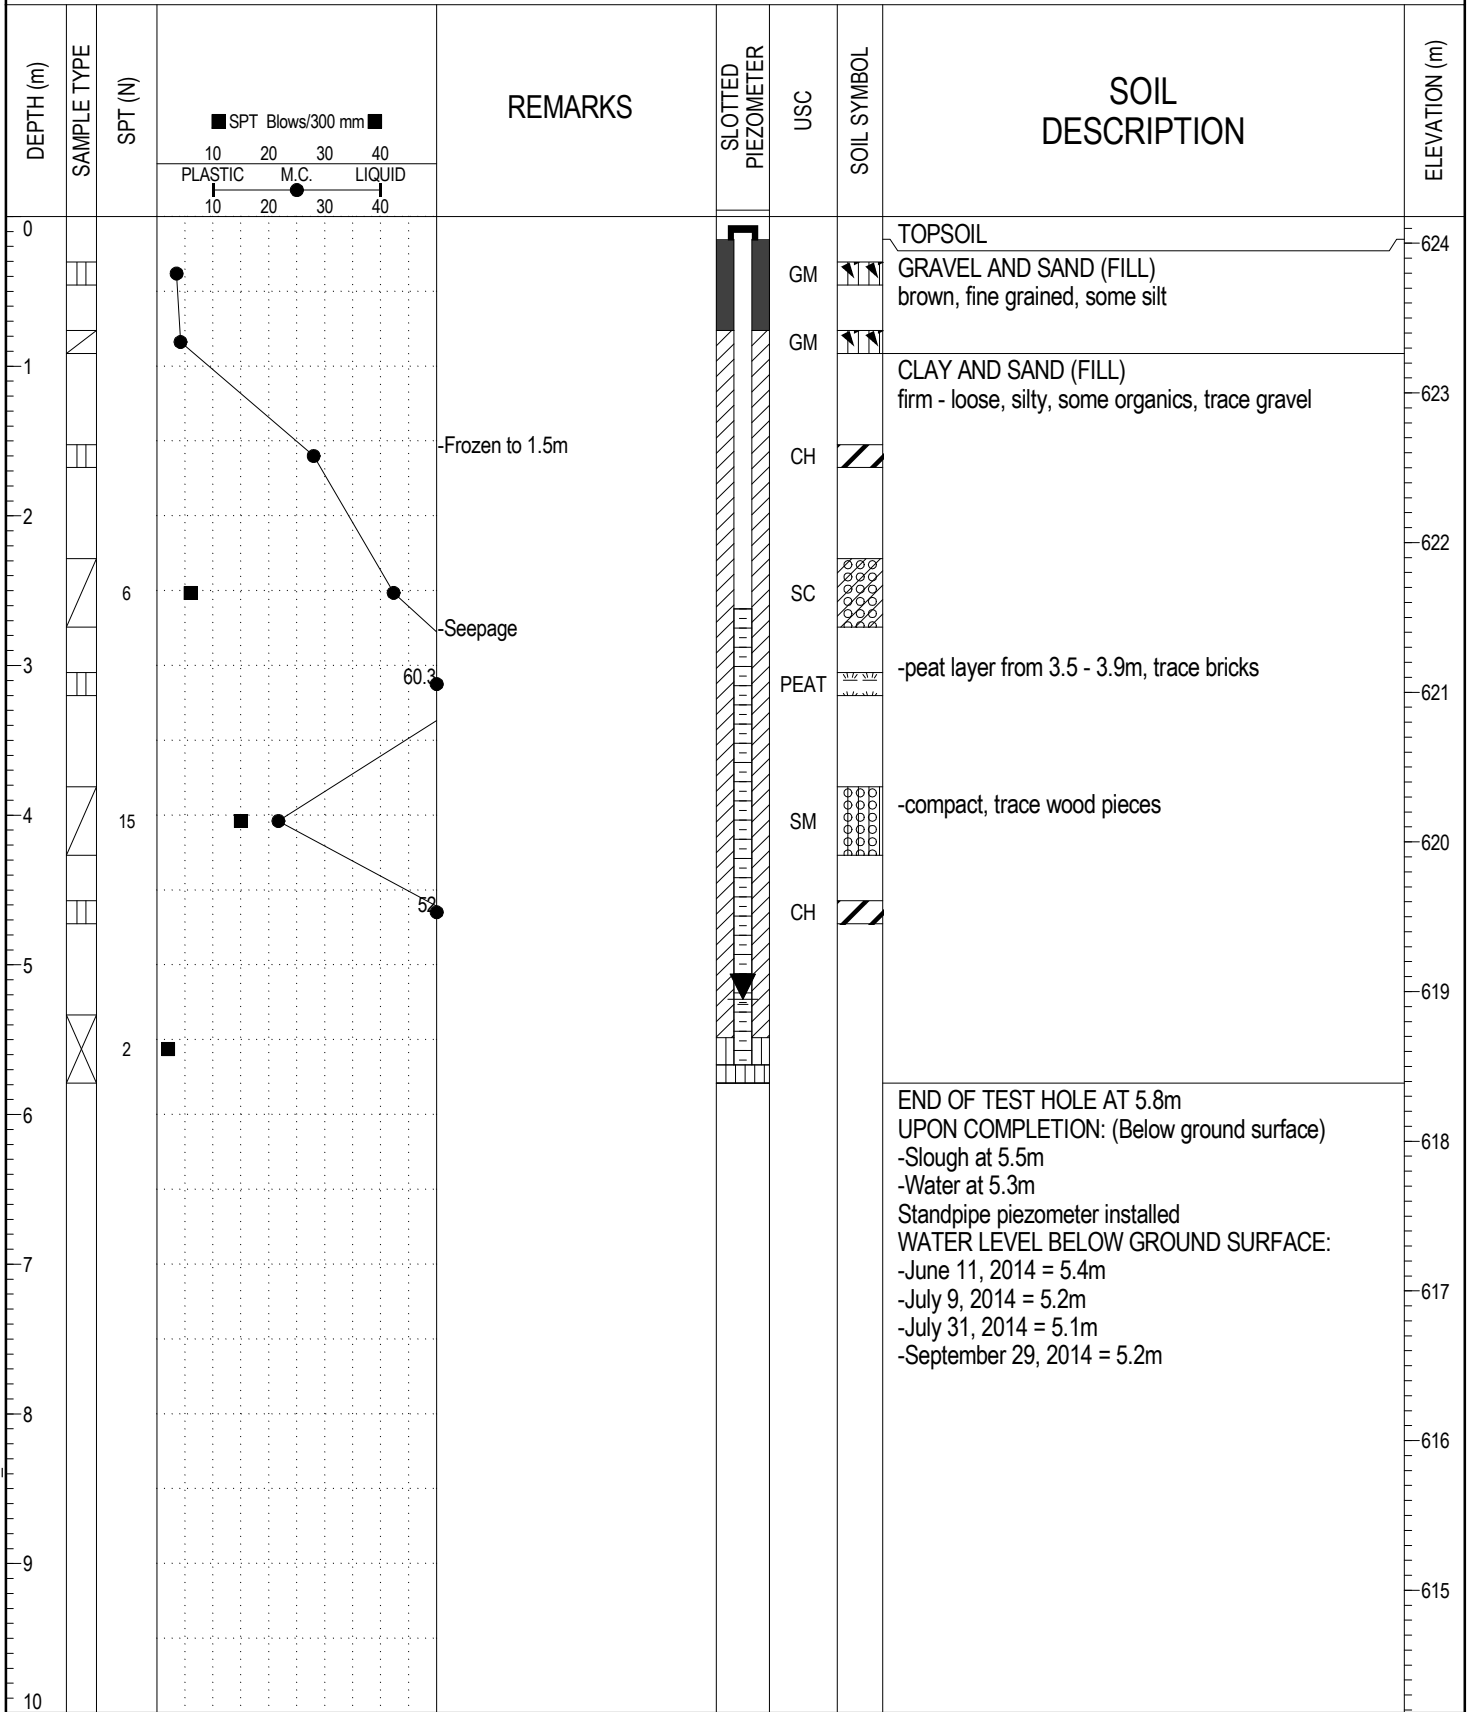
CLIENT: AECOM	PROJECT: EDMONTON SE LRT EXTENTION	BOREHOLE NO: TH14-2
DRILLING COMPANY: Mobile Augers & Research Ltd.	DATE DRILLED: March 24, 2014	PROJECT NO: 19-5438-102
DRILL/METHOD: M5 Truck / Solid Stem Augers	LOCATION: N5934322.72, E34321.18 3TM	ELEVATION: 624.18 (m)

SAMPLE TYPE	<input type="checkbox"/> GRAB SAMPLE	<input checked="" type="checkbox"/> SPT	<input checked="" type="checkbox"/> NO RECOVERY
BACKFILL TYPE	<input checked="" type="checkbox"/> BENTONITE	<input checked="" type="checkbox"/> DRILL CUTTINGS	<input type="checkbox"/> SLOUGH

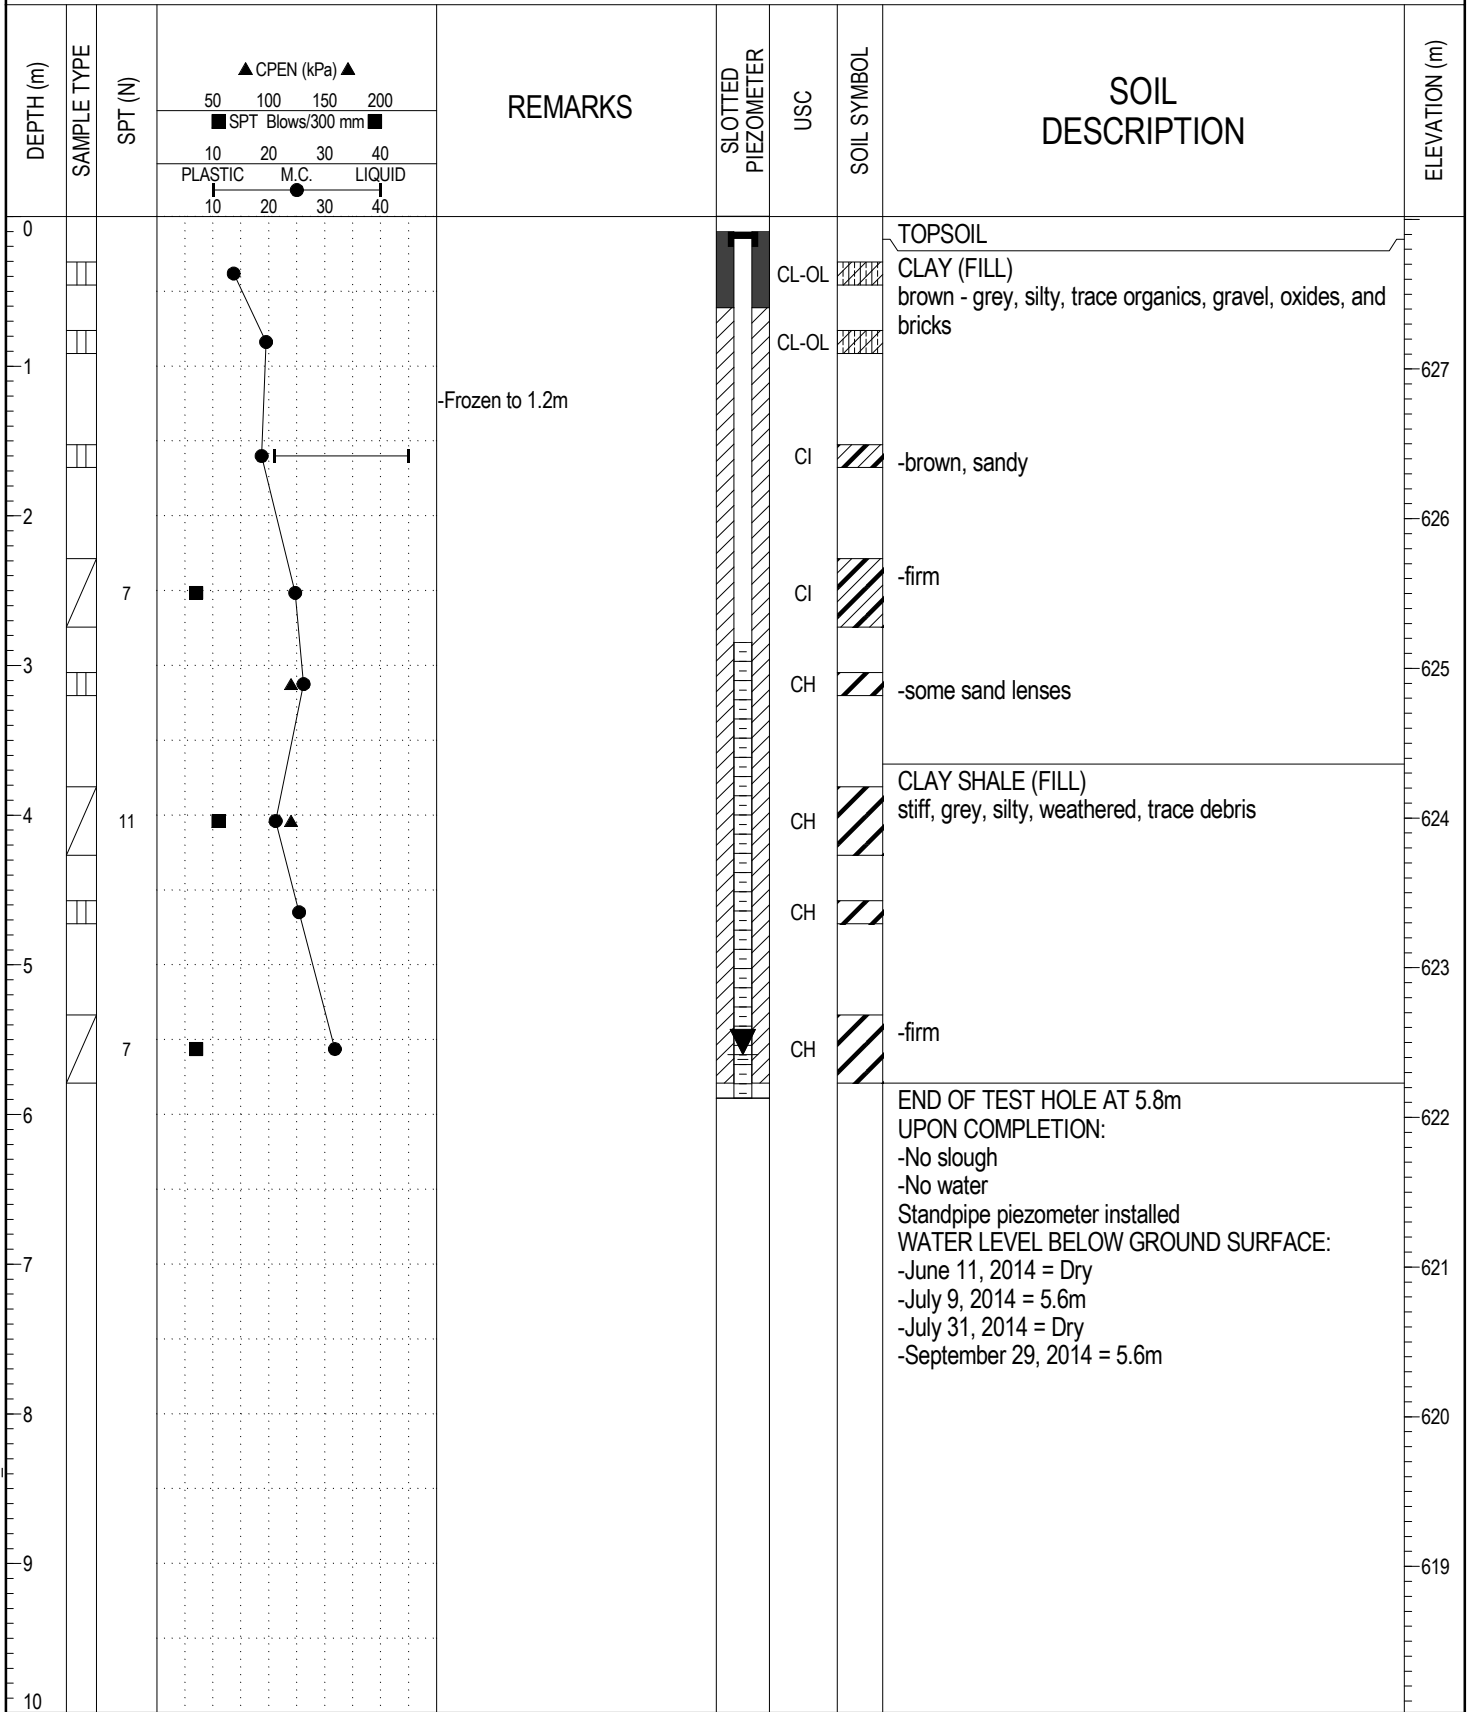
CLIENT: AECOM	PROJECT: EDMONTON SE LRT EXTENTION	BOREHOLE NO: TH14-4
DRILLING COMPANY: Mobile Augers & Research Ltd.	DATE DRILLED: March 24, 2014	PROJECT NO: 19-5438-102
DRILL/METHOD: M5 Truck / Solid Stem Augers	LOCATION: N5934376.95, E34599.26 3TM	ELEVATION: 628.02 (m)

SAMPLE TYPE	<input type="checkbox"/> GRAB SAMPLE	<input checked="" type="checkbox"/> SPT
BACKFILL TYPE	<input checked="" type="checkbox"/> BENTONITE	<input type="checkbox"/> DRILL CUTTINGS

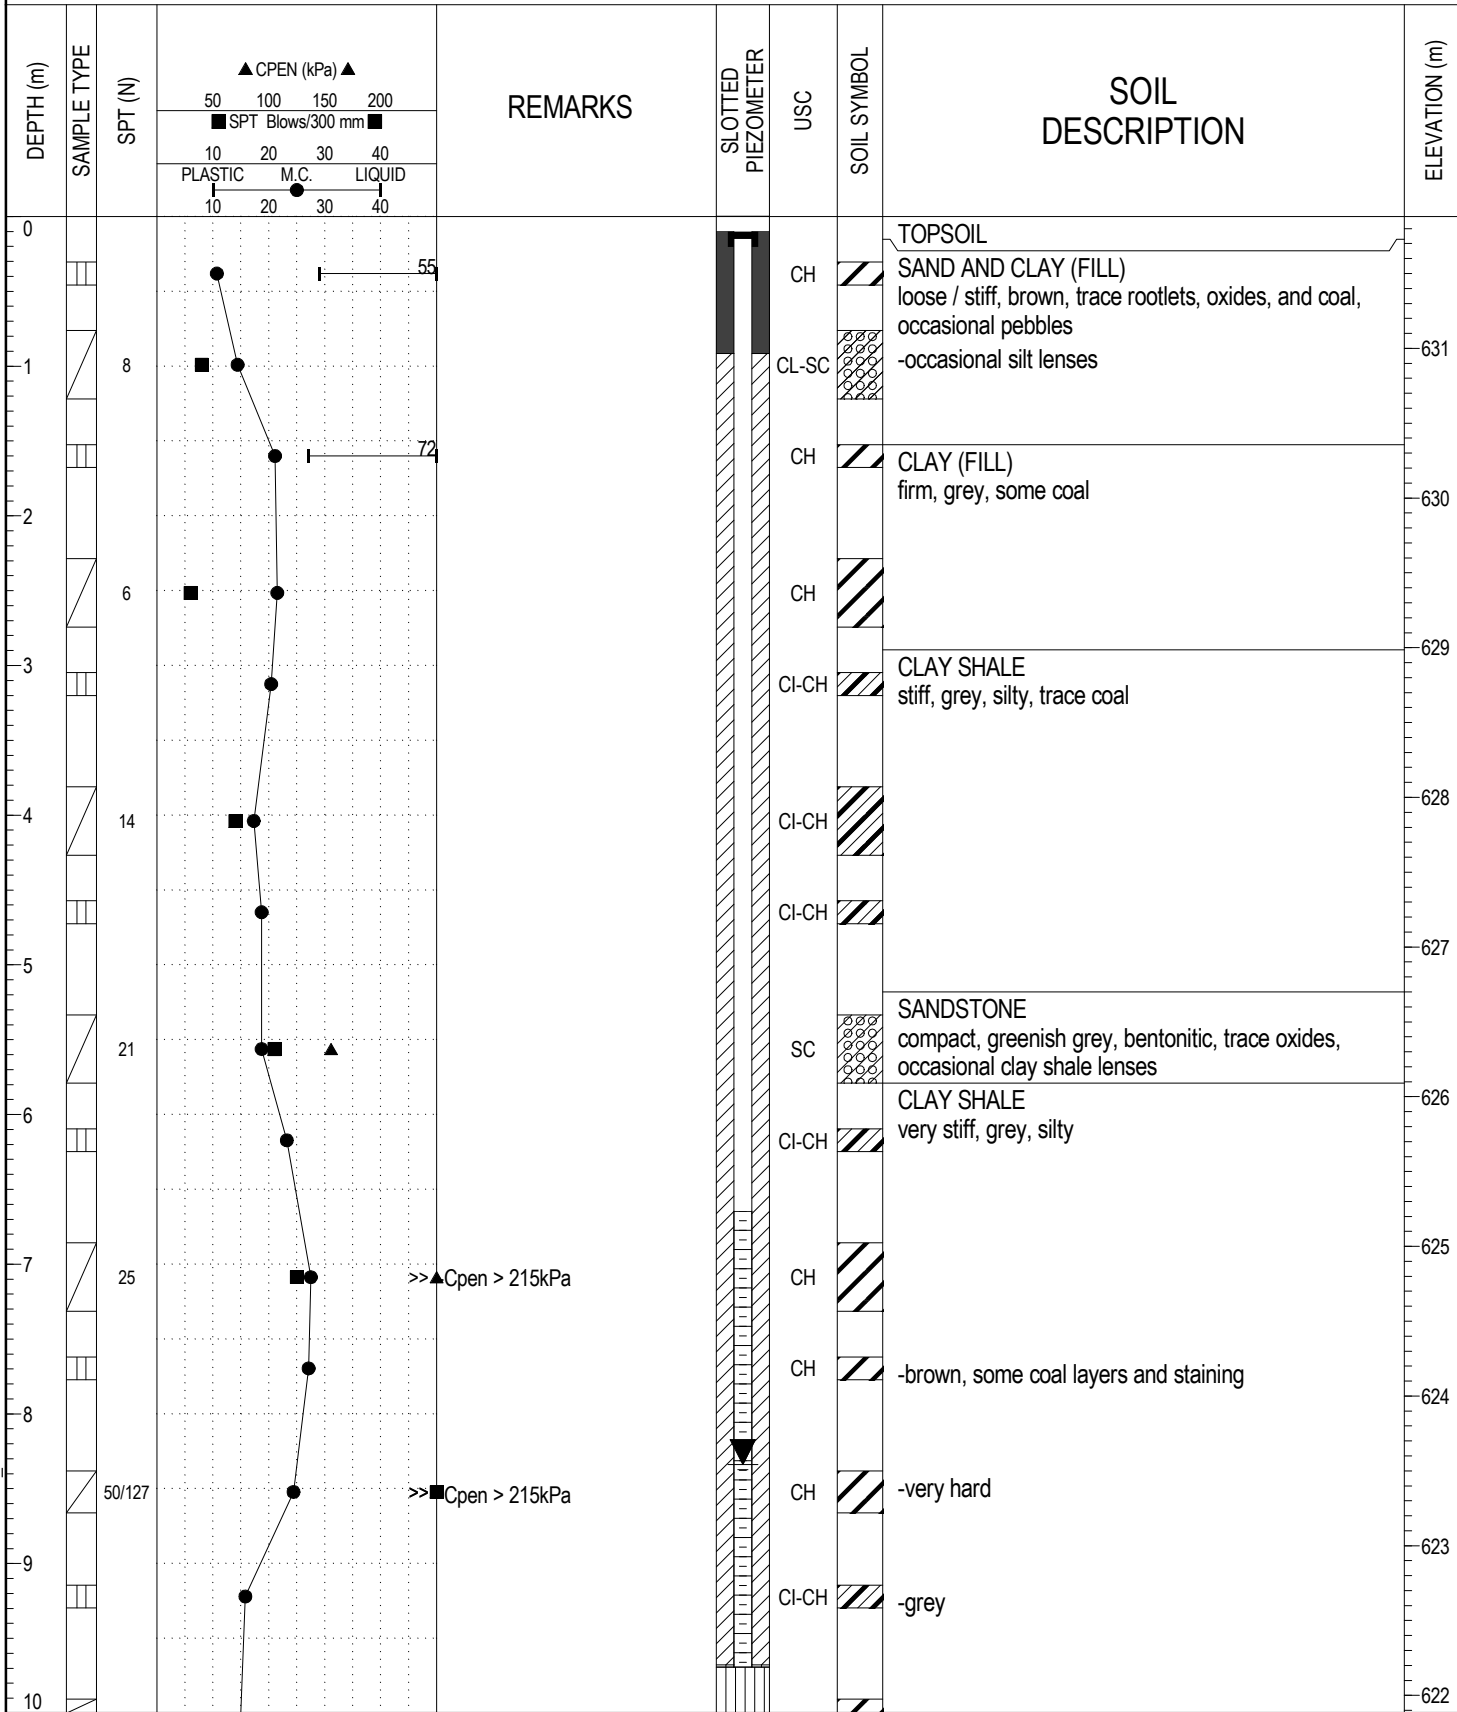
CLIENT: AECOM	PROJECT: EDMONTON SE LRT EXTENTION	BOREHOLE NO: TH14-5
DRILLING COMPANY: Mobile Augers & Research Ltd.	DATE DRILLED: March 24, 2014	PROJECT NO: 19-5438-102
DRILL/METHOD: M5 Truck / Solid Stem Augers	LOCATION: N5934394.61, E34775.98 3TM	ELEVATION: 631.88 (m)

SAMPLE TYPE	<input type="checkbox"/> GRAB SAMPLE	<input checked="" type="checkbox"/> SPT
BACKFILL TYPE	<input checked="" type="checkbox"/> BENTONITE	<input type="checkbox"/> DRILL CUTTINGS <input type="checkbox"/> SLOUGH

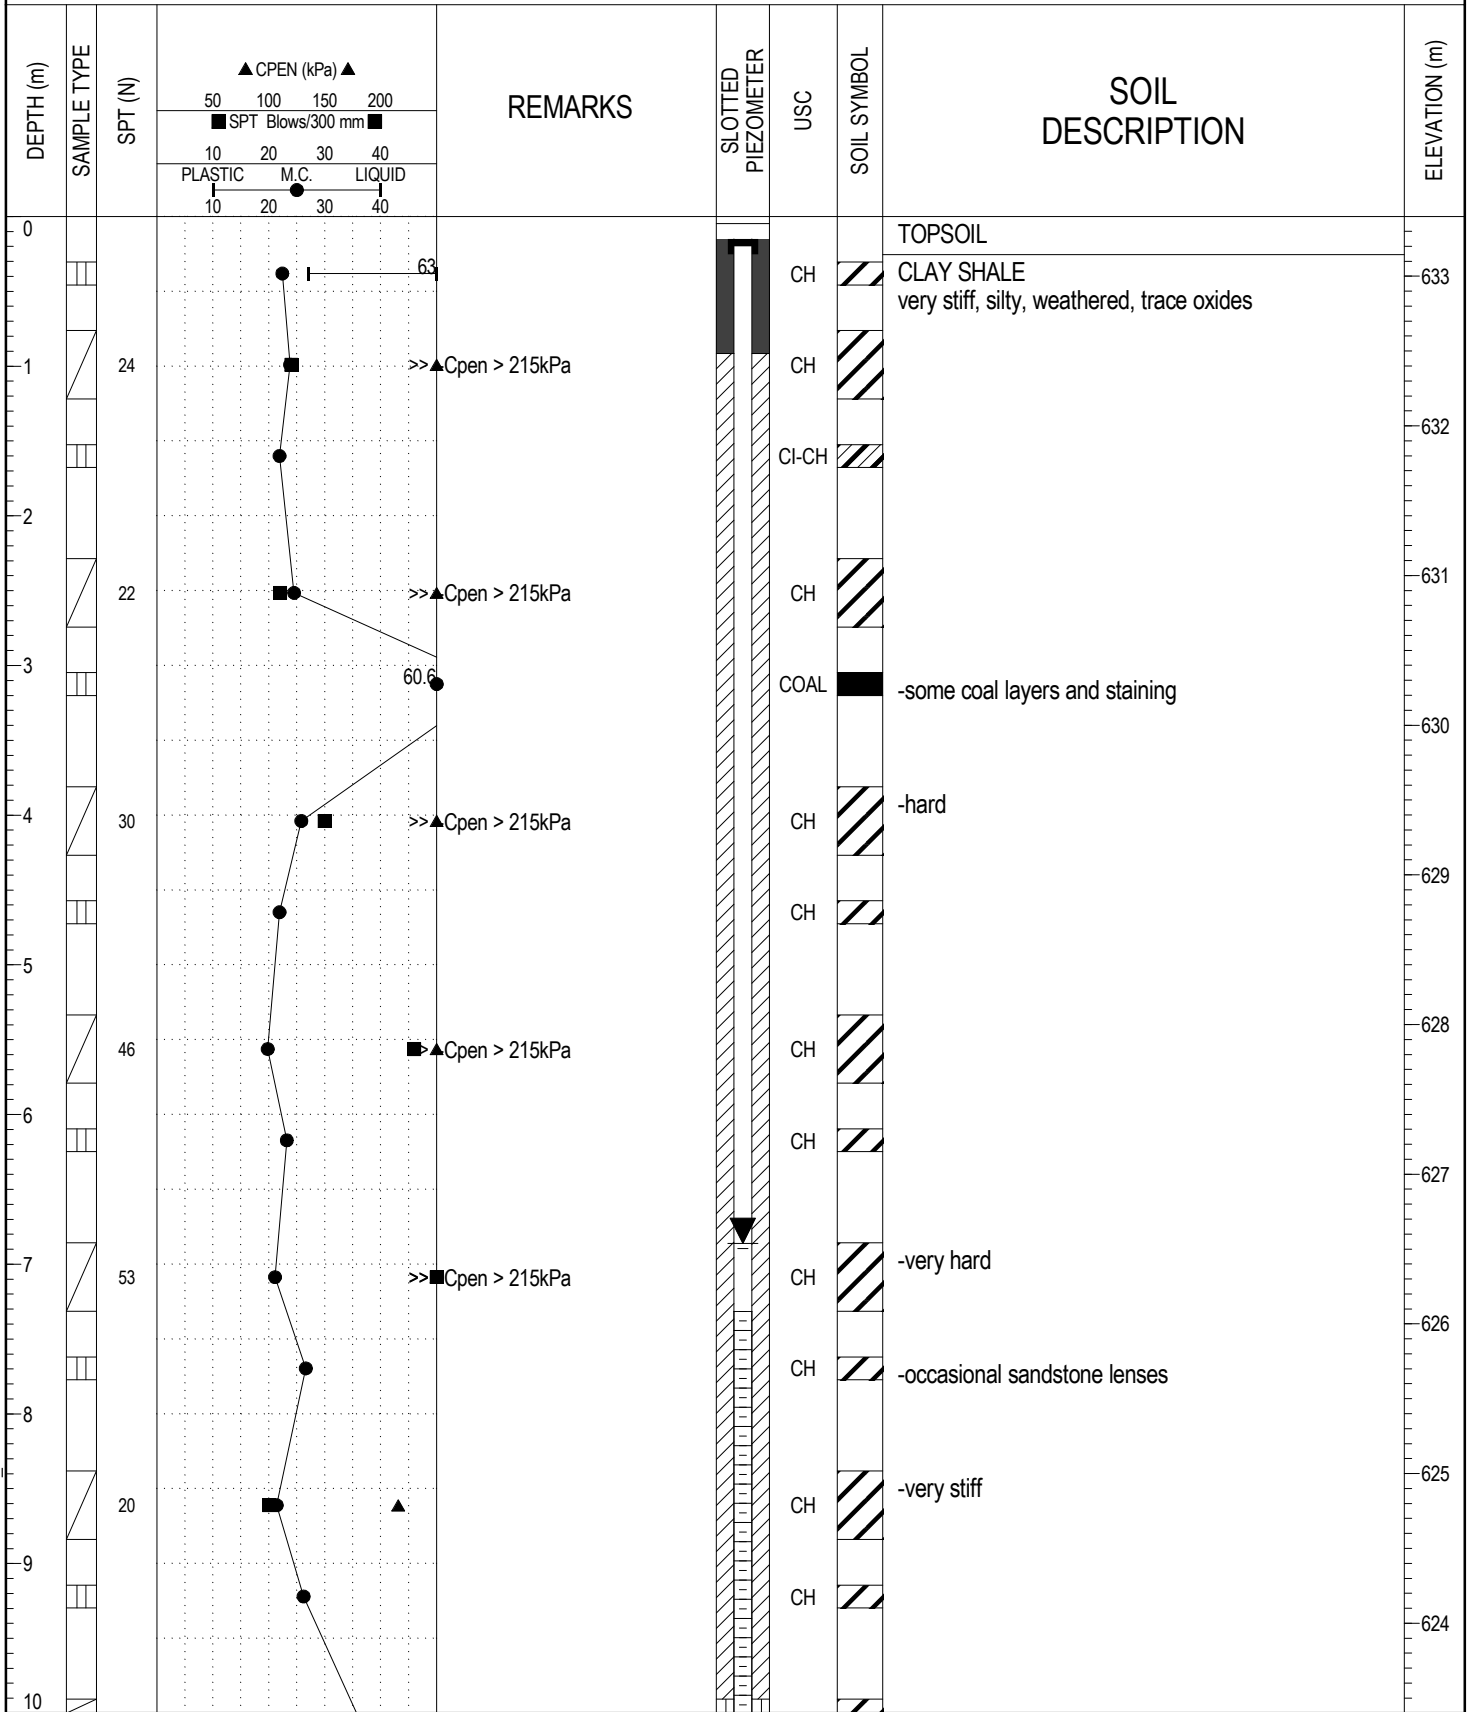
CLIENT: AECOM	PROJECT: EDMONTON SE LRT EXTENTION	BOREHOLE NO: TH14-6
DRILLING COMPANY: Mobile Augers & Research Ltd.	DATE DRILLED: March 24, 2014	PROJECT NO: 19-5438-102
DRILL/METHOD: M5 Truck / Solid Stem Augers	LOCATION: N5934388.42, E34840.38 3TM	ELEVATION: 633.40 (m)

SAMPLE TYPE	<input type="checkbox"/> GRAB SAMPLE	<input checked="" type="checkbox"/> SPT
BACKFILL TYPE	<input checked="" type="checkbox"/> BENTONITE	<input type="checkbox"/> DRILL CUTTINGS <input type="checkbox"/> SLOUGH

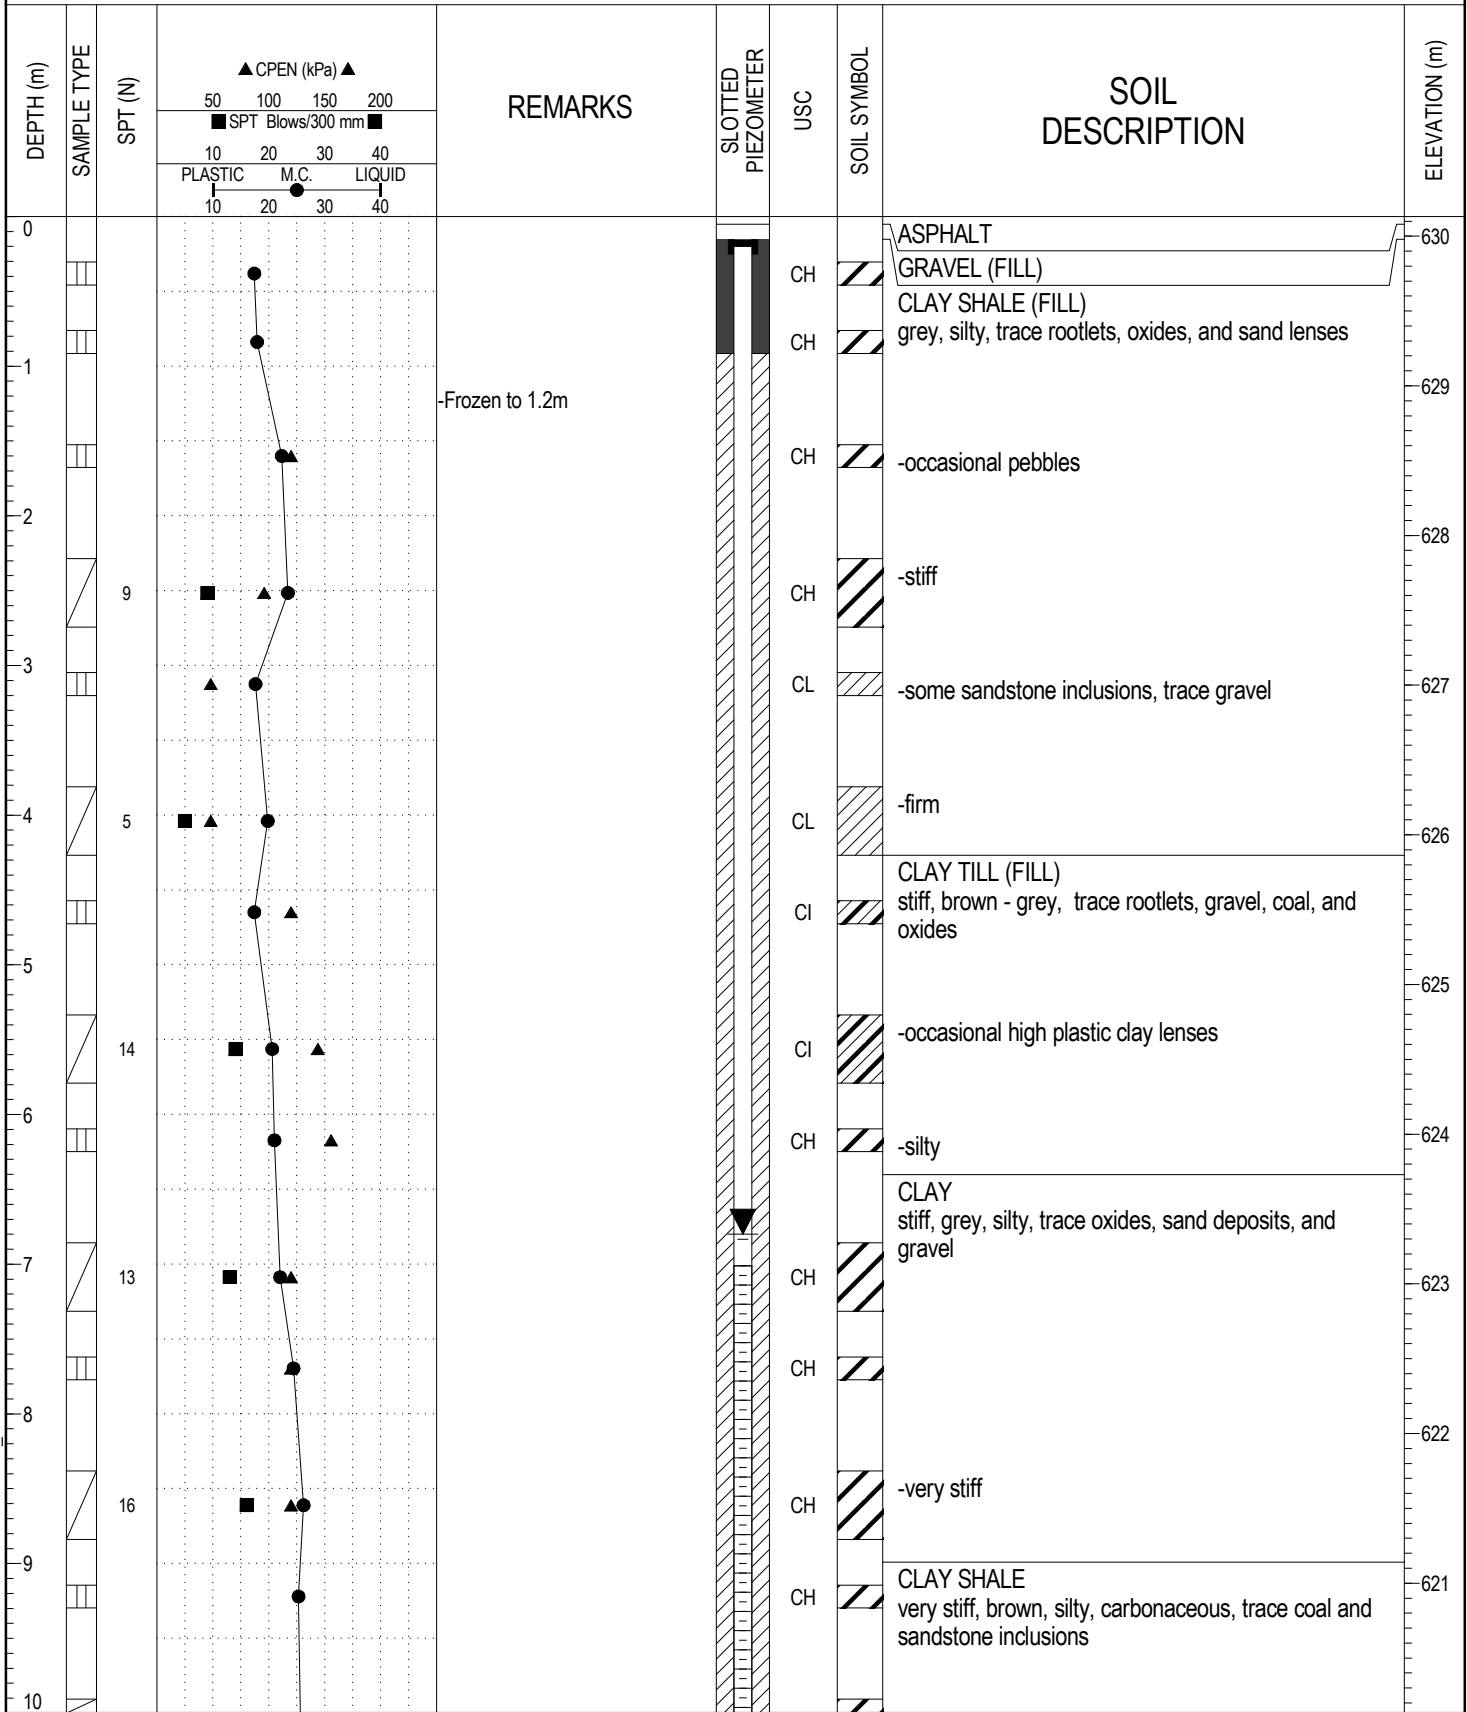
CLIENT: AECOM	PROJECT: EDMONTON SE LRT EXTENTION	BOREHOLE NO: TH14-7
DRILLING COMPANY: Mobile Augers & Research Ltd.	DATE DRILLED: March 25, 2014	PROJECT NO: 19-5438-102
DRILL/METHOD: M5 Truck / Solid Stem Augers	LOCATION: N5934401.22, E34639.49 3TM	ELEVATION: 630.13 (m)

SAMPLE TYPE	<input type="checkbox"/> GRAB SAMPLE	<input checked="" type="checkbox"/> SPT
BACKFILL TYPE	<input checked="" type="checkbox"/> BENTONITE	<input type="checkbox"/> DRILL CUTTINGS <input type="checkbox"/> SLOUGH

FIELD LOGGED BY: MW	COMPLETION DEPTH: 10.4 m
PREPARED BY: XW	COMPLETION DATE: 3/25/14
REVIEWED BY: HER

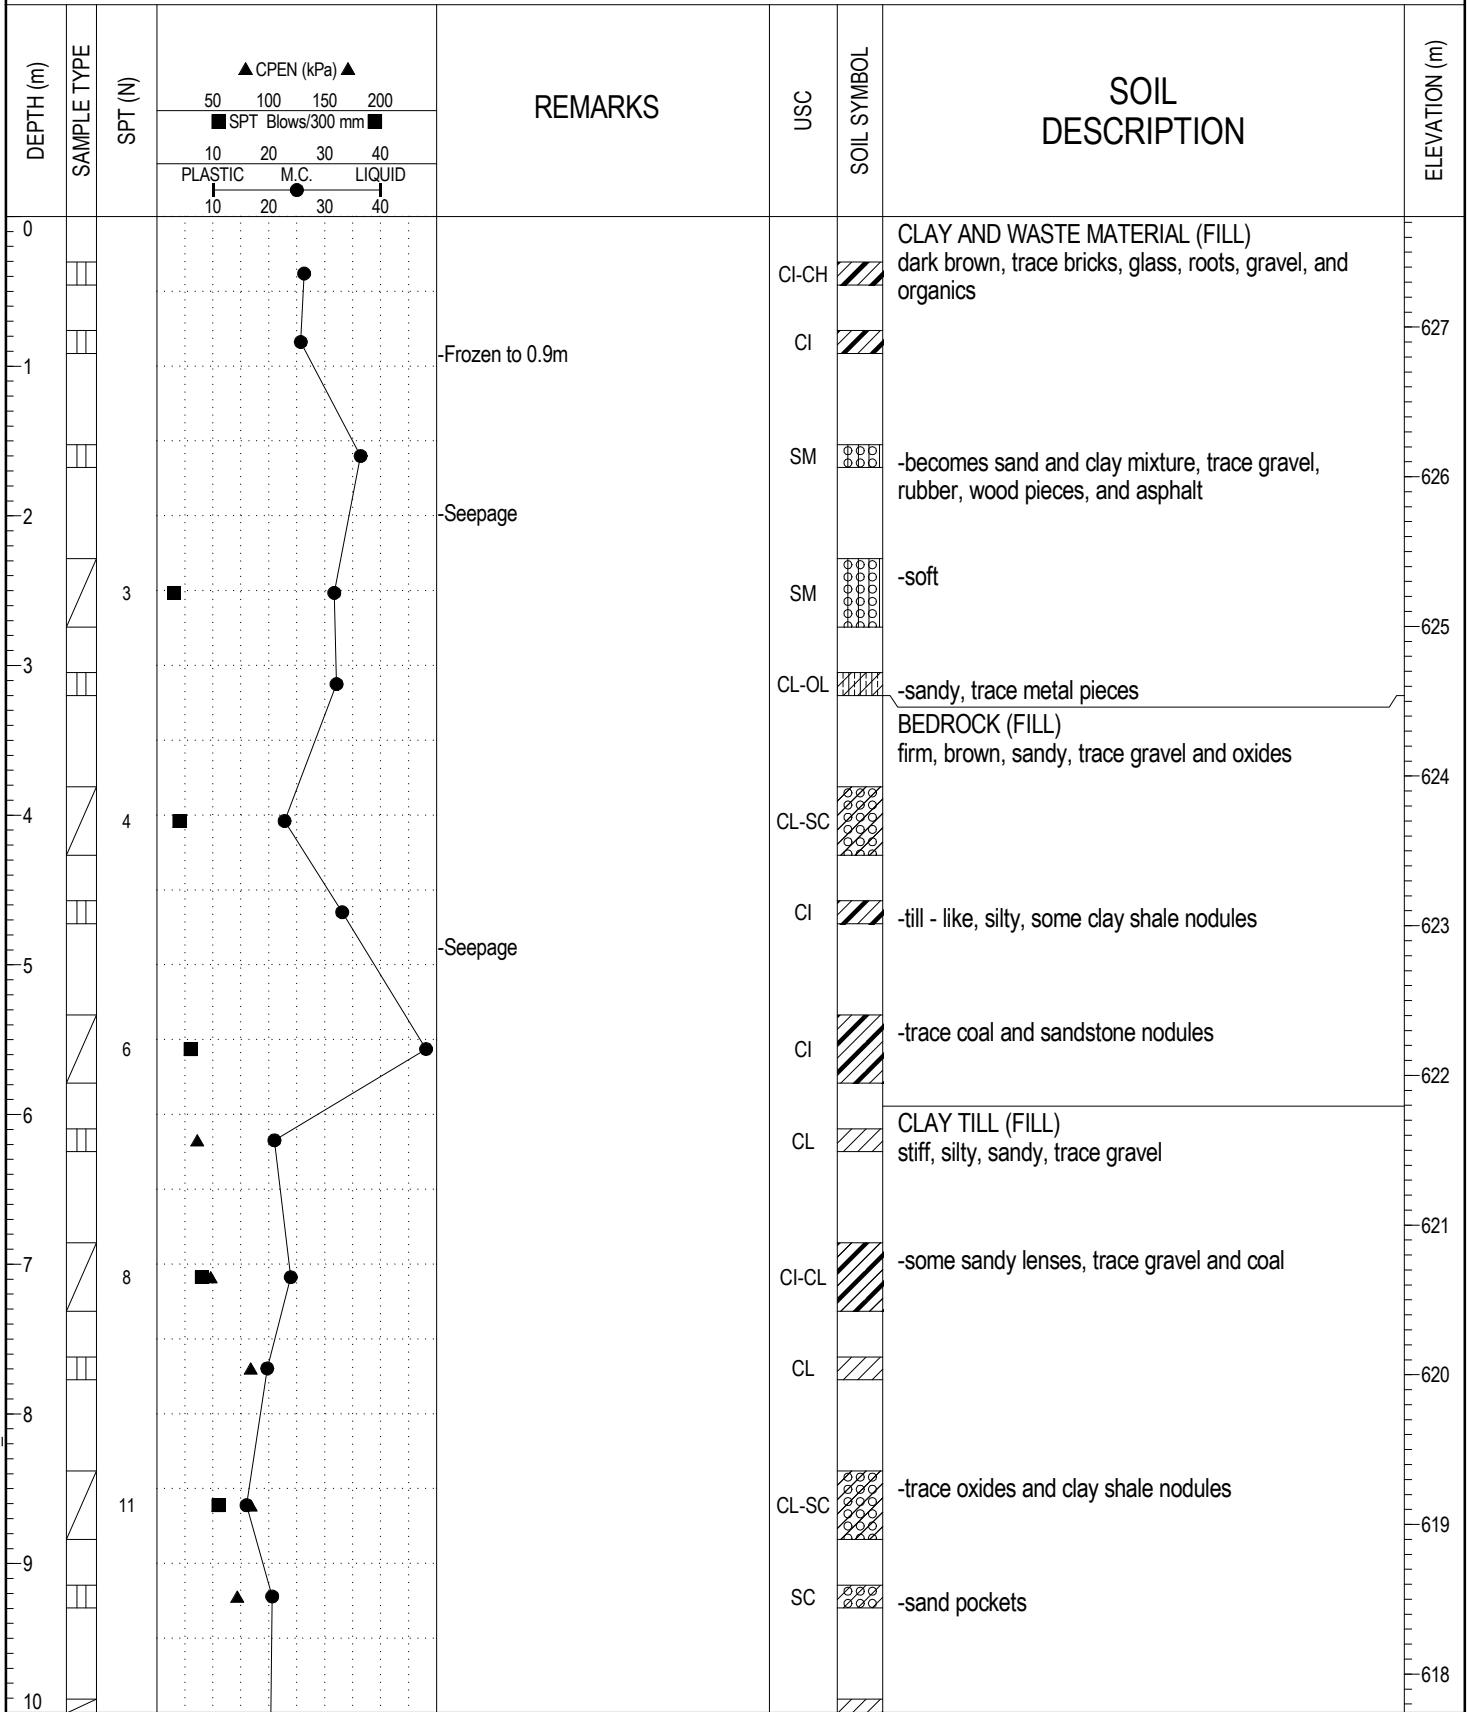
CLIENT: AECOM	PROJECT: EDMONTON SE LRT EXTENTION	BOREHOLE NO: TH14-8
DRILLING COMPANY: Mobile Augers & Research Ltd.	DATE DRILLED: March 25, 2014	PROJECT NO: 19-5438-102
DRILL/METHOD: M5 Truck / Solid Stem Augers	LOCATION: N5934381.75, E34667.58 3TM	ELEVATION: 627.74 (m)
SAMPLE TYPE <input type="checkbox"/> GRAB SAMPLE <input checked="" type="checkbox"/> SPT <input checked="" type="checkbox"/> NO RECOVERY

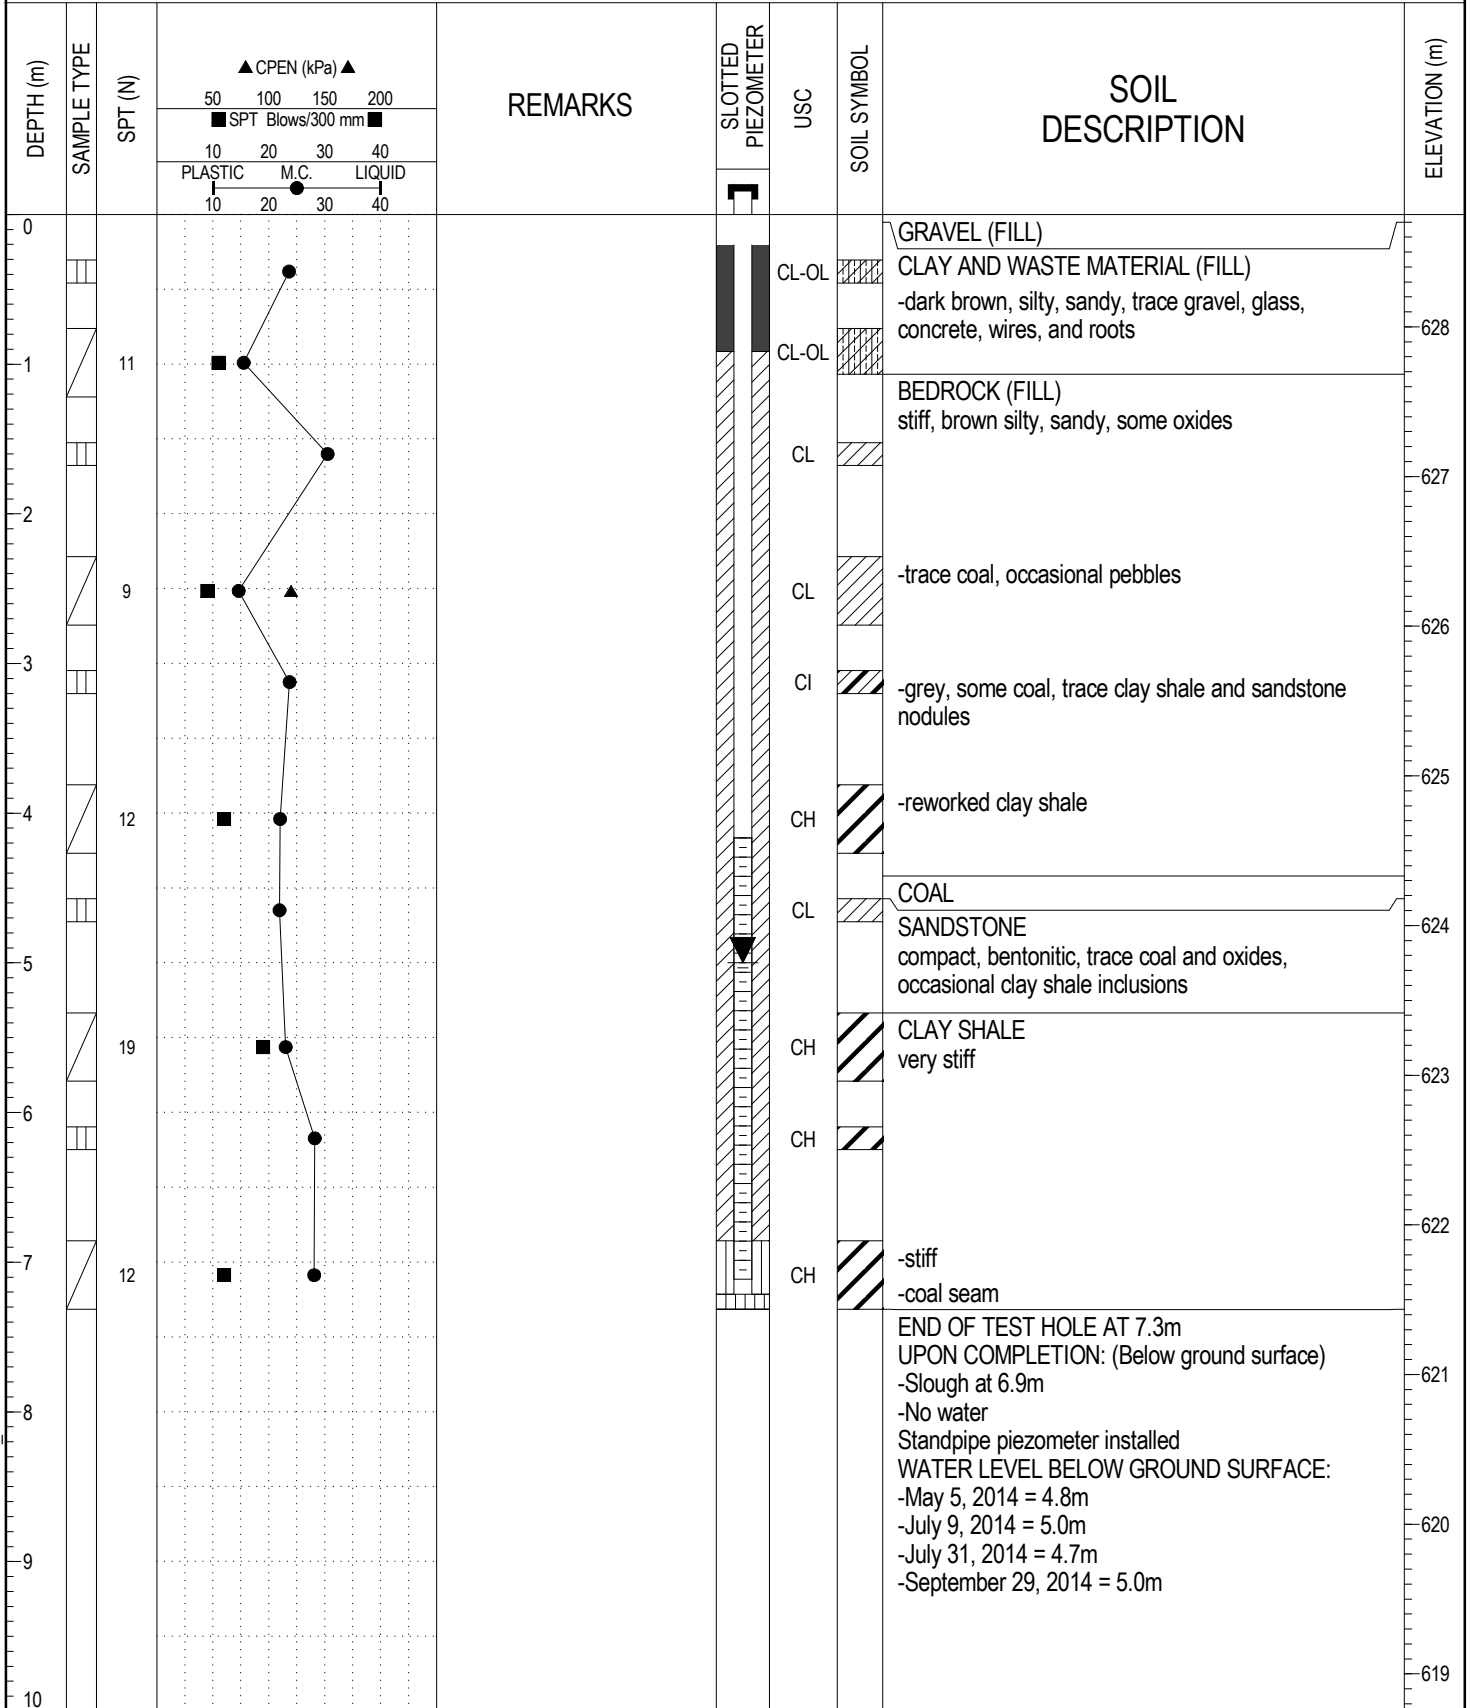
CLIENT: AECOM	PROJECT: EDMONTON SE LRT EXTENTION	BOREHOLE NO: TH14-9
DRILLING COMPANY: Mobile Augers & Research Ltd.	DATE DRILLED: March 25, 2014	PROJECT NO: 19-5438-102
DRILL/METHOD: M5 Track / Solid Stem Augers	LOCATION: N5934403.58, E34676.13 3TM	ELEVATION: 628.75 (m)

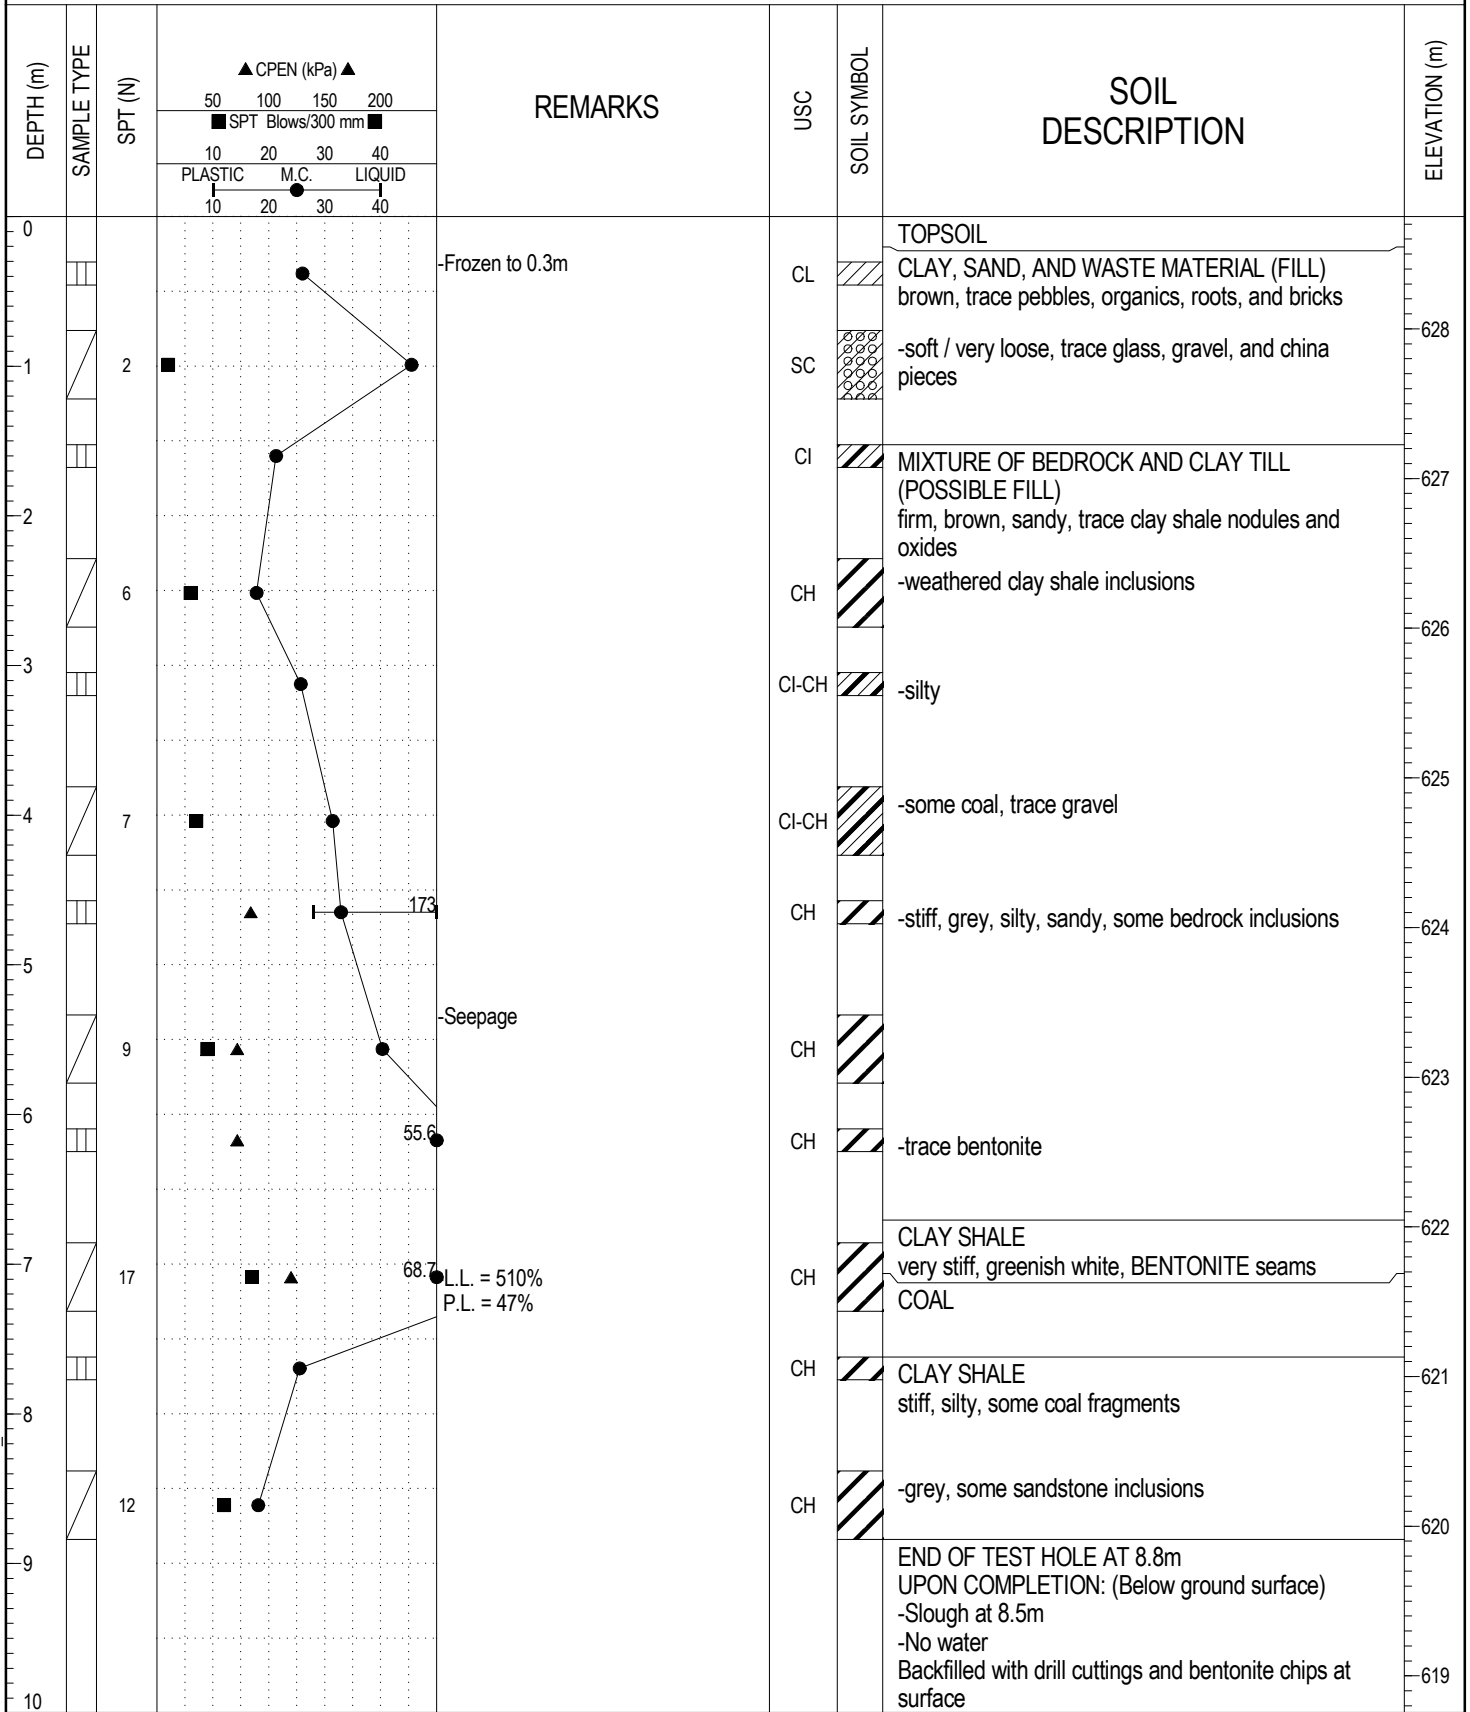
CLIENT: AECOM	PROJECT: EDMONTON SE LRT EXTENTION	BOREHOLE NO: TH14-10
DRILLING COMPANY: Mobile Augers & Research Ltd.	DATE DRILLED: March 25, 2014	PROJECT NO: 19-5438-102
DRILL/METHOD: M5 Truck / Solid Stem Augers	LOCATION: N5934399.65, E34689.76 3TM	ELEVATION: 628.75 (m)
