**City of Edmonton  
Valley Line Stage 1 – Light Rail Transit (LRT) Project  
Environmental Impact Screening Assessment Update**

**Final Report**

**Spencer Environmental  
Management Services Ltd.  
Edmonton, Alberta**

February 2015

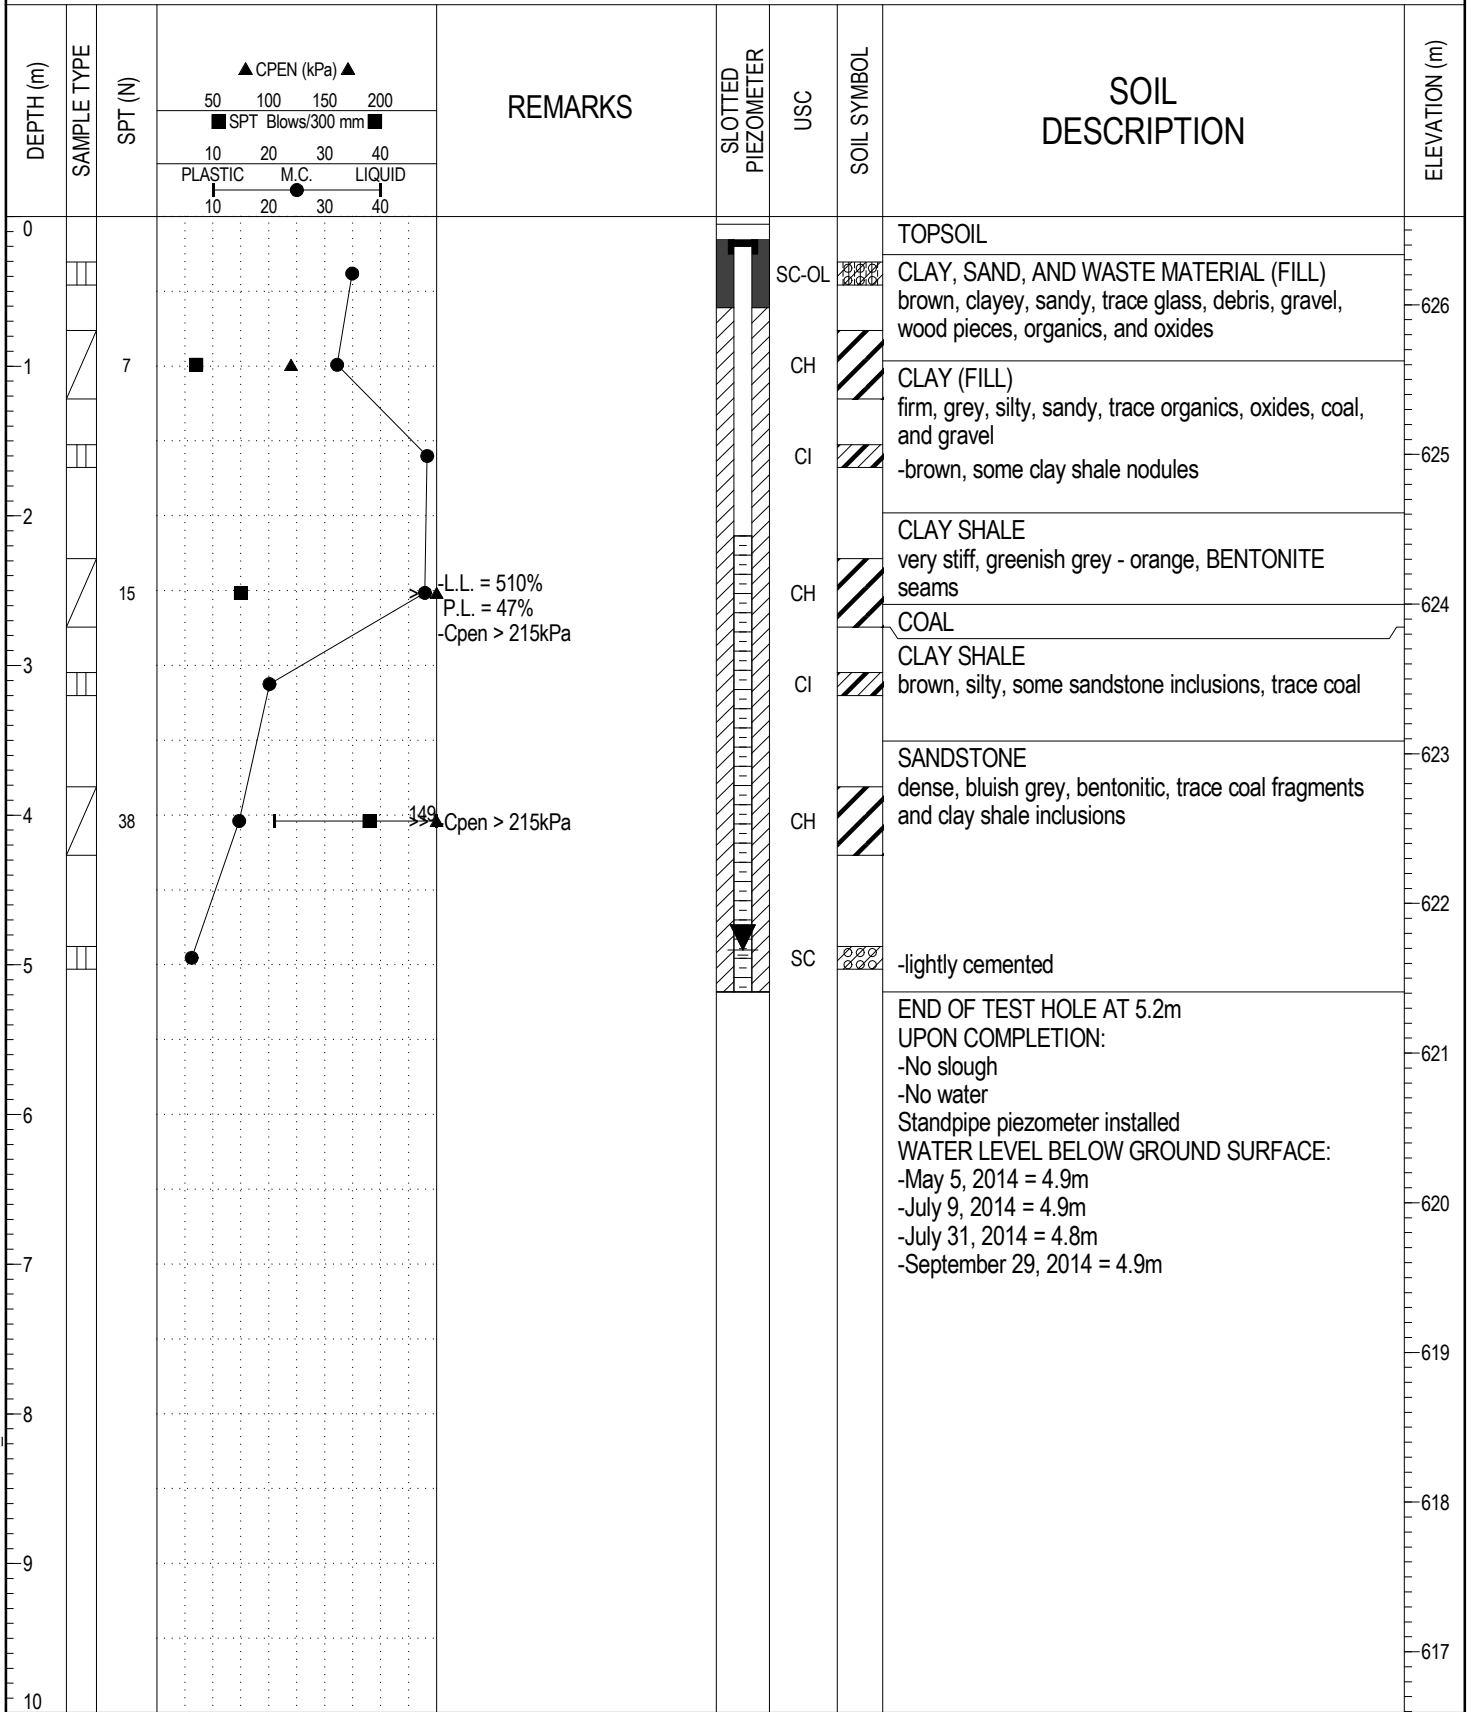
CLIENT: AECOM	PROJECT: EDMONTON SE LRT EXTENTION	BOREHOLE NO: TH14-11
DRILLING COMPANY: Mobile Augers & Research Ltd.	DATE DRILLED: March 26, 2014	PROJECT NO: 19-5438-102
DRILL/METHOD: M5 Track / Solid Stem Augers	LOCATION: N5934377.92, E34685.20 3TM	ELEVATION: 626.59 (m)

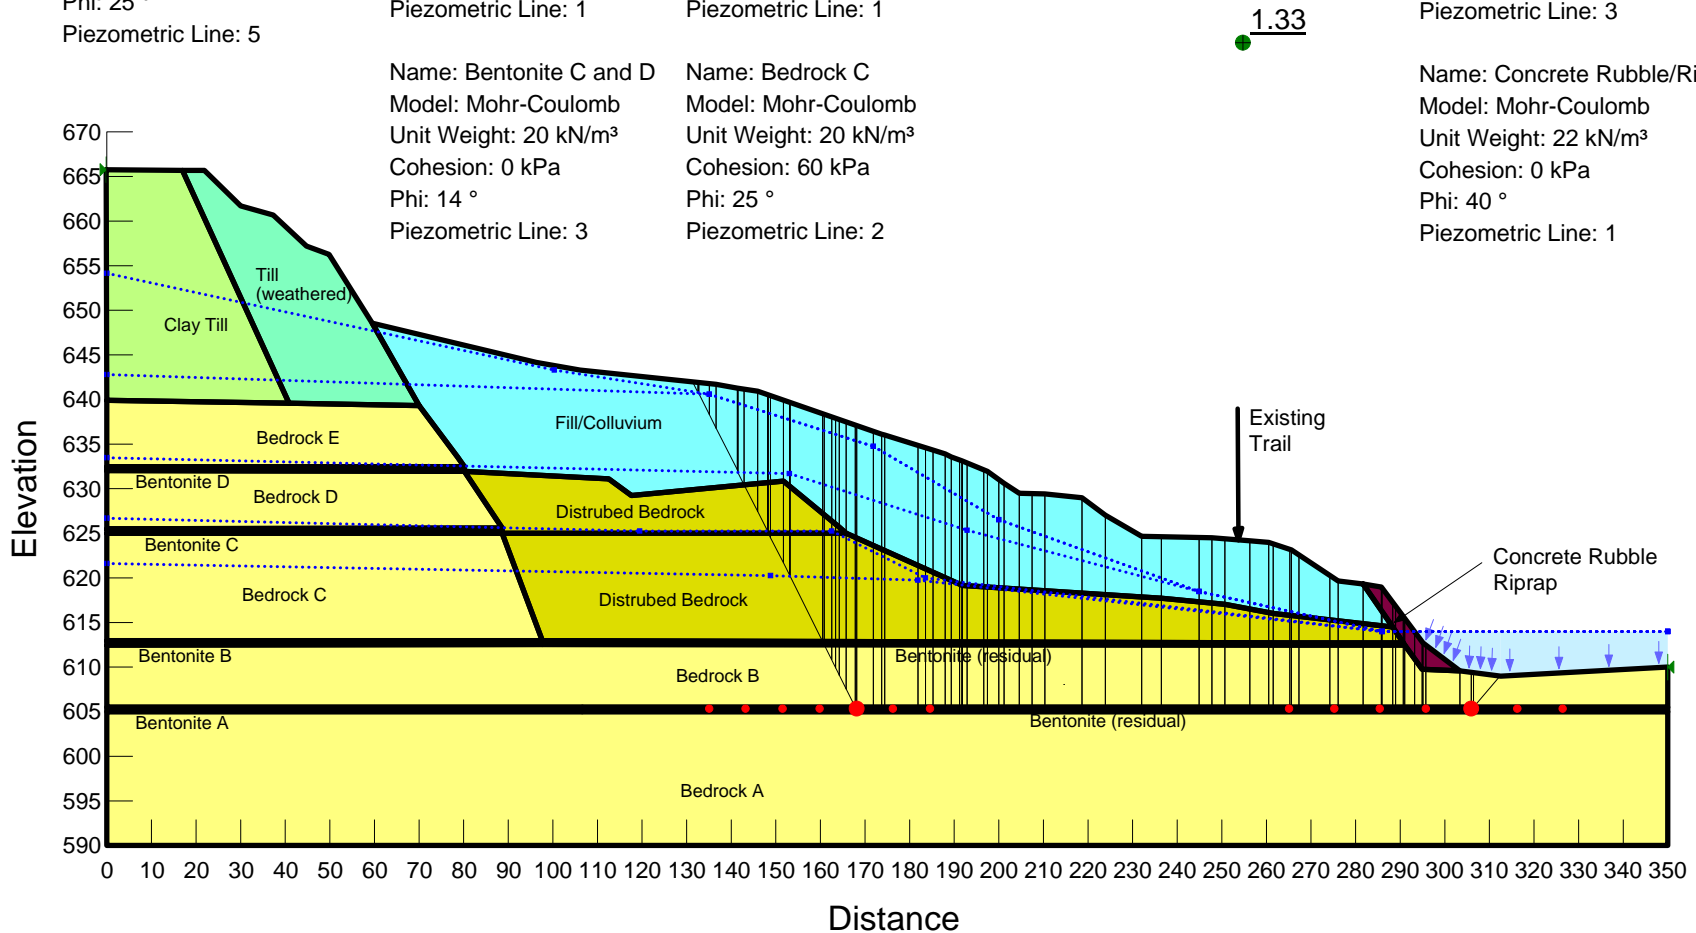
Name: Bedrock C  
 Model: Mohr-Coulomb  
 Unit Weight: 20 kN/m<sup>3</sup>  
 Cohesion: 60 kPa  
 Phi: 25 °  
 Piezometric Line: 2

Name: Concrete Rubble/Riprap  
 Model: Mohr-Coulomb  
 Unit Weight: 22 kN/m<sup>3</sup>  
 Cohesion: 0 kPa  
 Phi: 40 °  
 Piezometric Line: 1

Name: Clay Till  
 Model: Mohr-Coulomb  
 Unit Weight: 18 kN/m<sup>3</sup>  
 Cohesion: 20 kPa  
 Phi: 25 °  
 Piezometric Line: 5

Name: Clay Till (Weathered)  
 Model: Mohr-Coulomb  
 Unit Weight: 18 kN/m<sup>3</sup>  
 Cohesion: 5 kPa  
 Phi: 25 °  
 Piezometric Line: 5

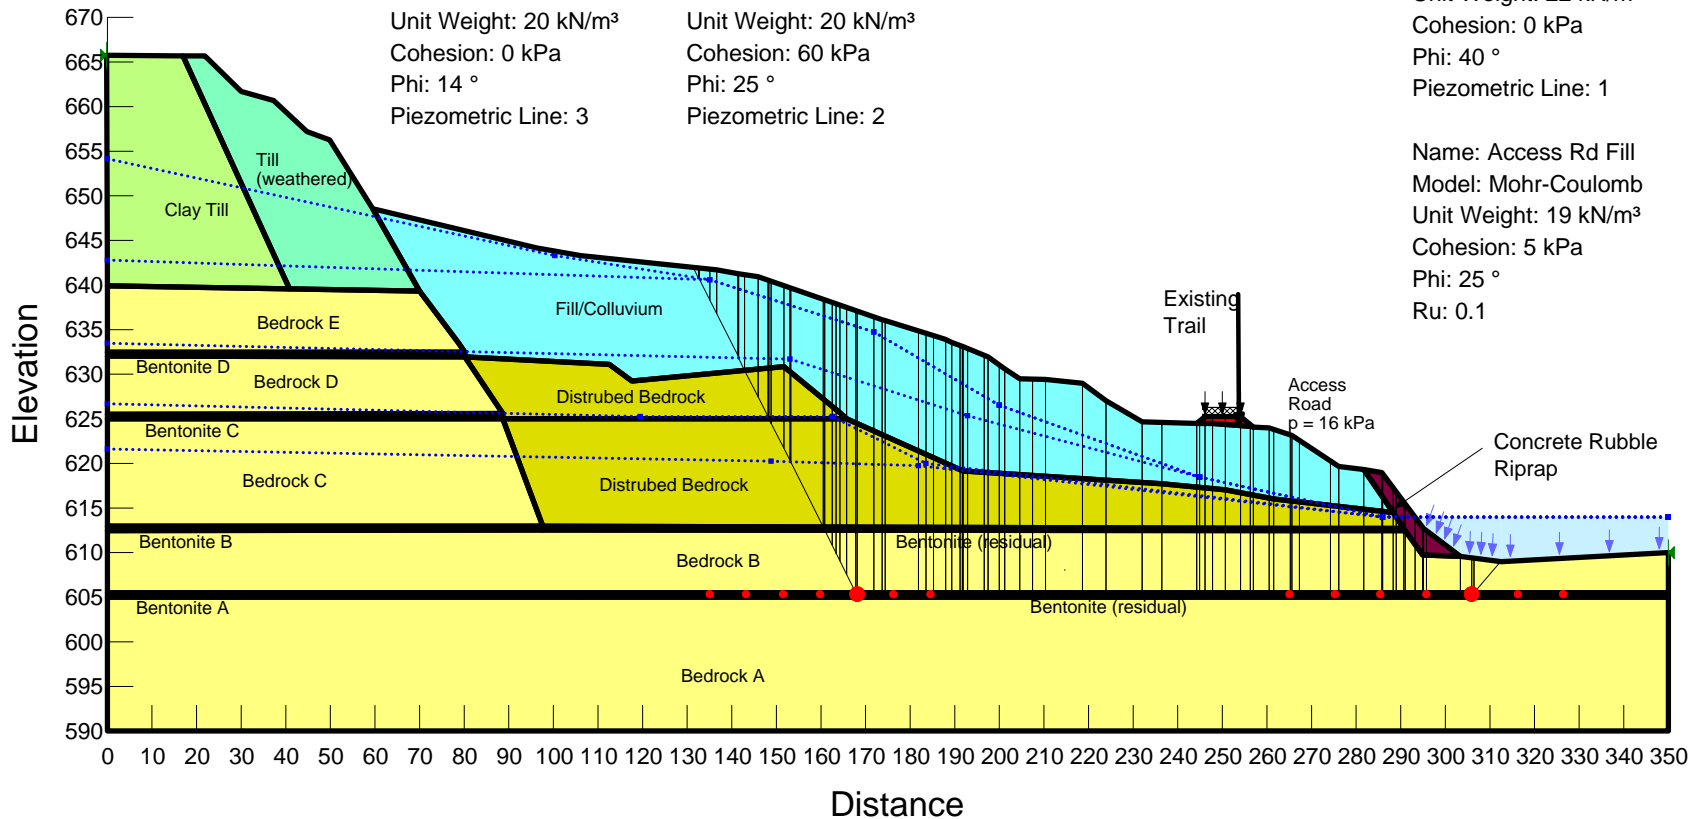
Name: Concrete Rubble/Riprap  
 Model: Mohr-Coulomb  
 Unit Weight: 22 kN/m<sup>3</sup>  
 Cohesion: 0 kPa  
 Phi: 40 °  
 Piezometric Line: 1

Name: Access Rd Fill  
 Model: Mohr-Coulomb  
 Unit Weight: 19 kN/m<sup>3</sup>  
 Cohesion: 5 kPa  
 Phi: 25 °  
 Ru: 0.1

Name: Clay Till  
 Model: Mohr-Coulomb  
 Unit Weight: 18 kN/m<sup>3</sup>  
 Cohesion: 20 kPa  
 Phi: 25 °  
 Piezometric Line: 5

Name: Fill and Colluvium  
 Model: Mohr-Coulomb  
 Unit Weight: 18 kN/m<sup>3</sup>  
 Cohesion: 2 kPa  
 Phi: 23 °  
 Piezometric Line: 5

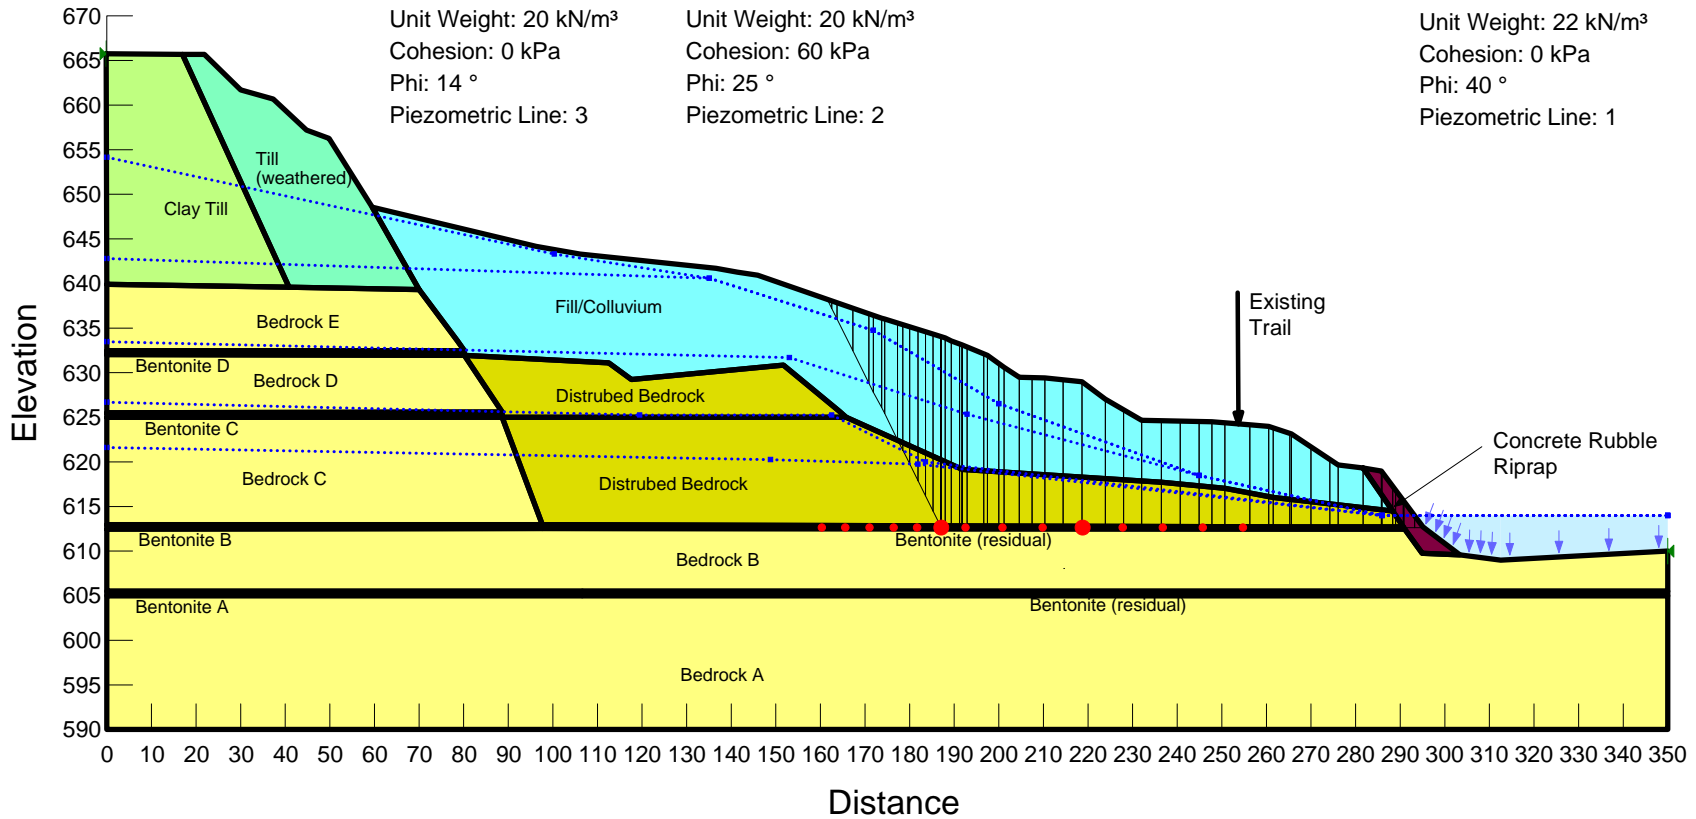
Name: Bedrock C  
 Model: Mohr-Coulomb  
 Unit Weight: 20 kN/m<sup>3</sup>  
 Cohesion: 60 kPa  
 Phi: 25 °  
 Piezometric Line: 2

Name: Concrete Rubble/Riprap  
 Model: Mohr-Coulomb  
 Unit Weight: 22 kN/m<sup>3</sup>  
 Cohesion: 0 kPa  
 Phi: 40 °  
 Piezometric Line: 1

Name: Clay Till  
 Model: Mohr-Coulomb  
 Unit Weight: 18 kN/m<sup>3</sup>  
 Cohesion: 20 kPa  
 Phi: 25 °  
 Piezometric Line: 5

Name: Clay Till (Weathered)  
 Model: Mohr-Coulomb  
 Unit Weight: 18 kN/m<sup>3</sup>  
 Cohesion: 5 kPa  
 Phi: 25 °  
 Piezometric Line: 5

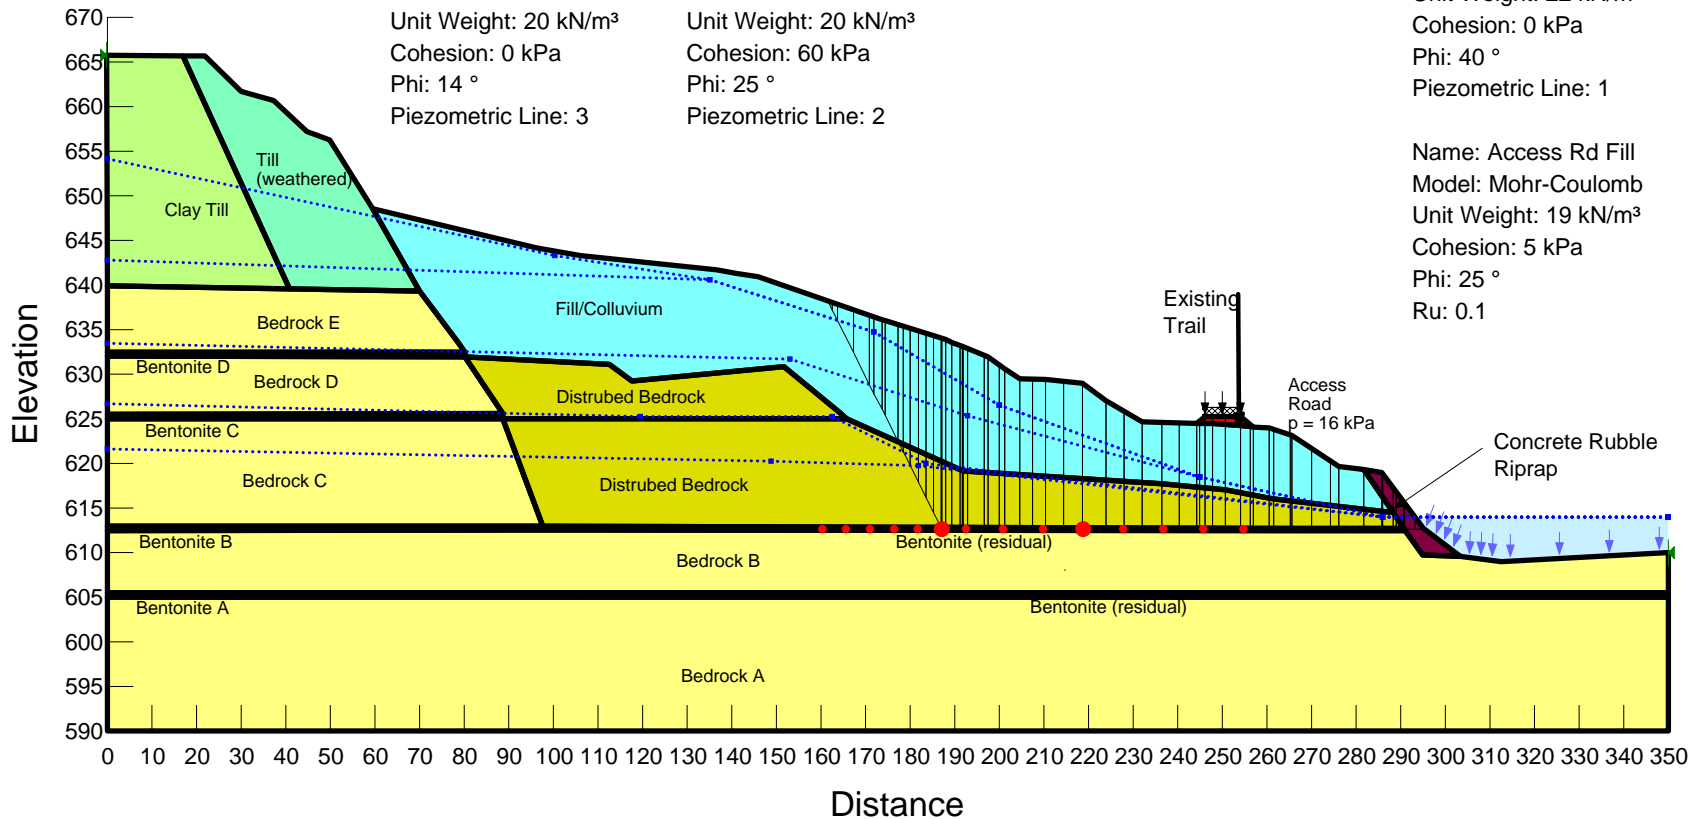
Name: Concrete Rubble/Riprap  
 Model: Mohr-Coulomb  
 Unit Weight: 22 kN/m<sup>3</sup>  
 Cohesion: 0 kPa  
 Phi: 40 °  
 Piezometric Line: 1

Name: Access Rd Fill  
 Model: Mohr-Coulomb  
 Unit Weight: 19 kN/m<sup>3</sup>  
 Cohesion: 5 kPa  
 Phi: 25 °  
 Ru: 0.1

Name: Clay Till  
 Model: Mohr-Coulomb  
 Unit Weight: 18 kN/m<sup>3</sup>  
 Cohesion: 20 kPa  
 Phi: 25 °  
 Piezometric Line: 5

Name: Clay Till (Weathered)  
 Model: Mohr-Coulomb  
 Unit Weight: 18 kN/m<sup>3</sup>  
 Cohesion: 5 kPa  
 Phi: 25 °  
 Piezometric Line: 5

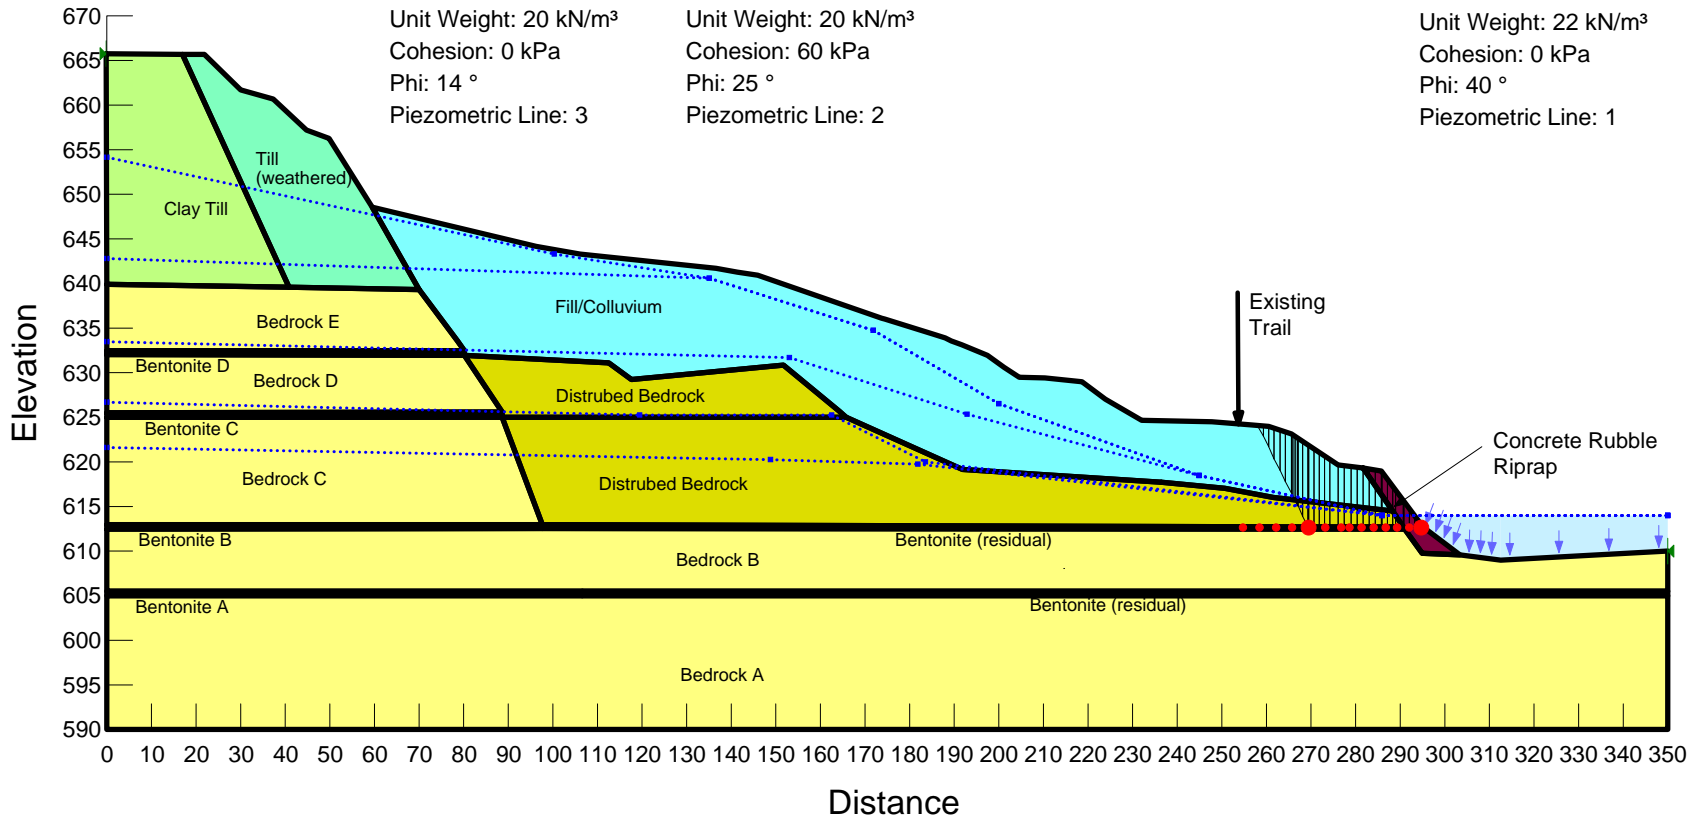
Name: Disturbed Bedrock  
 Model: Mohr-Coulomb  
 Unit Weight: 20 kN/m<sup>3</sup>  
 Cohesion: 15 kPa  
 Phi: 25 °  
 Piezometric Line: 3

Name: Concrete Rubble/Riprap  
 Model: Mohr-Coulomb  
 Unit Weight: 22 kN/m<sup>3</sup>  
 Cohesion: 0 kPa  
 Phi: 40 °  
 Piezometric Line: 1

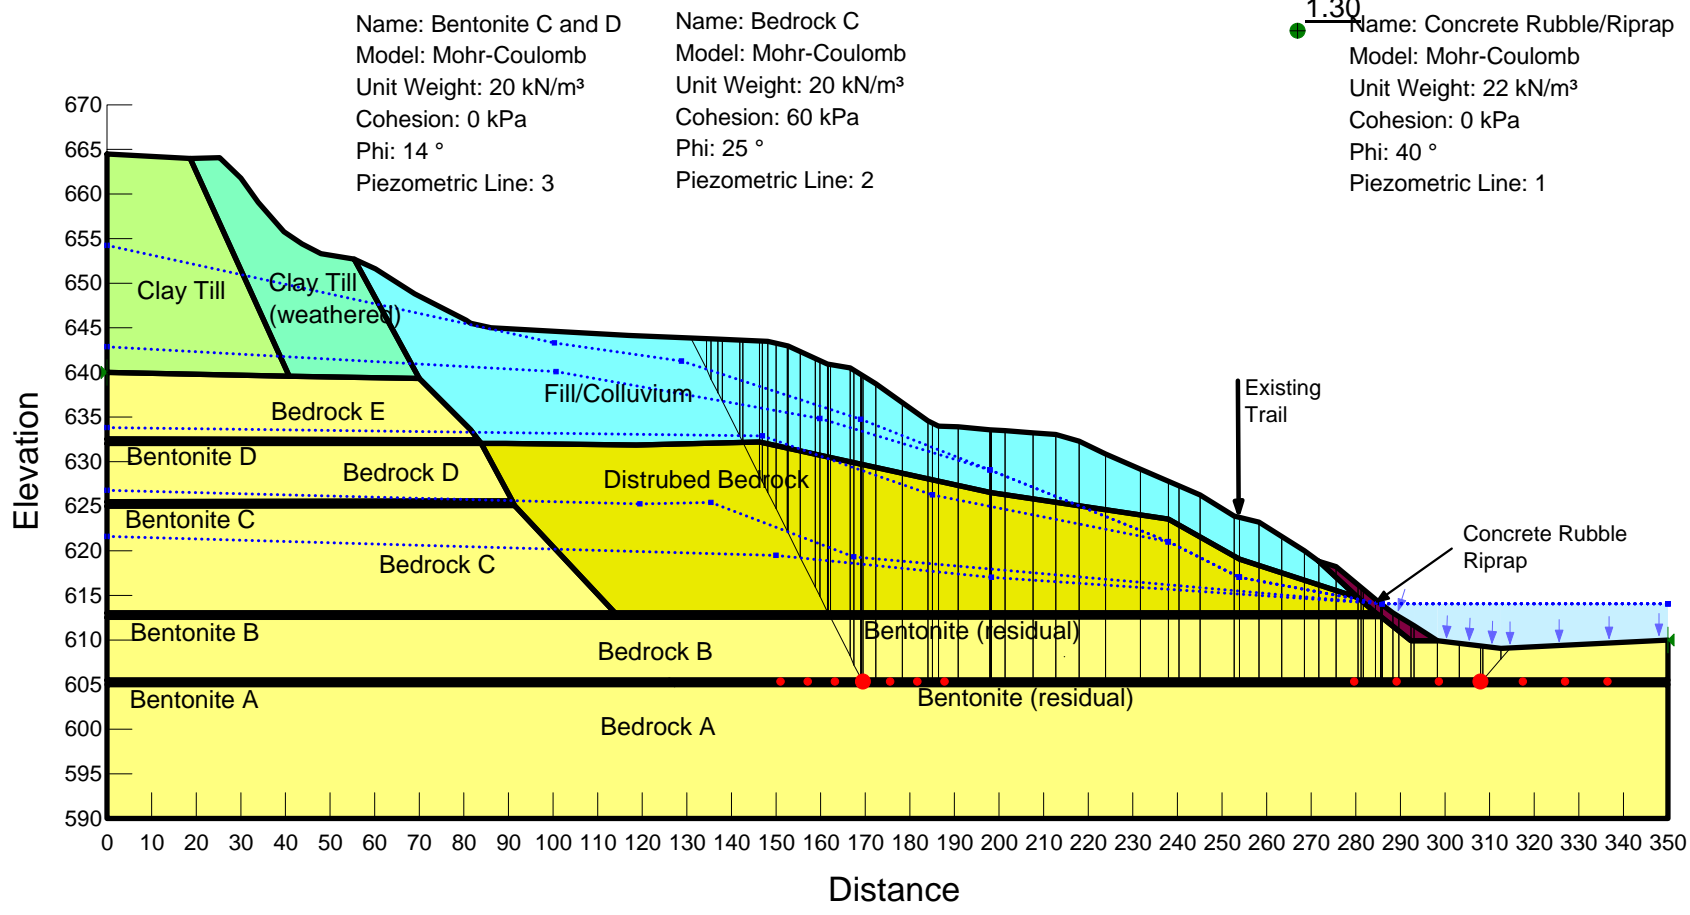
Name: Clay Till Model: Mohr-Coulomb Unit Weight: 18 kN/m <sup>3</sup> Cohesion: 20 kPa Phi: 25 ° Piezometric Line: 5	Name: Fill and Colluvium Model: Mohr-Coulomb Unit Weight: 18 kN/m <sup>3</sup> Cohesion: 2 kPa Phi: 23 ° Piezometric Line: 5	Name: Bentonite Seam (Residual) Model: Mohr-Coulomb Unit Weight: 20 kN/m <sup>3</sup> Cohesion: 0 kPa Phi: 9 ° Piezometric Line: 1	Name: Bedrock D Model: Mohr-Coulomb Unit Weight: 20 kN/m <sup>3</sup> Cohesion: 50 kPa Phi: 25 ° Piezometric Line: 3	Name: Bedrock E Model: Mohr-Coulomb Unit Weight: 20 kN/m <sup>3</sup> Cohesion: 50 kPa Phi: 25 ° Piezometric Line: 4
Name: Clay Till (Weathered) Model: Mohr-Coulomb Unit Weight: 18 kN/m <sup>3</sup> Cohesion: 5 kPa Phi: 25 ° Piezometric Line: 5	Name: Bentonite A and B Model: Mohr-Coulomb Unit Weight: 20 kN/m <sup>3</sup> Cohesion: 0 kPa Phi: 14 ° Piezometric Line: 1	Name: Bedrock A and B Model: Mohr-Coulomb Unit Weight: 20 kN/m <sup>3</sup> Cohesion: 80 kPa Phi: 25 ° Piezometric Line: 1		Name: Disturbed Bedrock Model: Mohr-Coulomb Unit Weight: 20 kN/m <sup>3</sup> Cohesion: 15 kPa Phi: 25 ° Piezometric Line: 3

Name: Clay Till  
 Model: Mohr-Coulomb  
 Unit Weight: 18 kN/m<sup>3</sup>  
 Cohesion: 20 kPa  
 Phi: 25 °  
 Piezometric Line: 5

Name: Fill and Colluvium  
 Model: Mohr-Coulomb  
 Unit Weight: 18 kN/m<sup>3</sup>  
 Cohesion: 2 kPa  
 Phi: 23 °  
 Piezometric Line: 5

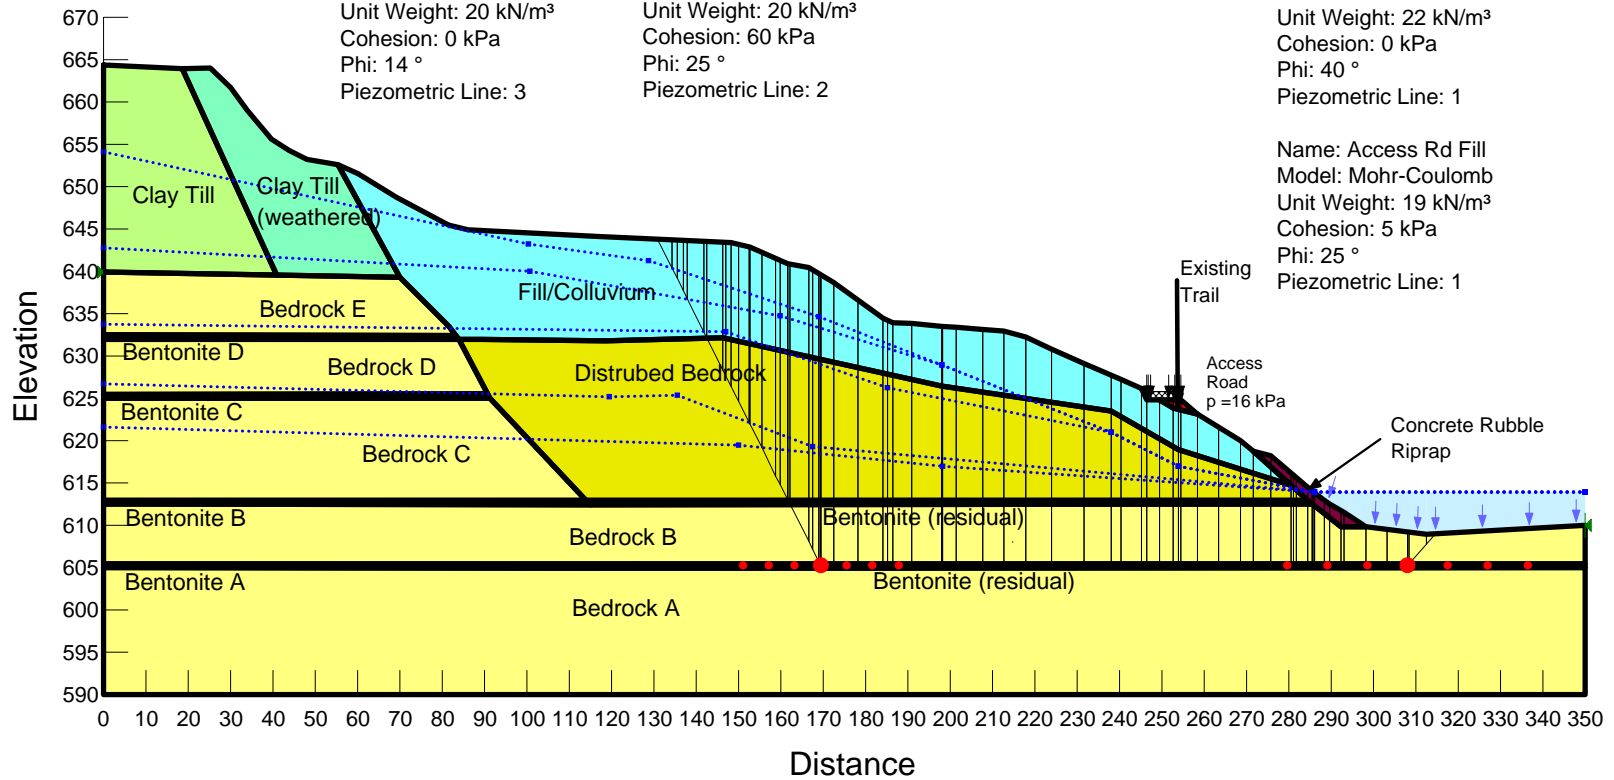
Name: Concrete Rubble/Riprap  
 Model: Mohr-Coulomb  
 Unit Weight: 22 kN/m<sup>3</sup>  
 Cohesion: 0 kPa  
 Phi: 40 °  
 Piezometric Line: 1

Name: Access Rd Fill  
 Model: Mohr-Coulomb  
 Unit Weight: 19 kN/m<sup>3</sup>  
 Cohesion: 5 kPa  
 Phi: 25 °  
 Piezometric Line: 1

Name: Clay Till Model: Mohr-Coulomb Unit Weight: 18 kN/m <sup>3</sup> Cohesion: 20 kPa Phi: 25 ° Piezometric Line: 5	Name: Fill and Colluvium Model: Mohr-Coulomb Unit Weight: 18 kN/m <sup>3</sup> Cohesion: 2 kPa Phi: 23 ° Piezometric Line: 5	Name: Bentonite Seam (Residual) Model: Mohr-Coulomb Unit Weight: 20 kN/m <sup>3</sup> Cohesion: 0 kPa Phi: 9 ° Piezometric Line: 1	Name: Bedrock D Model: Mohr-Coulomb Unit Weight: 20 kN/m <sup>3</sup> Cohesion: 50 kPa Phi: 25 ° Piezometric Line: 3	Name: Bedrock E Model: Mohr-Coulomb Unit Weight: 20 kN/m <sup>3</sup> Cohesion: 50 kPa Phi: 25 ° Piezometric Line: 4
Name: Clay Till (Weathered) Model: Mohr-Coulomb Unit Weight: 18 kN/m <sup>3</sup> Cohesion: 5 kPa Phi: 25 ° Piezometric Line: 5	Name: Bentonite A and B Model: Mohr-Coulomb Unit Weight: 20 kN/m <sup>3</sup> Cohesion: 0 kPa Phi: 14 ° Piezometric Line: 1	Name: Bedrock A and B Model: Mohr-Coulomb Unit Weight: 20 kN/m <sup>3</sup> Cohesion: 80 kPa Phi: 25 ° Piezometric Line: 1		Name: Disturbed Bedrock Model: Mohr-Coulomb Unit Weight: 20 kN/m <sup>3</sup> Cohesion: 15 kPa Phi: 25 ° Piezometric Line: 3

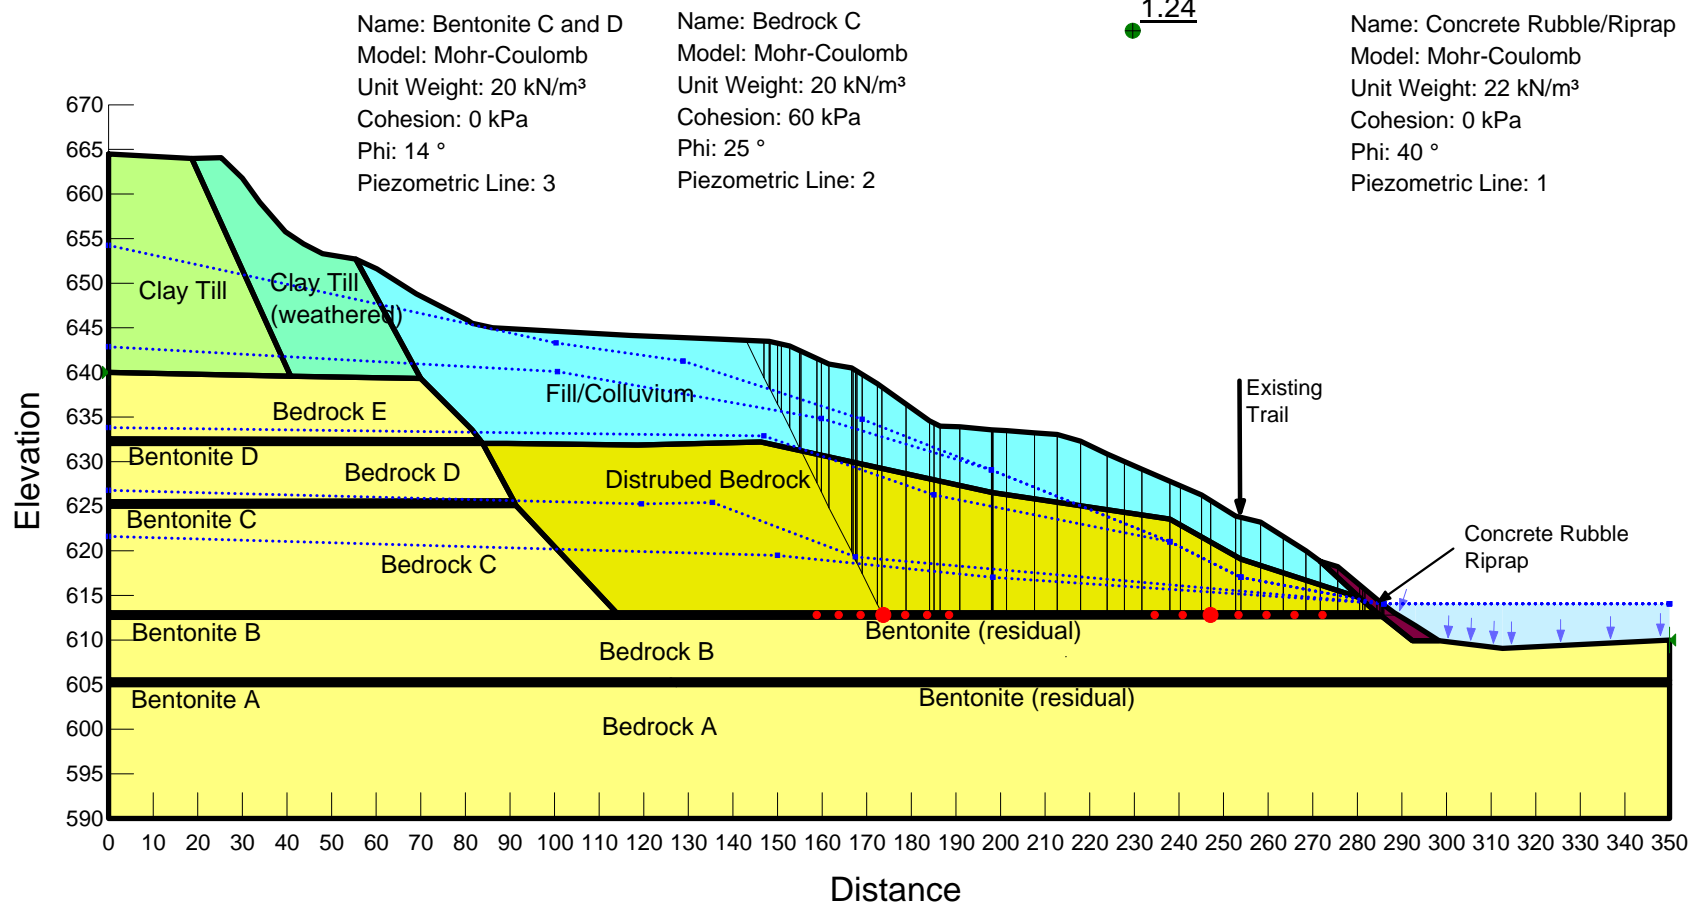
Name: Clay Till  
 Model: Mohr-Coulomb  
 Unit Weight: 18 kN/m<sup>3</sup>  
 Cohesion: 20 kPa  
 Phi: 25 °  
 Piezometric Line: 5

Name: Fill and Colluvium  
 Model: Mohr-Coulomb  
 Unit Weight: 18 kN/m<sup>3</sup>  
 Cohesion: 2 kPa  
 Phi: 23 °  
 Piezometric Line: 5

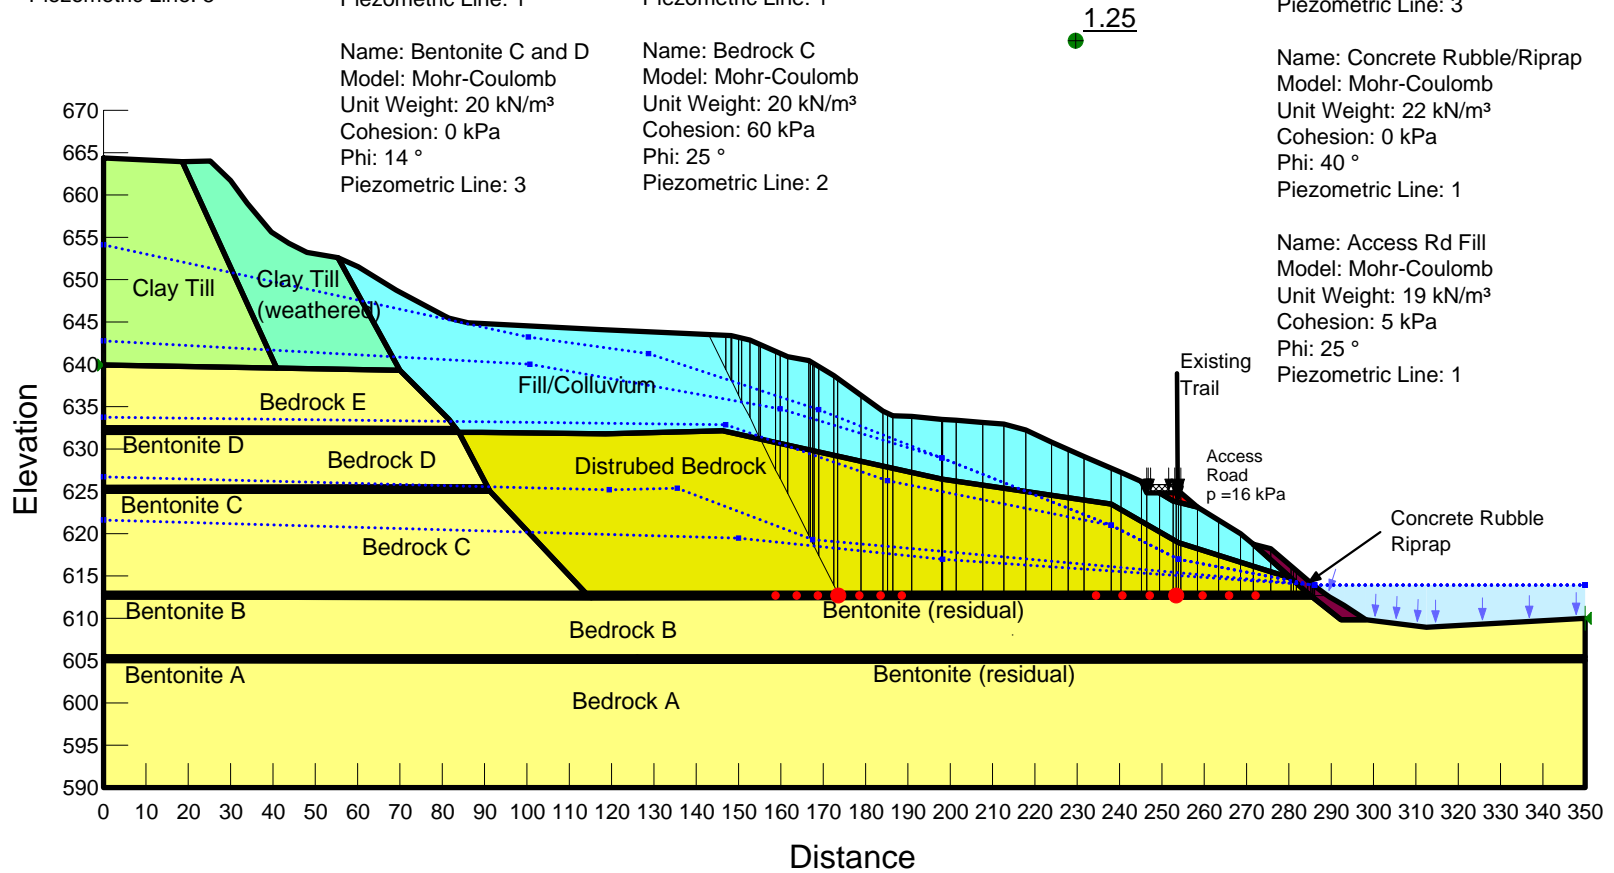
Name: Concrete Rubble/Riprap  
 Model: Mohr-Coulomb  
 Unit Weight: 22 kN/m<sup>3</sup>  
 Cohesion: 0 kPa  
 Phi: 40 °  
 Piezometric Line: 1

Name: Access Rd Fill  
 Model: Mohr-Coulomb  
 Unit Weight: 19 kN/m<sup>3</sup>  
 Cohesion: 5 kPa  
 Phi: 25 °  
 Piezometric Line: 1

Name: Clay Till Model: Mohr-Coulomb Unit Weight: 18 kN/m <sup>3</sup> Cohesion: 20 kPa Phi: 25 ° Piezometric Line: 5	Name: Fill and Colluvium Model: Mohr-Coulomb Unit Weight: 18 kN/m <sup>3</sup> Cohesion: 2 kPa Phi: 23 ° Piezometric Line: 5	Name: Bentonite Seam (Residual) Model: Mohr-Coulomb Unit Weight: 20 kN/m <sup>3</sup> Cohesion: 0 kPa Phi: 9 ° Piezometric Line: 1	Name: Bedrock D Model: Mohr-Coulomb Unit Weight: 20 kN/m <sup>3</sup> Cohesion: 50 kPa Phi: 25 ° Piezometric Line: 3	Name: Bedrock E Model: Mohr-Coulomb Unit Weight: 20 kN/m <sup>3</sup> Cohesion: 50 kPa Phi: 25 ° Piezometric Line: 4
Name: Clay Till (Weathered) Model: Mohr-Coulomb Unit Weight: 18 kN/m <sup>3</sup> Cohesion: 5 kPa Phi: 25 ° Piezometric Line: 5	Name: Bentonite A and B Model: Mohr-Coulomb Unit Weight: 20 kN/m <sup>3</sup> Cohesion: 0 kPa Phi: 14 ° Piezometric Line: 1	Name: Bedrock A and B Model: Mohr-Coulomb Unit Weight: 20 kN/m <sup>3</sup> Cohesion: 80 kPa Phi: 25 ° Piezometric Line: 1		Name: Disturbed Bedrock Model: Mohr-Coulomb Unit Weight: 20 kN/m <sup>3</sup> Cohesion: 15 kPa Phi: 25 ° Piezometric Line: 3

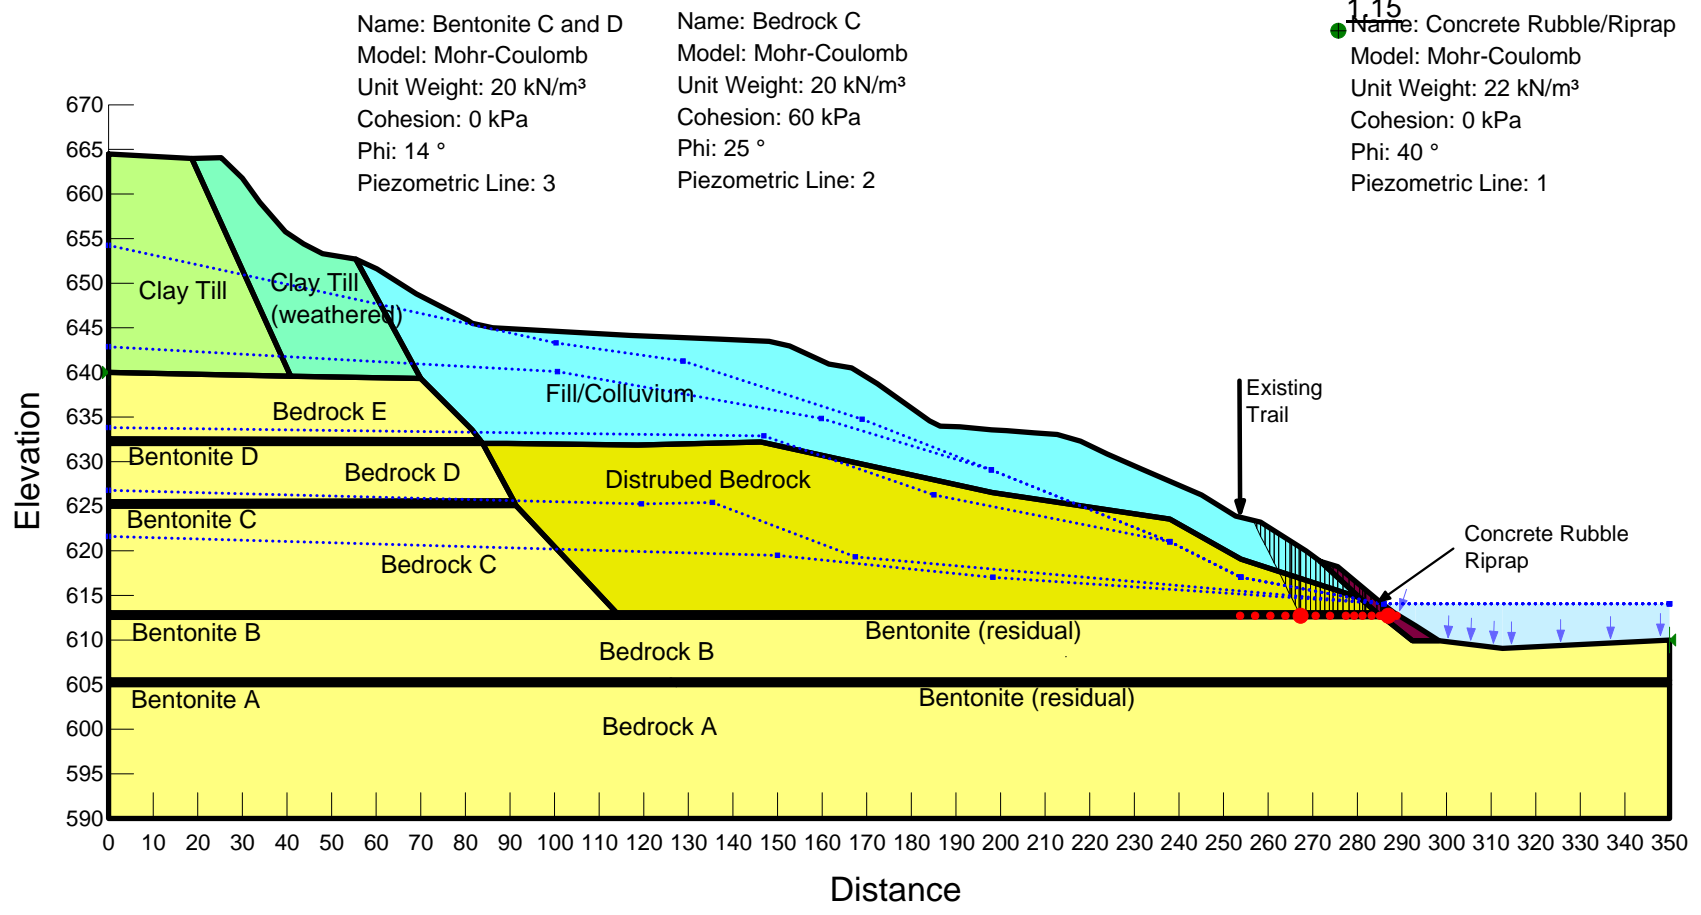
Name: Bentonite C and D Model: Mohr-Coulomb Unit Weight: 20 kN/m <sup>3</sup> Cohesion: 0 kPa Phi: 14 ° Piezometric Line: 3	Name: Bedrock C Model: Mohr-Coulomb Unit Weight: 20 kN/m <sup>3</sup> Cohesion: 60 kPa Phi: 25 ° Piezometric Line: 2		1, 15 Name: Concrete Rubble/Riprap Model: Mohr-Coulomb Unit Weight: 22 kN/m <sup>3</sup> Cohesion: 0 kPa Phi: 40 ° Piezometric Line: 1

Name: Clay Till  
 Model: Mohr-Coulomb  
 Unit Weight: 18 kN/m<sup>3</sup>  
 Cohesion: 20 kPa  
 Phi: 25 °  
 Piezometric Line: 5

Name: Fill and Colluvium  
 Model: Mohr-Coulomb  
 Unit Weight: 18 kN/m<sup>3</sup>  
 Cohesion: 2 kPa  
 Phi: 23 °  
 Piezometric Line: 5

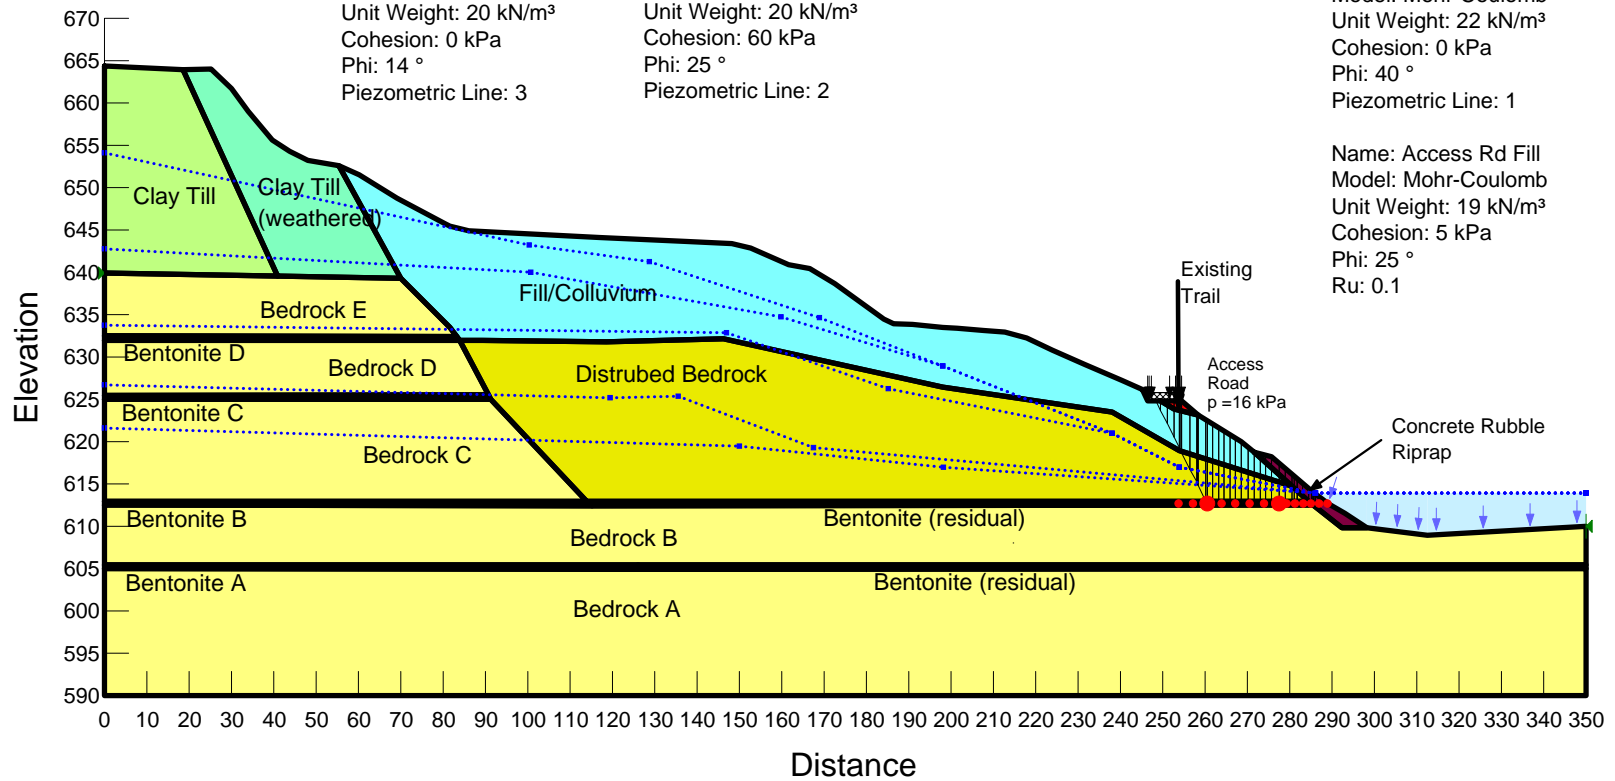
Name: Concrete Rubble/Riprap  
 Model: Mohr-Coulomb  
 Unit Weight: 22 kN/m<sup>3</sup>  
 Cohesion: 0 kPa  
 Phi: 40 °  
 Piezometric Line: 1

Name: Access Rd Fill  
 Model: Mohr-Coulomb  
 Unit Weight: 19 kN/m<sup>3</sup>  
 Cohesion: 5 kPa  
 Phi: 25 °  
 Ru: 0.1

Name: Clay Till  
 Model: Mohr-Coulomb  
 Unit Weight: 18 kN/m<sup>3</sup>  
 Cohesion: 20 kPa  
 Phi: 25 °  
 Piezometric Line: 5

Name: Fill and Colluvium  
 Model: Mohr-Coulomb  
 Unit Weight: 18 kN/m<sup>3</sup>  
 Cohesion: 2 kPa  
 Phi: 23 °  
 Piezometric Line: 5

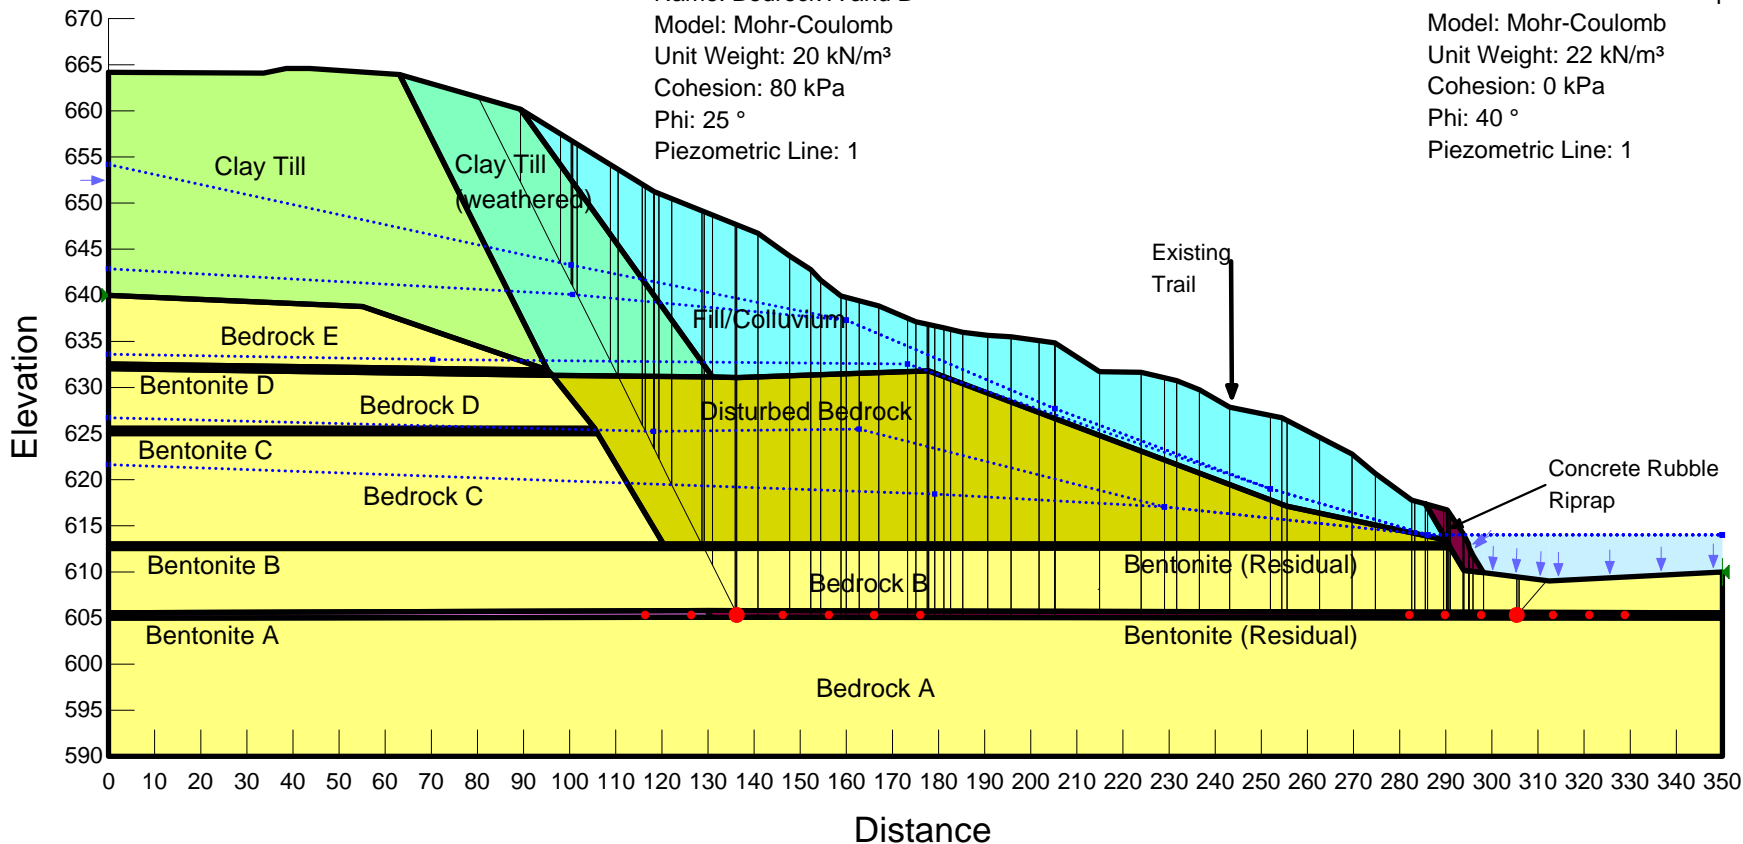
Name: Bedrock A and B  
 Model: Mohr-Coulomb  
 Unit Weight: 20 kN/m<sup>3</sup>  
 Cohesion: 80 kPa  
 Phi: 25 °  
 Piezometric Line: 1

Name: Concrete Rubble/Riprap  
 Model: Mohr-Coulomb  
 Unit Weight: 22 kN/m<sup>3</sup>  
 Cohesion: 0 kPa  
 Phi: 40 °  
 Piezometric Line: 1

Name: Clay Till  
 Model: Mohr-Coulomb  
 Unit Weight: 18 kN/m<sup>3</sup>  
 Cohesion: 20 kPa  
 Phi: 25 °  
 Piezometric Line: 5

Name: Fill and Colluvium  
 Model: Mohr-Coulomb  
 Unit Weight: 18 kN/m<sup>3</sup>  
 Cohesion: 2 kPa  
 Phi: 23 °  
 Piezometric Line: 5
