**City of Edmonton  
Valley Line Stage 1 – Light Rail Transit (LRT) Project  
Environmental Impact Screening Assessment Update**

**Final Report**

**Spencer Environmental  
Management Services Ltd.  
Edmonton, Alberta**

February 2015

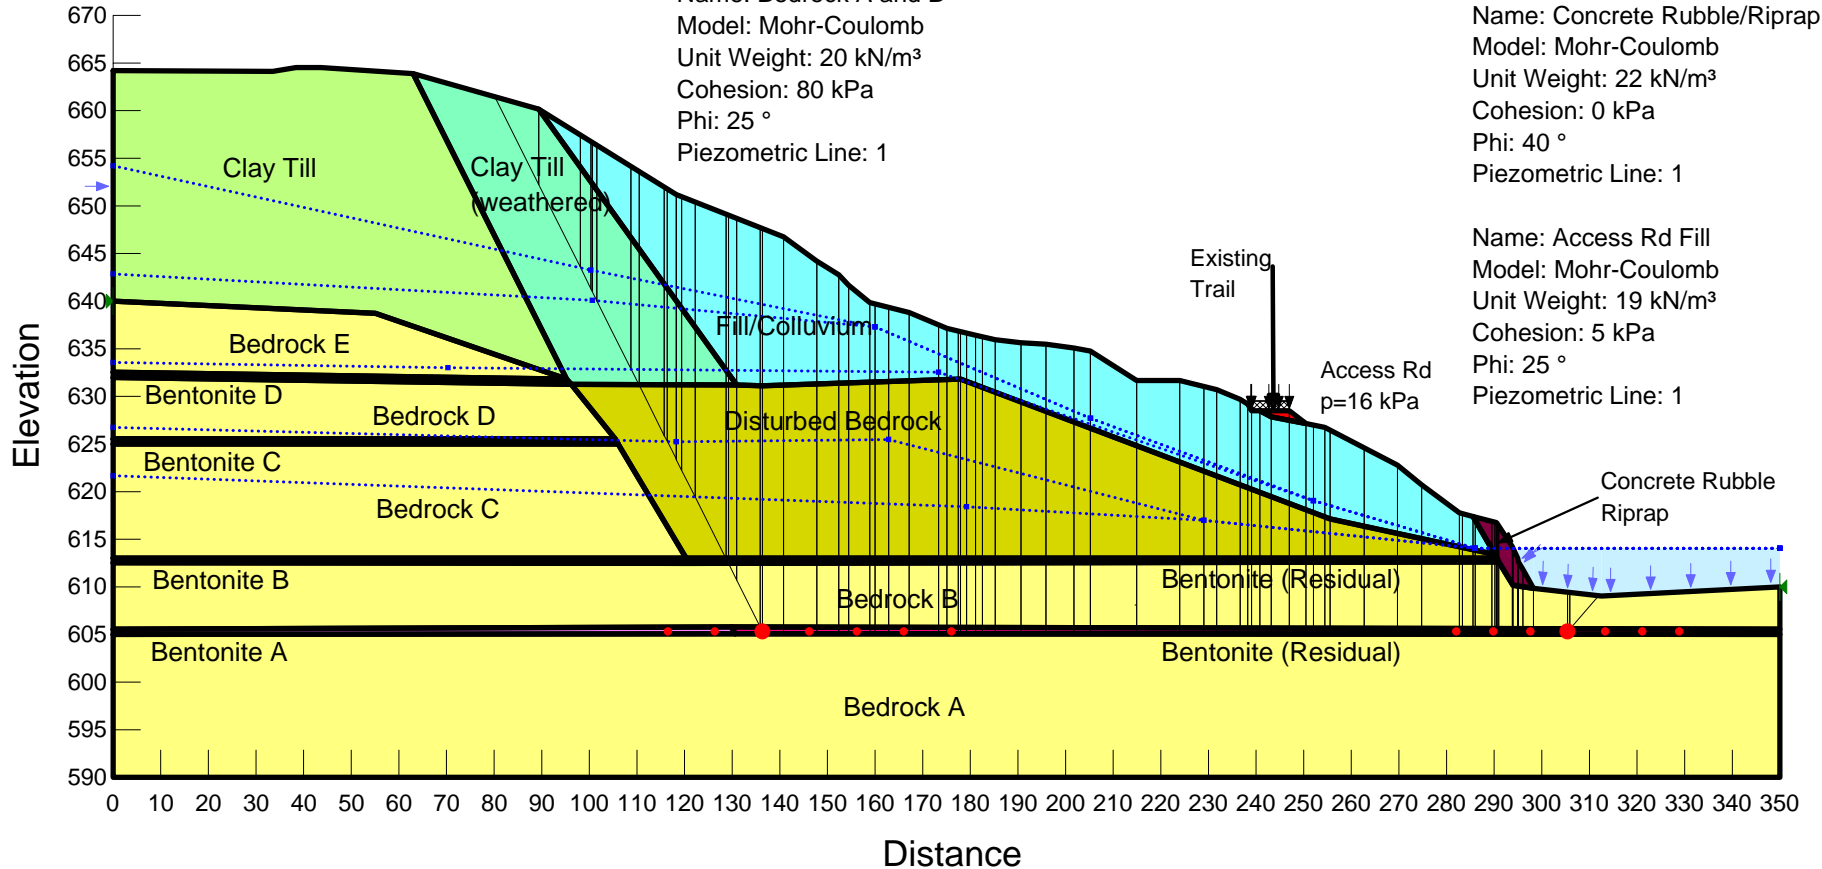
Name: Concrete Rubble/Riprap  
 Model: Mohr-Coulomb  
 Unit Weight: 22 kN/m<sup>3</sup>  
 Cohesion: 0 kPa  
 Phi: 40 °  
 Piezometric Line: 1

Name: Access Rd Fill  
 Model: Mohr-Coulomb  
 Unit Weight: 19 kN/m<sup>3</sup>  
 Cohesion: 5 kPa  
 Phi: 25 °  
 Piezometric Line: 1

Name: Clay Till  
 Model: Mohr-Coulomb  
 Unit Weight: 18 kN/m<sup>3</sup>  
 Cohesion: 20 kPa  
 Phi: 25 °  
 Piezometric Line: 5

Name: Fill and Colluvium  
 Model: Mohr-Coulomb  
 Unit Weight: 18 kN/m<sup>3</sup>  
 Cohesion: 2 kPa  
 Phi: 23 °  
 Piezometric Line: 5

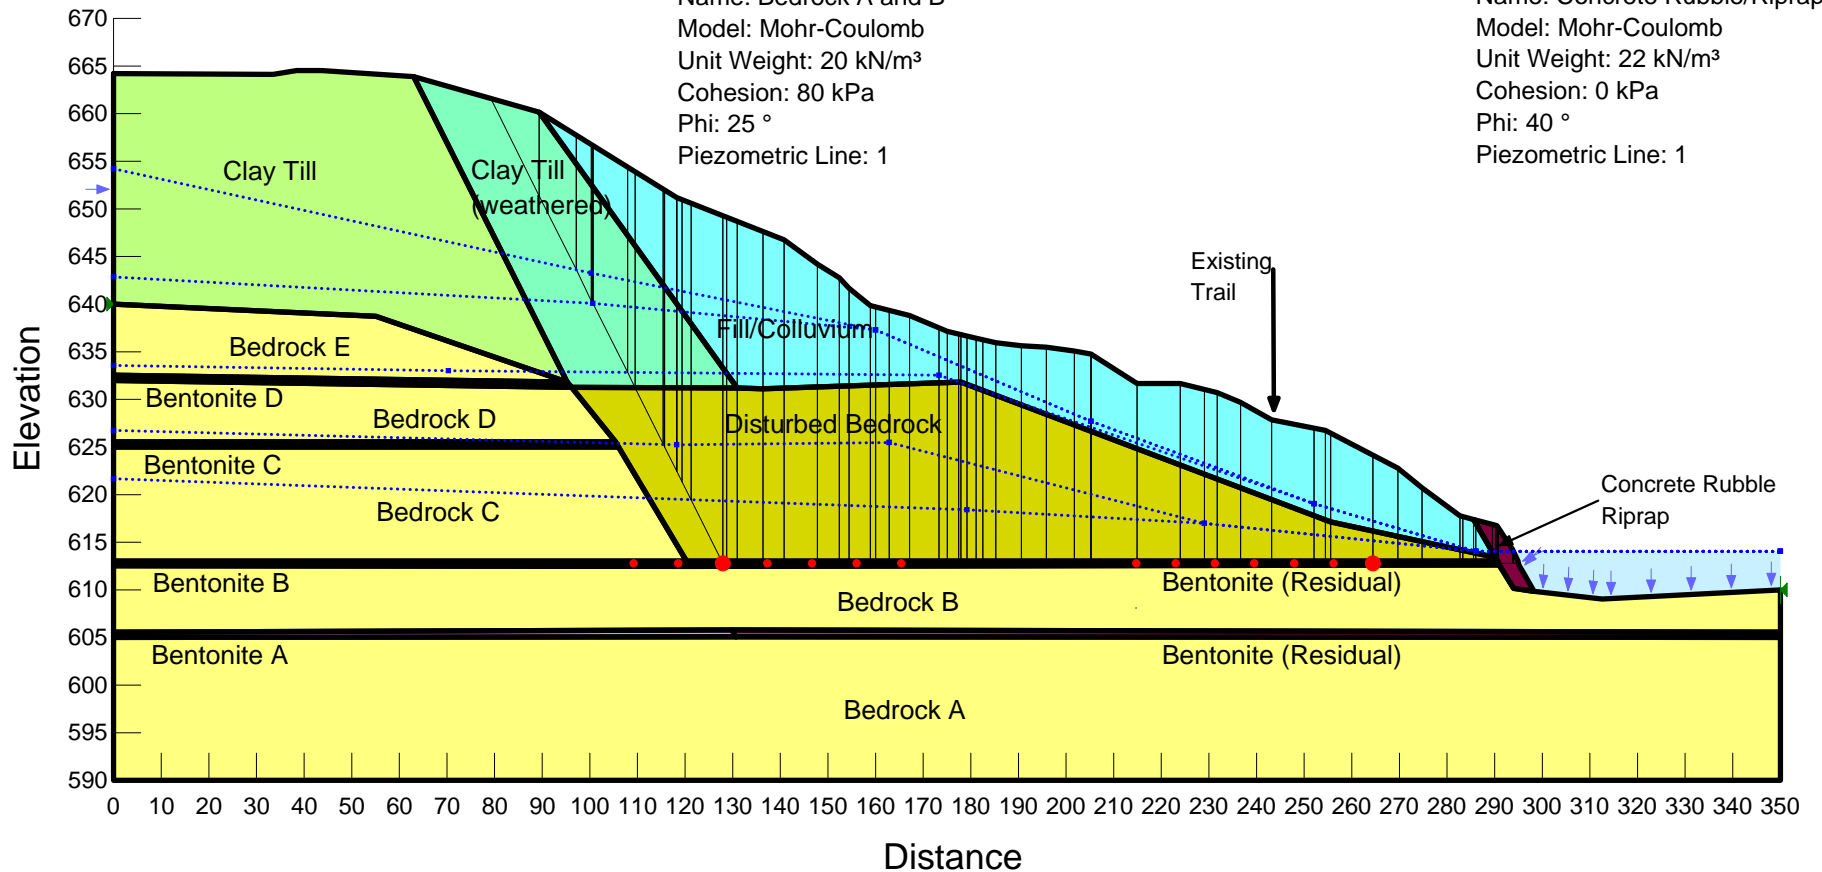
Name: Bedrock A and B  
 Model: Mohr-Coulomb  
 Unit Weight: 20 kN/m<sup>3</sup>  
 Cohesion: 80 kPa  
 Phi: 25 °  
 Piezometric Line: 1

Name: Concrete Rubble/Riprap  
 Model: Mohr-Coulomb  
 Unit Weight: 22 kN/m<sup>3</sup>  
 Cohesion: 0 kPa  
 Phi: 40 °  
 Piezometric Line: 1

Name: Clay Till  
 Model: Mohr-Coulomb  
 Unit Weight: 18 kN/m<sup>3</sup>  
 Cohesion: 20 kPa  
 Phi: 25 °  
 Piezometric Line: 5

Name: Fill and Colluvium  
 Model: Mohr-Coulomb  
 Unit Weight: 18 kN/m<sup>3</sup>  
 Cohesion: 2 kPa  
 Phi: 23 °  
 Piezometric Line: 5

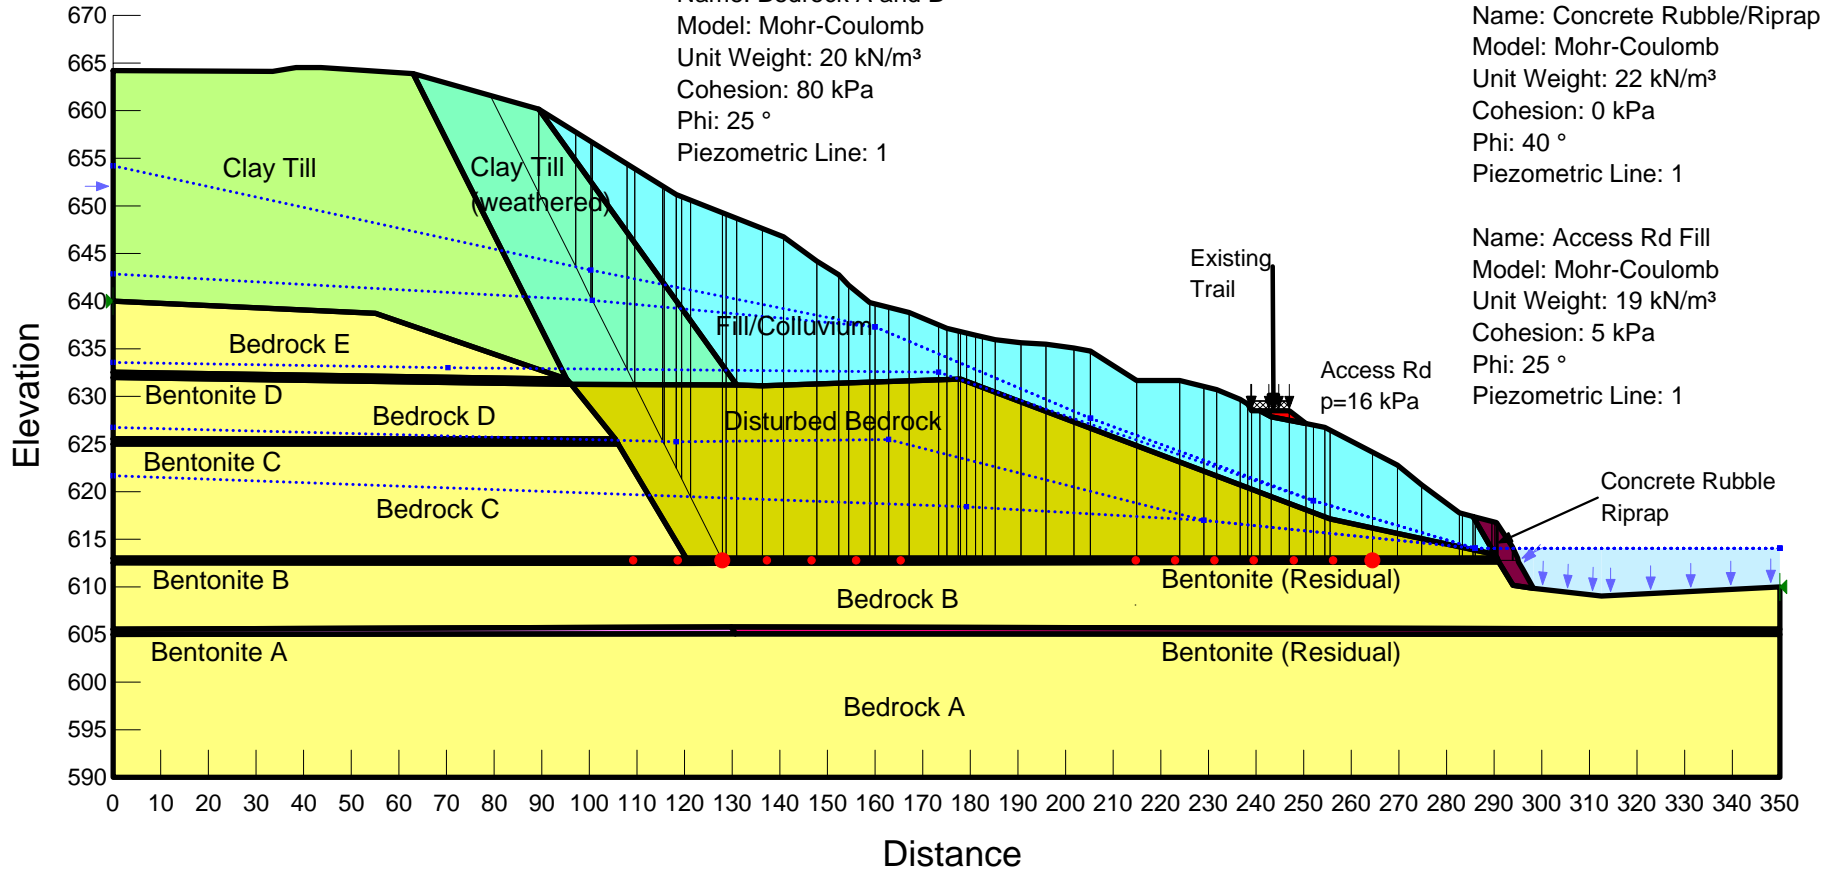
Name: Concrete Rubble/Riprap  
 Model: Mohr-Coulomb  
 Unit Weight: 22 kN/m<sup>3</sup>  
 Cohesion: 0 kPa  
 Phi: 40 °  
 Piezometric Line: 1

Name: Access Rd Fill  
 Model: Mohr-Coulomb  
 Unit Weight: 19 kN/m<sup>3</sup>  
 Cohesion: 5 kPa  
 Phi: 25 °  
 Piezometric Line: 1

Name: Clay Till  
 Model: Mohr-Coulomb  
 Unit Weight: 18 kN/m<sup>3</sup>  
 Cohesion: 20 kPa  
 Phi: 25 °  
 Piezometric Line: 5

Name: Fill and Colluvium  
 Model: Mohr-Coulomb  
 Unit Weight: 18 kN/m<sup>3</sup>  
 Cohesion: 2 kPa  
 Phi: 23 °  
 Piezometric Line: 5

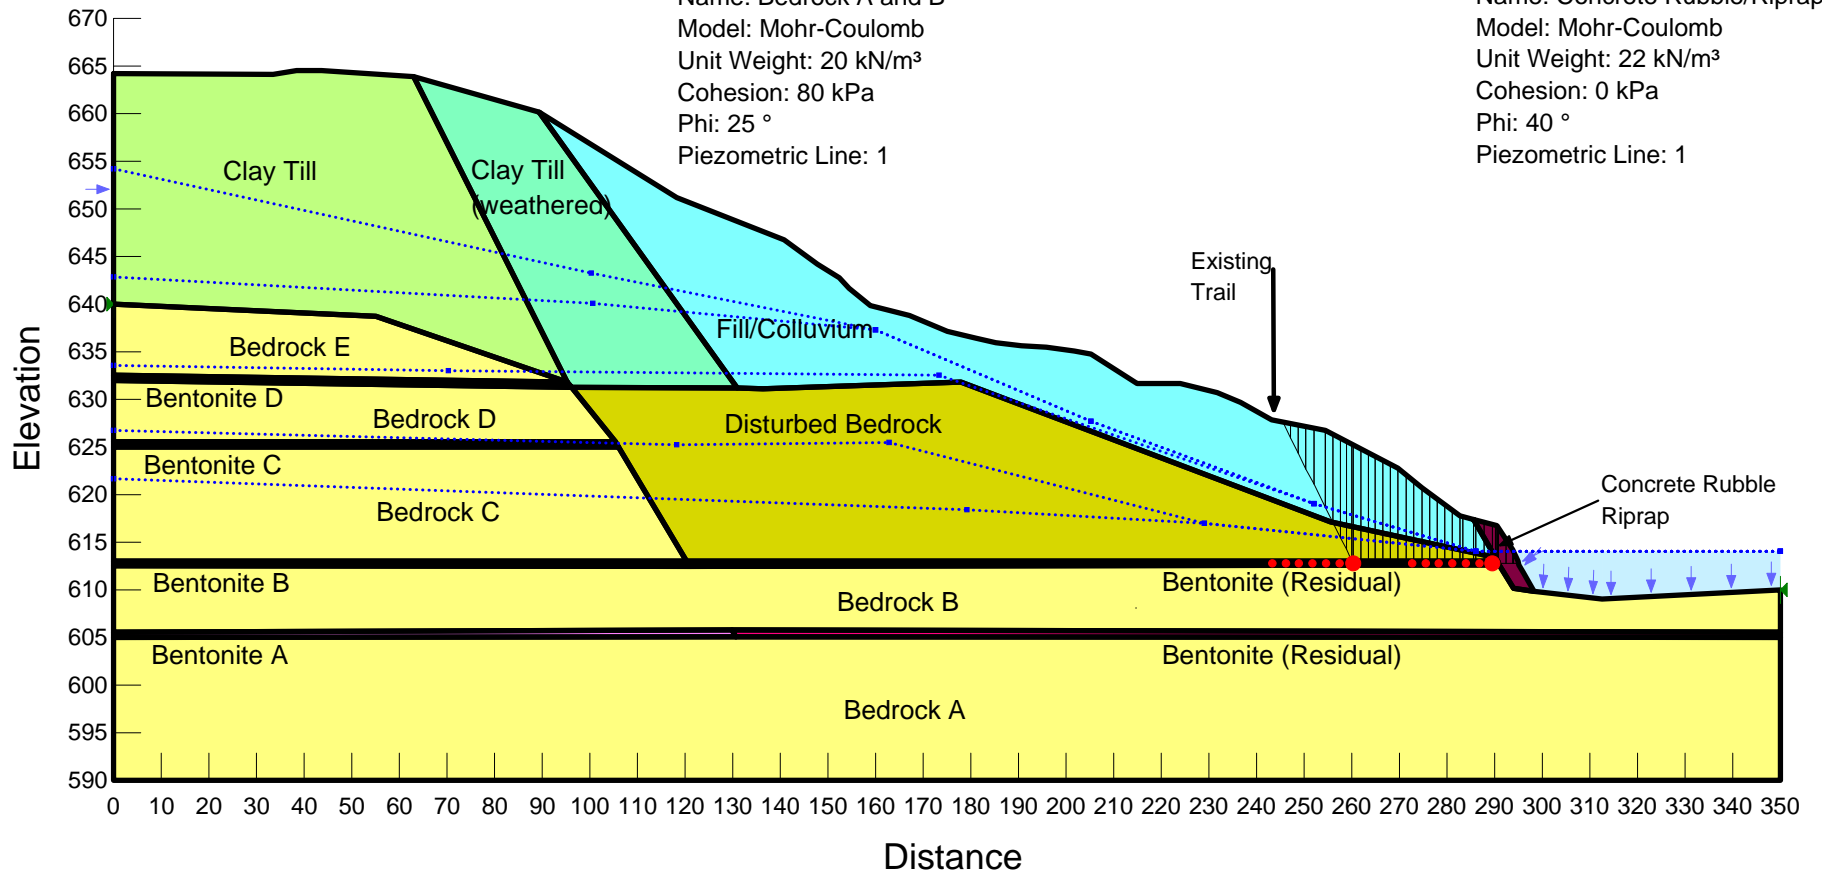
Name: Bedrock A and B  
 Model: Mohr-Coulomb  
 Unit Weight: 20 kN/m<sup>3</sup>  
 Cohesion: 80 kPa  
 Phi: 25 °  
 Piezometric Line: 1

Name: Concrete Rubble/Riprap  
 Model: Mohr-Coulomb  
 Unit Weight: 22 kN/m<sup>3</sup>  
 Cohesion: 0 kPa  
 Phi: 40 °  
 Piezometric Line: 1

Name: Clay Till  
 Model: Mohr-Coulomb  
 Unit Weight: 18 kN/m<sup>3</sup>  
 Cohesion: 20 kPa  
 Phi: 25 °  
 Piezometric Line: 5

Name: Fill and Colluvium  
 Model: Mohr-Coulomb  
 Unit Weight: 18 kN/m<sup>3</sup>  
 Cohesion: 2 kPa  
 Phi: 23 °  
 Piezometric Line: 5

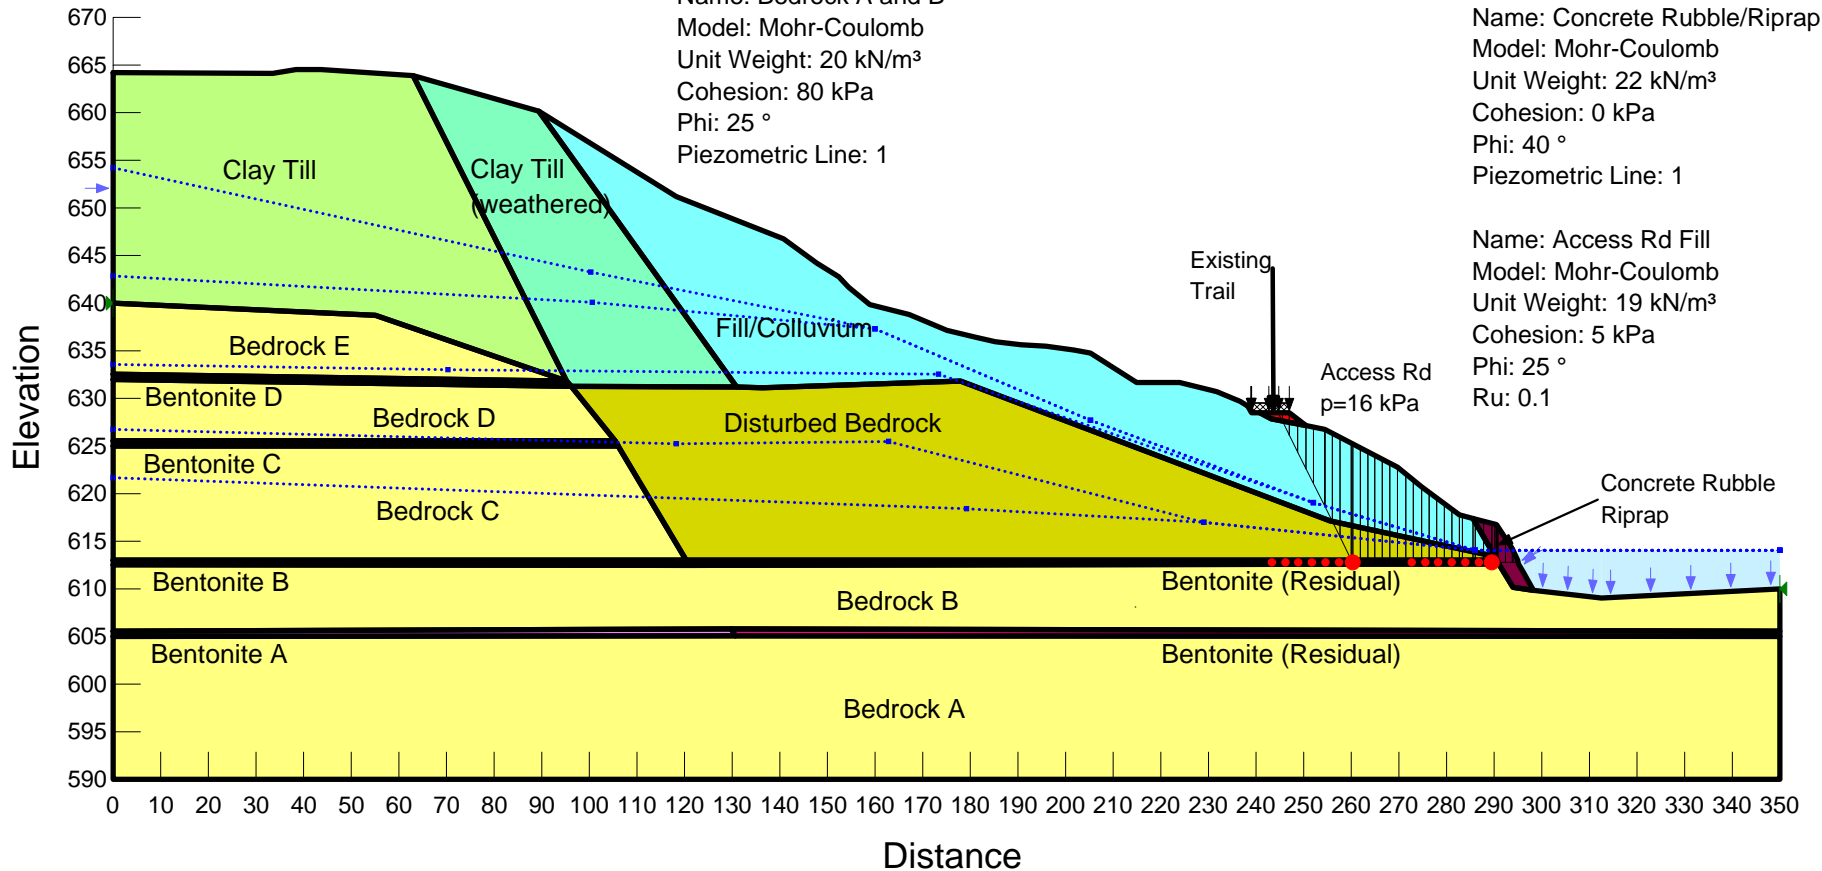
Name: Concrete Rubble/Riprap  
 Model: Mohr-Coulomb  
 Unit Weight: 22 kN/m<sup>3</sup>  
 Cohesion: 0 kPa  
 Phi: 40 °  
 Piezometric Line: 1

Name: Access Rd Fill  
 Model: Mohr-Coulomb  
 Unit Weight: 19 kN/m<sup>3</sup>  
 Cohesion: 5 kPa  
 Phi: 25 °  
 Ru: 0.1
