**Mill Creek Ravine Park Trail
Rehabilitation, Edmonton,
Alberta**

Environmental Review Report

Prepared for:
City of Edmonton

Prepared by:
Stantec Consulting Ltd.

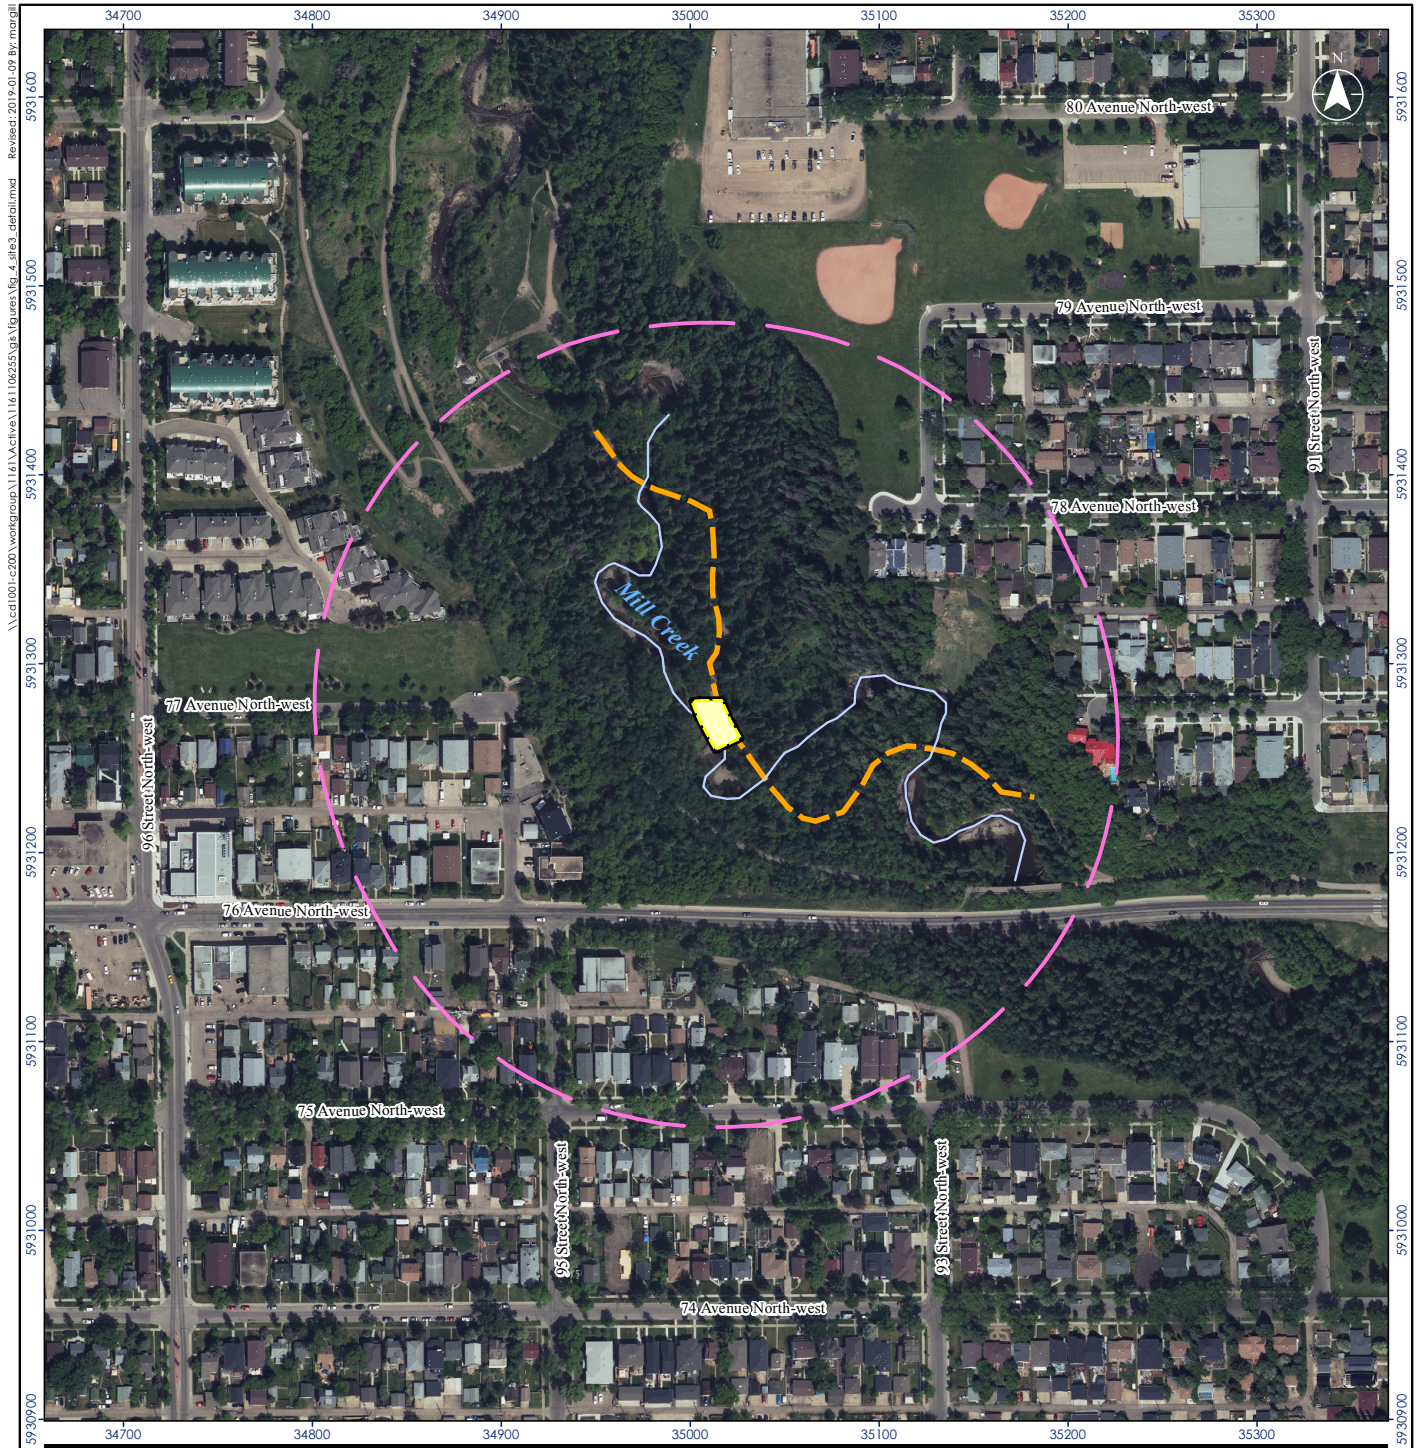
Site 3 is located approximately 135 m southwest of 78 Ave and 93 St, roughly 30 m north of Bridge 207, approximately 800 m south of Site 2 (Figure 4). The Site is generally rolling, with a knob immediately east of the existing trail. At Site 3, the existing trail has been narrowed from 3 m to 2 m over a length of 6 m where Mill Creek has eroded the east bank.

At Site 3, the existing trail will be rehabilitated in place and the east bank of Mill Creek will be armored to prevent further deterioration of the creek bank and trail. A post and rail fence will be installed downslope of the trail for public safety.

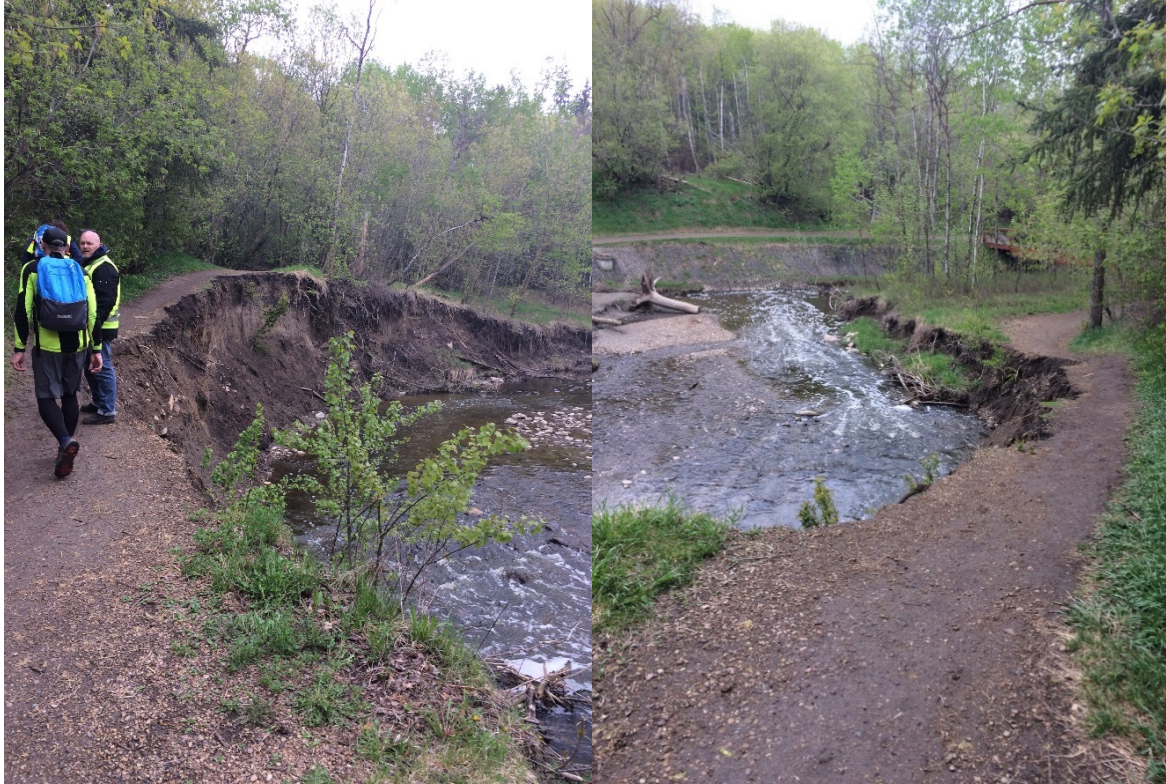
Figure 6 View of Site 1 trail eroding into creek - View looking south (left) and north (right).

The erosion area referred to as Site 1, is immediately south of Bridge 277, shown in **Figure 5**, on a north-south segment of gravel path connecting Connors Road to Mill Creek pool on the east side of Mill Creek. The Creek is actively cutting the toe of slope, **Figure 6**, resulting in an approximately 3 m high vertical bank which has encroached on the trail and narrowed it to the point that it is no longer serviceable. Trail users have adopted a detour using an unmaintained path around the erosion site, connecting to the main trail north of the bridge as shown in **Figure 7**.

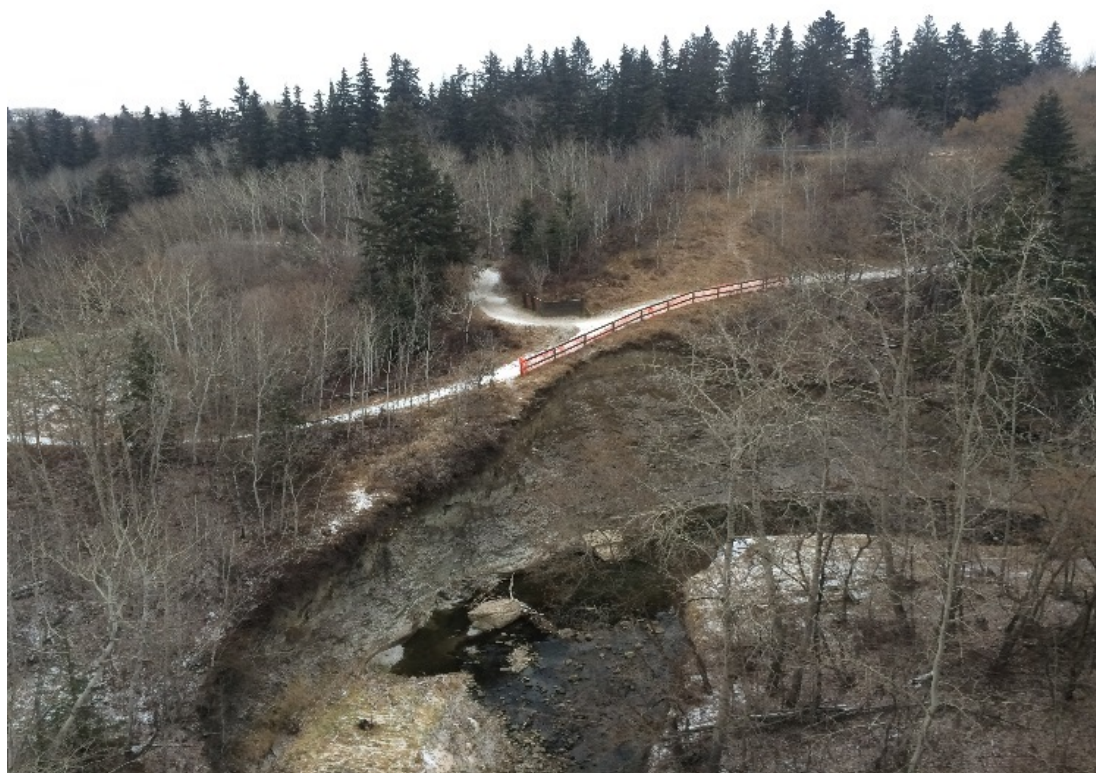
Figure 8 Site 2 viewed from 82 Avenue Bridge, looking east

The trail connecting Mill Creek Pool to 76 Avenue traverses ancient landslide features and follows the top of a steep bank at the erosion site identified as Site 2 as shown in **Figure 8**. At this location the creek impinges on the valley wall, creating a nearly vertical 10 m high bank adjacent to the trail. A timber hand rail protects trail users from the drop, but that too is at risk of failure from on-going erosion.

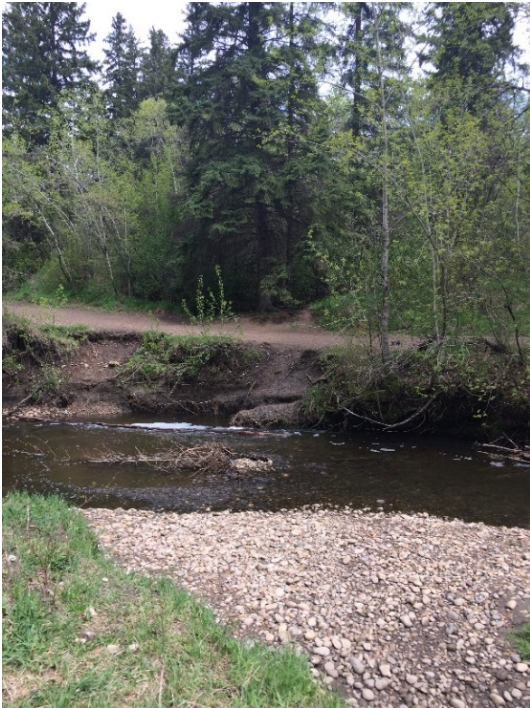
Figure 9 Site 3 looking east from a gravel side bar

Erosion Site 3 is located on the trail connecting Mill Creek Pool to 76 Avenue, immediately north of Bridge 207. At this site, the creek has created a gravel side bar on the west bank which directs flow to the east, impinging on the bank at Site 3 as shown in **Figure 9**. The relatively low bank is actively eroding as the creek turns west in a tight radius curve. The trail is still serviceable, having lost approximately 1 m of width, but users are exposed to a 2 m high cut bank.

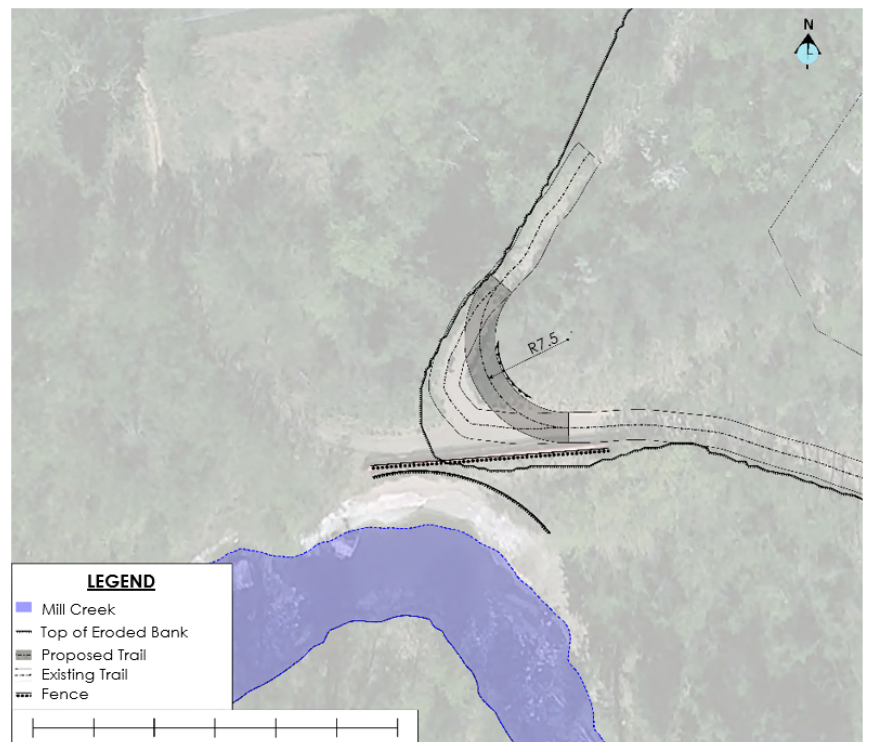
Figure 13 Site 2 - Option 1: Local Trail Realignment – Short Wall

By introducing a short radius curve into the existing trail alignment and construction of a short retaining wall in the slope, the trail can be set back a safe distance from the valley wall. For this option, the retaining wall would be in the order of 1.5 m high and 8 m long. Tie-in to the existing trail would form a continuous grade of approximately 3% rising to the south, as shown in **Figure 13**.

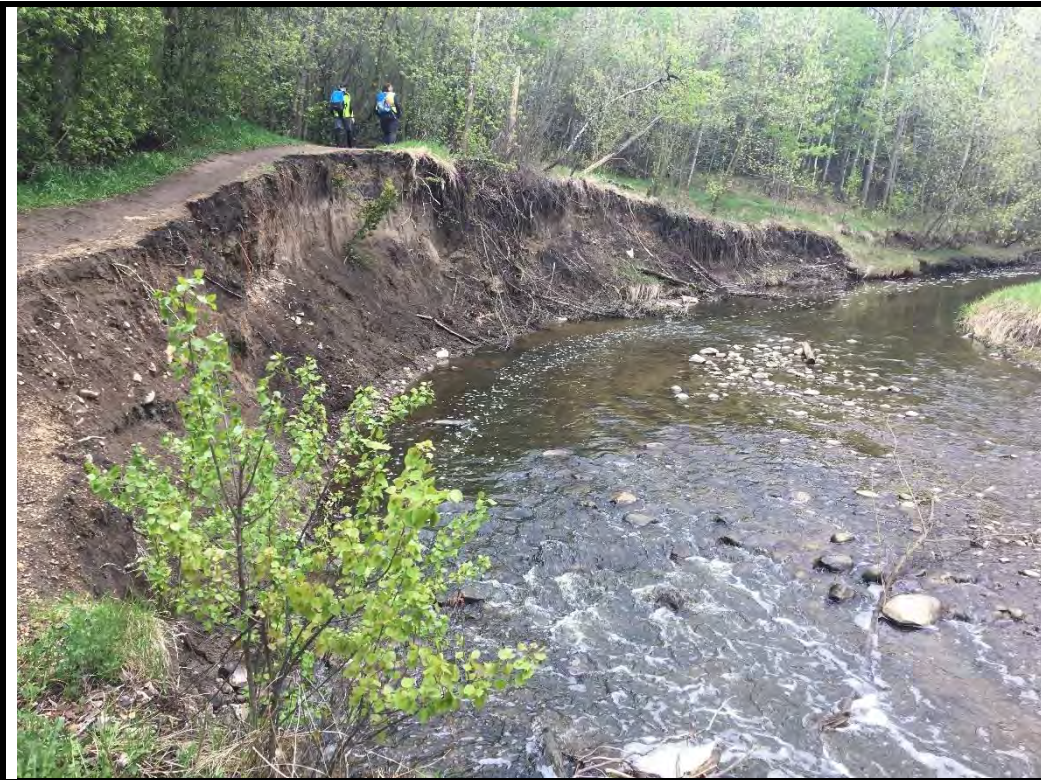
Photo 1: Site 1; eroded right bank of Mill Creek (facing east)

Site 1 (**Figure 2** in **Appendix B**) is approximately 20 metres (m) south of Bridge 277 on the east side of Mill Creek. The terrain at the site is generally flat to gently rolling, and there appears to be a slightly raised terrace at the base of the valley wall. The main trail at this site is located at the base of the ravine, along the top of the creek bank. At the distressed location, the trail follows the outside bend of a meander, which is currently being undercut by the creek (**Photo 1** and **Photo 2, Appendix C**), resulting in significant erosion. The creek encounters the bank at a nearly 90° angle. The height of the bank varies from approximately 1.5 m 3.5 m.

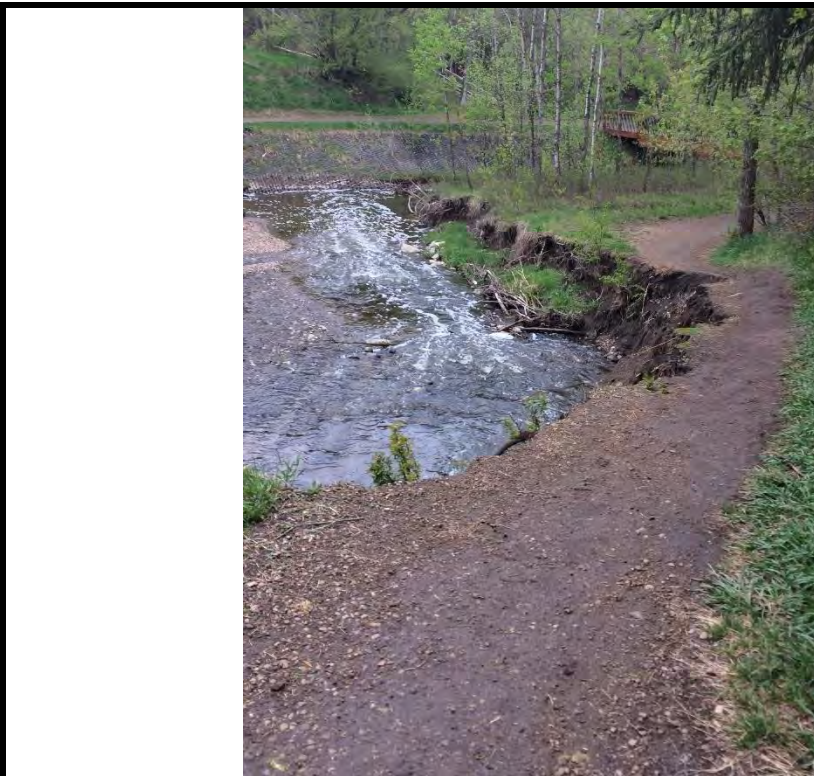
Photo 2: Site 1; impact of erosion on trail (facing northwest)

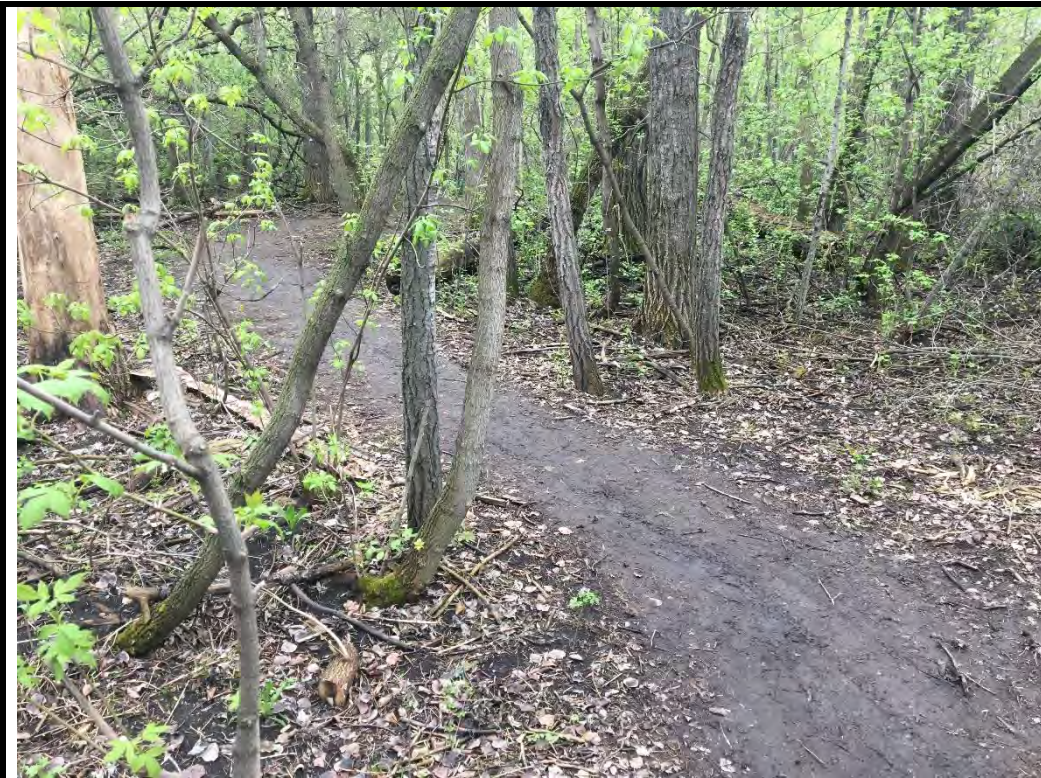
Photo 3: Site 1; existing secondary single track trail east of main trail

The main trail is currently closed at this location; however, the public is still able to access the eroded section. A secondary single track trail traverses the treed area to the east and upslope of the main trail (**Photo 3, Appendix C**). Much of this secondary trail appears to be situated on colluvial material from relic landslides along the toe of the Mill Creek Ravine slope.

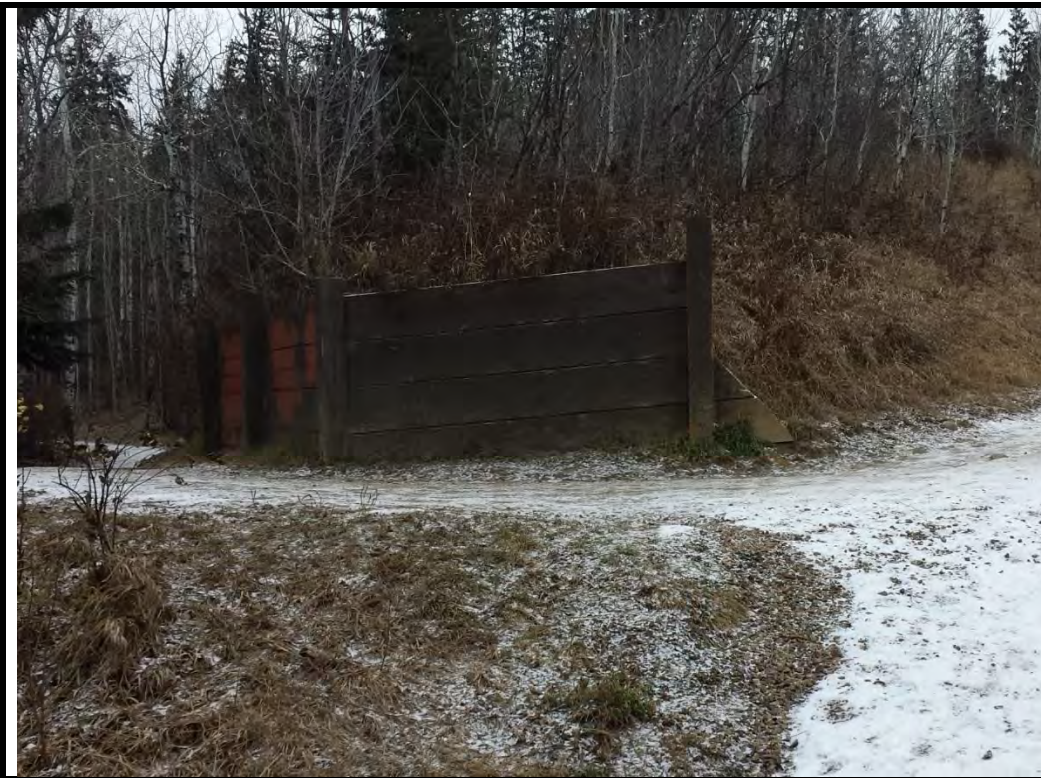
Photo 4: Site 2; existing retaining wall at toe of 5H:1V slope (facing northeast, taken November 19, 2016)

The knob of land between the landslides and above the trail is sloped at approximately 5 horizontal to 1 vertical (5H:1V) from trail level to the crest of Mill Creek Ravine. A timber retaining structure is currently located at the toe of this upper slope at trail level (**Photo 4, Appendix C**).

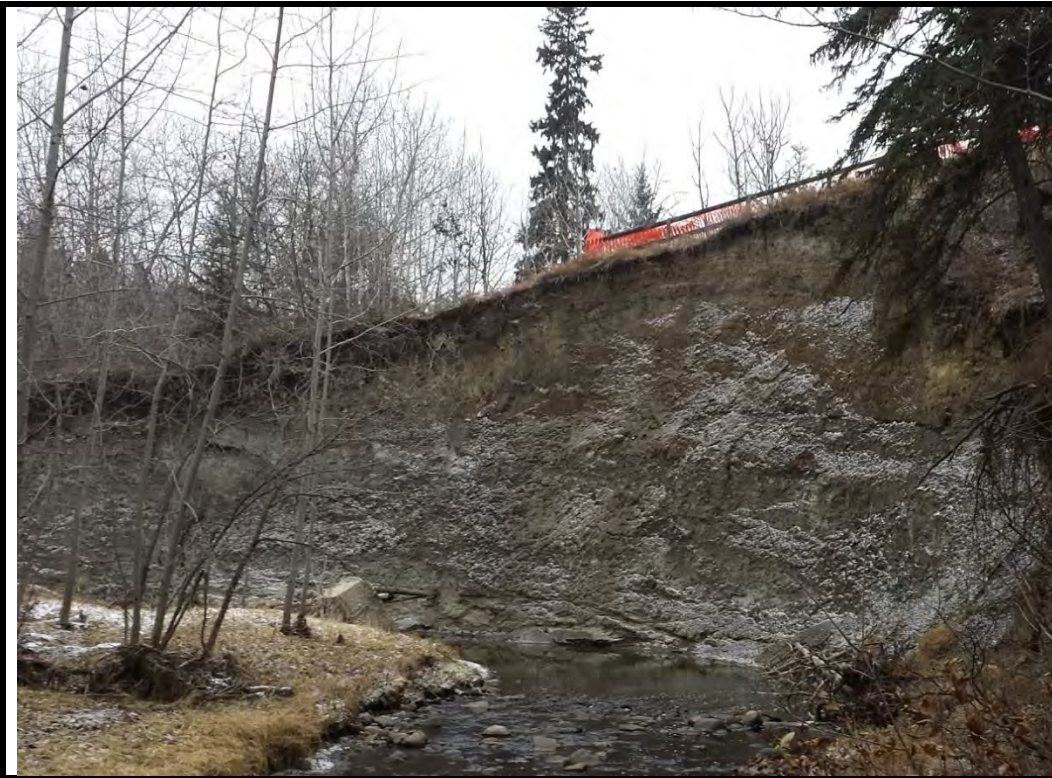
Photo 5: Site 2; eroding bank below trail (facing north, taken November 19, 2016)

Below the trail, the bank of Mill Creek Ravine, is nearly vertical over a distance of approximately 30 m, and sits along the outside bend of a meander (**Photo 5, Appendix C**). The bank is currently being eroded by the creek, which impacts the bank at a nearly 90° angle. A wooden fence is currently installed at the crest of the near-vertical bank for public safety. A visual inspection of the near-vertical bank indicated that the bedrock contact is about 6 m to 7 m above creek level. Toe erosion is likely to continue, which will have an impact on the long term usability of the trail at its existing location.

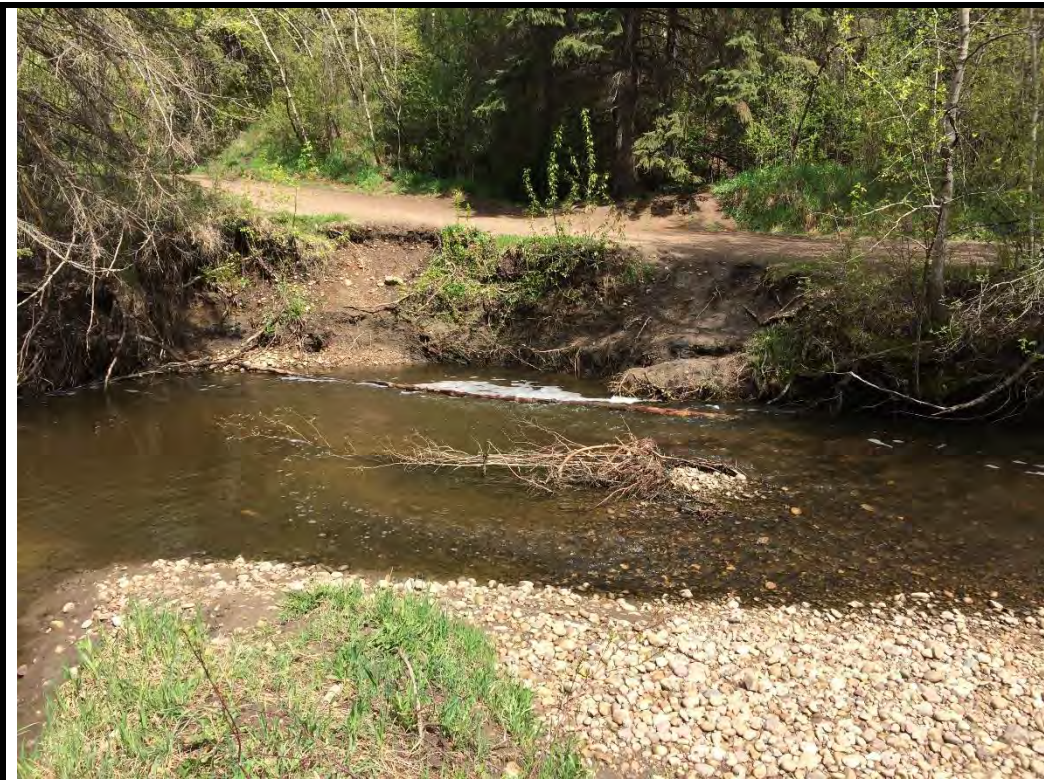
Photo 6: Site 3; eroded bank impacting trail (facing northeast)

Site 3 is approximately 150 m south west of the 93 Street NW and 78 Avenue NW intersection, and about 30 m north of Bridge 207. The main trail at this site is 3 m wide, and is located at the top of the bank along the outside bend of a meander, which is currently being undercut by the creek (**Photo 6, Appendix C**). Creek erosion has resulted in a reduced trail width of approximately 2 m over a 6 m long section. Similar to the other two sites, the creek is impacting the bank at an approximately 90° angle. The trail is currently still open to the public.

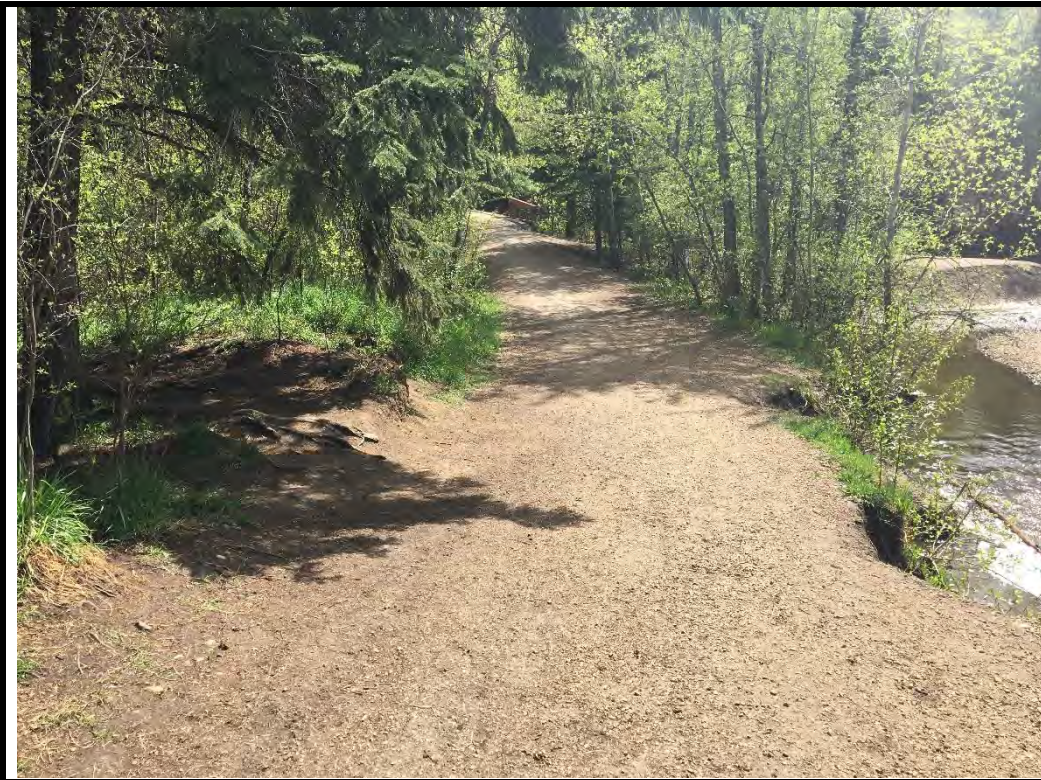
Photo 7: Site 3; eroded bank impacting trail at right of photo, intersection with single track trail at left of photo (facing south)

The height of the bank is approximately 1.5 m to 2.0 m above the creek. The surrounding area is generally flat to gently rolling. The trail appears to be located adjacent to the toe of the ravine slope. A secondary single track trail is located within the treed area to the east of the main trail (**Photo 7, Appendix C**).

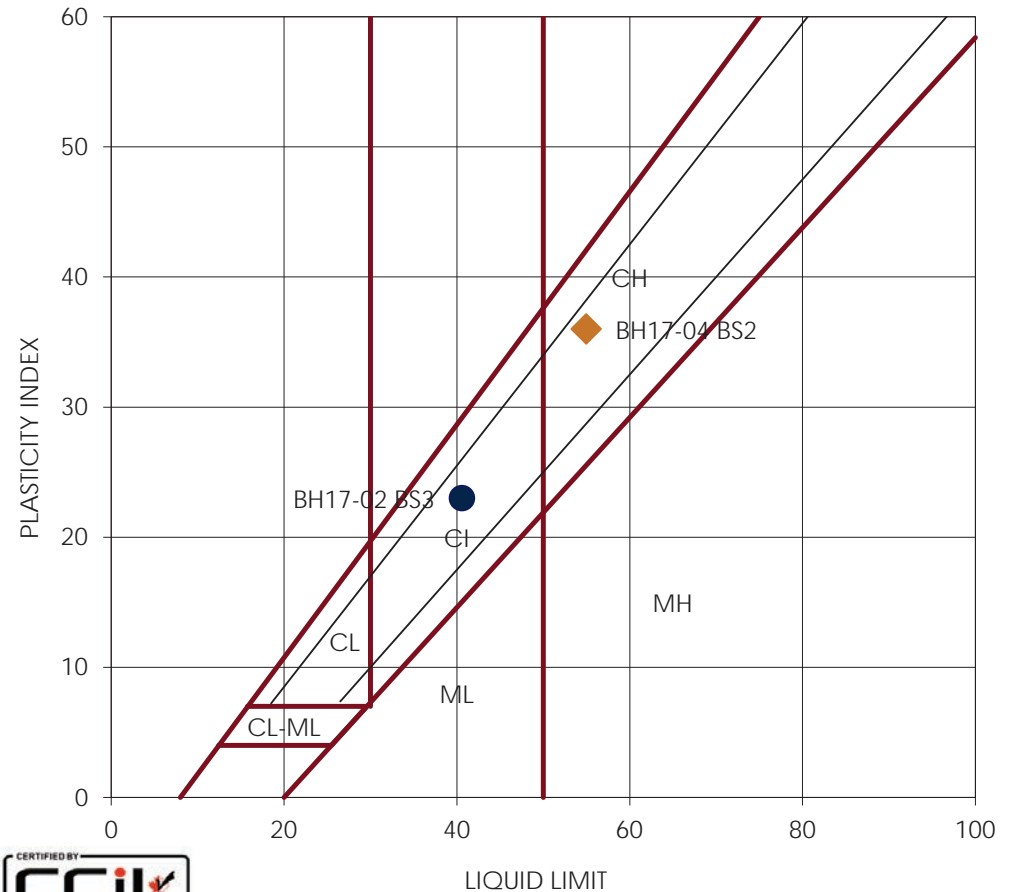
Sample: BH17-02 BS3		Sample: BH17-04 BS2	
LIQUID		LIQUID	
1	2	Trial No.	1 2
29	30	Number of Blows	27 29
21B	4B	Container Number	42B 35B
36.17	38.83	Wt. Sample (wet+tare)(g)	36.39 36.26
30.34	32.14	Wt. Sample (dry+tare)(g)	29.08 29.04
15.54	15.50	Wt. Tare (g)	15.61 15.70
14.8	16.6	Wt. Dry Soil (g)	13.5 13.3
5.8	6.7	Wt. Water (g)	7.3 7.2
39.4%	40.2%	Water Content (%)	54.3% 54.1%
40.1%	41.1%	Corrected Water Content (%)	54.8% 55.1%
PLASTIC		PLASTIC	
1	2	Trial No.	1 2
AF	BS	Container Number	BN BV
20.2	20.41	Wt. Sample (wet+tare)(g)	20.41 20.88
19.26	19.38	Wt. Sample (dry+tare)(g)	19.38 19.82
14.07	13.90	Wt. Tare (g)	14.04 14.15
5.2	5.5	Wt. Dry Soil (g)	5.3 5.7
0.9	1.0	Wt. Water (g)	1.0 1.1
18.1%	18.8%	Water Content (%)	19.3% 18.7%
AVERAGE VALUES		AVERAGE VALUES	
1	2	1	2
LL	41	LL	55
PL	18	PL	19
PI	23	PI	36
Natural MC (%)	12.7%	Natural MC (%)	25.0%
CLASSIFICATION		CLASSIFICATION	
CI		CH

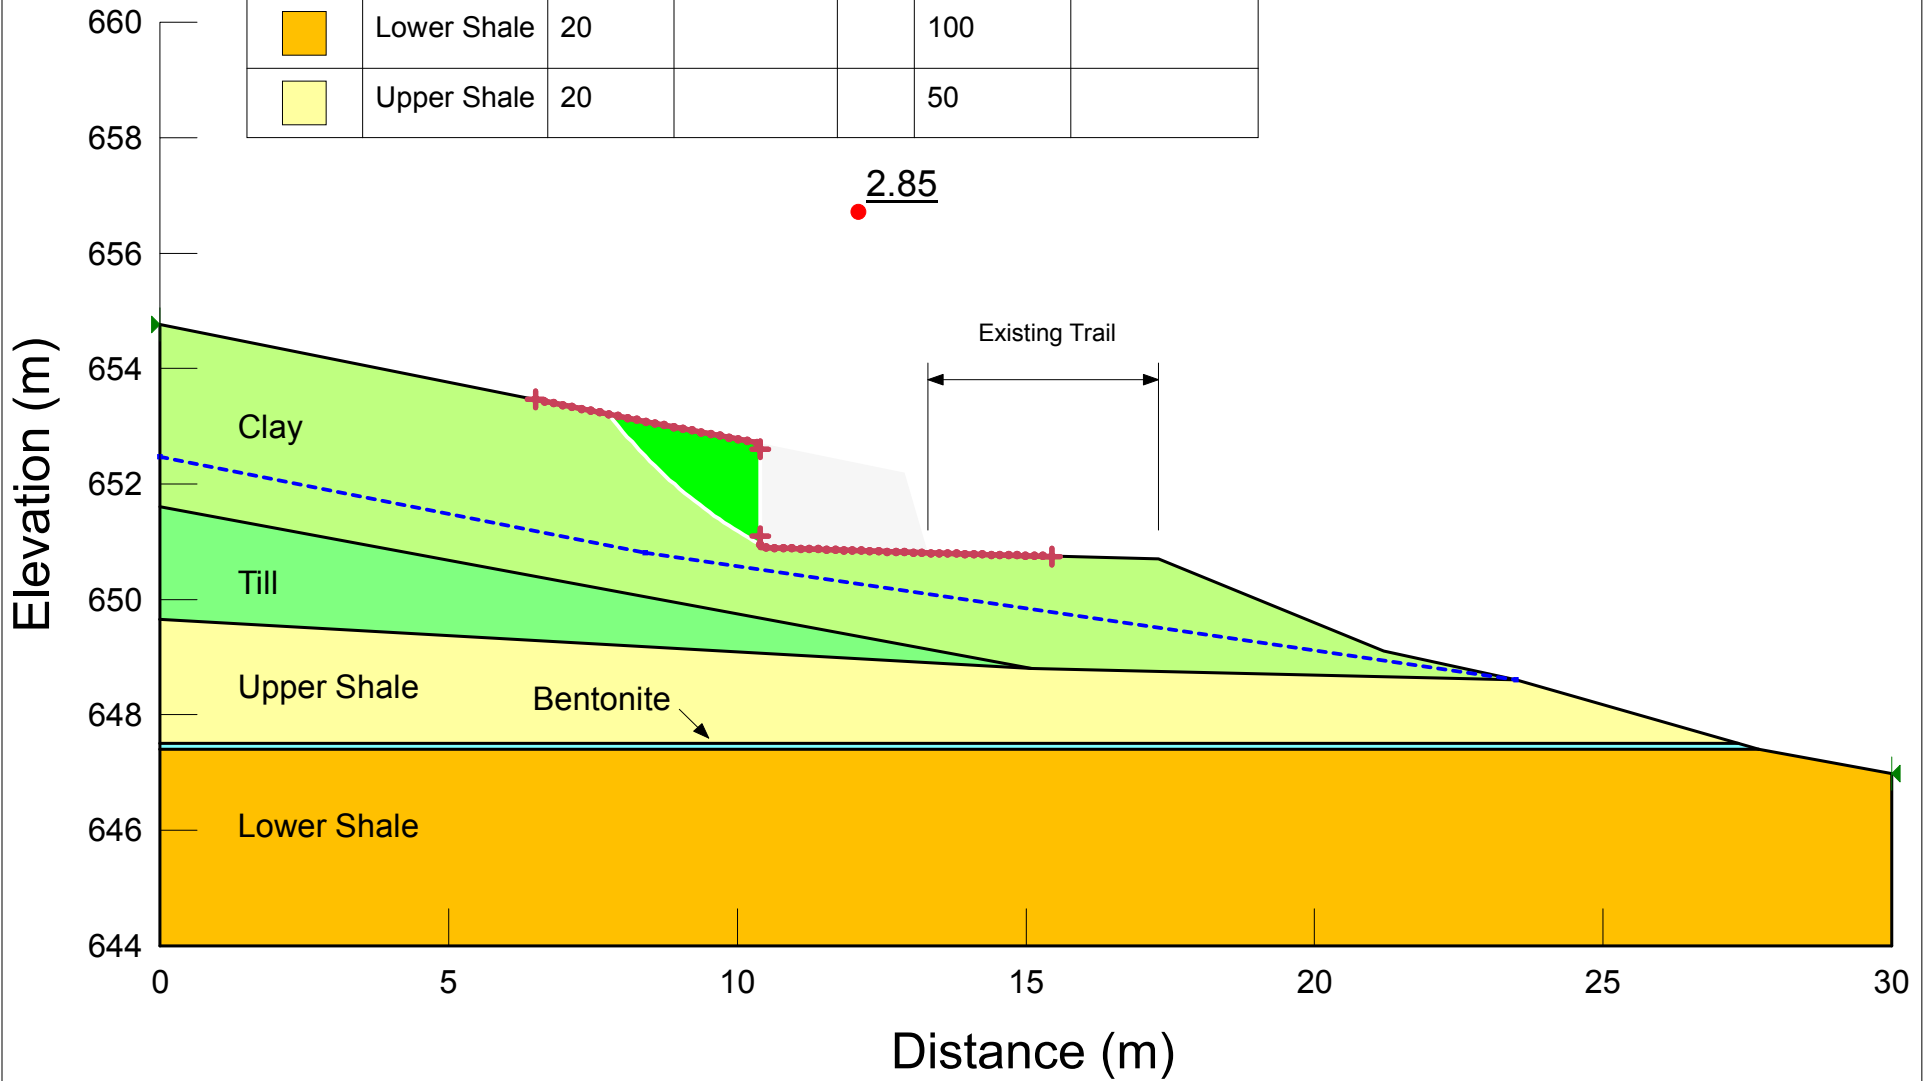
Figure G.7
 Cross-Section A
 Option 1: Short Radius
 Vertical Cut Slope

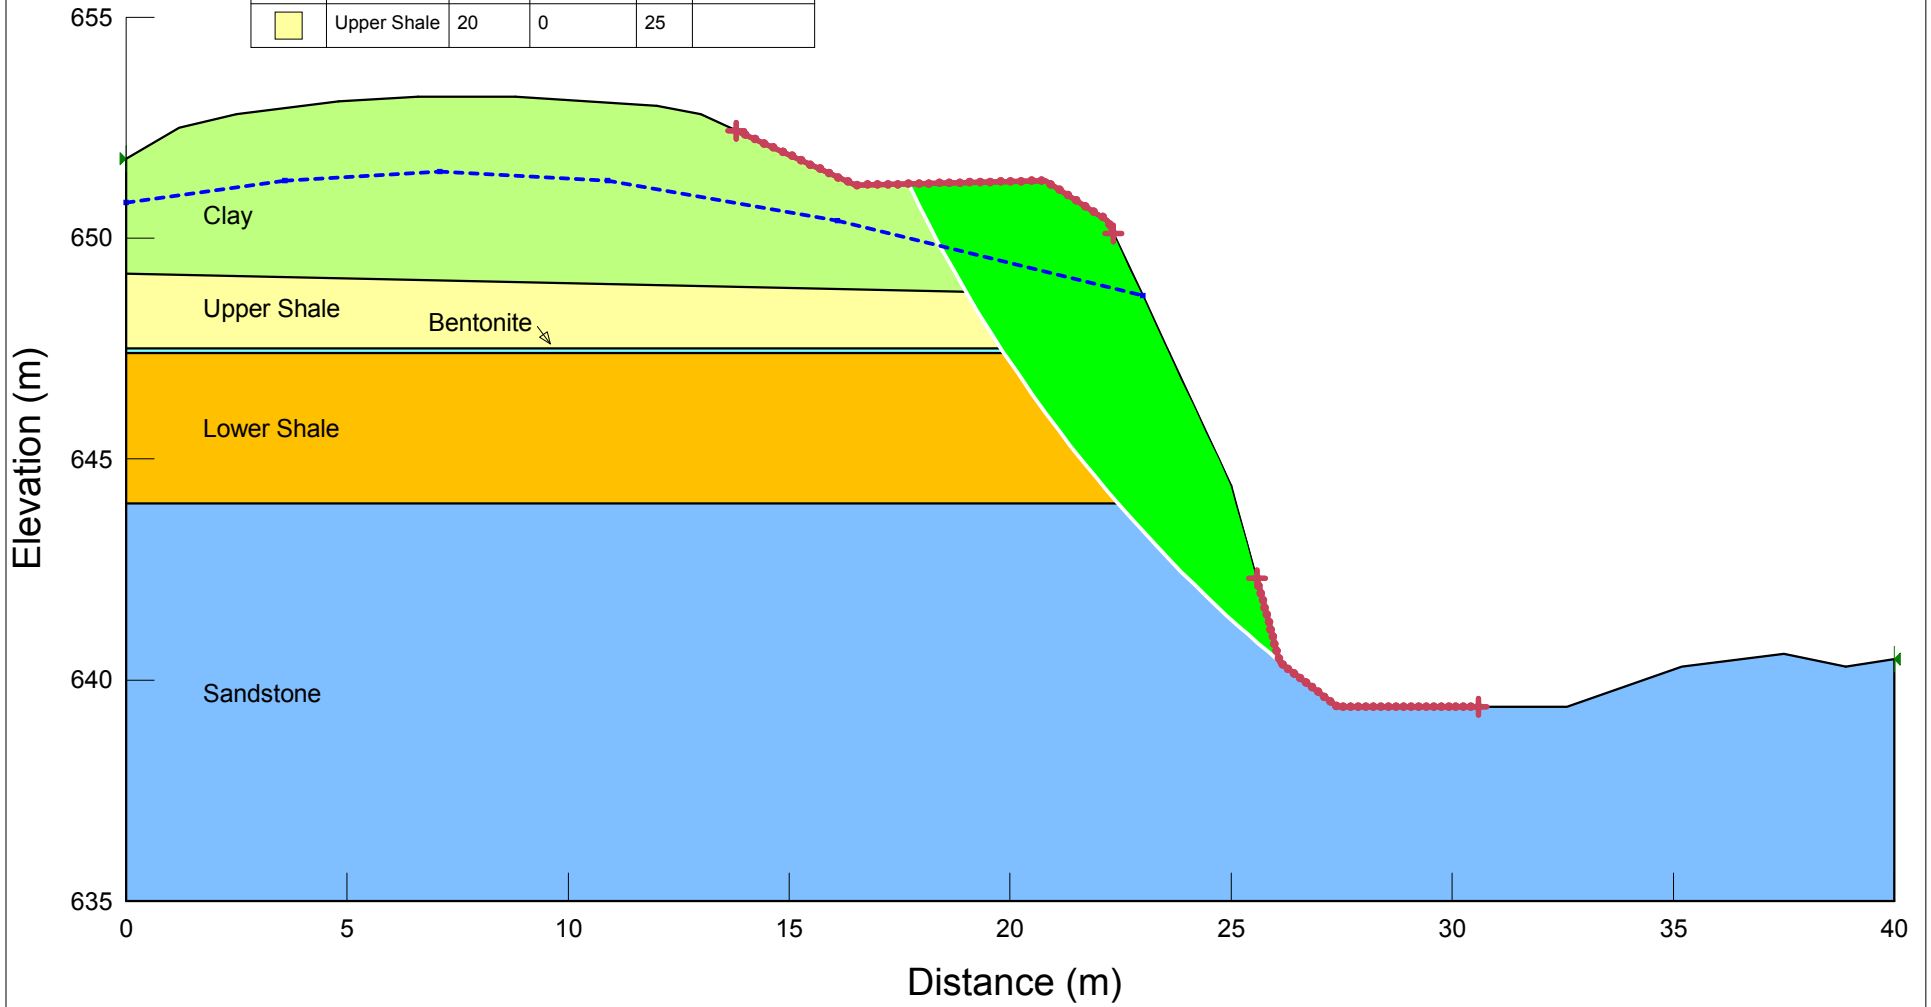
Color	Name	Unit Weight (kN/m ³)	Cohesion' (kPa)	Phi' (°)	Piezometric Line
■	Bentonite	18	0	14	
■	Clay	19	0	20	1
■	Lower Shale	20	50	25	
■	Sandstone	21	20	35	
■	Upper Shale	20	0	25

Figure G.11
Cross-Section B
Existing Geometry
Steep Bank
