Valley Line West LRT Crossing Assessment Summary of Results - 87 Avenue and 178 Street

87 Avenue and 178 Street Intersection

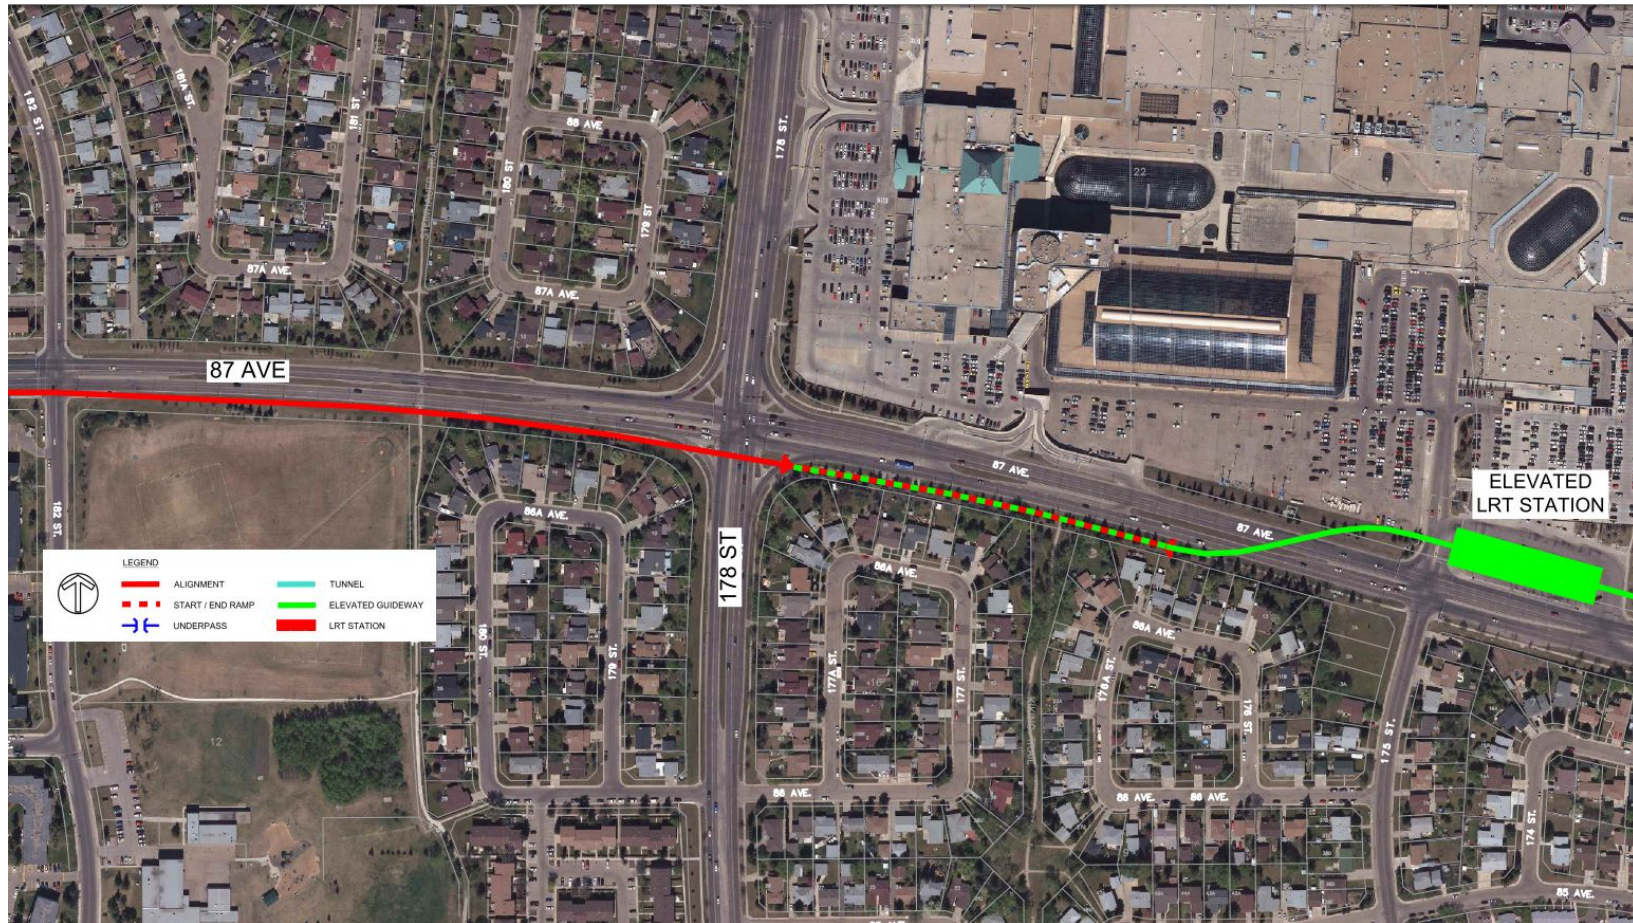
At-Grade LRT, South Alignment

Various design options were considered. The three options that performed the best against the assessment criteria are: 1) elevated LRT guideway crossing over 178 Street along the south side of 87 Avenue, 2) elevated LRT guideway crossing over 178 Street along a median alignment of 87 Avenue, and 3) at-grade LRT crossing of 178 Street along the south side of 87 Avenue. Options 1 and 2 deviate from the approved LRT concept plan.

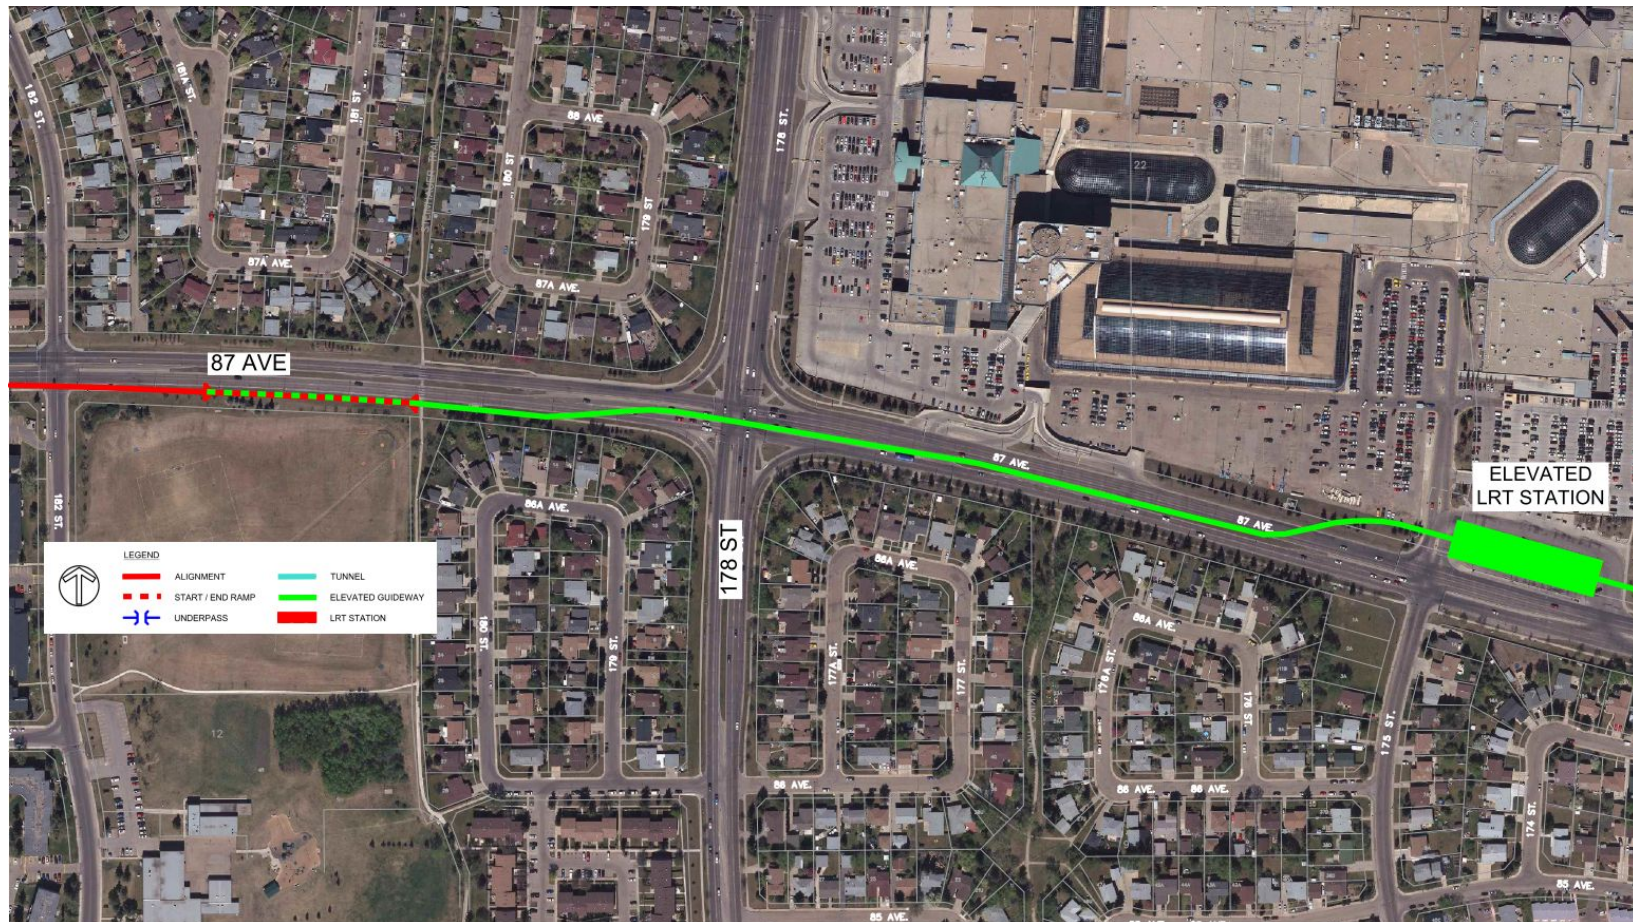
Elevated LRT Guideway, Median Alignment

Based on the LRT crossing assessment, the elevated LRT guideway along the median alignment performed marginally better than the elevated LRT guideway along the south alignment. The two elevated guideway options performed well in the categories of accessibility, network operations and urban design and social environment. The median alignment option performed better in the urban design and social environment category for the greater distance between elevated guideway structure and the adjacent south side residents. The south alignment option performed incrementally better in the accessibility category due to no impact to adjacent commercial accesses, more consistent roadway geometry and better sightlines along the 87 Avenue roadway. The south alignment option also performed incrementally better in the network operations category as the crossing of the 87 Avenue at one location, instead of two, is more efficient for LRT operation.

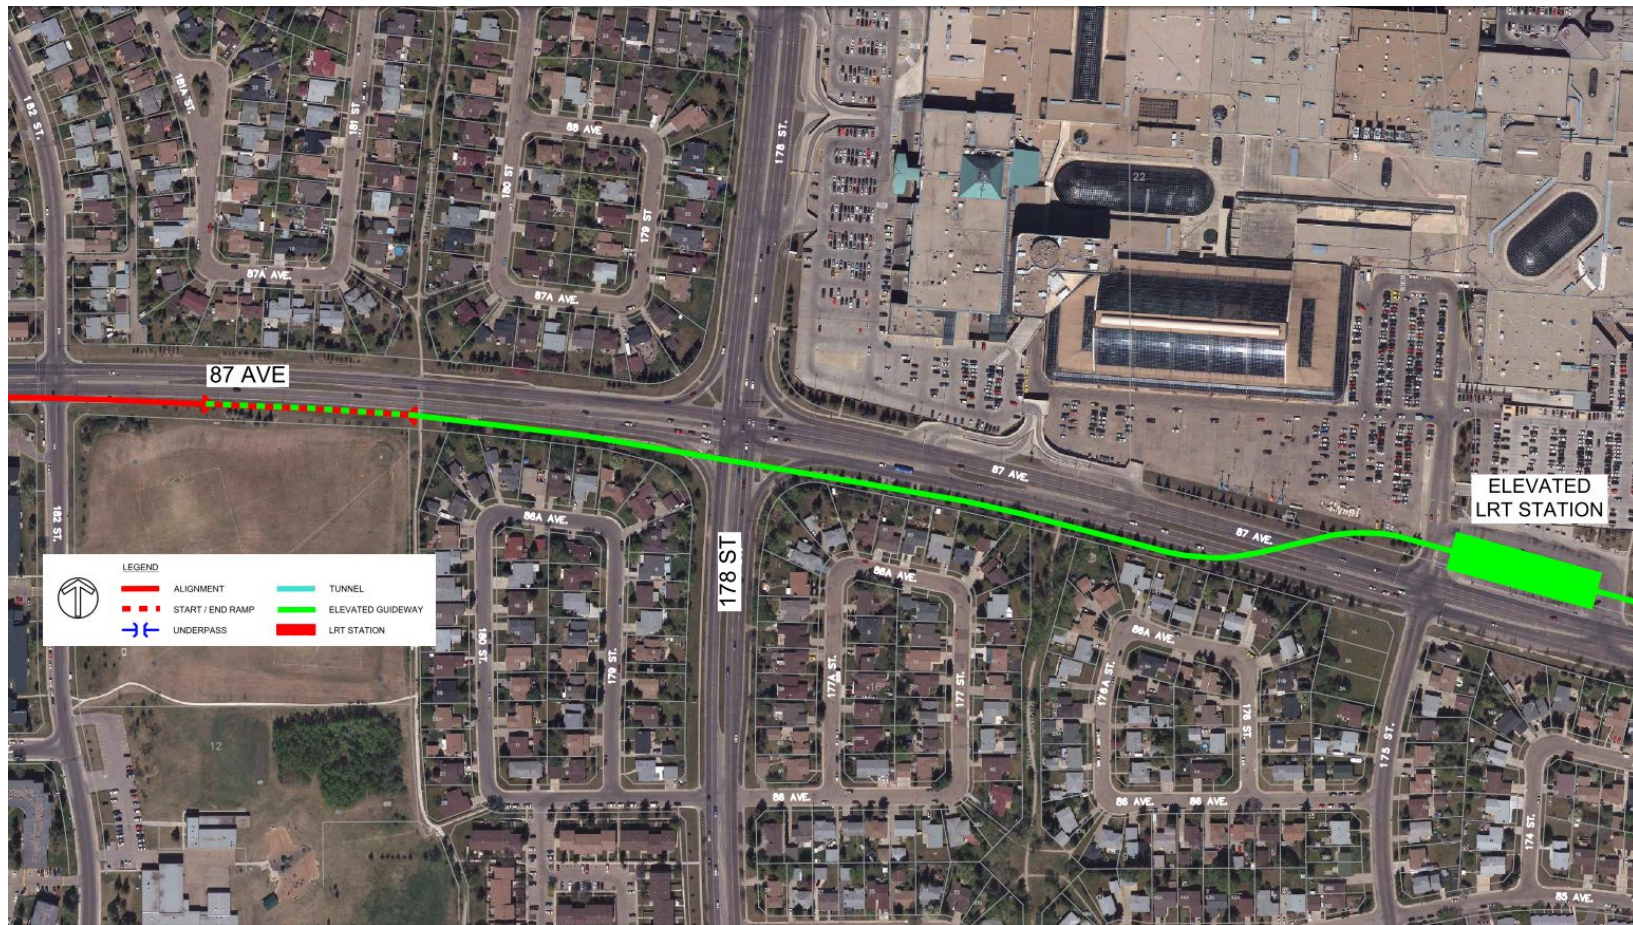
Elevated LRT Guideway, South Alignment

Based on these considerations, the elevated LRT guideway along the south alignment is recommended. The LRT would continue westbound on an elevated guideway from the West Edmonton Mall Station, transitioning to the south side of 87 Avenue and crossing over 178 Street before descending to grade level east of 182 Street.
